Standing Rock Sioux Tribe

Pavement Management Plan

May 2017

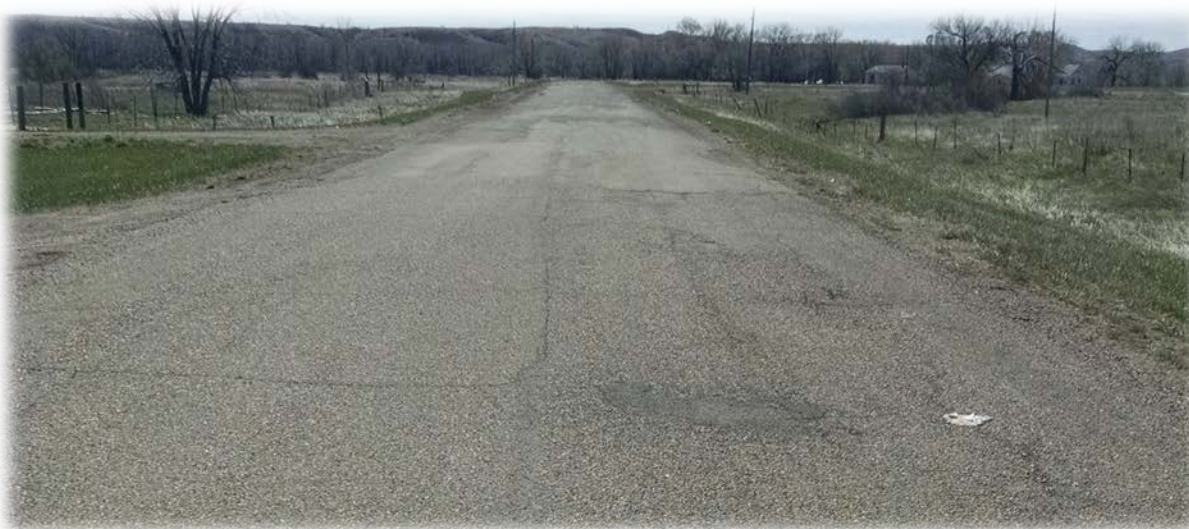
Photo of a PASER Rating 4 Road on the Standing Rock Reservation

Poor. Heavy cracking and rutting with moderate visible potholes. Heavy patching with some patches on old patches. Limited striping. Shoulders are deteriorated. Cracks are not sealed. You cannot drive this entire road at the posted speed limit. Drivers need to slow down in areas. Example: BIA Route 3400, south from Little Eagle, SD.

Due to significant signs of aging, a structural overlay is required (greater than 2").

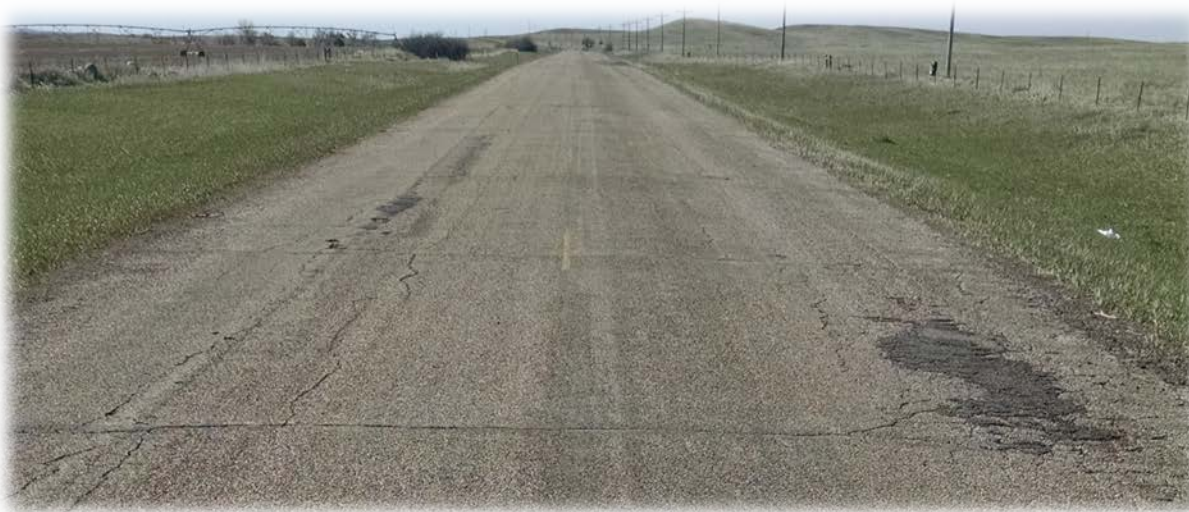
Photo of a PASER Rating 5 Road on the Standing Rock Reservation

Fair. Moderate to heavy cracking with moderate rutting. Moderate patching with some patches on old patches. Limited striping. Cracks are mostly not sealed. You can still drive this road at the posted speed limit. Example: BIA Route 1, south of Cannon Ball, ND.

Primarily consists of aging asphalt, but with sound structural conditions. The roadway can benefit from patching where necessary, followed by a non-structural overlay (less than 2”).

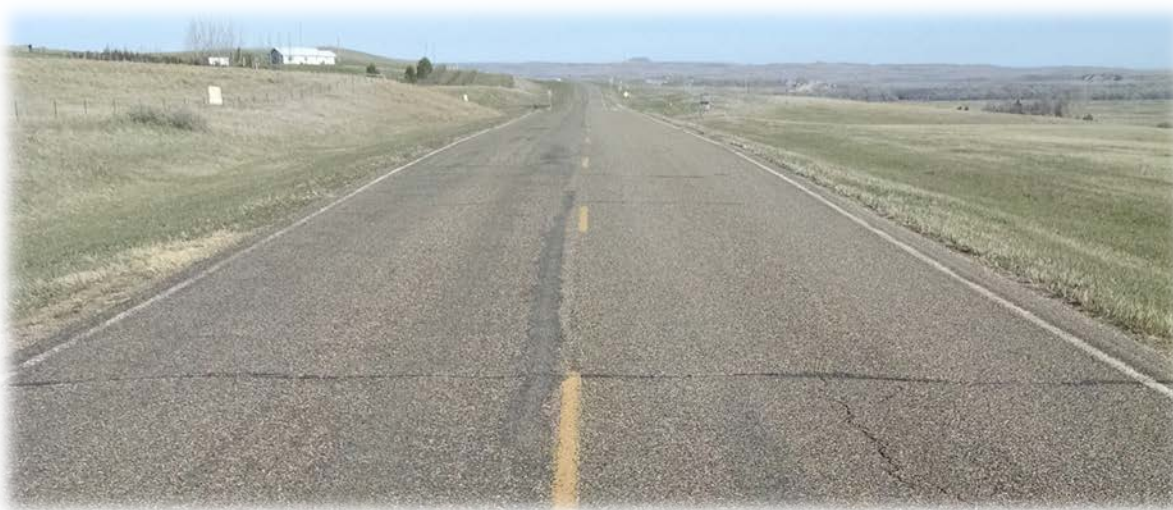
Photo of a PASER Rating 6 Road on the Standing Rock Reservation

Fair. Moderate to heavy cracking or some raveling and rutting exists. Moderate polishing with occasional patches visible. Cracks are mostly sealed. Example: BIA Route 7 near Porcupine, ND.

Light signs of aging. The roadway life can be extended with routine crack sealing and a sealcoat.

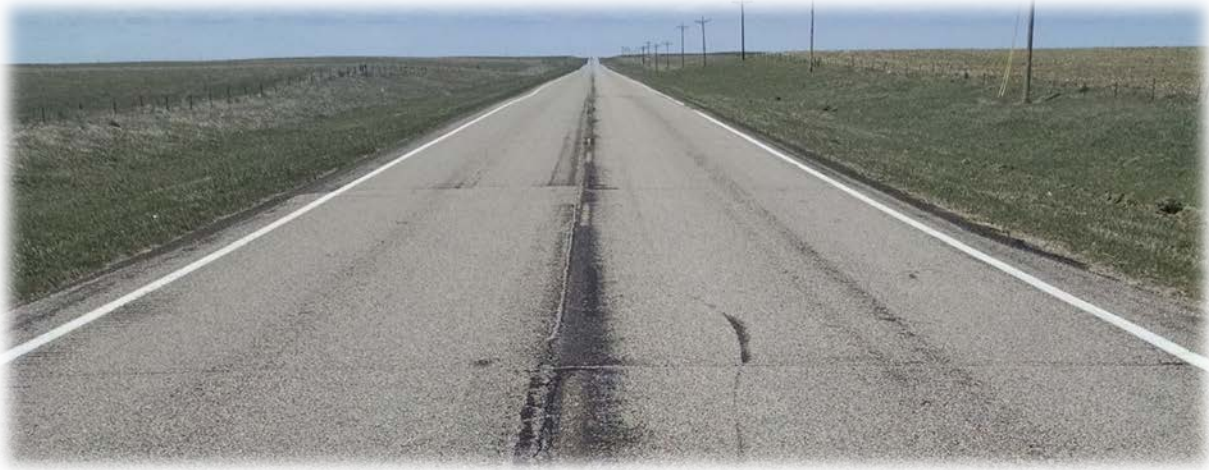
Photo of a PASER Rating 7 Road on the Standing Rock Reservation

Good. Some cracking, no raveling and little rutting. No patches are visible. Cracks are sealed. This roadway is not in need of immediate repair. Example: BIA Route 20, near Bullhead, SD.

Roadway shows very few signs of aging and can be maintained with routine crack filling.

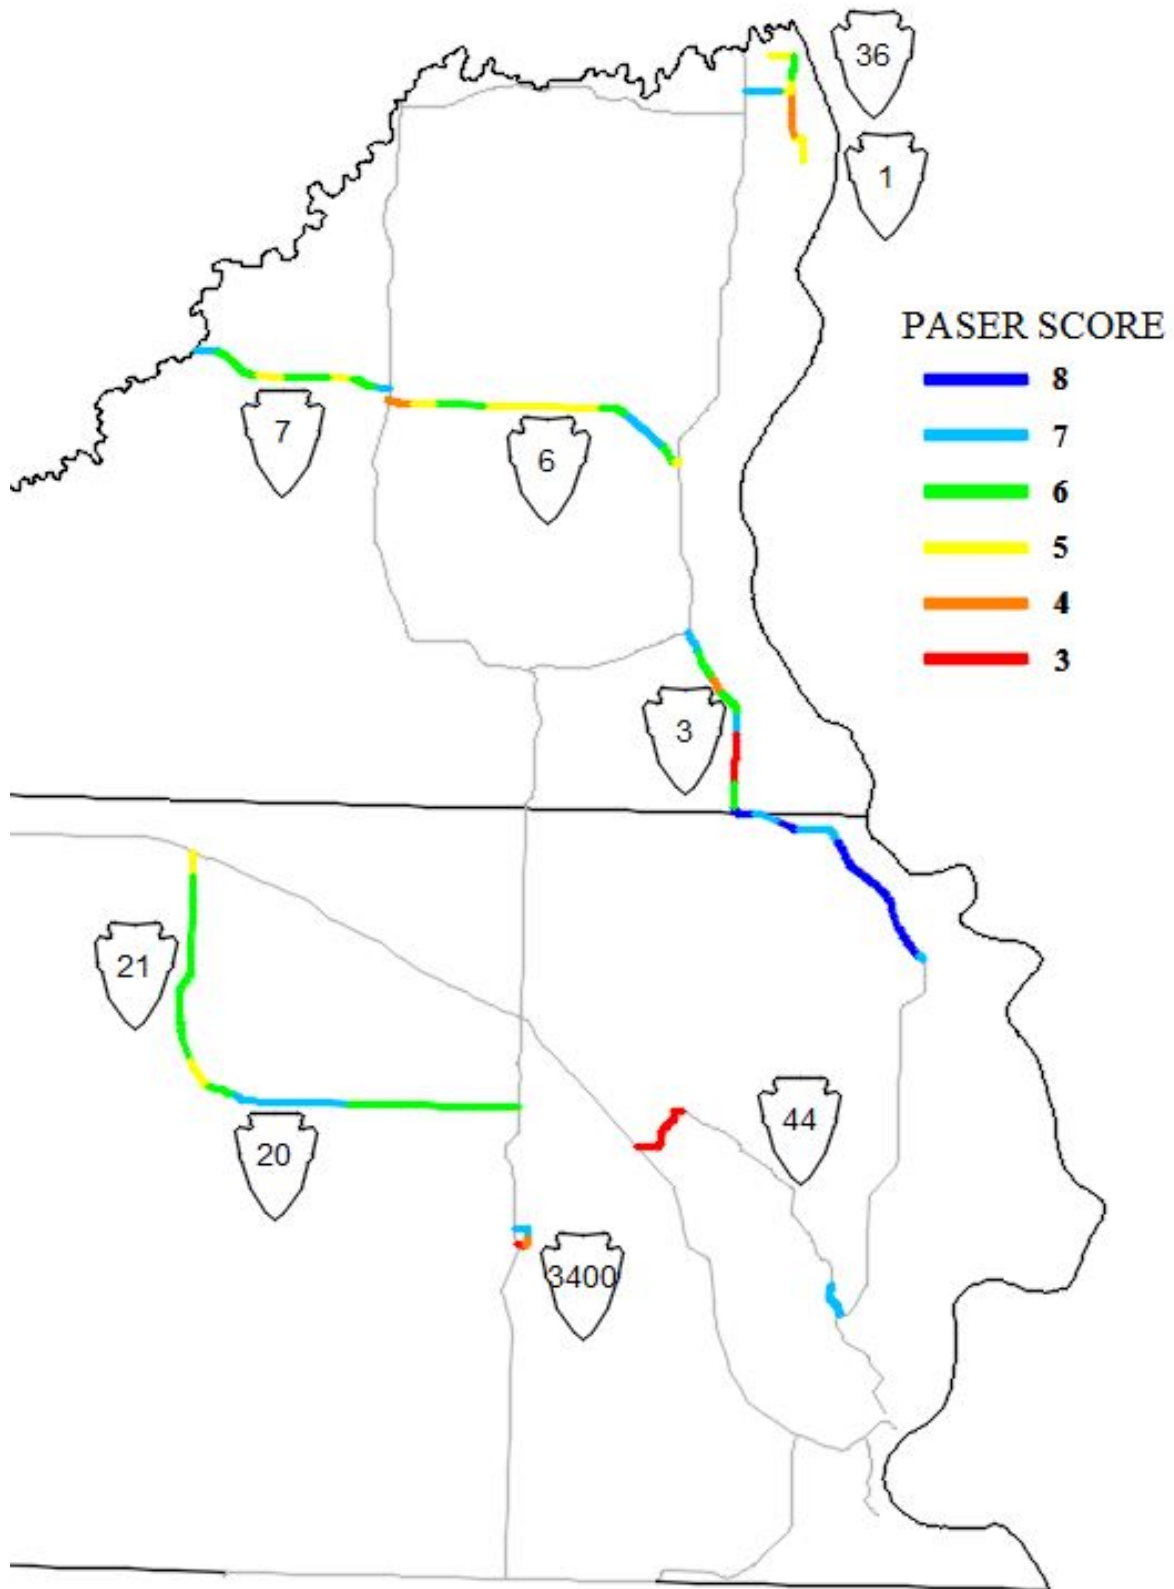
Figure 3 – Existing Pavement Conditions (2017)

Every one-mile segment of highway was given a PASER score and the results were mapped. Figure 3 is a map that displays the PASER ratings in a color coded system. Blue being the highest values or best conditions going down through the rainbow with red and black being the lowest values or worst conditions found in the study area. Figure 3 is also attached as an 11"x17" as Exhibit 3 at the end of this report.

Approximately 83 miles of tribal/BIA roadway were assigned PASER ratings throughout the course of the study. The average (mean) rating for the studied roadways was 5.99. That number may not signify much, but it does indicate that the Standing Rock highways scored tend to be in fair to good condition. In fact, if a rating of five is to be considered the minimum acceptable pavement condition, (able to drive at posted speed limit) then 86% of scored roads meet that standard today. This is visualized in the Figure 3 as it indicates there are more miles of orange, green, and blue than there are of red and black. There were 4 miles of roads rated an eight or nine. These miles in great or excellent condition were short intermittent segments along the southern half of BIA 3 near Kenel, SD.
