Bridge Inspection Report for Minnehaha County South Dakota **2022**

Structure No. 50-216-015 Jasper Street / Co. Hwy 104

Dell Rapids Township

10/28/22

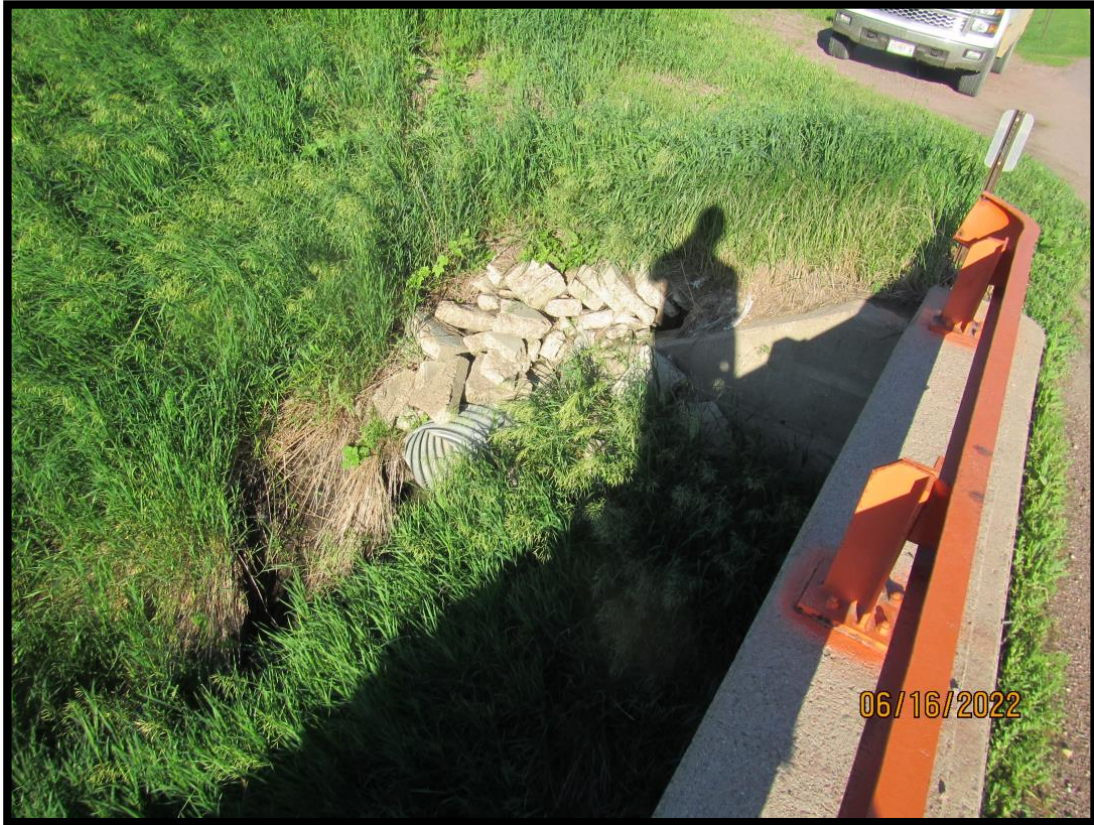
50-216-015_2022_5_CDI_CMP Culvert Outlet at SW Corner of Structure

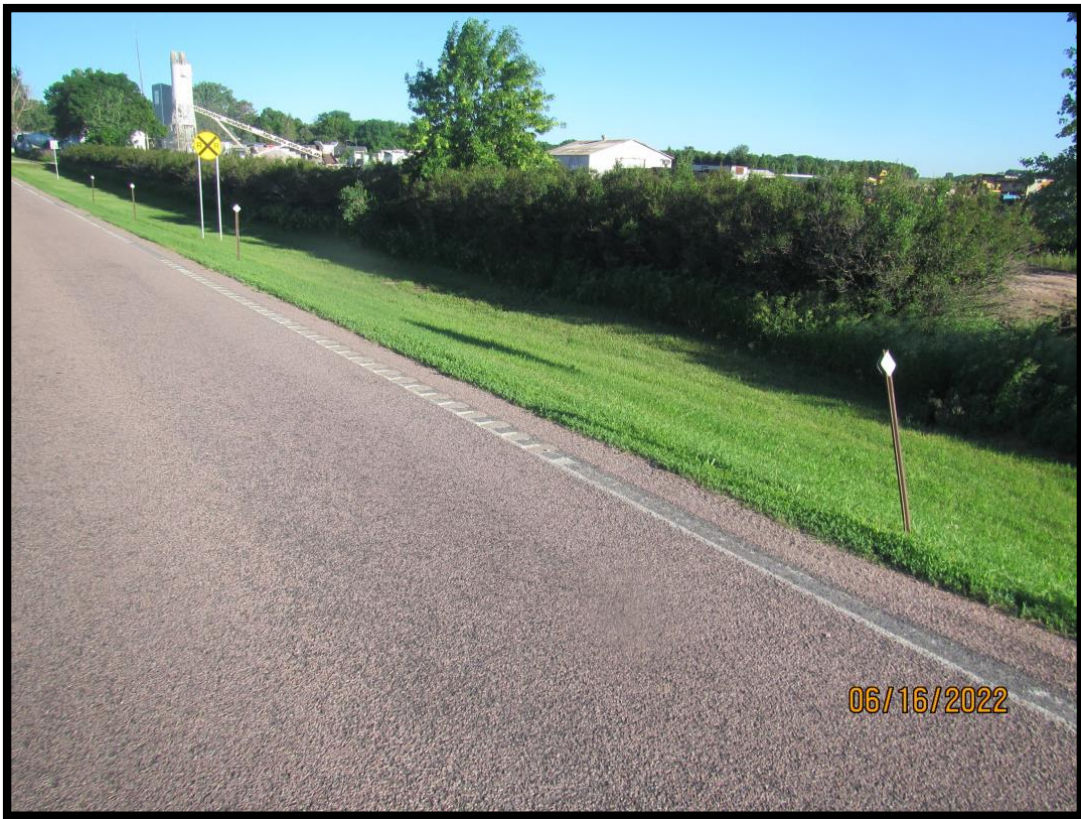
50-216-015_2022_7_CDI_1st NW Approach Delineator Slightly Bent

1. Install bridge railing rubrails and approach guardrails as required.
2. Install NE object marker that is damaged and lying on ground.
3. Straighten the 1st delineator along the NW approach.
4. Clean and repair/patch areas of scaling, spalling, and exposed rebar on the underside of the concrete slab.
5. Clean and repair/patch areas of deterioration and honeycombing at the center columns in the east & west bents.
6. Patch hole in slab along south side of original slab in west span.
7. Monitor underside of concrete slab for continued deterioration.
8. **Structure is currently in the 5-year capital improvement plan & scheduled for future replacement.**

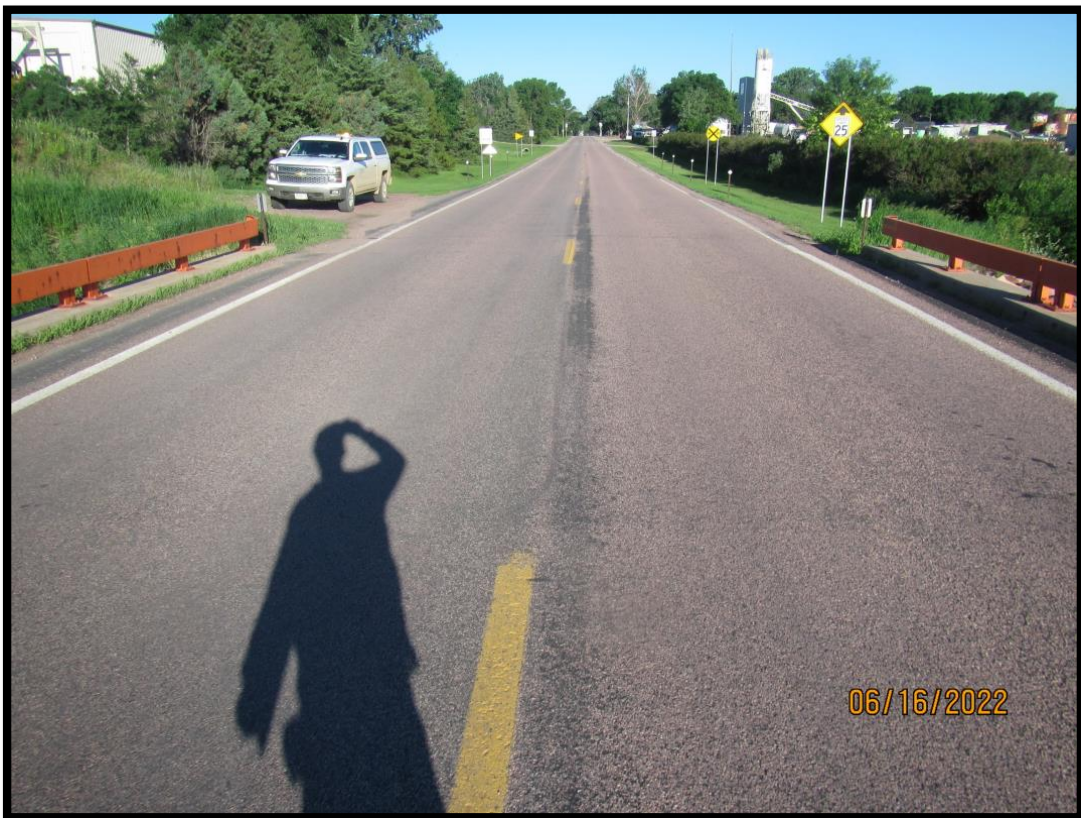
Bituminous - Approximate 6-inch average depth, smooth. Light vegetation growth is evident along edges of overlay.
3. JOINTS - OPENINGS - None
4. DRAINS - None
5. CURBS AND MEDIAN - Cast-in-place concrete - Some vertical hairline cracks and areas of light scaling and rust staining are evident throughout. Overall, the concrete curbs appear to be in relatively good condition.
6. SIDEWALKS - None
7. RAILING OR BARRIER - The railings consist of a painted steel channel mounted on painted double steel angle posts. The paint on the railing members appears to be in fair to good condition with some areas of surface rust evident.
8. LIGHTING - None
9. UTILITIES - None
10. DECK DELAMINATION SURVEY - Unable to perform a deck delamination survey due to the bituminous overlay.

50-216-015_2022_8_CDI_Top of Bituminous Overlay looking West

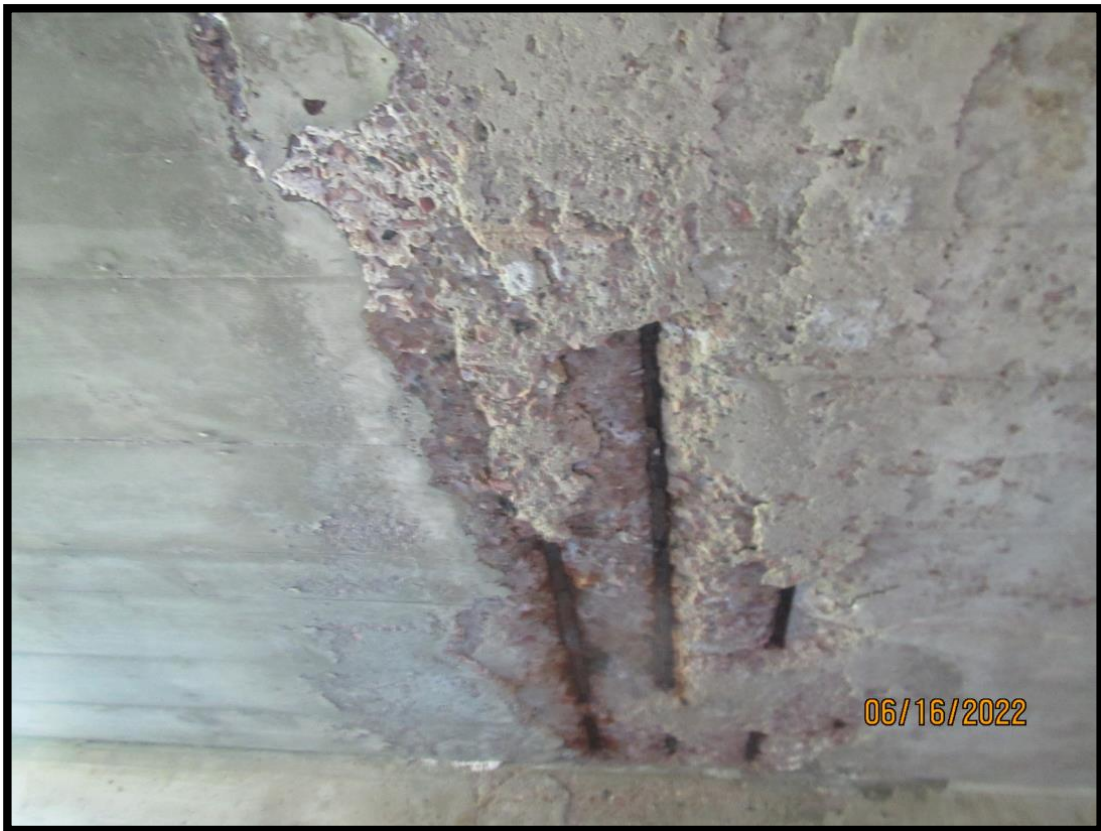
| 1. UNDERSIDE OF DECK - | Cast-in-place concrete - The original structure appears to have been widened approximately 7 ft along both sides. A significant amount of spalling is evident along the south side of the original slab in all spans and along north side of original slab in east span which have exposed reinforcing steel. The exposed portions of the reinforcing steel are heavily rusted with plating evident and moderate section loss, but does not appear to be affecting structure capacity at the time of inspection. Stalactites are evident along south side of original slab at the west and center spans. There are longitudinal hairline cracks and areas of light scaling evident throughout the original portion of the slab with a couple areas of efflorescence evident. Areas of light scaling are also evident on the underside of the widening portions of the concrete slab. There is an approximate 3"x5"x10" deep hole in the south side of the original slab in the west span which appears to extend to the bottom of the bituminous overlay. |

50-216-015_2022_12_CDI_Underside of Existing Slab, South side of East Span

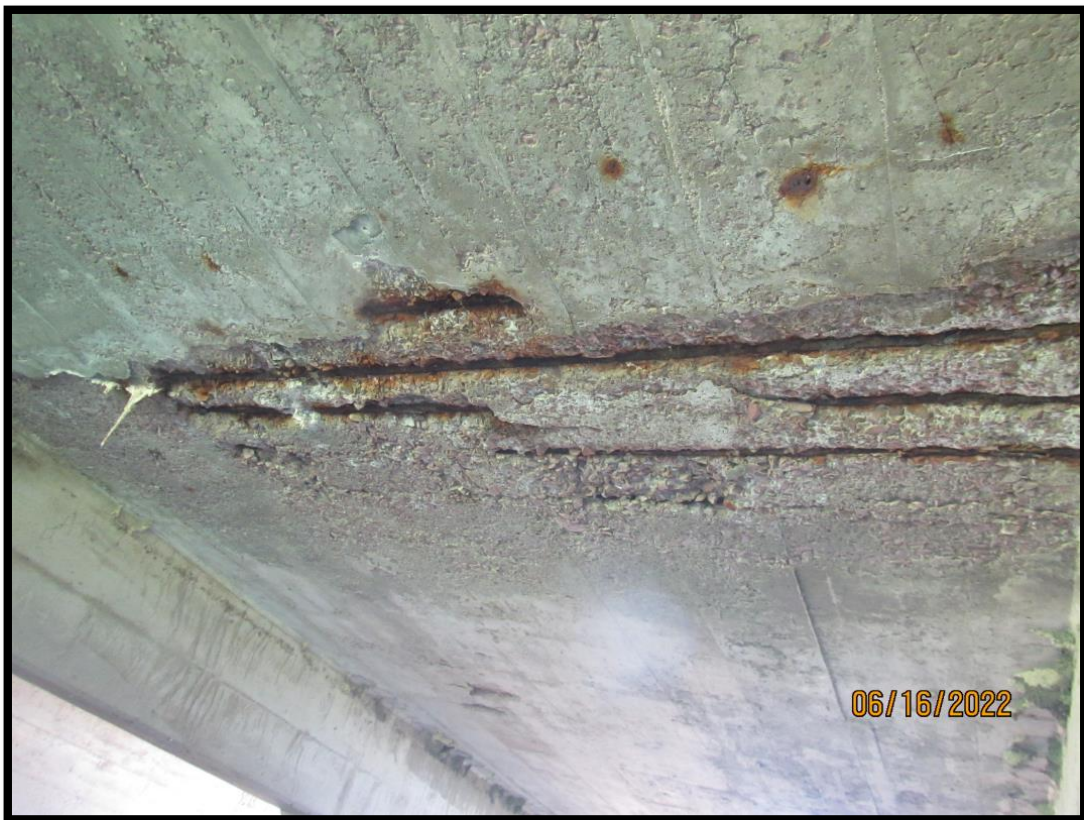
50-216-015_2022_14_CDI_Underside of Existing Slab, South side of Center Span

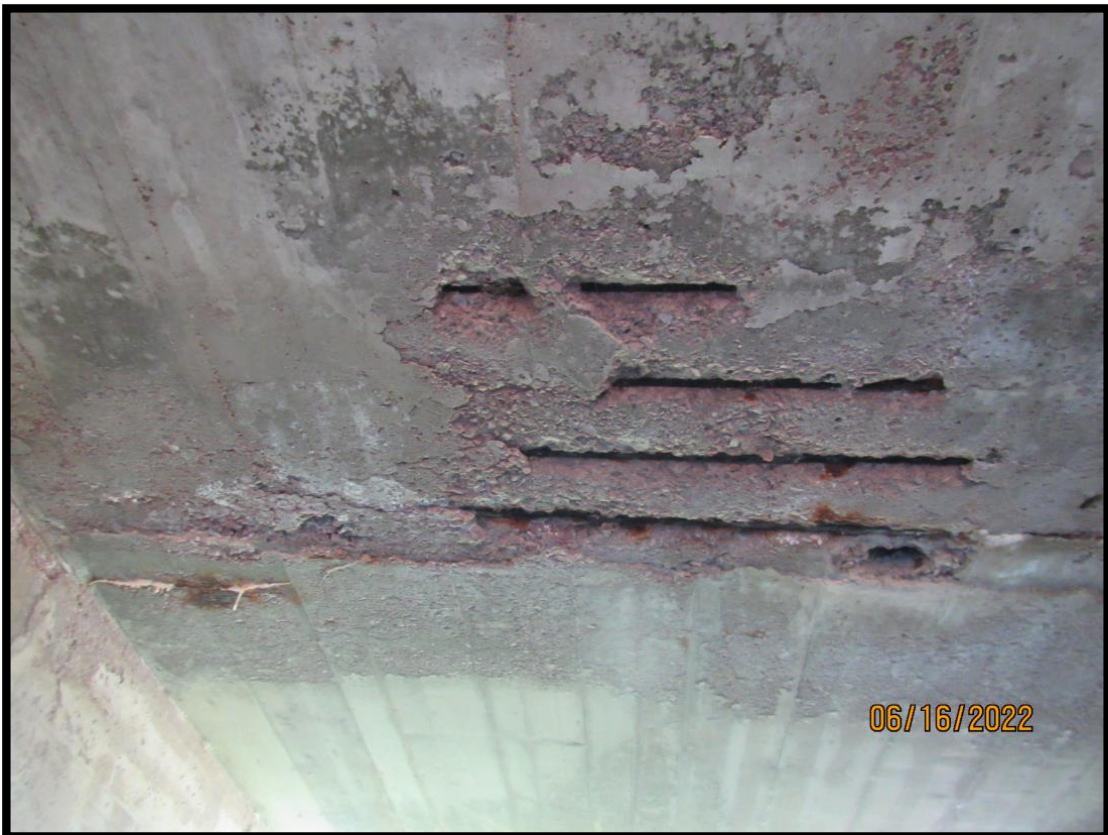
50-216-015_2022_16_CDI_Underside of Existing Slab, South side of West Span

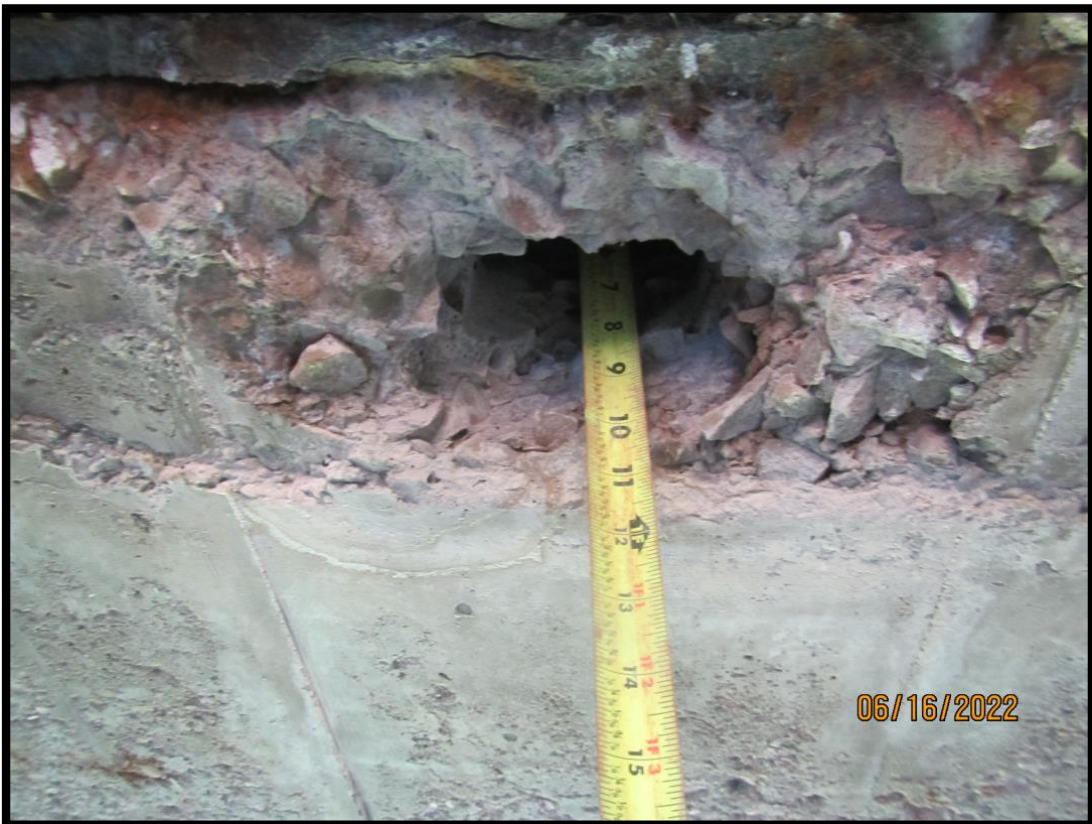
50-216-015_2022_18_CDI_Hole in underside of Slab, South side of West Span

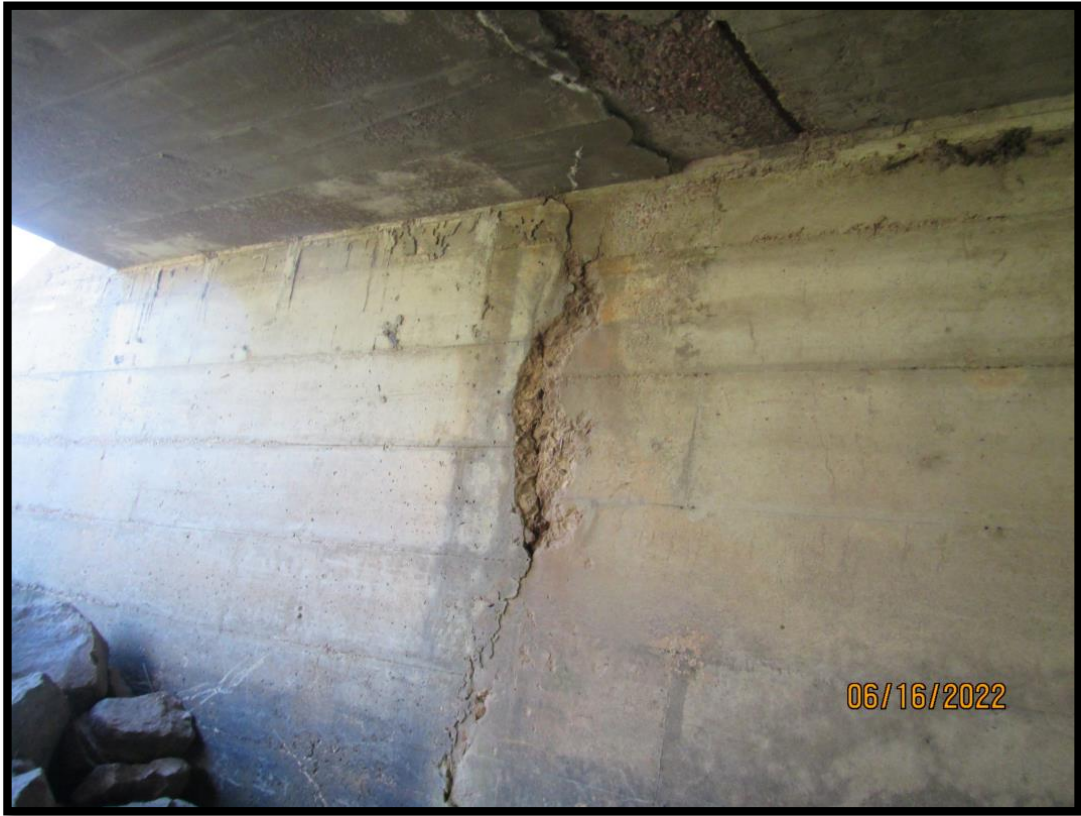
- B. BACKWALLS - The backwalls consist of cast-in-place concrete. Both ends of the original backwalls were extended when the structure was widened. There are some areas of honeycombing evident in the original portions of the backwalls. A spall is evident at the north end of the original portion of the east backwall. The widening portions of the backwalls appear to be in relatively good condition.

50-216-015_2022_21_CDI_NE Backwall Spall

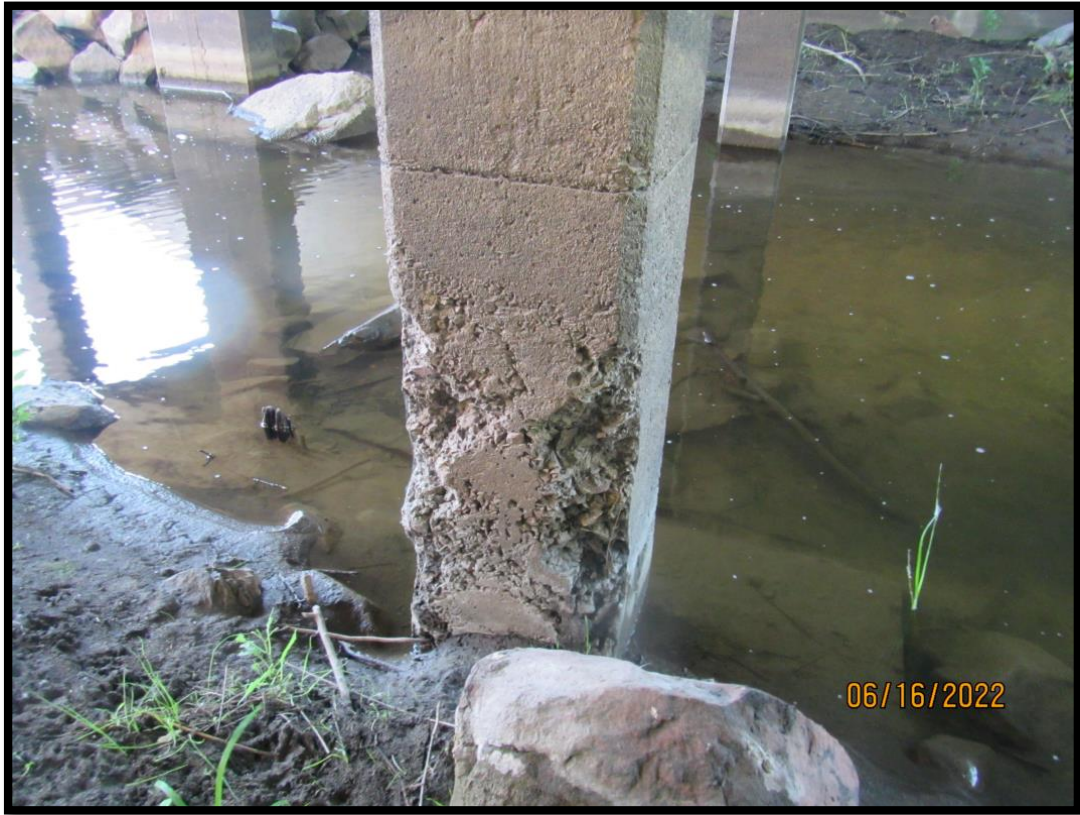
- B. COLUMNS - Cast-in-place concrete - There are five (5) concrete columns per bent (10 total columns). The original bents consisted of three (3) columns. The original end columns were added onto and an additional column was added at the ends of the bents when the structure was widened. A significant amount of deterioration and a lack of consolidation is evident towards the bottom of the center column in both bents.

50-216-015_2022_23_CDI_West Bent Center Column Honeycombing

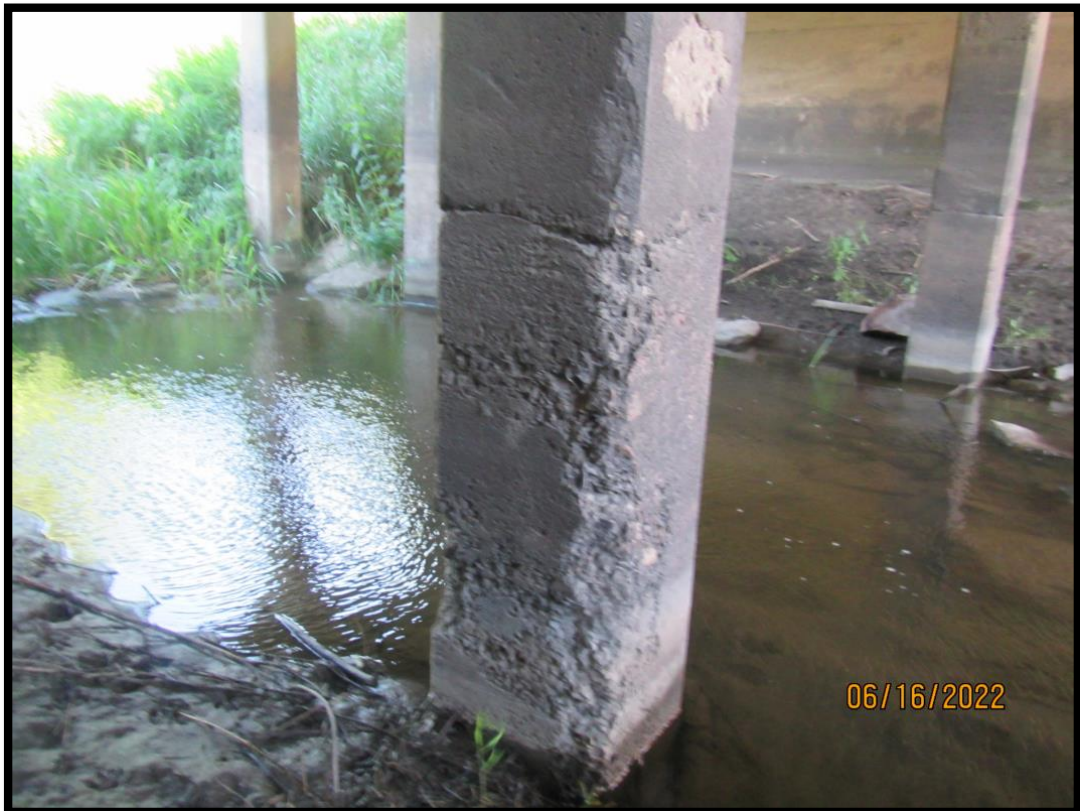
50-216-015_2022_24_CDI_East Bent Center Column Honeycombing

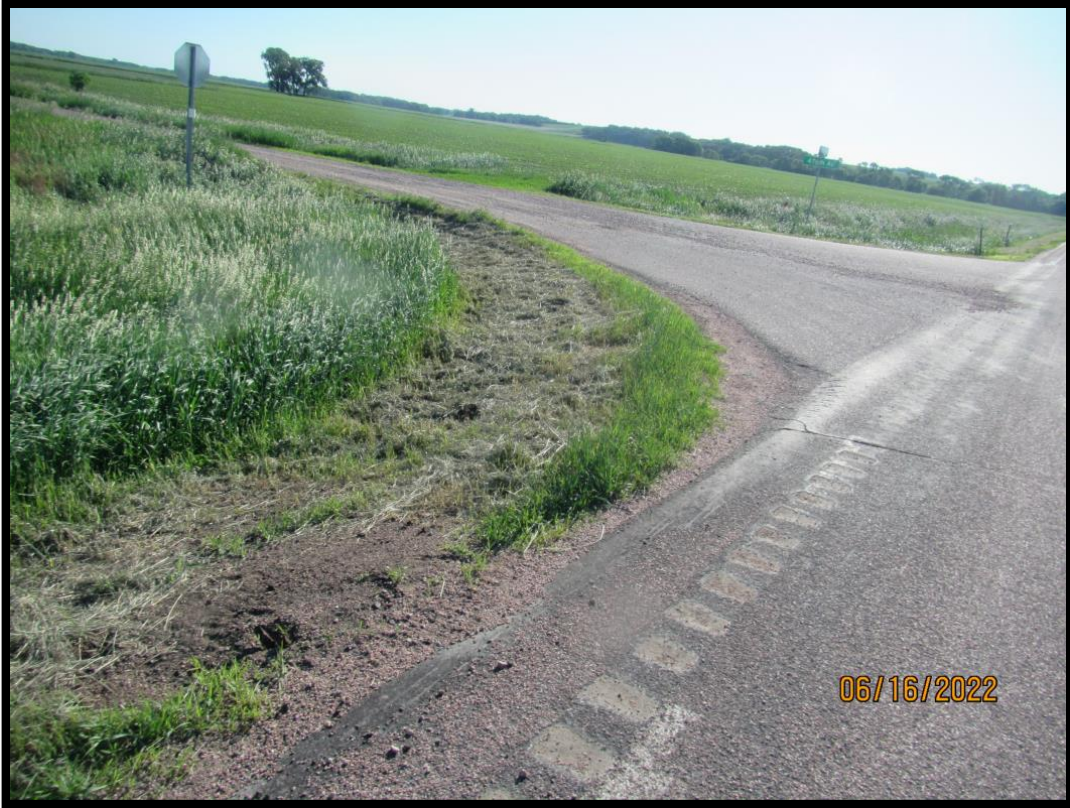
Delineators - There are four (4) delineators located off the NW, SW, and SE corners and two (2) delineators located off the NE corner of the structure. The 2nd delineator along the NE approach was not installed due to a roadway intersection. The 1st NE delineator is missing. The 2nd SE delineator is bent downward.
8. GPS COORDINATES - Latitude: 43.82597 North Longitude: -96.68737 West

50-219-015_2022_5_CDI_1st NE Approach Delineator Missing

1. Install bridge railing rubrails and approach guardrails as required.
2. Install 1st NE and 2nd SE approach delineators that are damaged or missing.
3. Clear the deck drains as required.
4. Completely remove and replace the damaged section of the north concrete bridge railing as required.
5. Repair the scaling on the north column at the center bent.
6. Monitor cracking, efflorescence, and stalactites along edges of concrete slab.
7. **Structure is currently in the 5-year capital improvement plan & scheduled for future replacement.**

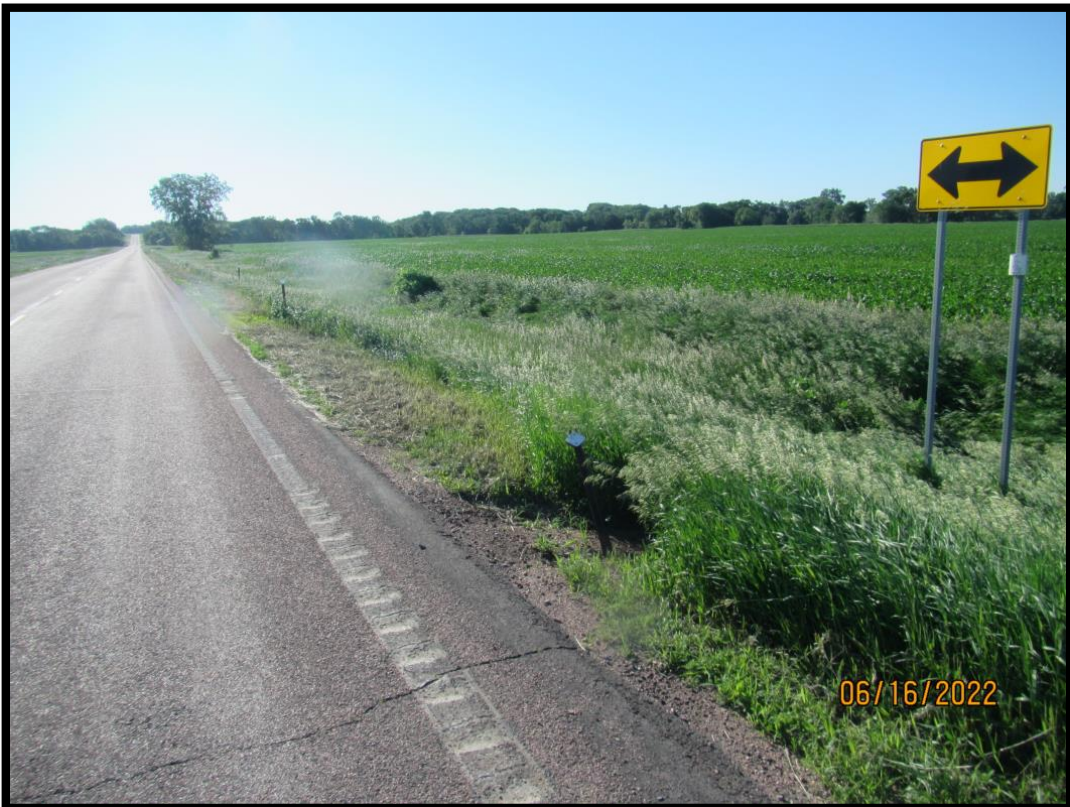
50-219-015_2022_6_CDI_2nd SE Approach Delineator Bent

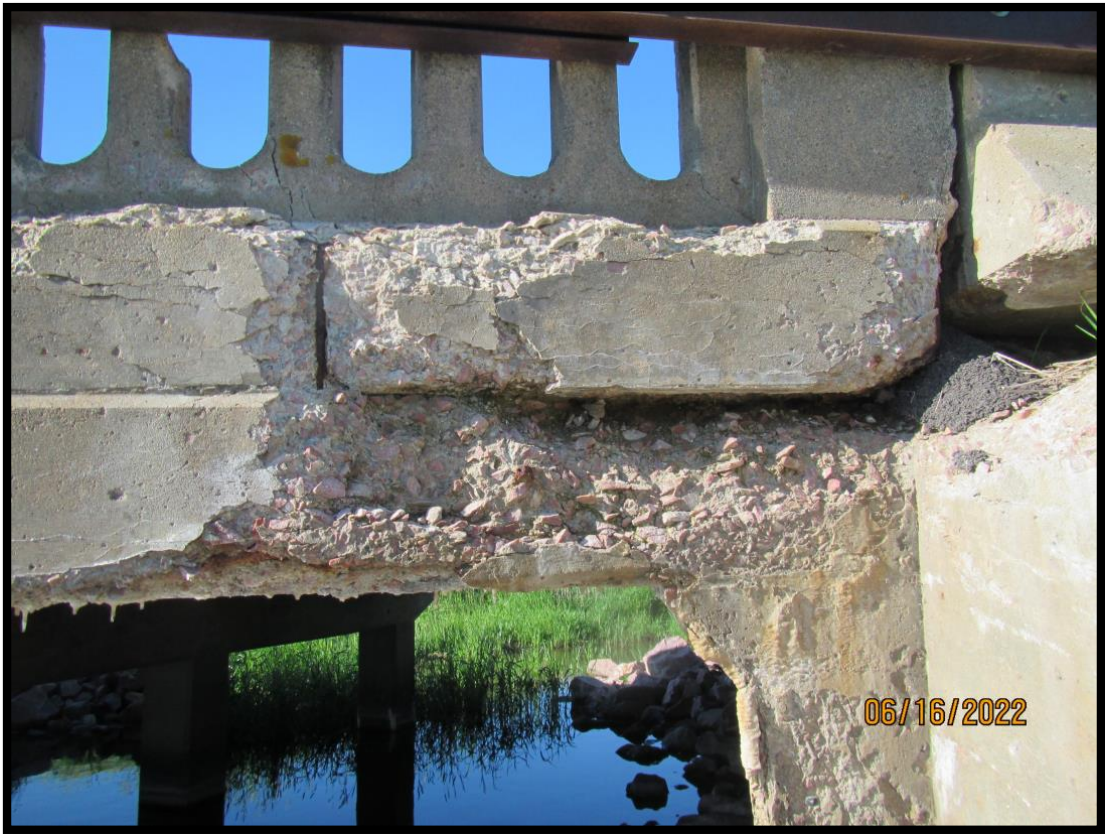
50-219-015_2022_9_CDI_NW Slab and Curb Edge Deterioration and Damage

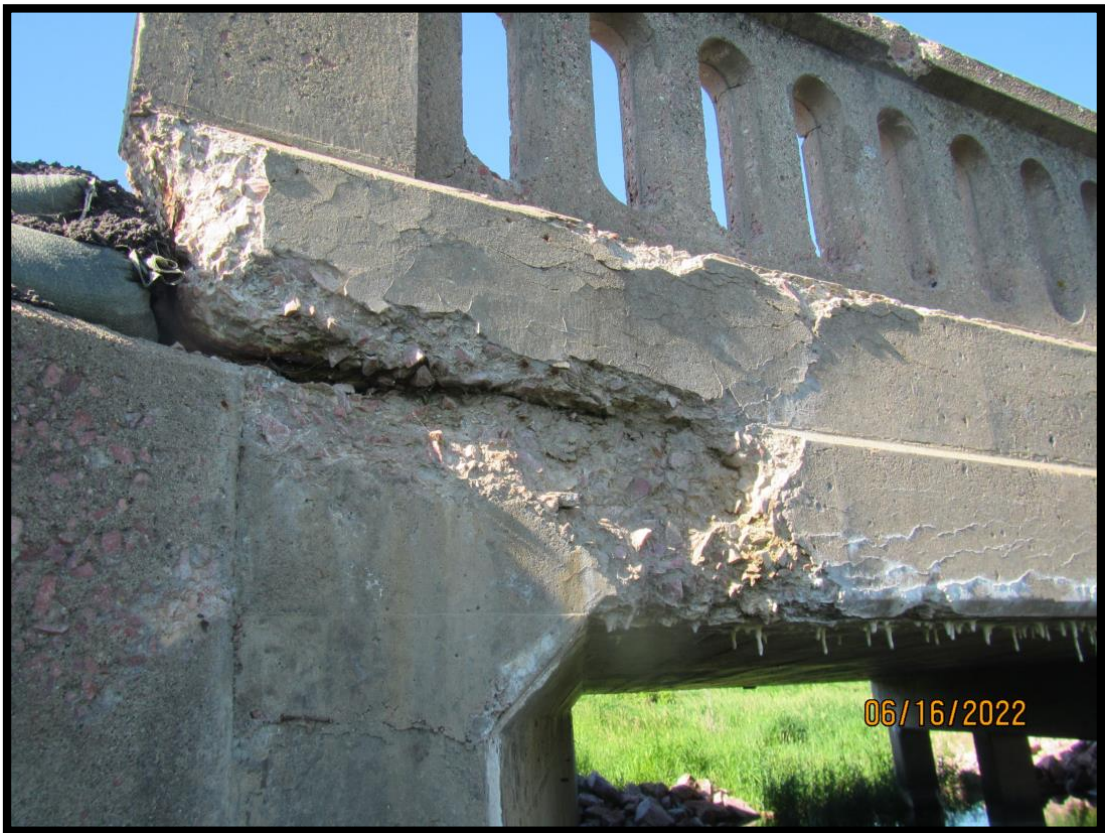
50-219-015_2022_10_CDI_NE Slab and Curb Edge Deterioration

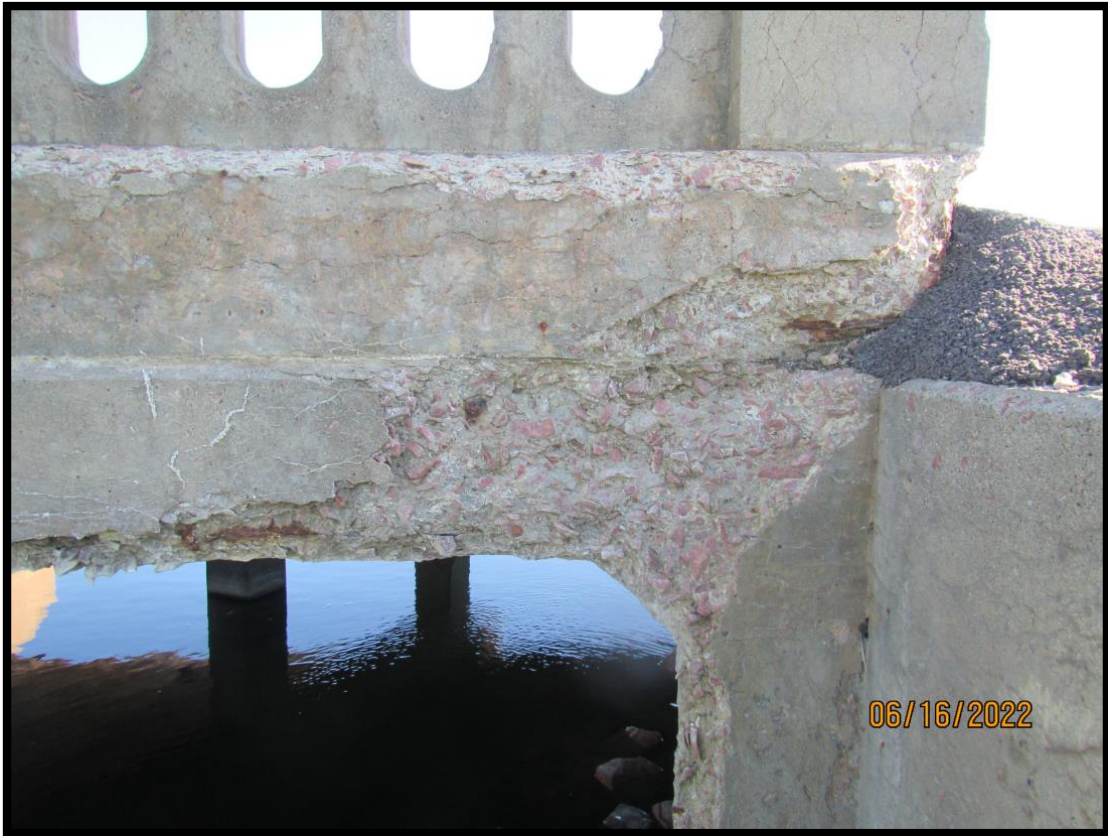
50-219-015_2022_11_CDI_SE Slab and Curb Edge Deterioration

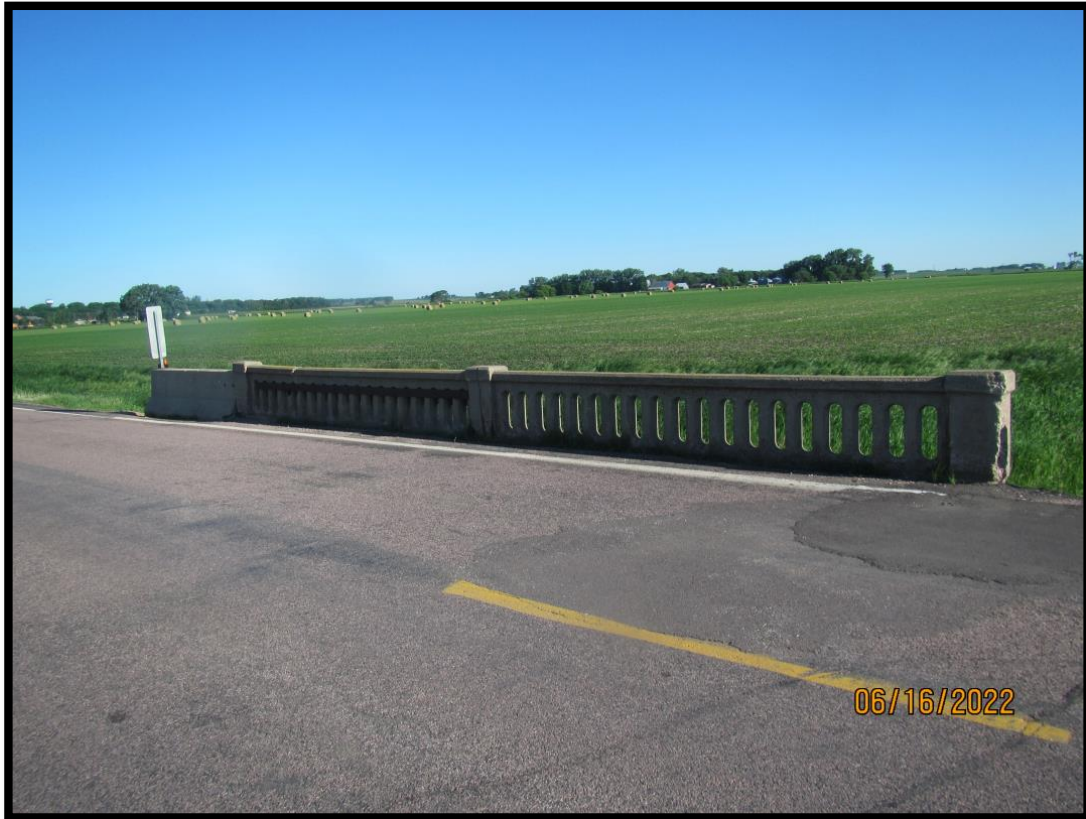
The railings consist of reinforced concrete pigeon hole railings. A moderate to significant amount of scaling is evident throughout with areas of exposed reinforcing steel. It appears a significant vehicle impact occurred at the west end of the north railing. The top concrete railing member, some of the spindles, and the concrete curb have been significantly damaged. A portable concrete barrier curb section has been placed off the west end of the north railing. Steel channels have been installed along the outside face of the railing and are anchored into the concrete barrier curb section. A steel plate has been installed along the inside face of the railing. The steel channels and steel plate are bolted together with bolts running through the pigeon holes. The concrete barrier curb section and steel channels do not provide a railing with the same amount of strength as the original concrete bridge railing before the vehicle impact, but they are providing additional strength to what is provided by the damaged concrete bridge railing. The damaged section of the north concrete bridge railing needs to be completely replaced.

50-219-015_2022_13_CDI_North Rail

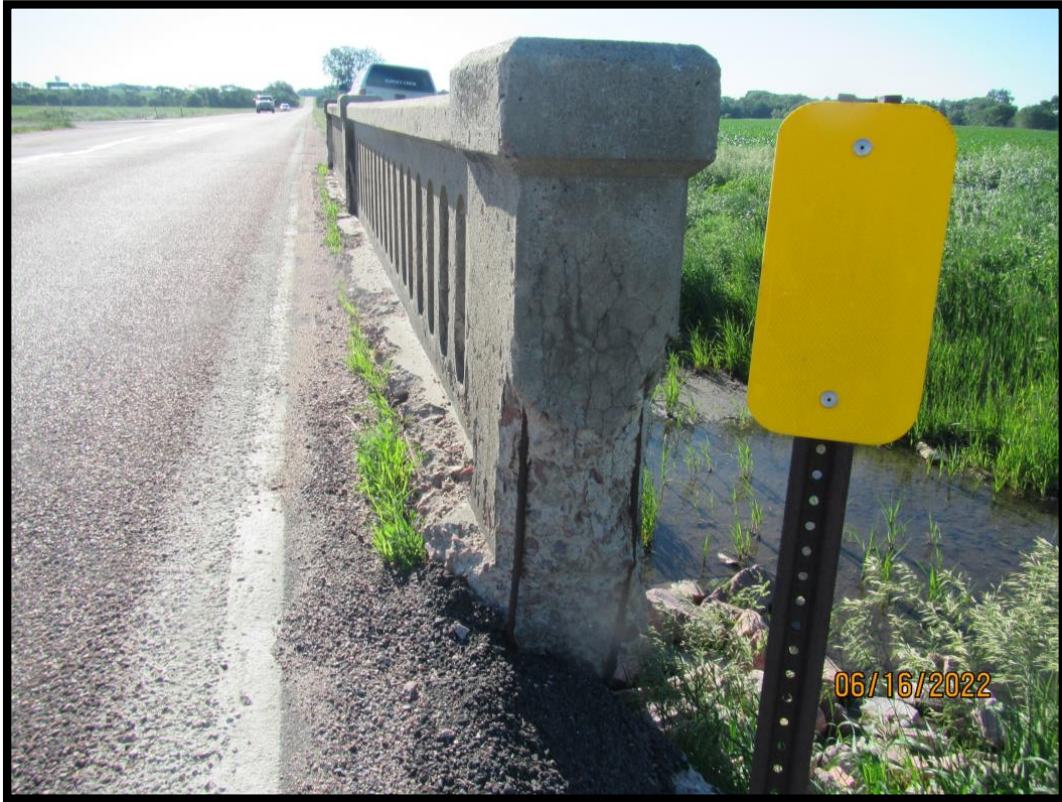
50-219-015_2022_15_CDI_SW Rail end Spall with Exposed Rebar

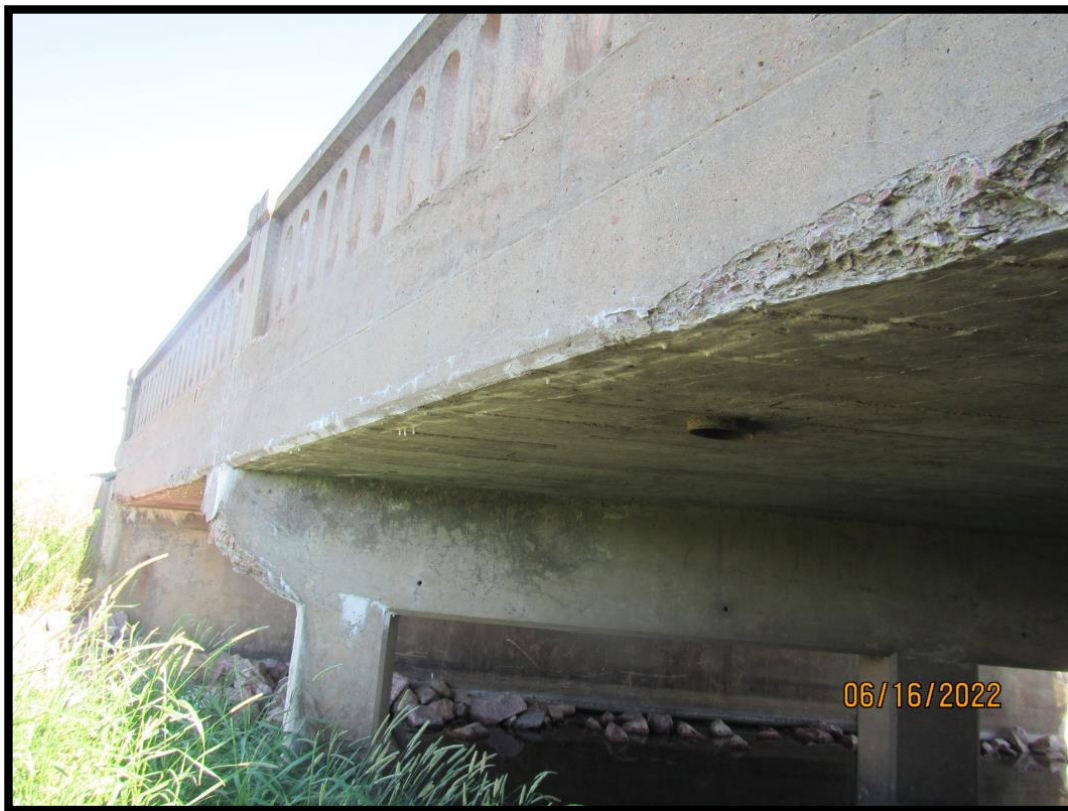
| 1. UNDERSIDE OF DECK - | Cast-in-place concrete - Transverse cracks, longitudinal cracks, and areas of map cracking are evident throughout. A significant amount of efflorescence is evident along both the north and south side (outside 1 ft edge) of the concrete slab in the both spans. The efflorescence along edges of slab has advanced to active stalactites dripping along both edges of the east and west spans. The south edge has minor stalactites and the north edge has moderate to substantial stalactites evident. Scaling and some spalls are evident along the bottom exterior edges of the slab at the corners of the structure. |

50-219-015_2022_21_CDI_South Edge of Slab with Efflorescence and Minor Stalactites

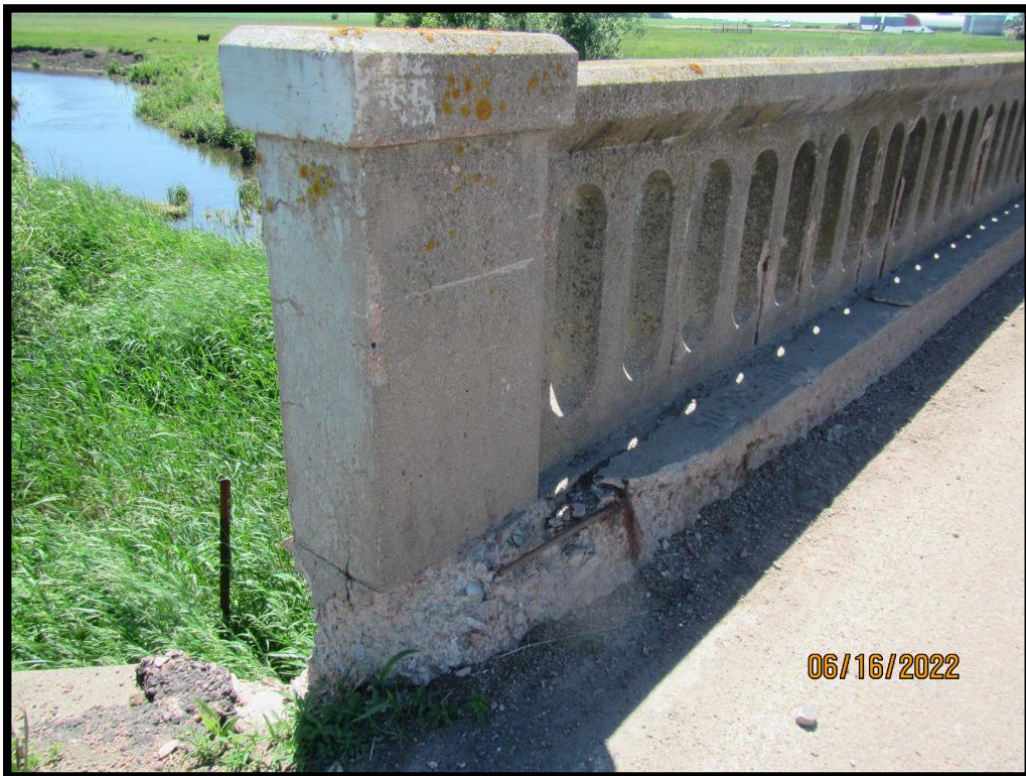
50-277-015_2022_10_CDI_SE Concrete Curb Spall with Exposed Rebar

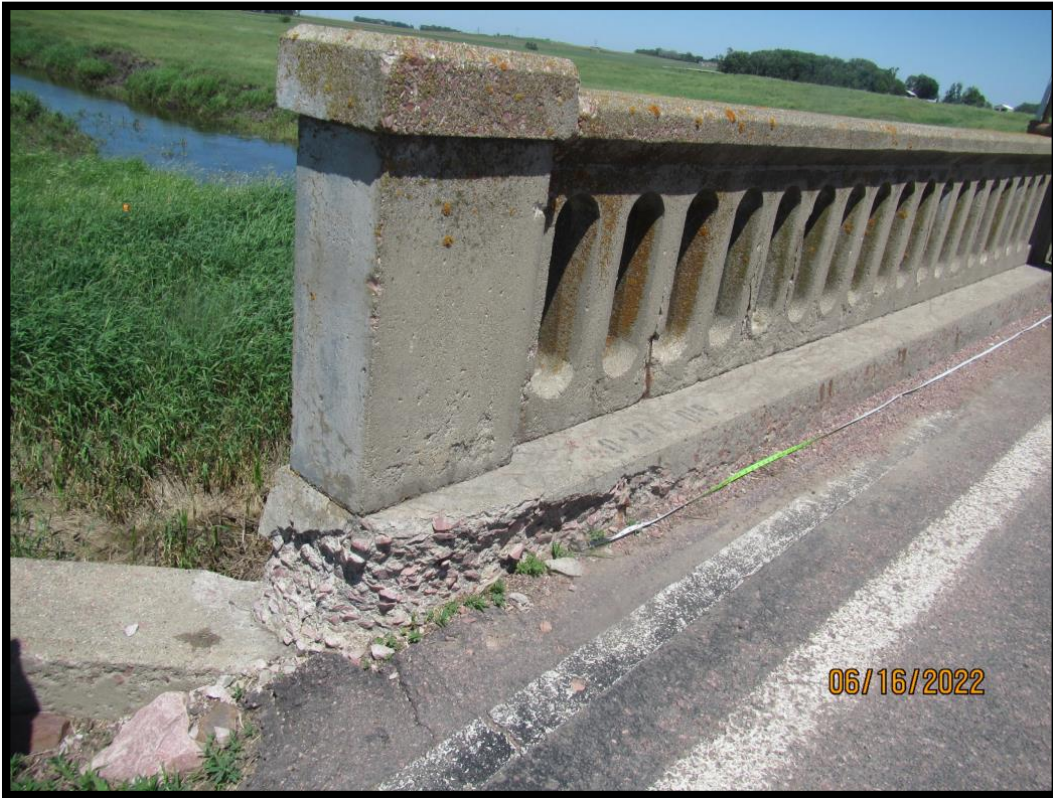
50-277-015_2022_11_CDI_NW Concrete Curb Spall

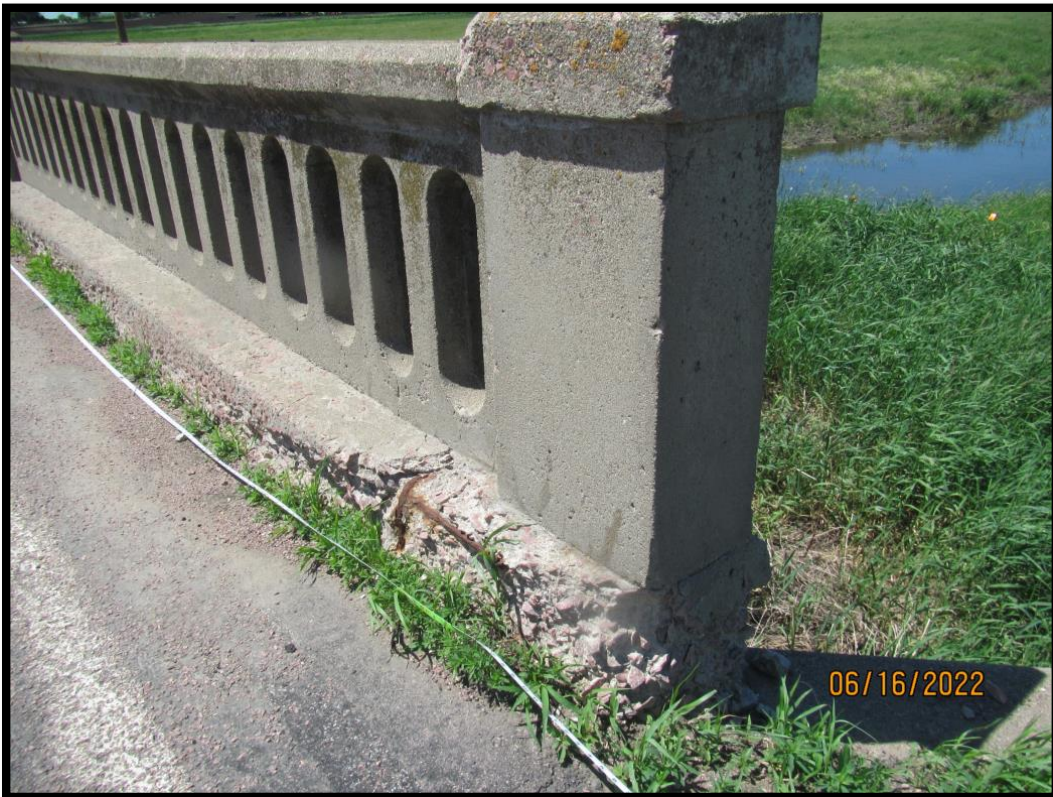
50-277-015_2022_12_CDI_NE Concrete Curb Spall with Exposed Rebar

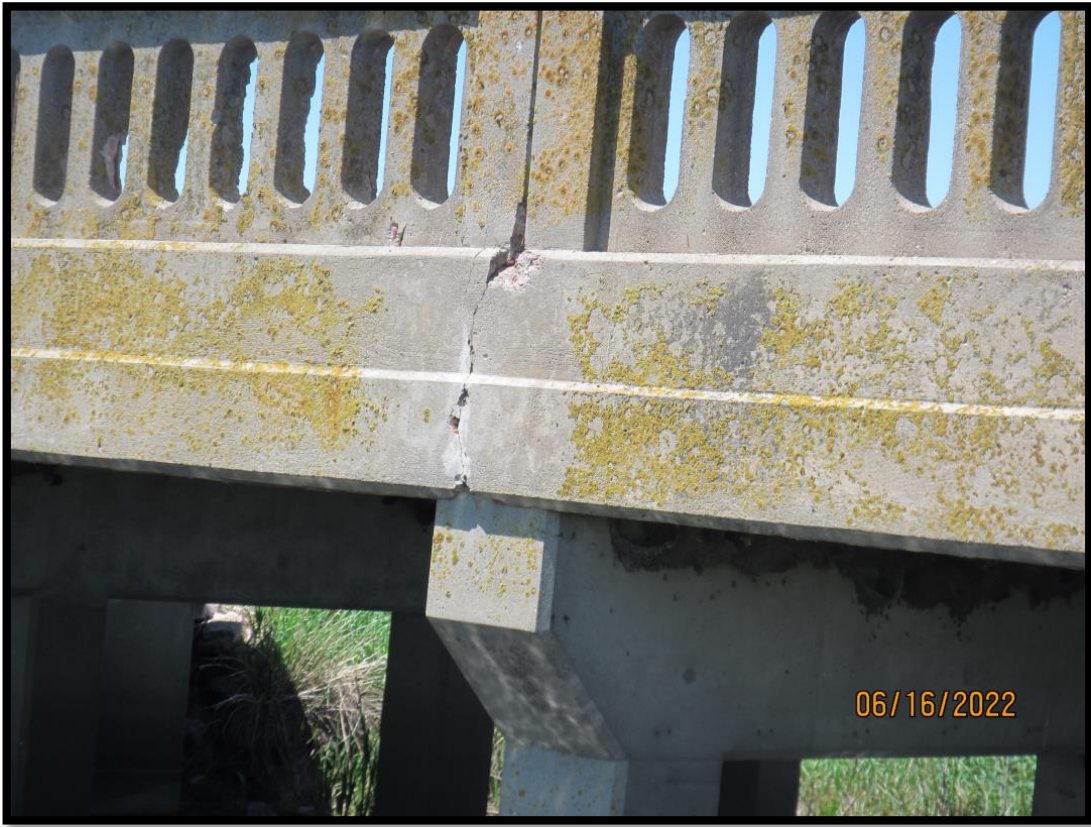
50-277-015_2022_13_CDI_South Curb and Slab Vertical Crack over Center Bent

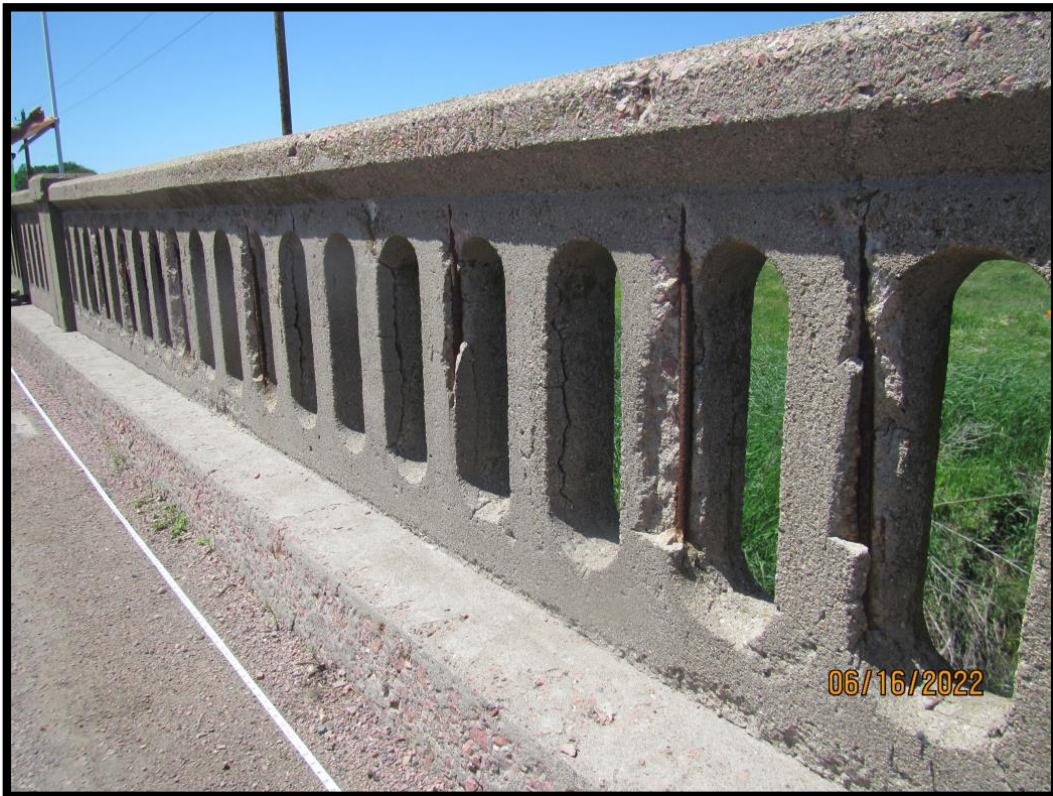
50-277-015_2022_16_CDI_Typical Concrete Railing Spalling with Exposed Rebar
