Bridge Inspection Report for Minnehaha County South Dakota **2022**

Structure No. 50-216-015 Jasper Street / Co. Hwy 104

Dell Rapids Township

10/28/22

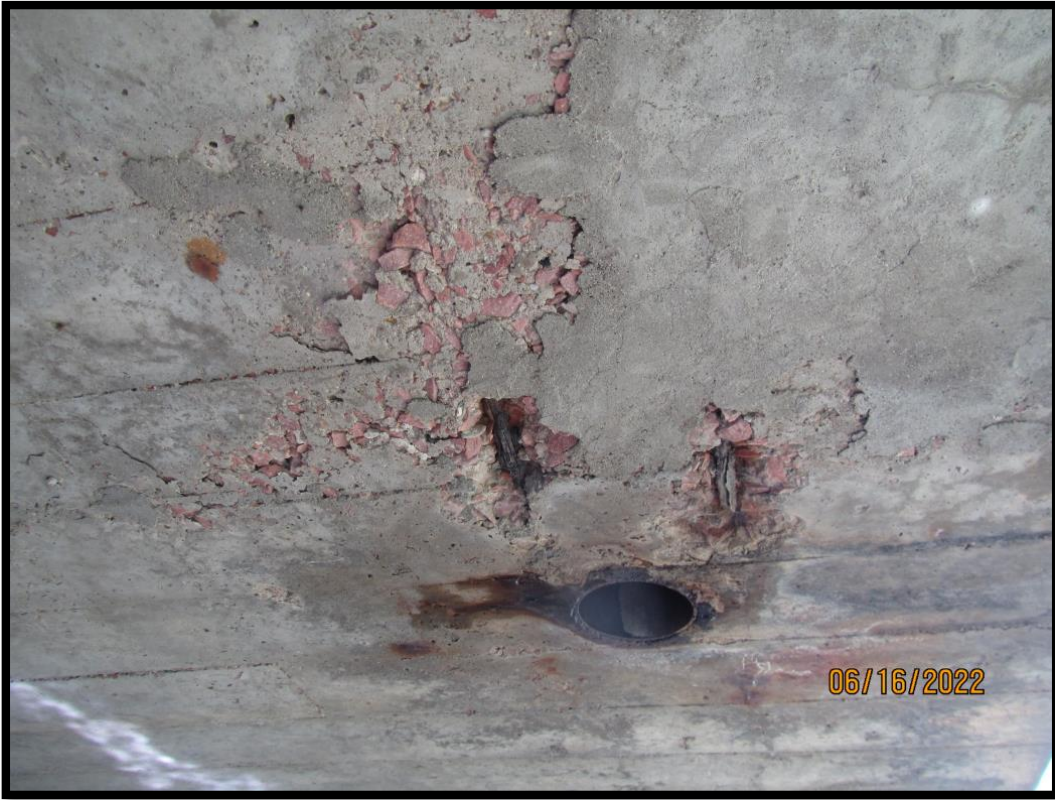
50-277-015_2022_19_CDI_Underside of Slab Span #4 Spall with Exposed Rebar at South Deck Drain

1. Straighten 1st NE and 4th SW approach delineators that are bent.
2. Install bridge railing rubrails and approach guardrails as required.
3. Clear deck drains as required.
4. Monitor scour at the bents.
5. **Structure is currently in the 5-year capital improvement plan & scheduled for future replacement.**

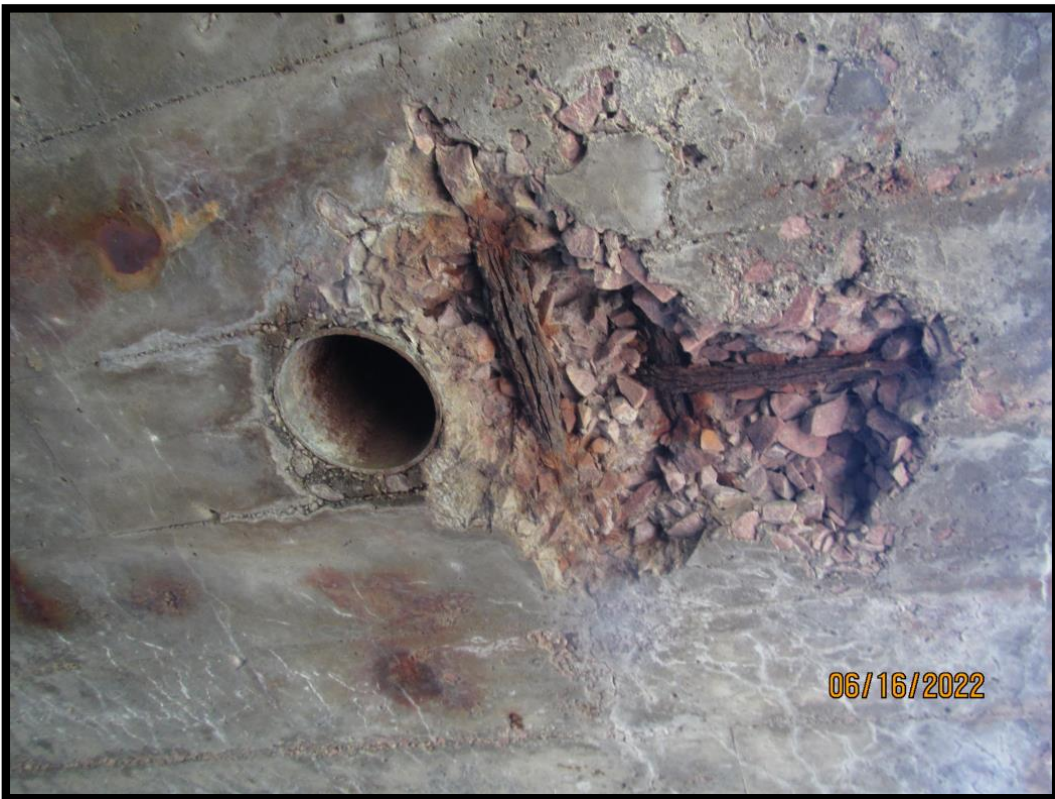
50-277-015_2022_20_CDI_Underside of Slab Span #4 Spall with Exposed Rebar at North Deck Drain

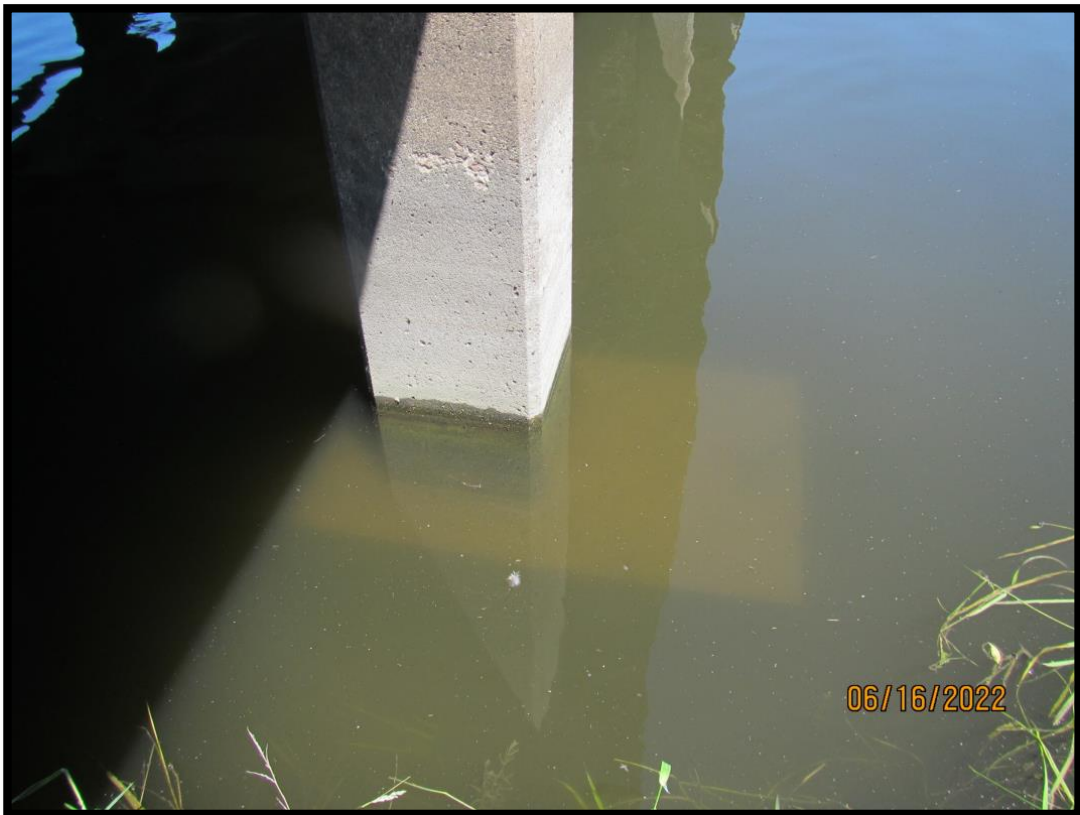
50-277-015_2022_24_CDI_West Bent Column #1 (South) Exposed Footing

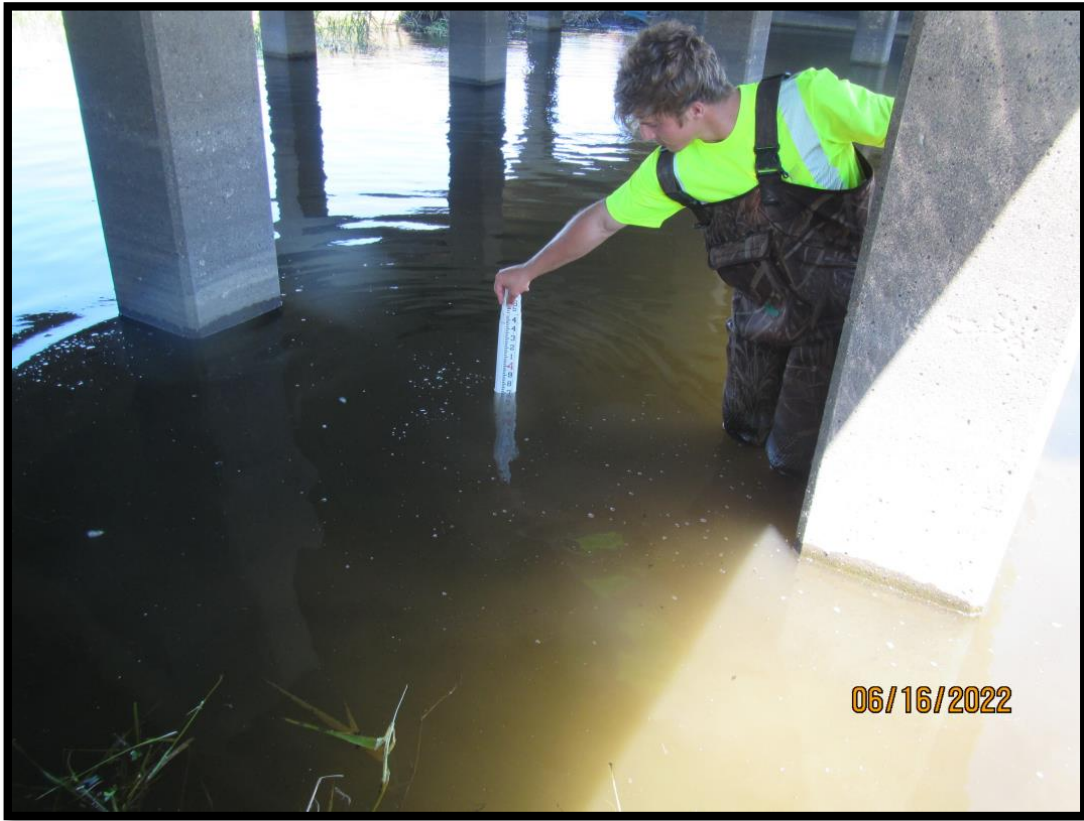
50-277-015_2022_27_CDI_Scour at West Bent between Column #1 and #2

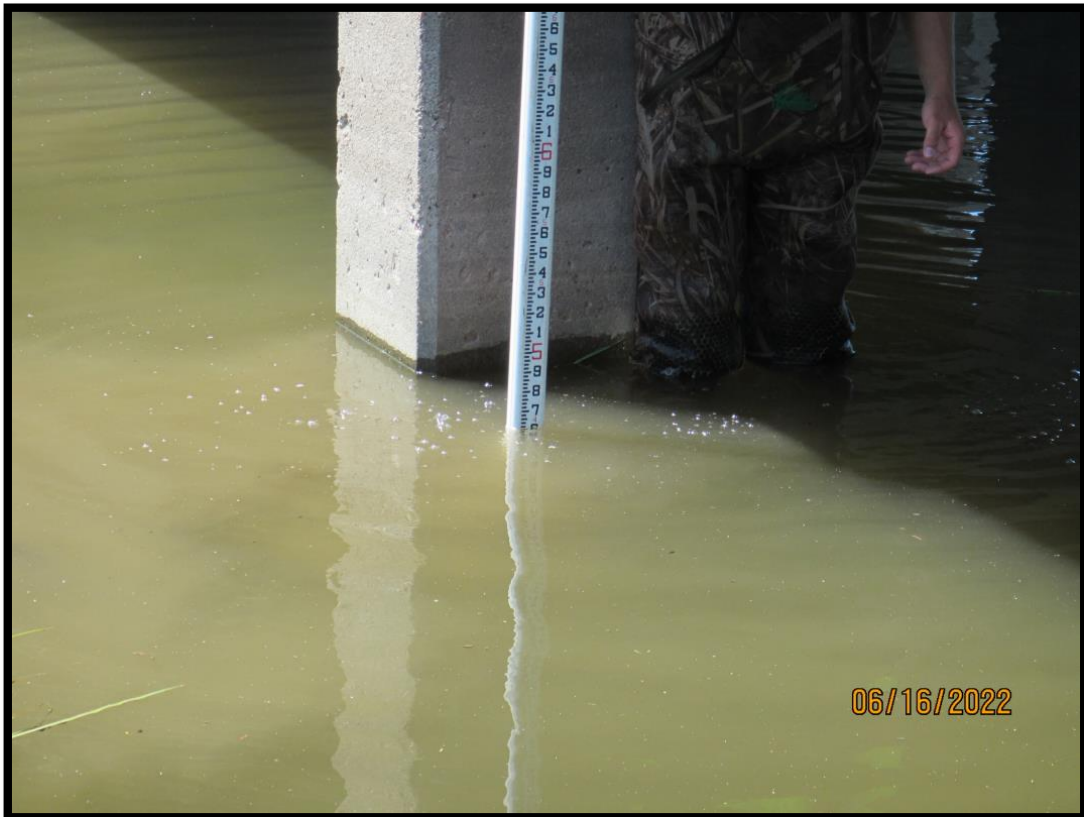
50-277-015_2022_28_CDI_Scour at Center Bent Column #1 (South)
