Bridge Inspection Report for Minnehaha County South Dakota **2022**

Structure No. 50-216-015 Jasper Street / Co. Hwy 104

Repair and Posting Recommendations Bridges Maintained by Local Governments

Structure No. 50-216-015 **Hwy or Street** Jasper St. / Co. Hwy. 104
FA Route No. 6250 **Agency Responsible for Maintenance** Minnehaha Co.
Location 1.2 miles east and 0.2 miles north of Dell Rapids, SD.
Bridge Description 34.0 ft Three Span Continuous Concrete Bridge with Concrete Abutments.
0 Degree Skew - 30.2 ft Roadway Width.
Date Inspected 6/16/2022 **Year Built** 1922 - Reconstructed 1966

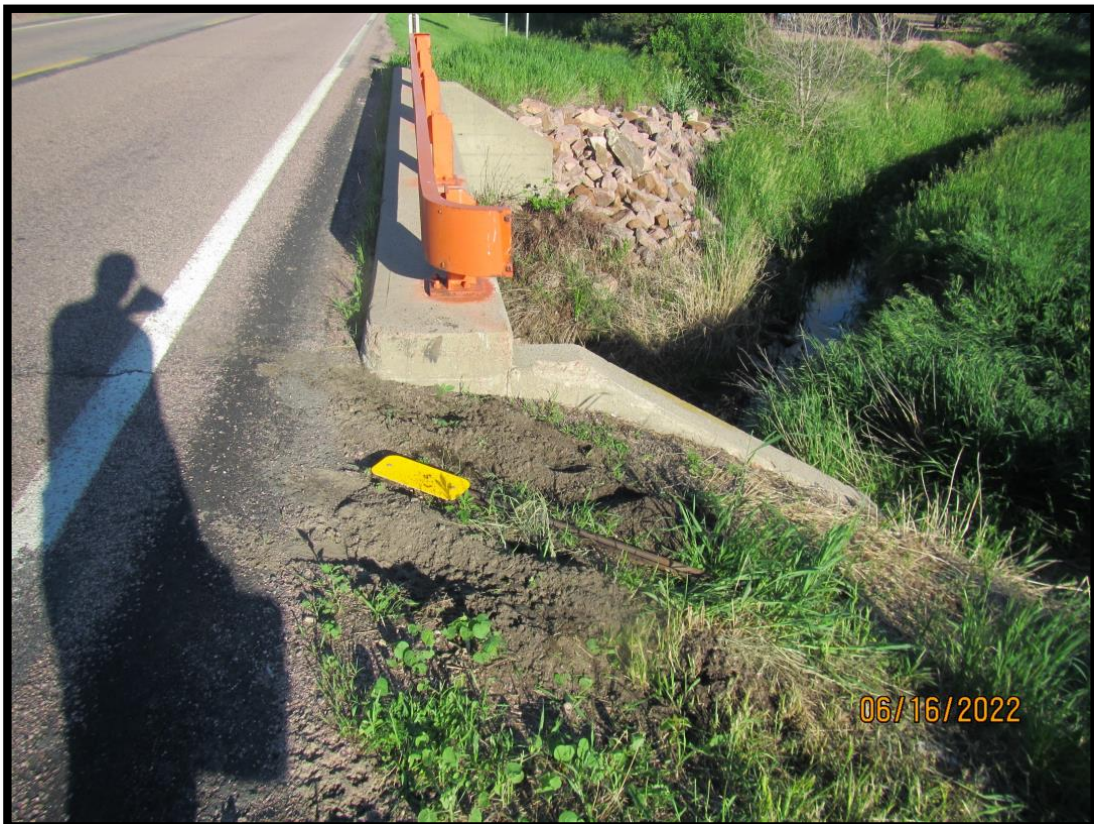
50-216-015_2022_6_CDI_NE Object Marker Damaged and on Ground

1. Install bridge railing rubrails and approach guardrails as required.
2. Install NE object marker that is damaged and lying on ground.
3. Straighten the 1st delineator along the NW approach.
4. Clean and repair/patch areas of scaling, spalling, and exposed rebar on the underside of the concrete slab.
5. Clean and repair/patch areas of deterioration and honeycombing at the center columns in the east & west bents.
6. Patch hole in slab along south side of original slab in west span.
7. Monitor underside of concrete slab for continued deterioration.
8. **Structure is currently in the 5-year capital improvement plan & scheduled for future replacement.**

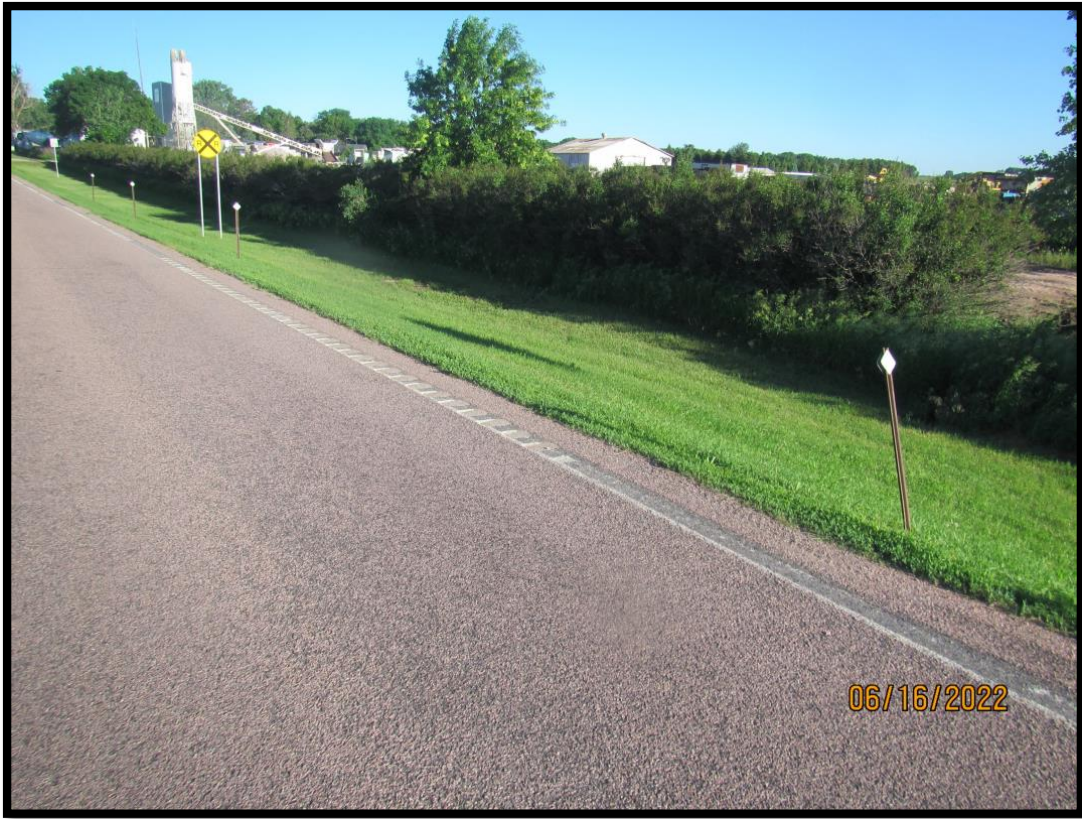
50-216-015_2022_7_CDI_1st NW Approach Delineator Slightly Bent

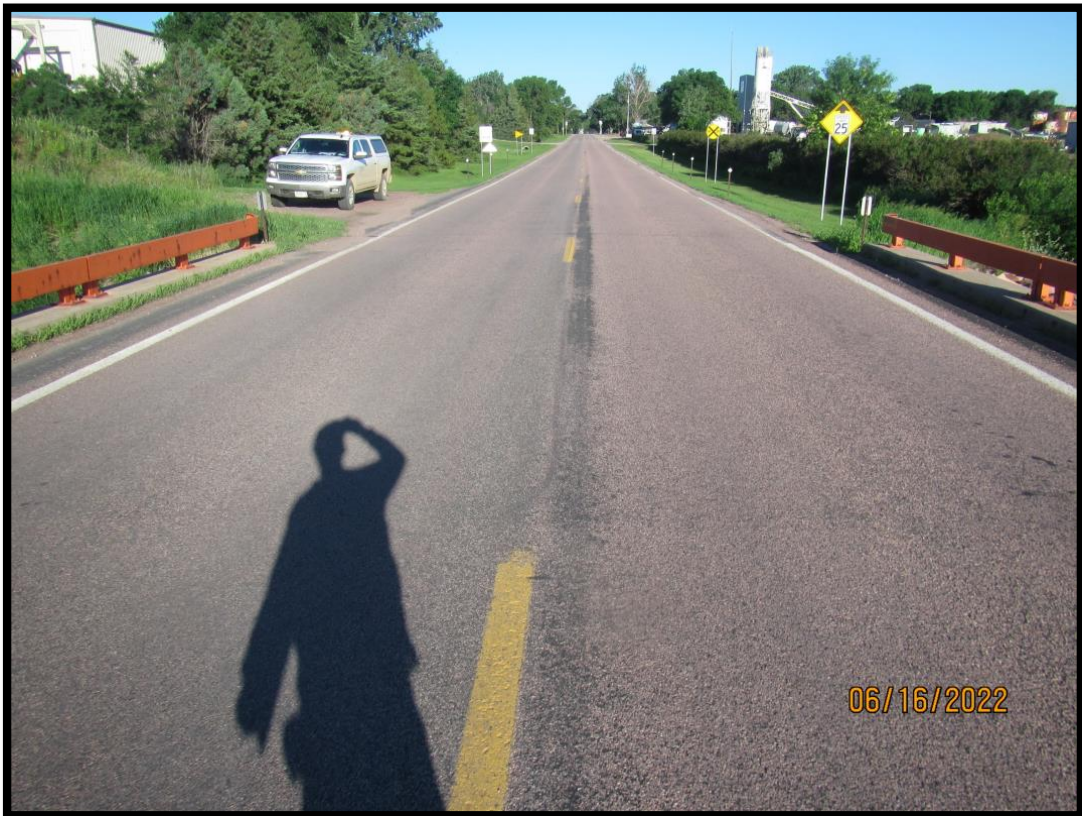
50-216-015_2022_8_CDI_Top of Bituminous Overlay looking West

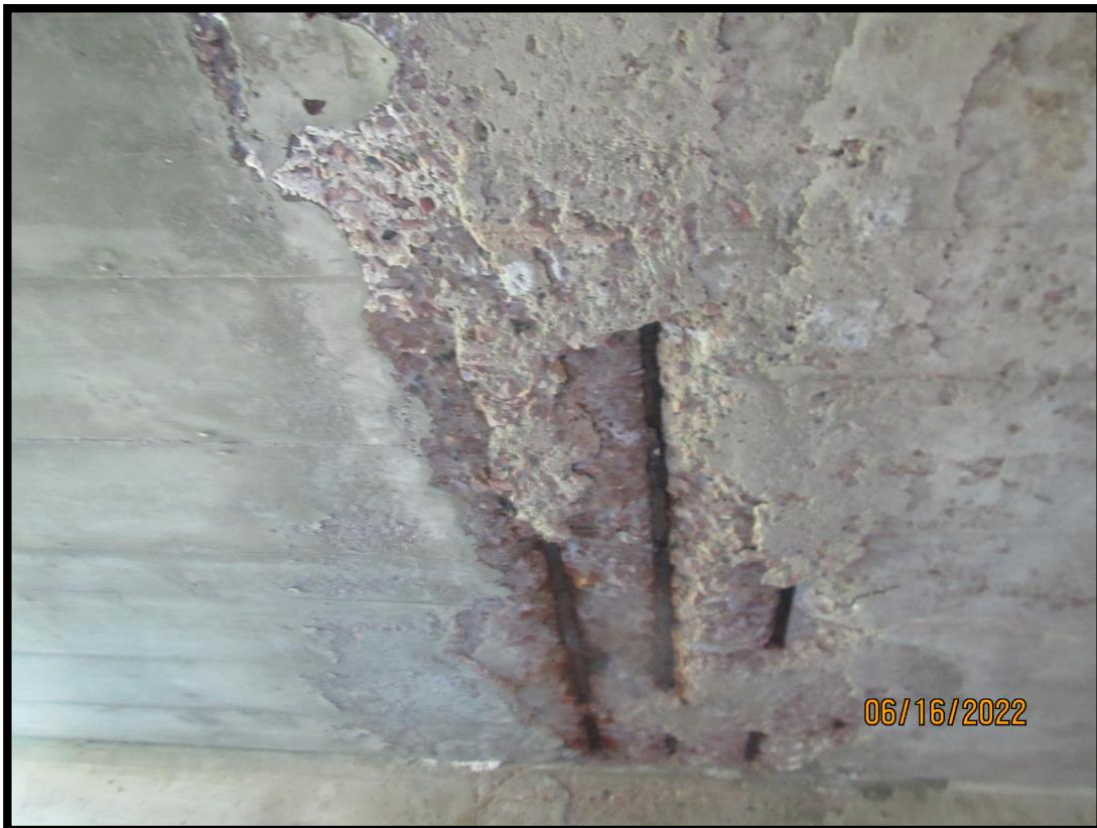
| 1. UNDERSIDE OF DECK - | Cast-in-place concrete - The original structure appears to have been widened approximately 7 ft along both sides. A significant amount of spalling is evident along the south side of the original slab in all spans and along north side of original slab in east span which have exposed reinforcing steel. The exposed portions of the reinforcing steel are heavily rusted with plating evident and moderate section loss, but does not appear to be affecting structure capacity at the time of inspection. Stalactites are evident along south side of original slab at the west and center spans. There are longitudinal hairline cracks and areas of light scaling evident throughout the original portion of the slab with a couple areas of efflorescence evident. Areas of light scaling are also evident on the underside of the widening portions of the concrete slab. There is an approximate 3"x5"x10" deep hole in the south side of the original slab in the west span which appears to extend to the bottom of the bituminous overlay. |

50-216-015_2022_12_CDI_Underside of Existing Slab, South side of East Span

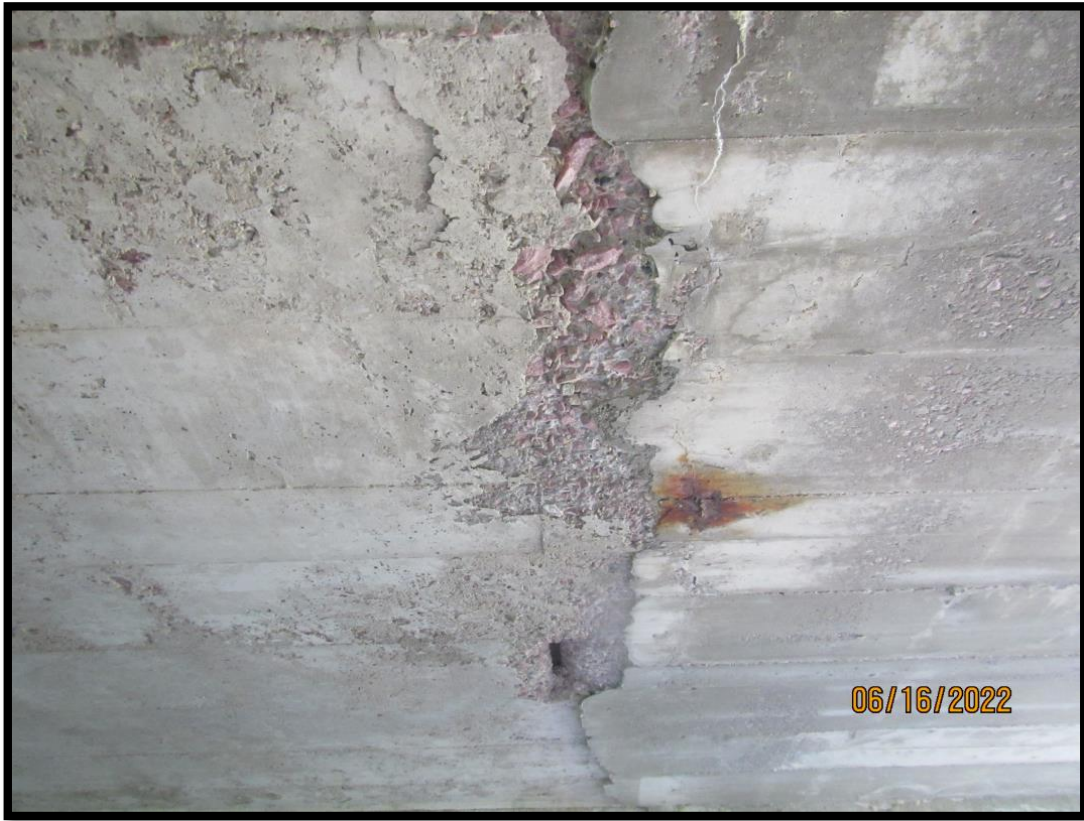
50-216-015_2022_13_CDI_Underside of Existing Slab, North side of East Span

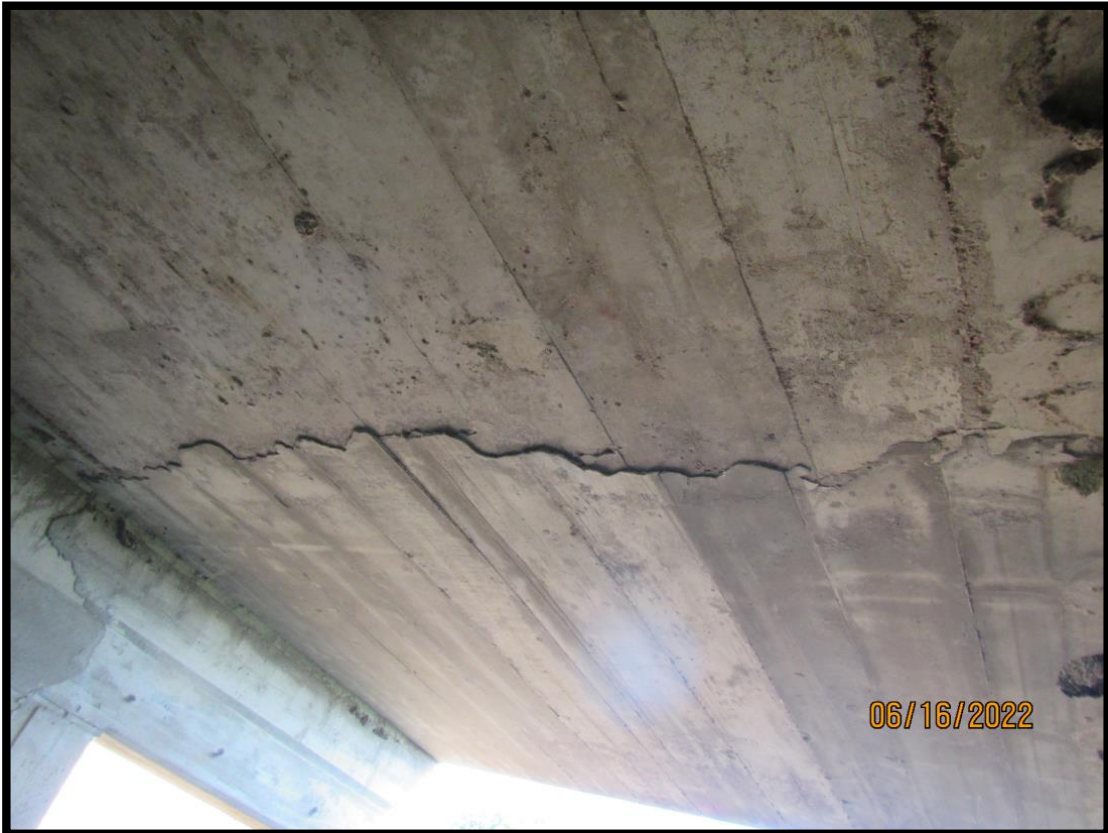
50-216-015_2022_15_CDI_Underside of Existing Slab, North side of Center Span

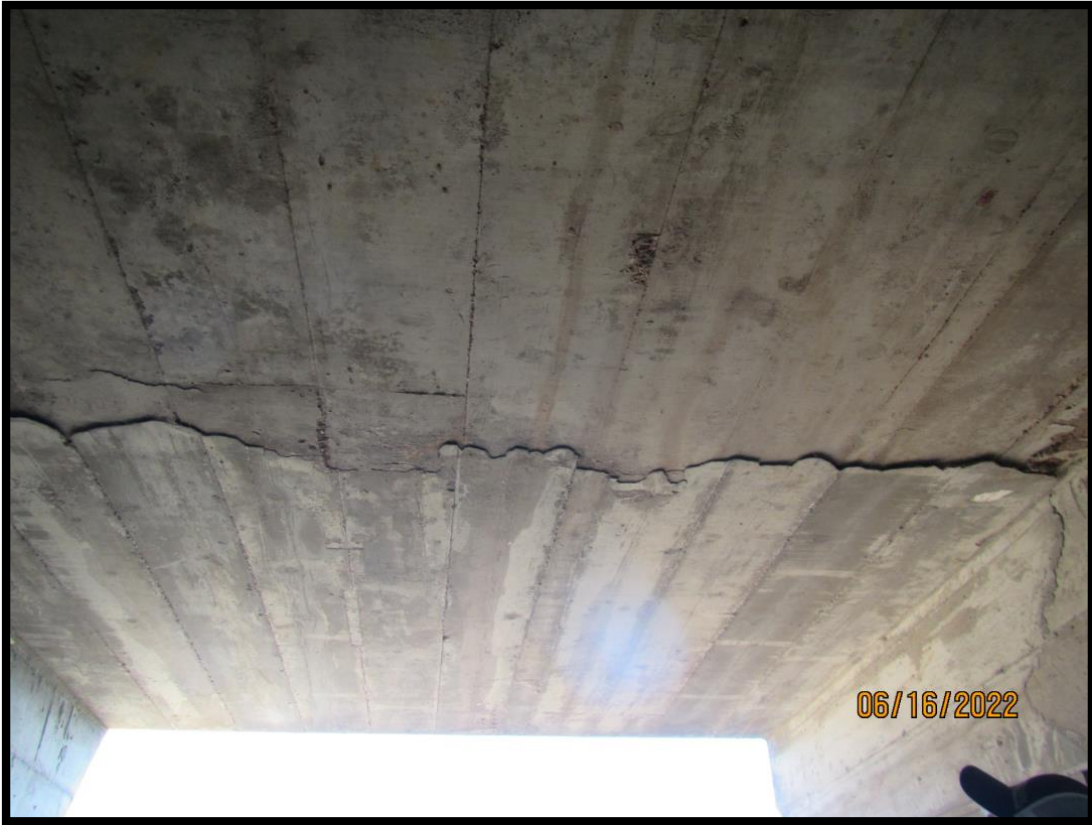
50-216-015_2022_17_CDI_Underside of Existing Slab, North side of West Span

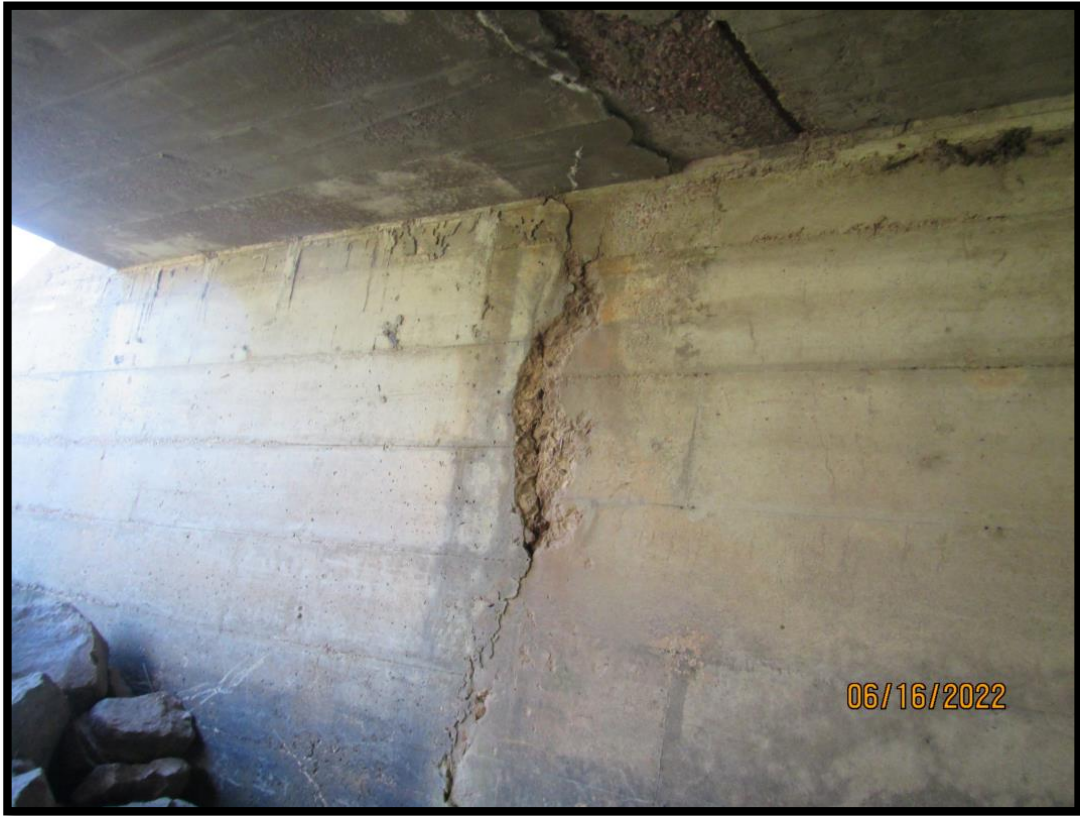
50-216-015_2022_21_CDI_NE Backwall Spall

-									
Re Conc Abutment	MAIN	215	2	68.00	ft	28.00	40.00	0.00	0.00
<p>The backwalls consist of cast-in-place concrete. Both ends of the original backwalls were extended when the structure was widened. There are some areas of honeycombing evident in the original portions of the backwalls. A spall is evident at the north end of the original portion of the east backwall. The widening portions of the backwalls appear to be in relatively good condition.</p> <p>The wingwalls consist of cast-in-place concrete and are direct extensions of the backwalls. Some chips are evident along the tops of the wingwalls. It appears these chips occurred during the placement of the riprap. Overall, the wingwalls appear to be in relatively good condition.</p>									
Delamination/Spall/Patched Area	MAIN	1080	2	40.00	ft	0.00	40.00	0.00	0.00

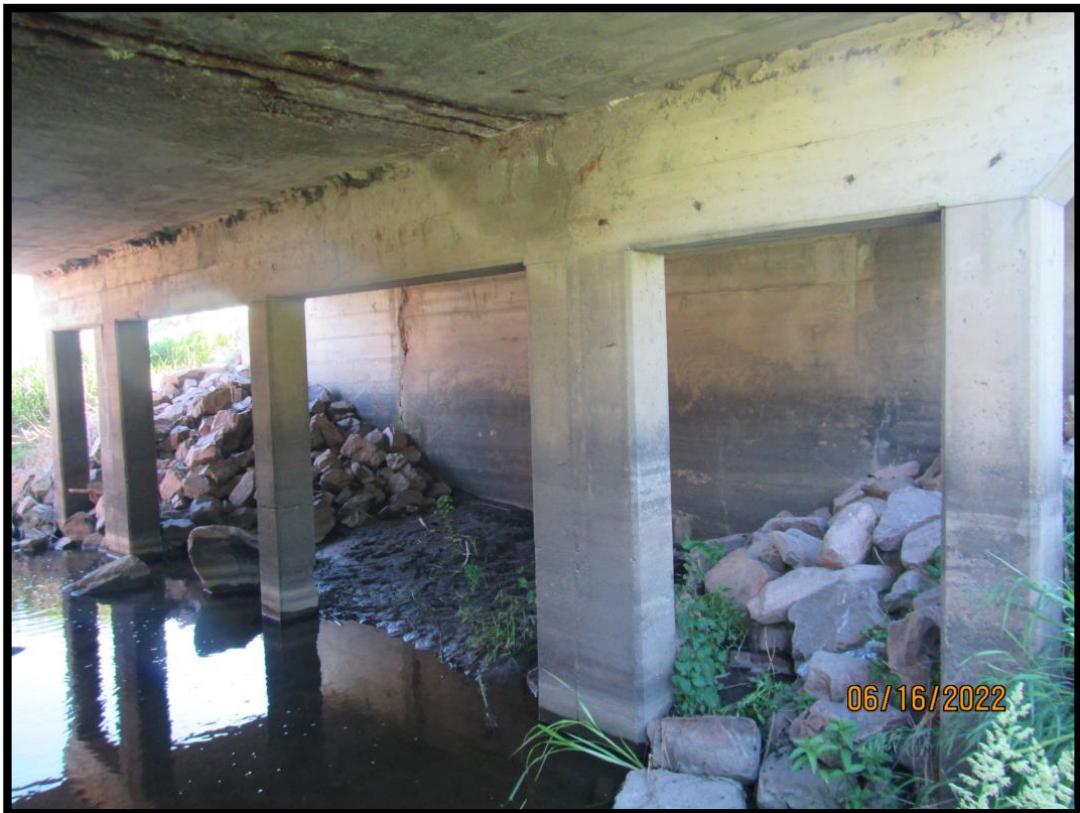
- A. CAPS - Cast-in-place concrete - The original concrete caps were extended when the structure was widened. Some areas of light to moderate scaling are evident throughout and some vertical hairline cracks are evident over the columns. Overall, the concrete bent caps appear to be in satisfactory condition.
- B. COLUMNS - Cast-in-place concrete - There are five (5) concrete columns per bent (10 total columns). The original bents consisted of three (3) columns. The original end columns were added onto and an additional column was added at the ends of the bents when the structure was widened. A significant amount of deterioration and a lack of consolidation is evident towards the bottom of the center column in both bents.
- C. FOOTINGS - The portion of the concrete footings at columns #2 - #5 in both bents have been exposed, but do not appear to be undermined.

50-216-015_2022_22_CDI_Typical Configuration of Bent

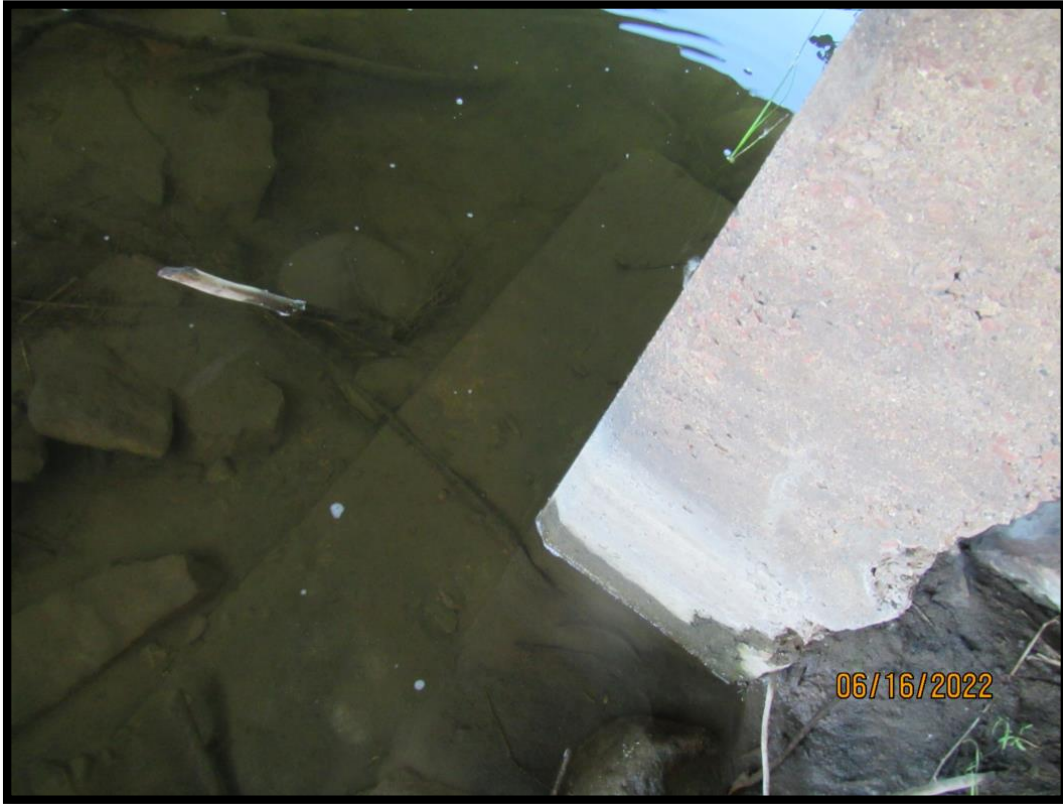
50-216-015_2022_25_CDI_Typical Exposed Concrete Footing (West Bent Column #3 shown)
