Bridge Inspection Report for Minnehaha County South Dakota **2022**

Structure No. 50-219-015 Jasper Street / Co. Hwy 104

Repair and Posting Recommendations Bridges Maintained by Local Governments

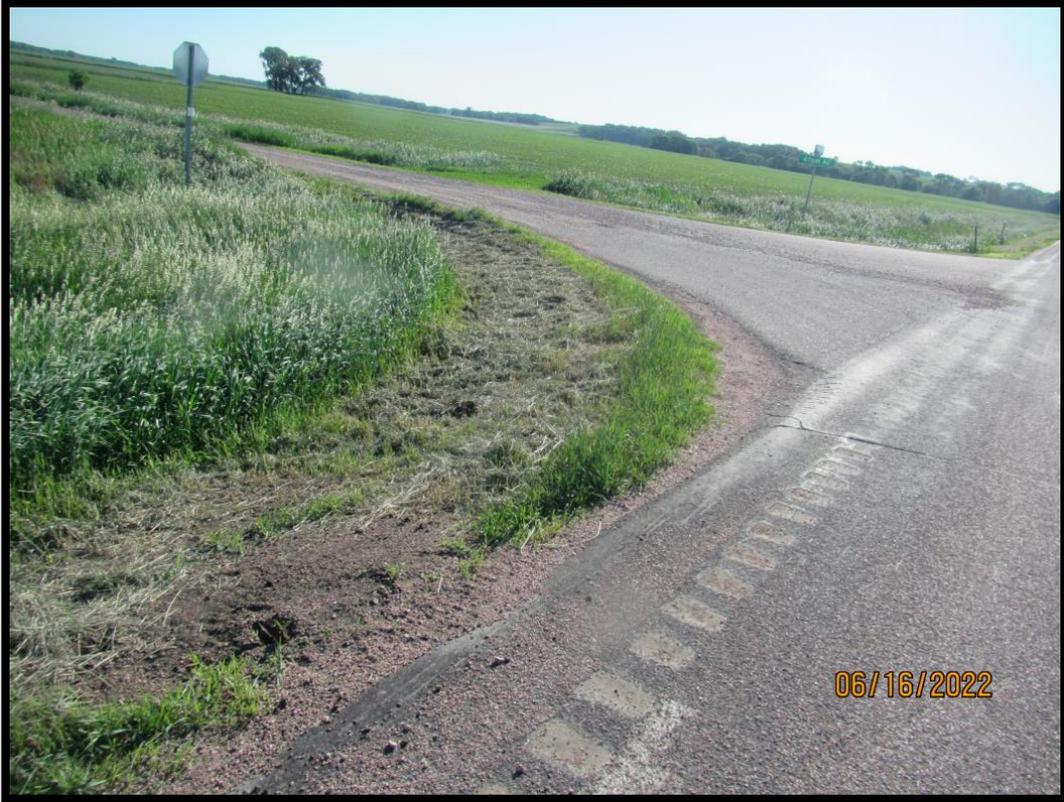
50-219-015_2022_5_CDI_1st NE Approach Delineator Missing

1. Install bridge railing rubrails and approach guardrails as required.
2. Install 1st NE and 2nd SE approach delineators that are damaged or missing.
3. Clear the deck drains as required.
4. Completely remove and replace the damaged section of the north concrete bridge railing as required.
5. Repair the scaling on the north column at the center bent.
6. Monitor cracking, efflorescence, and stalactites along edges of concrete slab.
7. **Structure is currently in the 5-year capital improvement plan & scheduled for future replacement.**

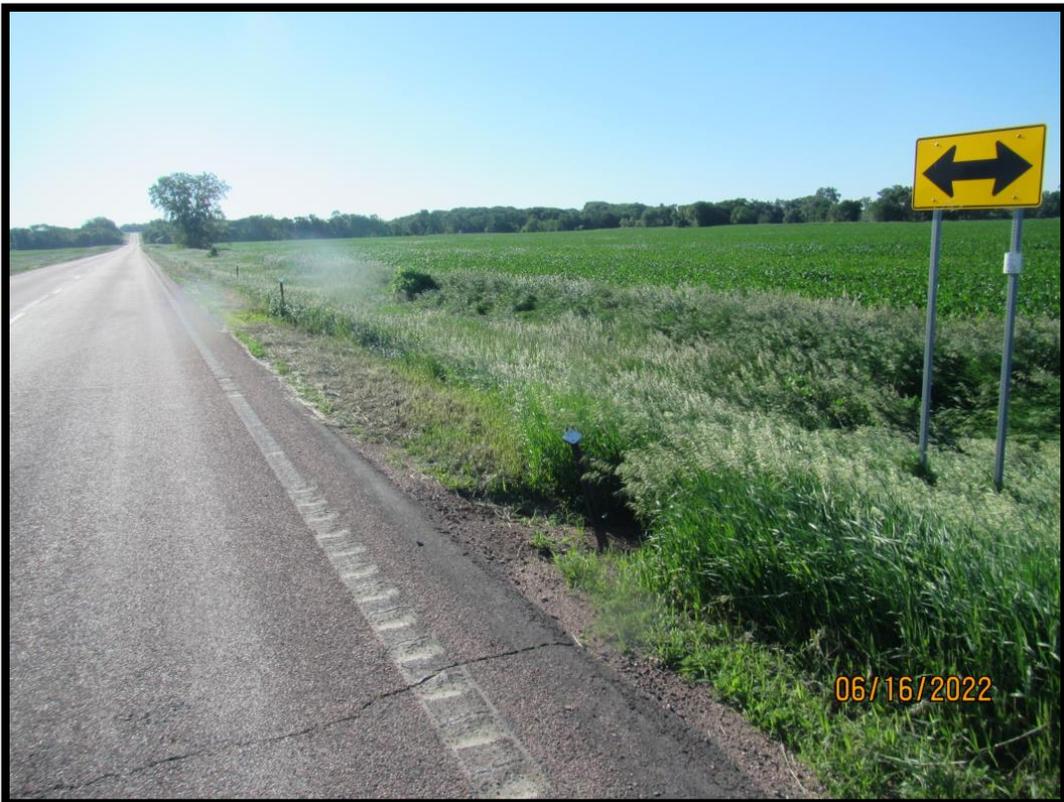
50-219-015_2022_6_CDI_2nd SE Approach Delineator Bent

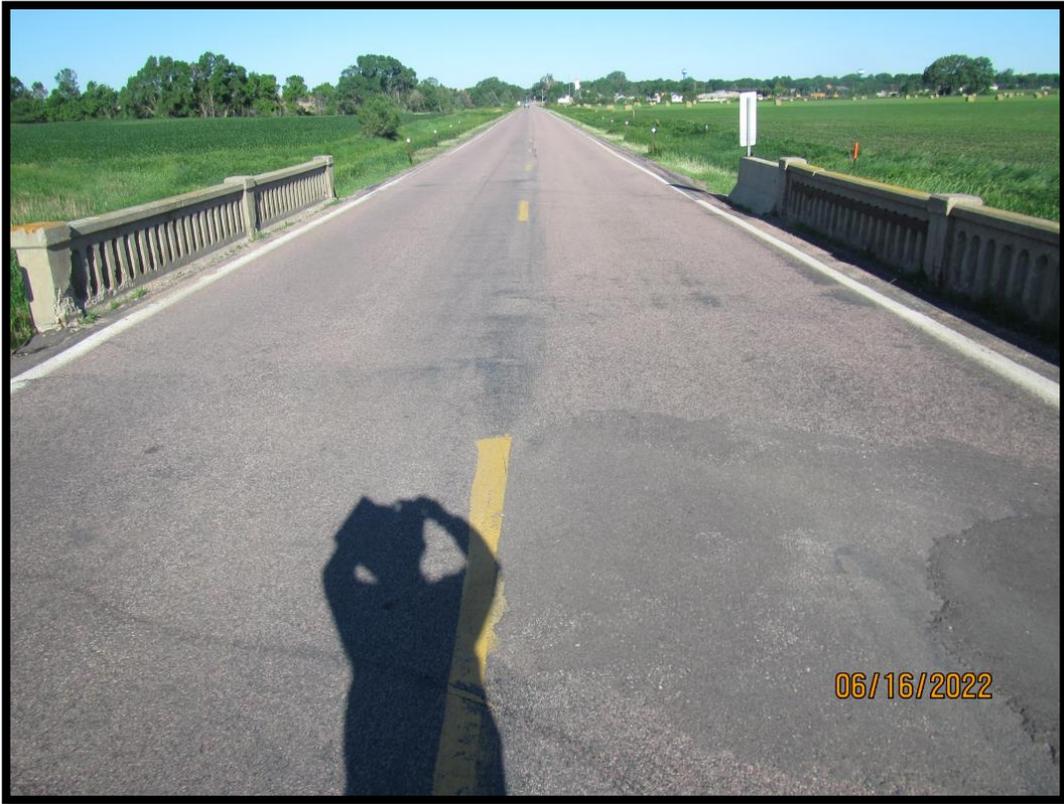
Gravel and bituminous overlay - Approximate 12-inch average total depth. The bituminous surfacing is relatively smooth.
3. JOINTS - OPENINGS - None
4. DRAINS - Deck drains (6-inch dia.) 2 per side, 4 total - All of the deck drains have been covered with gravel and the bituminous overlay surfacing.

50-219-015_2022_7_CDI_Top of Bituminous Overlay looking West

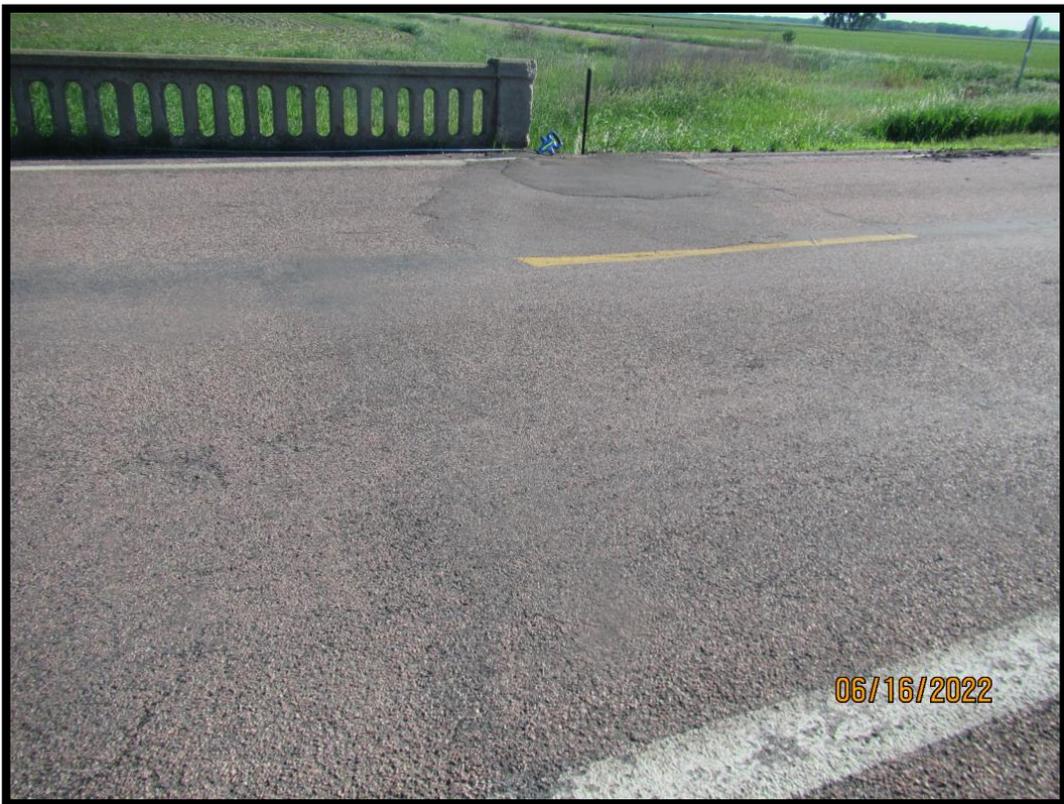
50-219-015_2022_8_CDI_Bituminous Patch at NE Bridge end

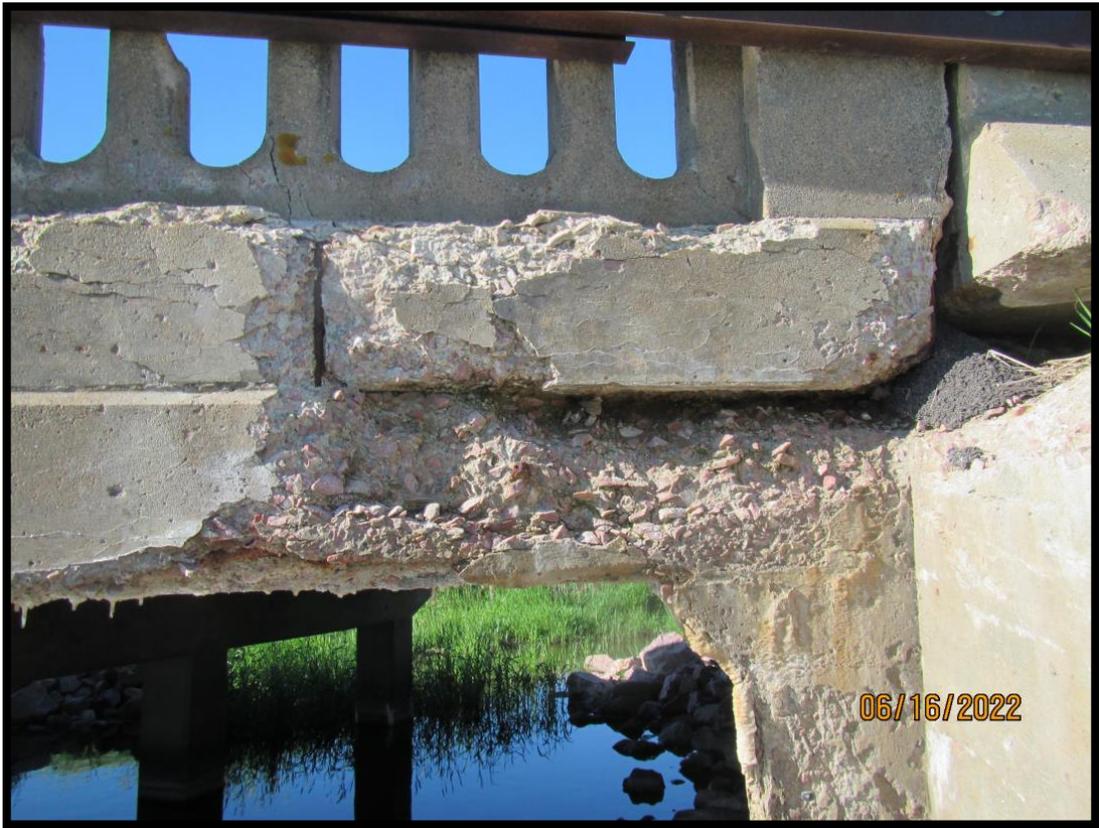
5. CURBS AND MEDIAN - Cast-in-place concrete - The inside faces of the curbs are not visible due to the gravel and bituminous overlay. A moderate amount of scaling is evident along the exterior faces of the curbs and a significant amount of scaling is evident at the ends of the curbs with some areas of exposed rebar.

50-219-015_2022_9_CDI_NW Slab and Curb Edge Deterioration and Damage

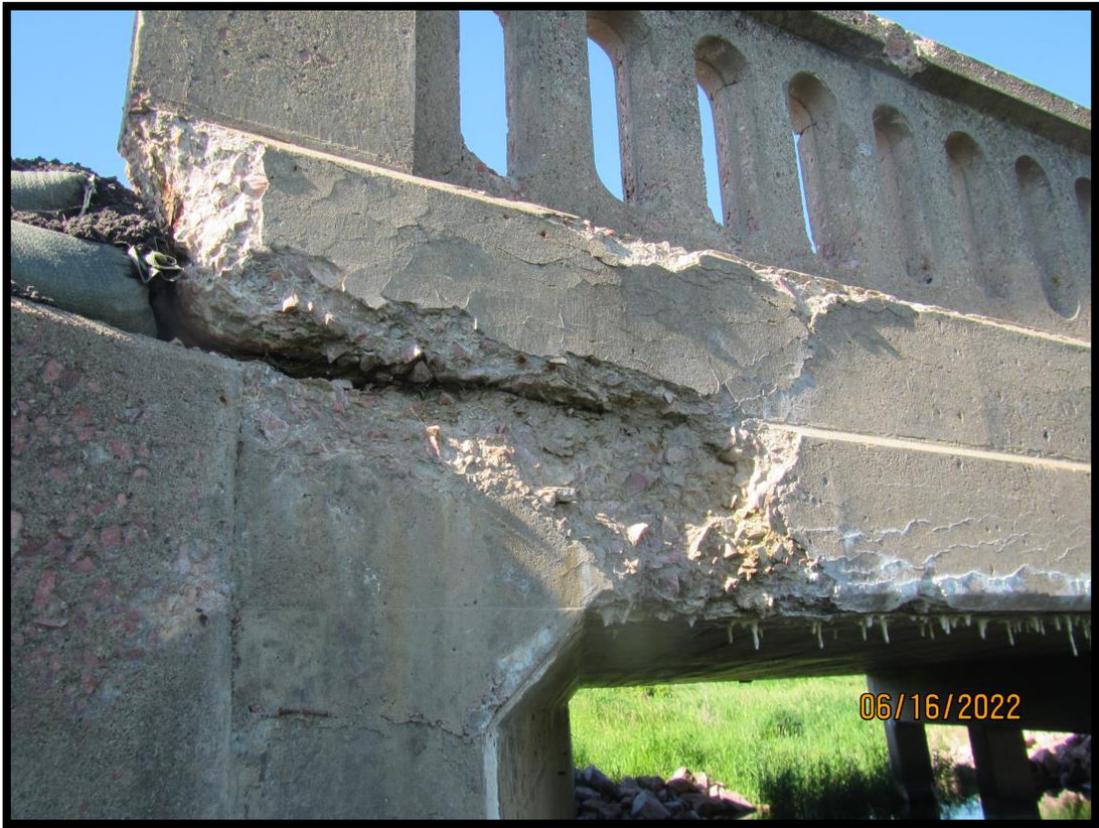
50-219-015_2022_10_CDI_NE Slab and Curb Edge Deterioration

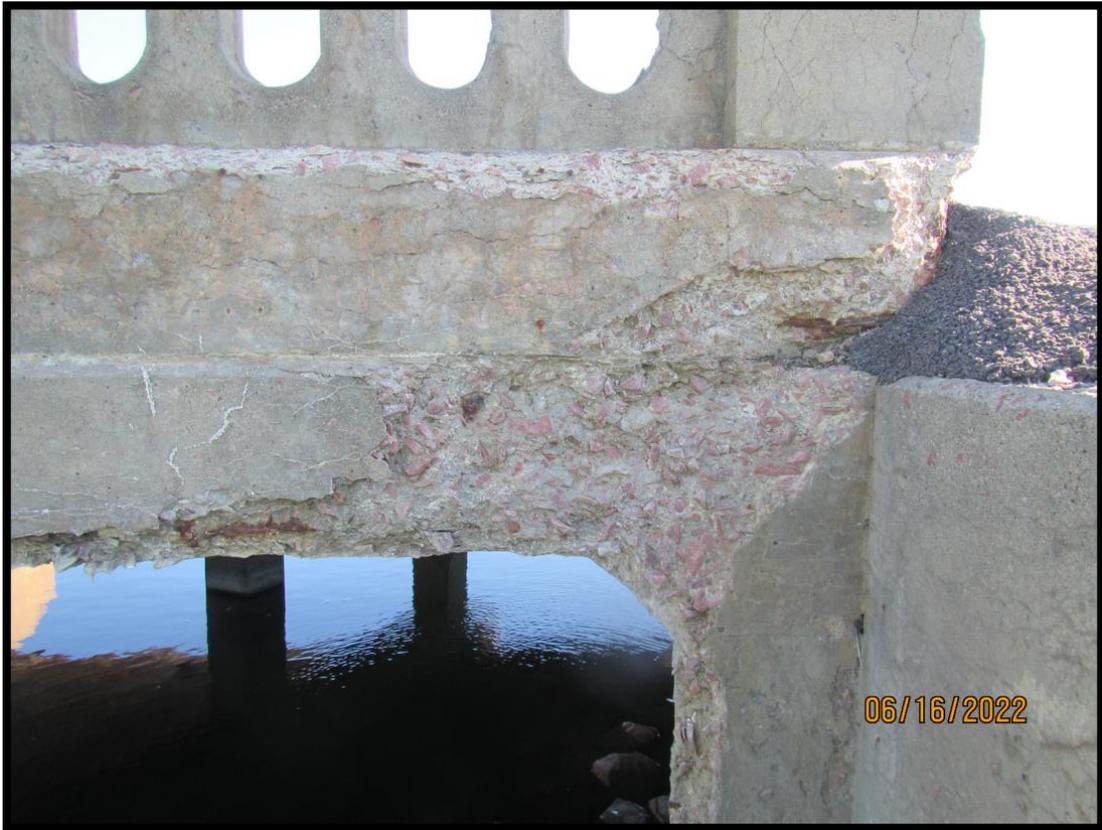
50-219-015_2022_11_CDI_SE Slab and Curb Edge Deterioration

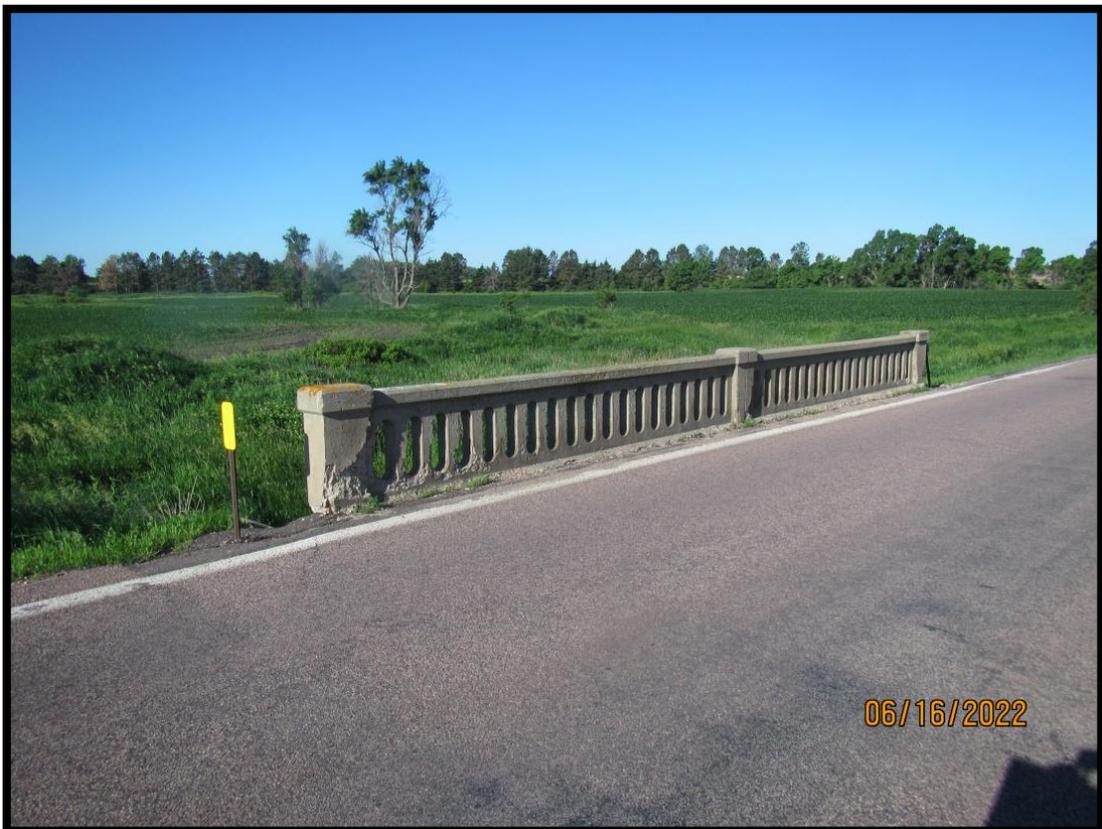
6. SIDEWALKS - None
7. RAILING OR BARRIER - The railings consist of reinforced concrete pigeon hole railings. A moderate to significant amount of scaling is evident throughout with areas of exposed reinforcing steel. It appears a significant vehicle impact occurred at the west end of the north railing. The top concrete railing member, some of the spindles, and the concrete curb have been significantly damaged. A portable concrete barrier curb section has been placed off the west end of the north railing. Steel channels have been installed along the outside face of the railing and are anchored into the concrete barrier curb section. A steel plate has been installed along the inside face of the railing. The steel channels and steel plate are bolted together with bolts running through the pigeon holes. The concrete barrier curb section and steel channels do not provide a railing with the same amount of strength as the original concrete bridge railing before the vehicle impact, but they are providing additional strength to what is provided by the damaged concrete bridge railing. The damaged section of the north concrete bridge railing needs to be completely replaced.

50-219-015_2022_12_CDI_South Rail

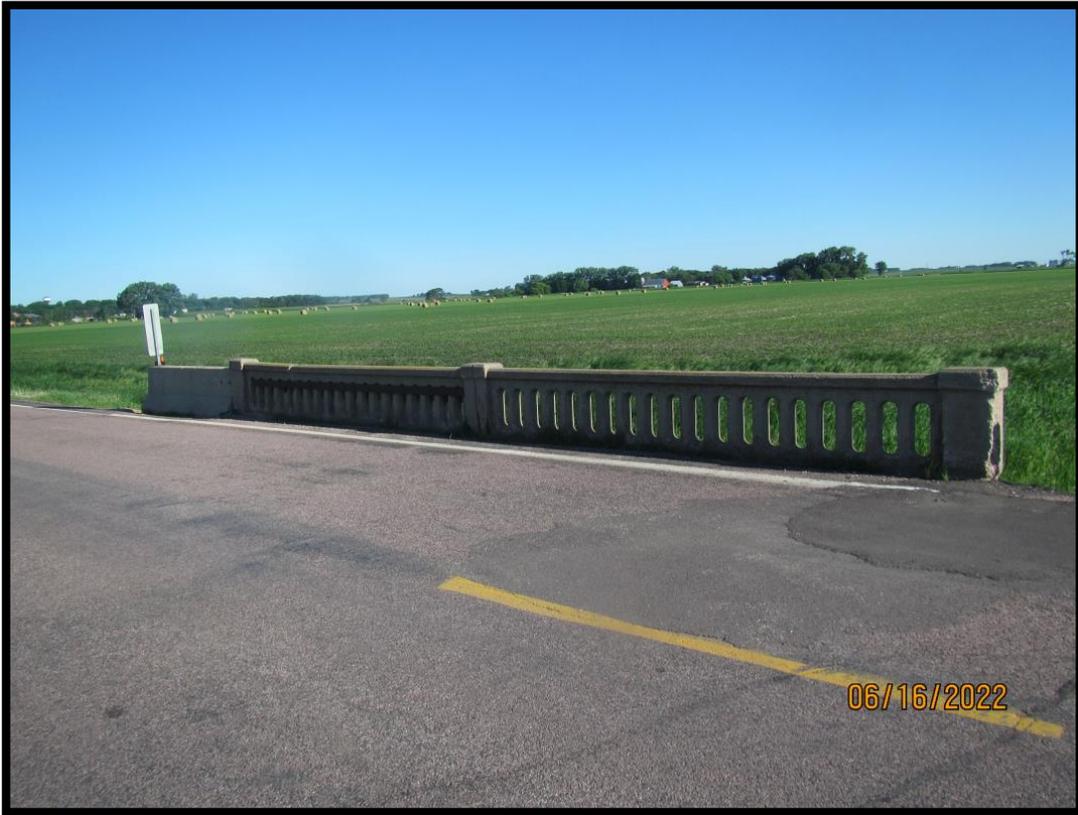
50-219-015_2022_13_CDI_North Rail

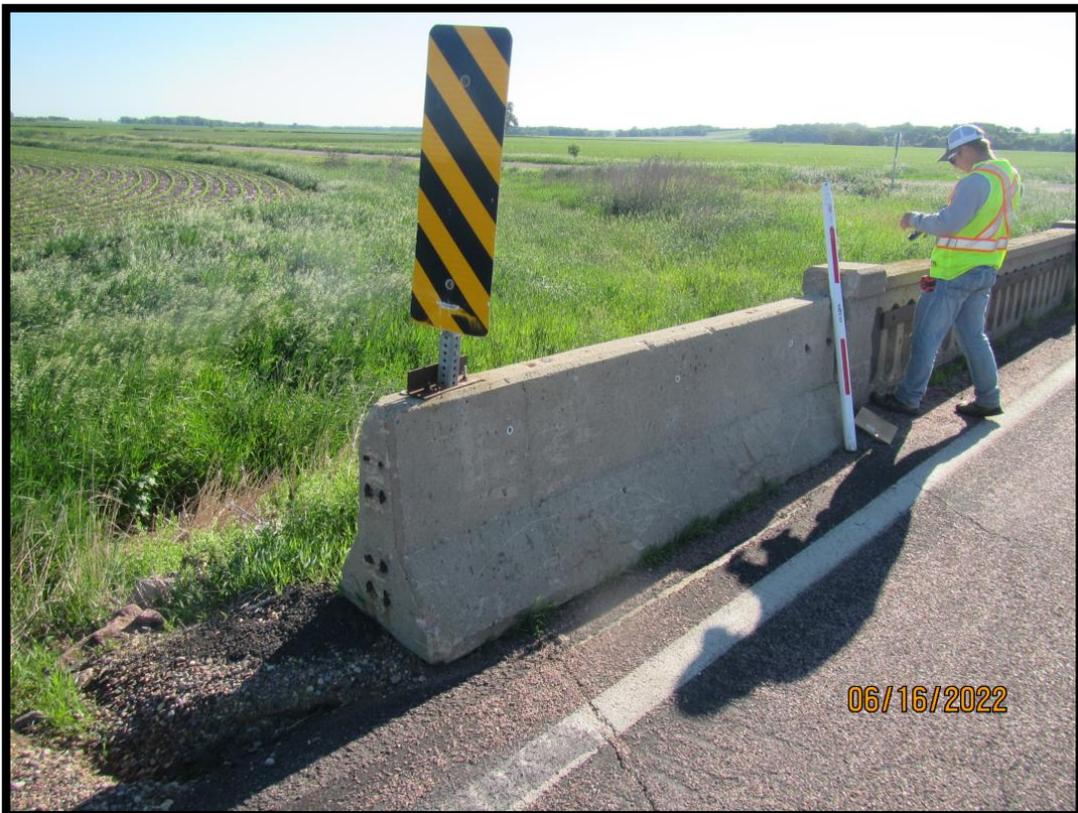
50-219-015_2022_14_CDI_NW Portable Concrete Jersey Barrier

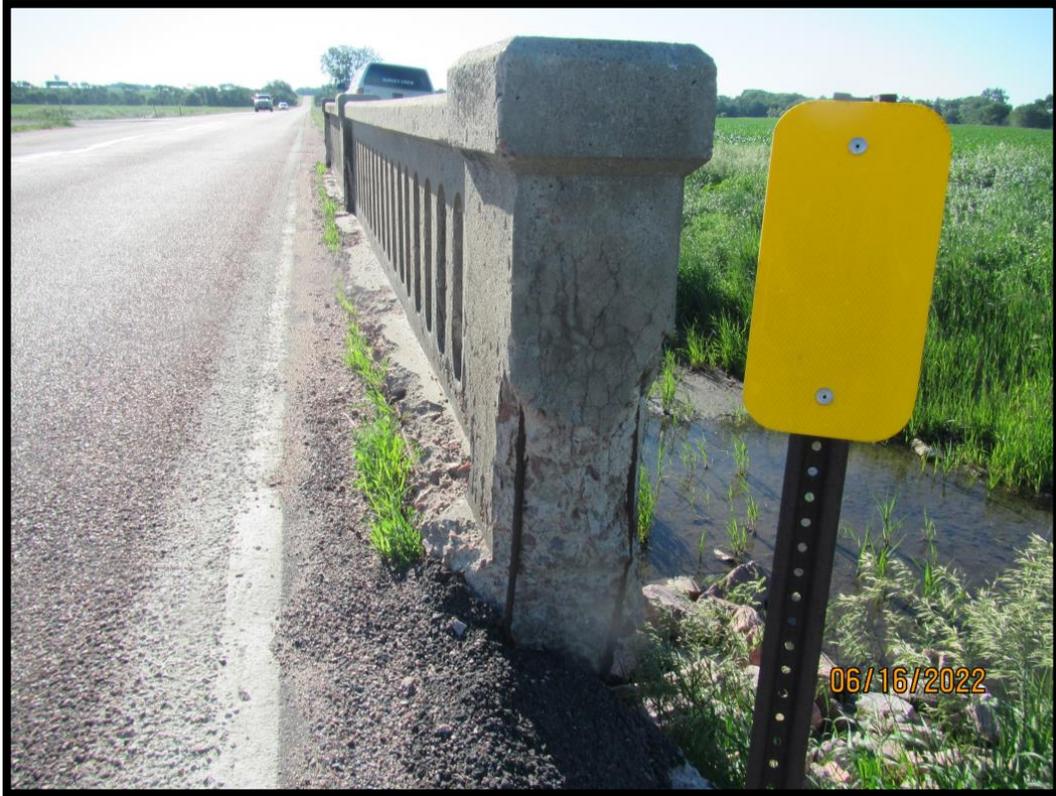
50-219-015_2022_15_CDI_SW Rail end Spall with Exposed Rebar

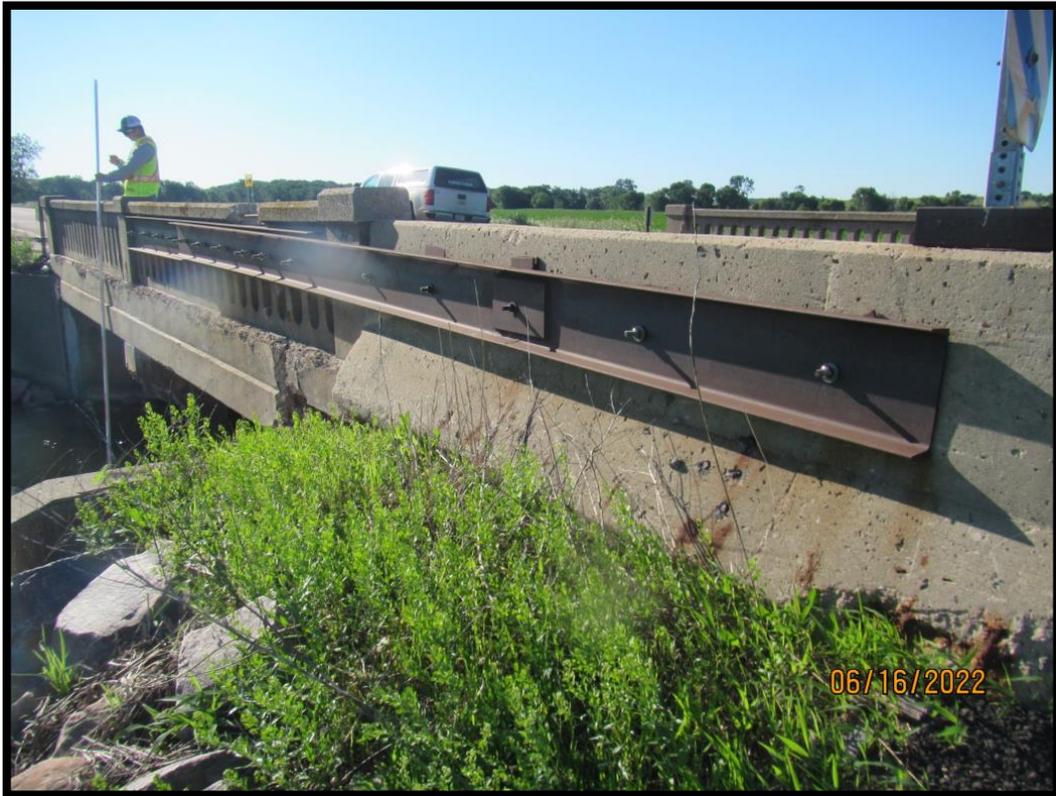
50-219-015_2022_16_CDI_Steel Channel Attached to Backside of NW Railing

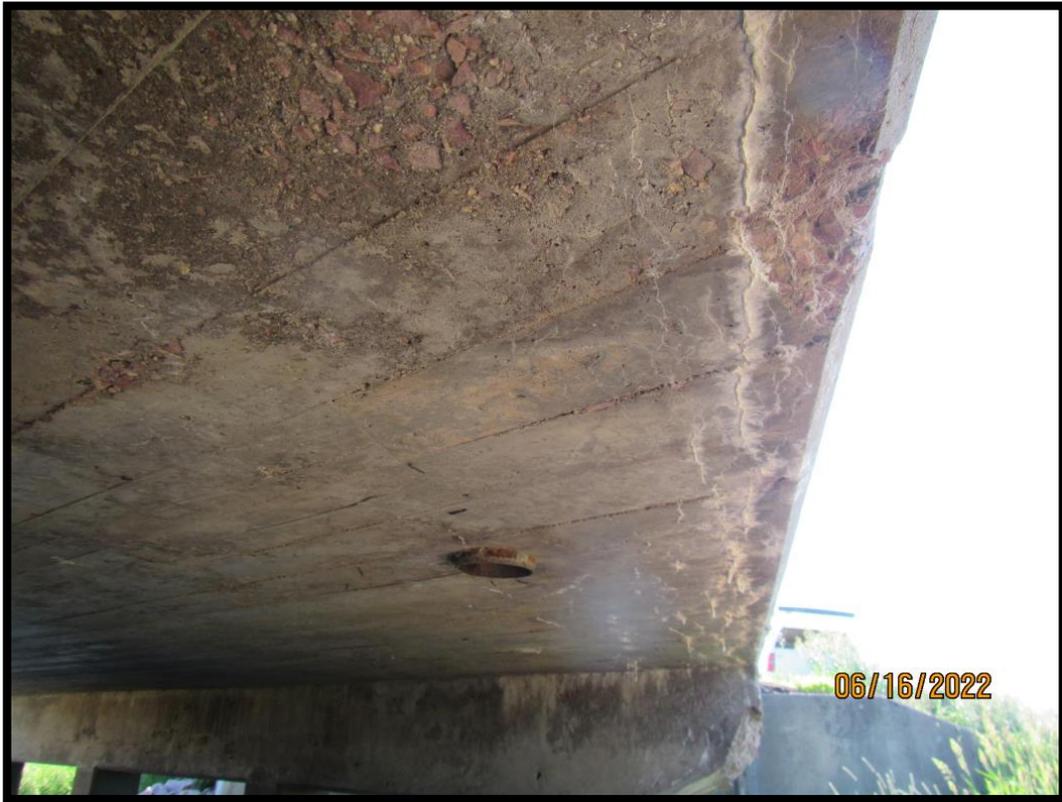
| 1. UNDERSIDE OF DECK - | Cast-in-place concrete - Transverse cracks, longitudinal cracks, and areas of map cracking are evident throughout. A significant amount of efflorescence is evident along both the north and south side (outside 1 ft edge) of the concrete slab in the both spans. The efflorescence along edges of slab has advanced to active stalactites dripping along both edges of the east and west spans. The south edge has minor stalactites and the north edge has moderate to substantial stalactites evident. Scaling and some spalls are evident along the bottom exterior edges of the slab at the corners of the structure. |

50-219-015_2022_17_CDI_Underside of South Edge of Slab in West Span with Stalactites

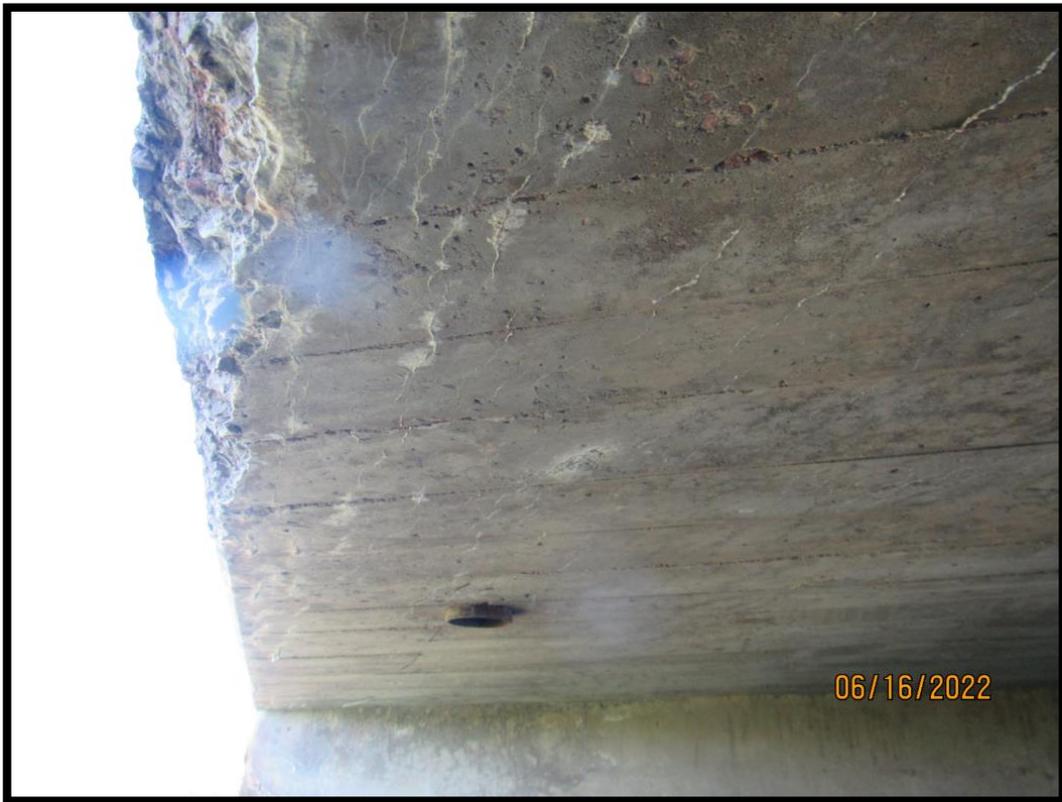
50-219-015_2022_18_CDI_Underside of South Edge of Slab in East Span with Stalactites

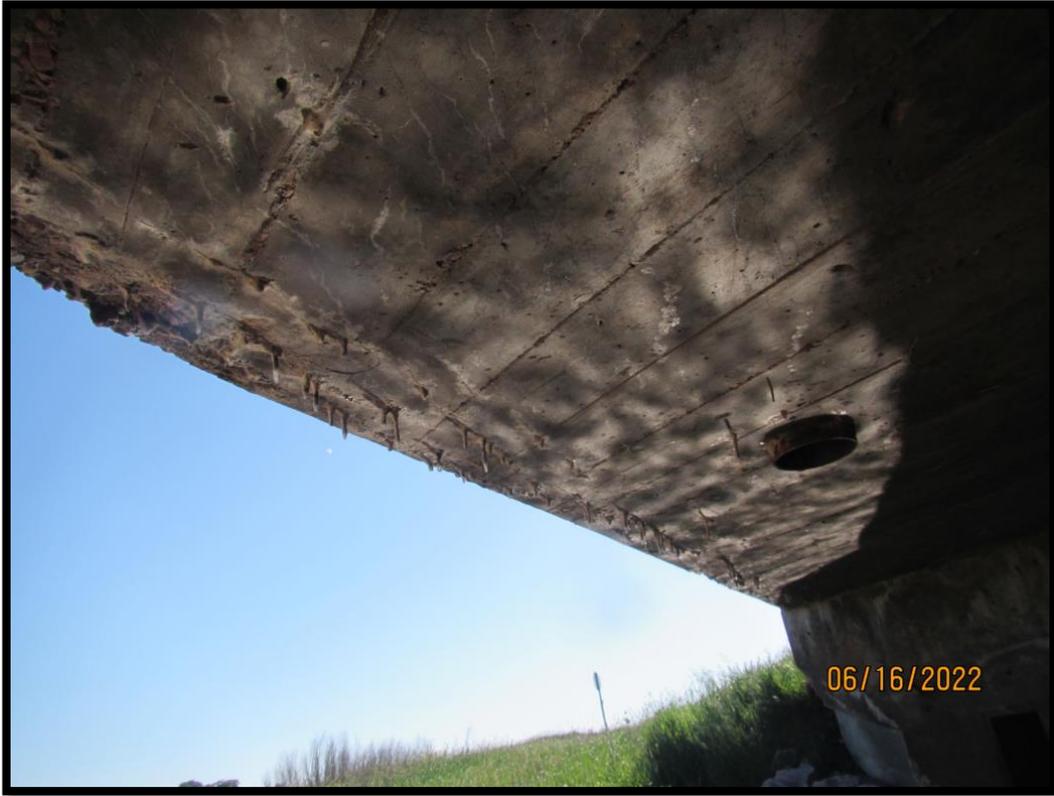
50-219-015_2022_19_CDI_Underside of North Edge of Slab in West Span
with Stalactites

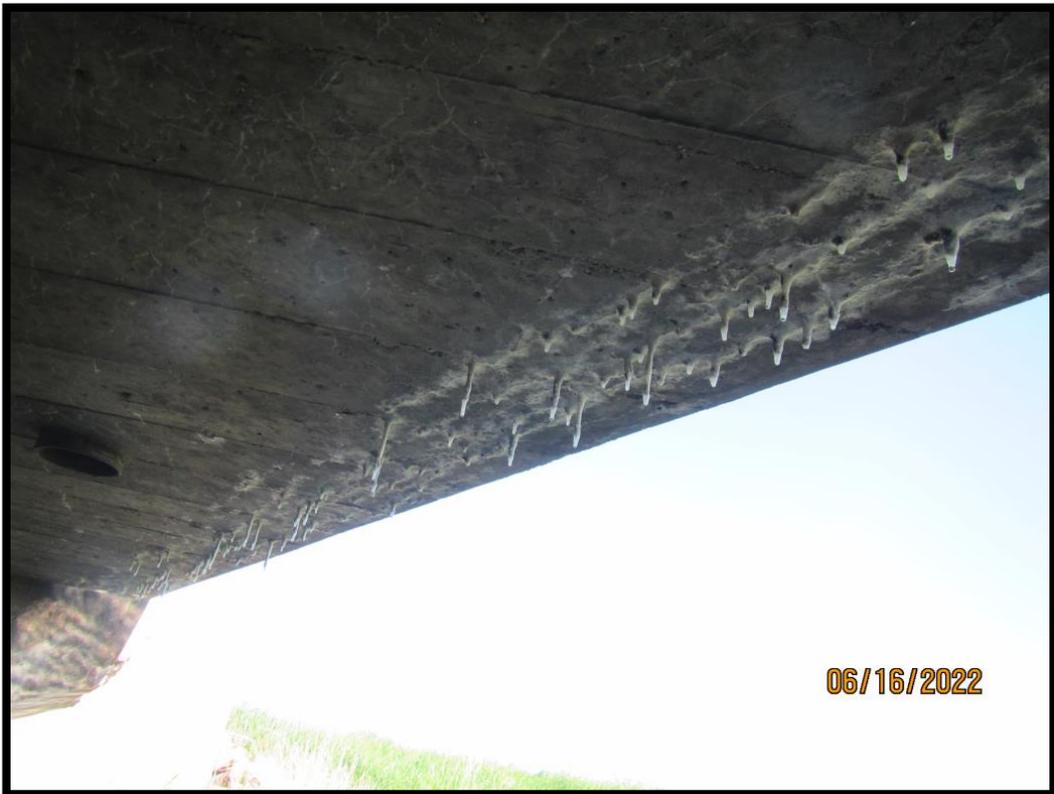
50-219-015_2022_20_CDI_Underside of North Edge of Slab in East Span
with Stalactites

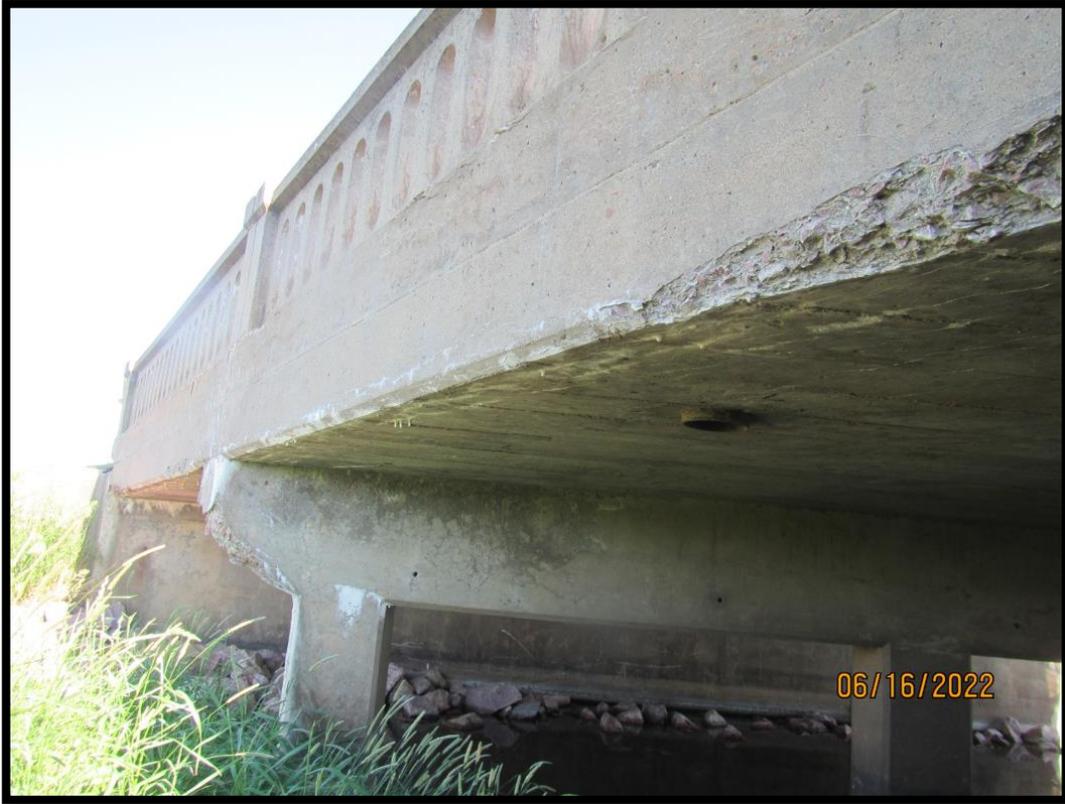
50-219-015_2022_21_CDI_South Edge of Slab with Efflorescence and Minor Stalactites

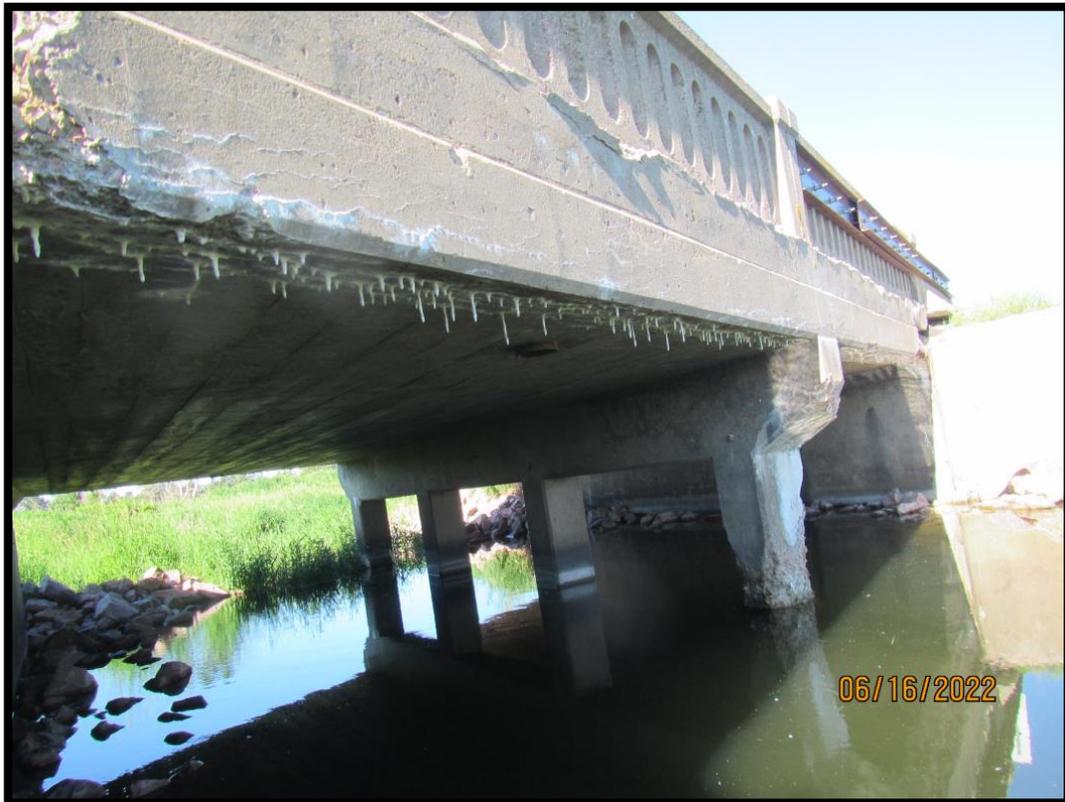
50-219-015_2022_22_CDI_North Edge of Slab with Active Stalactite Dripping

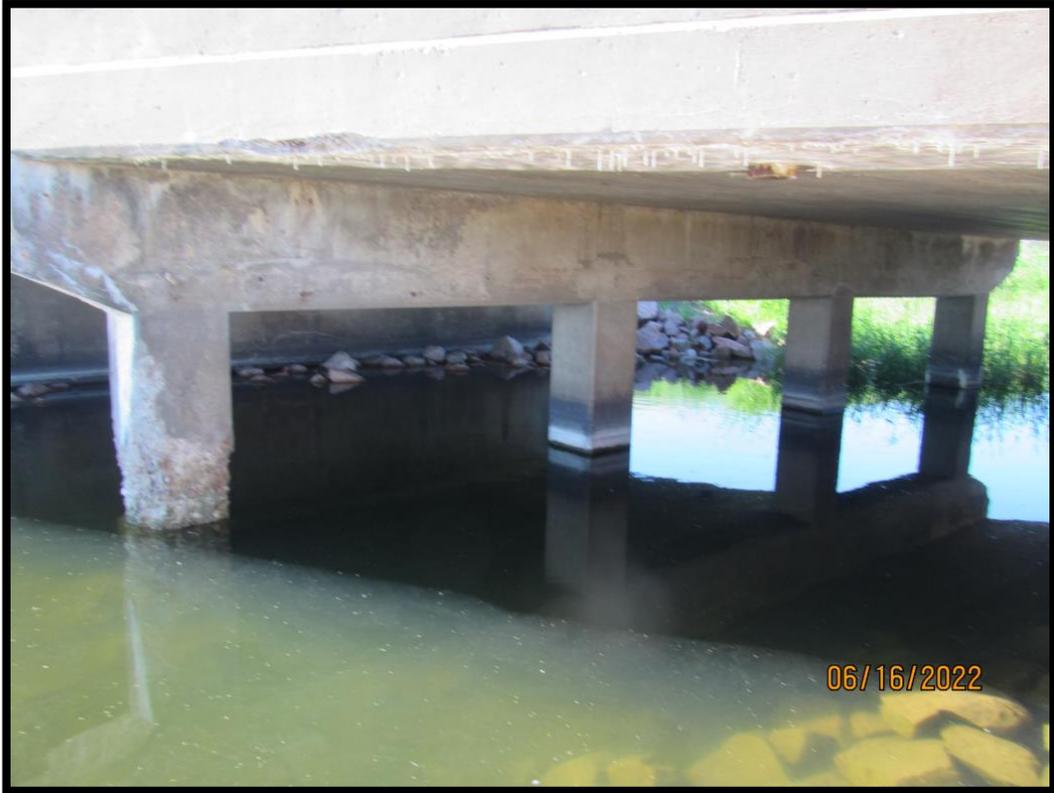
50-219-015_2022_23_CDI_Center Bent

- D. PILE CAPS - None
2. PIERS OR BENTS -
 - A. CAPS - Cast-in-place concrete - The bent cap consists of a concrete beam. There are vertical hairline cracks evident between and over the columns. Significant scaling is observed along the north and south ends of the cap.

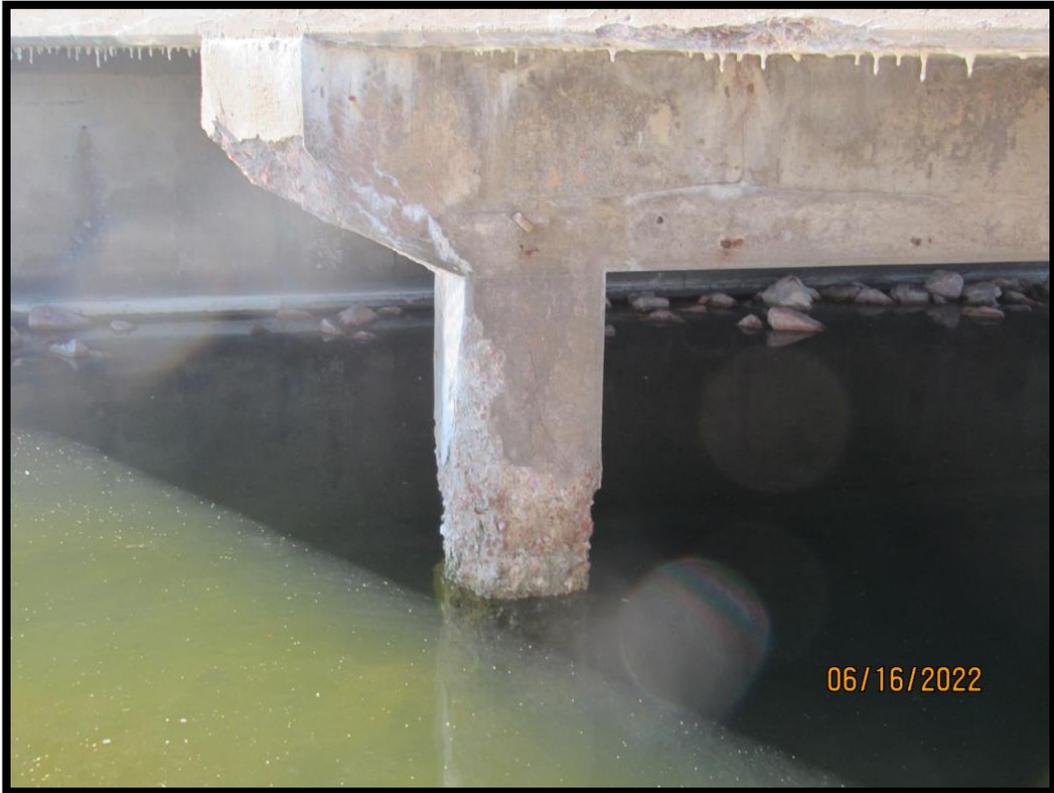
- B. COLUMNS - Cast-in-place concrete - There are four (4) concrete columns at the bent. A significant amount of scaling is evident on the north column at the bent. There does not appear to be a significant amount of section loss or exposed reinforcing steel at this time. Vertical hairline cracking is evident in the columns. The south column has efflorescence buildup along the south face which appears to be coming from the underside of slab and from the scaling bent cap.

50-219-015_2022_24_CDI_North Bent Column Scaling

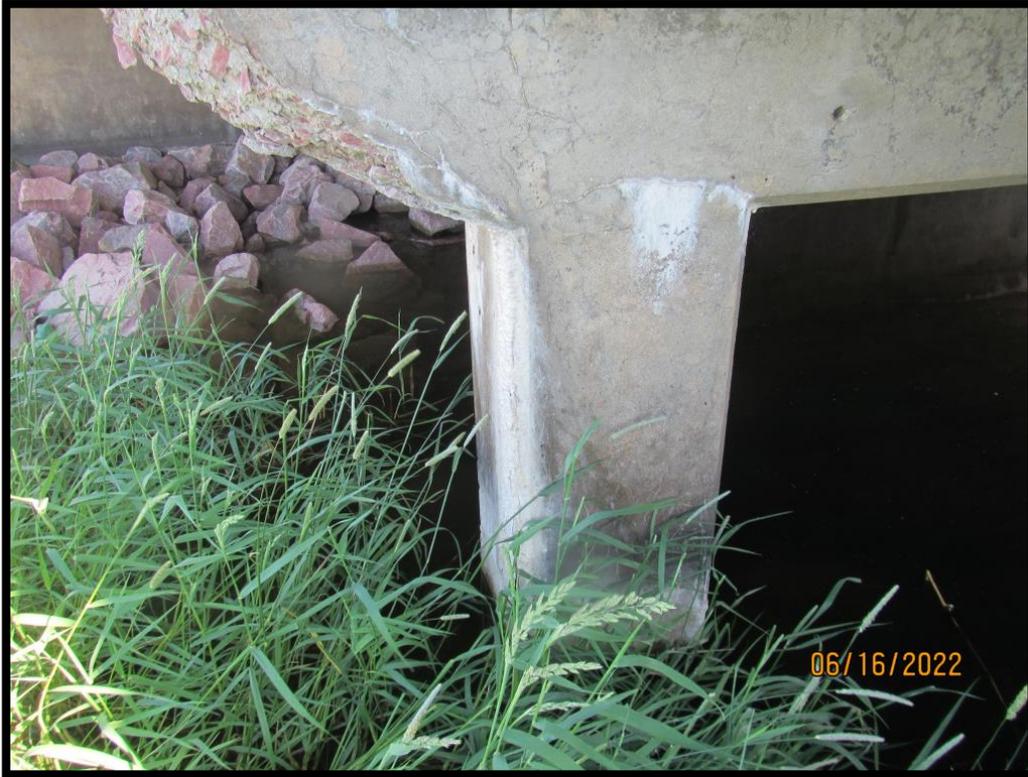
50-219-015_2022_25_CDI_Center Bent South Column Efflorescence Buildup

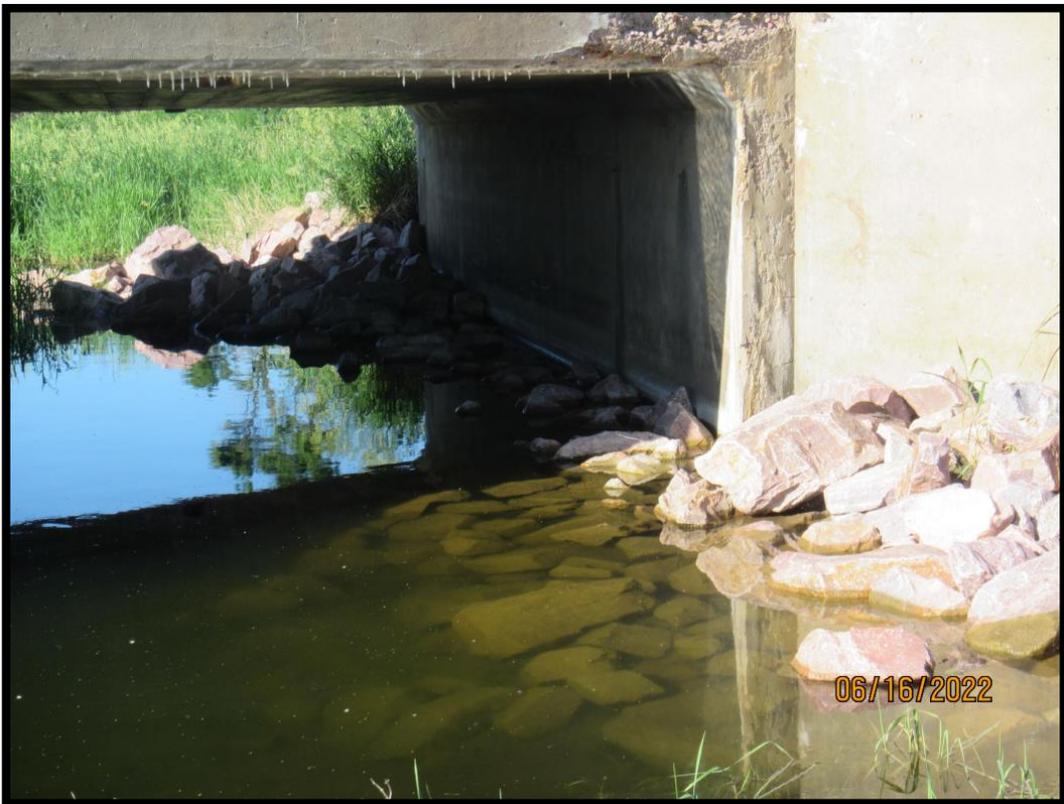
1. CHANNEL -
 - A. ALIGNMENT - The channel alignment is good.
 - B. VEGETATION - Good
 - C. SCOUR - Previously, a minor to moderate amount of scour appeared to be occurring in front of the backwalls as the footings could be felt. The north half of the east backwall footings were beginning to undermine, due to approximately 3 feet of scour. Approximately 2-3 feet of scour at inlet and under north half of structure were evident. This scour and undermining has been mitigated with riprap along the east and west abutments.

50-219-015_2022_28_CDI_Riprap in front of West Abutment

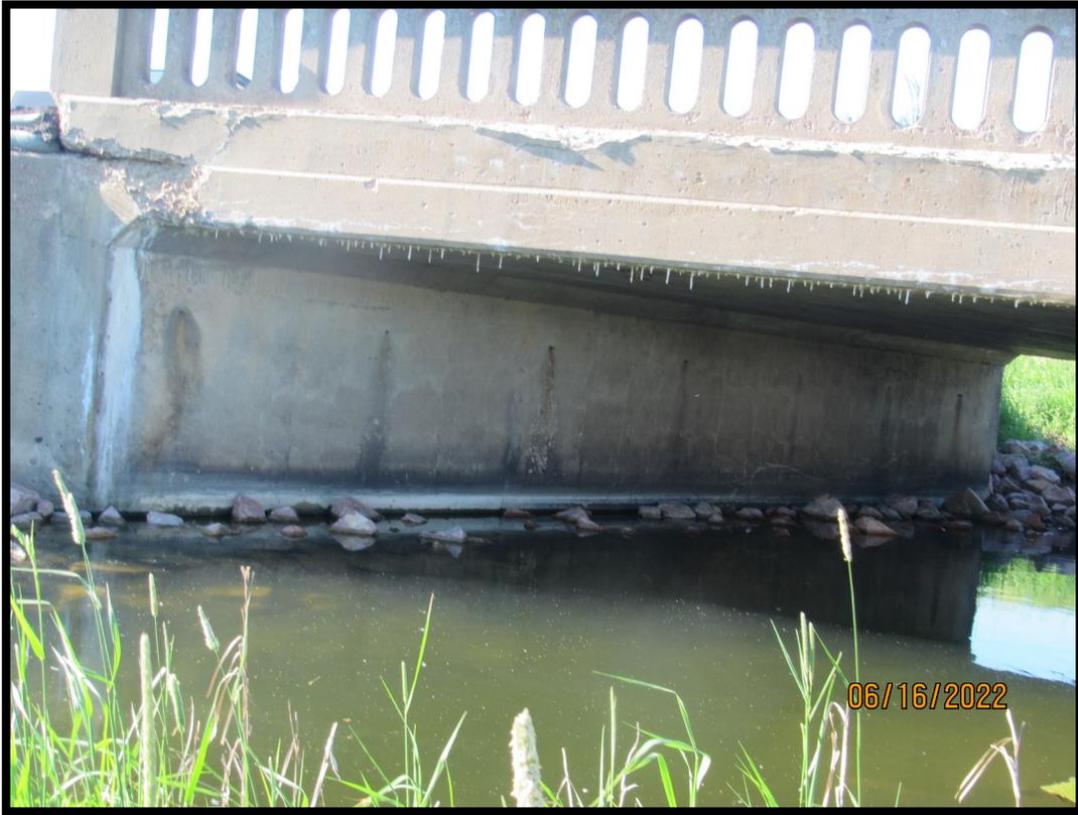
50-219-015_2022_29_CDI_Riprap in front of East Abutment
