Bridge Inspection Report for Minnehaha County South Dakota 2022

Structure No. 50-277-015 Jasper Street / Co. Hwy 104

Bridge Inspection Report

Structure No. 50-277-015 **Maint. Proj. No.** _____
Feature Carried Jasper St. / Co. Hwy. 104 **County** Minnehaha Co.
Feature Crossed West Pipestone Creek
Location 7.3 miles east and 0.2 miles north of Dell Rapids, SD.
Bridge Description 70.8 ft Four Span Continuous Concrete Bridge with Concrete Abutments.
0 Degree Skew - 24.3 ft Roadway Width.

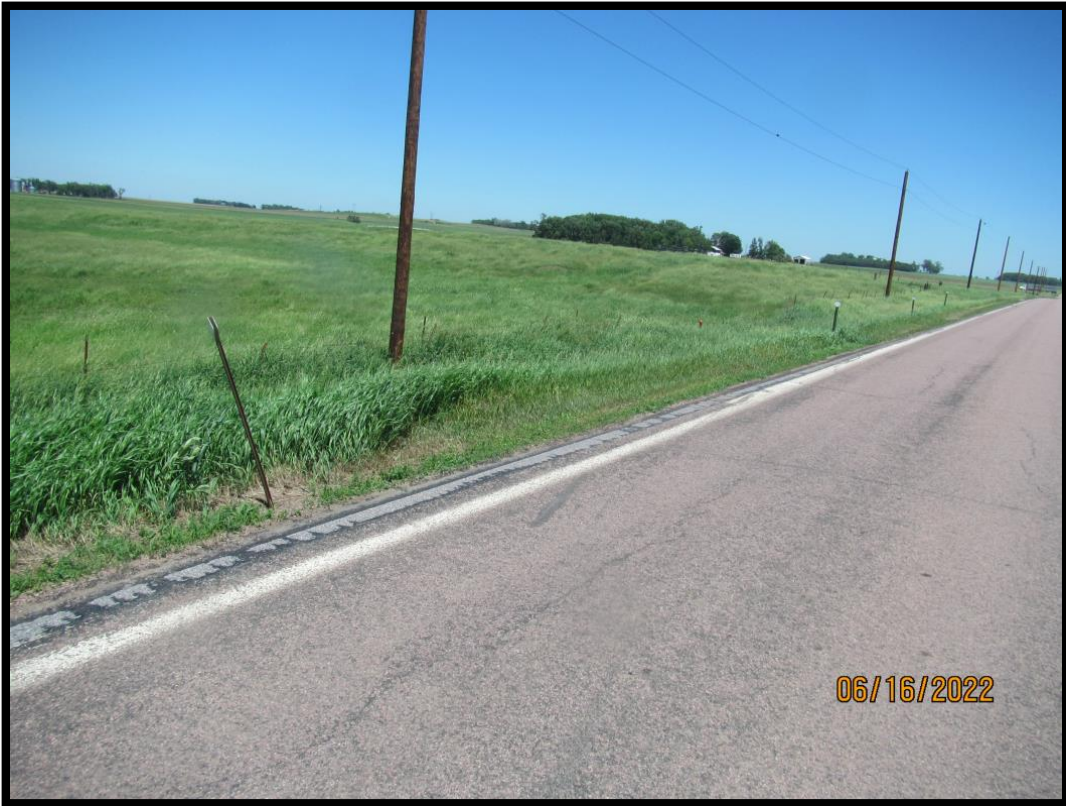
Delineators - There are four (4) delineators located off of all four (4) corners of the structure. The 1st NE approach delineator and 4th SW approach delineator are bent downward.
8. GPS COORDINATES - Latitude: 43.82635 North Longitude: -96.57830 West

50-277-015_2022_5_CDI_1st NE Approach Delineator Bent

1. Straighten 1st NE and 4th SW approach delineators that are bent.
2. Install bridge railing rubrails and approach guardrails as required.
3. Clear deck drains as required.
4. Monitor scour at the bents.
5. **Structure is currently in the 5-year capital improvement plan & scheduled for future replacement.**

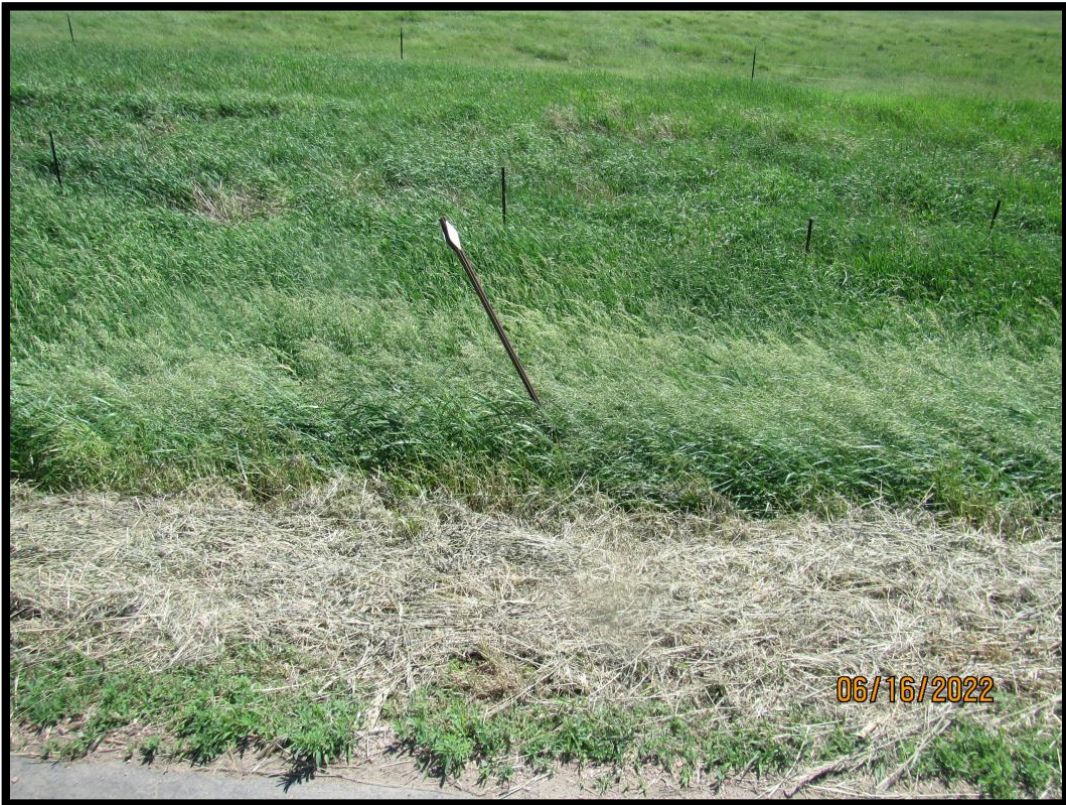
50-277-015_2022_6_CDI_4th SW Approach Delineator Bent

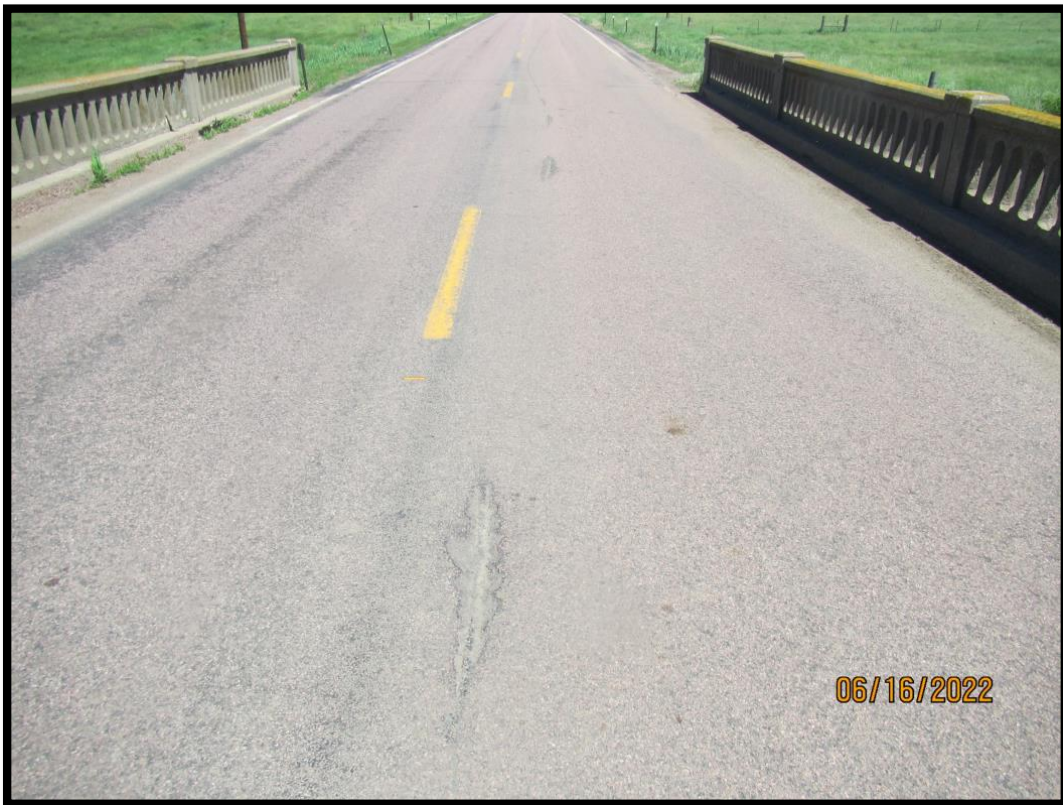
Bituminous - Approximate 5-inch average depth. There are three (3) gouges in overlay toward centerline of eastbound lane due to an apparent piece of dragging equipment.
3. JOINTS - OPENINGS -

50-277-015_2022_8_CDI_Bituminous Overlay Gouges in Eastbound Lane

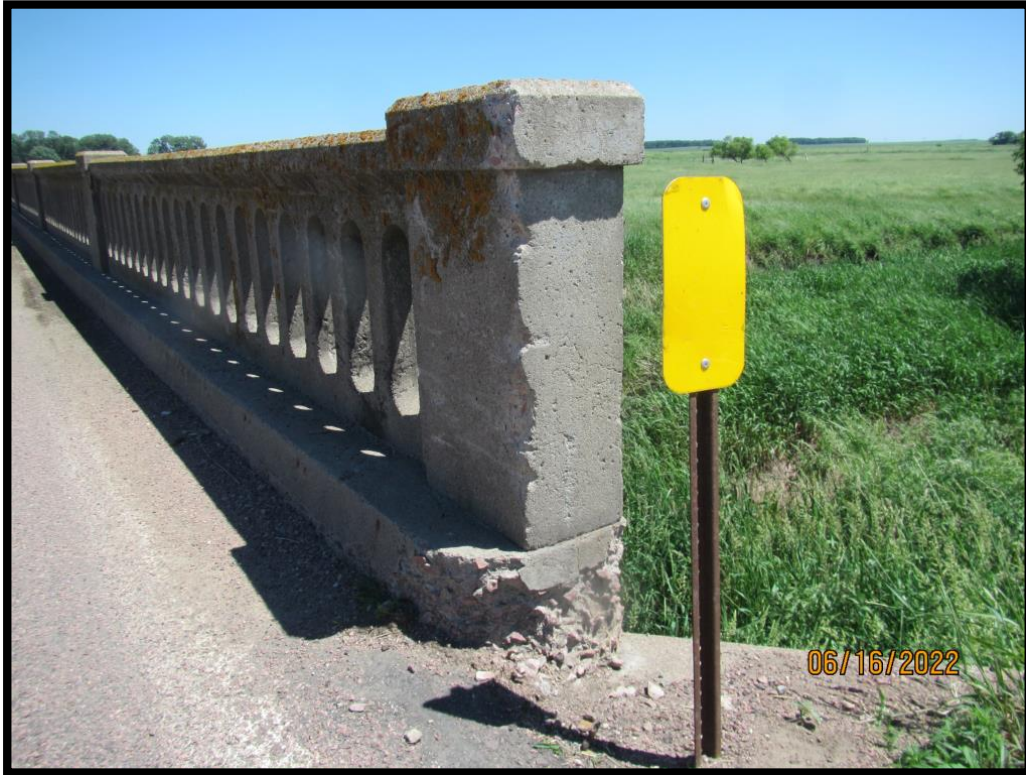
Cast-in-place concrete - A significant amount of spalling and scaling is evident along the inside face of the north curb. There is some section loss evident in the face of the north curb over the east bent. The south curb exterior face has a vertical crack over center bent. A moderate amount of scaling is evident along the inside face of the south curb. A significant amount of the spalling and exposed reinforcing steel is evident at the east end of the north and south curbs.
6. SIDEWALKS -

50-277-015_2022_9_CDI_SW Concrete Curb and Railing Spall

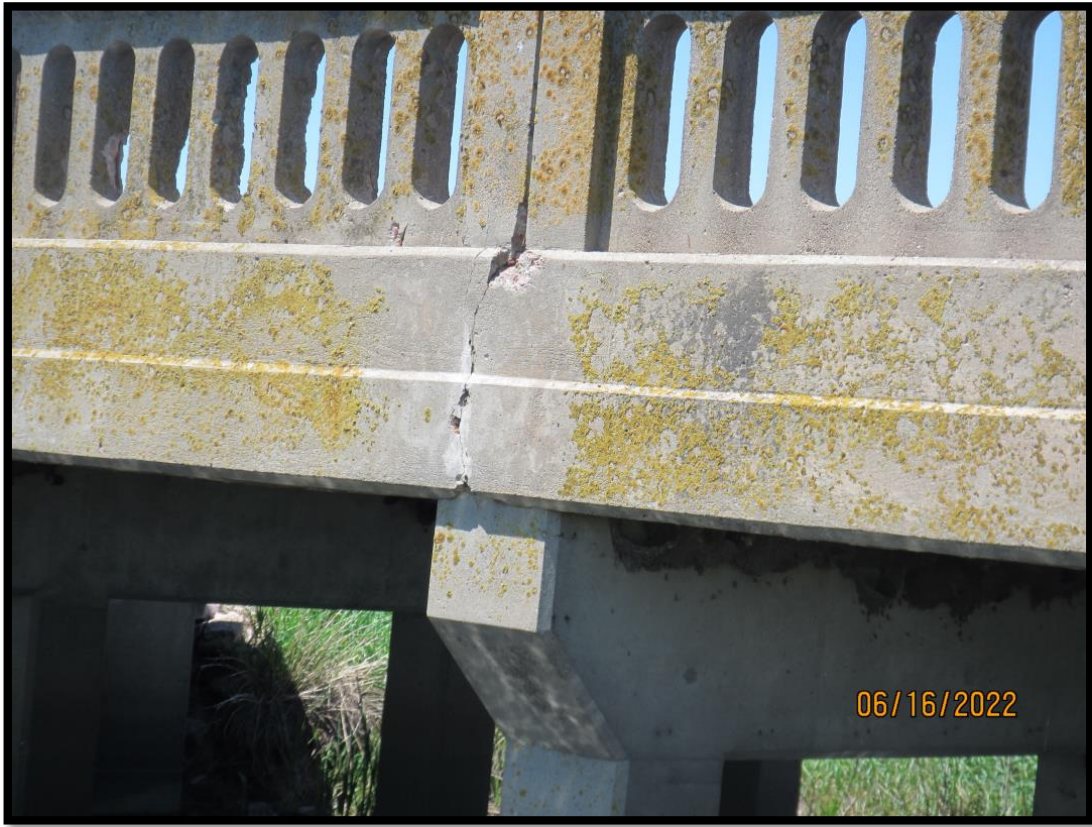
50-277-015_2022_13_CDI_South Curb and Slab Vertical Crack over Center Bent

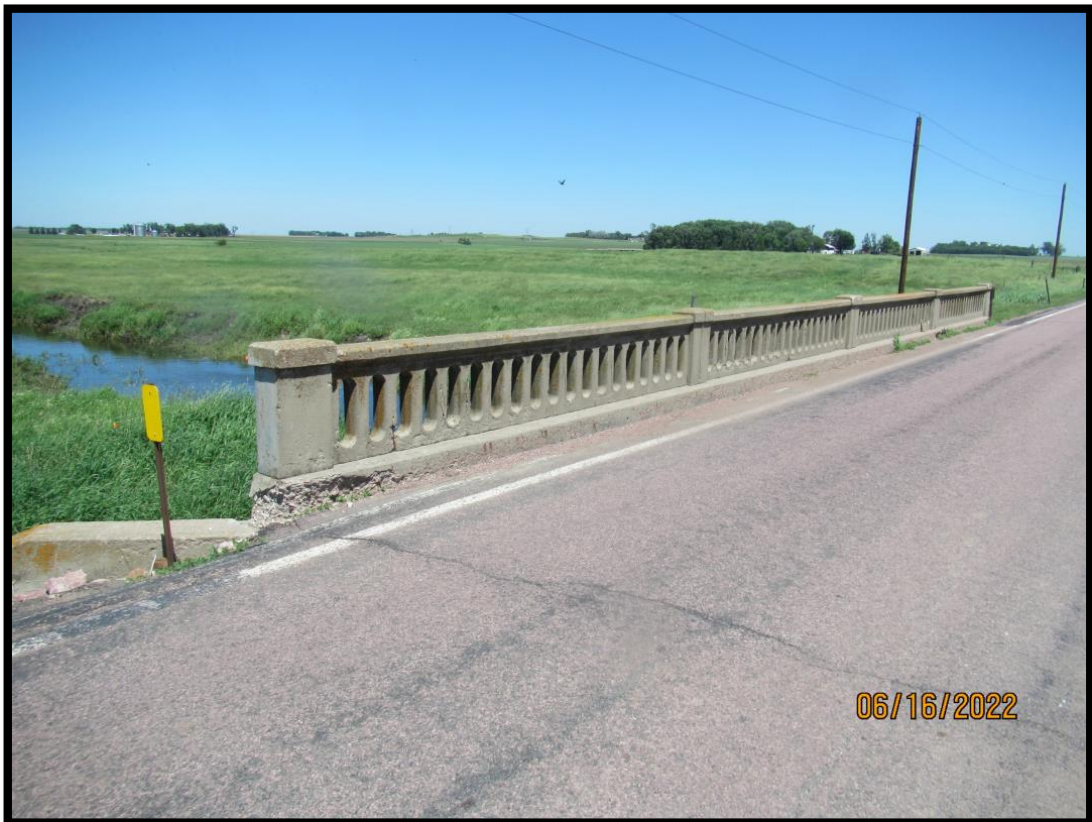
50-277-015_2022_14_CDI_North Bridge Rail

The railings consist of reinforced concrete pigeon hole railings. Several spalls, cracks, and areas of exposed reinforcing steel are evident throughout. The south railing has a moderately to heavily weathered appearance with some moss evident on the surface of the railing. There are some small chips and some scrapes evident at the west end of the south railing. It appears these chips and scrapes are due to a vehicle impact.
8. LIGHTING -

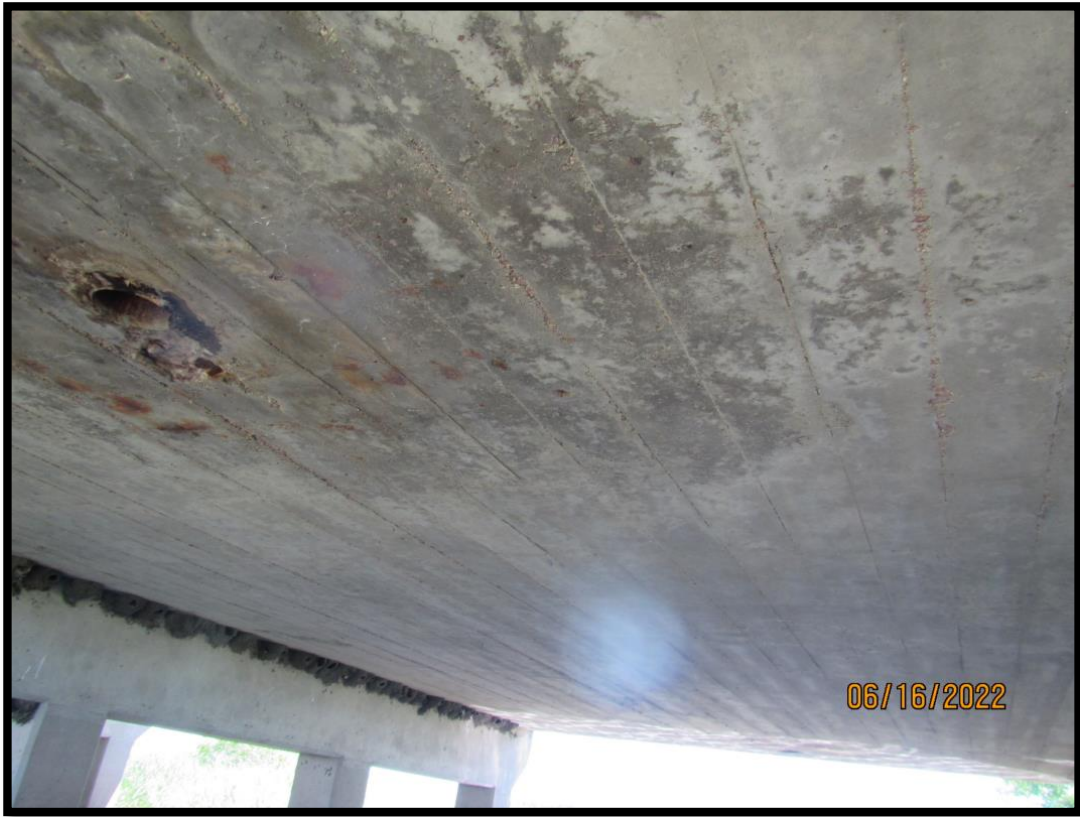
50-277-015_2022_17_CDI_Underside of Slab Span #2

| 1. UNDERSIDE OF DECK - | Cast-in-place concrete - There are longitudinal hairline cracks evident towards the center portion of the slab. Some areas of minor honeycombing are evident throughout. There is an approximate 4 ft x 8 ft area of map cracking and efflorescence along the north side of the west span. There are several cementitious patches in span #3 from the west. It appears these patches are filling some honeycombed areas. Large spalls, which have exposed reinforcing steel, are evident at several of the deck drain locations. Some of the exposed reinforcing steel is plating with minor section loss. The exposed portions of the reinforcing steel have a heavily rusted appearance. |

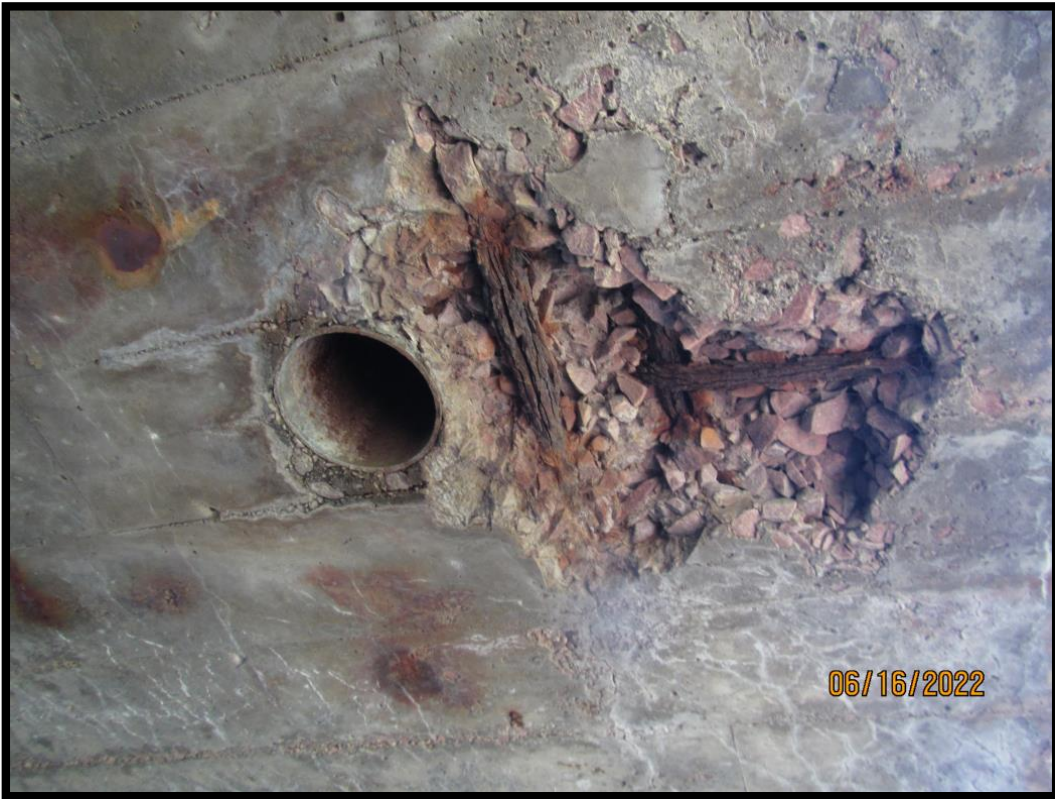
Deck drains - The deck drains have been overlaid with the bituminous overlay and are plugged.
5. CURBS AND MEDIAN -

50-277-015_2022_20_CDI_Underside of Slab Span #4 Spall with Exposed Rebar at North Deck Drain

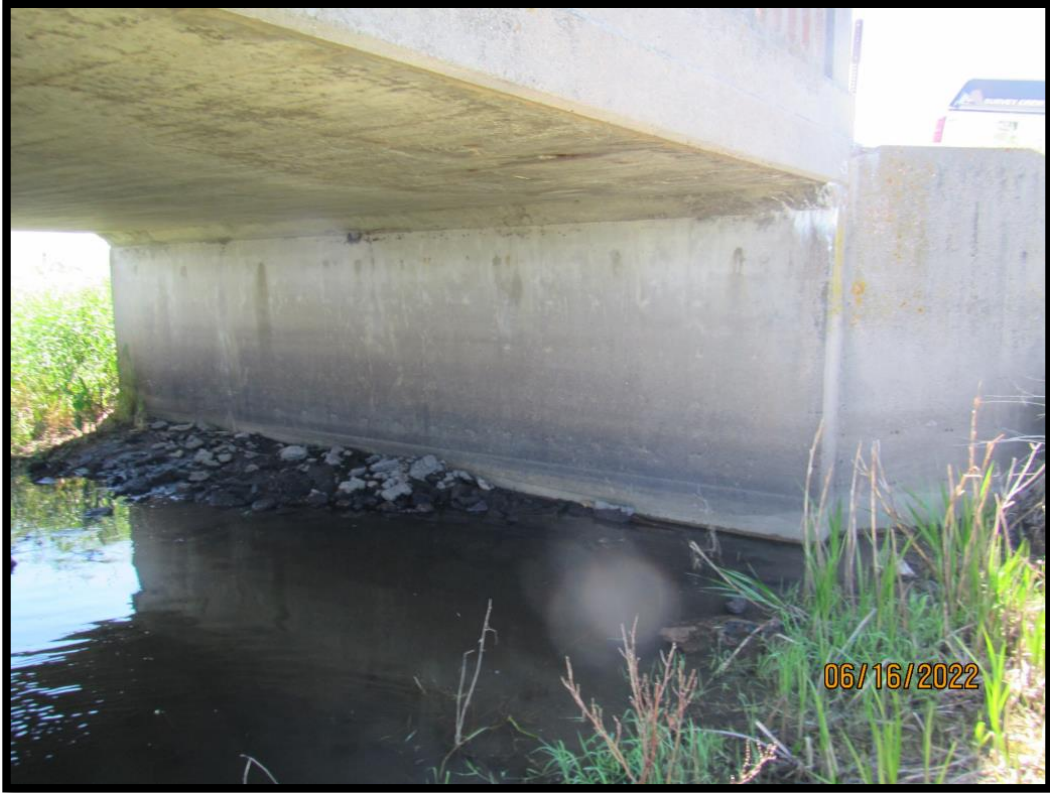
50-277-015_2022_21_CDI_West Abutment

1. ABUTMENTS -
 - A. WINGWALLS - Cast-in-place concrete - The wingwalls have areas of light to moderate scaling evident, but overall, the wingwalls appear to be in satisfactory condition.
 - B. BACKWALLS - Cast-in-place concrete - Some vertical hairline cracks and areas of light to moderate scaling are evident, but overall, the backwalls appear to be in satisfactory condition.
 - C. FOOTINGS - None
 - D. PILE CAPS - None

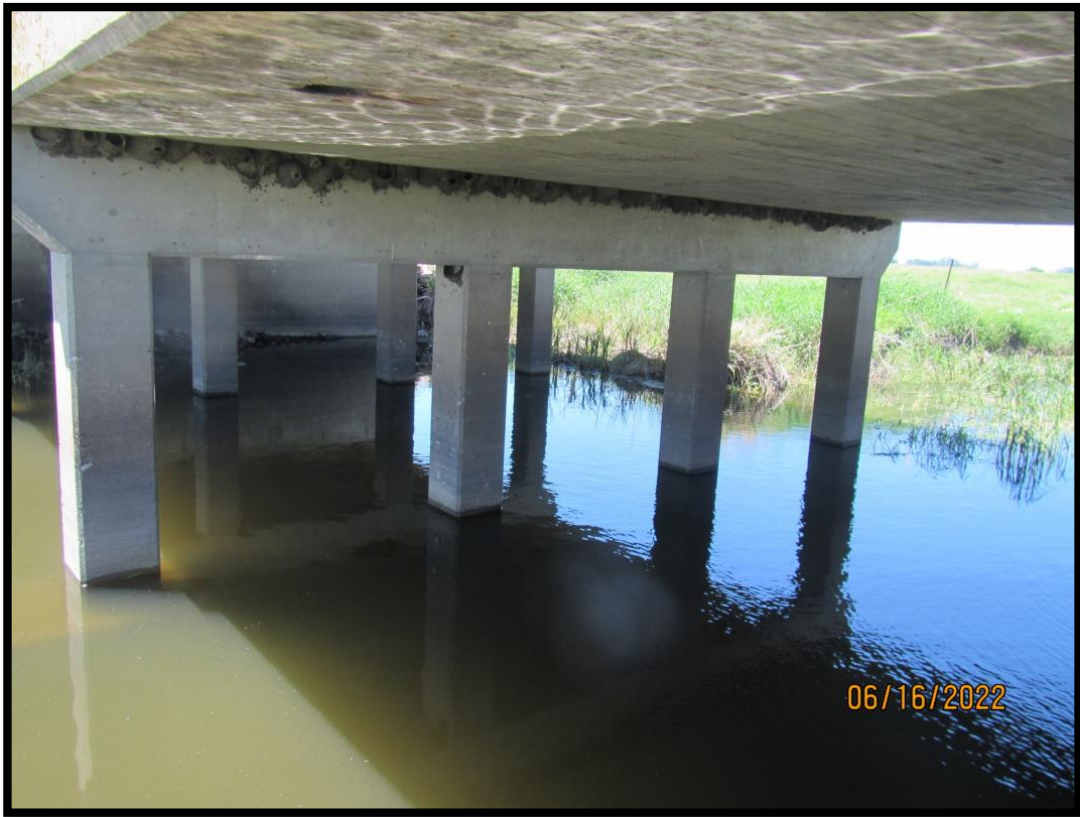
50-277-015_2022_23_CDI_Typical Configuration of Bent

2. PIERS OR BENTS -
 - A. CAPS - Cast-in-place concrete - The bent caps consist of concrete beams. There are vertical cracks, slightly bigger than hairline, evident between, and over, the columns. Overall, the bent caps appear to be in relatively good condition.
 - B. COLUMNS - Cast-in-place concrete - There are four (4) concrete columns per bent (12 total columns). Areas of scaling are evident, but overall, the concrete columns appear to be in relatively good condition.
 - C. FOOTINGS - Bent footings are exposed but do not appear to be undermined. It appears they observed scour previously and are actively silting back in.

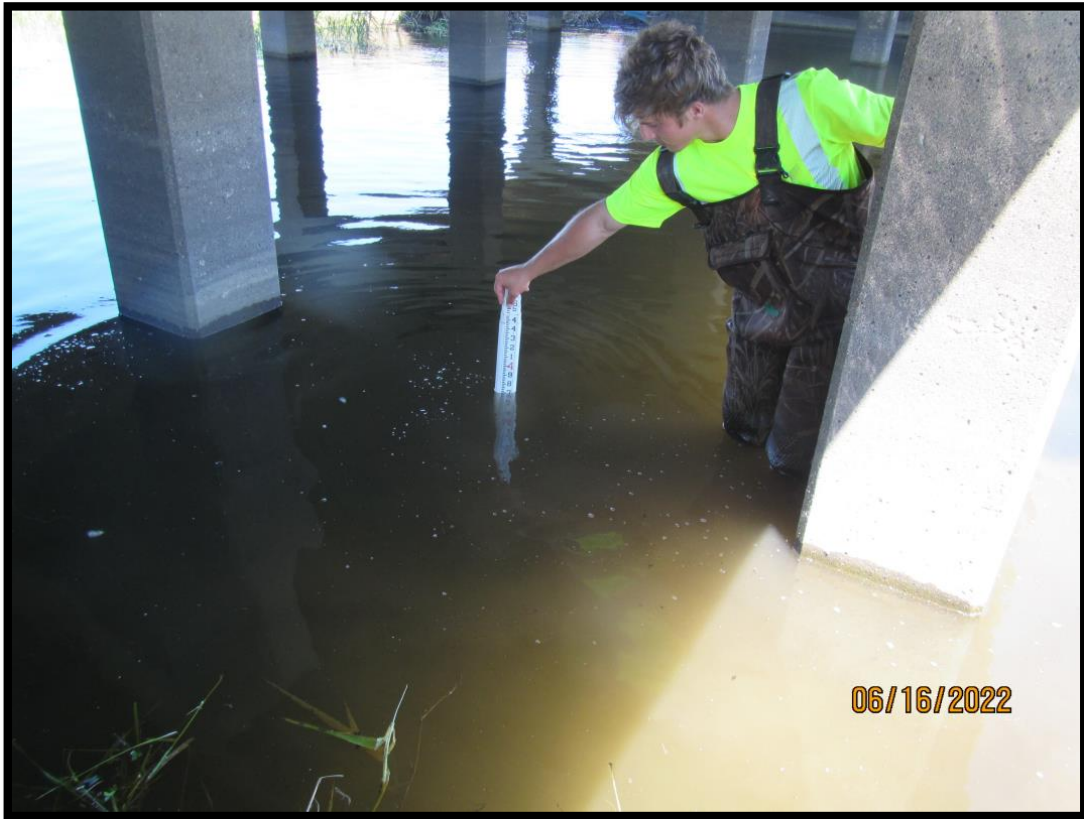
1. CHANNEL -
 - A. ALIGNMENT - The channel alignment is good.
 - B. VEGETATION - Good
 - C. SCOUR - Moderate scour of approximately 3 feet at column #1 & #2 footings (2020 - 3'-5' scour) in the west and center bent. Previously observed scour at upstream side of structure has silted back in, but downstream side still has approximately 3 feet of scour. Scour does not appear to be endangering structure at the time of inspection.

50-277-015_2022_27_CDI_Scour at West Bent between Column #1 and #2

CURRENT 2022 INSPECTION - Moderate scour of approximately 3 feet at column #1 & #2 footings (2020 - 3'-5' scour) in the west and center bent. Previously observed scour at upstream side of structure has silted back in, but downstream side still has approximately 3 feet of scour. Scour does not appear to be endangering structure at the time of inspection.

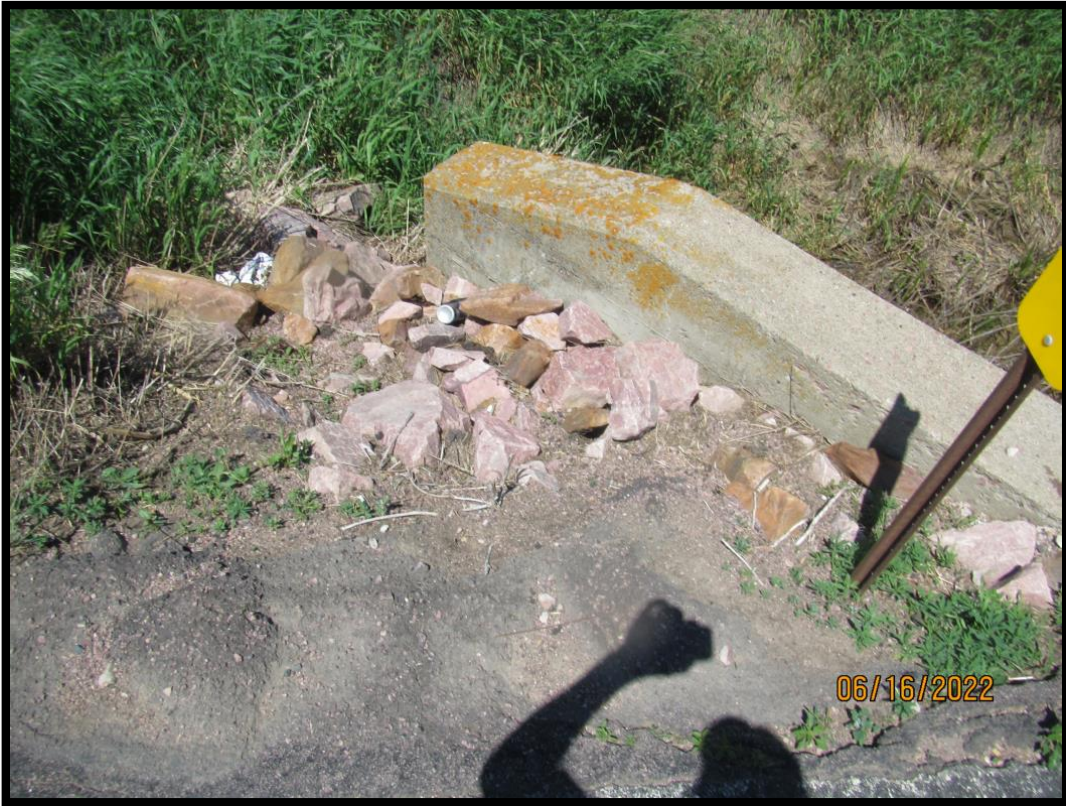
5. WING DAMS - None
6. RIP RAP - None, except as noted behind the NW and NE wingwalls.
7. OBSERVED HIGH WATER ELEVATION - Appears to be approximately 2 to 3 feet below the bottom of the concrete slab.

50-277-015_2022_29_CDI_Riprap behind NW Wingwall

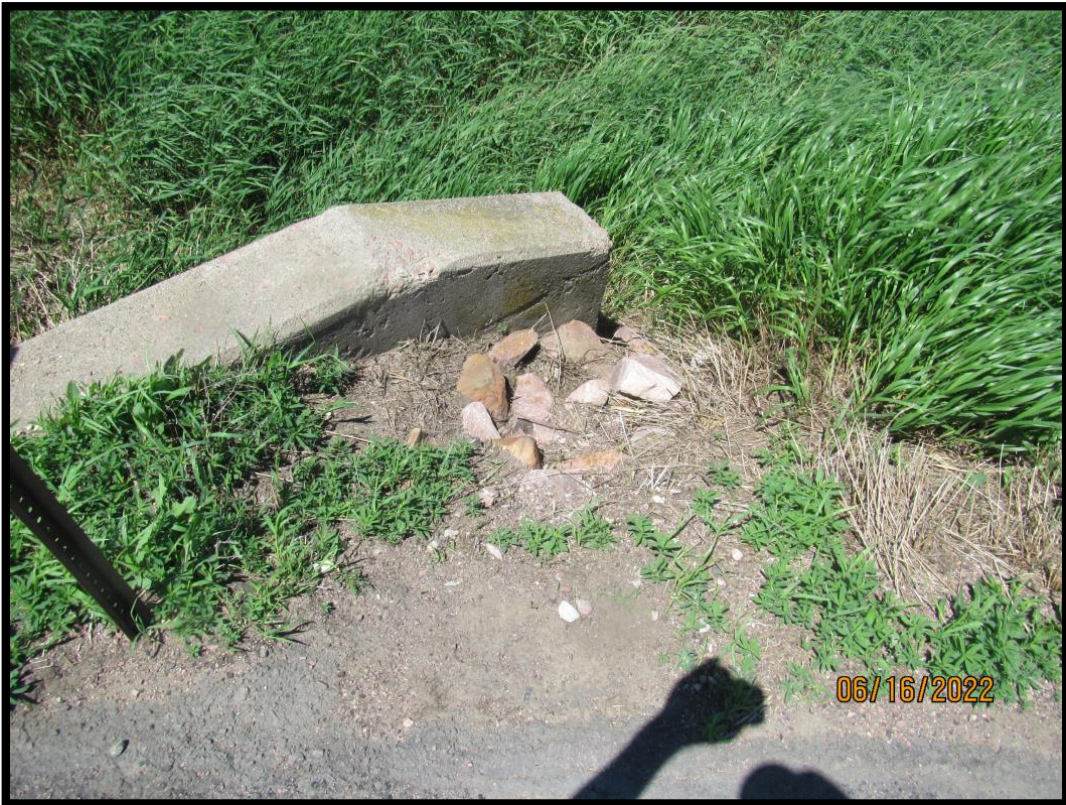
50-277-015_2022_30_CDI_Riprap behind NE Wingwall

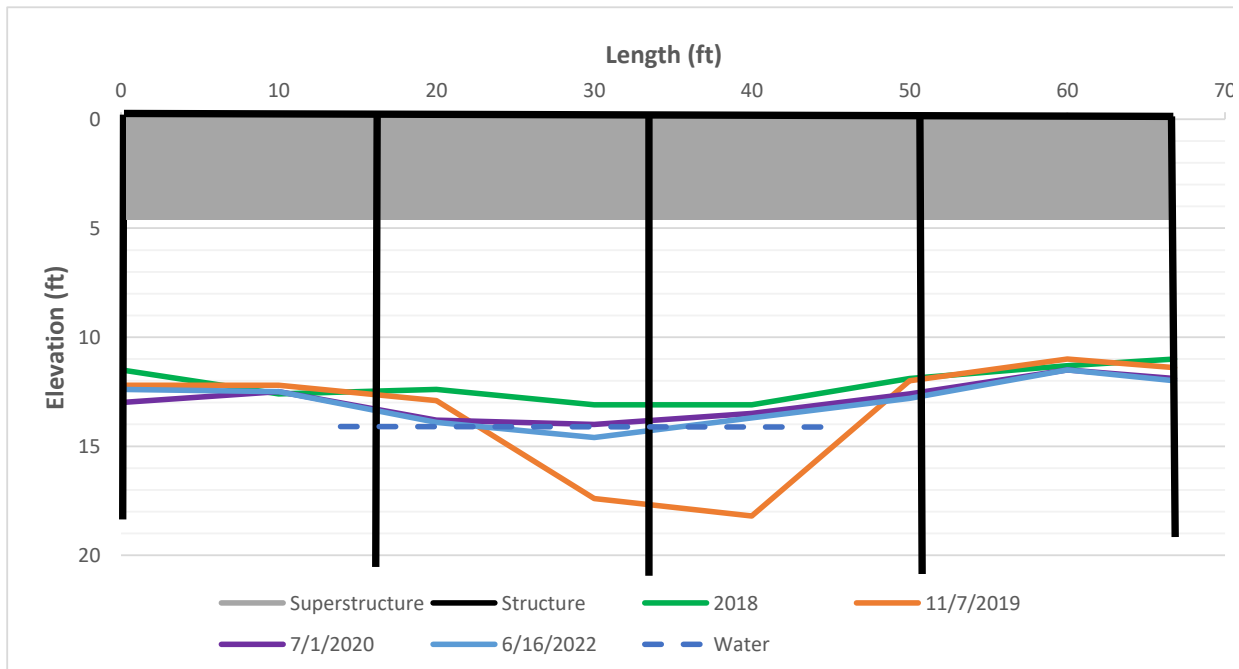
CHANNEL PROFILE

8. STREAM BED - Appears to have previously scoured at the bent locations and is actively silting back in at the structure location.

2018	11/7/2019	7/1/2020	6/16/2022
West End	0	11.5	12.2	13.0	12.4
	10	12.6	12.2	12.5	12.5
	20	12.4	12.9	13.8	13.9
	30	13.1	17.4	14.0	14.6
	40	13.1	18.2	13.5	13.7
	50	11.9	12.0	12.6	12.8
East End	66.8	11.0	11.4	11.9	12.0

OUTLET SIDE	7/1/2020	6/16/2022
At Bent 2:	16.0	13.3
At Bent 3:	17.0	13.7
At Bent 4:	12.7	12.7
