Minnesota Department of Transportation (Mn/DOT)

Historic Bridge Management Plan

Bridge Number: 4190

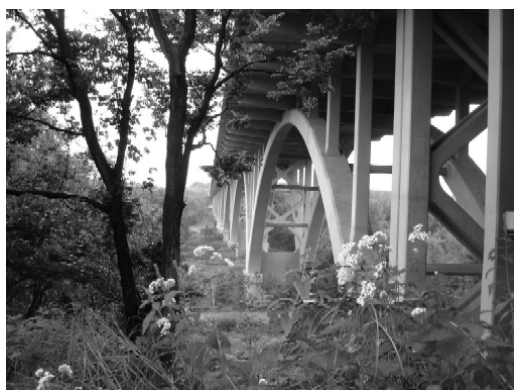
Figure 1. Looking east along the north side of bridge. Components below the deck appear in excellent condition.

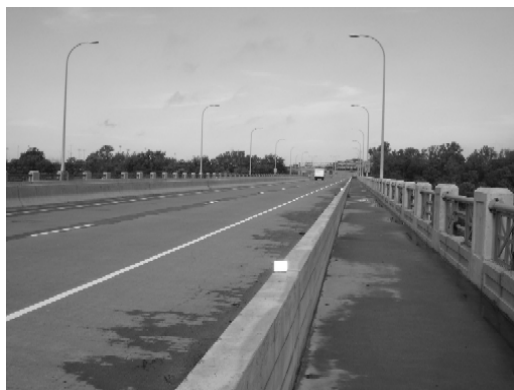
Localized ponding on both sidewalks was observed during the site visit. The galvanized steel drainage components appear in good condition.

Figure 2. Looking west from the north sidewalk near the middle of the bridge. The vehicular barriers appear in excellent condition. Localized ponding of water is evident on both sidewalks.

1. Seal the cracks on the top of the deck to minimize the intrusion of salt-laden water. Utilize standard Mn/DOT crack sealing procedures.
2. Provide penetrating sealers or durable polymeric coating, such as epoxy, on the sidewalks to minimize the intrusion of salt-laden water. Continue the coating two inches up the vertical faces of adjacent concrete barriers. The coating may require the incorporation of grit or sand to provide a surface with adequate roughness to prevent slipping by pedestrians. The color of the coating should match the existing concrete.
3. Spot paint the steel components of the ornamental pedestrian railing using standard Mn/DOT procedures to arrest corrosion.

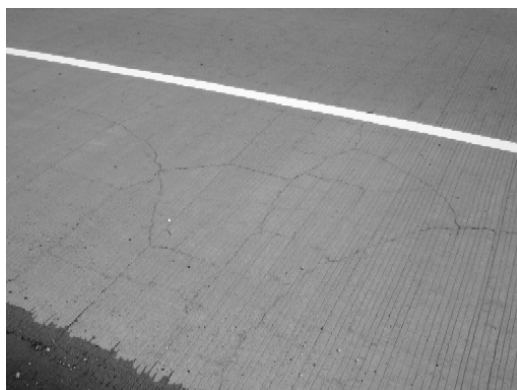
There are longitudinal cracks on the bottom of the deck over both arch ribs in most spans. Mn/DOT inspectors note longitudinal cracking on the top of the deck for the full length of the deck. Isolated map cracking in the top of the deck was also noted in the inspection report .

Figure 3. Isolated instances of map cracking appear in the deck. Longitudinal cracks in the deck are noted in the inspection report.

1. Remove the graffiti at both ends of the bridge.
2. Remove debris from the abutment seats.
3. Conduct a study to determine the cause of the longitudinal cracking in the deck. Possible causes include: restraint caused by the deck and shrinkage, a faulty reinforcing detail, temperature effects, or heavy vehicular loading. Seal cracks using bonding crack sealers, such as low viscosity epoxy or methylmethacrylate.

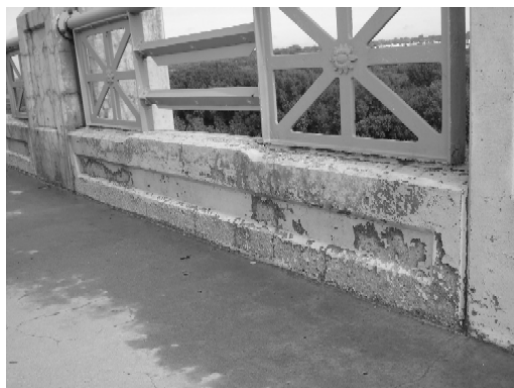
The concrete and steel components of the ornamental pedestrian railings have modest deterioration in most locations (rust staining from connections, discolored concrete, grout pop-outs). In isolated locations, the deterioration is advanced for a railing reconstructed in 1992 with significant scaling and spalling. The sides of railing elements exposed to snow-plowing operations are in poorer condition than others, due to contact with salt laden snow and minor impact damage.

The ornamental railing contains details where rectangular, cast-steel panels are embedded in a concrete base. The extended interface between the two materials appears to be a common location for accelerated deterioration.

Figure 4. Deteriorated concrete appears in the north ornamental railing. The extensive level of deterioration visible here is not typical. However, form-tie popouts, cracking, and small spalls are typical.

4. Conduct material testing of the existing ornamental railing's steel and concrete components. Determine the typical paint system characteristics and the reasons for the early failure of the paint system. Determine the characteristics of the different concretes and grouts used in the ornamental railing. Identify the reasons for the early failure of these components. Determine the level of chloride intrusion into the concrete elements.

5. Prepare construction documents and material specifications for the ornamental railing that can be used to repair the railing when warranted or to reconstruct the entire railing. For programming purposes, it is assumed that the railing needs to be reconstructed.

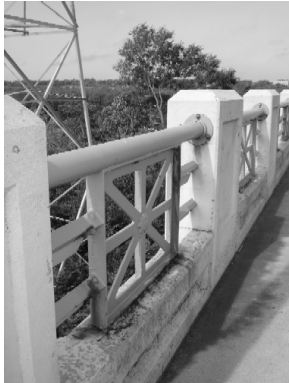
Figure 5. Deteriorated concrete and steel components in the south ornamental railing. Rust staining and scaling are more prevalent on surfaces subject to snowplow spray.

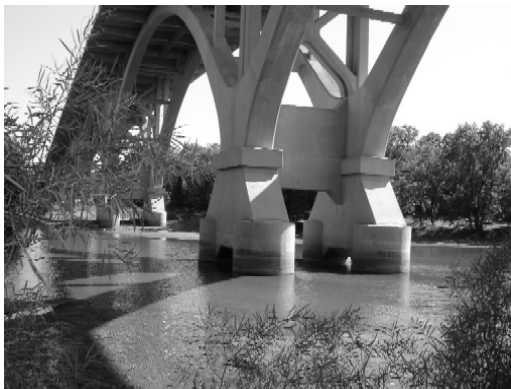
Figure 6. Arch ribs and foundation components appear in excellent condition.

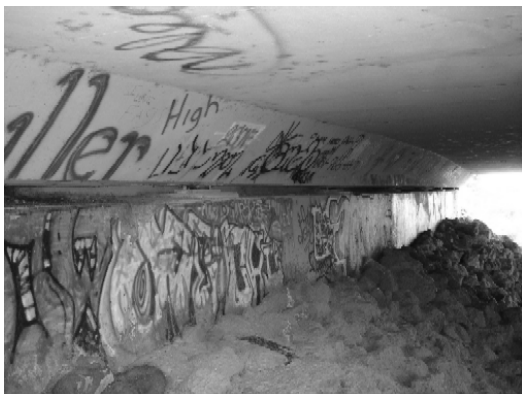
Construction debris (bits of concrete, fine and coarse aggregate) has collected on both abutment bridge seats. The debris may be the result of 1992 construction activities or subsequent replacement of expansion joint glands.

Figure 7. Graffiti and concreted rip rap at the east abutment. Debris on the bridge seats of both abutments appears to be the result of past failure of expansion joint glands.

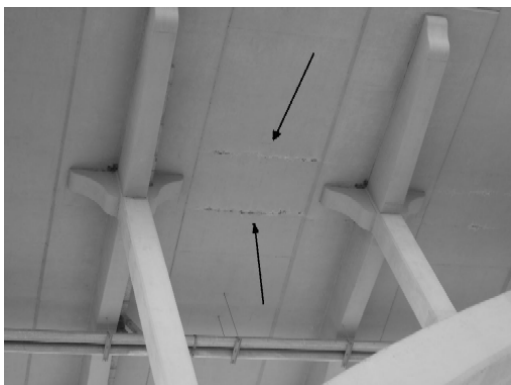
Figure 8. Longitudinal cracking in the deck over both arch ribs is typical. The galvanized drainage system components appear in good condition.
