INTERSTATE 94 over SUNSET DR/NW MANDAN INT.

Location: 5 EAST OF ND 25

Inspection Date: 04/26/2023

IDENTIFICATION	
(1) State Names	38 - North Dakota
(8) Structure Number	0094-152.329 L
(5) Inventory Route	1
(2) Highway Agency District	1 - Bismarck
(3) County Code	30 - Morton

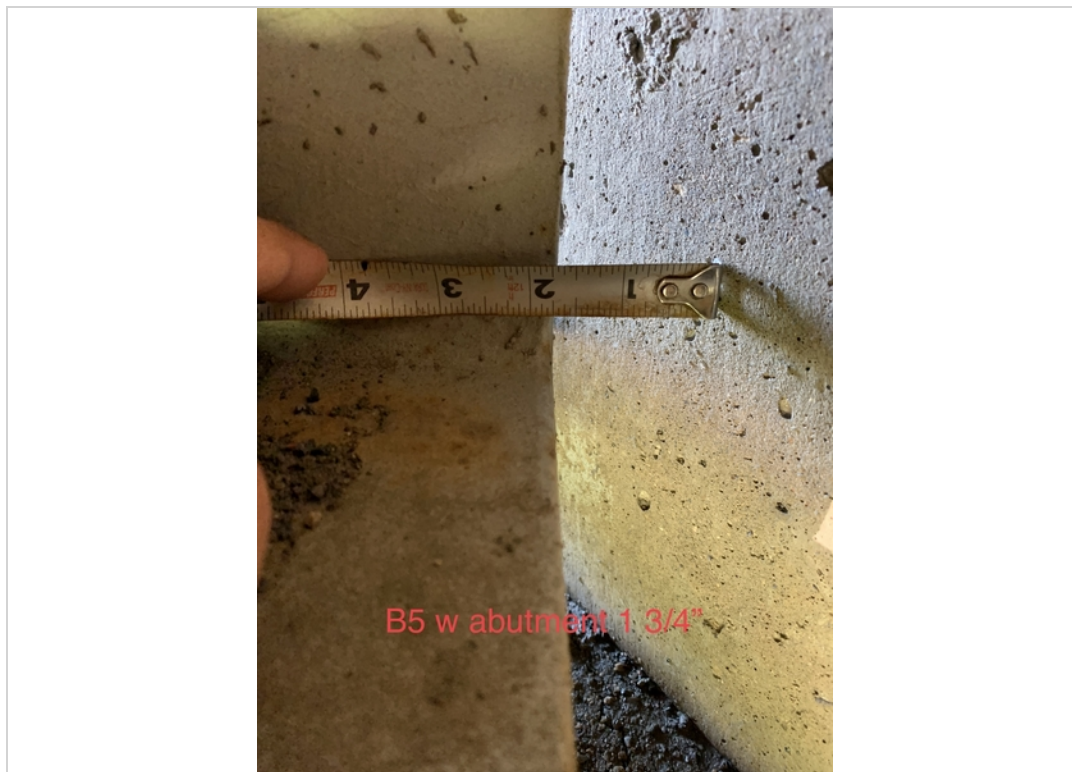
Beam5 west abutment 1 3/4"

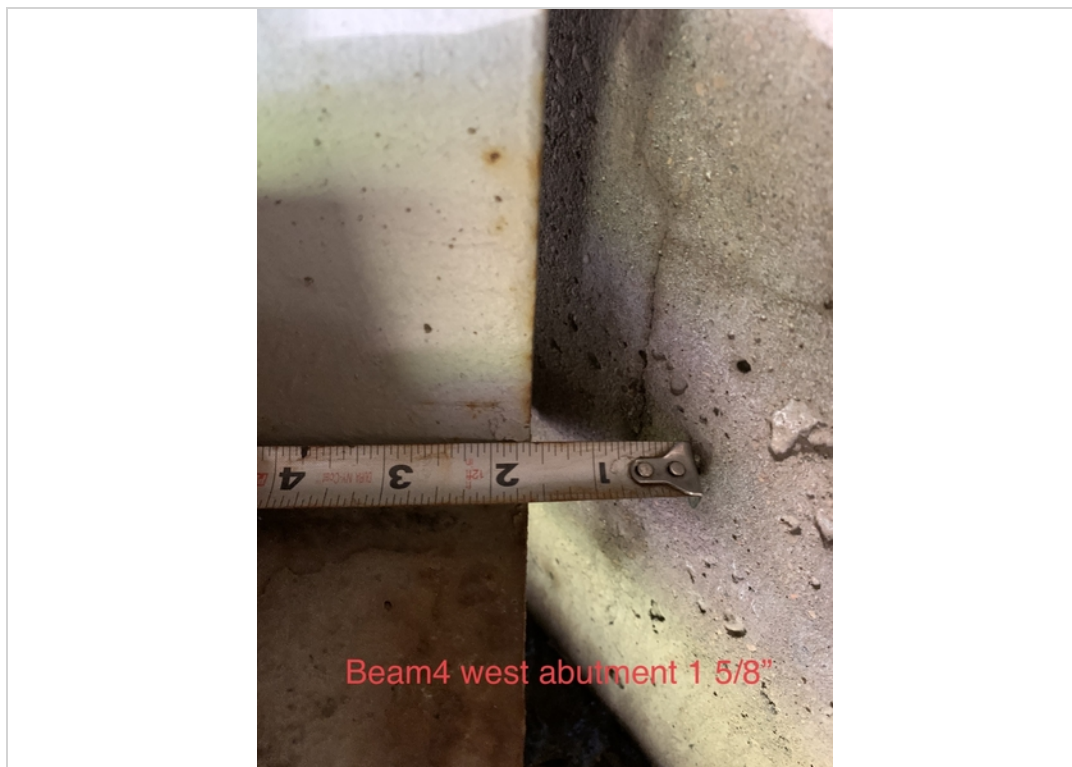
Beam 4 west abutment 1 5/8"

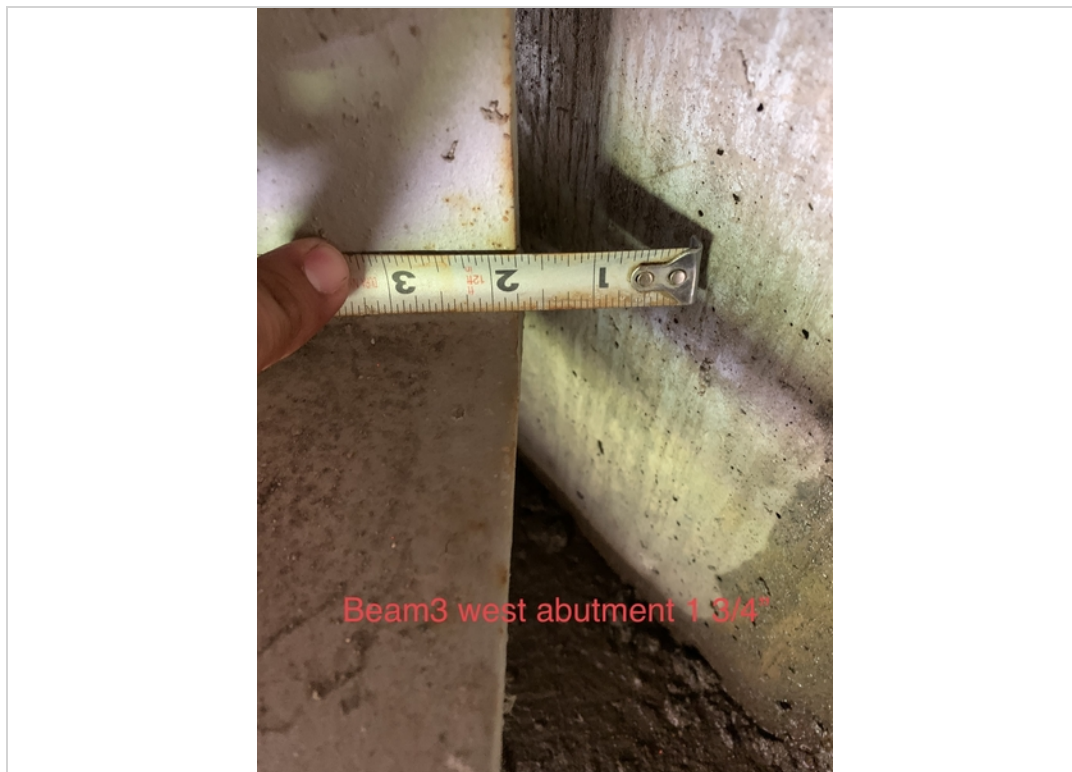
Beam 3 west abutment 1 3/4"

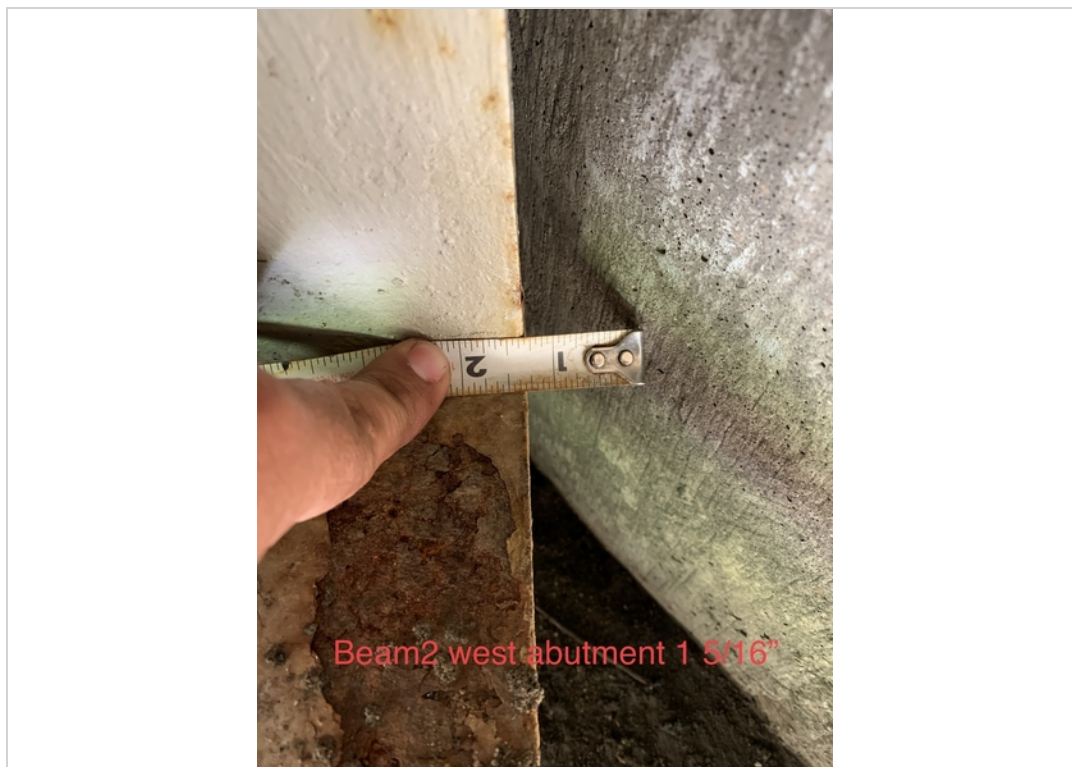
Beam 2 west abutment 1 5/16"

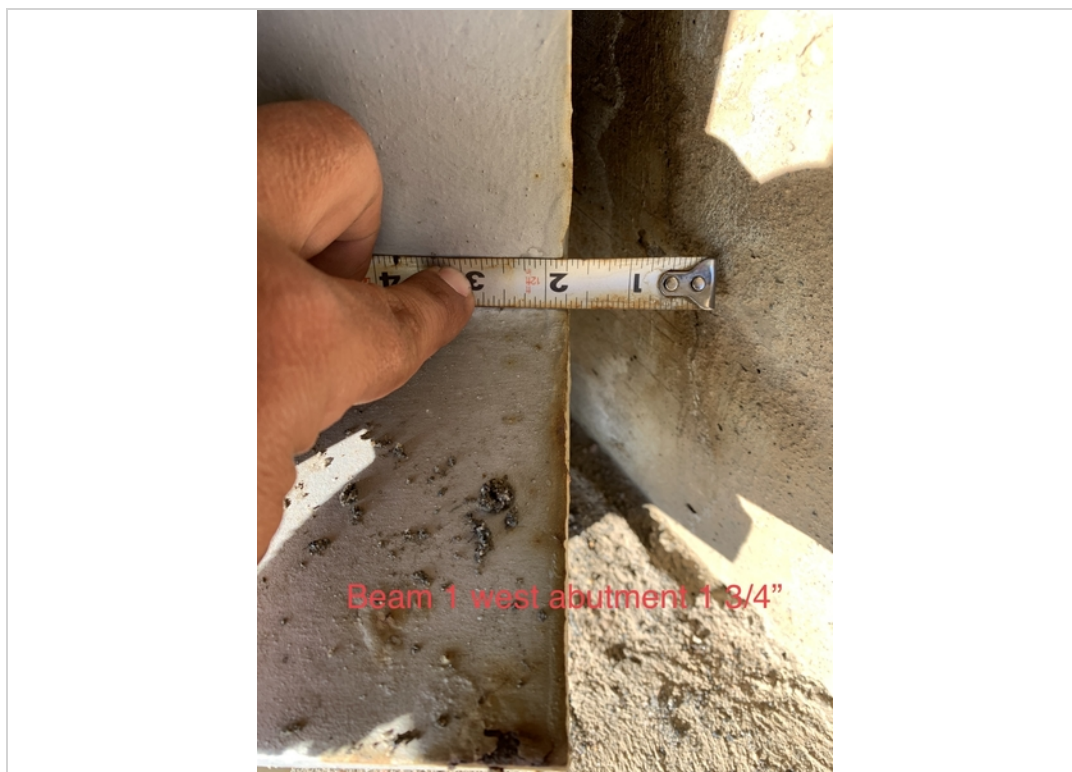
Beam 1 west abutment 1 3/4"

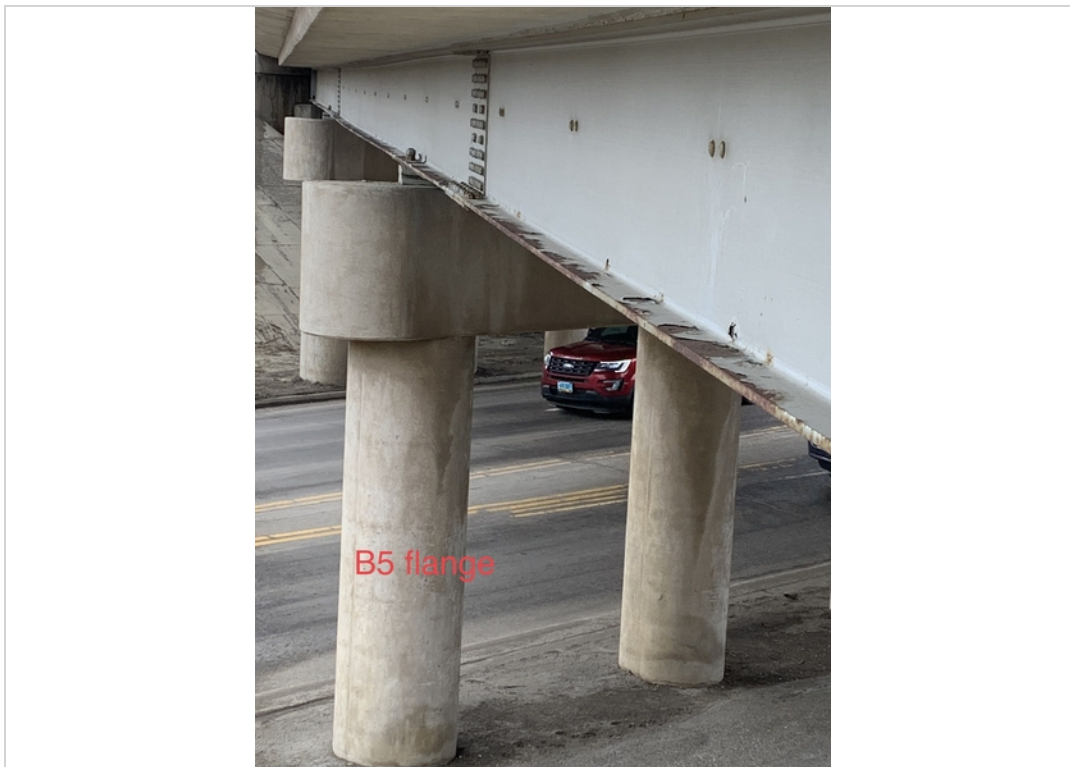
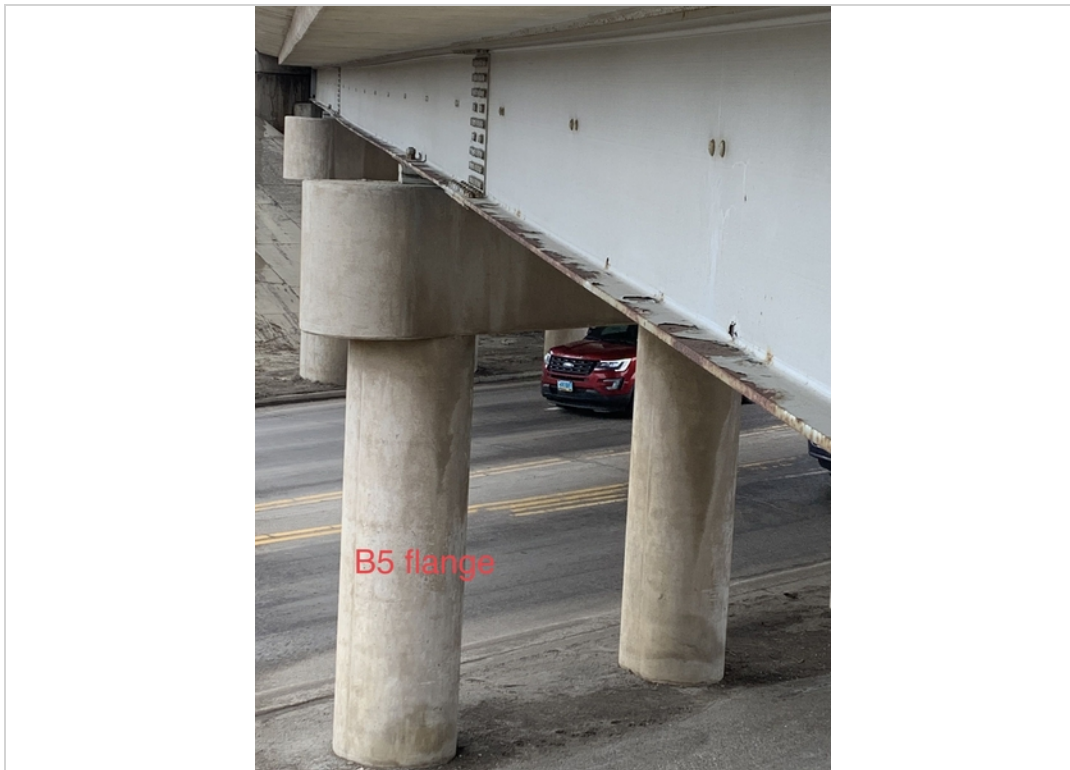
Beam 5 flange corrosion

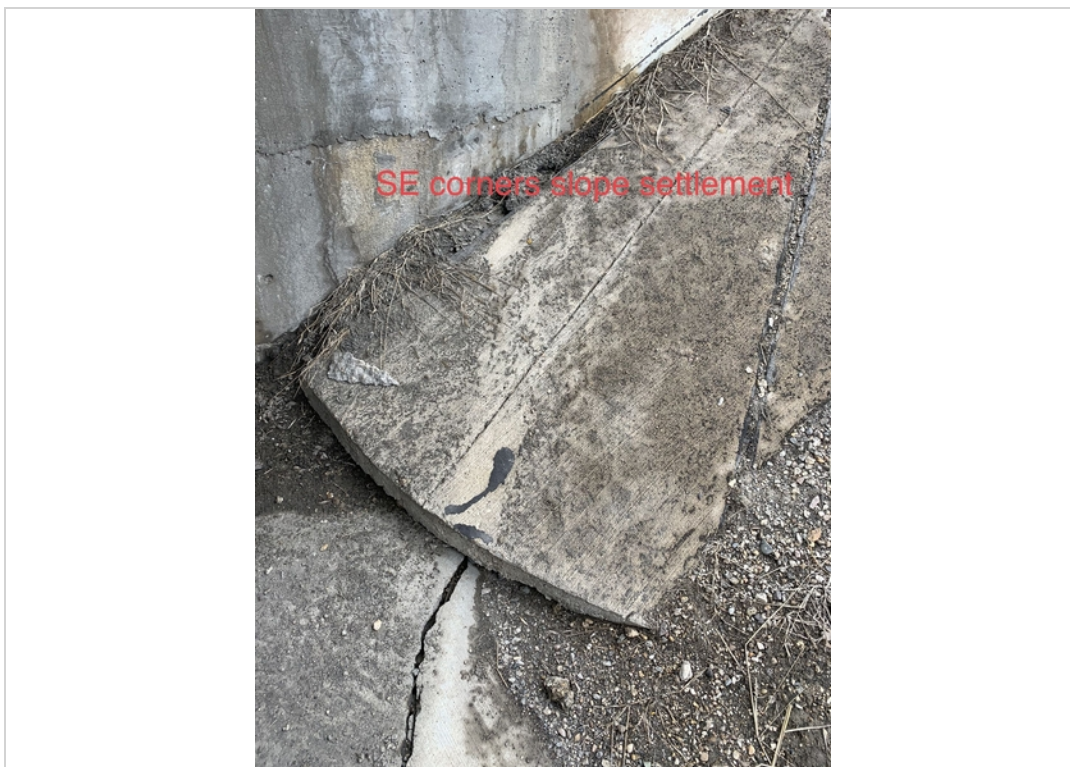
SE corner slope protection settlement

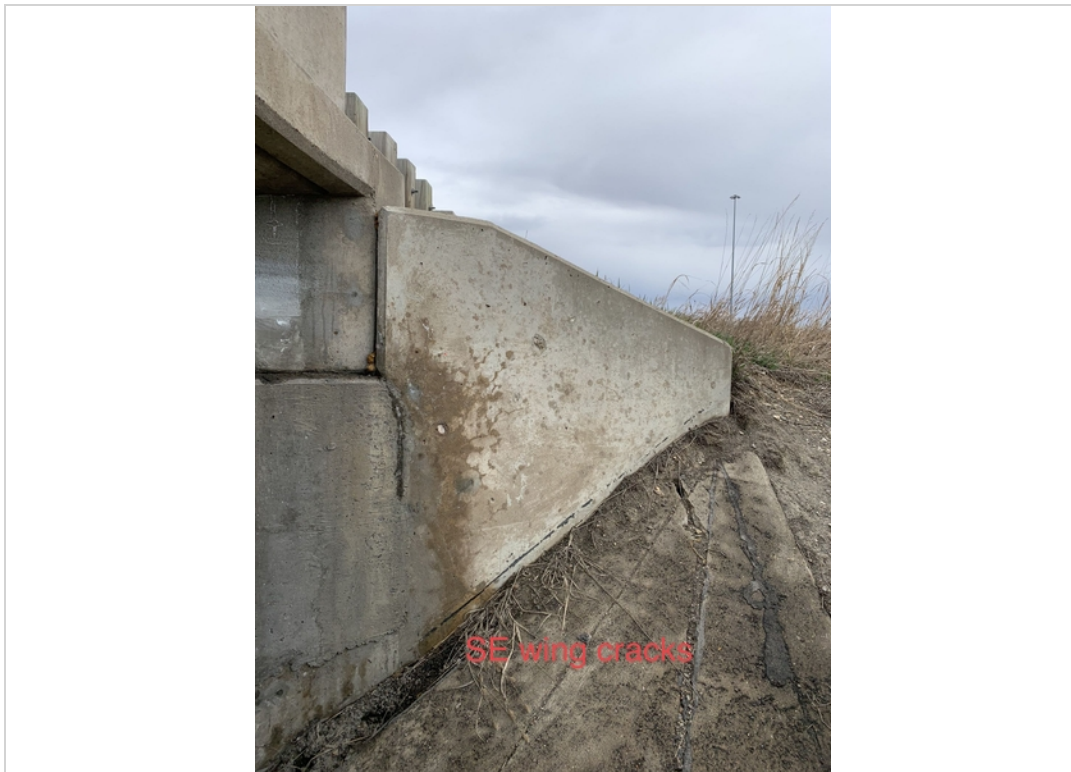
8401	Wings	EA	4	2	2	0	0
1130	Cracking (RC and Other)	EA	2	0	2	0	0
(1130-8401) The Southeast wing has a crack that measures approximately 0.004 in width. 15April2021 26April2023 - In addition to the previous entry, the Northwest wing has a crack.

SE wing cracks

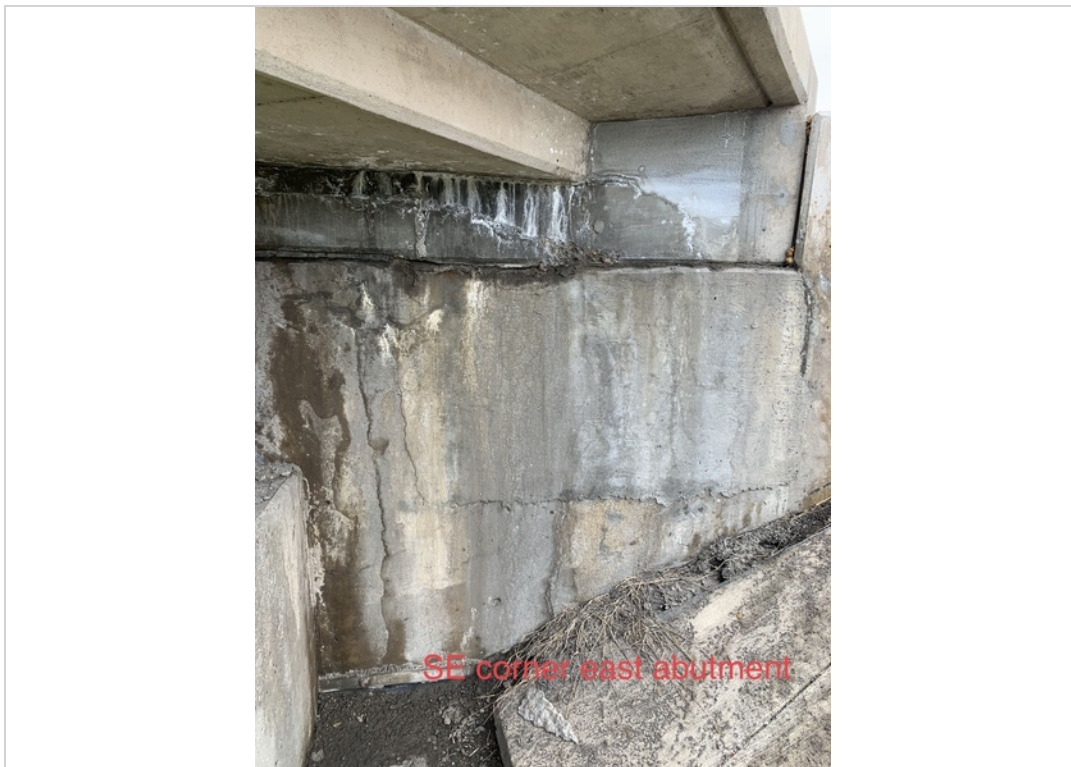
SE corner east abutment cracks efflorescence

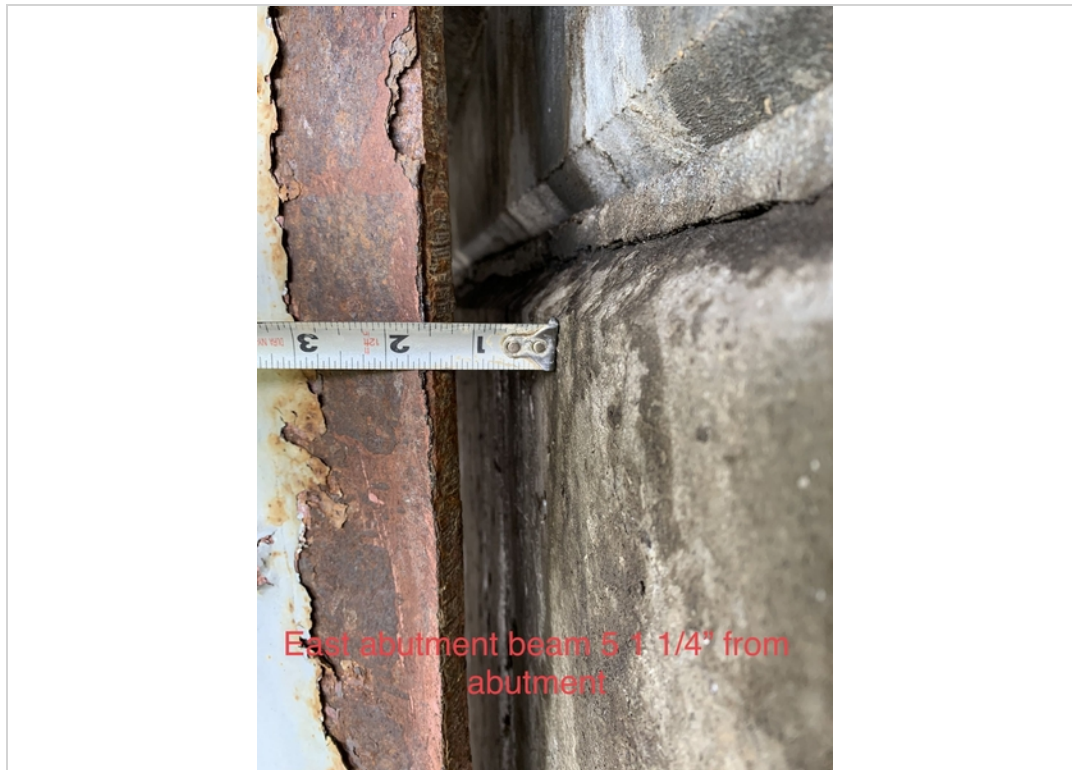
East abutment beam 5 1 1/4" from abutment

East abutment beam 5 , 1 1/4" for abutment

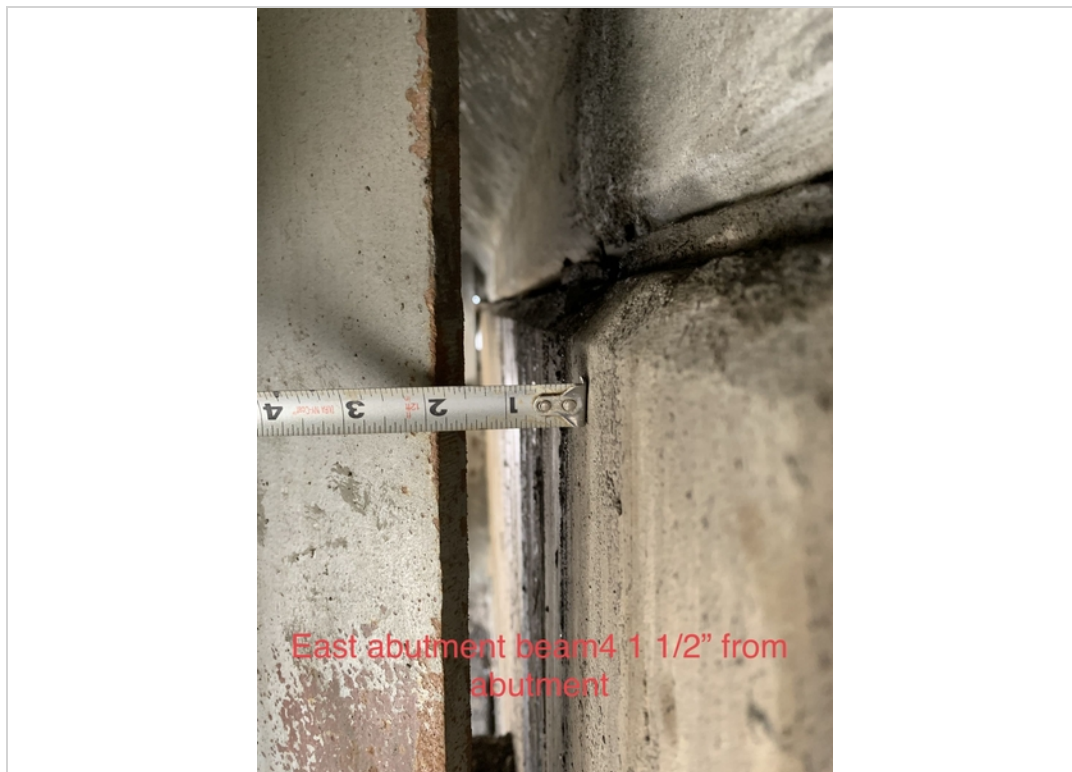
East abutment beam 4 , 1 1/2" from abutment

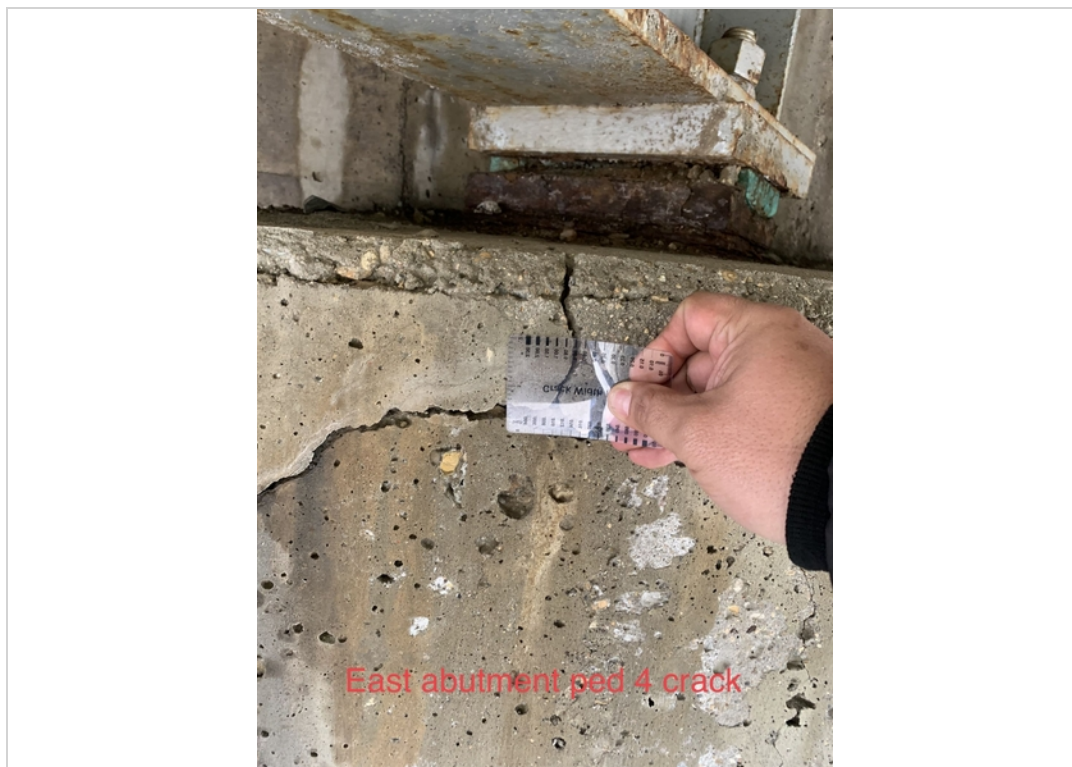
East abutment pier 4 crack

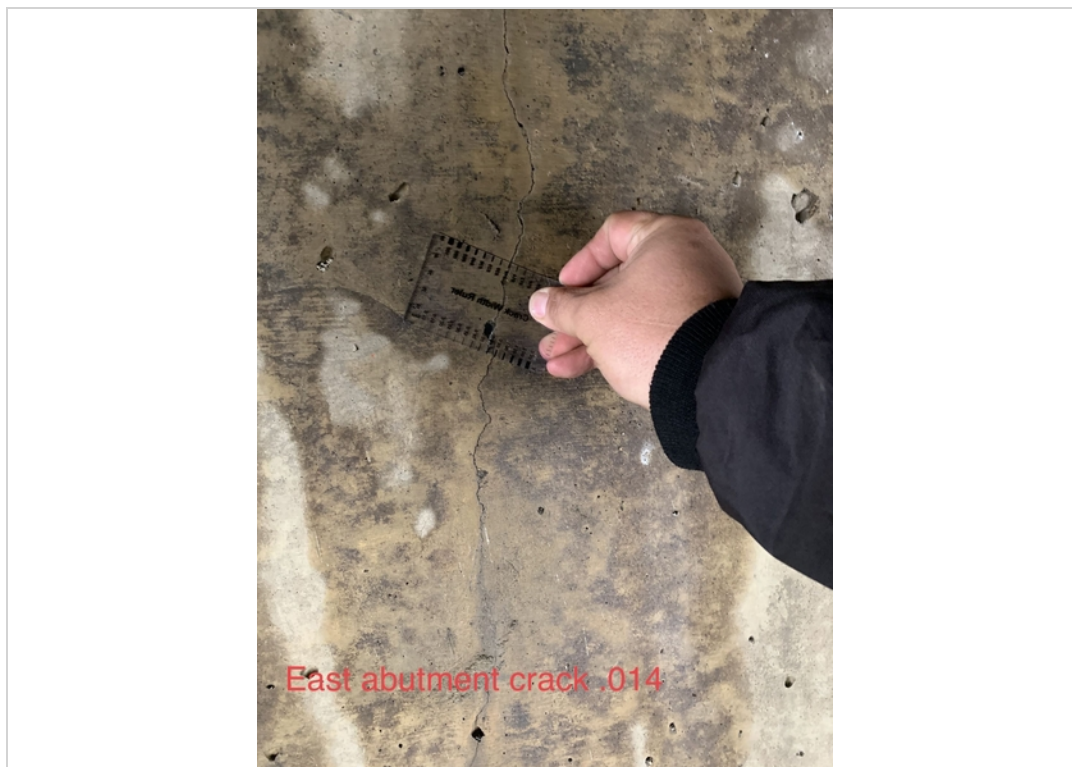
East abutment crack .014

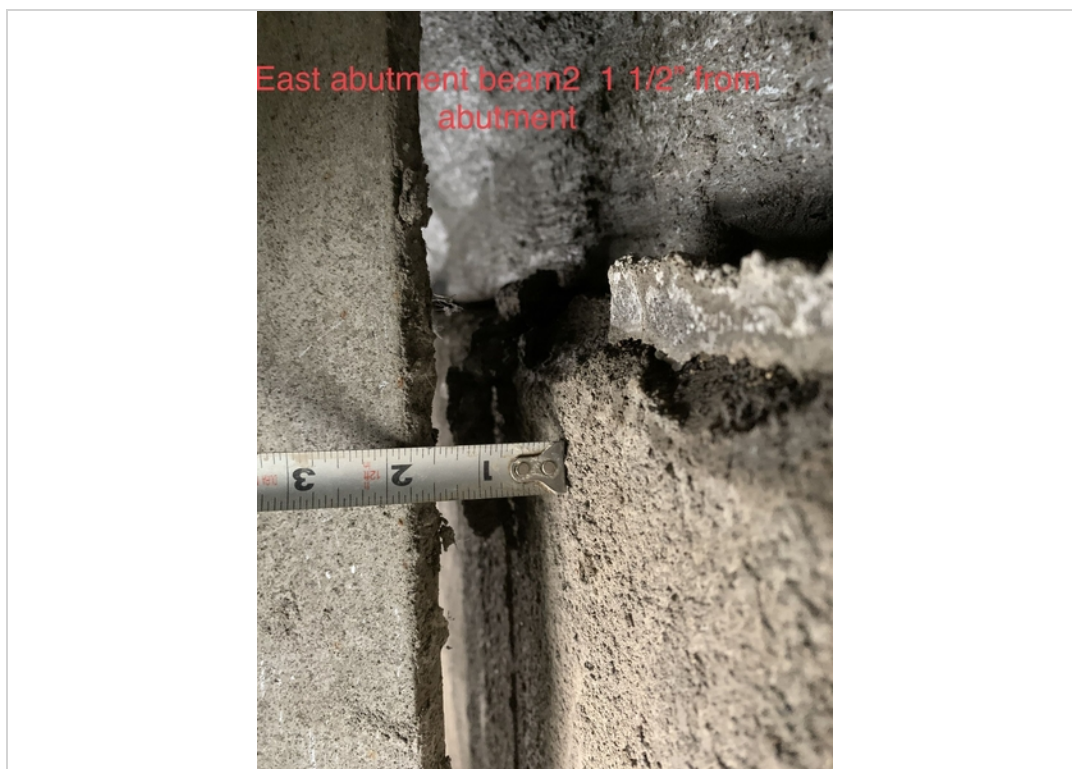
East abutment beam 2 , 1 1/2" from abutment

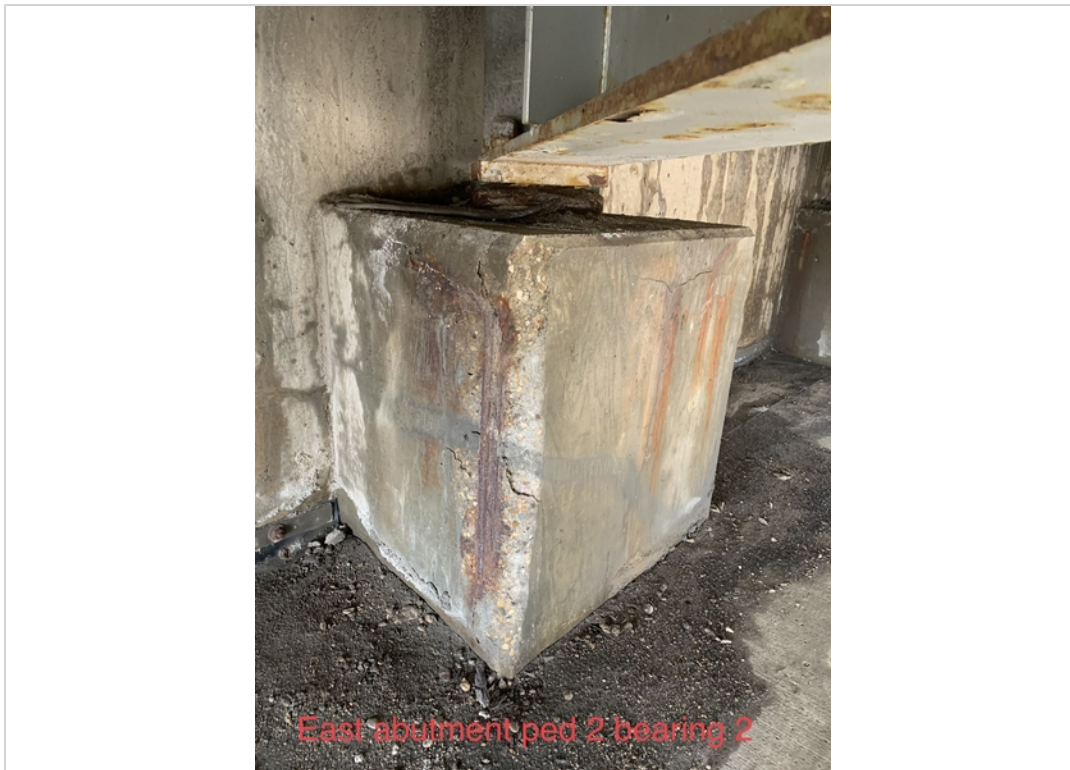
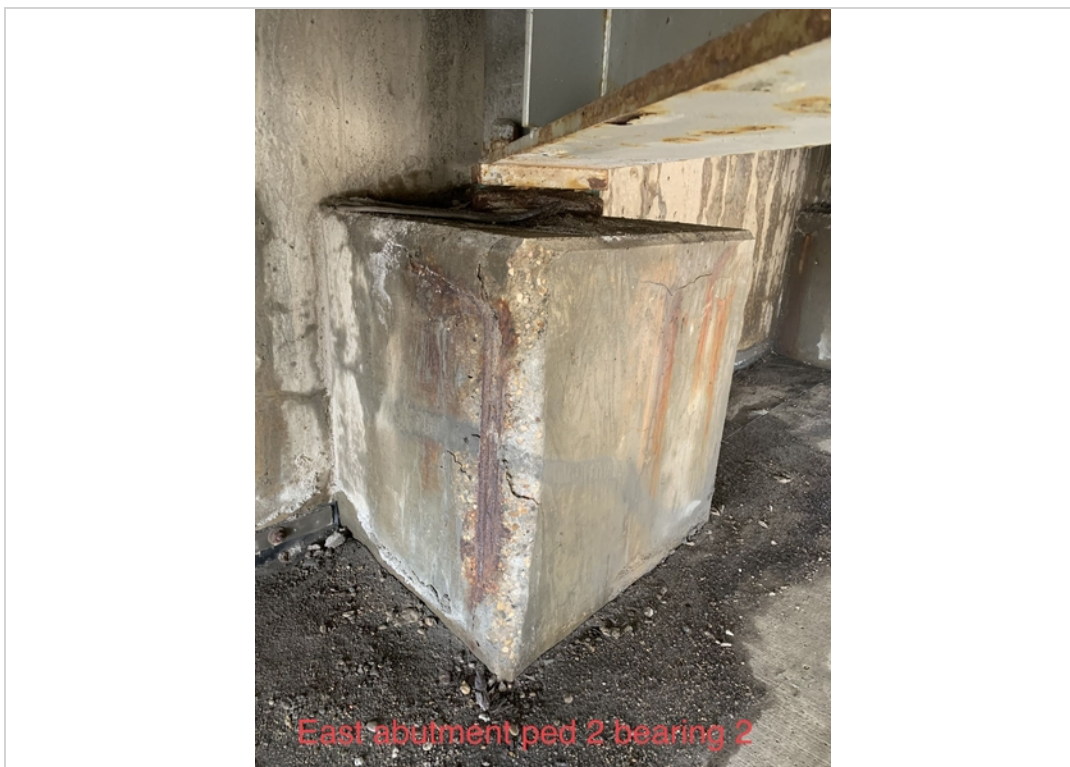
East abutment ped 2 exposed rebar and bearing 2

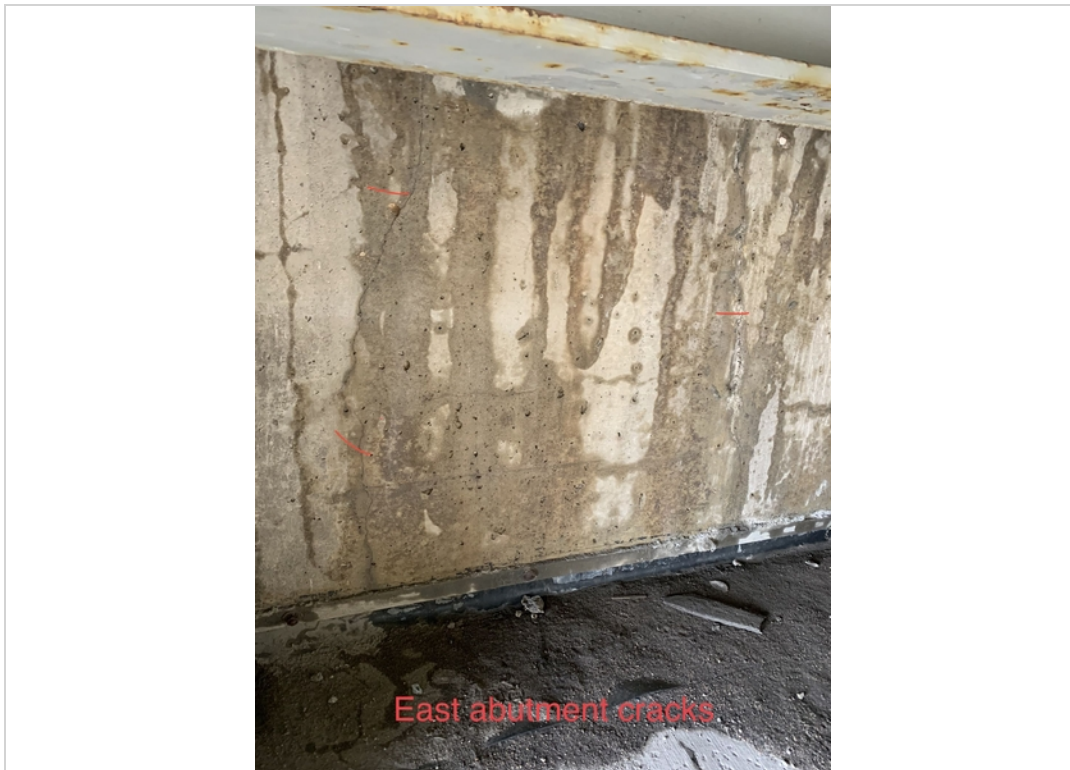
East abutment cracks

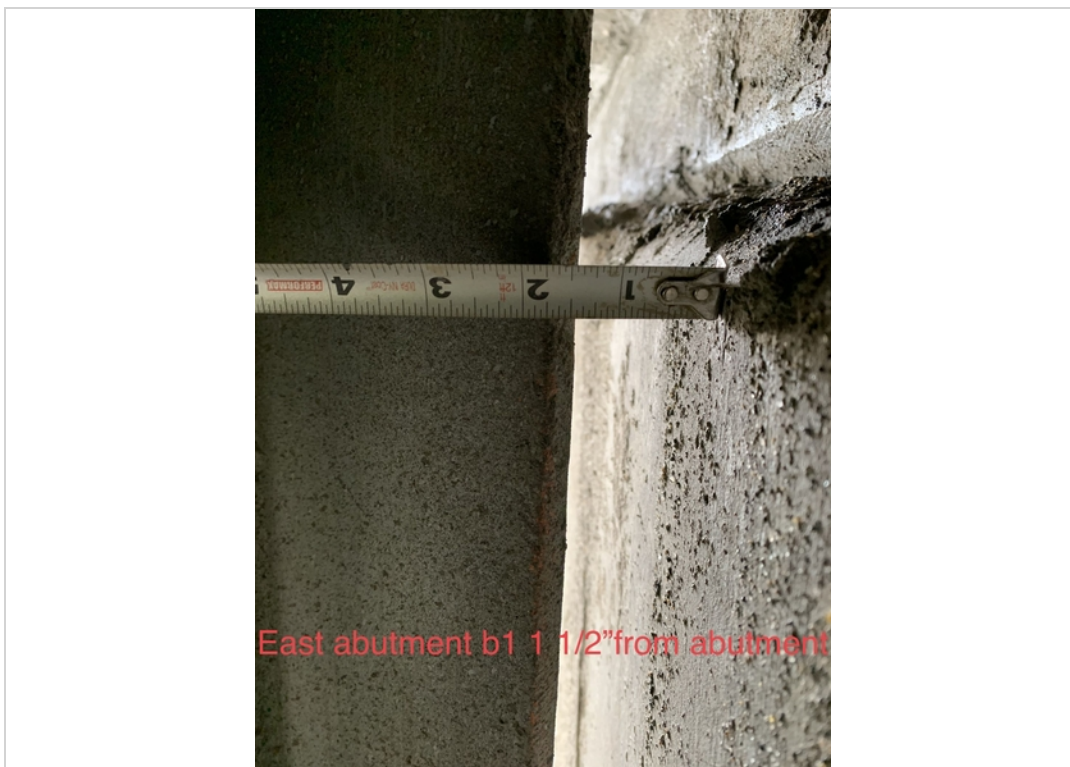
East abutment beam 1 , 1 1/2" from abutment

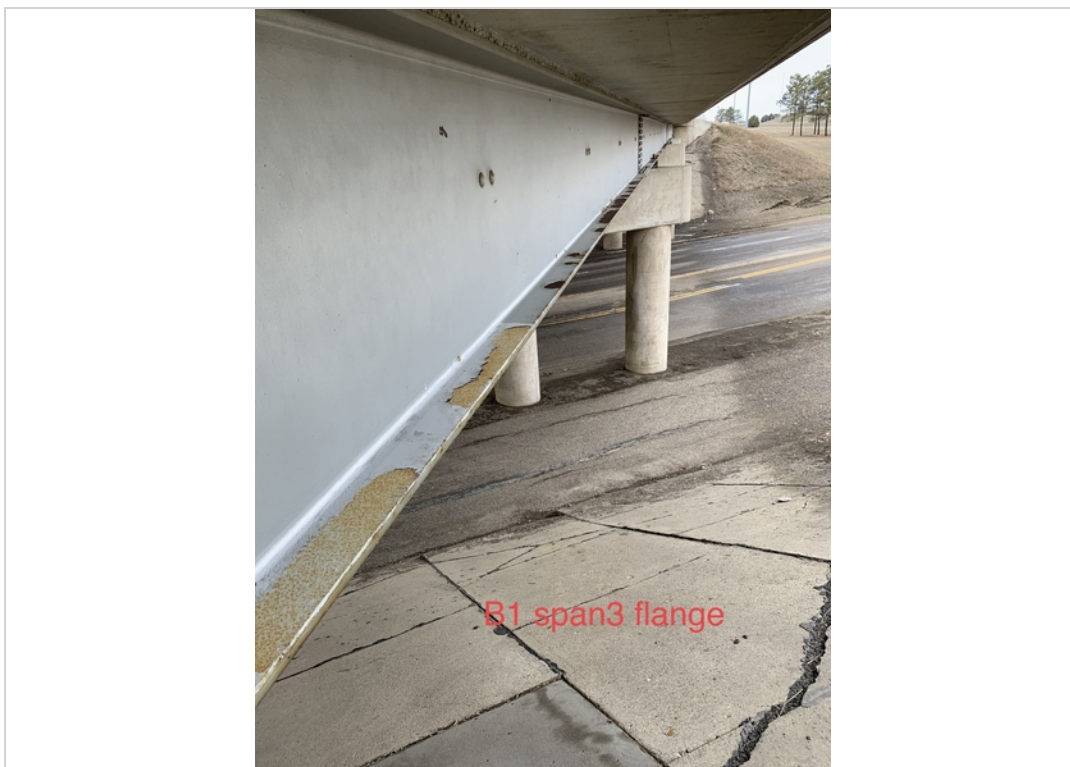
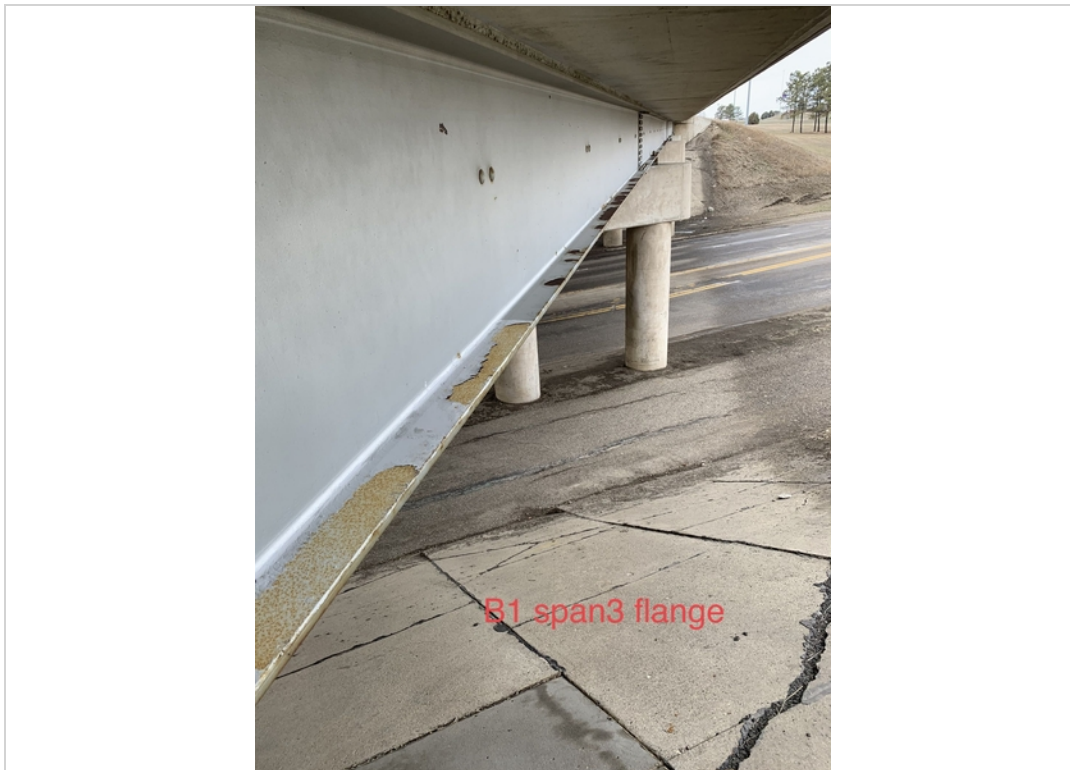
Beam 1 span 3 flange corrosion

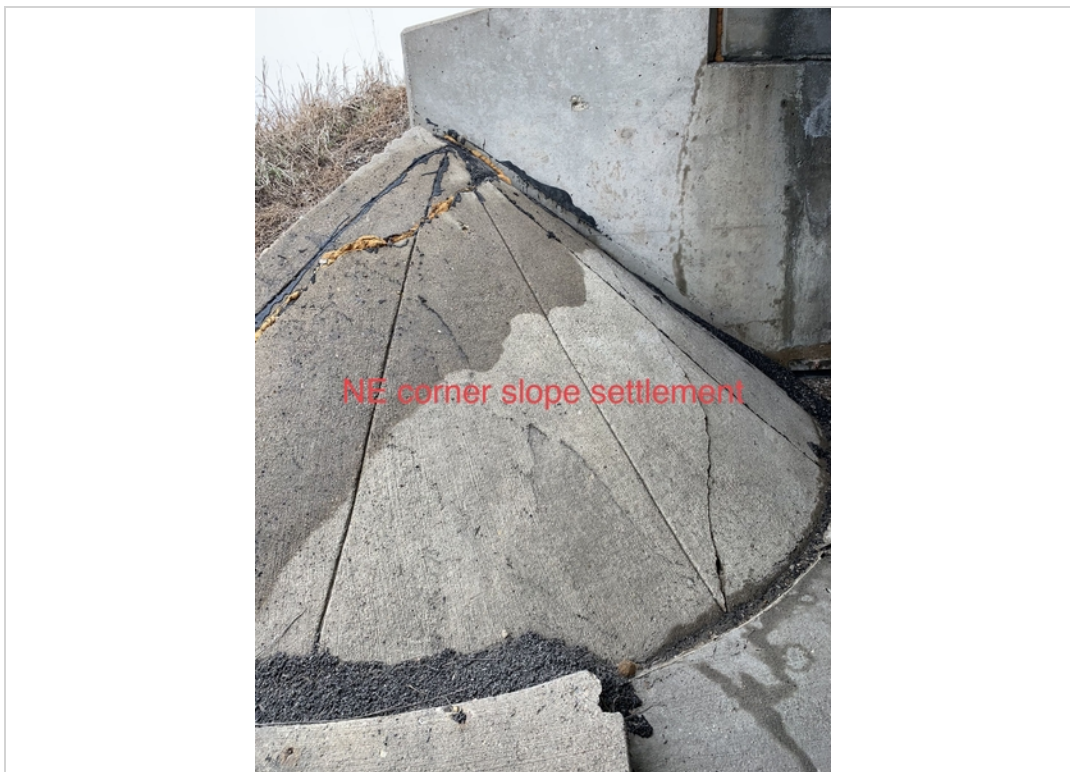
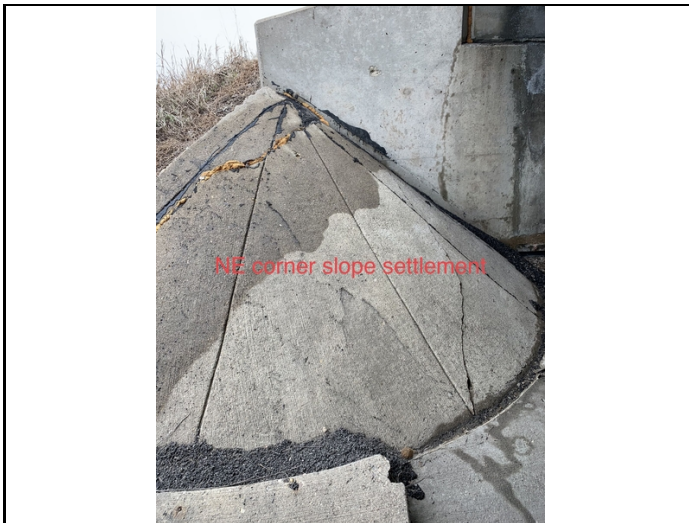
NE corner slope protection settlement

The West needs to have some joints sealed. The East slope protection by the wings has pulled away.

Recommend seal both slope protections and repairing the East slope protection. 15April2021, 26April2023

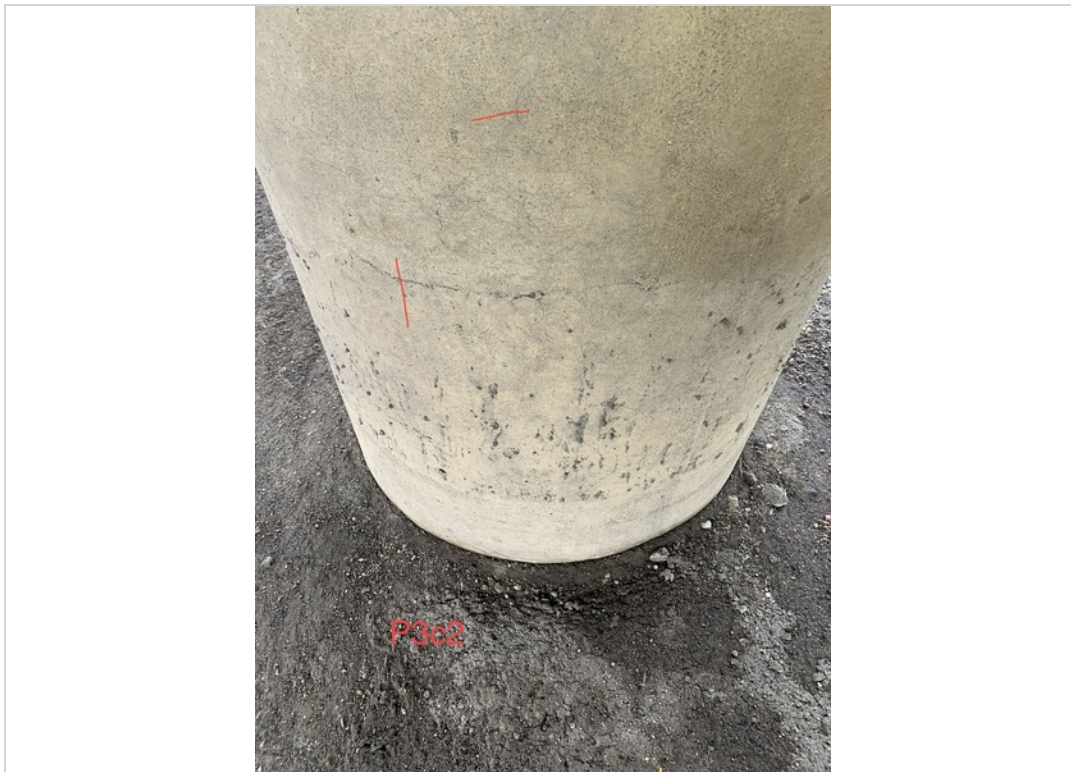
Pier 3 column 2 cracks

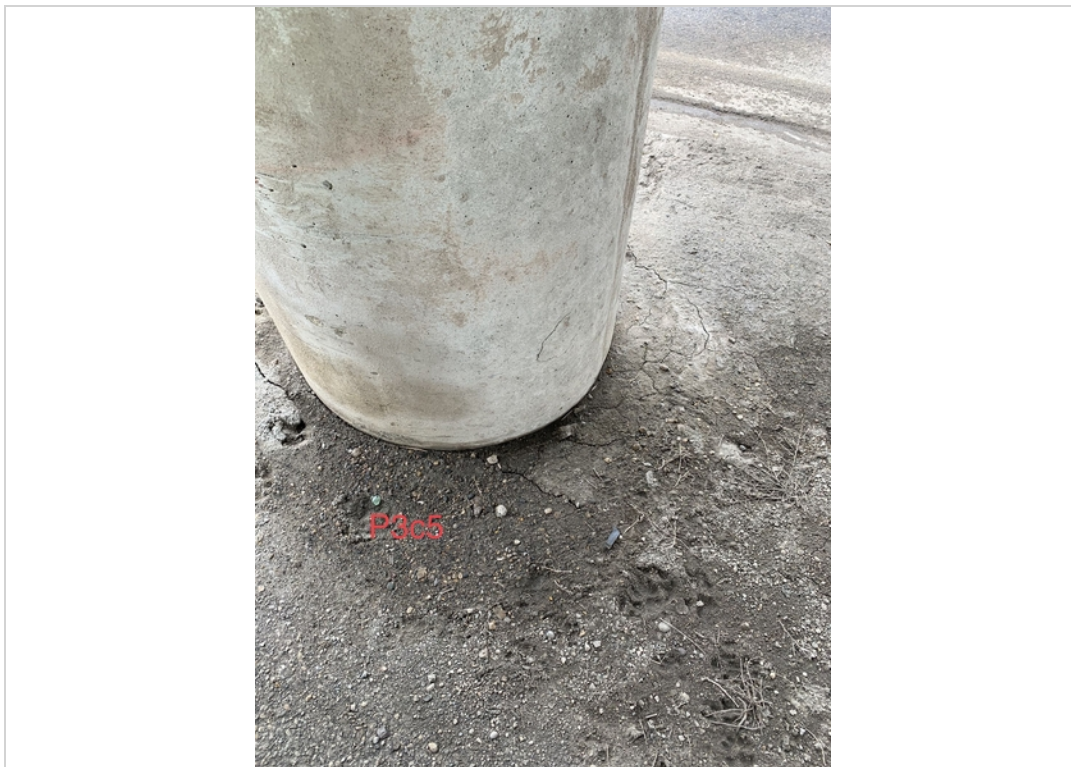
Pier 3 column 5 delam

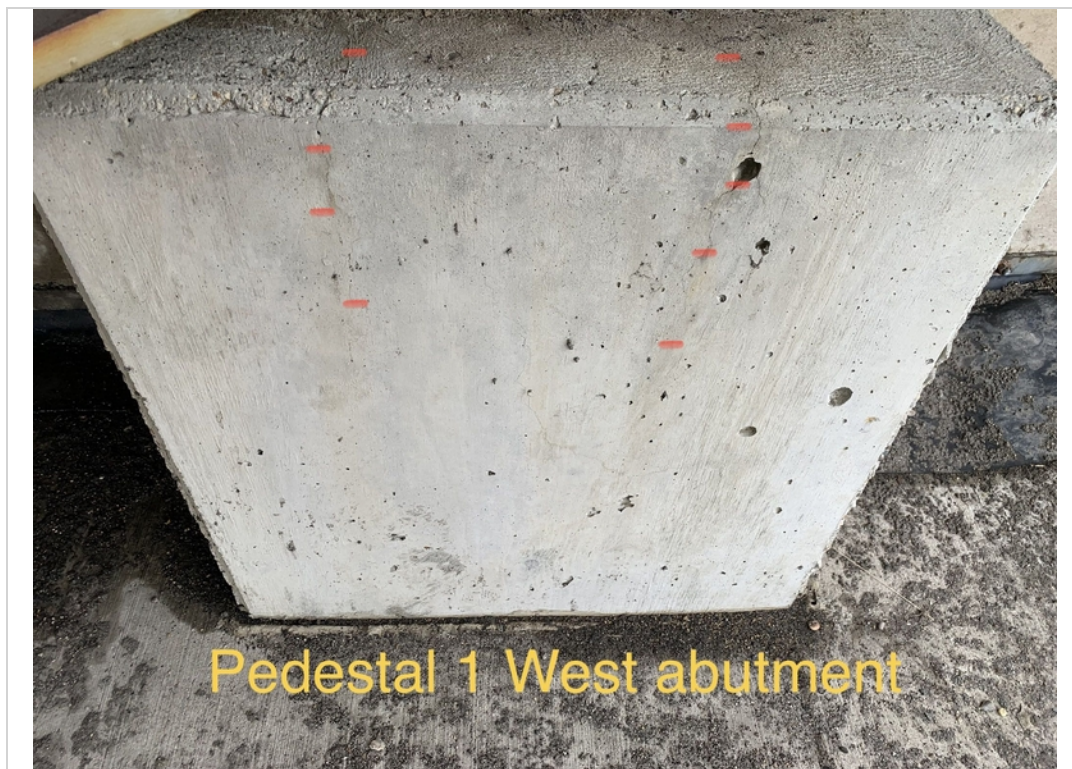
Ped 1 west abutment cracks

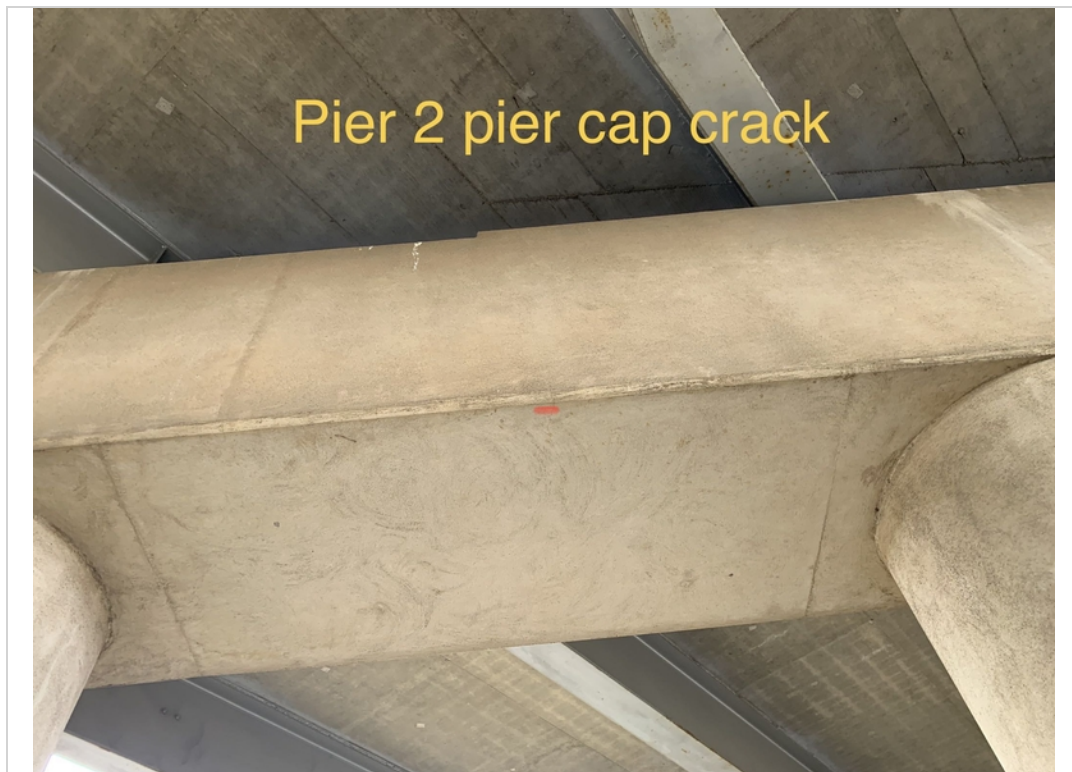
Pier 2 cap crack

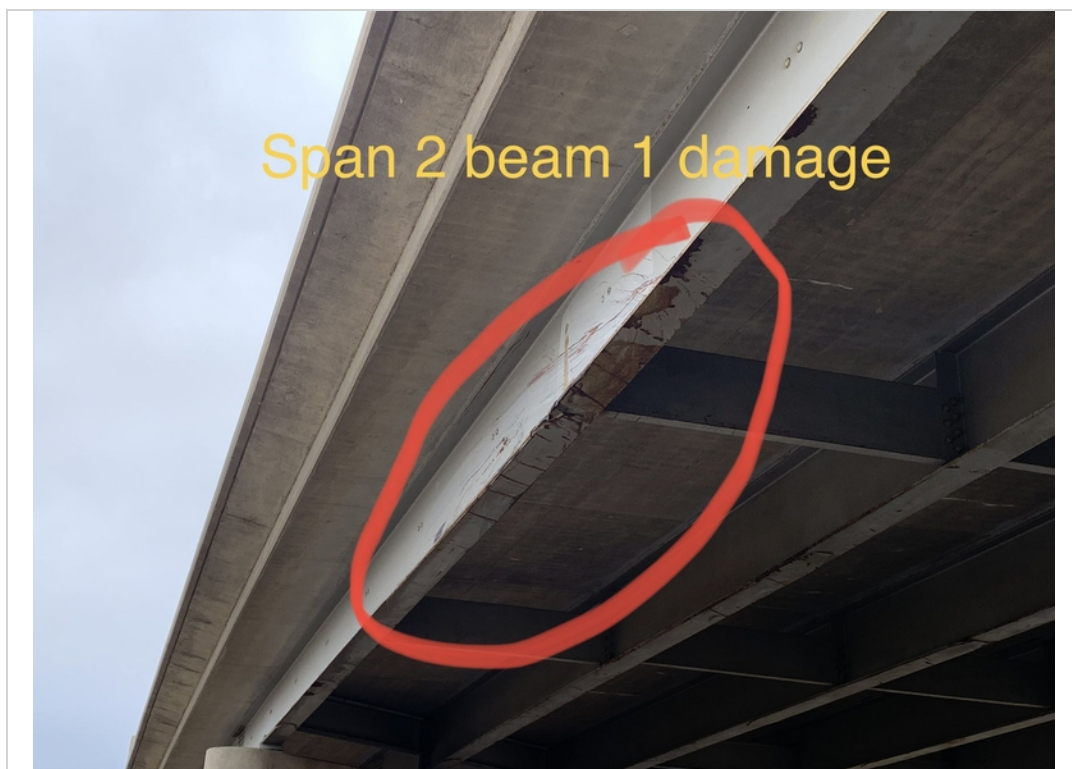
Span 2 beam 1 damage
