INTERSTATE 94 over SUNSET DR/NW MANDAN INT.

Location: 5 EAST OF ND 25

Inspection Date: 04/26/2023

IDENTIFICATION	
(1) State Names	38 - North Dakota
(8) Structure Number	0094-152.329 L
(5) Inventory Route	1
(2) Highway Agency District	1 - Bismarck
(3) County Code	30 - Morton

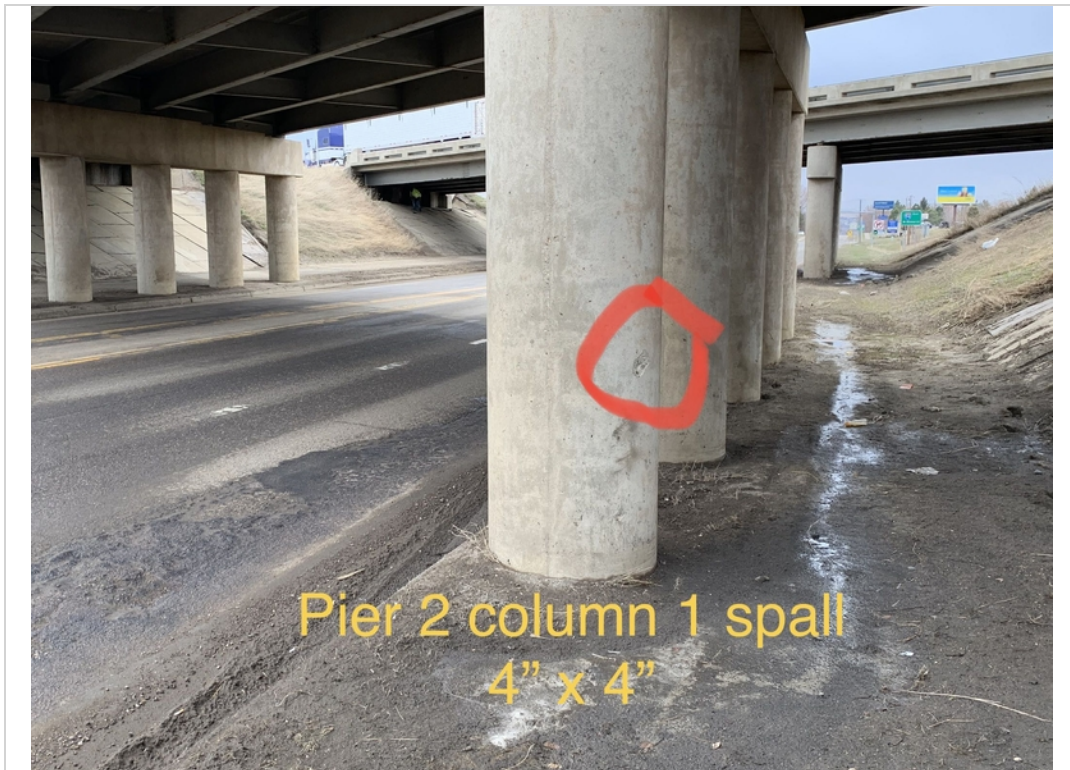
Pier 2 column 1 spall 4"x4"

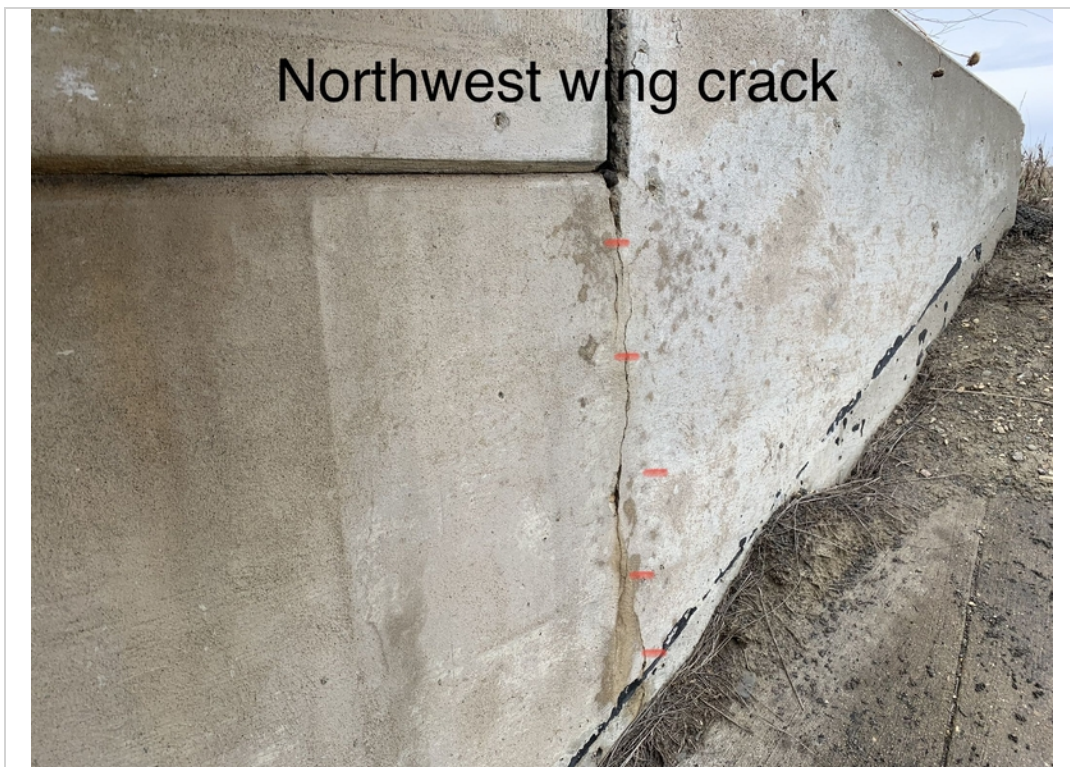
NW wing crack

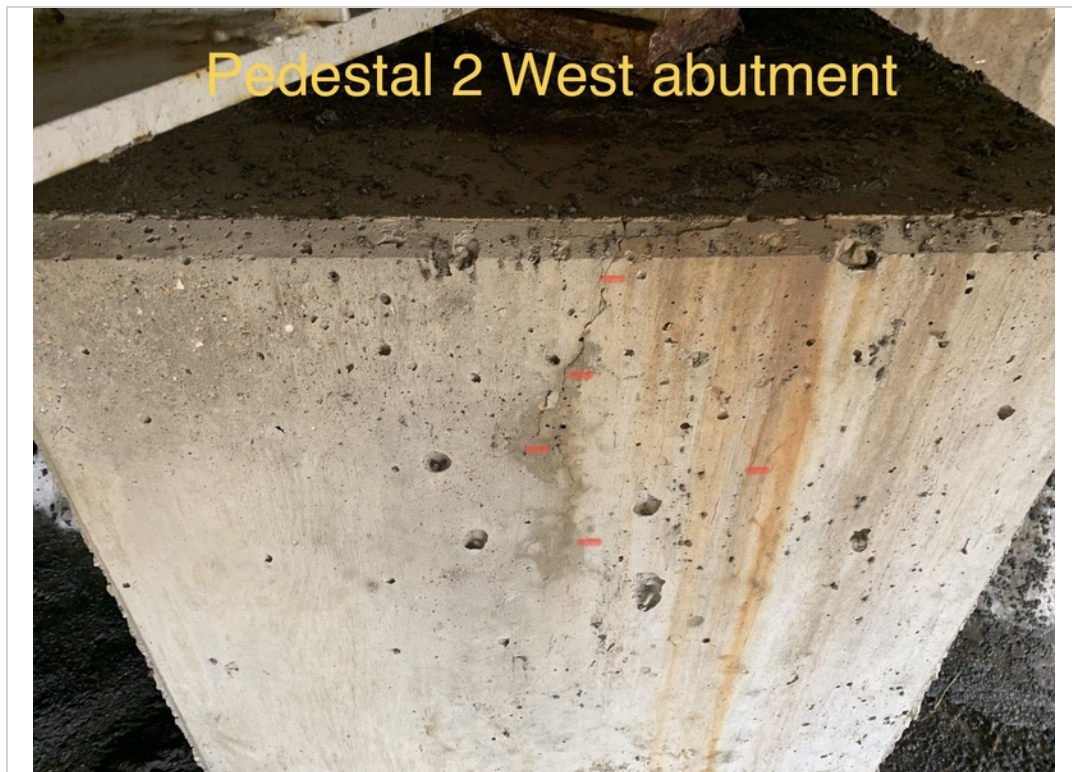
Ped 2 west abutment crack

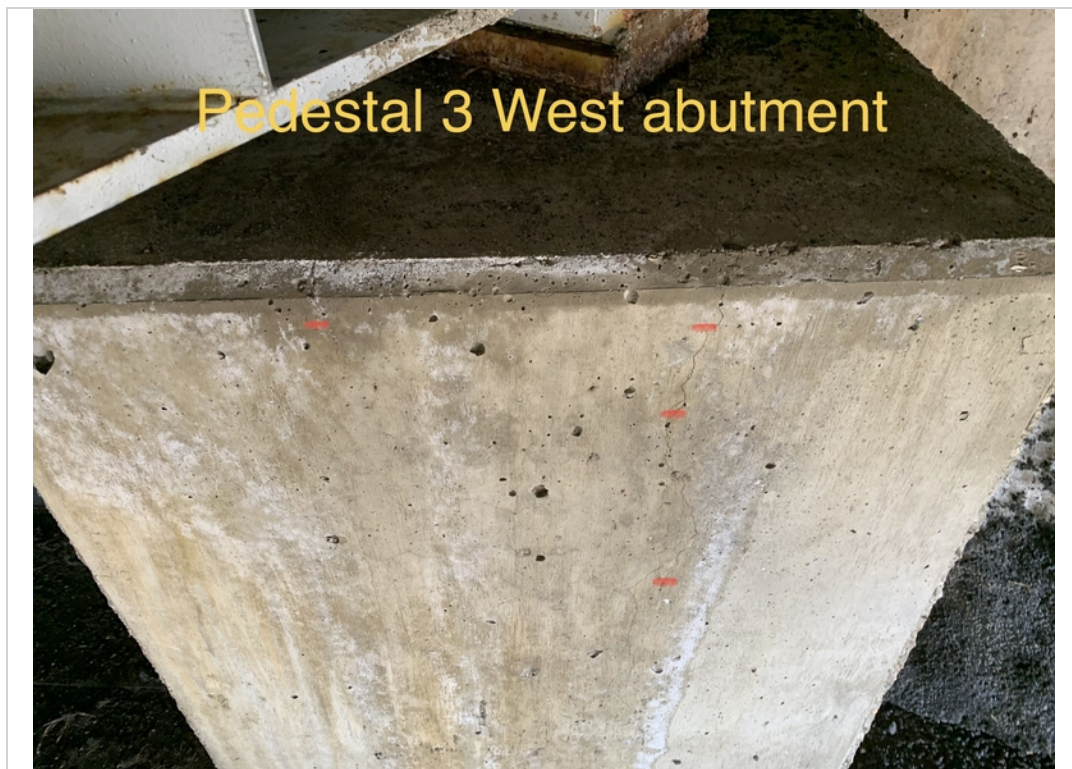
Ped 3 crack west abutment

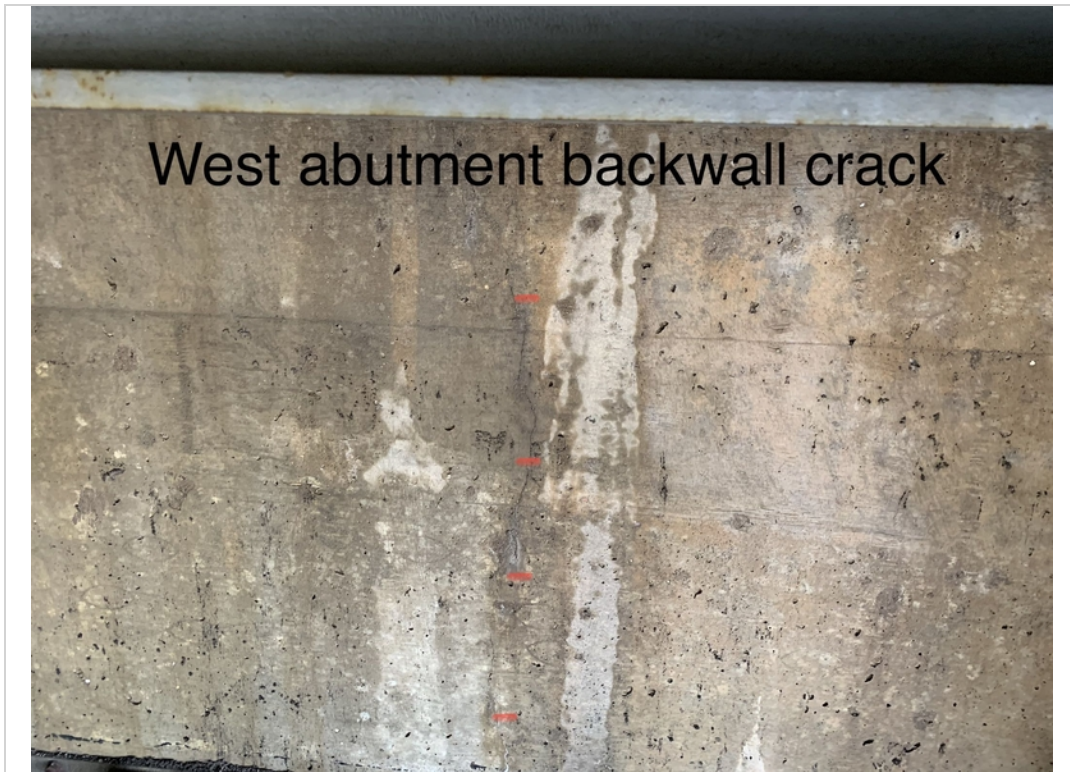
West abutment backwall crack

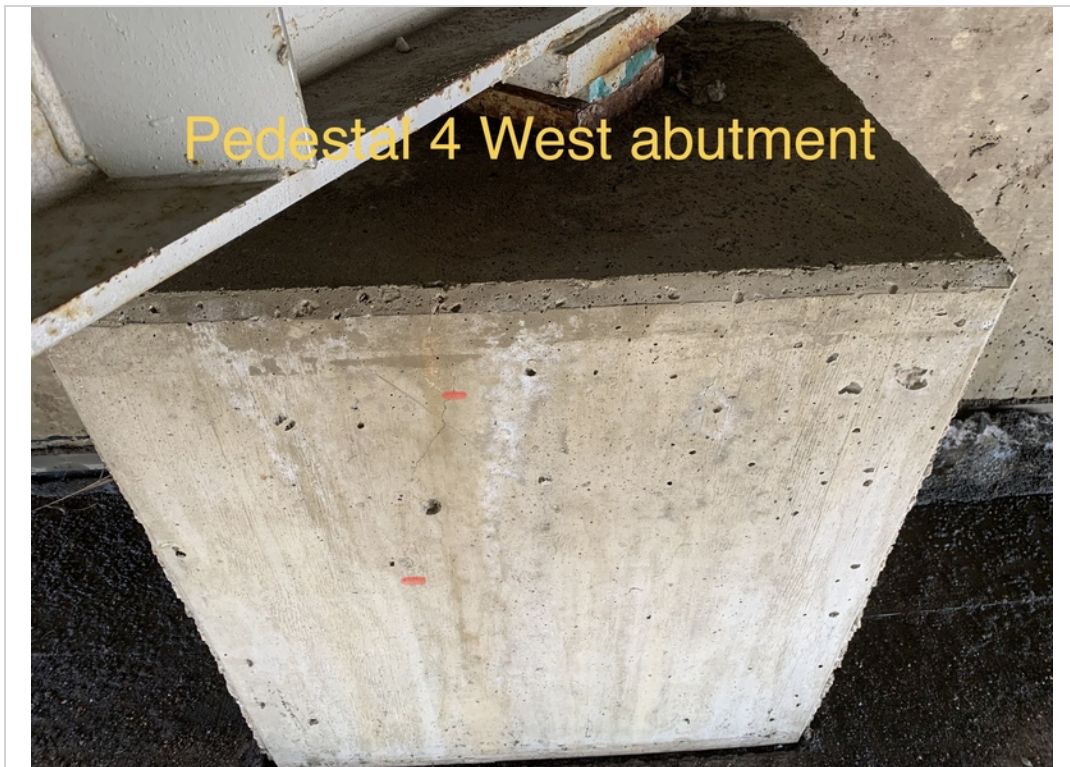
Ped 4 crack west abutment

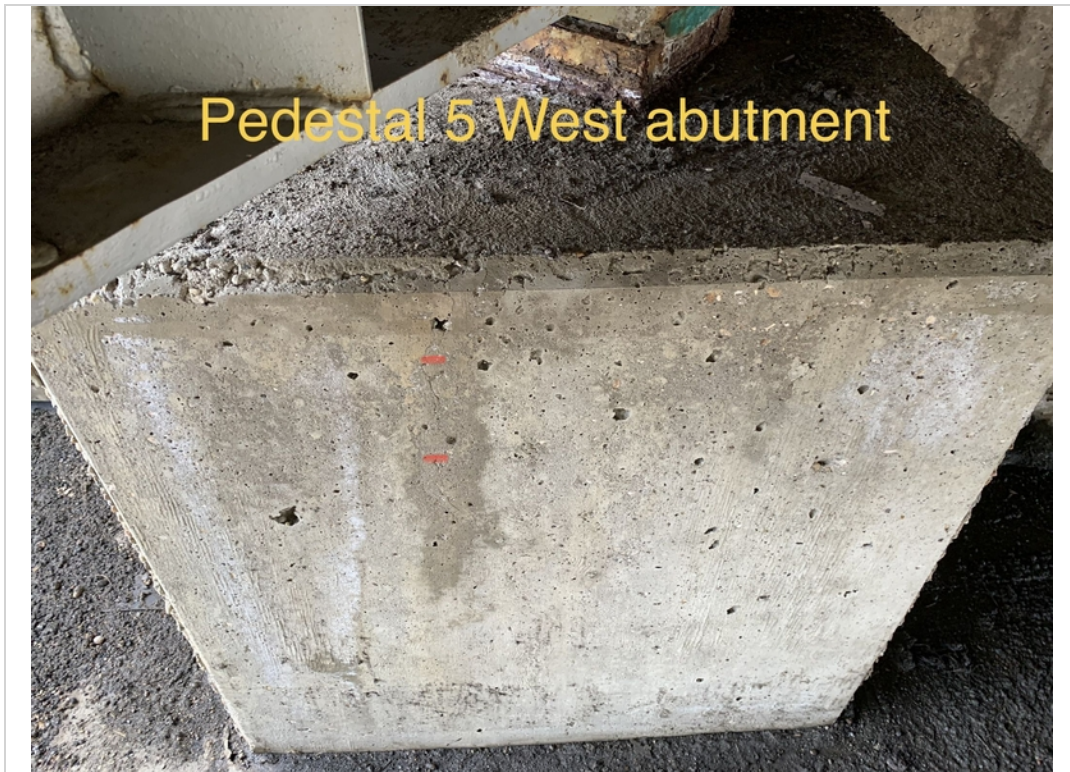
Ped 5 west abutment crack

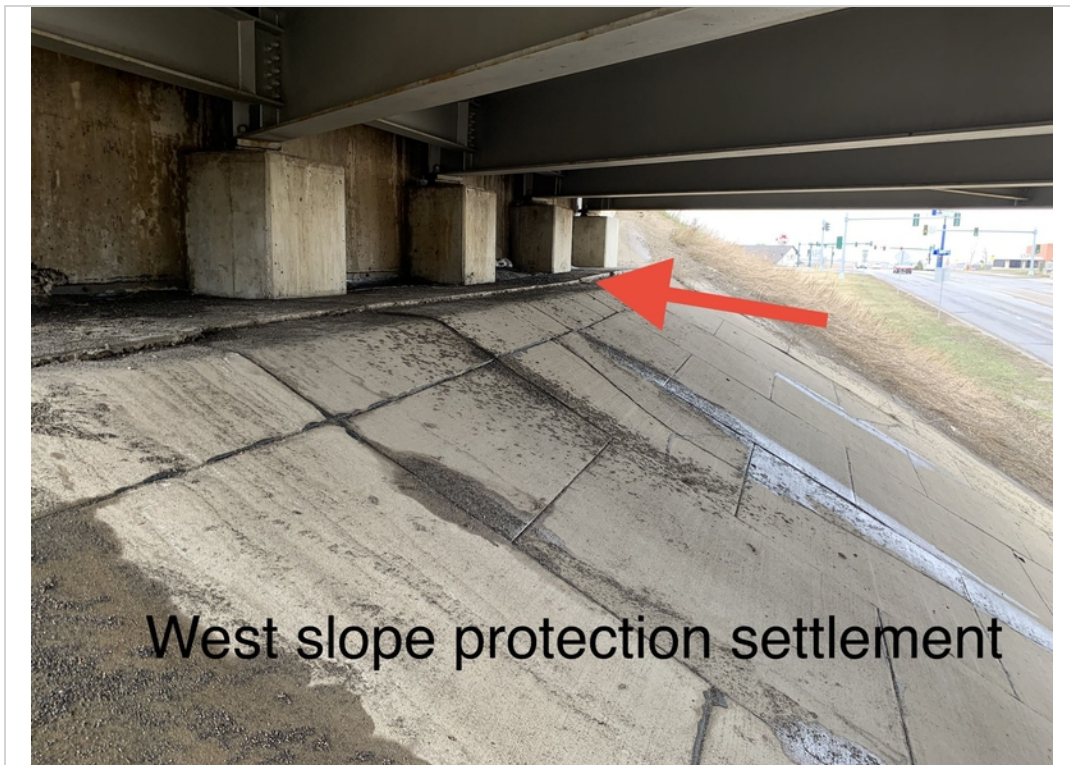
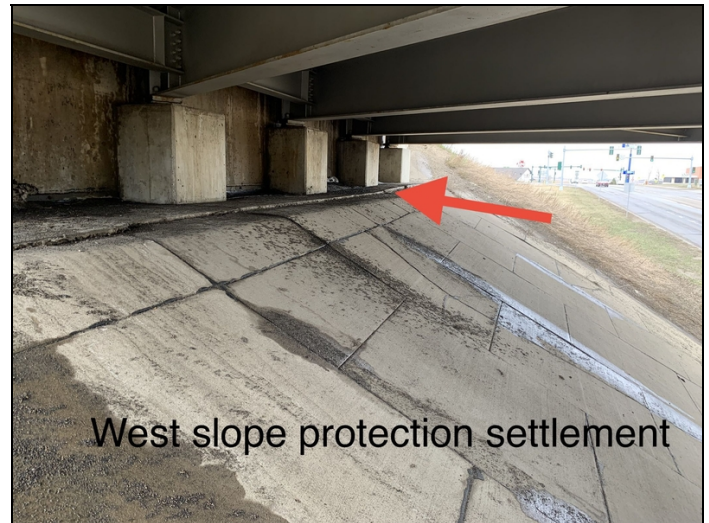
West slope protection settlement

The West needs to have some joints sealed. The East slope protection by the wings has pulled away.

Recommend seal both slope protections and repairing the East slope protection. 15April2021, 26April2023

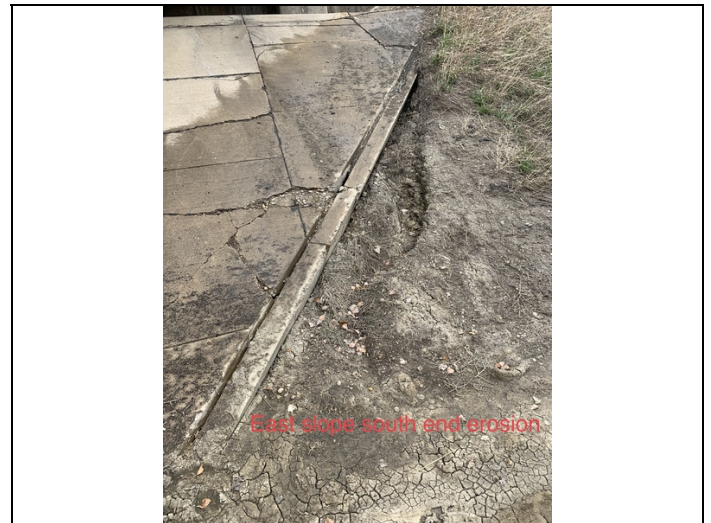
East slope south side of slope protection erosion taking place along edge of concrete protection

East slope south end erosion

Recommend repair erosion
