**INTERSTATE 94 over SUNSET DR/NW MANDAN INT.**

**Location: 5 EAST OF ND 25**

**Inspection Date: 04/26/2023**

IDENTIFICATION	
(1) State Names	38 - North Dakota
(8) Structure Number	0094-152.329 R
(5) Inventory Route	1
(2) Highway Agency District	1 - Bismarck
(3) County Code	30 - Morton

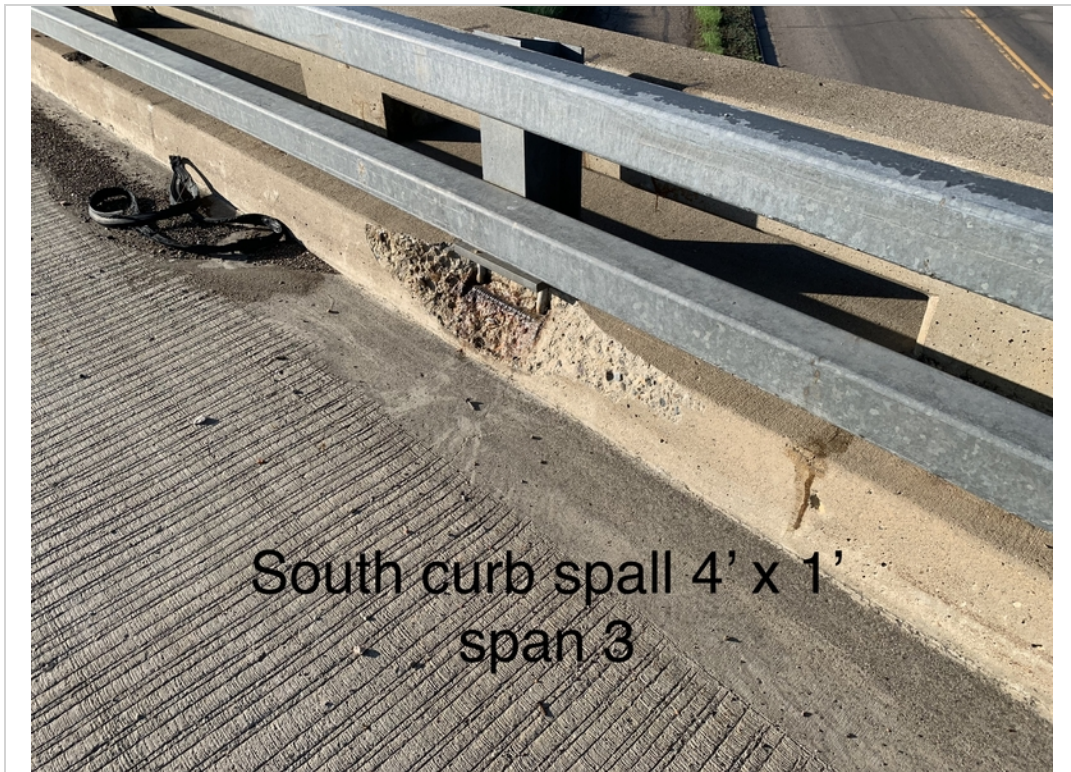
South curb spall 4'x1' span 3

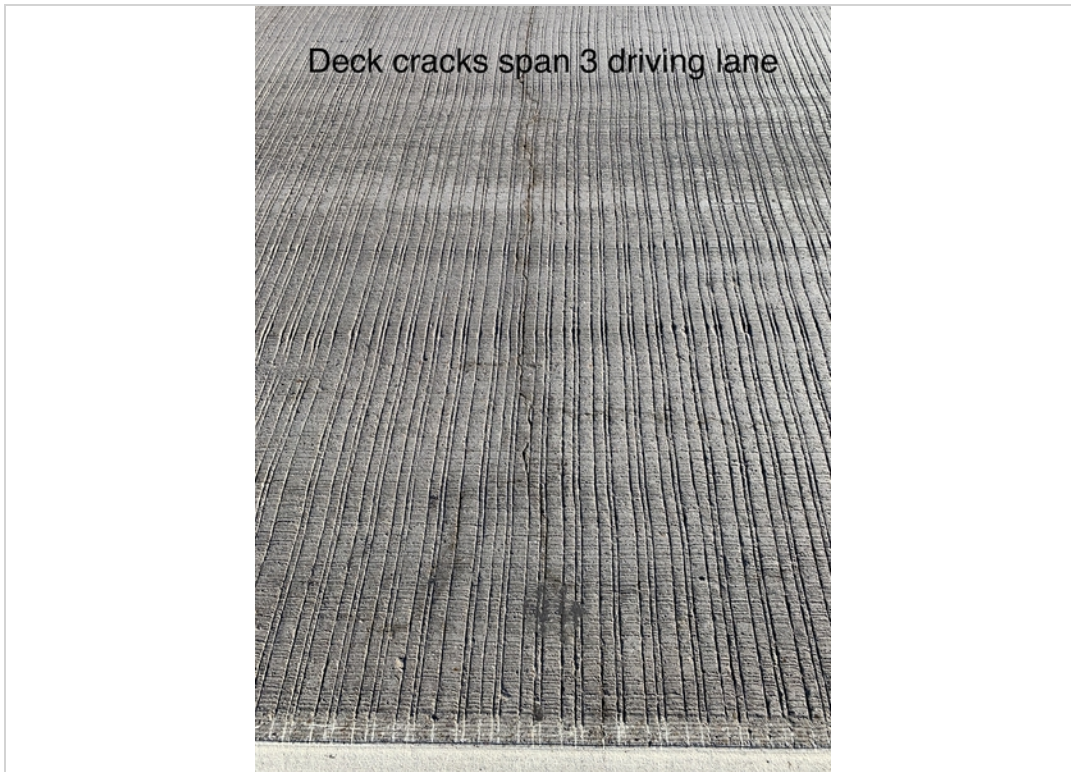
Deck cracks span 3 drive lane

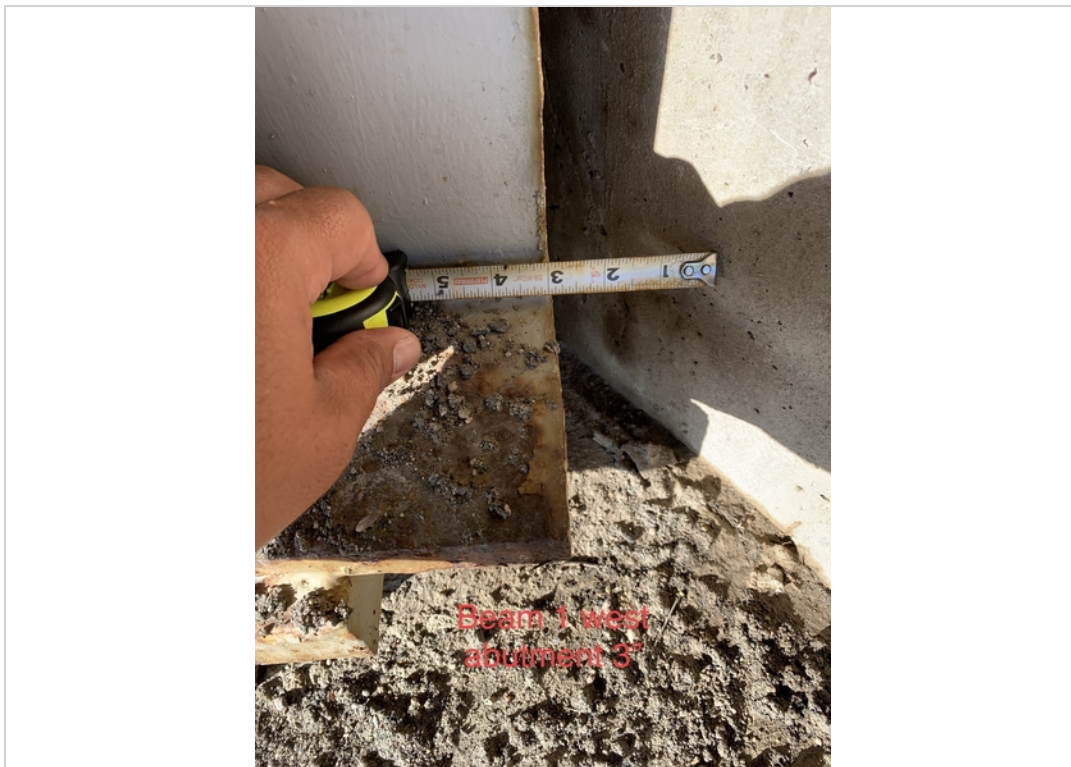
Beam 1 west abutment 3"

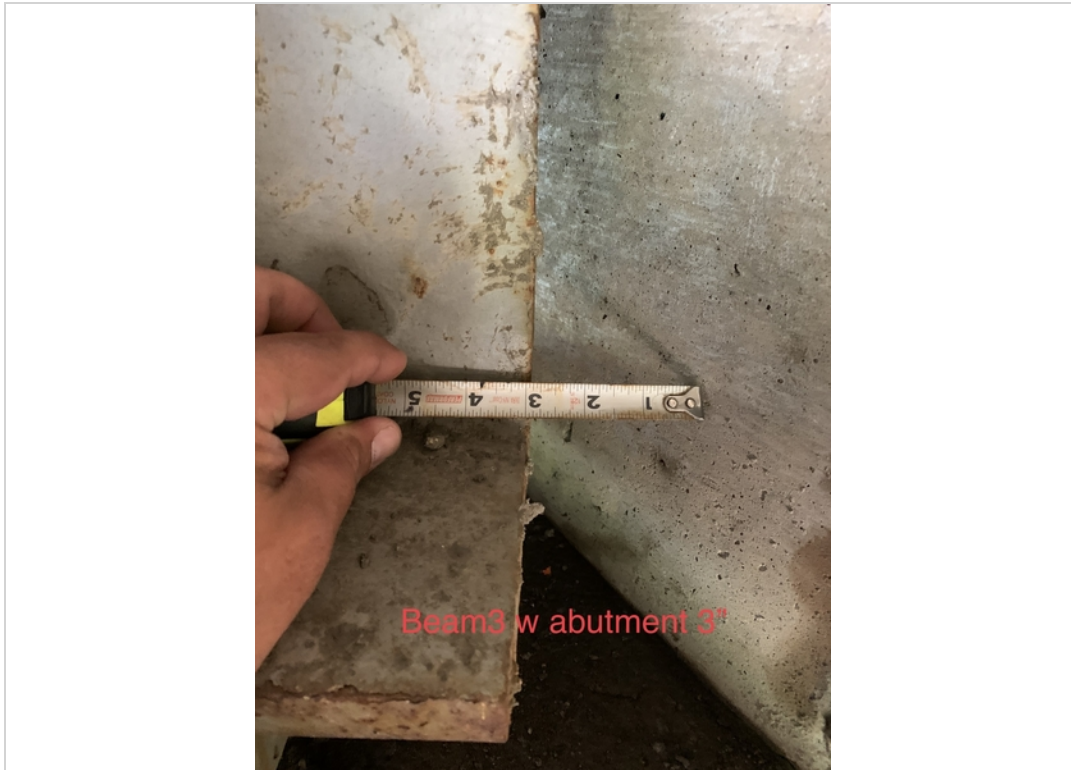
Beam 3 west abutment 3"

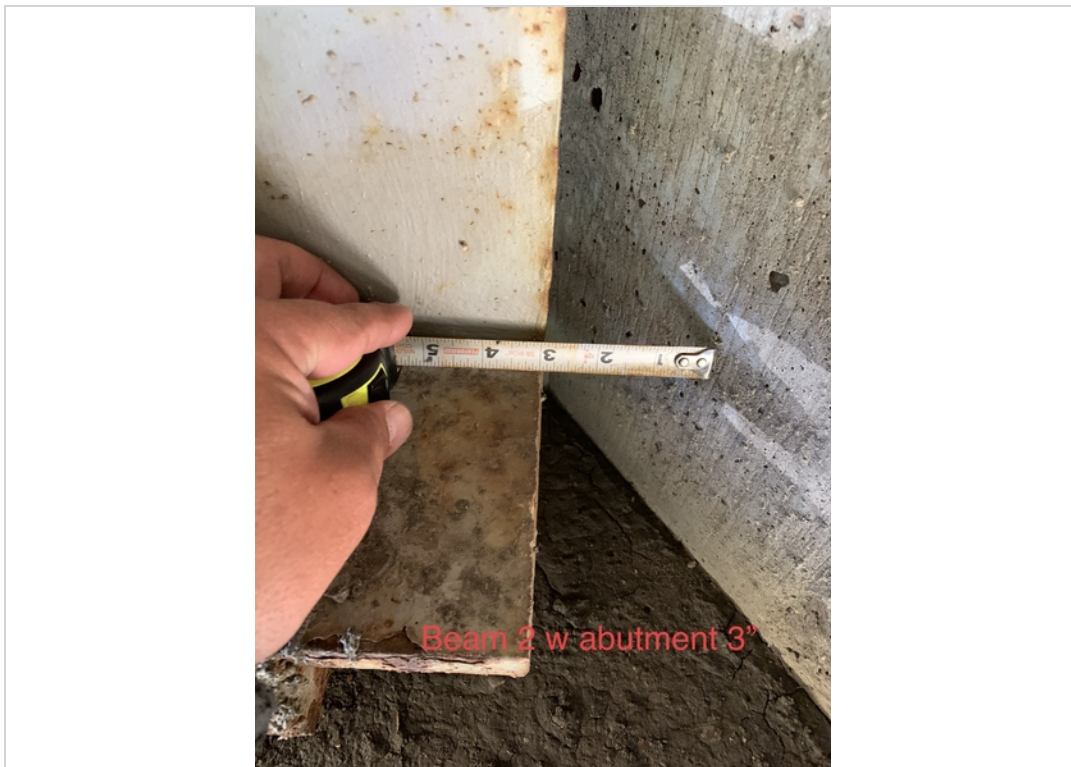
Beam 2 west abutment 2"

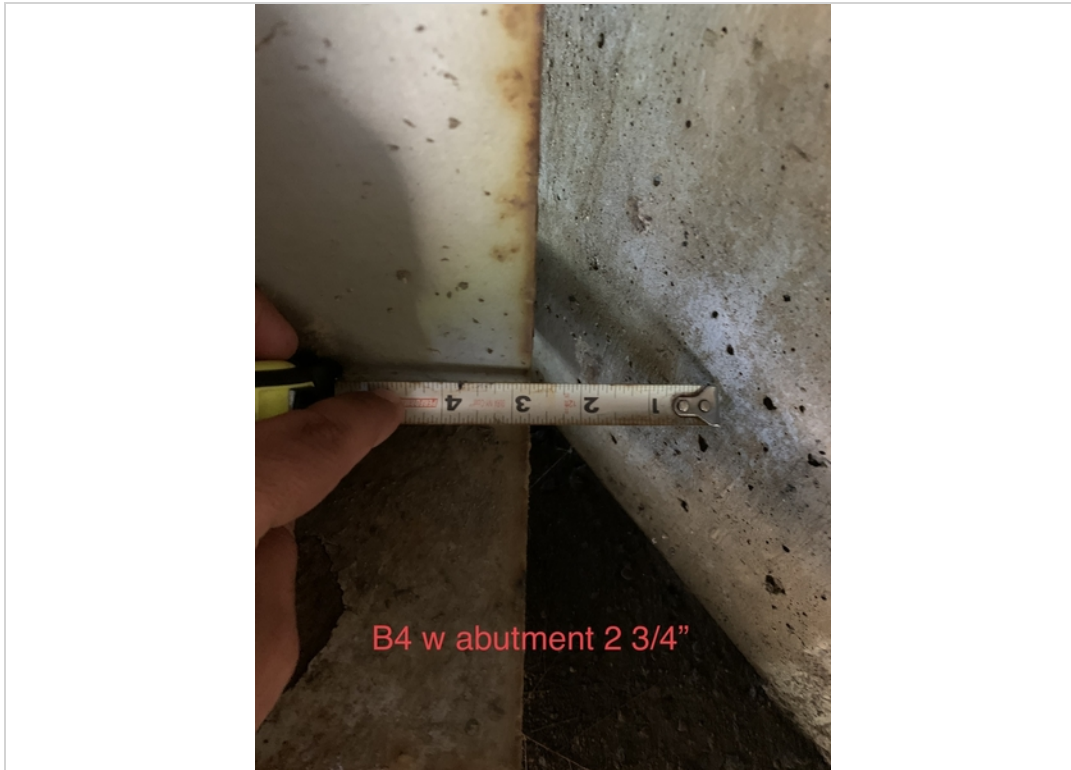
Beam 4 west abutment 2 3/4"

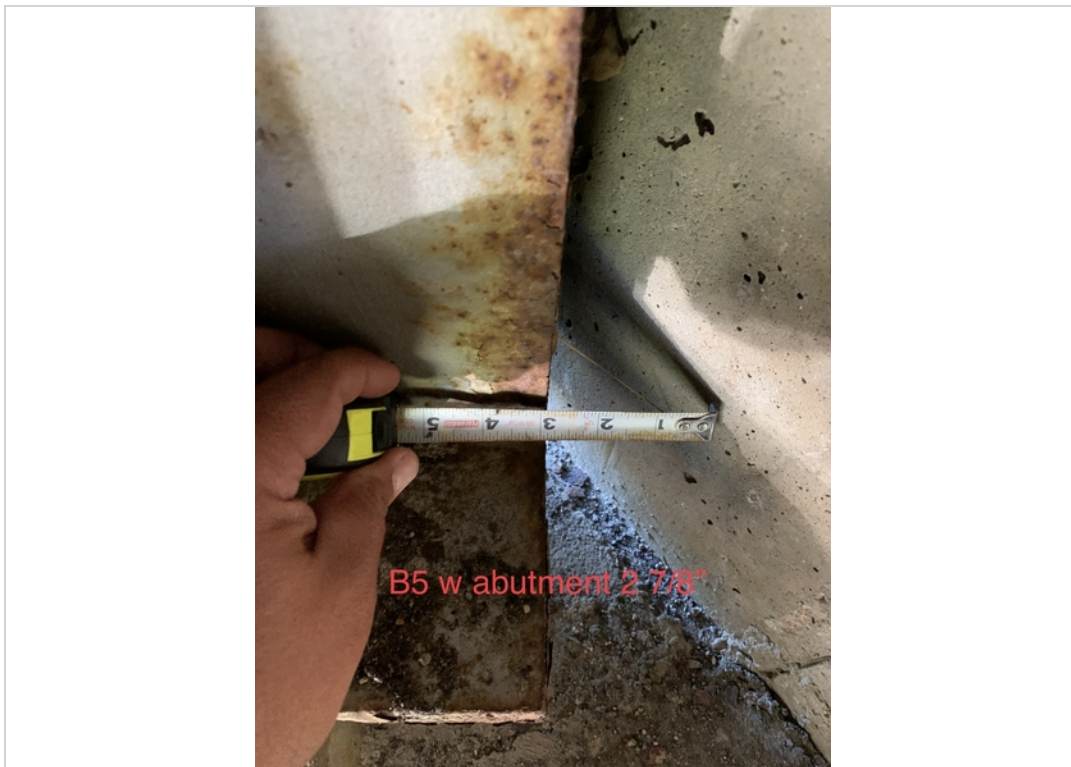
Beam 5 west abutment 2 7/8"

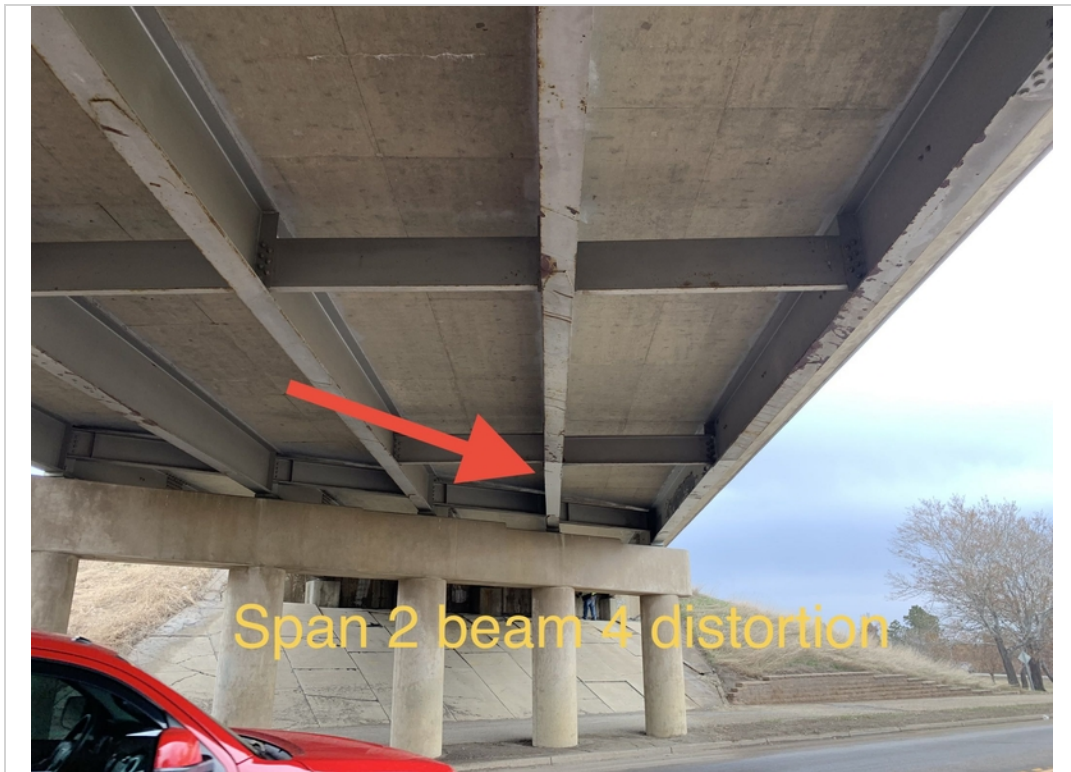
1September2022 - The structure was impacted by an over height vehicle in the Northbound lane. Beam 2 was bent out of plane at the lower flange. The upper flange remained in place and no deck concrete was broken. Beams 5, 4 and 3 were impacted with only minor damage to the lower flanges and to a diaphragm stiffener on Beam 4. The underside of the deck next to the top flange of Beam 5 is cracked and beginning to spall. Beam 5 was damaged on the bottom flange from an over height impact.

Span 2 beam 4 distortion

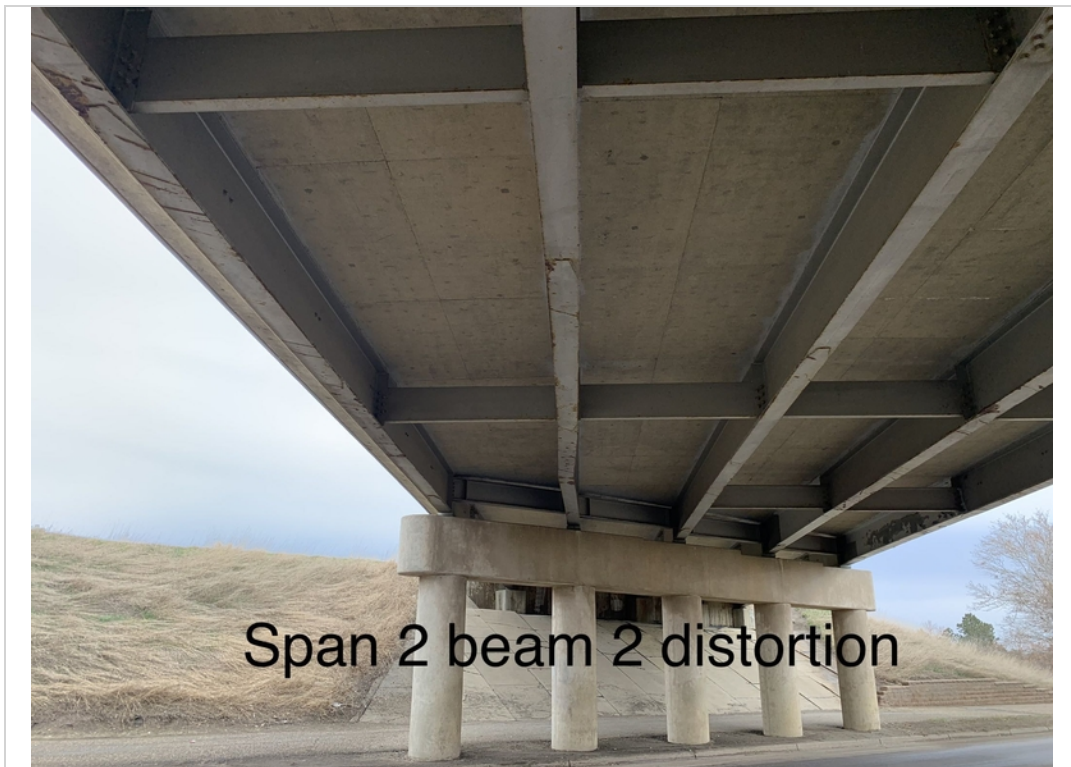
Span2 beam 2 distortion

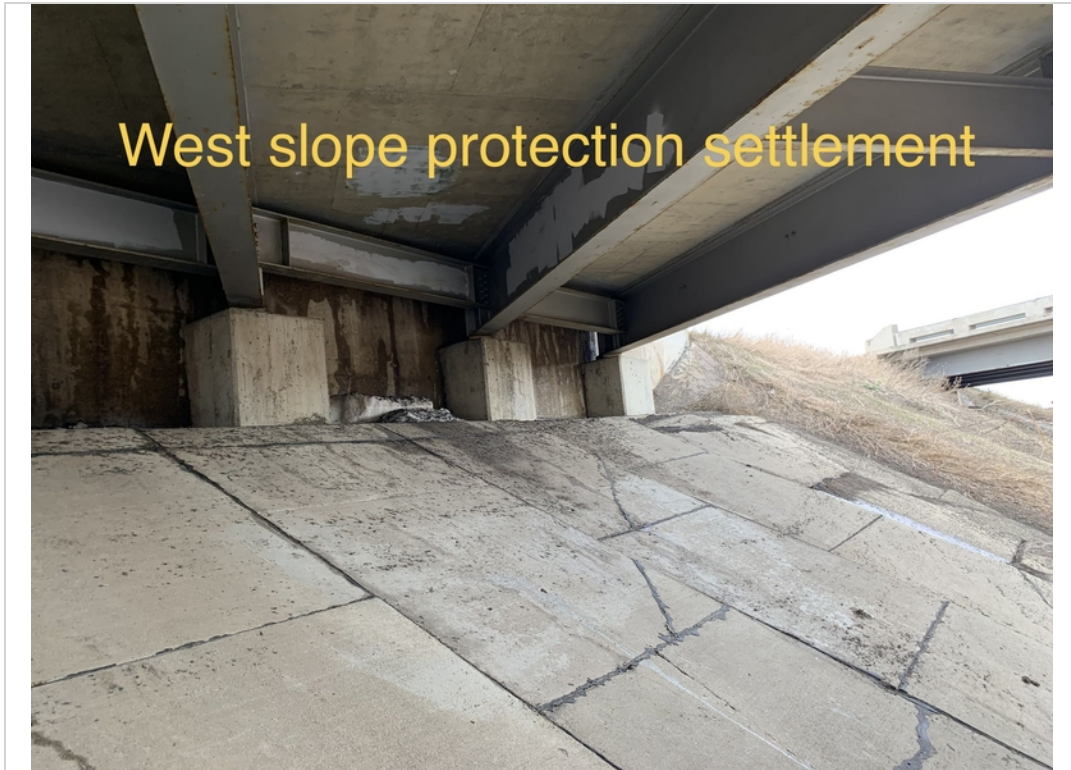
West slope protection settlement

The West slope protection has an area (approximately 3 panels) at the North end that has shifted and undermined. The East slope protection has shifted and has panels that have warped.

Recommend filling any voids and repairing or resetting panels and sealing joints. 15April2021, 26April2023

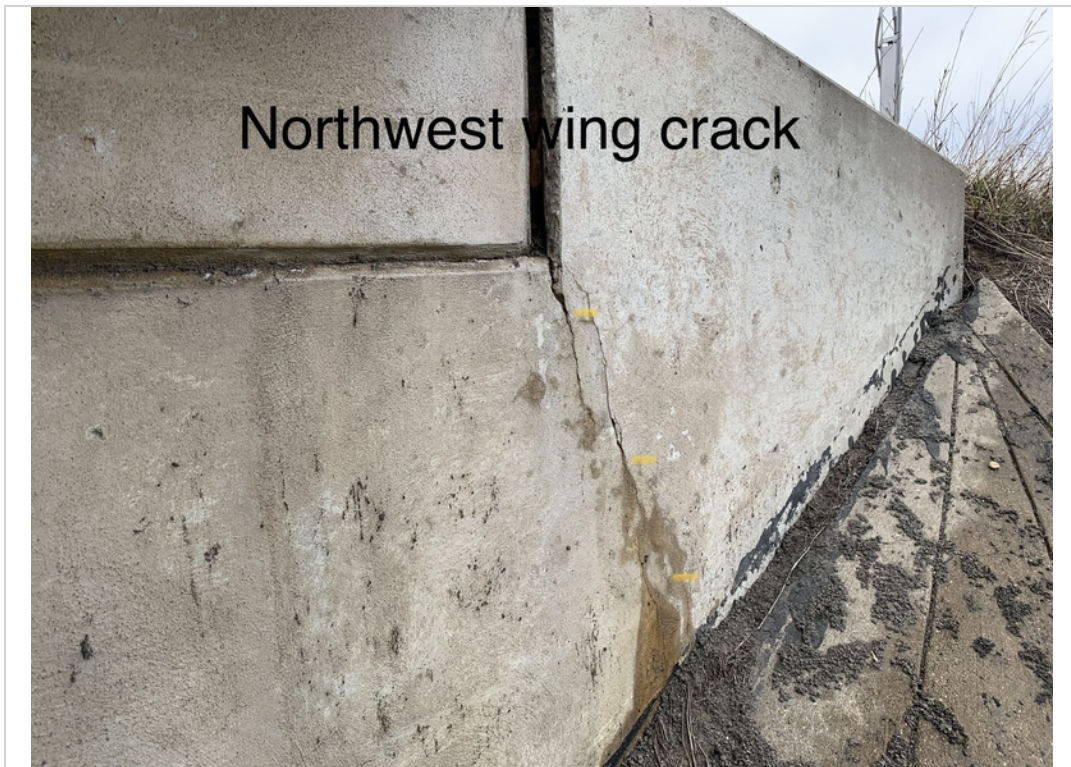
ELEMENTS	DESCRIPTION	UNITS	TOTAL	CS1	CS2	CS3	CS4
(1130-8401)	All wings have minor cracking - 4/1/2019  Thee Northwest wing has a crack that. Measured approximately 0.012 in width where the wing meets the abutment. 15April2021 26April2023 - There is no change to this defect.

NW wing crack

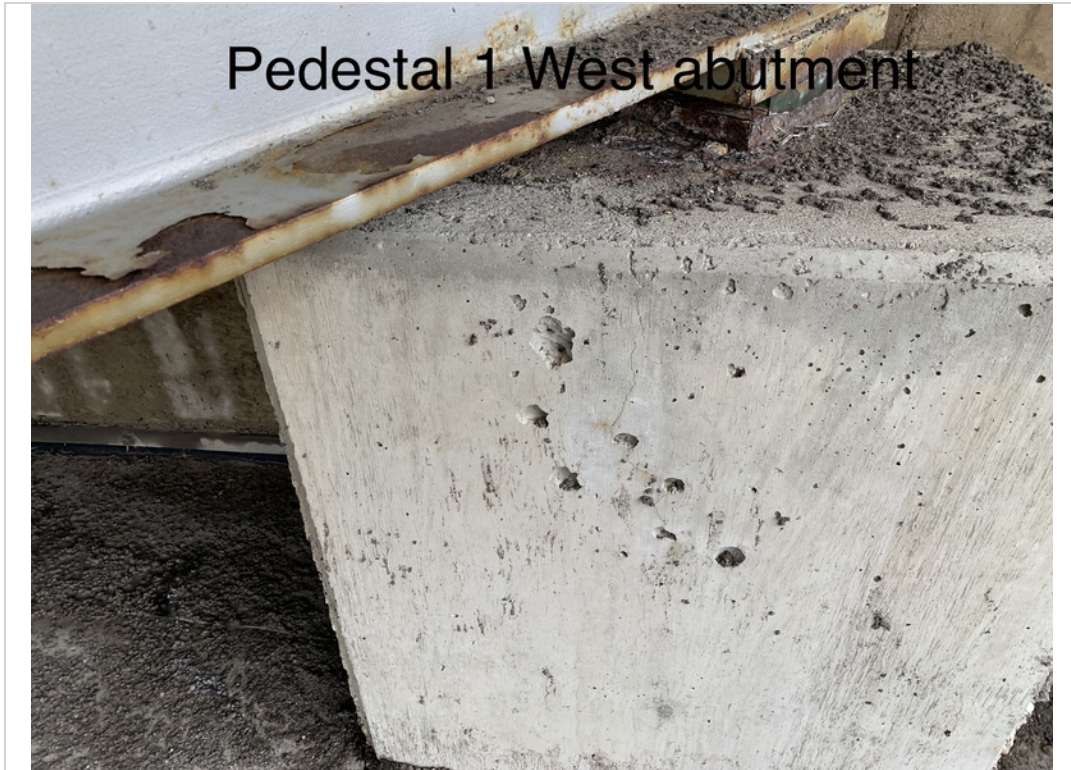
Pedestal 1 West abutment

Ped 1 west abutment crack

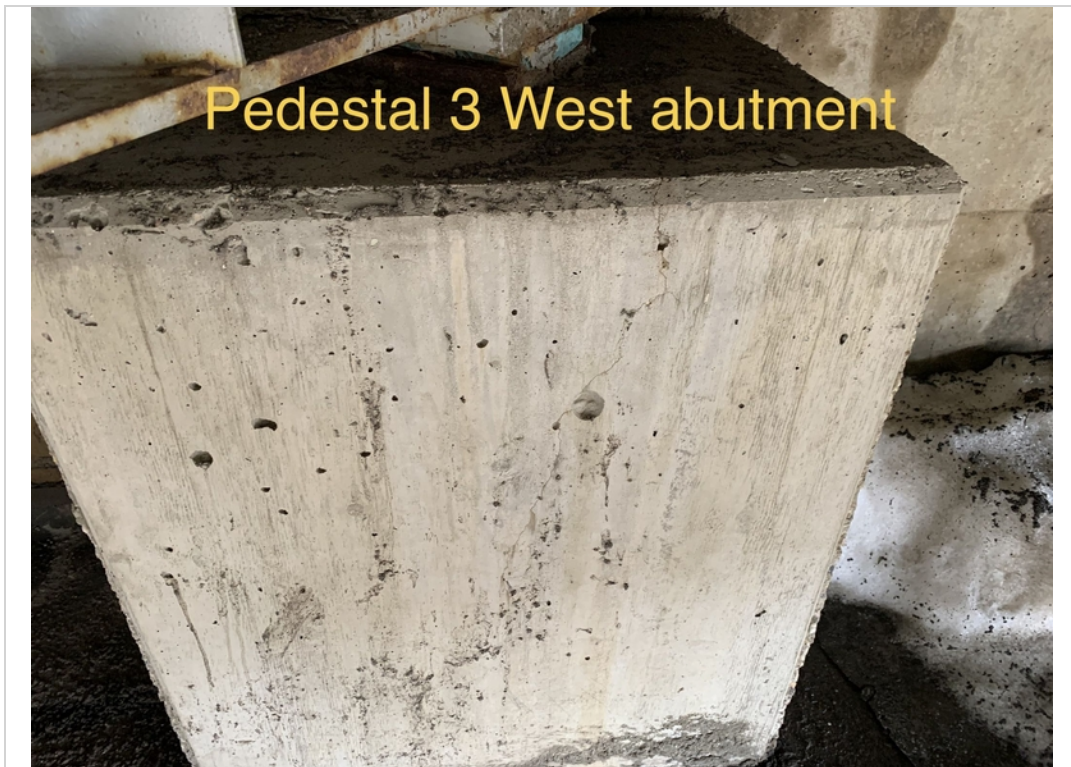
Pedestal 3 West abutment

Ped 3 west abutment crack

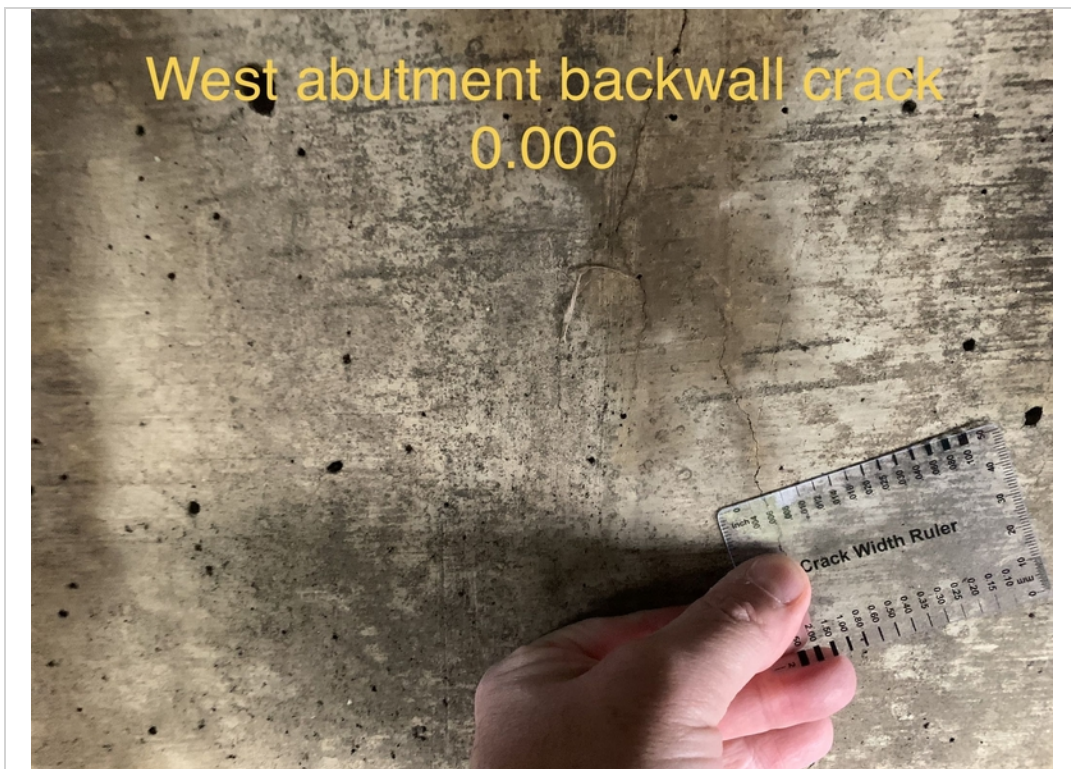
West abutment backwall crack .006

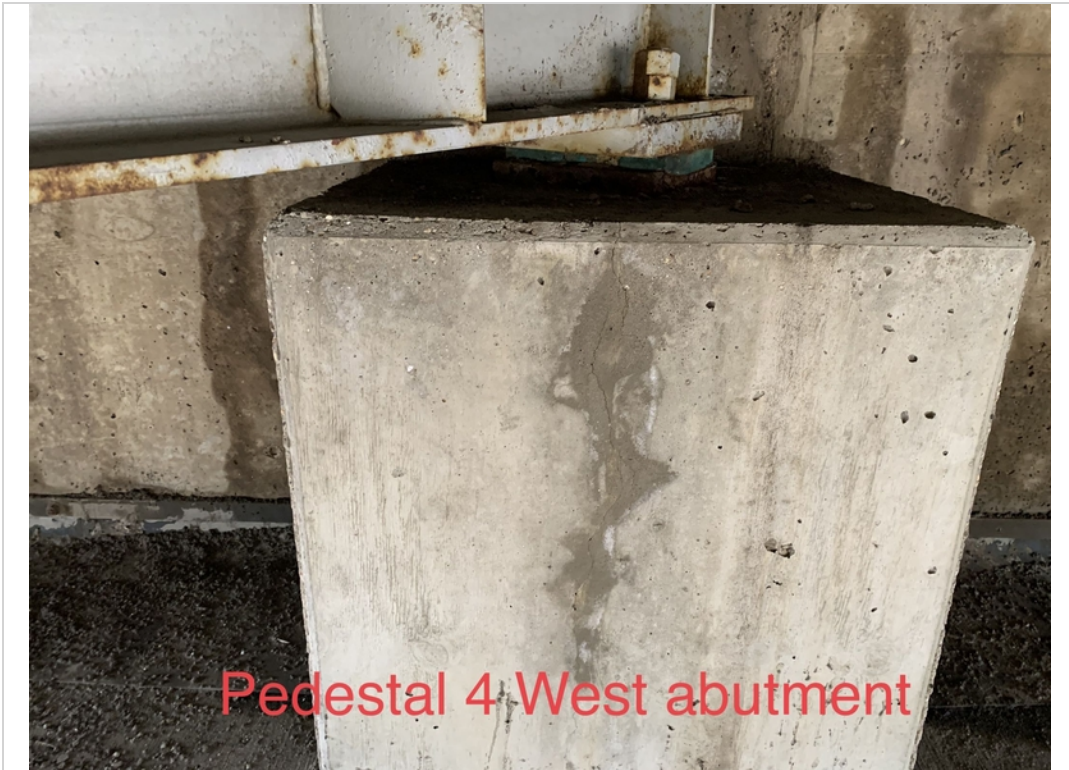
Ped 4 west abutment crack

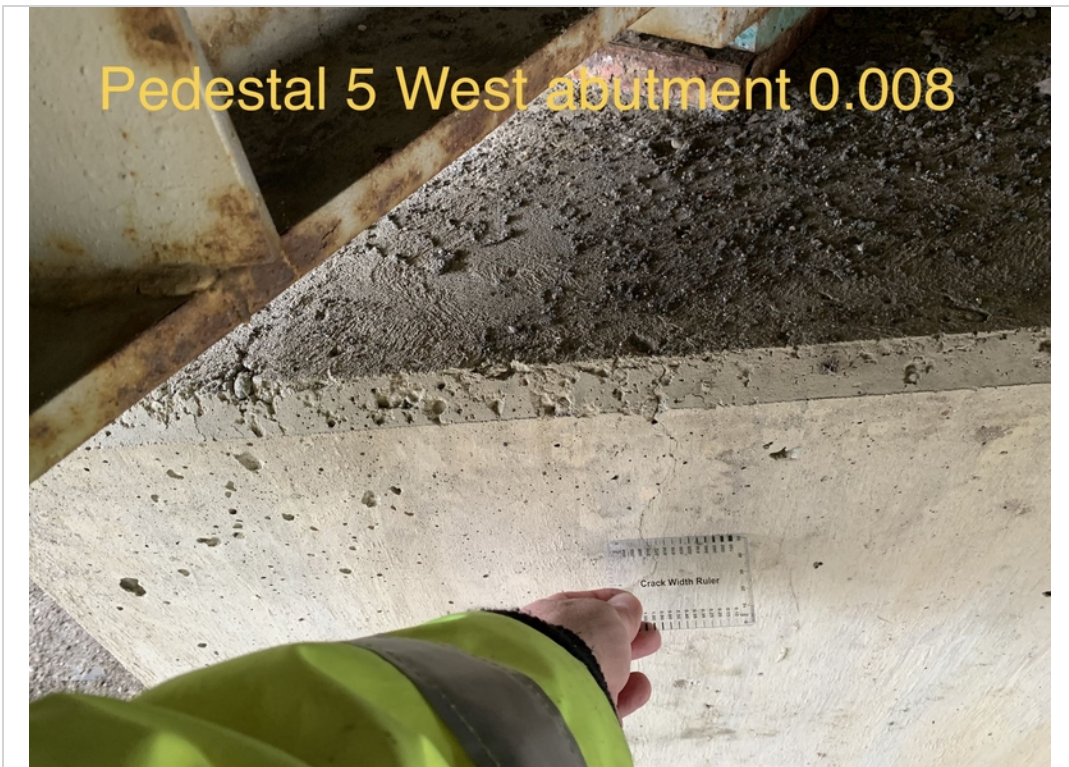
Ped 5 west abutment crack .008

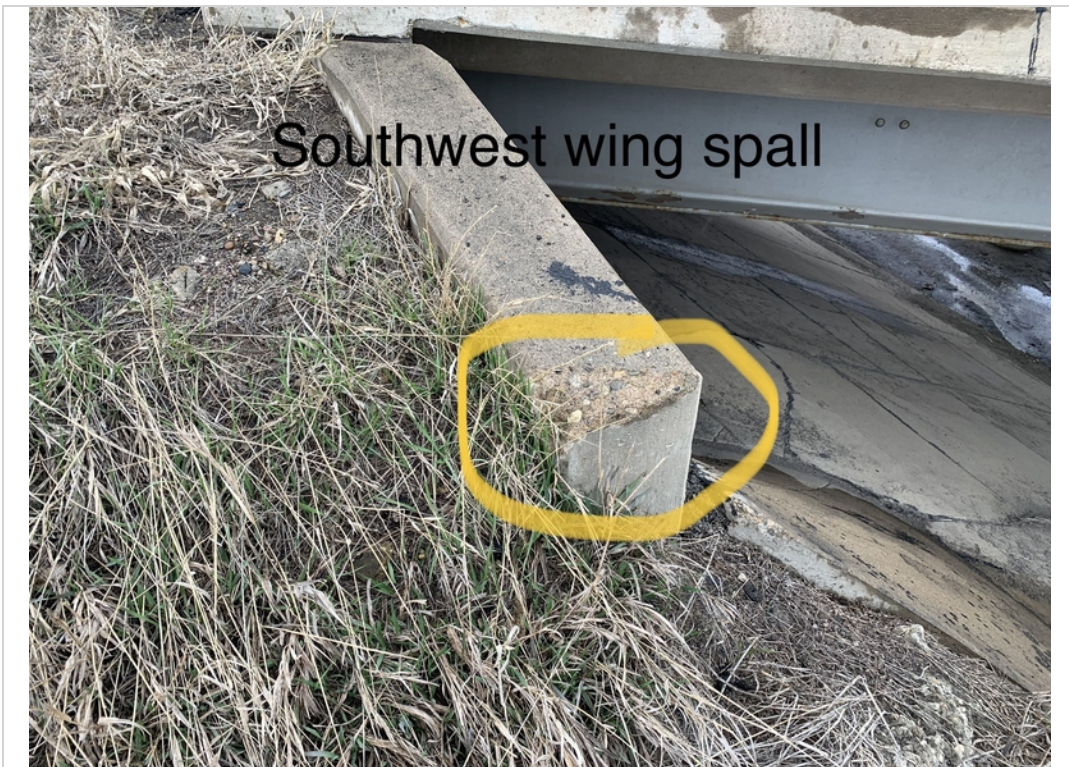
<p>(8401) All wings have minor cracking - 4/1/2019</p> <p>(1080-8401) 26April2023 - The Southwest wing has a spall on the end of the wing that is approximately 8 inches by 6 inches in size.</p>

SW wing spall

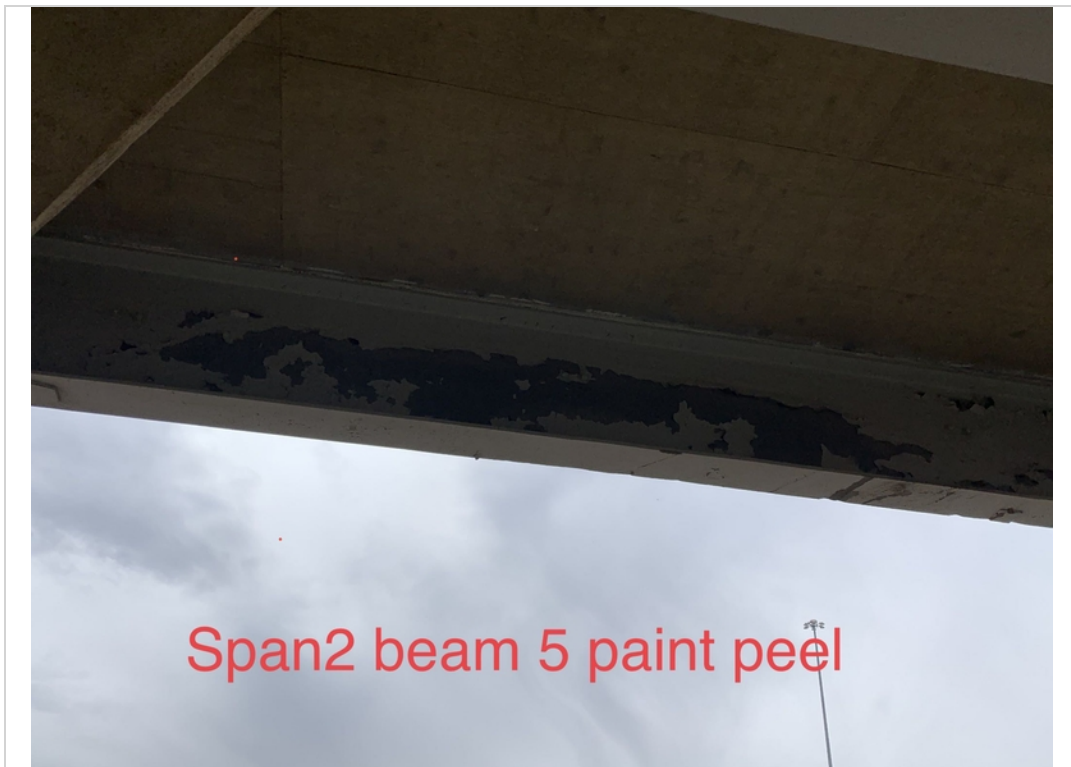
Span 2 beam 5 paint peel

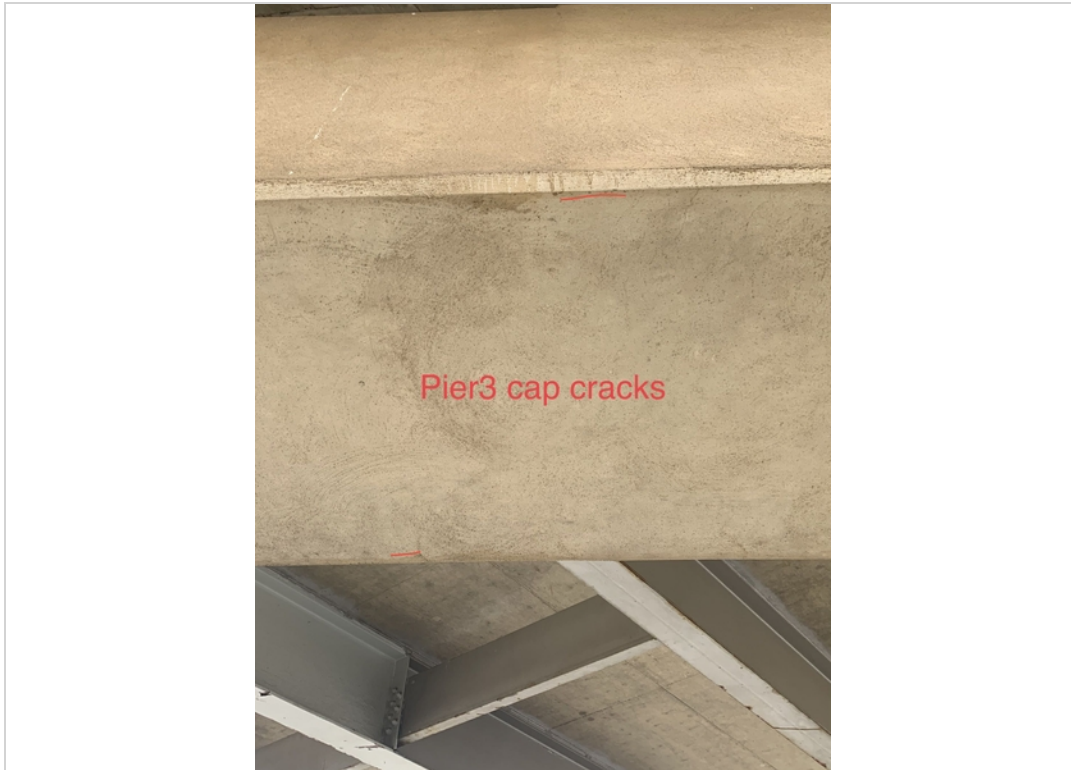
Pier 3 cap cracks

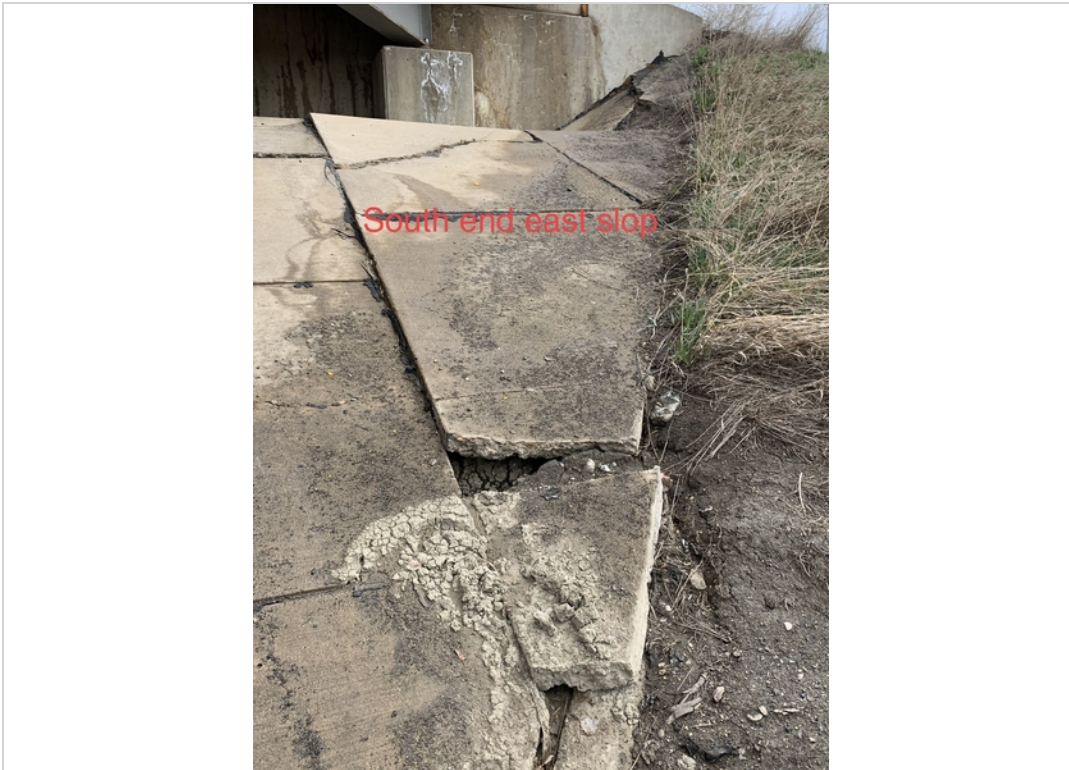
South end east slope protection broke and erosion

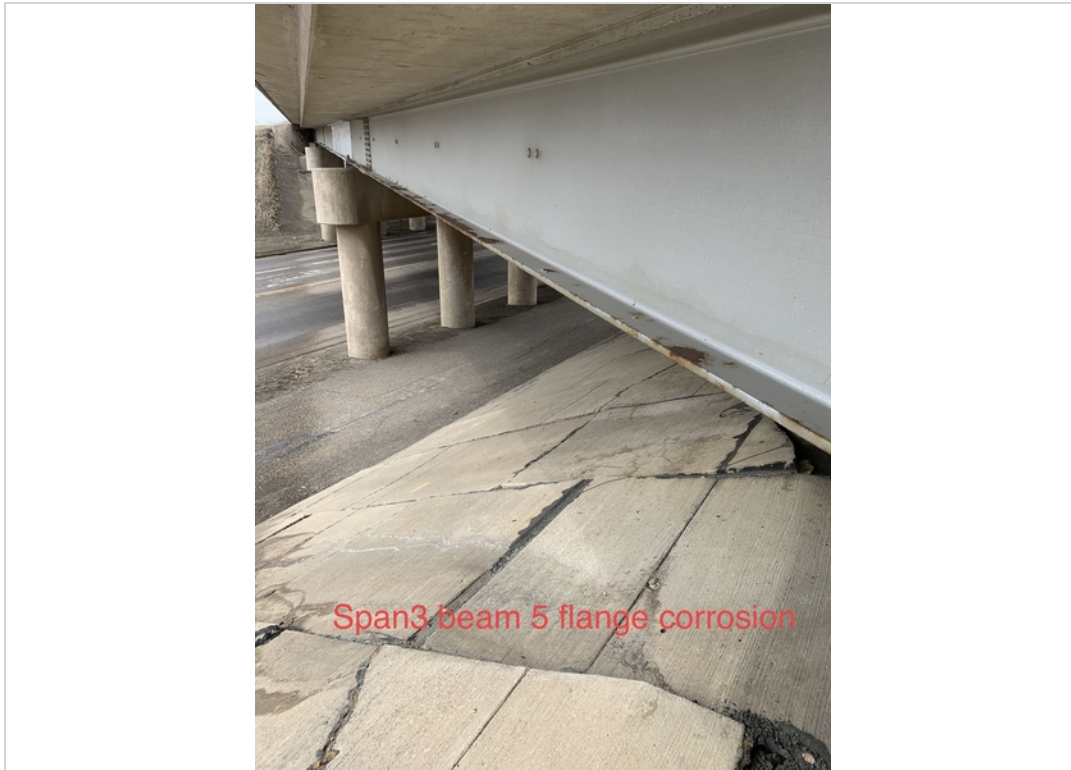
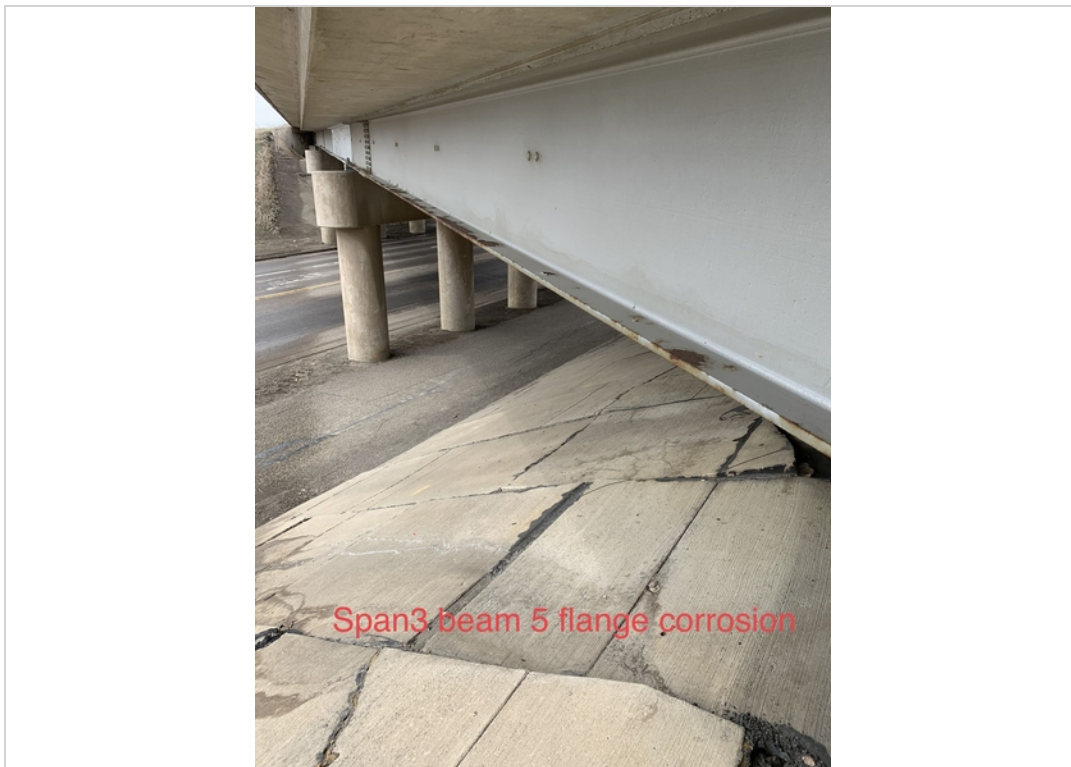
Span 3 beam 5 flange corrosion

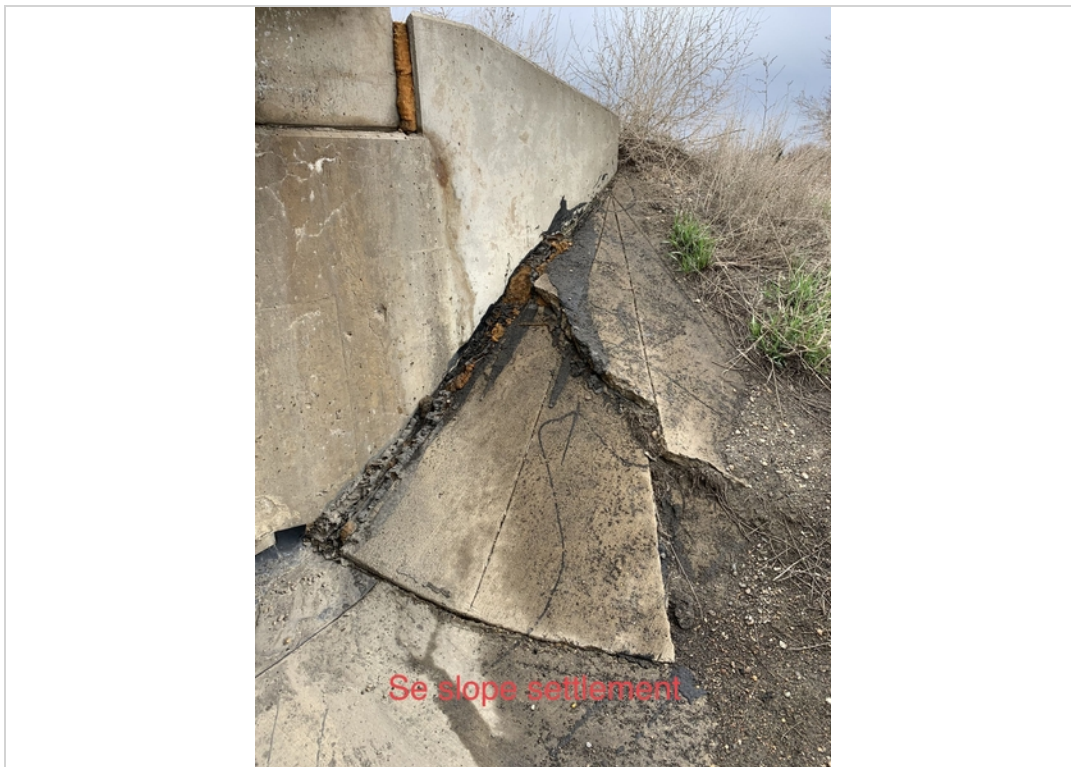
Se slope settlement

SE slope protection settlement

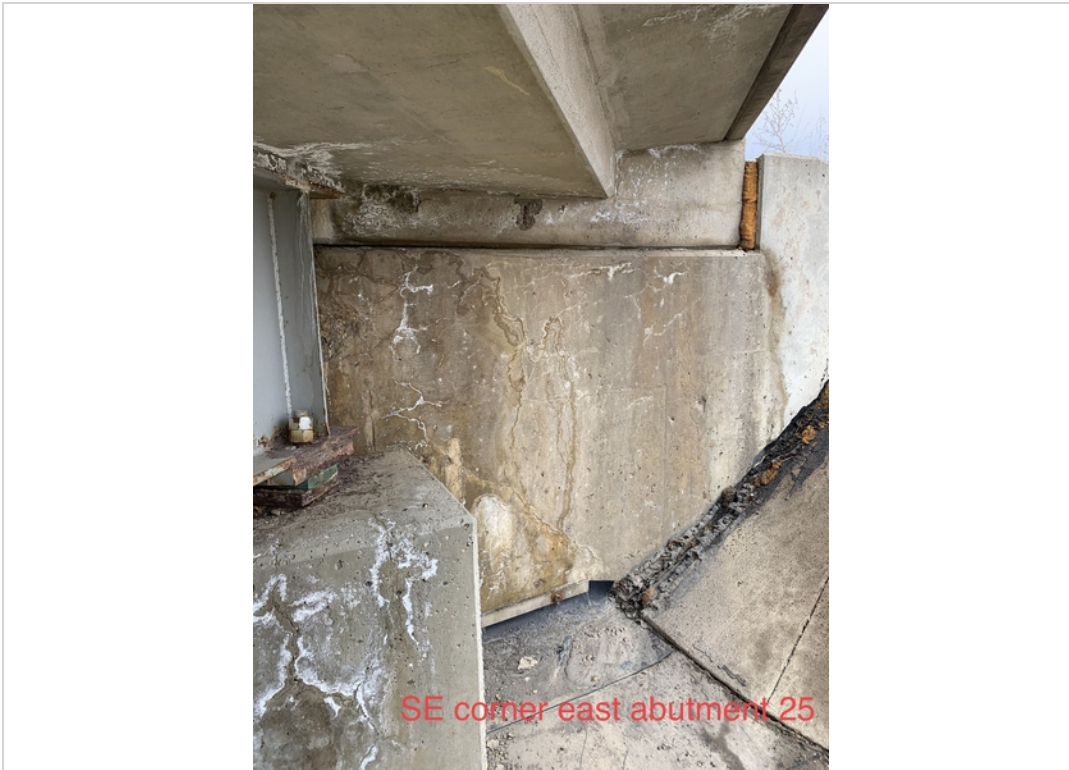
SE corner east abutment cracks efflorescence (25)
