**INTERSTATE 94 over SUNSET DR/NW MANDAN INT.**

**Location: 5 EAST OF ND 25**

**Inspection Date: 04/26/2023**

IDENTIFICATION	
(1) State Names	38 - North Dakota
(8) Structure Number	0094-152.329 R
(5) Inventory Route	1
(2) Highway Agency District	1 - Bismarck
(3) County Code	30 - Morton

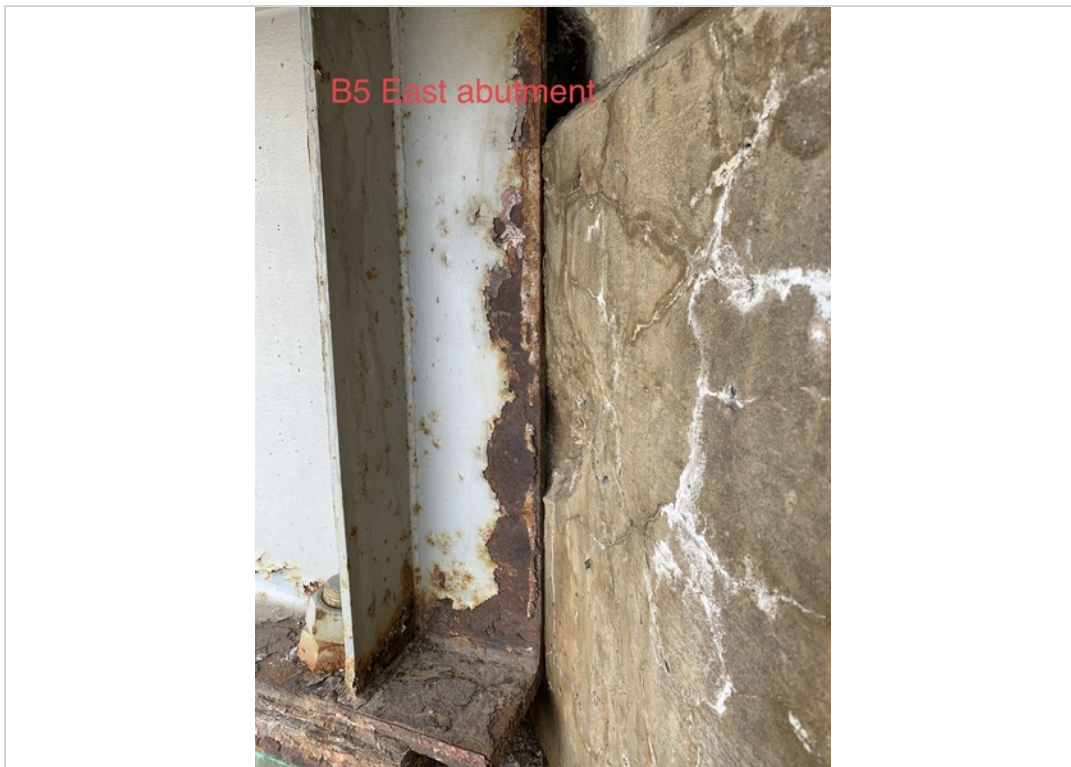
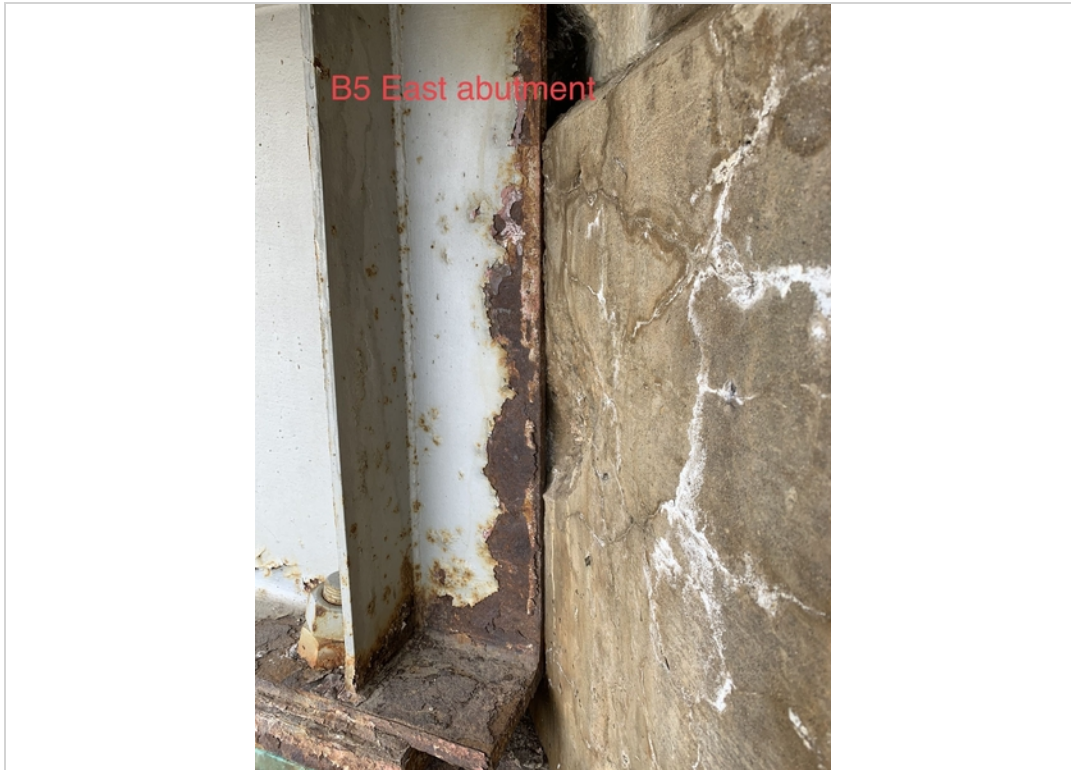
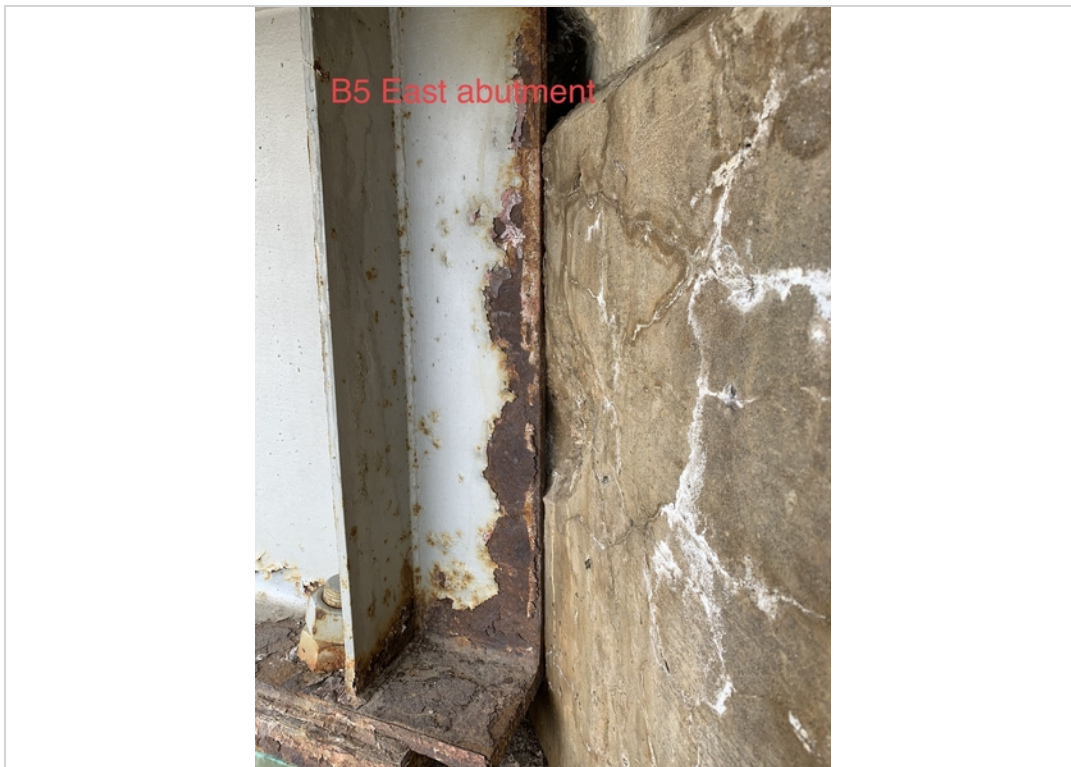
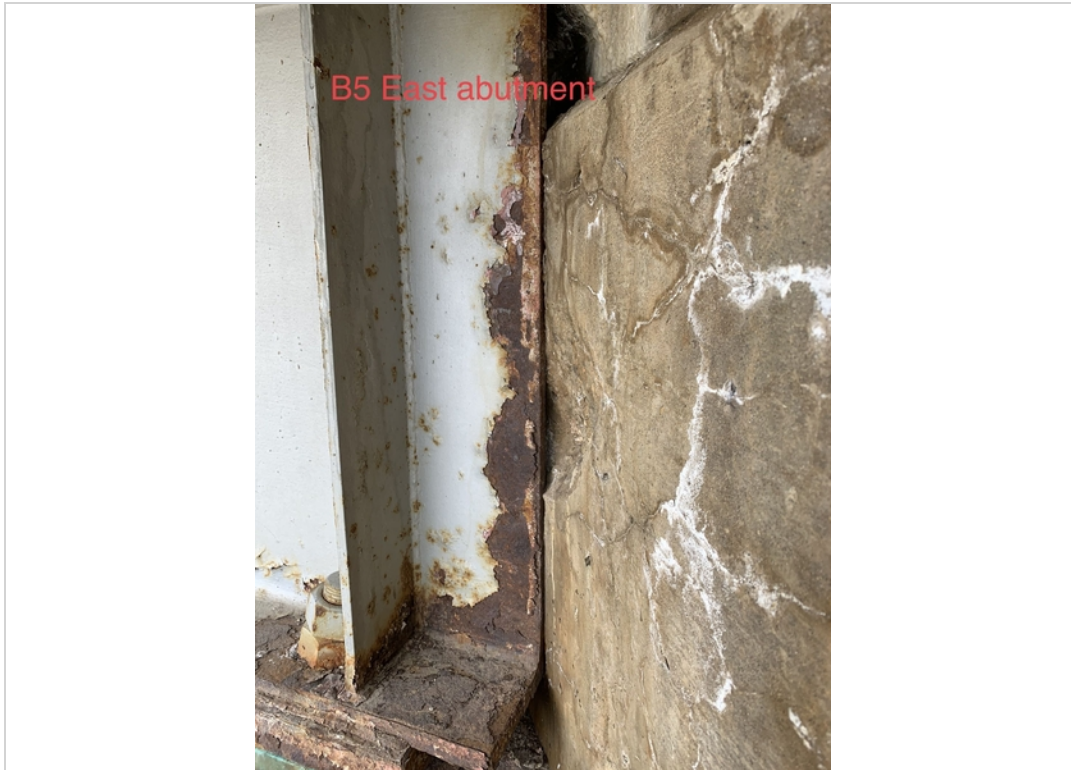
815	Re Conc Backwall	LF	95	84	10	1	0
1080	Delamination/Spall/Patched Area	LF	1	0	0	1	0
1130	Cracking (RC and Other)	LF	10	0	10	0	0
<p>(1080-815) 26April2023 - There is a 1 foot by 6 inch spall on the East abutment at the end of beam 5.</p> <p>(1130-815) 26April2023 - All the pedestals have cracks.</p>							
8399	Slope Protection, RC	EA	2	0	1	1	0
4000	Settlement	EA	2	0	1	1	0
<p>(8399) both slope protections show some movement due to settlement. - 4/1/2019</p> <p>(4000-8399) Both slope protections have settled causing minor movement. - 4/1/2019</p> <p>The West slope protection has an area (approximately 3 panels) at the North end that has shifted and undermined. The East slope protection has shifted and has panels that have warped. 15April2021 26April2023 - There is no change to this defect.</p>							
8401	Wings	EA	4	2	1	1	0
1080	Delamination/Spall/Patched Area	EA	1	0	0	1	0
1130	Cracking (RC and Other)	EA	1	0	1	0	0

Beam 5 east abutment ,backwall spall, beam touching

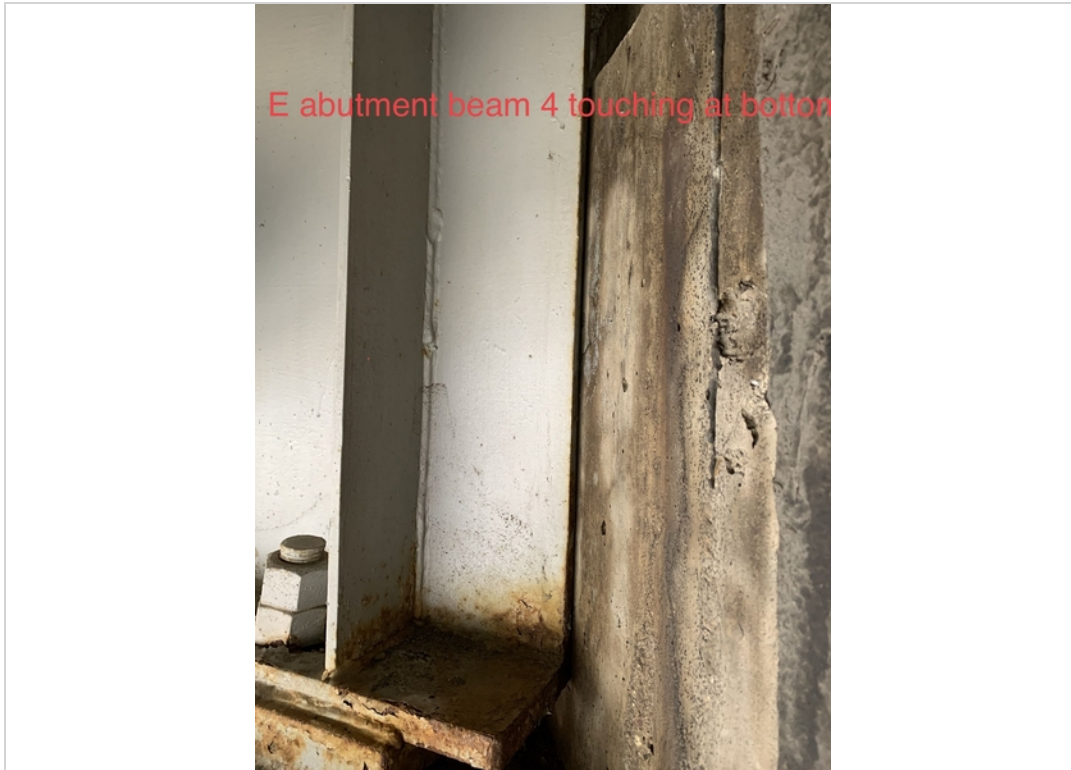
East abutment beam 4 touching abutment

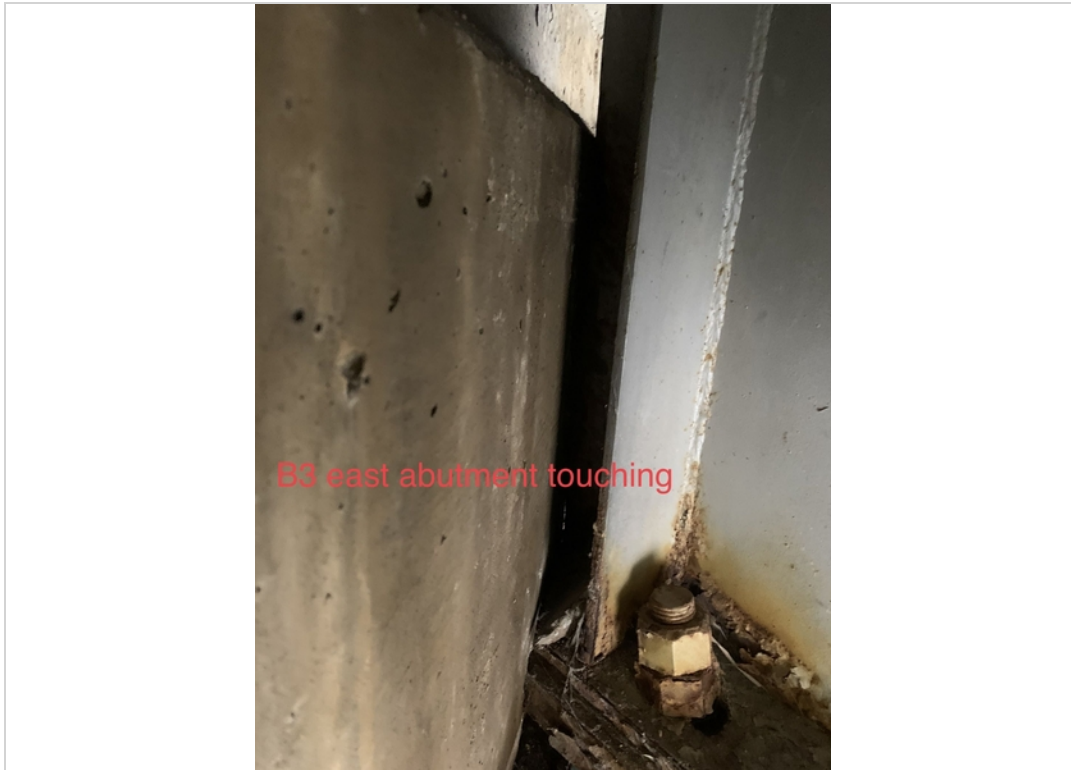
East abutment beam 3 touching

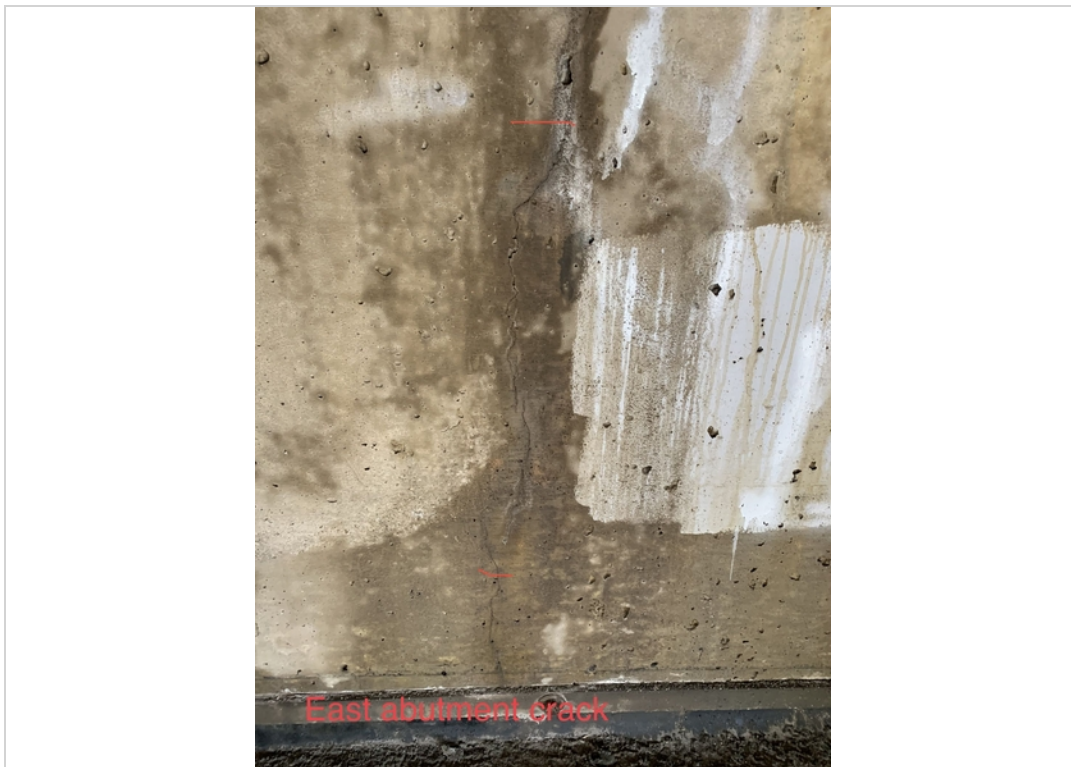
East abutment crack

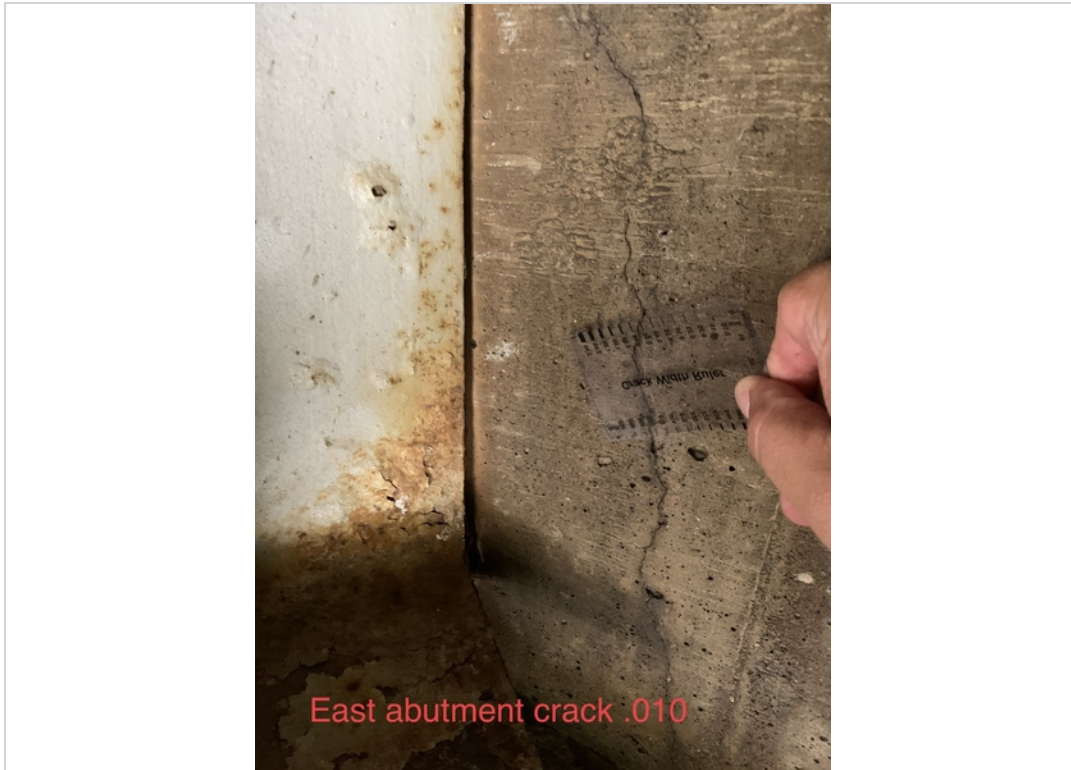
East abutment backwall crack .010

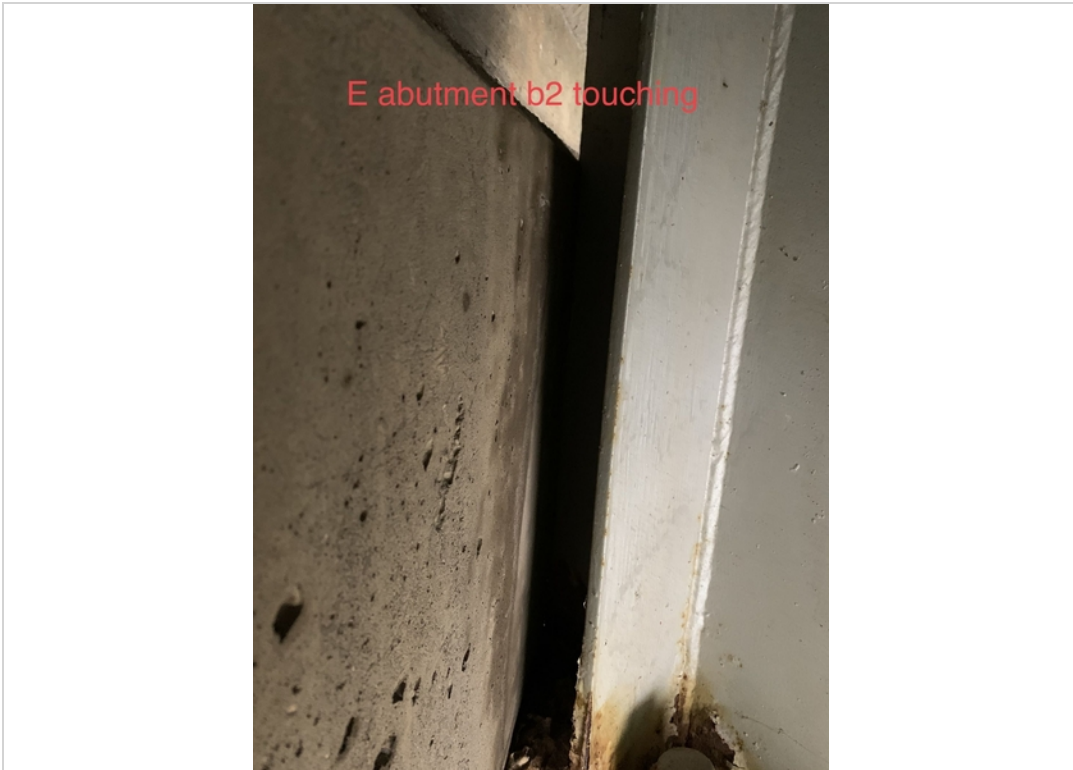
East abutment beam 2 touching abutment

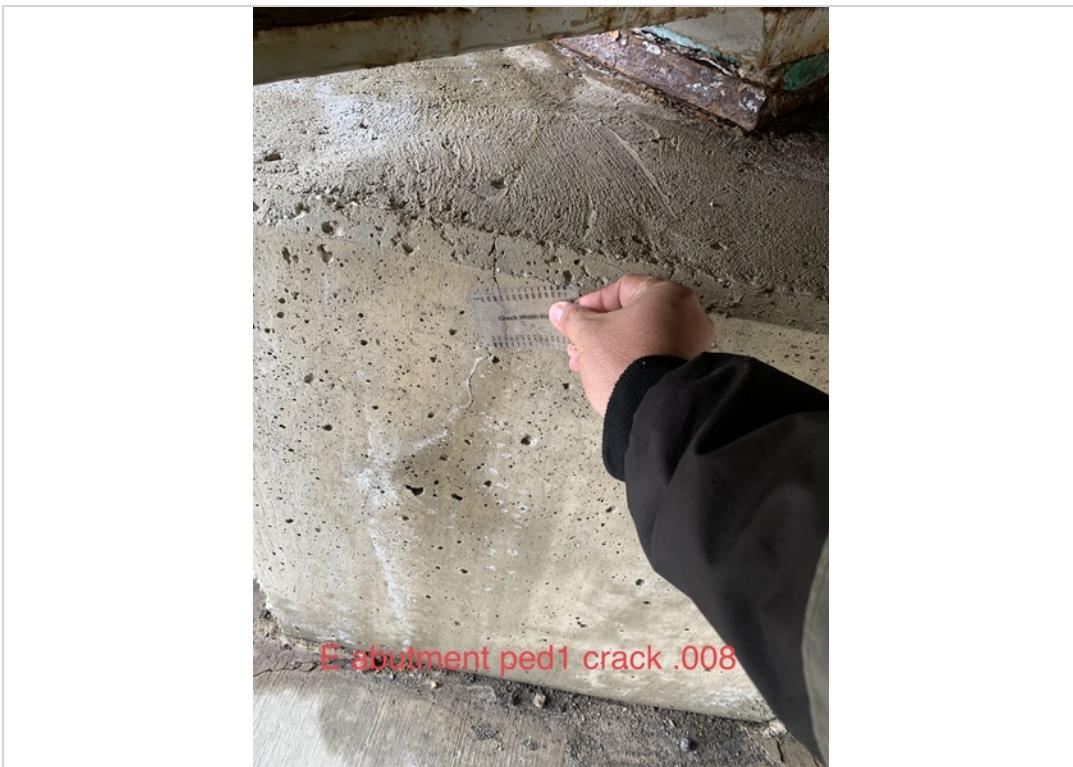
East abutment ped 1 crack .008

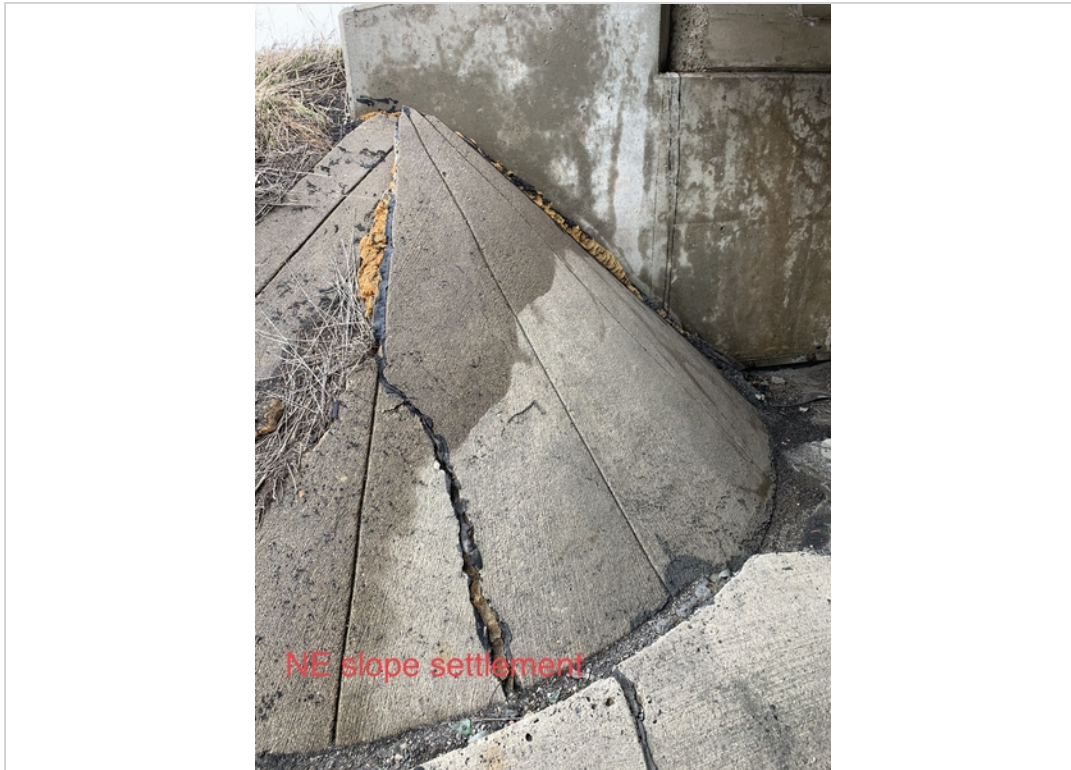
NE corner slope protection settlement

The West slope protection has an area (approximately 3 panels) at the North end that has shifted and undermined. The East slope protection has shifted and has panels that have warped.

Recommend filling any voids and repairing or resetting panels and sealing joints. 15April2021, 26April2023

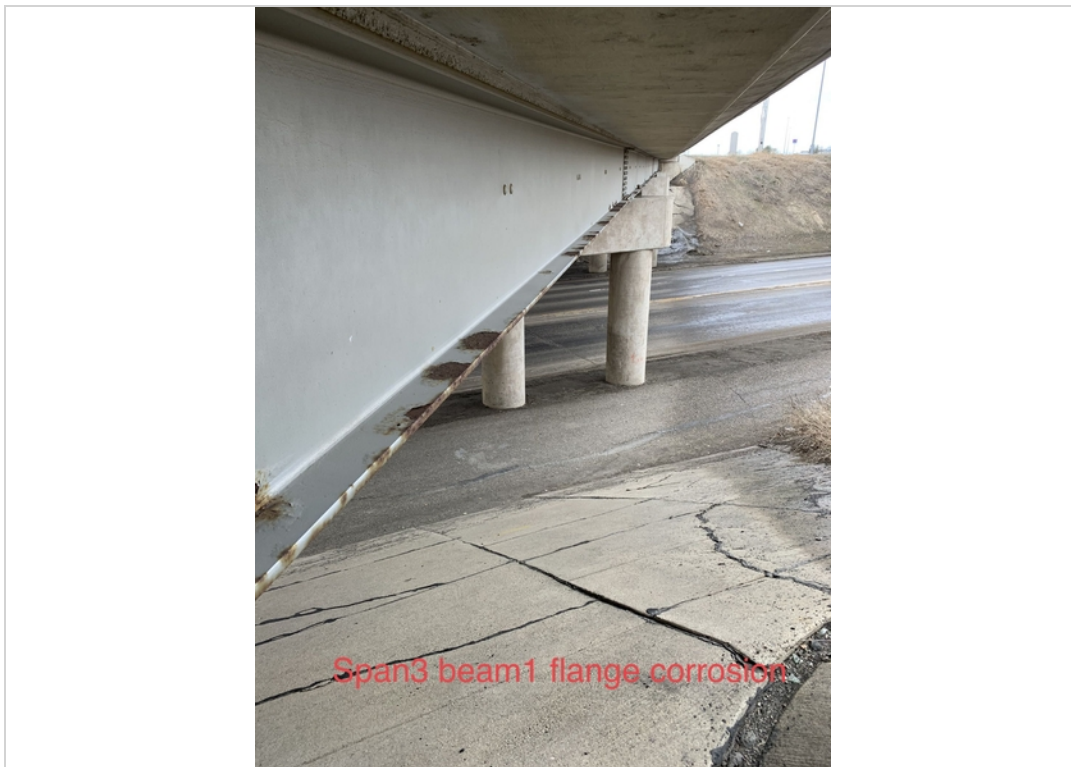
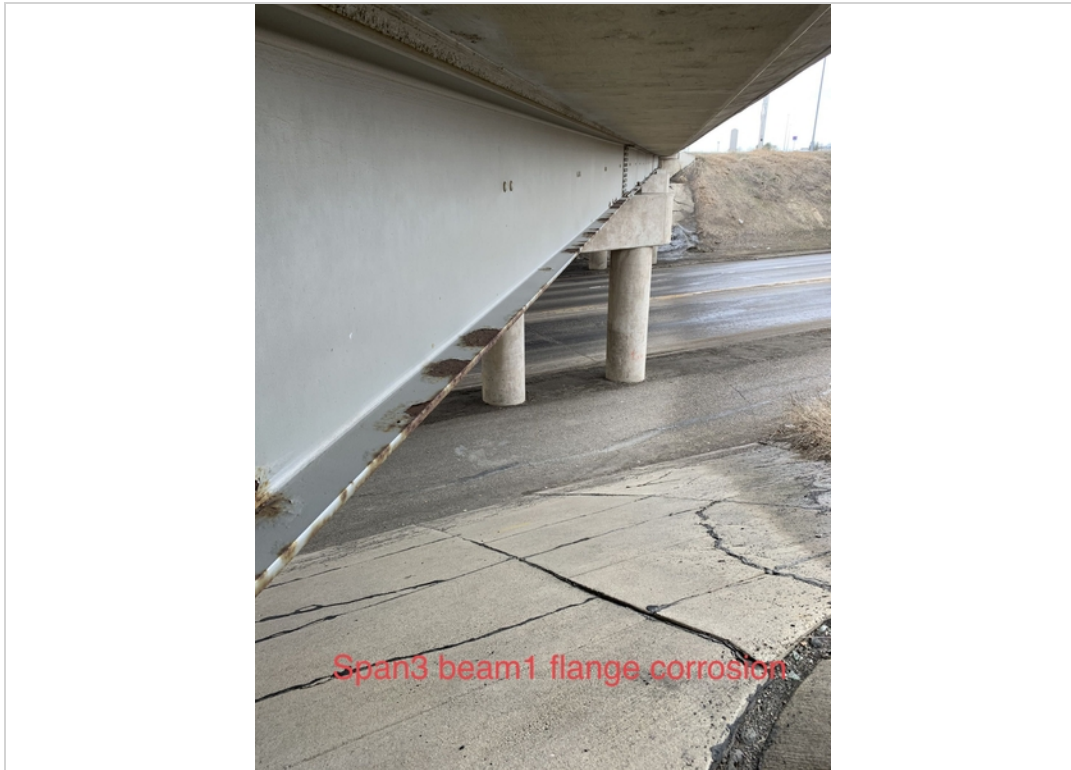
Span3 beam 1 bottom flange corrosion

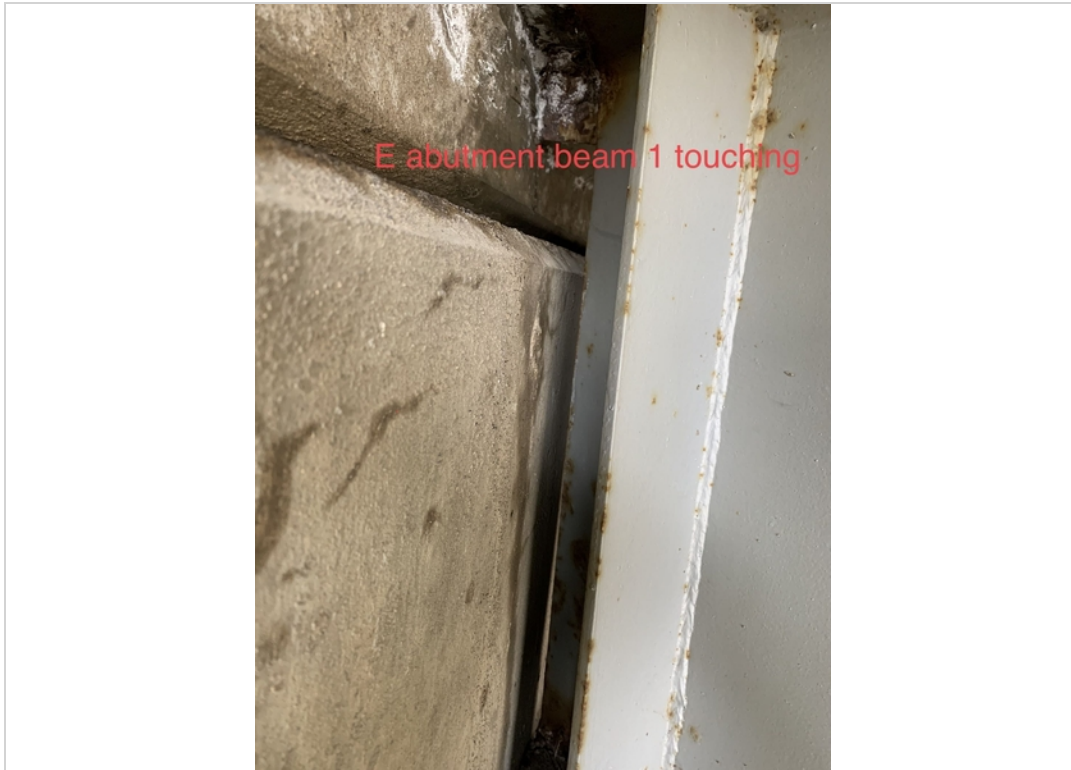
East abutment beam 1 touching abutment

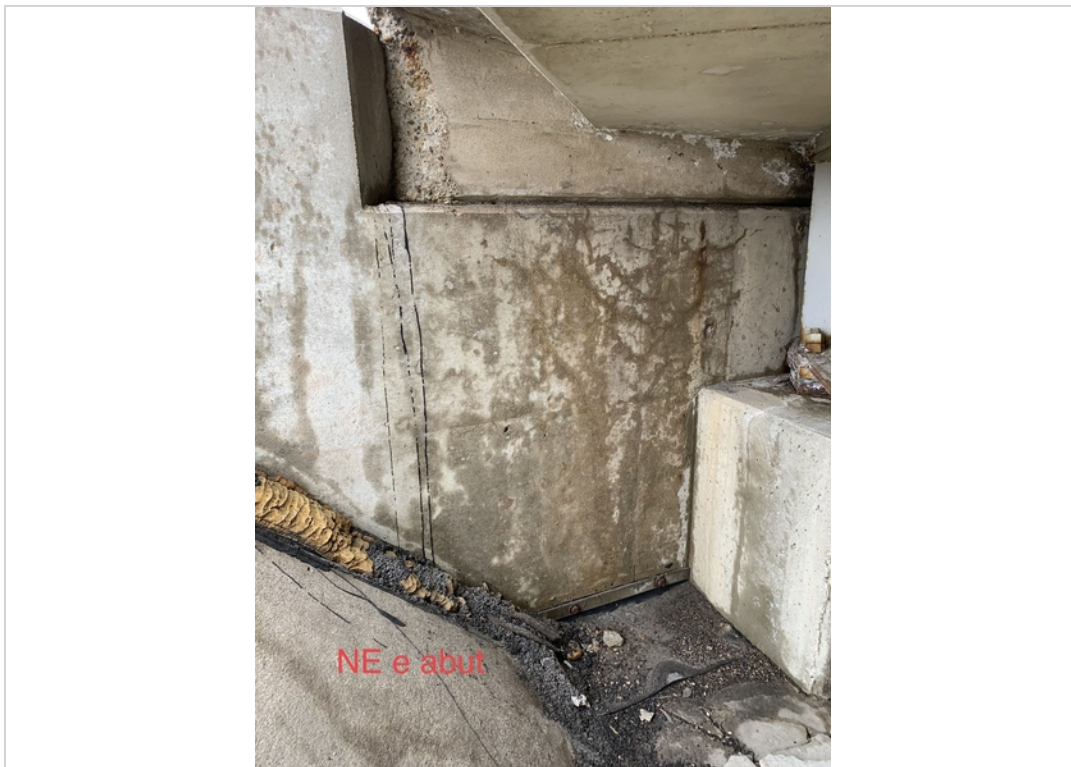
NE east corner east abutment cracks

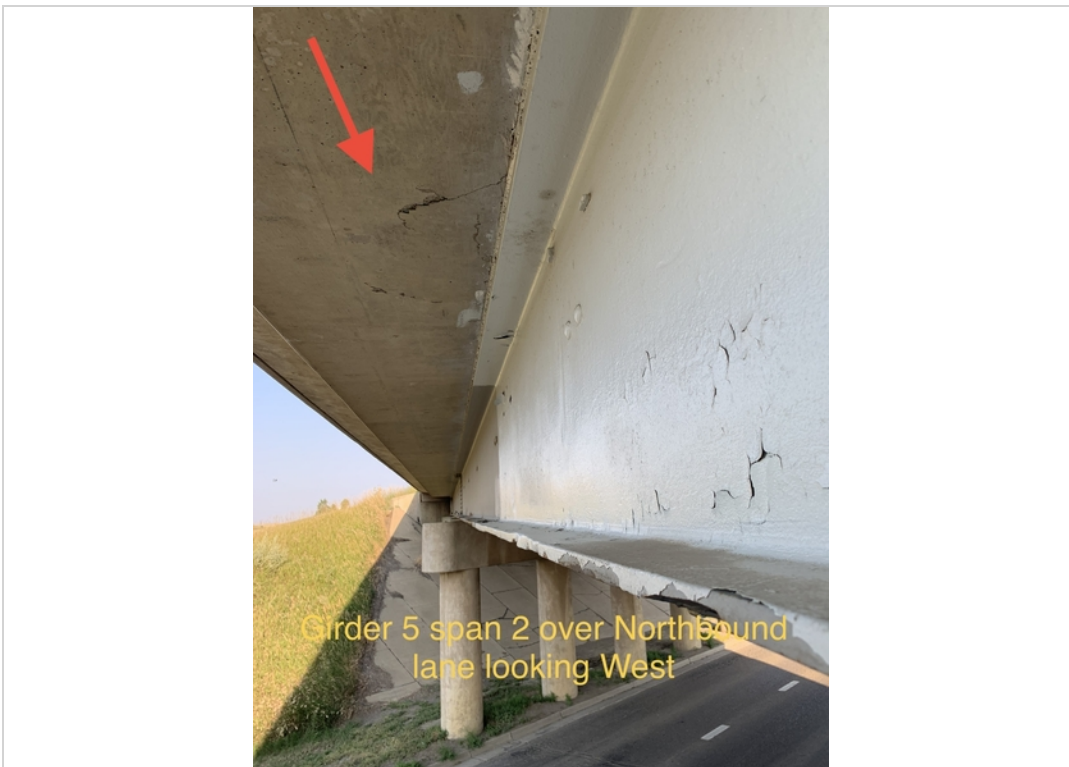
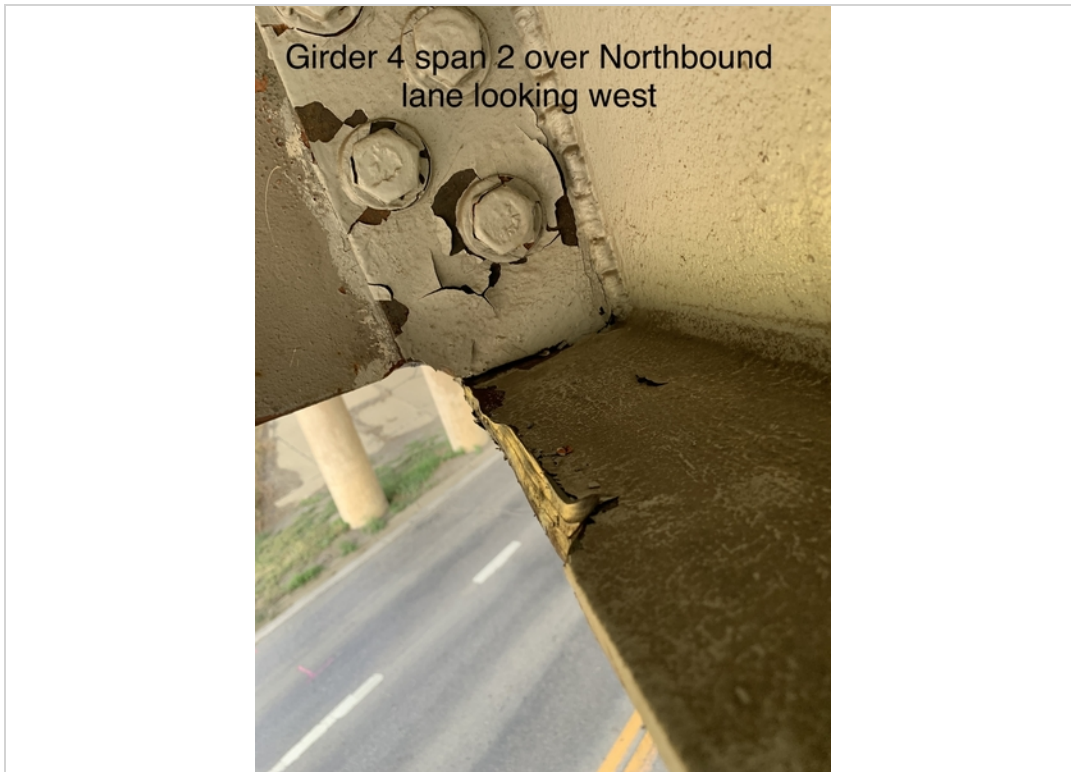
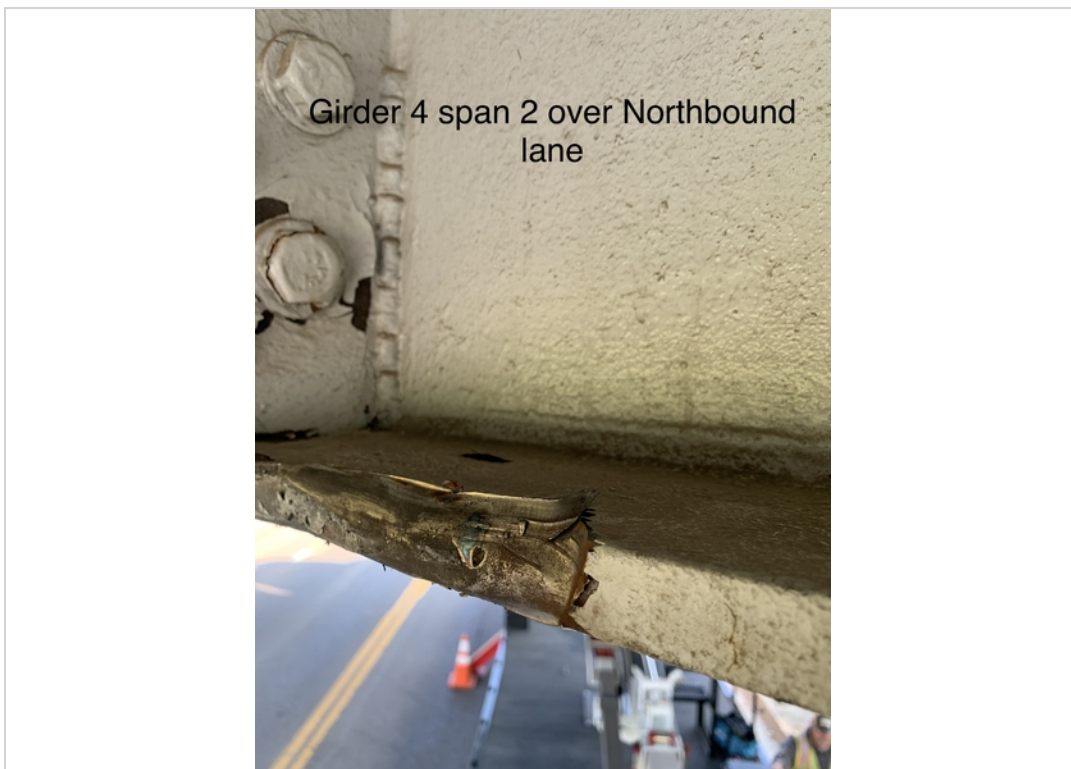
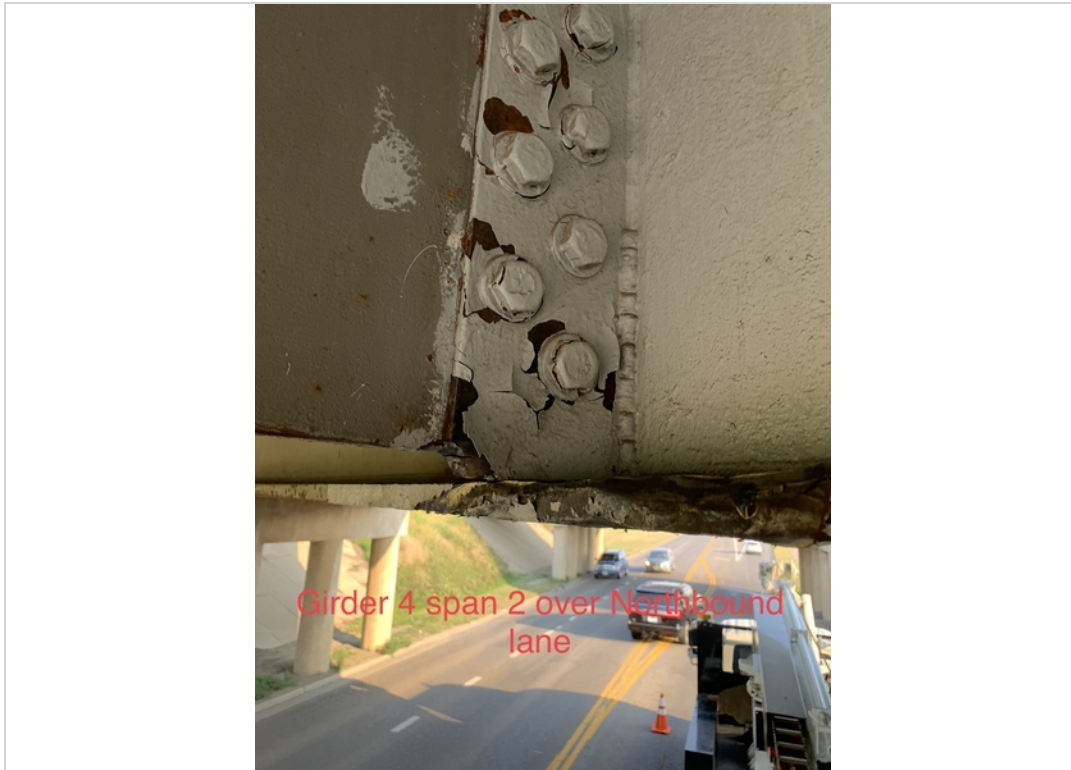
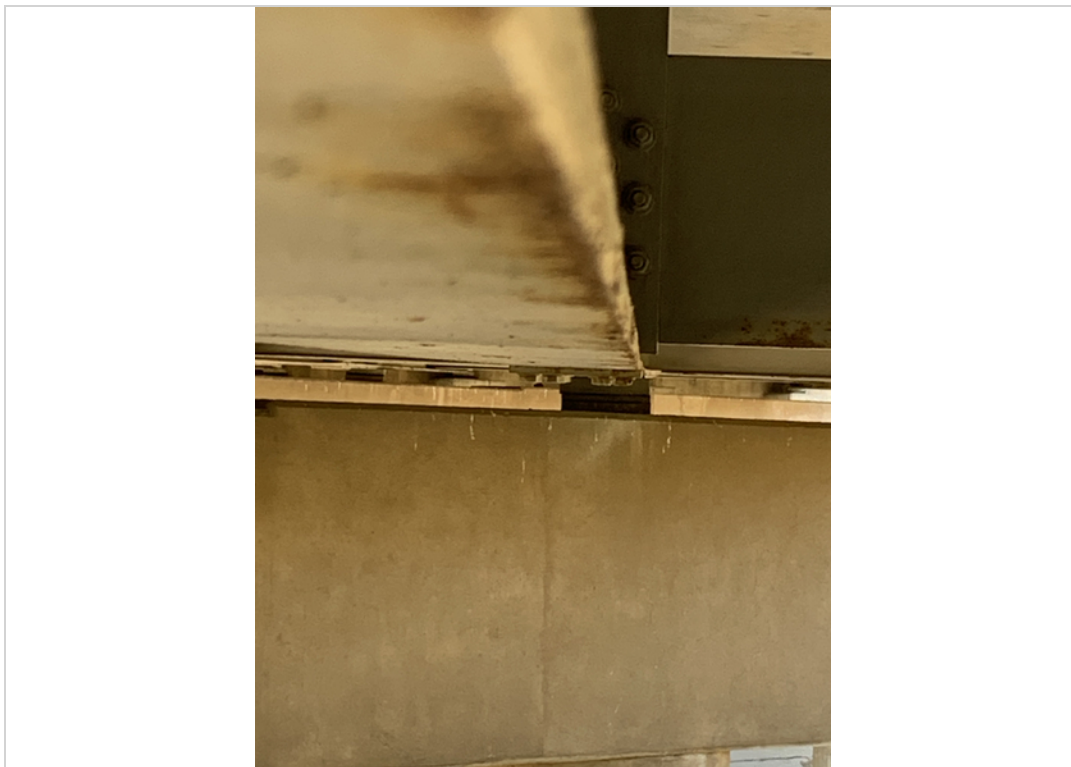
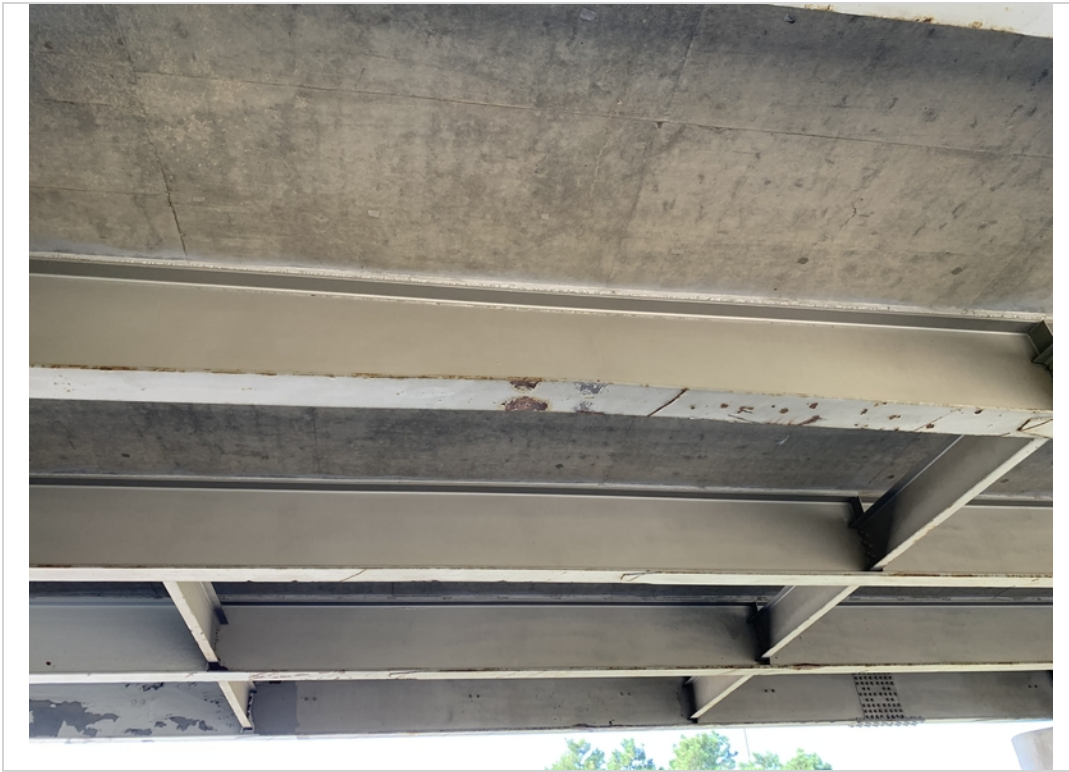
1September2022 - The structure was impacted by an over height vehicle in the Northbound lane. Beam 2 was bent out of plane at the lower flange. The upper flange remained in place and no deck concrete was broken. Beams 5, 4 and 3 were impacted with only minor damage to the lower flanges and to a diaphragm stiffener on Beam 4. The underside of the deck next to the top flange of Beam 5 is cracked and beginning to spall. Beam 5 was damaged on the bottom flange from an over height impact.

Damage

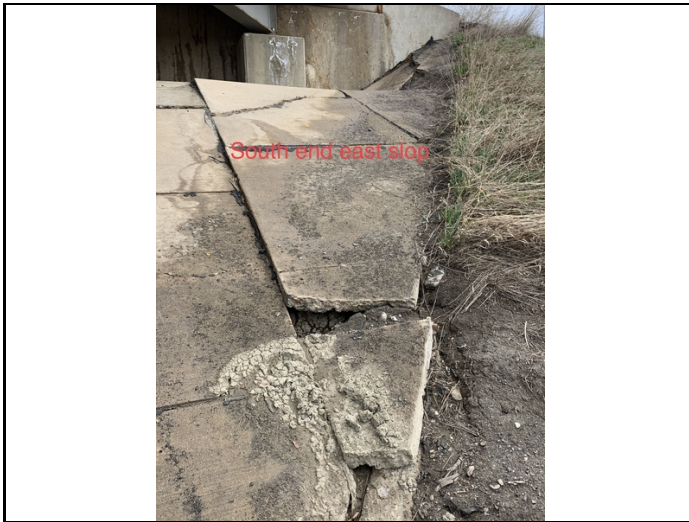
South end east slope protection broke and erosion
