IDENTIFICATION	
(1) State Names	38 - North Dakota
(8) Structure Number	0029-069.374
(5) Inventory Route	1
(2) Highway Agency District	8 - Fargo
(3) County Code	9 - Cass

(4) Place Code	65860
(6) Features Intersected	I-29/NORTH FARGO INT
(7) Facility Carried	CASS COUNTY 20
(9) Location	3 SOUTH OF HARWOOD
(11) Mile Point	0.1 mi

INSPECTIONS *			
(90) Inspection Date	07/17/2023		
(91) Frequency	24		
(92) Critical Feature Inspection	Done	Freq. (Mon)	Date
A: Fracture Critical Detail	No		
B: Underwater Inspection	No		
C: Other Special Inspection			
* The inspection date and frequency information in this box contains the current NBI date and frequency information. Please refer to the report header for the date this inspection was conducted.

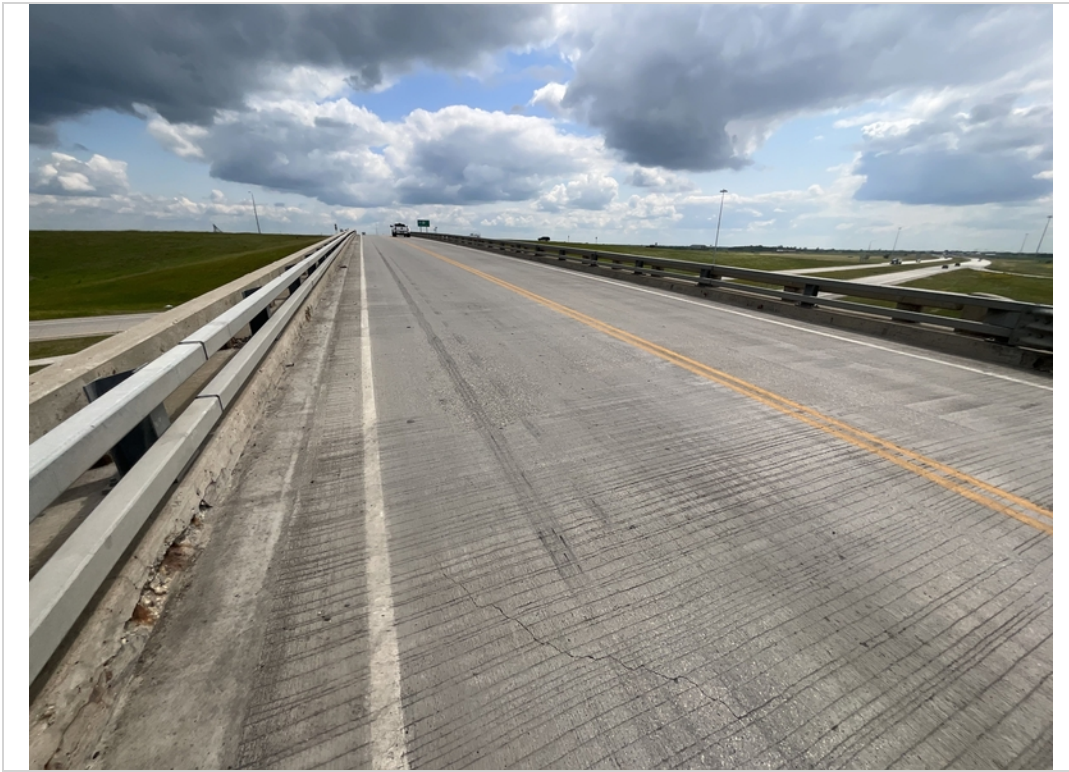
Facing NW. Exposed Rebar to North Railing Post 1.

Recommendation to Remove Delaminated Concrete and perform spall repairs/patches to the various areas. See Photos.

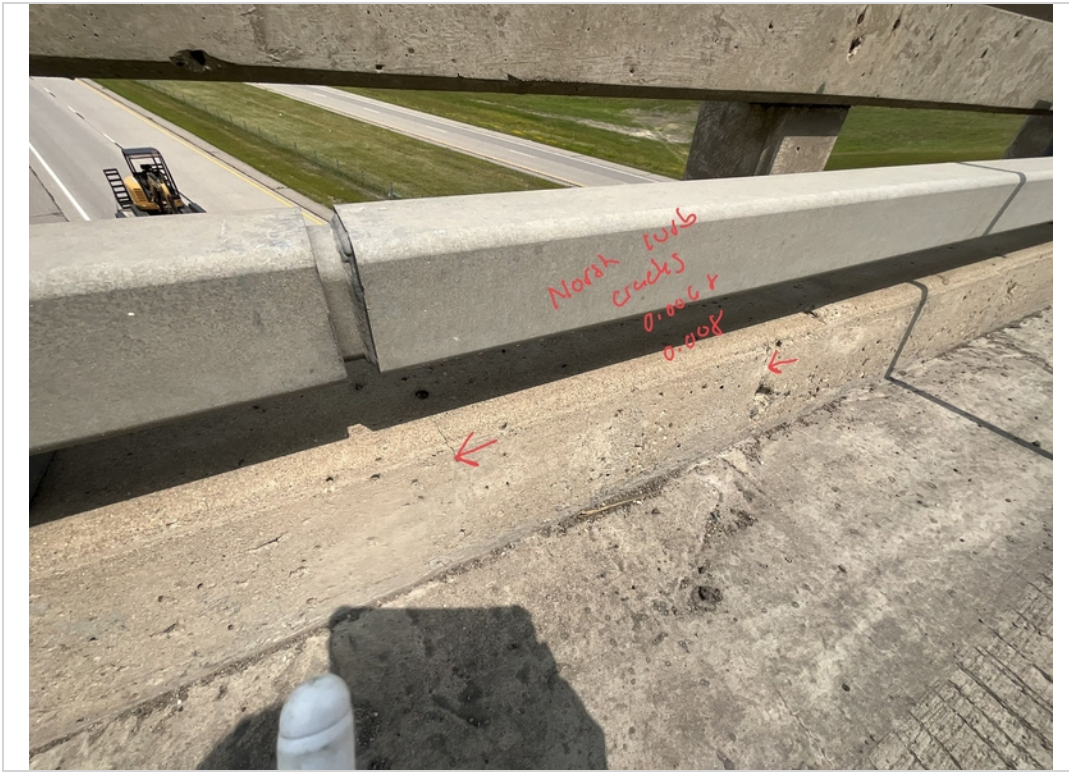
Facing NW. Delamination to Face of North Curb near Post 17.

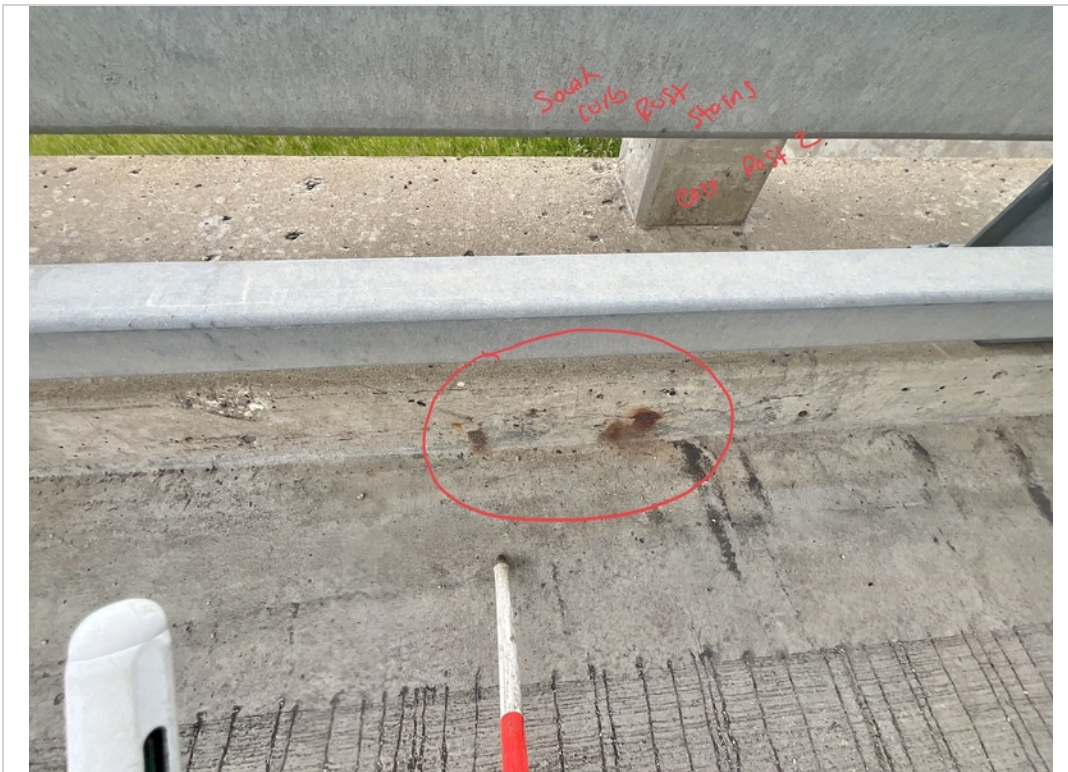
Facing South and Downward. Typical Cracks to South Curb.

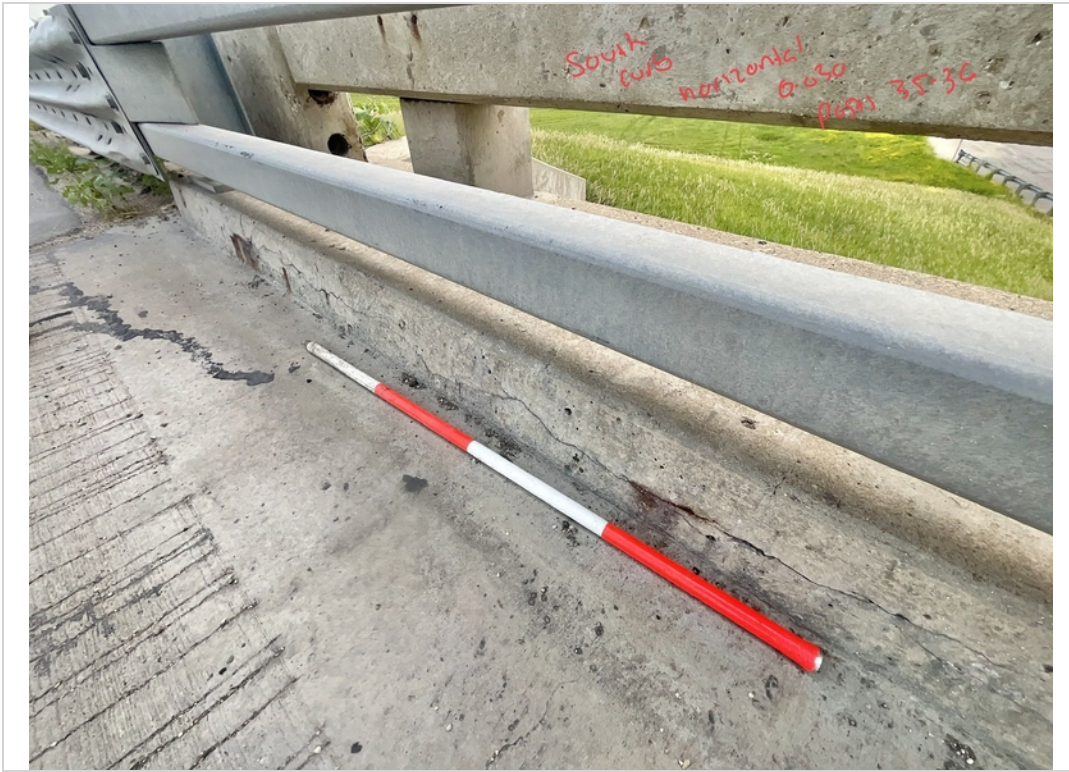
Facing SW. Various Cracks to South curb near Post 1.

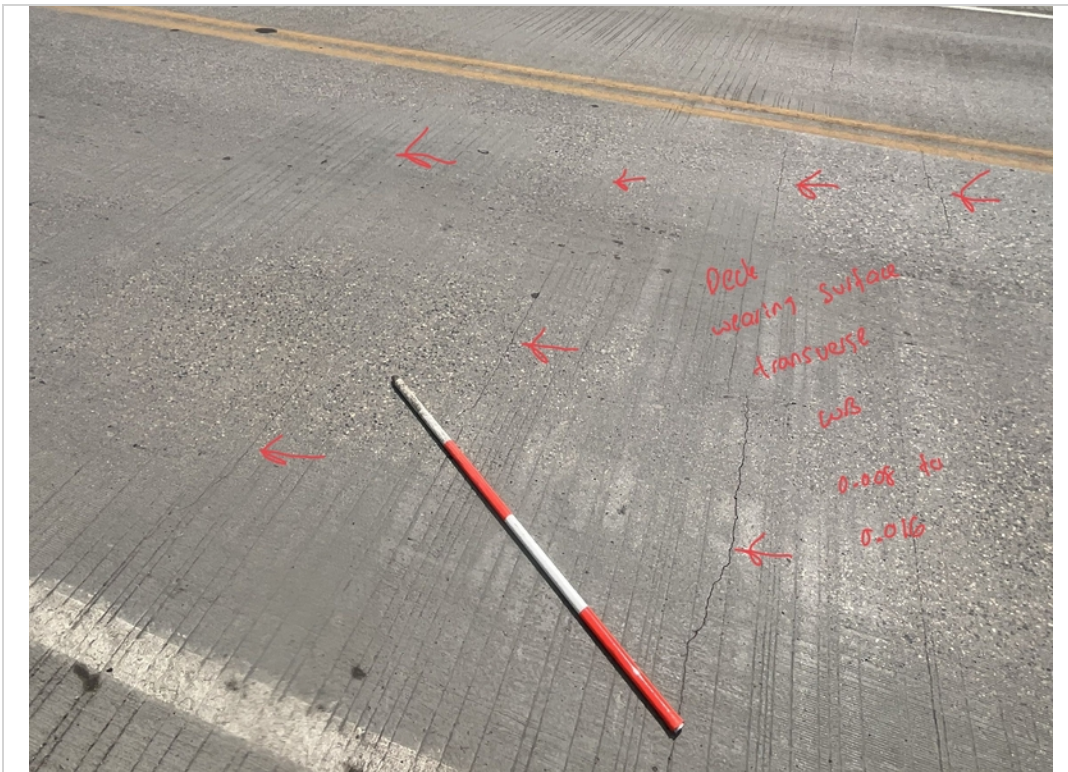
Facing South and Downward. Transverse Crack to Deck Wearing Surface WB Lane.

Recommendation to apply appropriate and approved sealant to cracking as per the Maintenance Manual. See Photos.

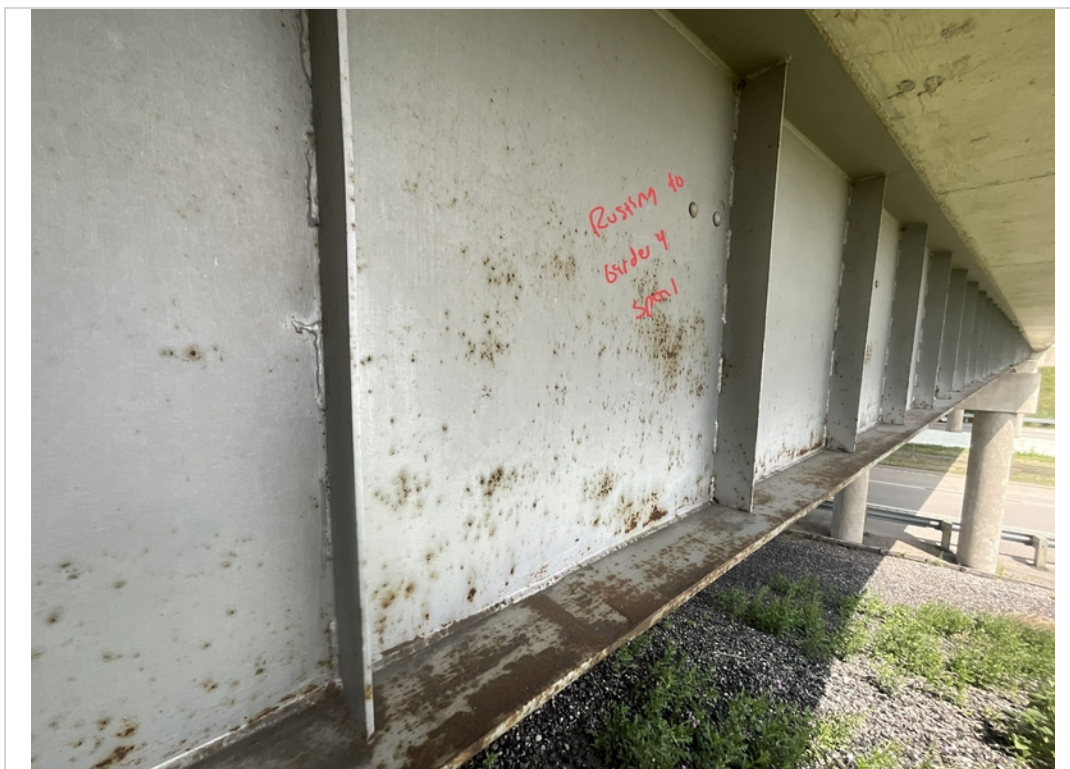
ELEMENTS	DESCRIPTION	UNITS	TOTAL	CS1	CS2	CS3	CS4
4000	Settlement	EA	1	0	1	0	0
(8398) 7/12/2021 - West Slope Protection of Rock and Oil. Vegetation beginning to grow within Slope Protection. (4000-8398) 7/12/2021 - West Slope Protection with lateral movement away from Abutment up to 1'. See Photos. 7/17/2023 - West Slope Protection with continuation and advancement of Rock Separating from Abutment. Observed 1'-3" causing a trough along Abutment. See Photos.							
8401	Wings	EA	4	4	0	0	0

Facing South. West Slope Protection along Abutment with Lateral Separation.

Recommendation to fill with appropriate rock and apply oil to area along Abutment. See Photos.

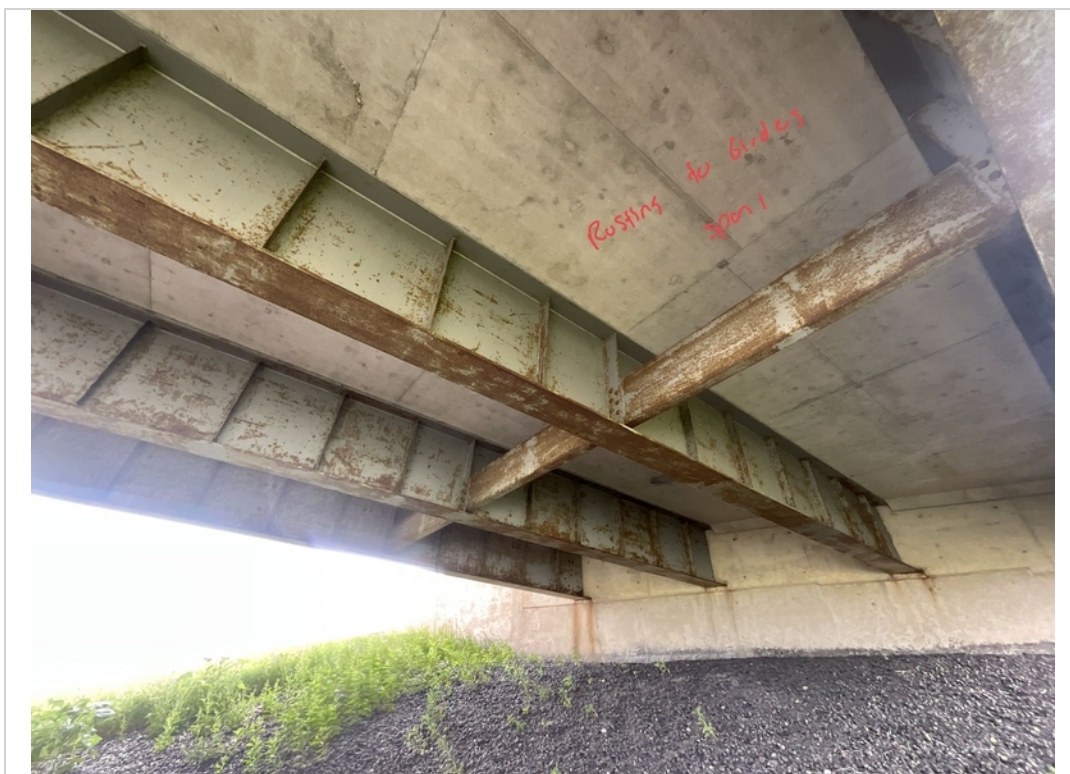
(3440-515-107) 7/12/2021 - CS 4 Loss of Effectiveness of coating to Girders 1-4 with rusting to bare metal. Estimated 60% of Coating System. See Photos. 7/17/2023 - No Change to Condition State or Quantity. See Photos.							
205	Reinforced Concrete Column	EA	12	9	2	1	0
1080	Delamination/Spall/Patched Area	EA	1	0	0	1	0
1090	Exposed Rebar	EA	2	0	2	0	0
1130	Cracking (RC and Other)	EA	1	1	0	0	0
(1080-205) 7/12/2021 - Delamination to Column 3 at Pier 2. Column was previously patched and is sound. See photo. 7/17/2023 - Patch is now unsound and Delaminating, Changed to CS 3. See photo.							
(1090-205) 7/12/2021, 7/17/2023 - Exposed rebar to Columns progressing with, Pier 2: Column 2. Pier 3: Column 3. See photos.							
(1130-205) Vertical cracking in pier 2 columns 2 and 4 - 10/31/2019 7/12/2021 - Vertical CS 1 cracking to Column 1 at Pier 2, width of 0.004". See photo. 7/17/2023 - No change in condition state or quantity. See photo.

Facing South and Upwards. Effectiveness of Coating to Girders in span 1.
