IDENTIFICATION	
(1) State Names	38 - North Dakota
(8) Structure Number	0029-069.374 N
(5) Inventory Route	1
(2) Highway Agency District	8 - Fargo
(3) County Code	9 - Cass

(4) Place Code	25700
(6) Features Intersected	BNRR
(7) Facility Carried	COUNTY HIGHWAY
(9) Location	EAST OF NO. FARGO INTCHG
(11) Mile Point	0.1 mi
(12) Base Highway Network	No

INSPECTIONS *			
(90) Inspection Date	07/17/2023		
(91) Frequency	24		
(92) Critical Feature Inspection	Done	Freq. (Mon)	Date
A: Fracture Critical Detail	No		
B: Underwater Inspection	No		
C: Other Special Inspection			
* The inspection date and frequency information in this box contains the current NBI date and frequency information. Please refer to the report header for the date this inspection was conducted.

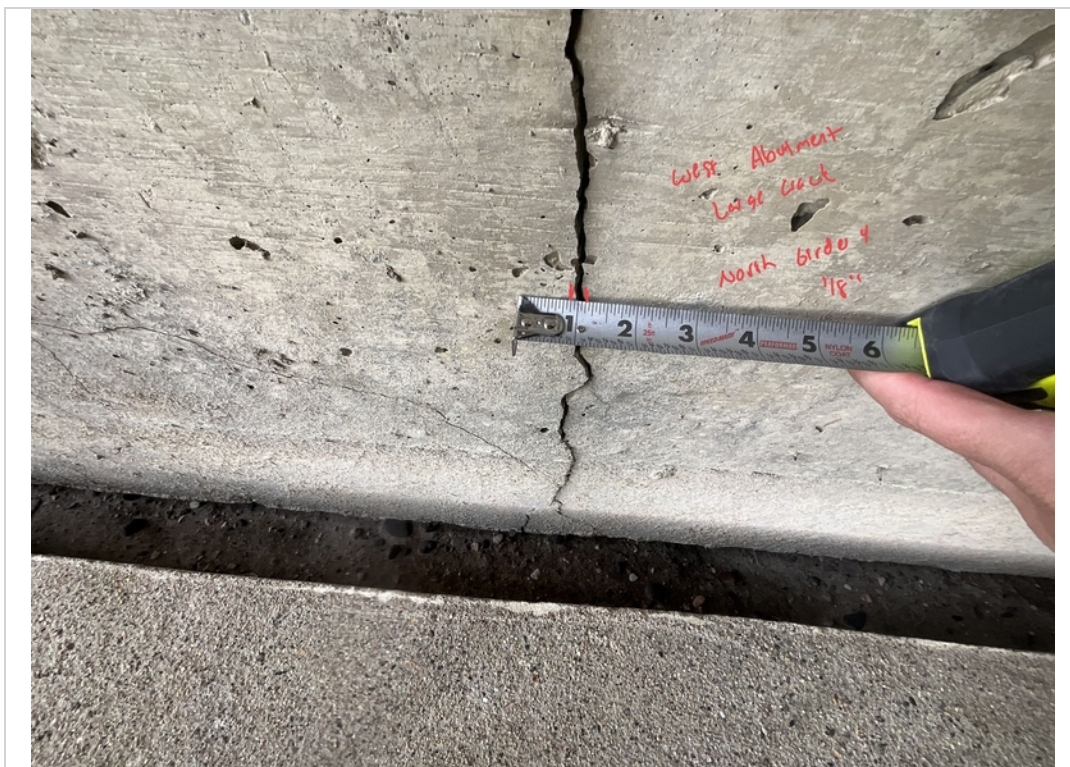
Facing West and Downward. Large Vertical Crack Opening to West Abutment.

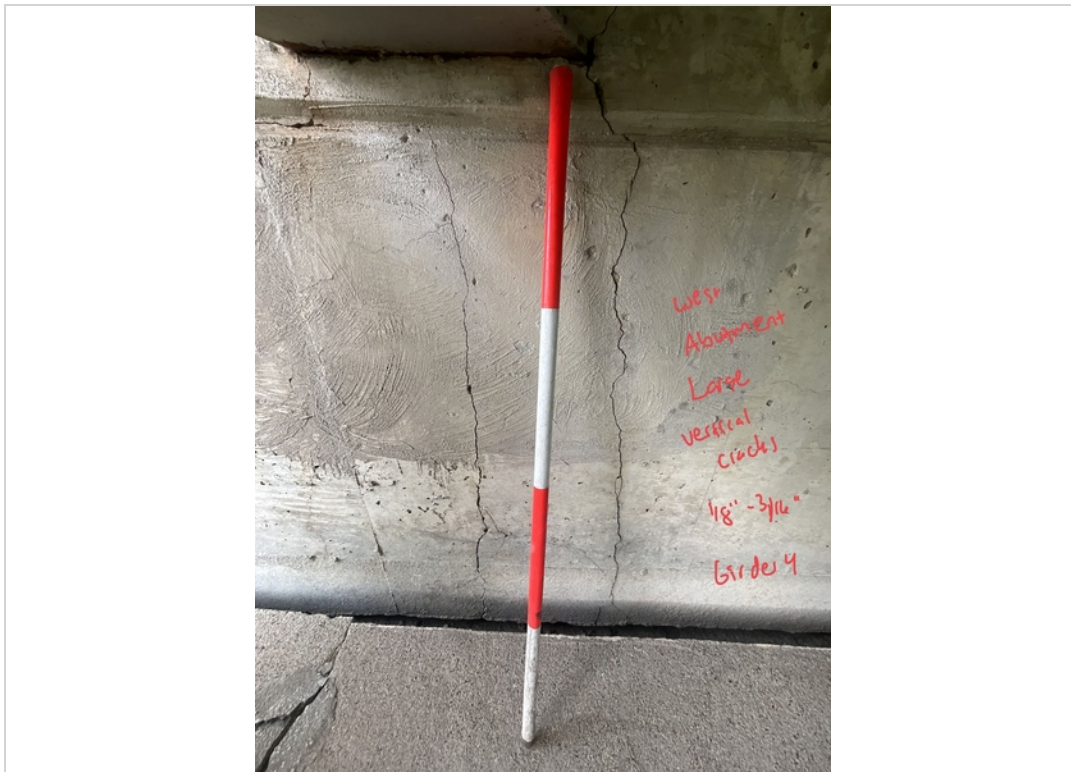
Large Vertical Cracks to West Abutment under and North of Girder 4. Crack Openings 1/8" to 3/16".

Facing West. Large Vertical Cracks to West Abutment under Girder 4.

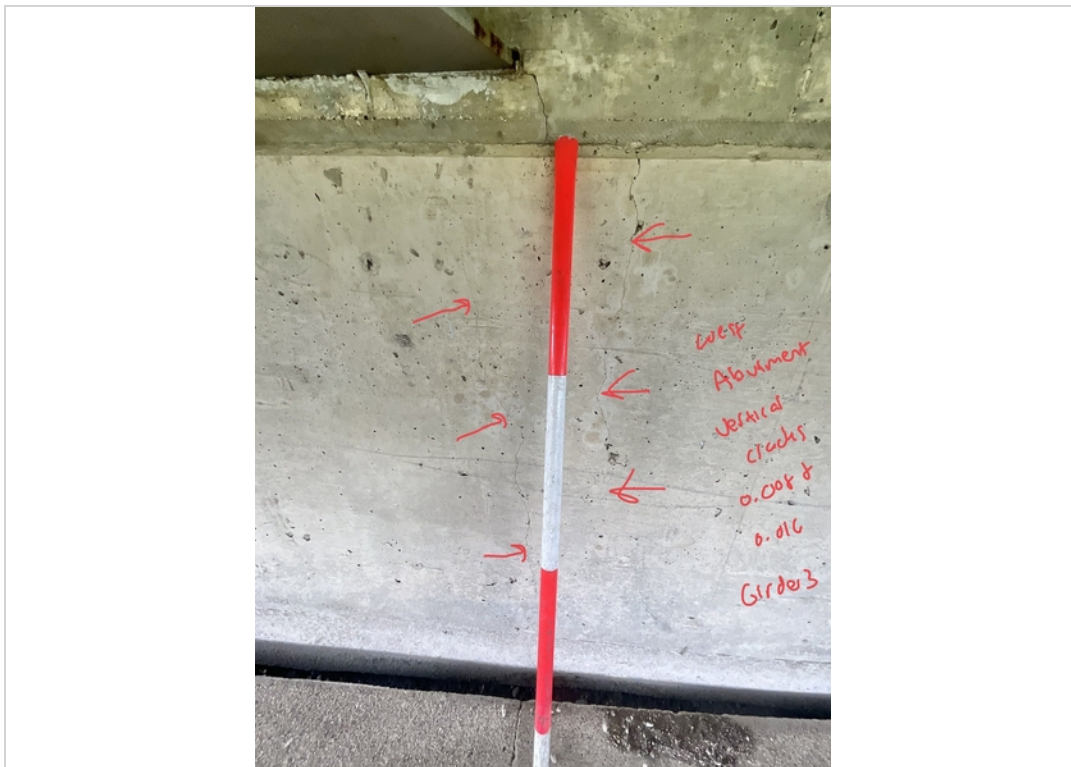
Facing West. Vertical Cracks to West Abutment under Girder 3.

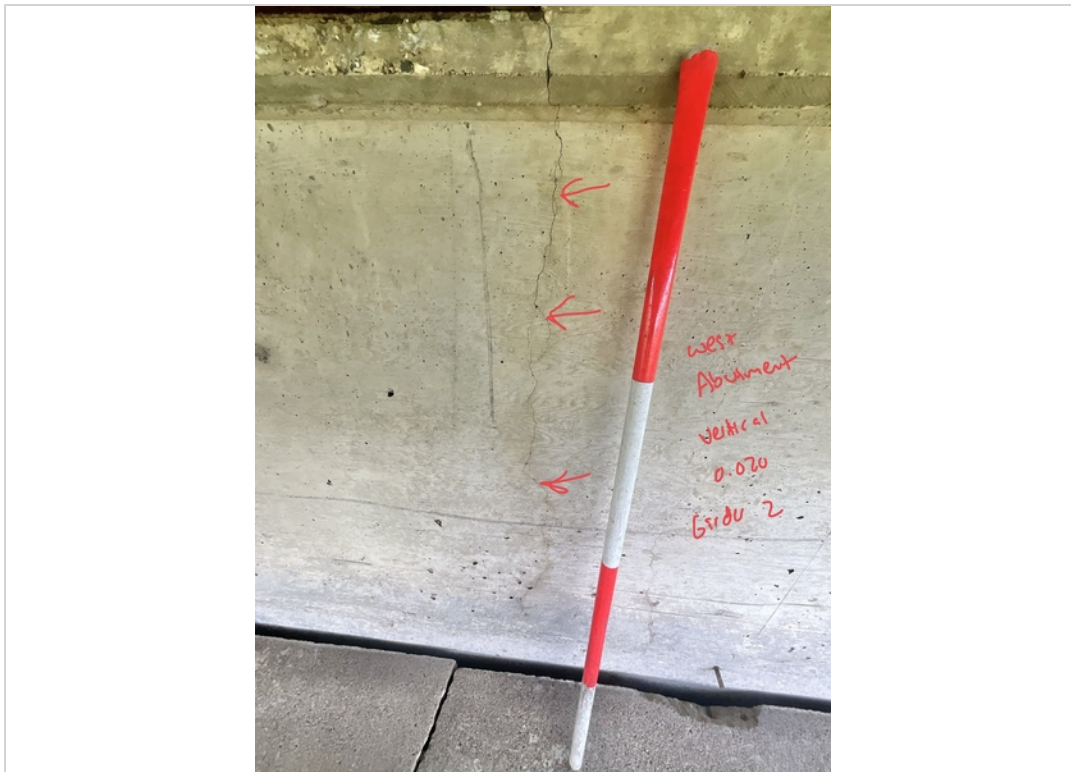
Facing West. Vertical Crack to West Abutment under Girder 2.

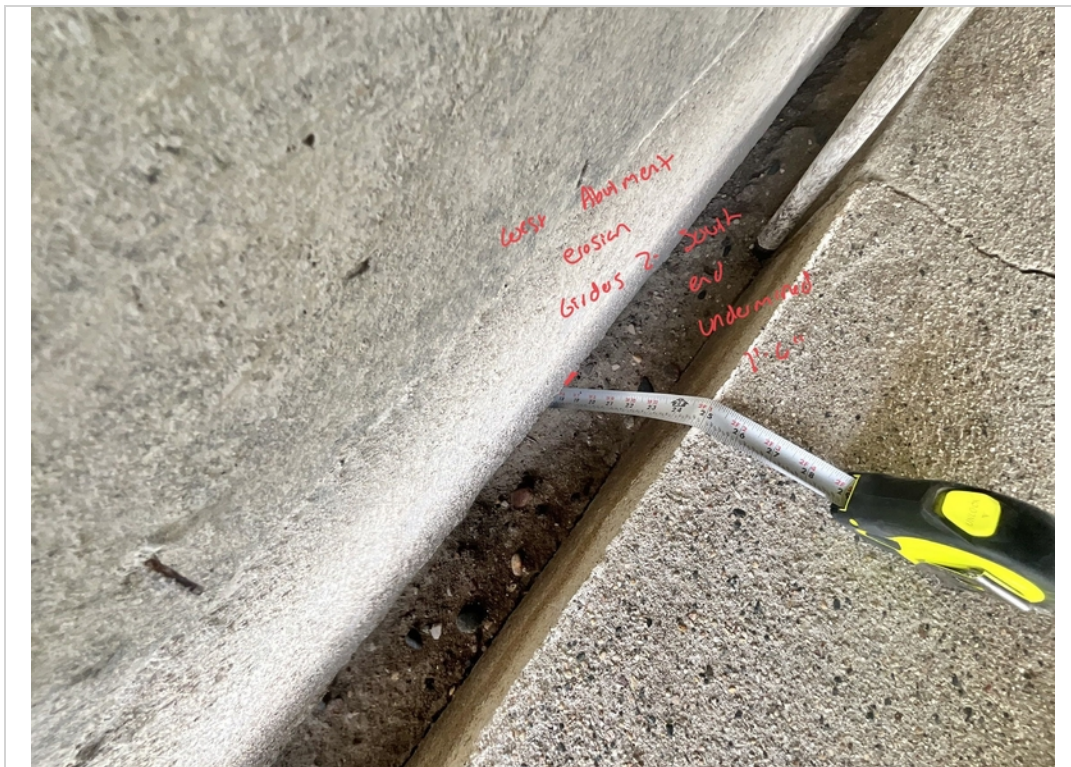
Erosion and Undermining along West Abutment with an area of 16' L x 1" to 8" H x 1'-6" Undermined.

Facing NW and Downward. Erosion and Undermining Depth to West Abutment.

Recommendation to provide fill and grade along both Abutments and Pier 2 Cap Footing. See Photos.

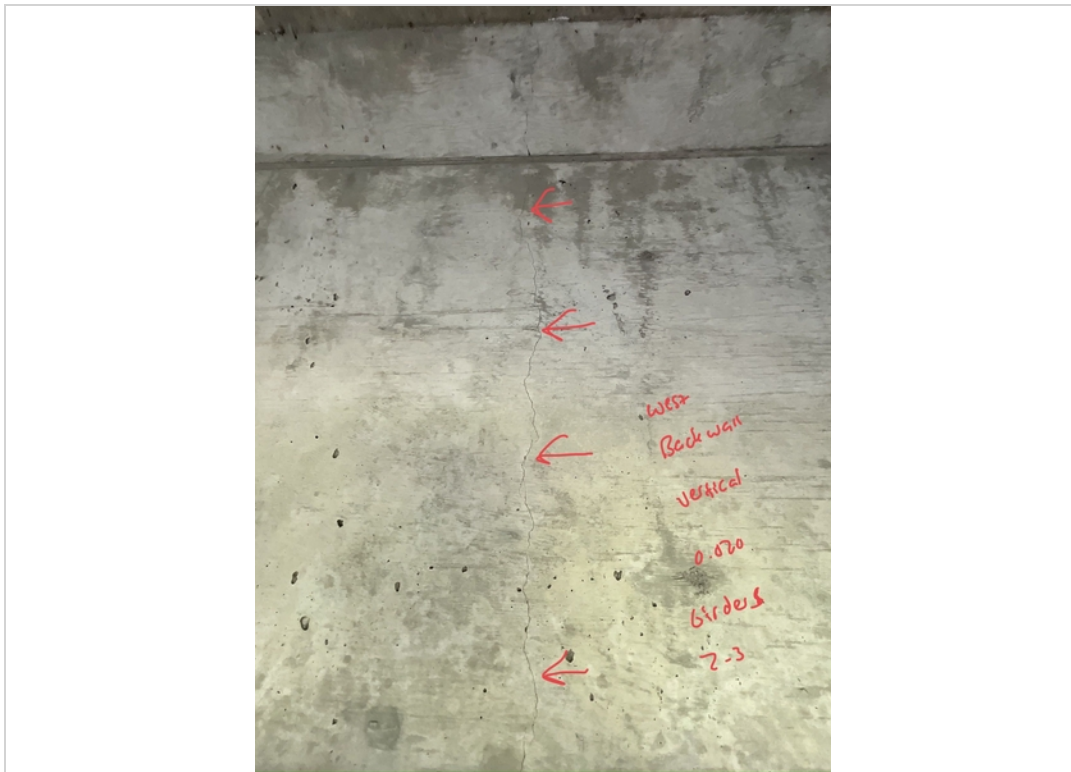
Facing West. Vertical Crack to West Backwall in-between Girders 2 and 3.

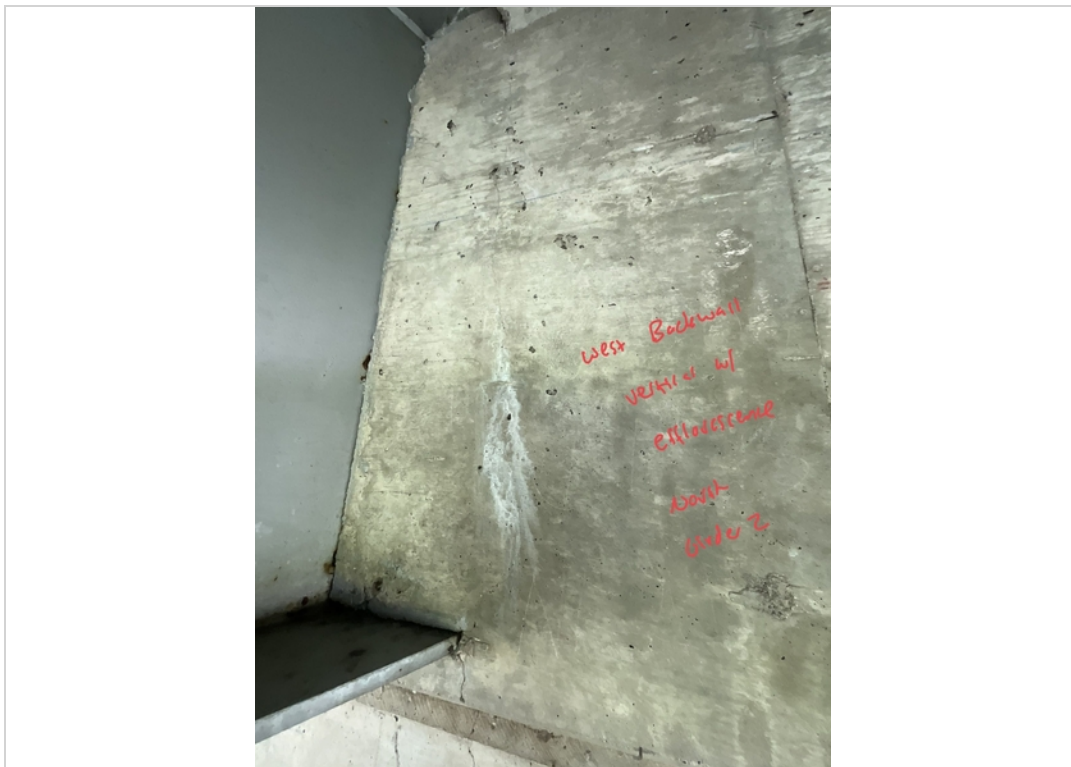
Facing SW. Vertical Crack with some seepage and efflorescence to West Backwall North of Girder 2.

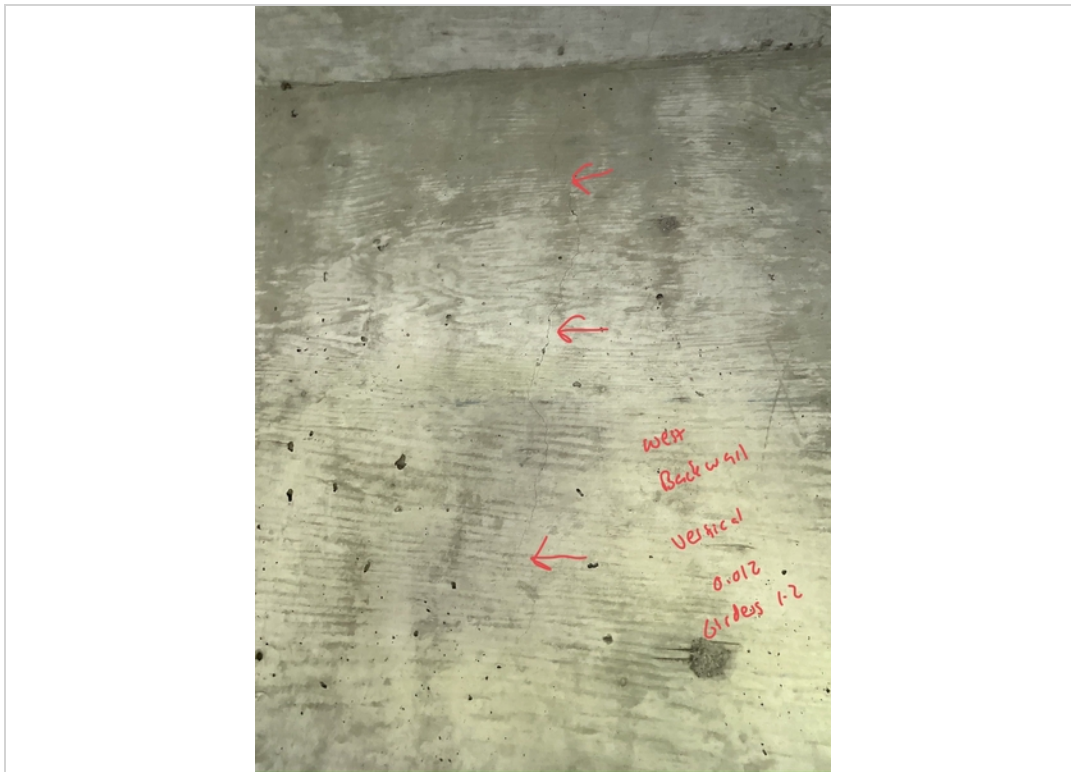
Facing West. Vertical Crack to West Backwall in-between Girders 1 and 2.

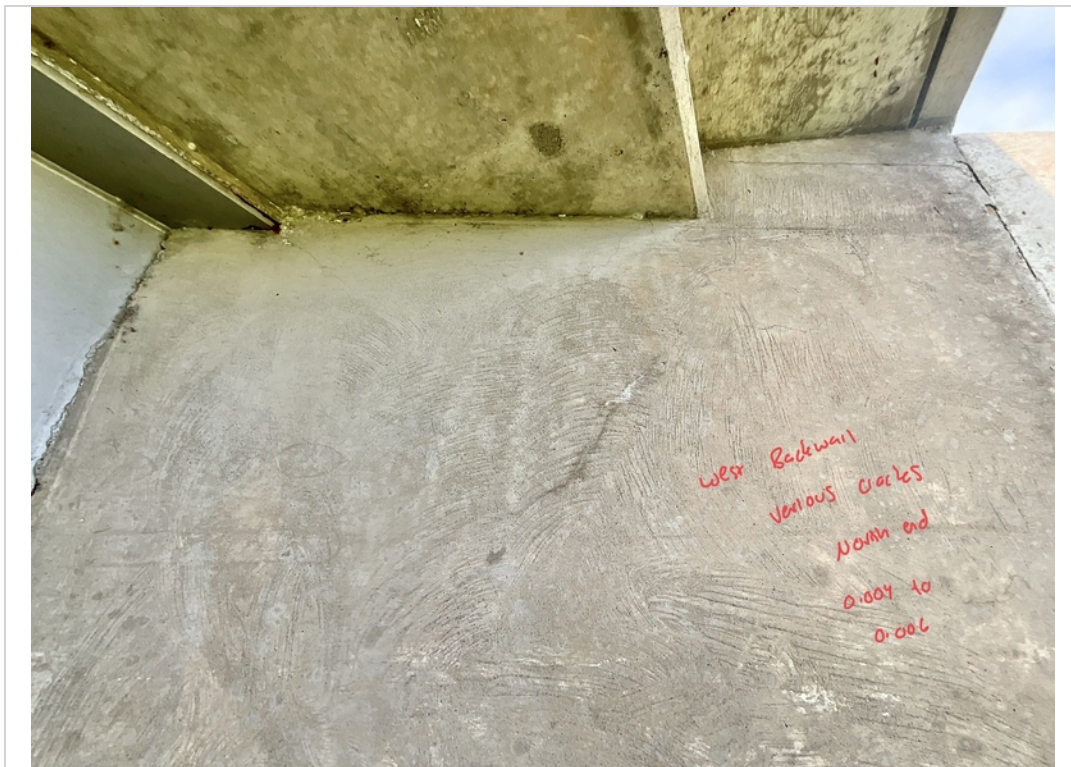
Facing West and Upwards. Diagonal Cracks to West Backwall North End.

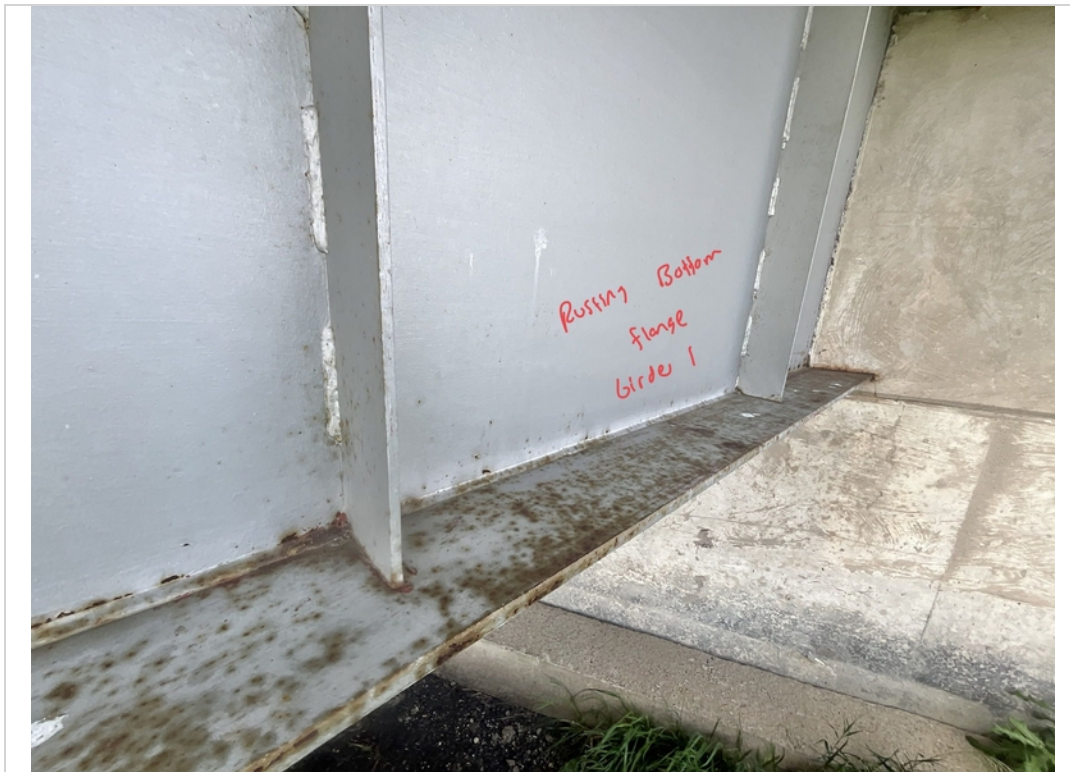
Facing SW. Freckled Rusting to Bottom Flange of Girders near West End.

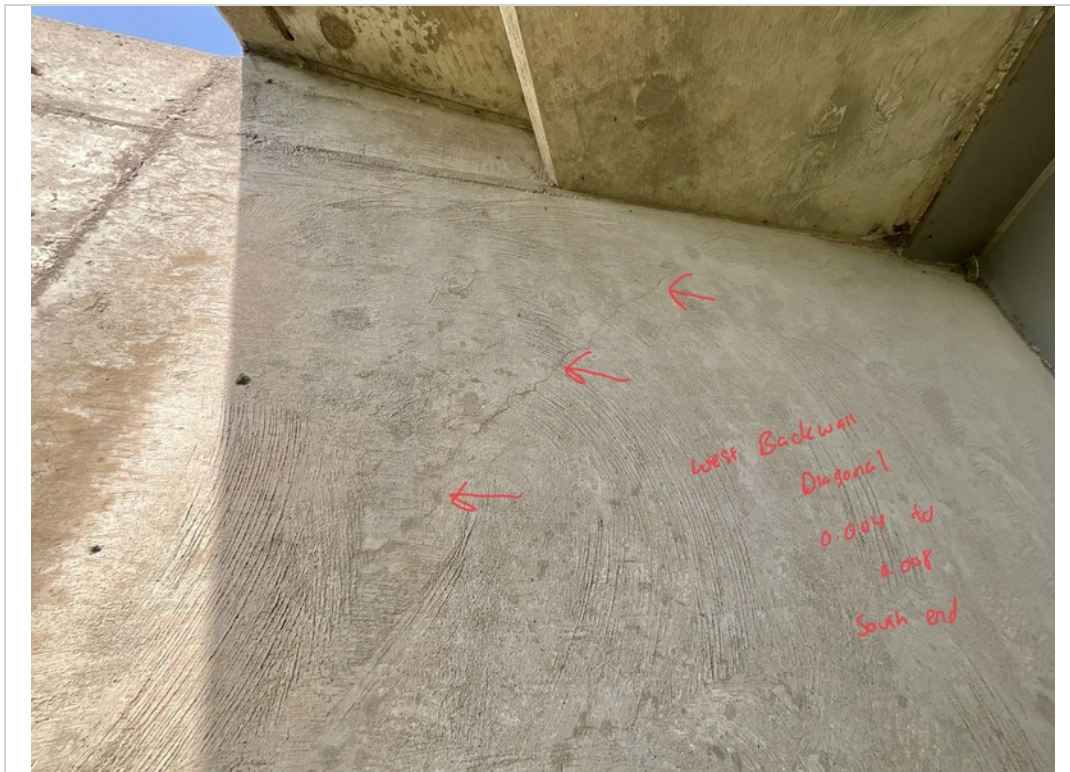
Facing West and Upwards. Diagonal Crack to West Backwall South End.

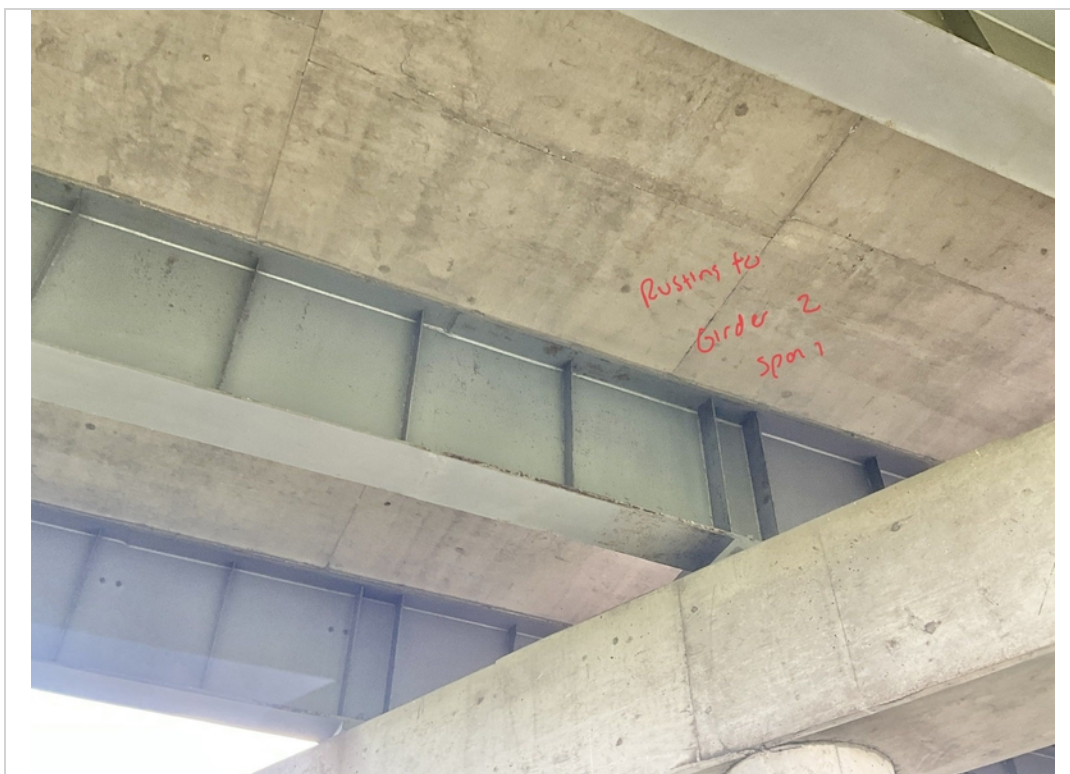
Facing NE and Upwards. Rusting to Girder 2 near Pier 2.

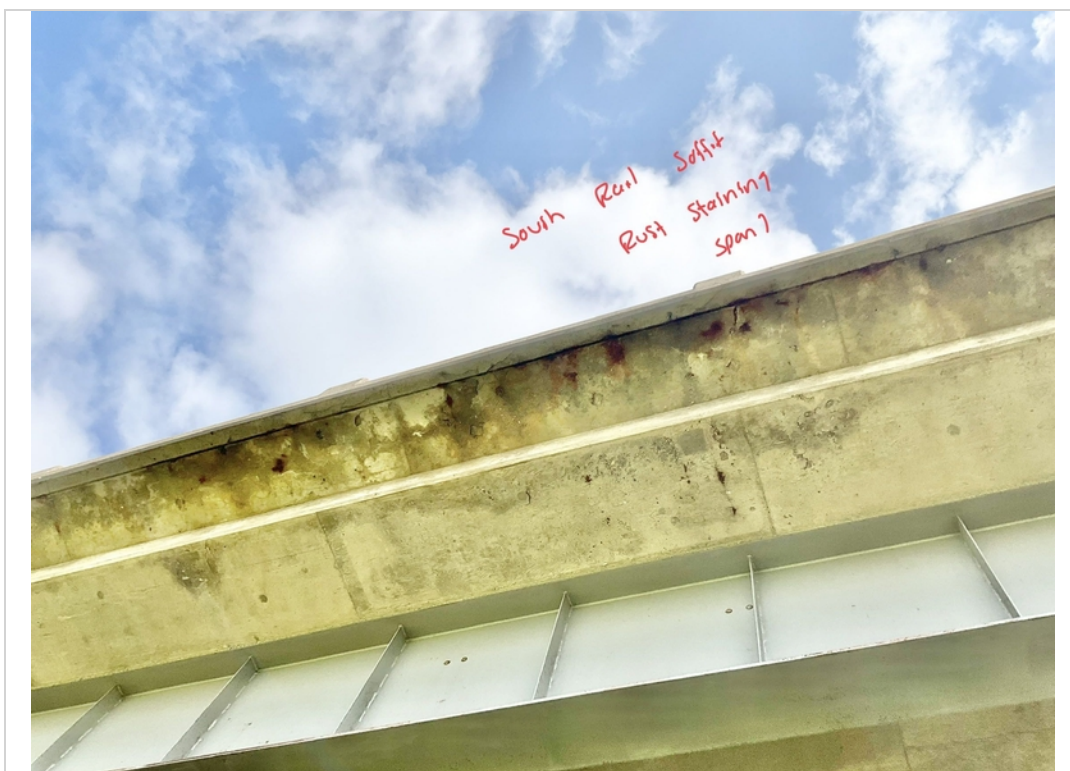
Facing North and Upwards. Rust Staining to South Curb Soffit in Span 1.

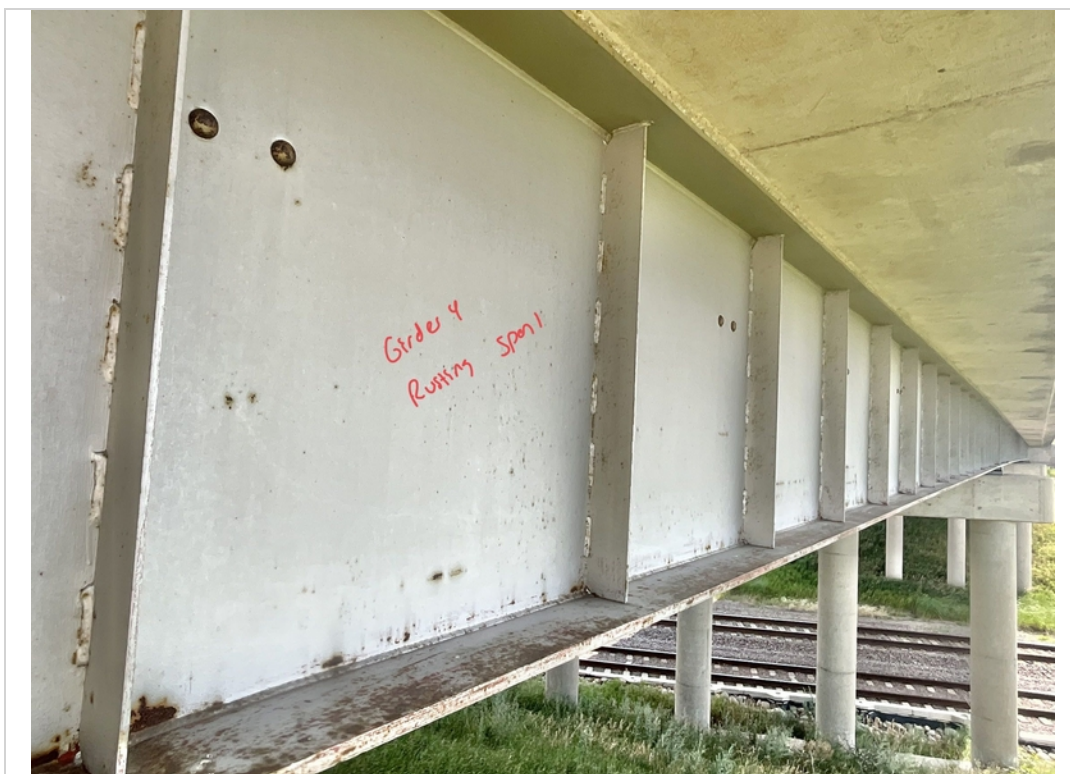
Facing NW. Rusting to Girder 4 in Span 1.

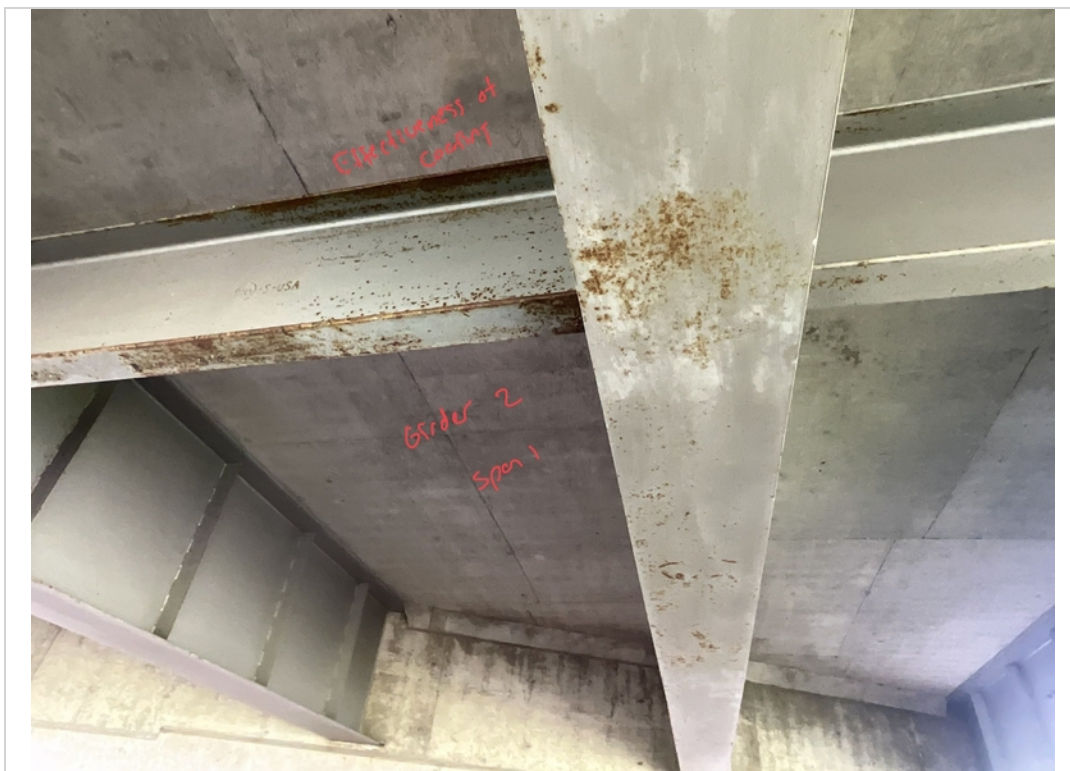
Facing West and Upwards. Effectiveness of Coating underside bottom flange of Girder in Span 1

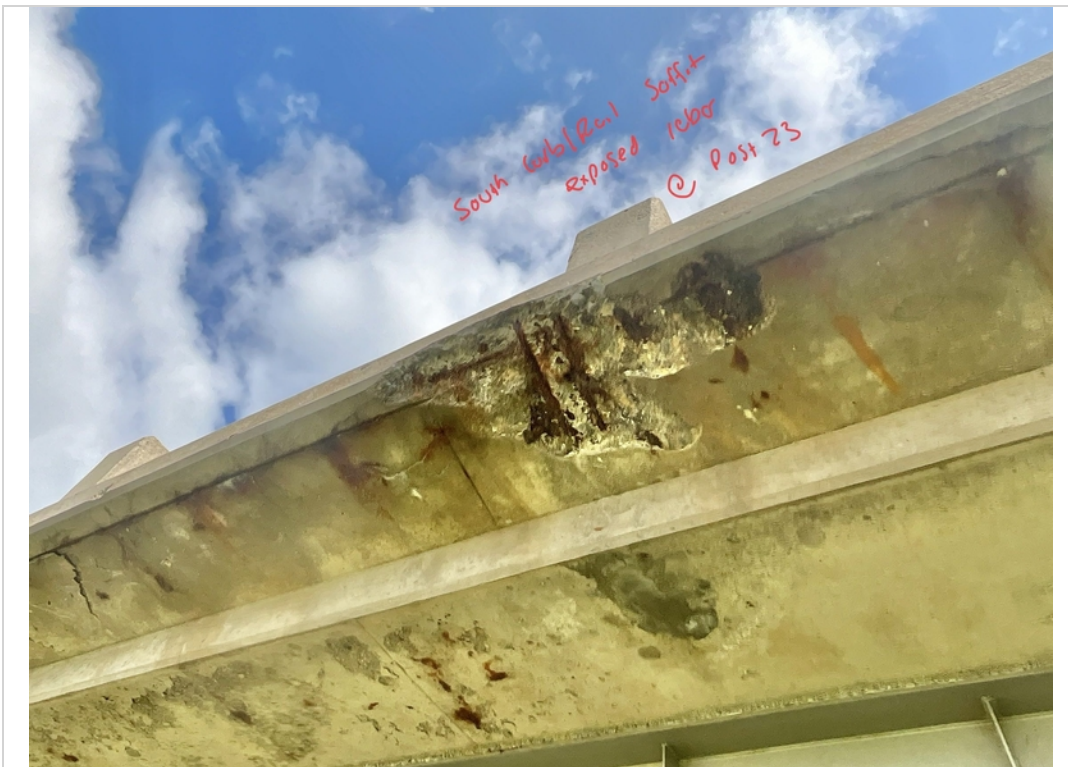
Facing NW and Upwards. Spalling with Exposed Rebar to South Railing at Post 23.

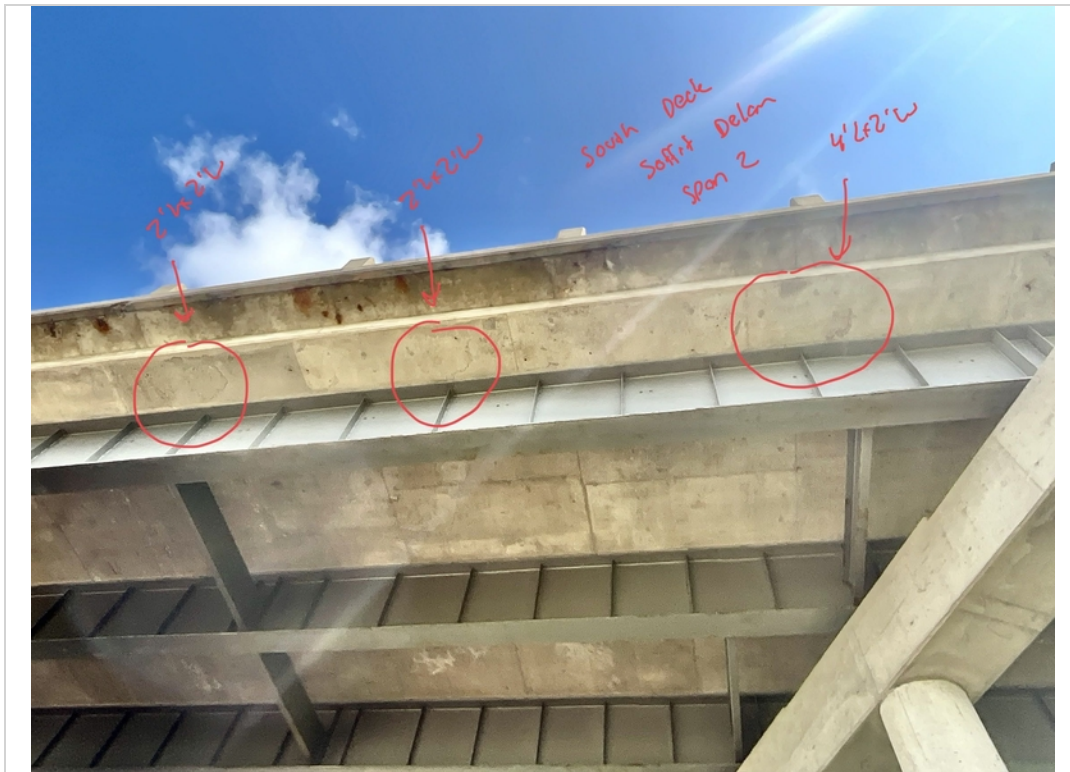
Facing North and Upwards. Areas of Delamination to South Deck Soffit in Span 2.

Recommendation to remove delaminated Concrete and patch area. See Photo.

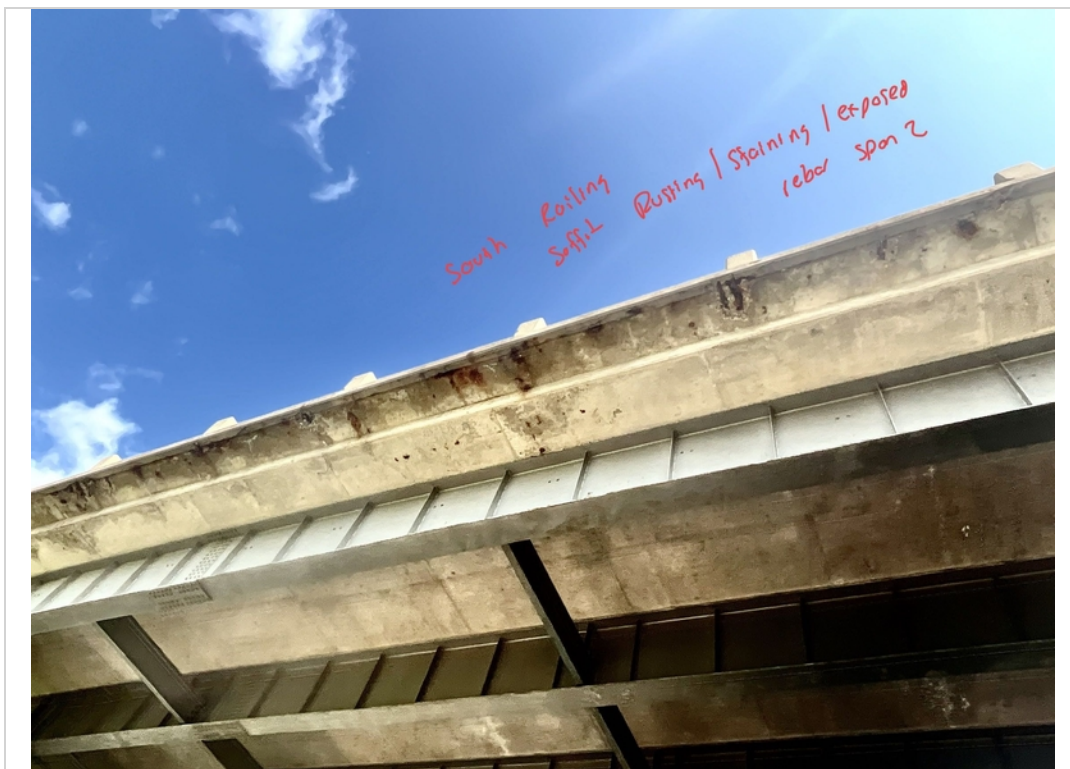
Facing North and Upwards. South Curb Soffit with Rust Staining in Span 2.

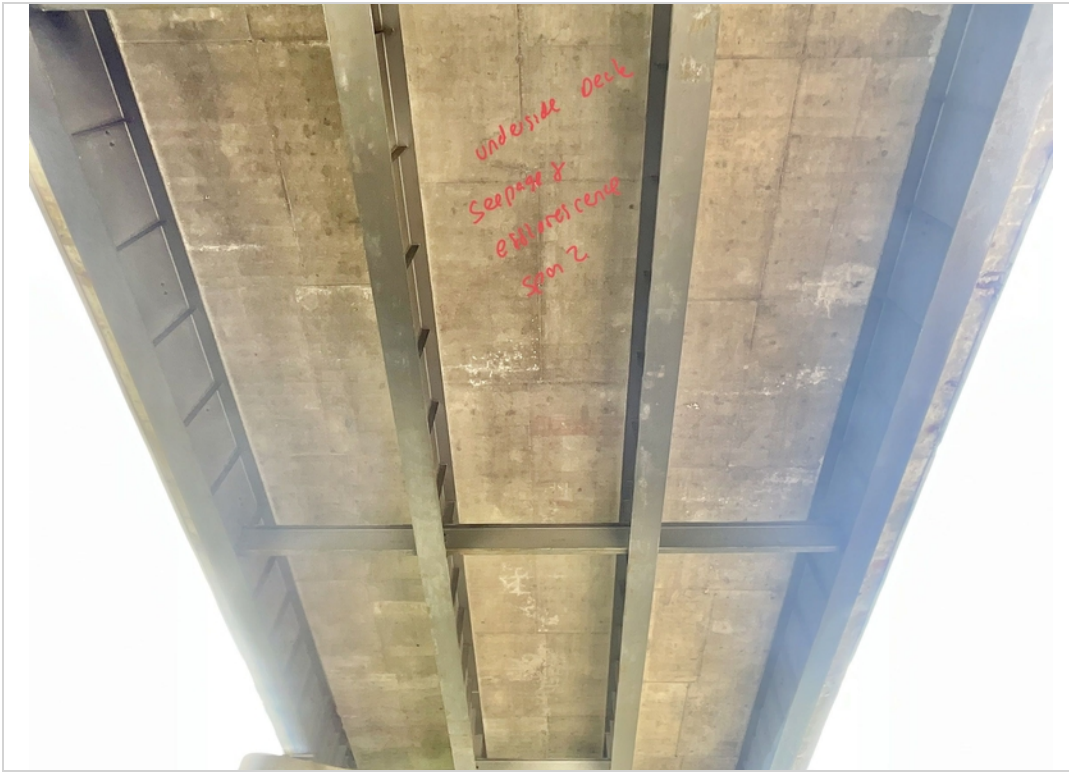
Facing East and Upwards. Underside Deck Seepage and Efflorescence in Span 2.

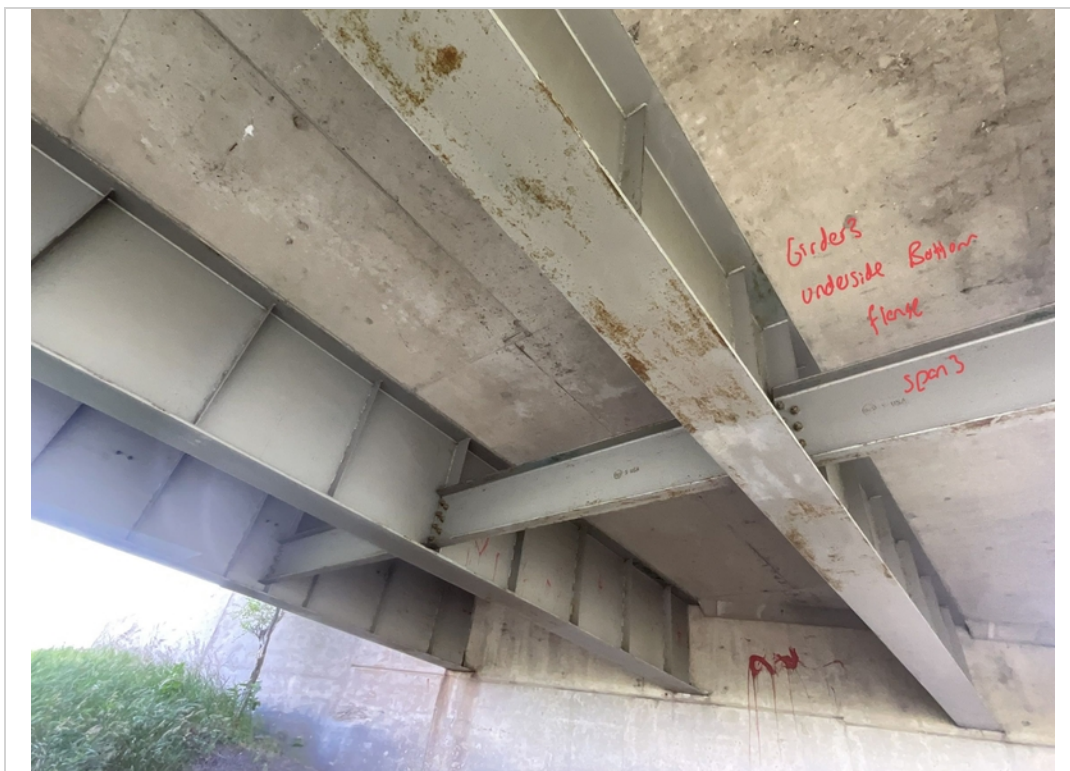
Facing NE and Upwards. Rusting to underside bottom flanges of Girders in Span 3.

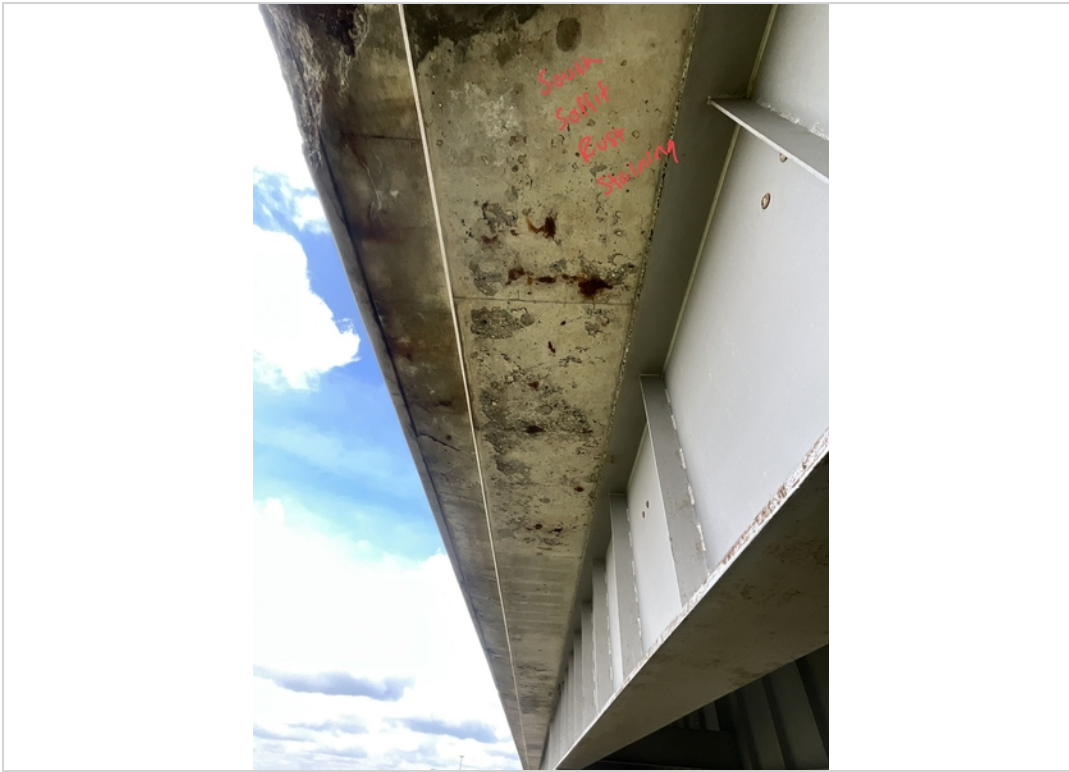
Facing West and Upwards. Rust Staining to South Deck Soffit in Span 3.

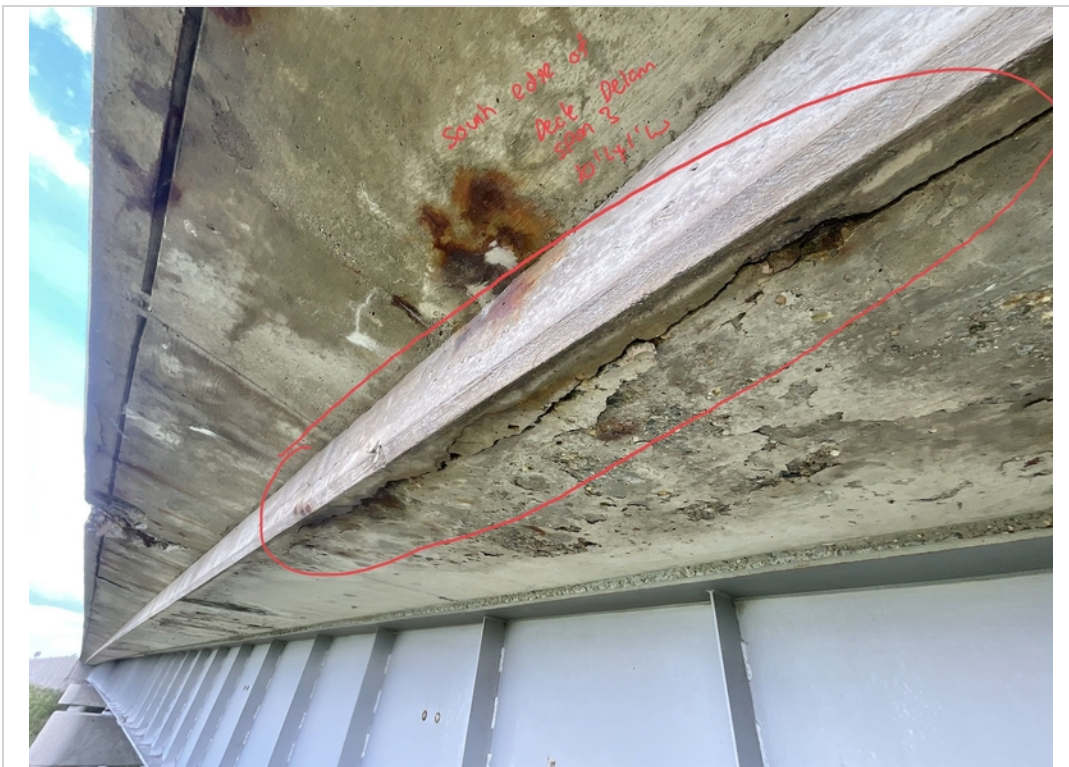
Facing NW. Moderate area of Cracking with Delamination to South Edge of Deck near East End.

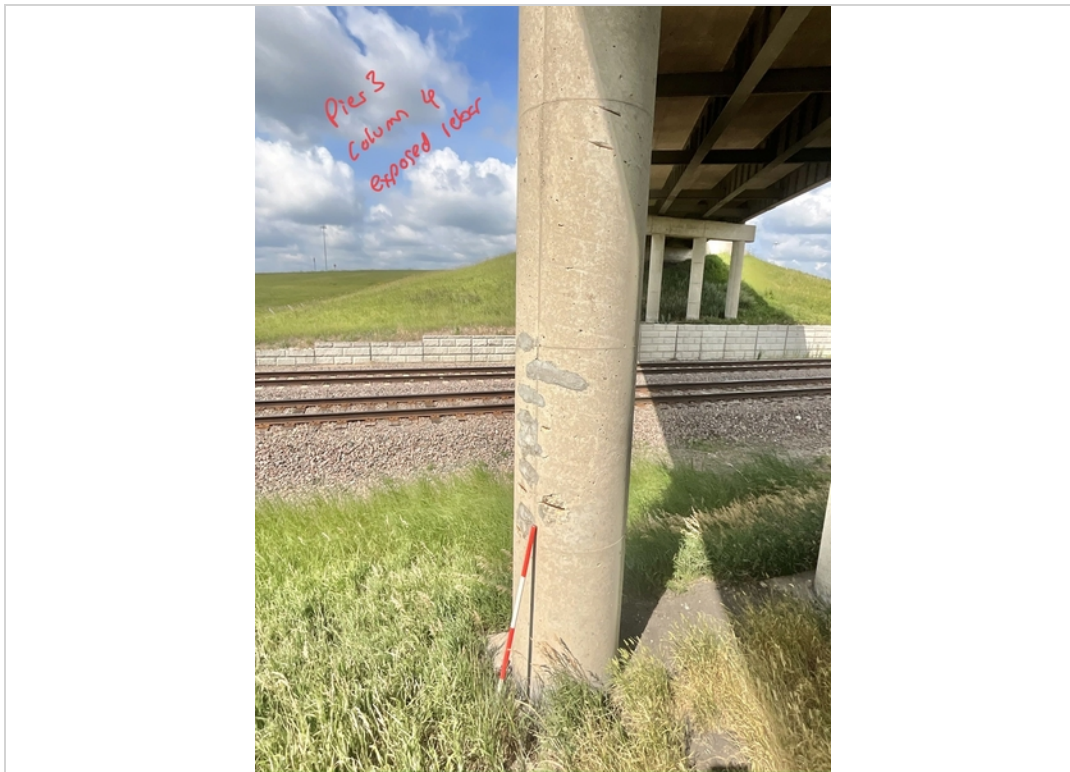
Facing West. Exposed Rebar to Pier 2 Column 4.

Recommendation to remove any concrete, clean rebar and perform patch repairs to Column. See Photos.

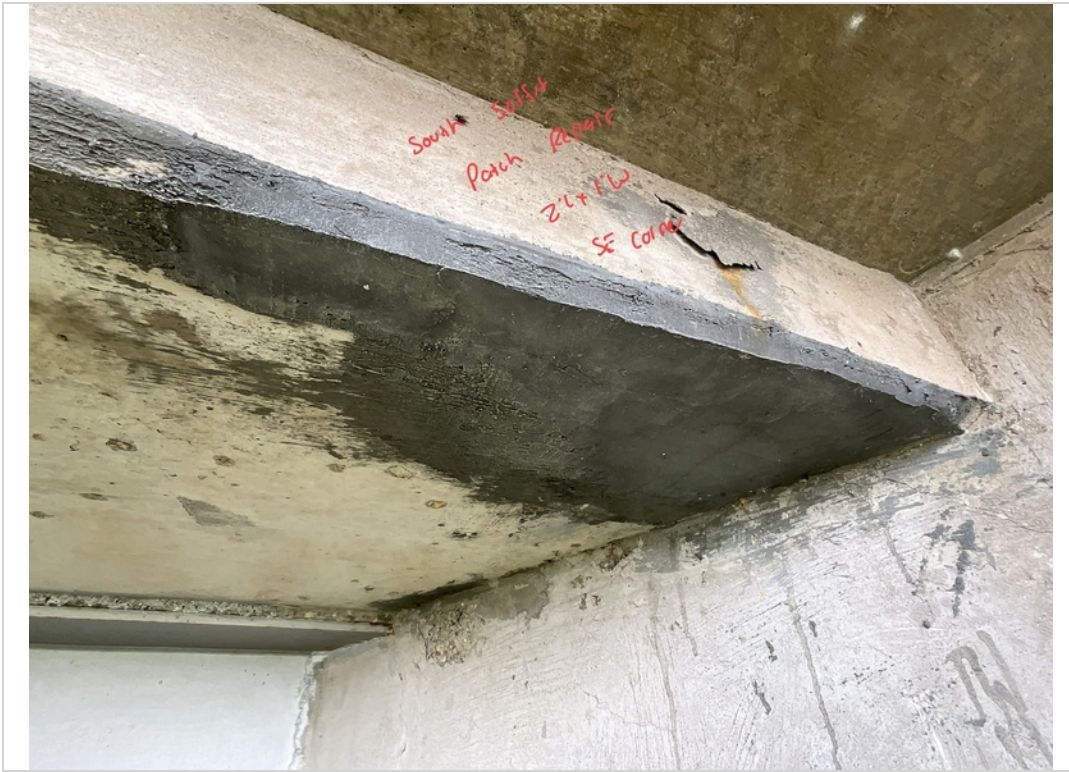
Facing NE. Patch Repair to South Soffit near SE Corner.

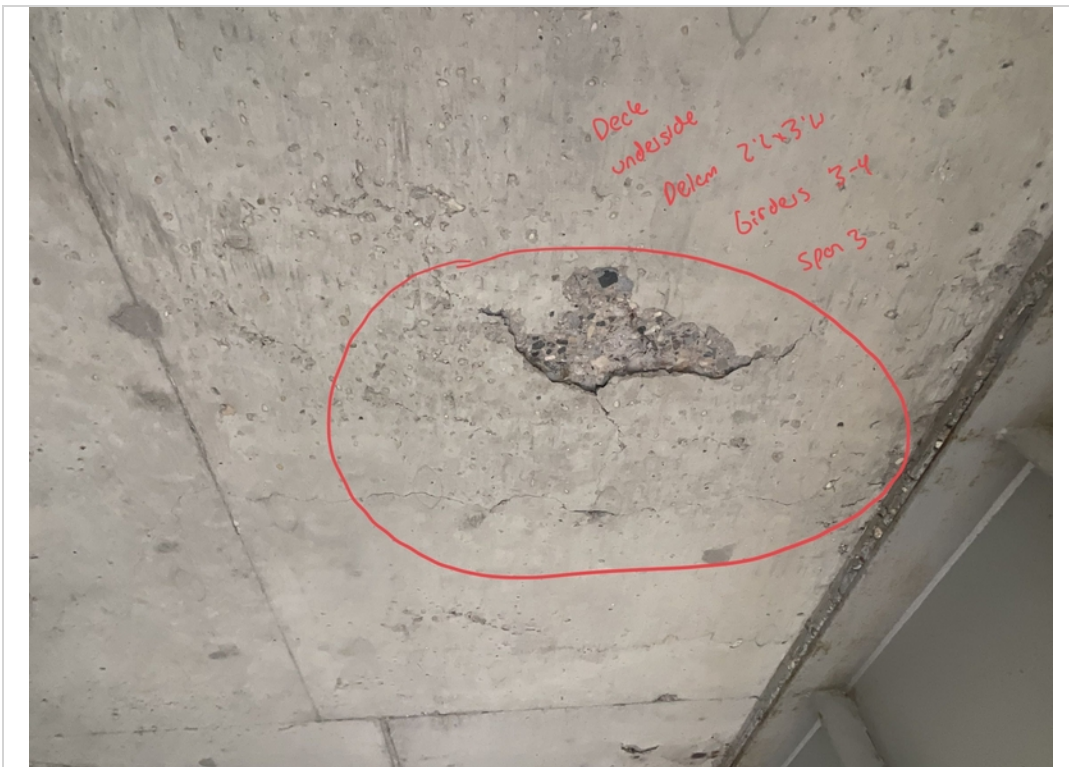
Facing East and Upwards. Underside Deck Delamination in-between Girders 3 and 4 near East End.

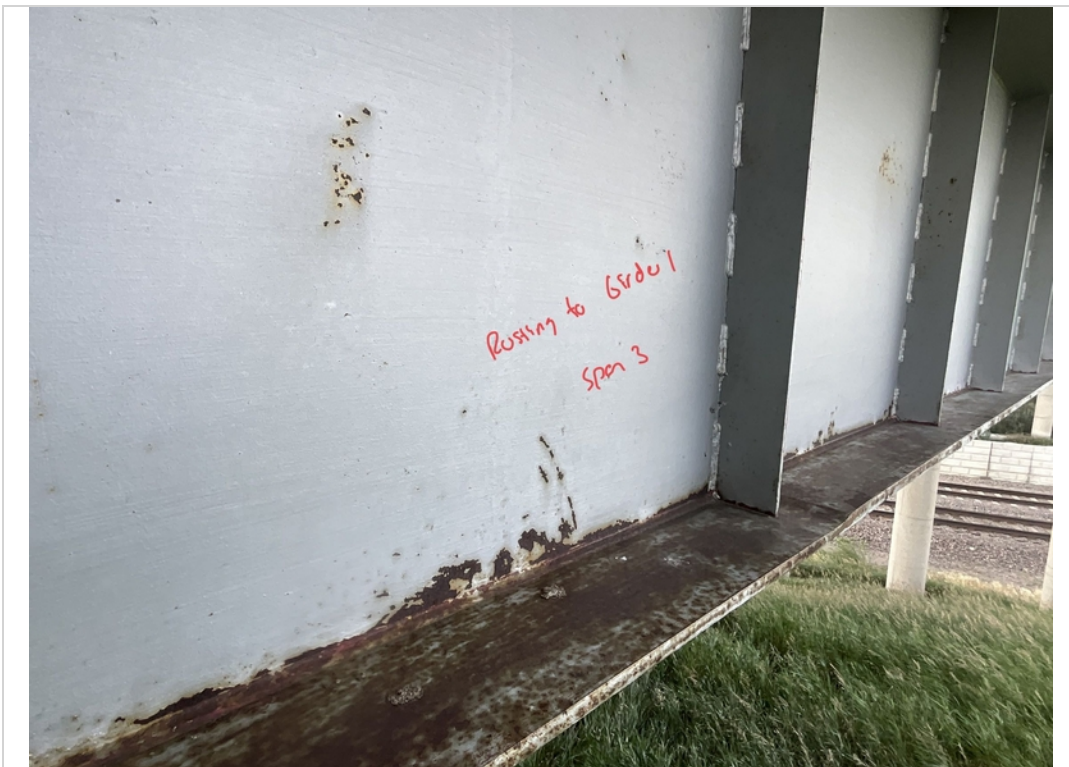
Facing SW. Rusting to Bottom flange to Girder 1 in Span 3.

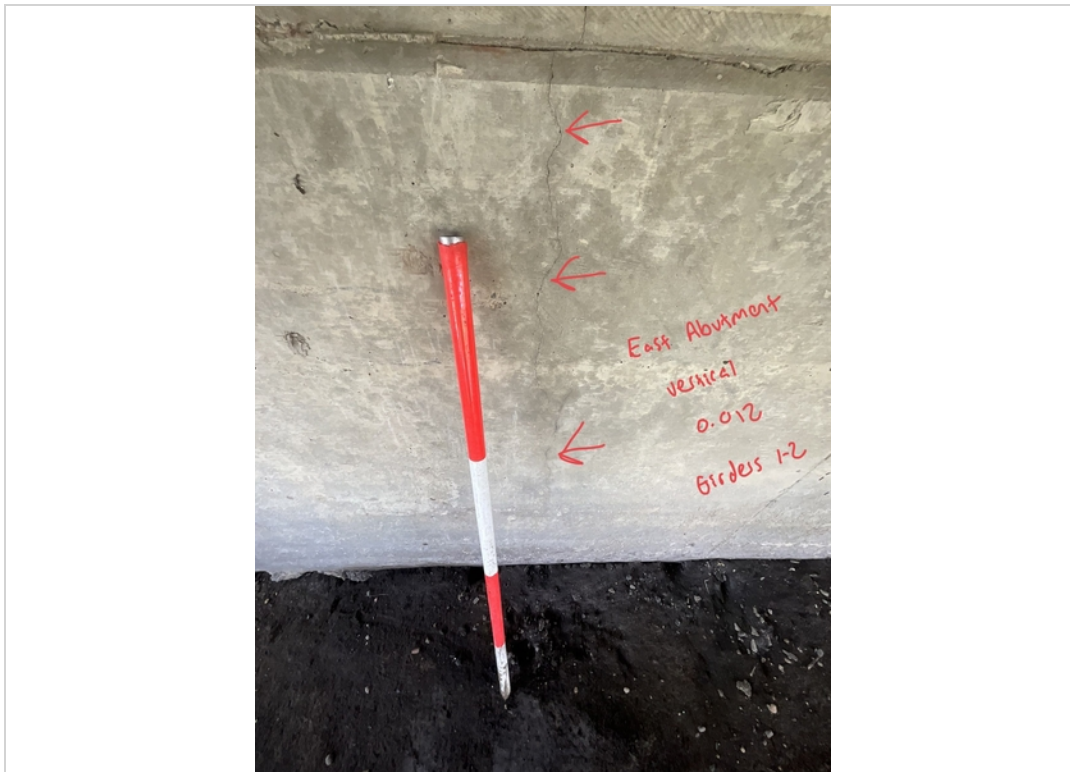
Facing East. Vertical Crack to East Abutment in-between Girders 1 and 2.
