IDENTIFICATION	
(1) State Names	38 - North Dakota
(8) Structure Number	0029-069.374 N
(5) Inventory Route	1
(2) Highway Agency District	8 - Fargo
(3) County Code	9 - Cass

(4) Place Code	25700
(6) Features Intersected	BNRR
(7) Facility Carried	COUNTY HIGHWAY
(9) Location	EAST OF NO. FARGO INTCHG
(11) Mile Point	0.1 mi
(12) Base Highway Network	No

INSPECTIONS *			
(90) Inspection Date	07/17/2023		
(91) Frequency	24		
(92) Critical Feature Inspection	Done	Freq. (Mon)	Date
A: Fracture Critical Detail	No		
B: Underwater Inspection	No		
C: Other Special Inspection			
* The inspection date and frequency information in this box contains the current NBI date and frequency information. Please refer to the report header for the date this inspection was conducted.

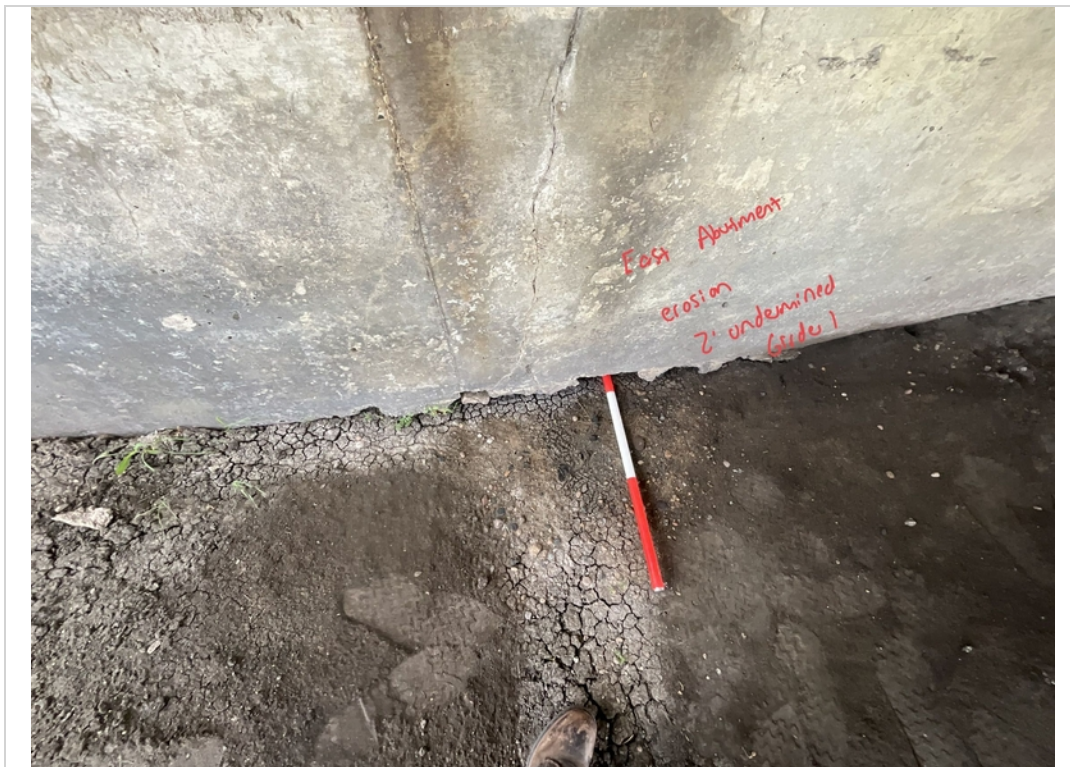
Erosion to East Abutment with an area of 4' L x 1" to 2 1/2" H x 2' Undermined.

Facing East and Downward. Erosion and Undermining to East Abutment in-between Girders 1 and 2.

Recommendation to provide fill and grade along both Abutments and Pier 2 Cap Footing. See Photos.

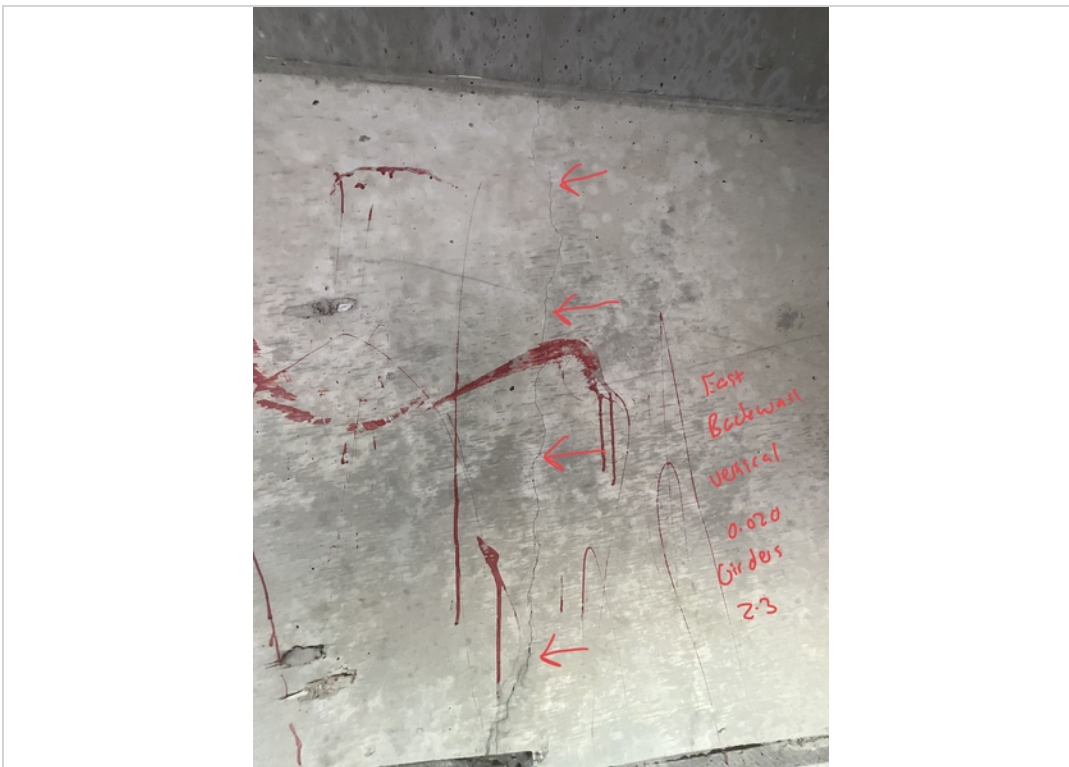
Facing East. Vertical Crack to East Backwall in-between Girders 2 and 3.

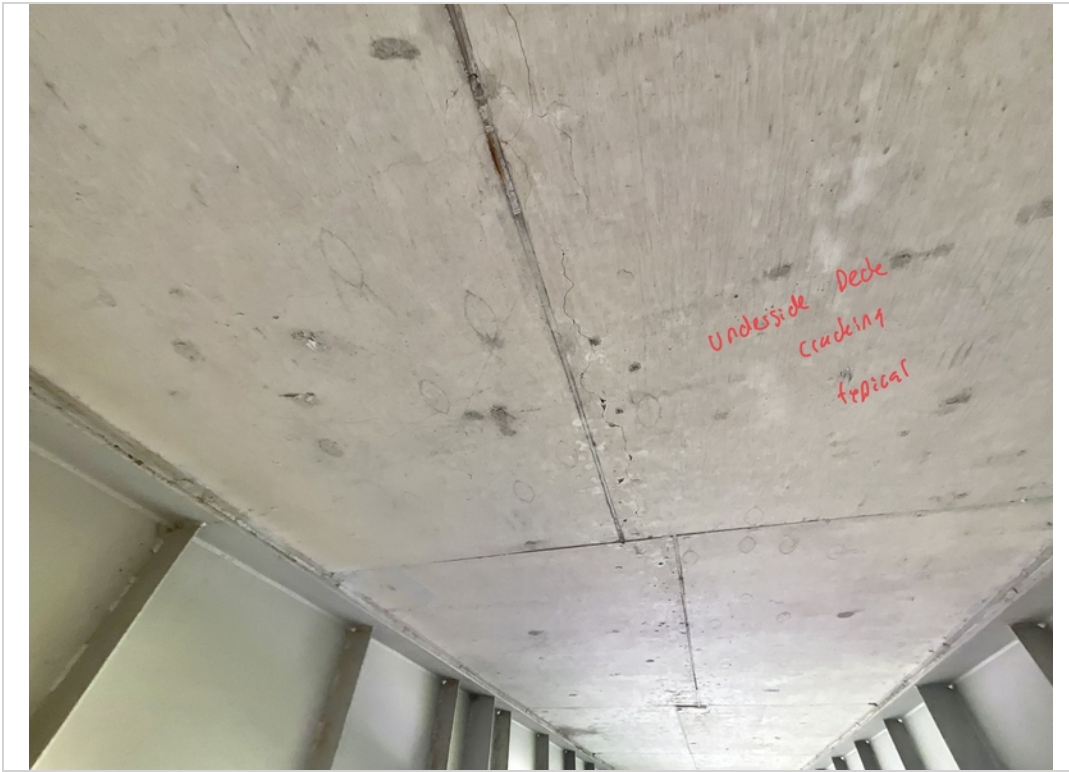
Facing West and Upwards. Underside Deck Cracking throughout. Typical.

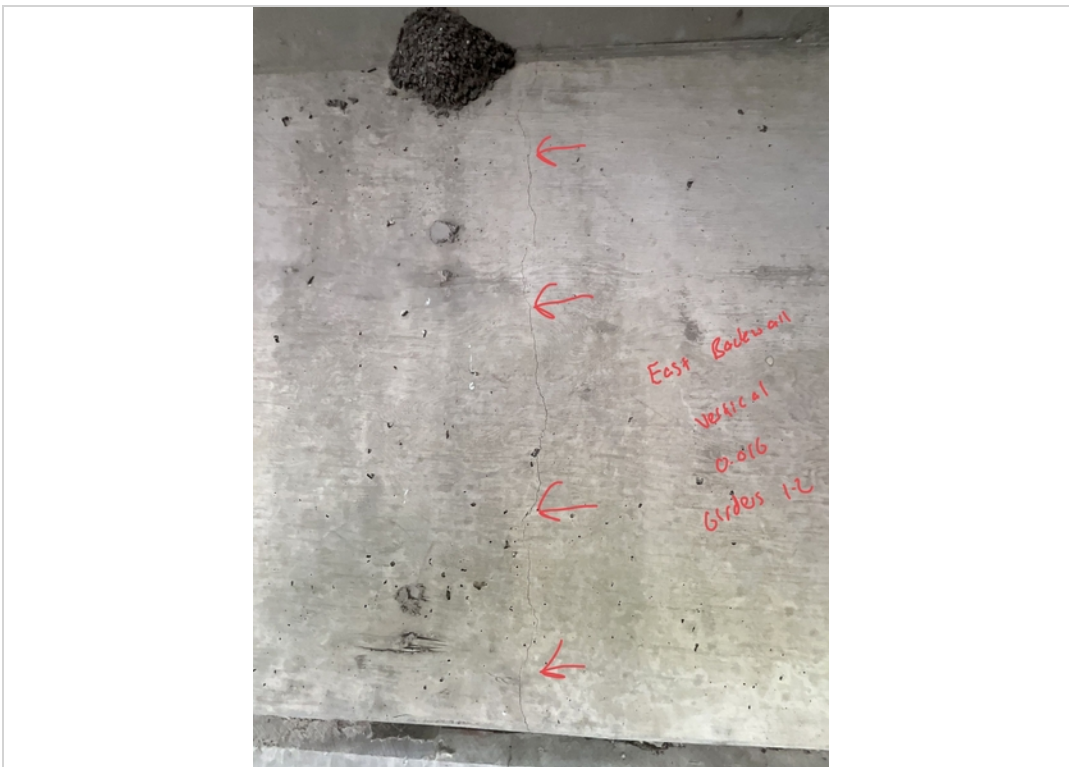
Facing East. Vertical Crack to East Backwall in-between Girders 1 and 2.

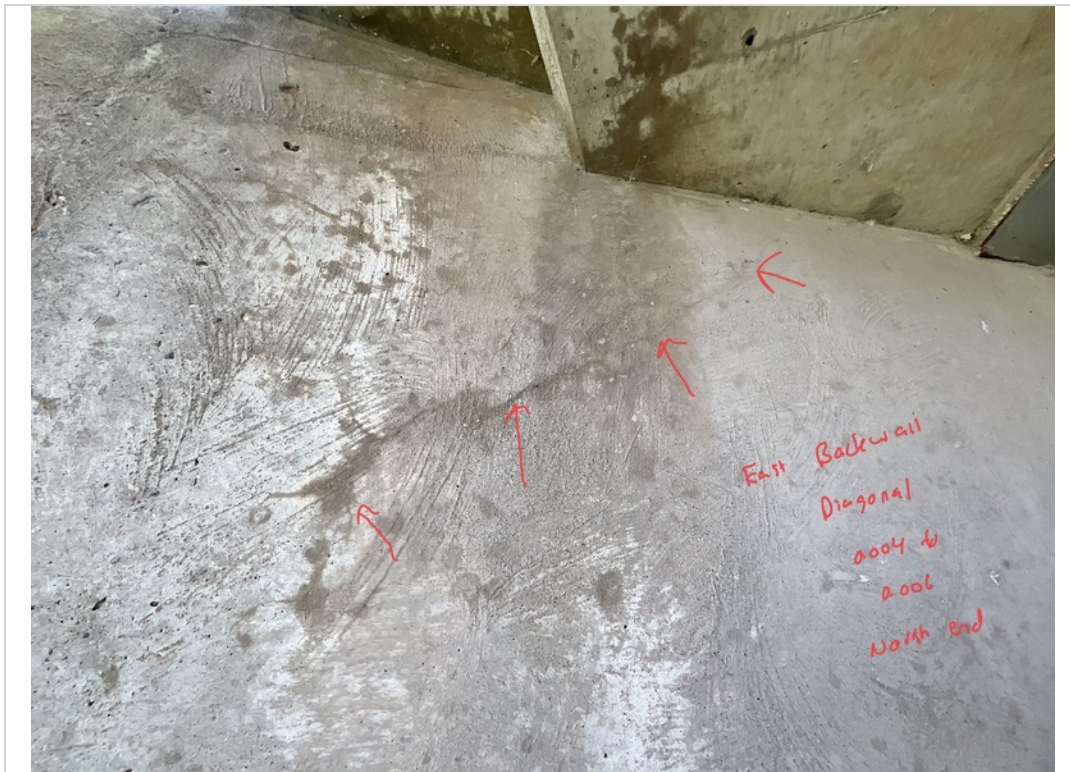
Facing East and Upwards. Diagonal Crack to East Backwall North of Girder.

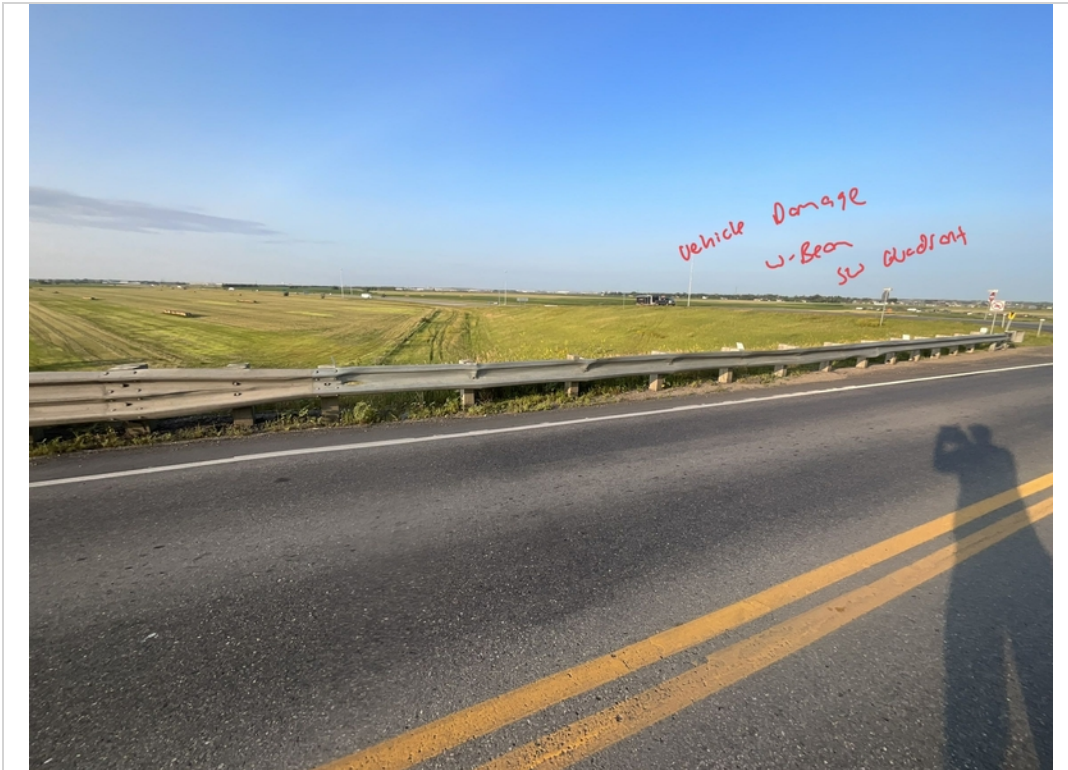
Facing SW. Vehicle Damage to W-Beam within SW Quadrant.

Recommendation to remove and replace sections of W-Beam in the SW and NE Quadrants along with the cracked wood posts. See Photos.

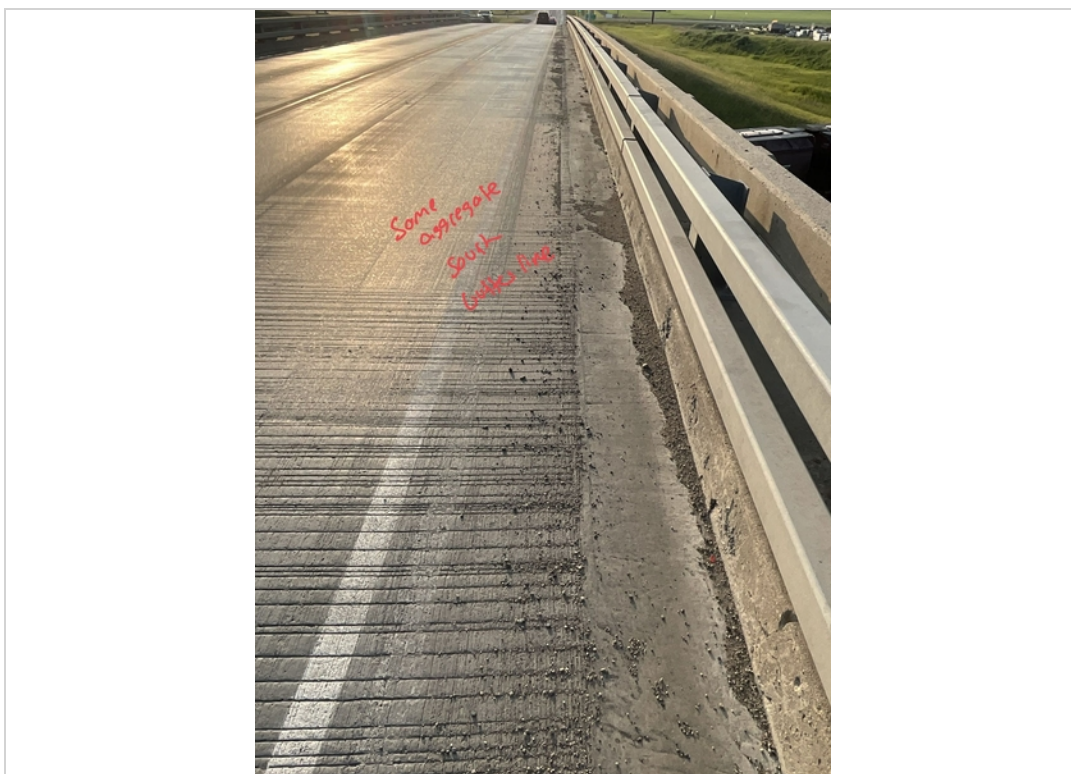
Facing East and Downward. Aggregate along South Gutter Line.

Recommendation to Sweep and clean out deck along Gutterlines. See Photos.

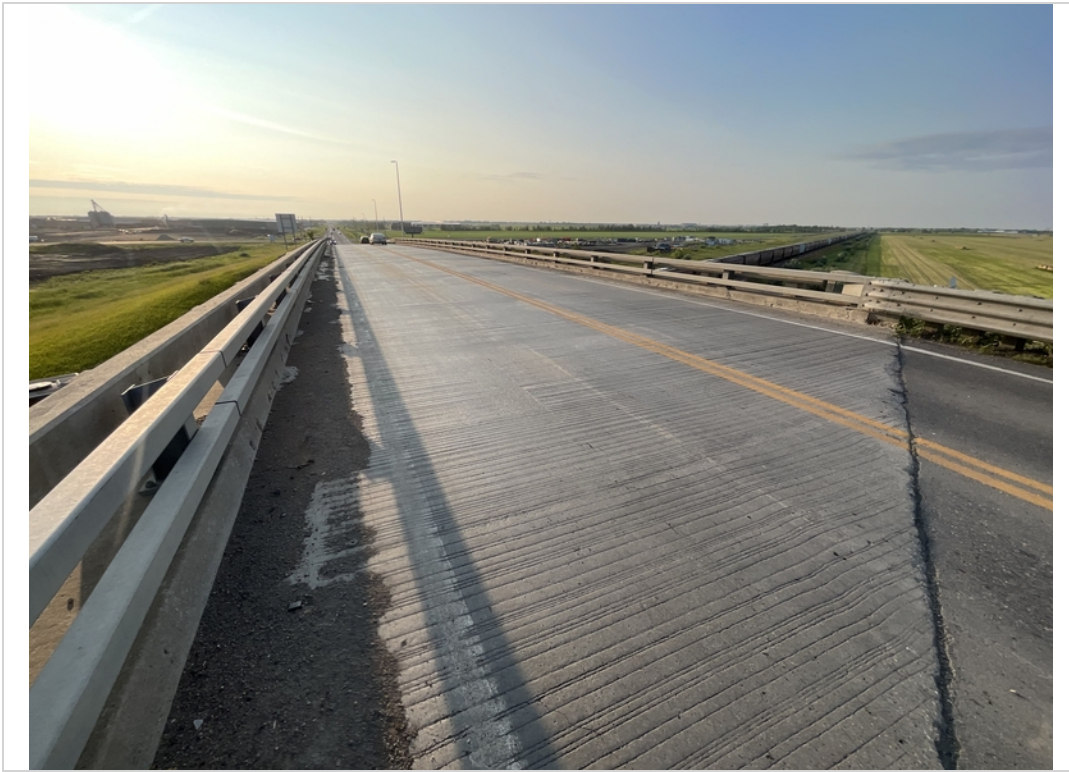
Facing East. General of Deck Wearing Surface

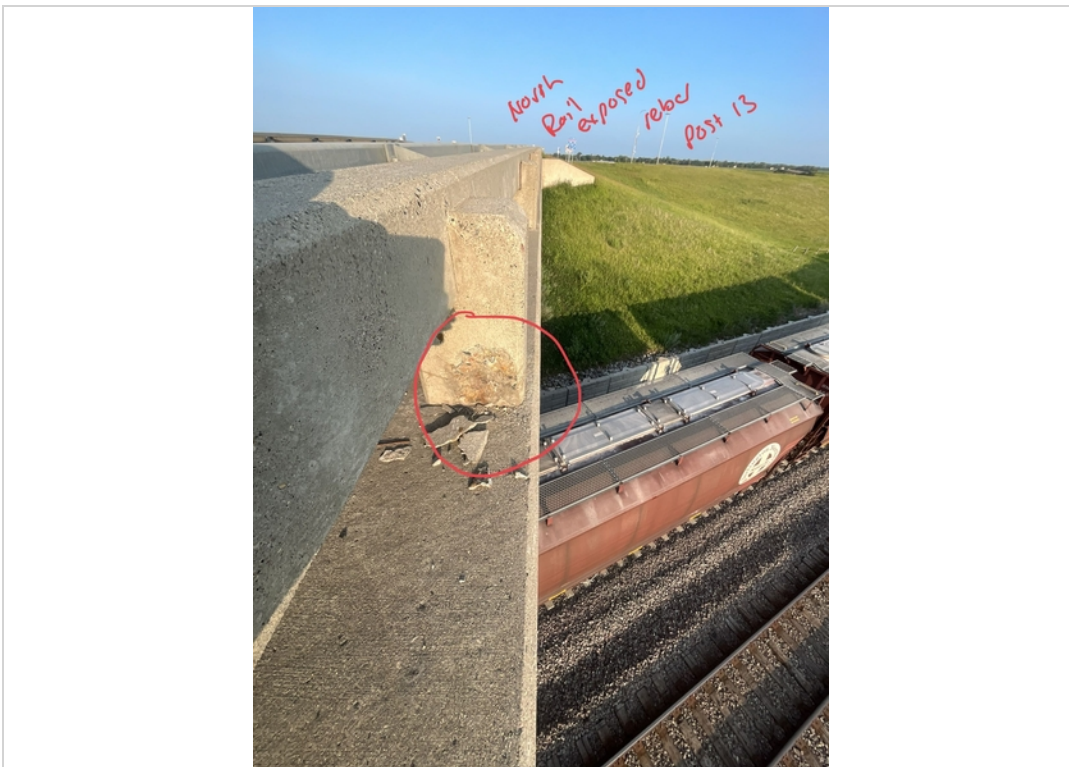
Facing West. Exposed Rebar to North Railing at Post 13.

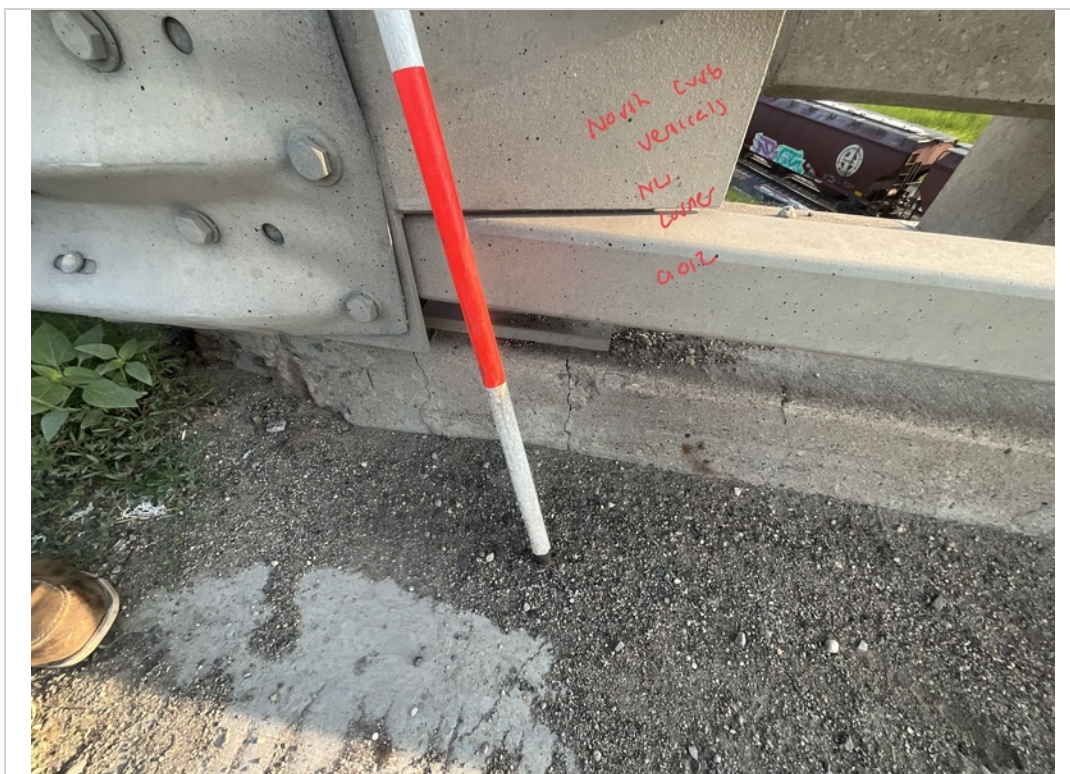
Facing North. Cracks to North Curb near NW Corner.

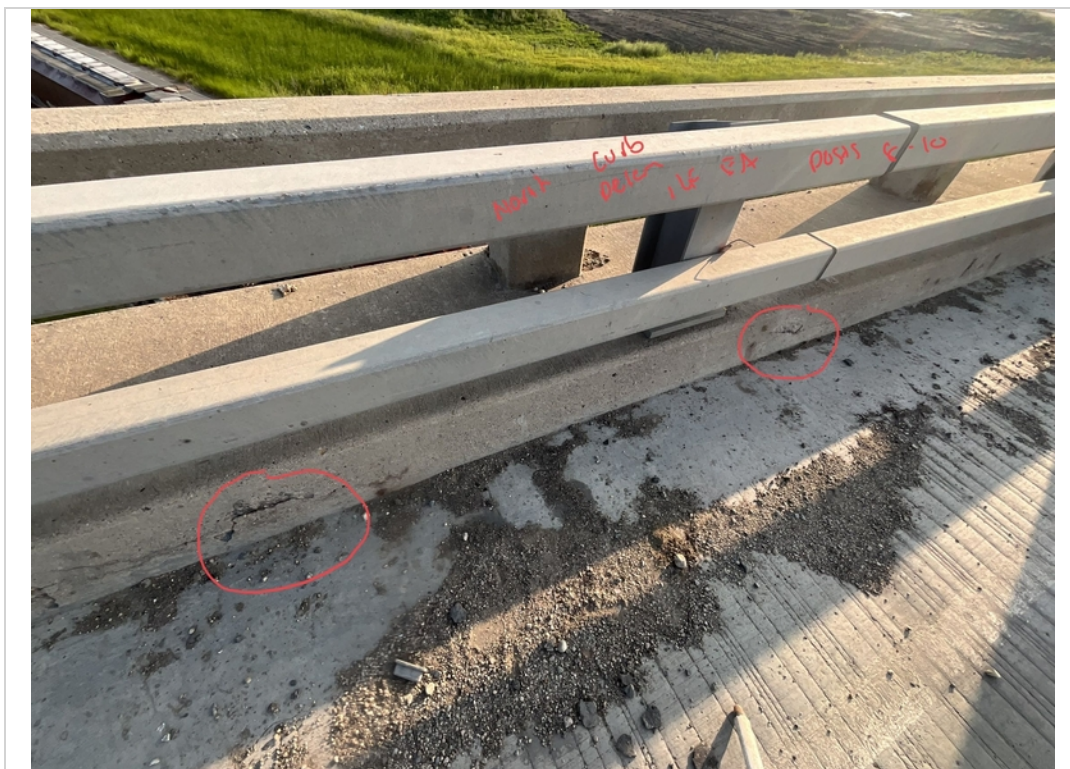
Facing NE. Delamination to North Curb from Posts 8-10.

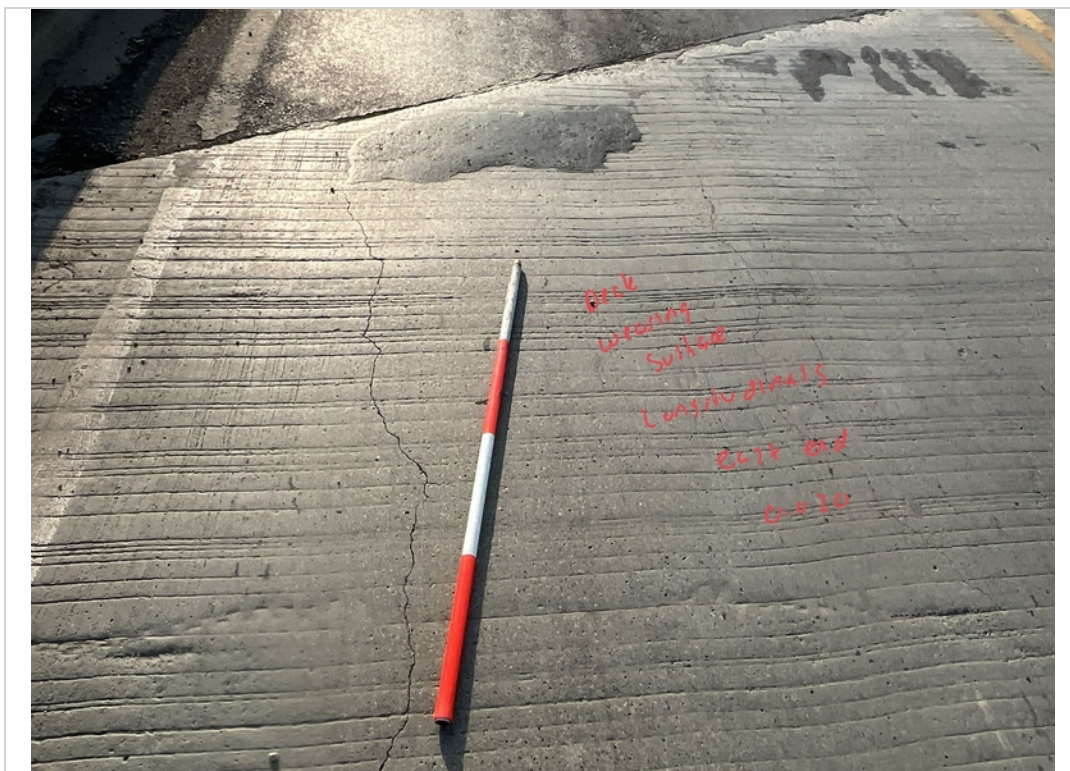
Facing East and Downward. Longitudinal Cracks to Deck Wearing Surface East End.

Recommendation to apply appropriate sealant to cracking per the Maintenance Manual. See Photos.

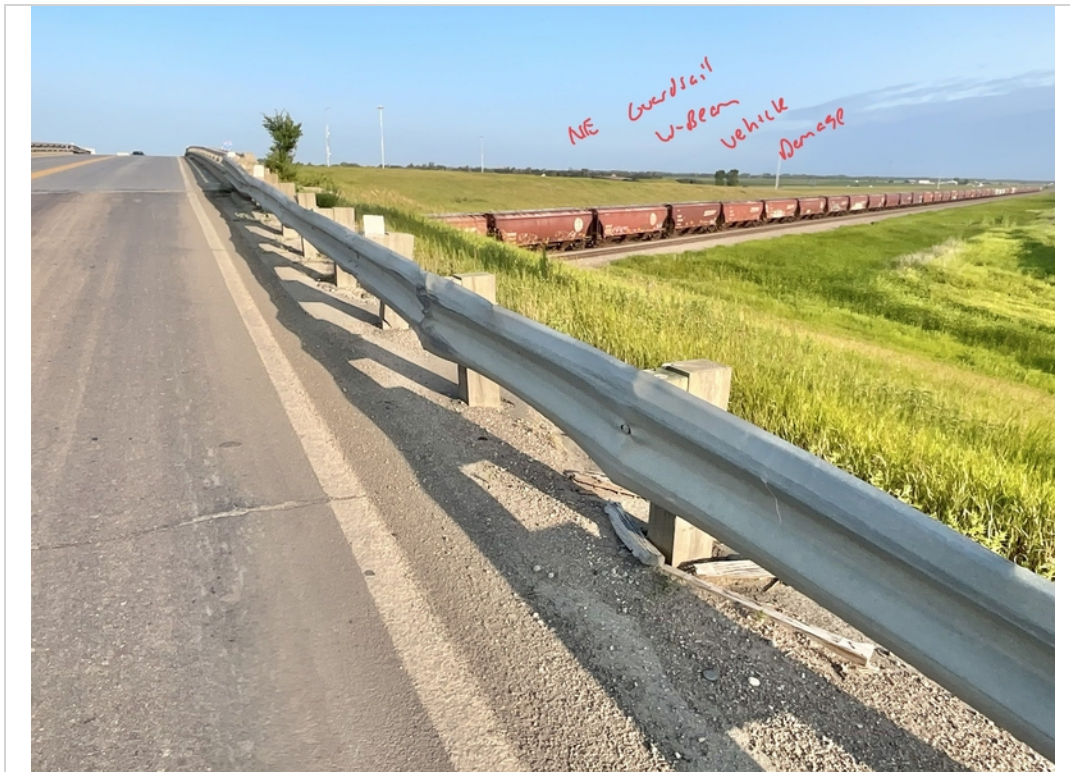
Facing West. Vehicle Impact to W-beam in NE Quadrant.

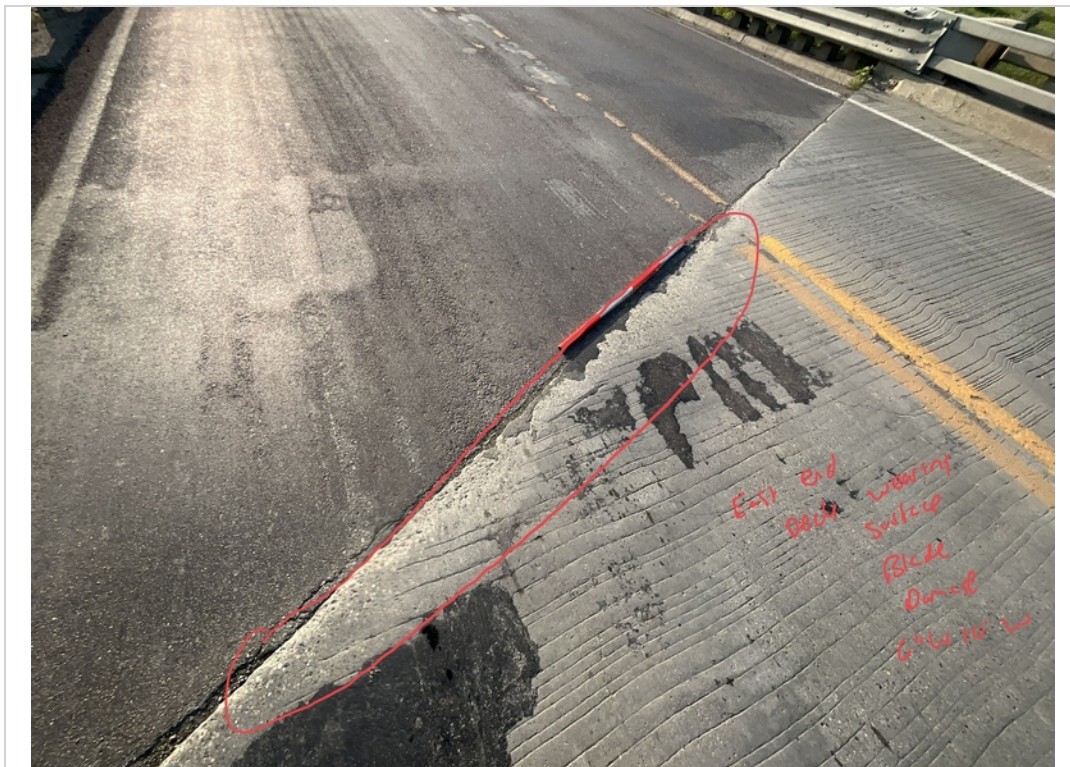
Facing SE and Downward. Blade Damage to Deck Wearing Surface East End WB Lane.

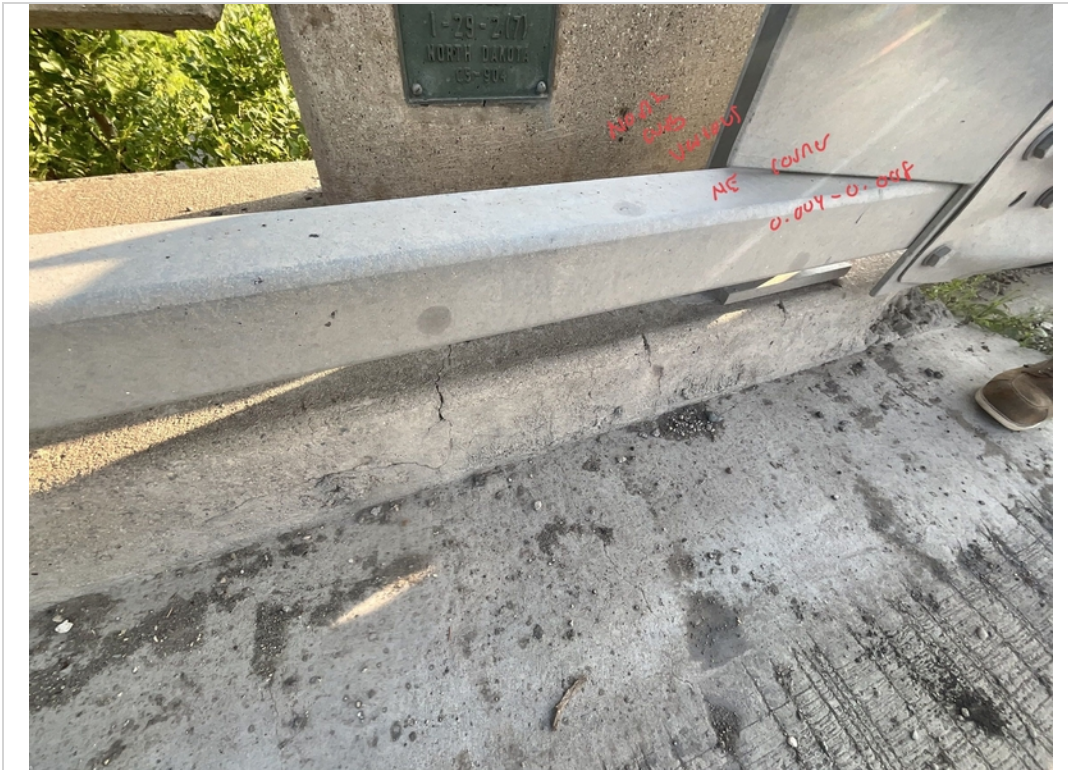
Facing North. Cracking to North Curb near NE Corner.

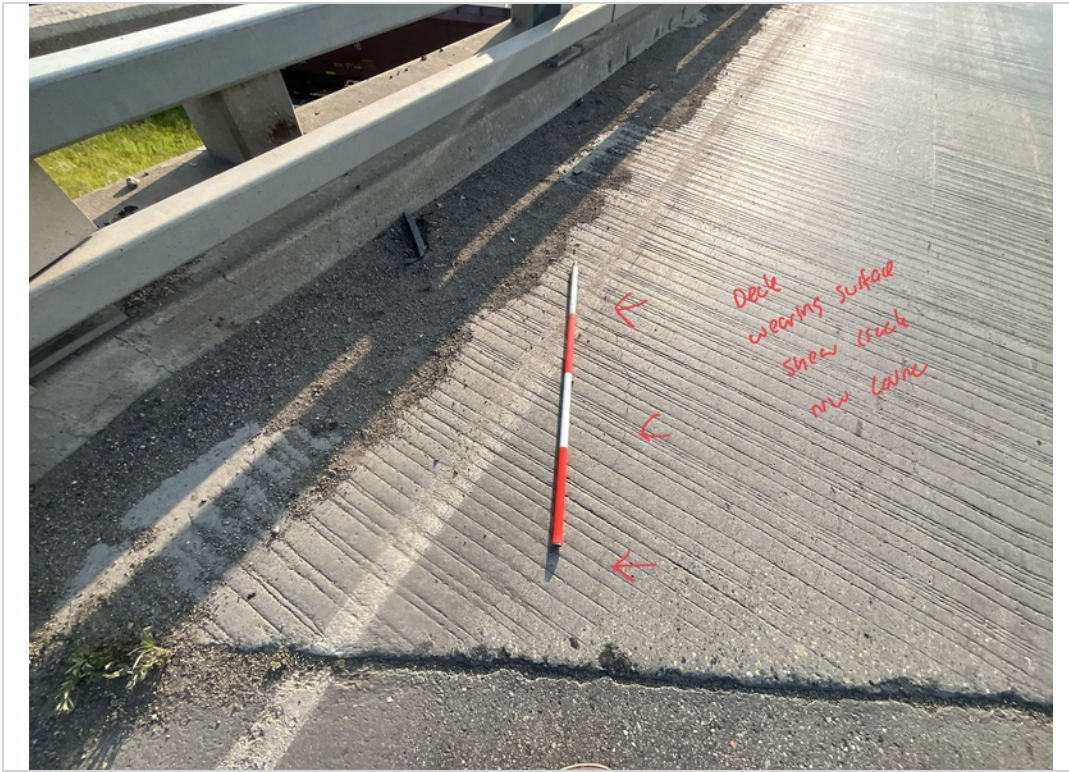
Facing East and Downward. Shear Crack to Deck Wearing Surface near NW Corner.

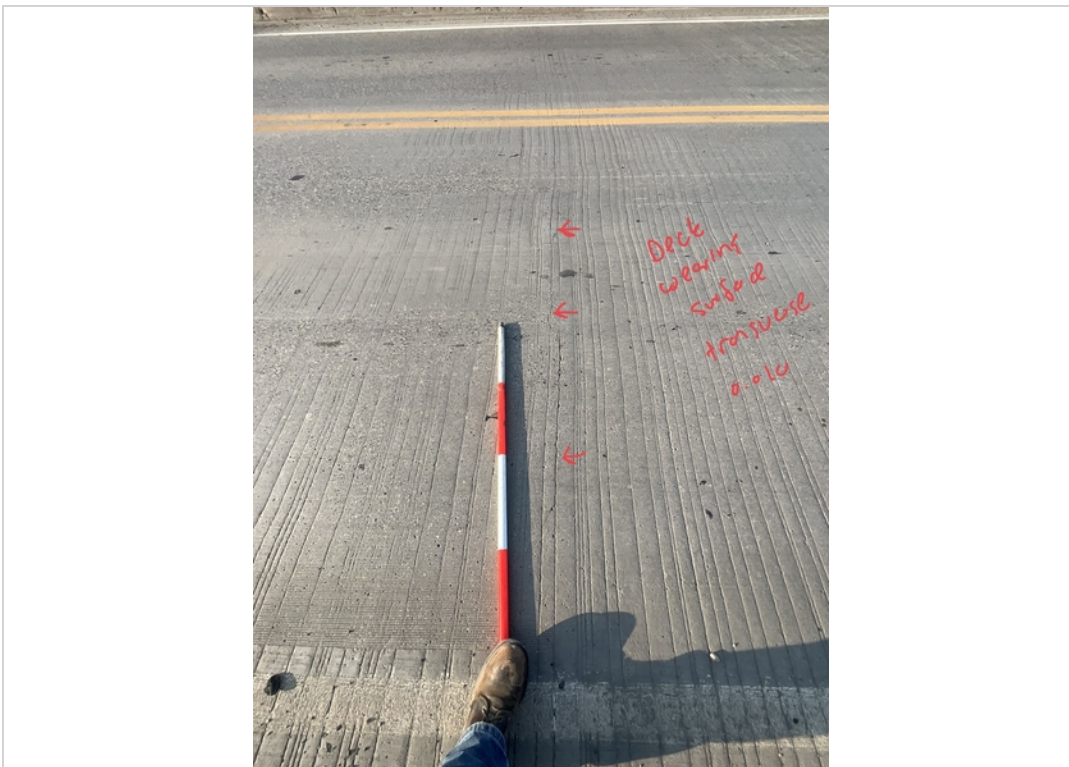
Facing South and Downward. Transverse Crack to Deck Wearing Surface WB Lane.

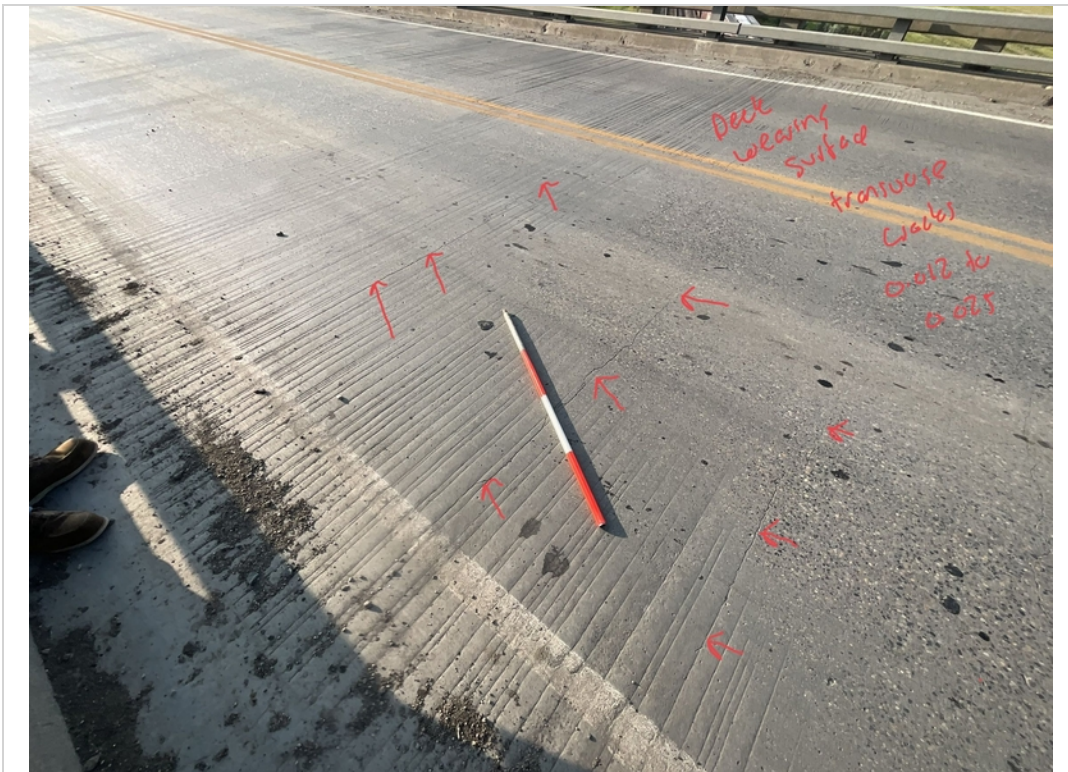
Facing SE and Downward. Transverse Cracks to Deck Wearing Surface WB Lane.

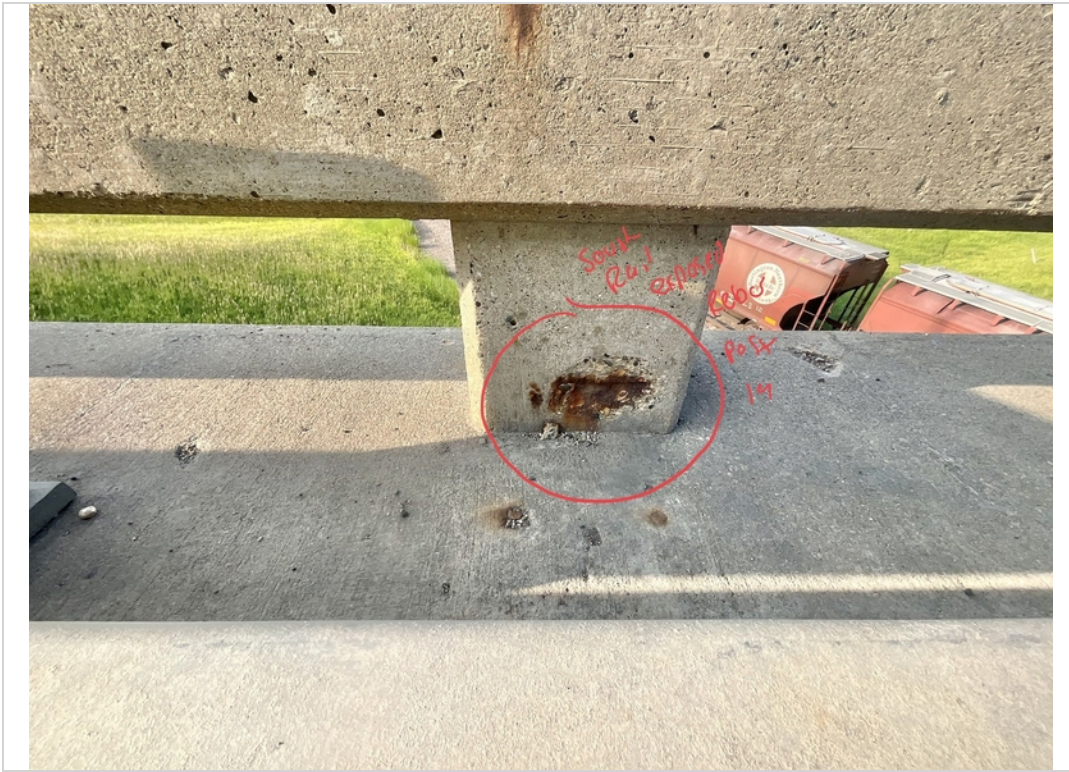
Facing South. Exposed Rear to South Railing Post 19.

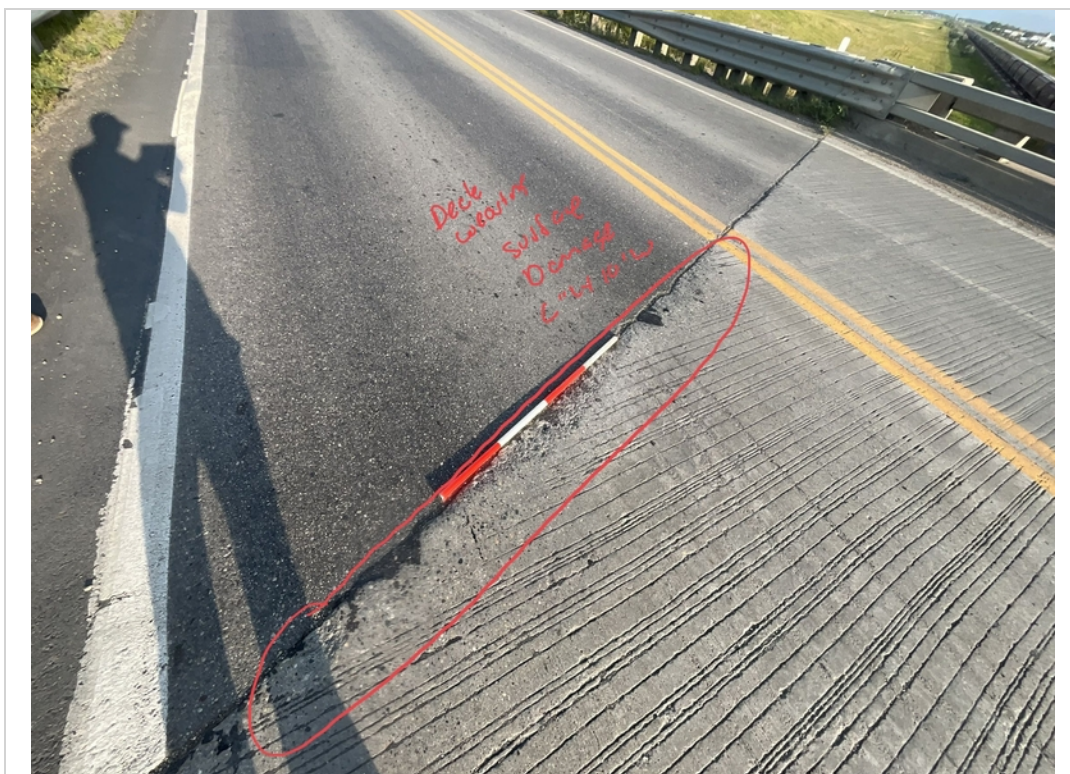
Facing NW and Downward. Blade Damage to Deck Wearing Surface EB Lane West End.

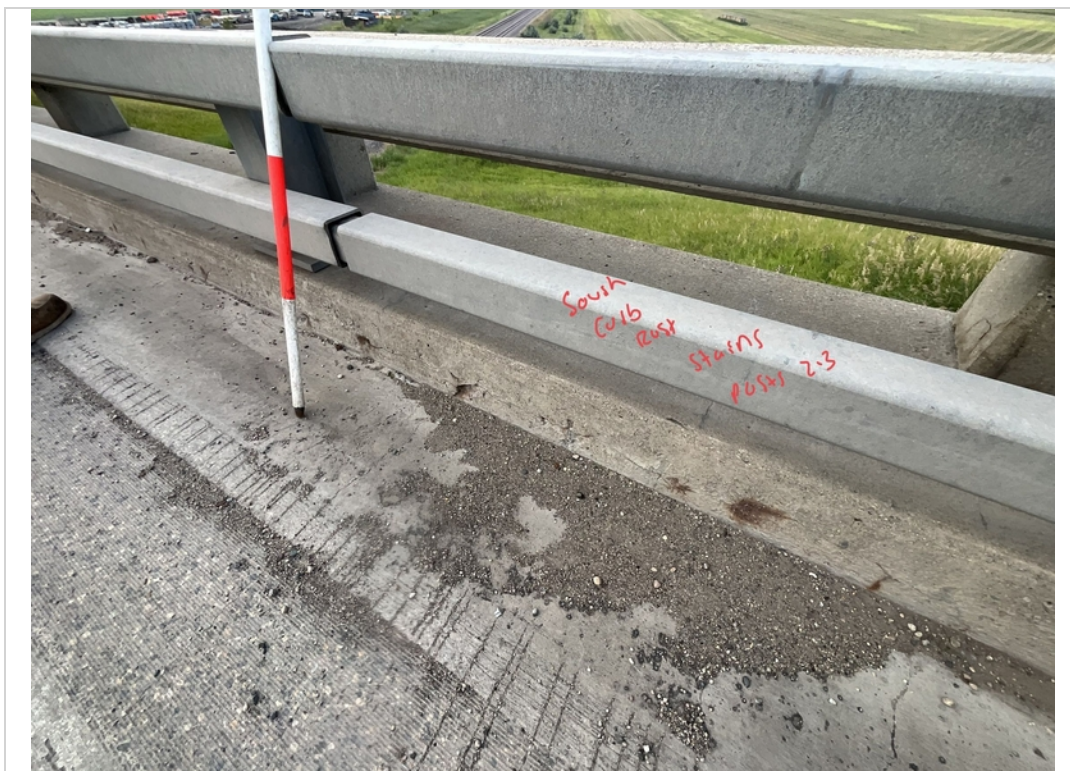
Facing South. Rust Stains to South Curb from Posts 2-3

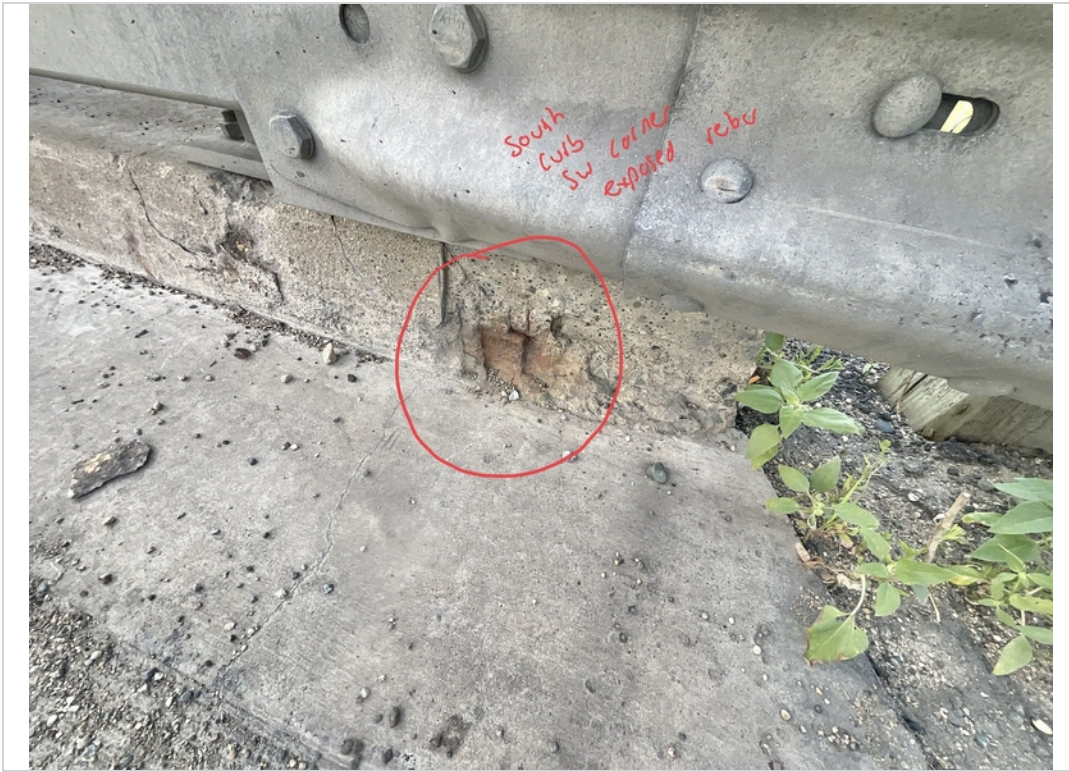
Facing South. Exposed Rebar to South Curb near SW Corner.

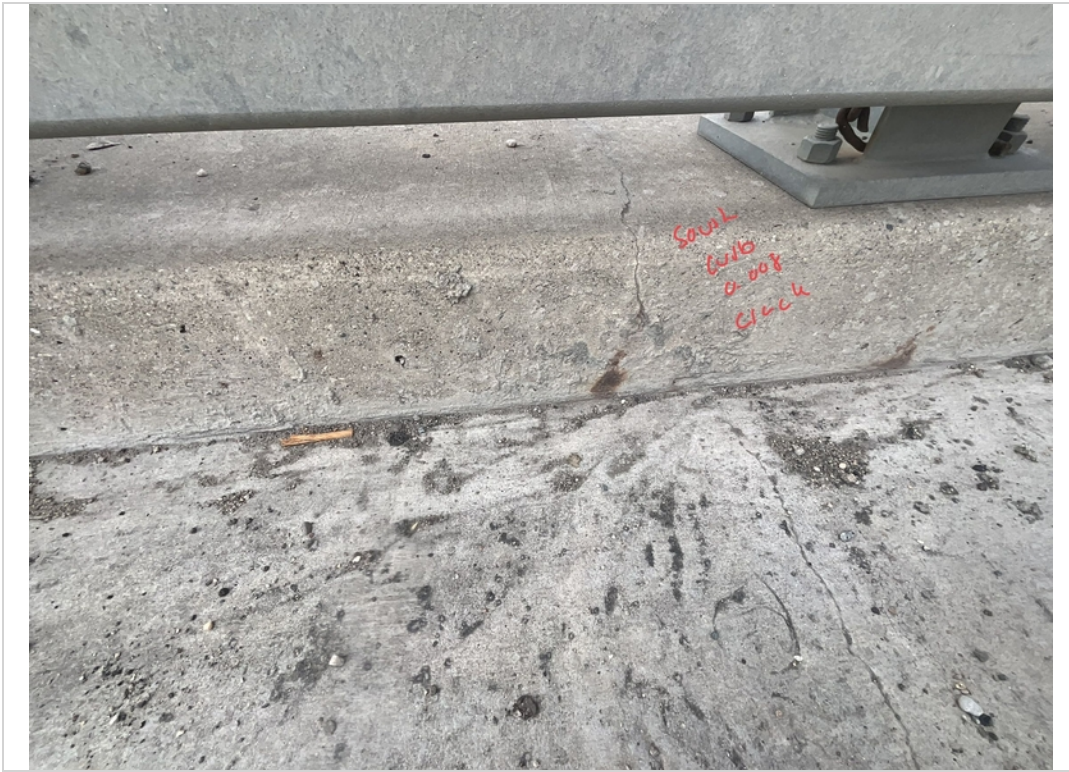
Facing South. Crack to South Curb.

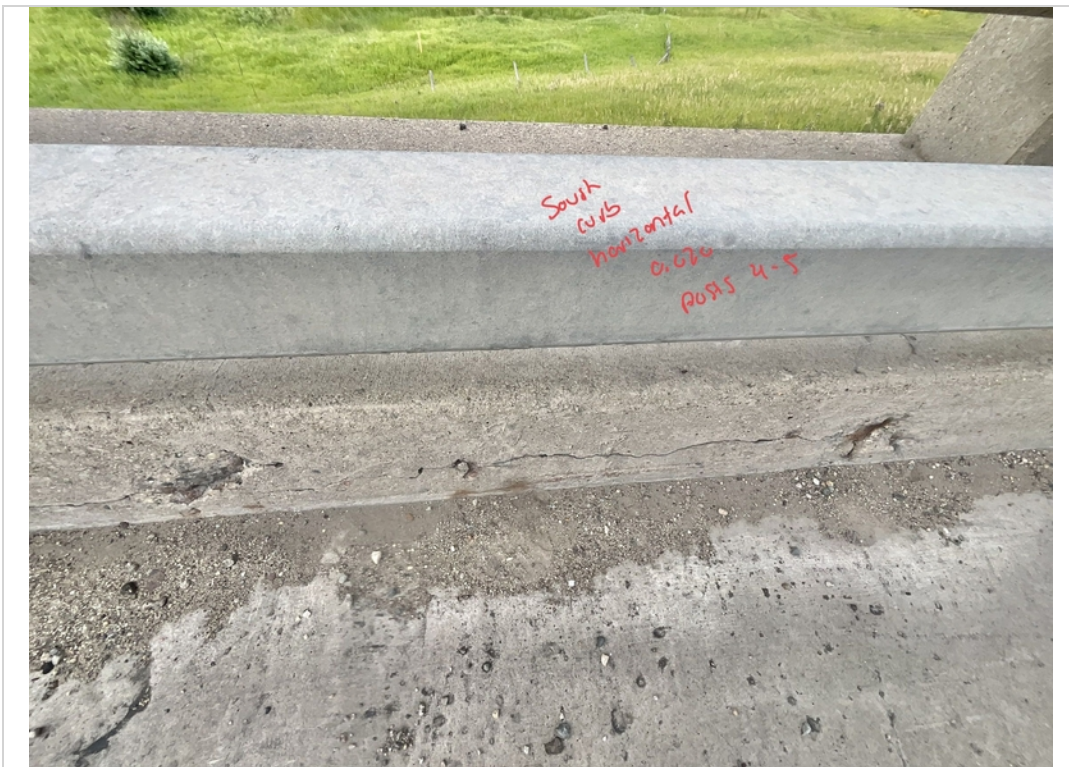
Facing South. Horizontal Crack to South Curb from Posts 4-5

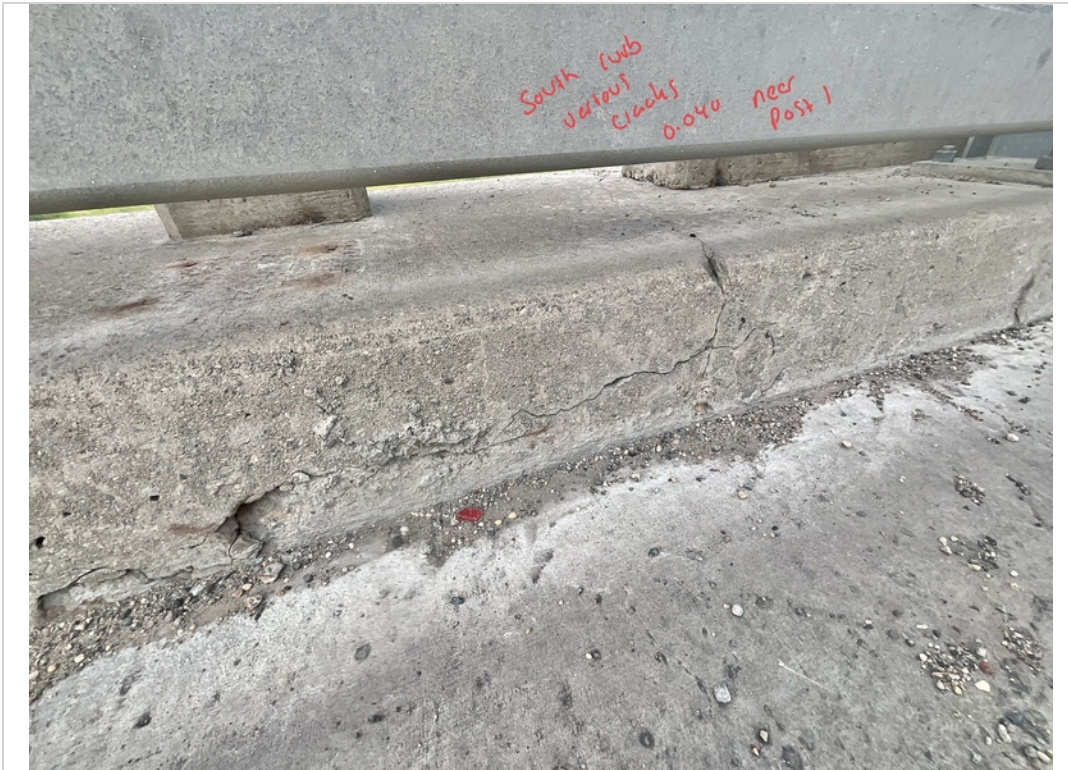
Facing SW. Horizontal Crack to South Curb near Post 1.

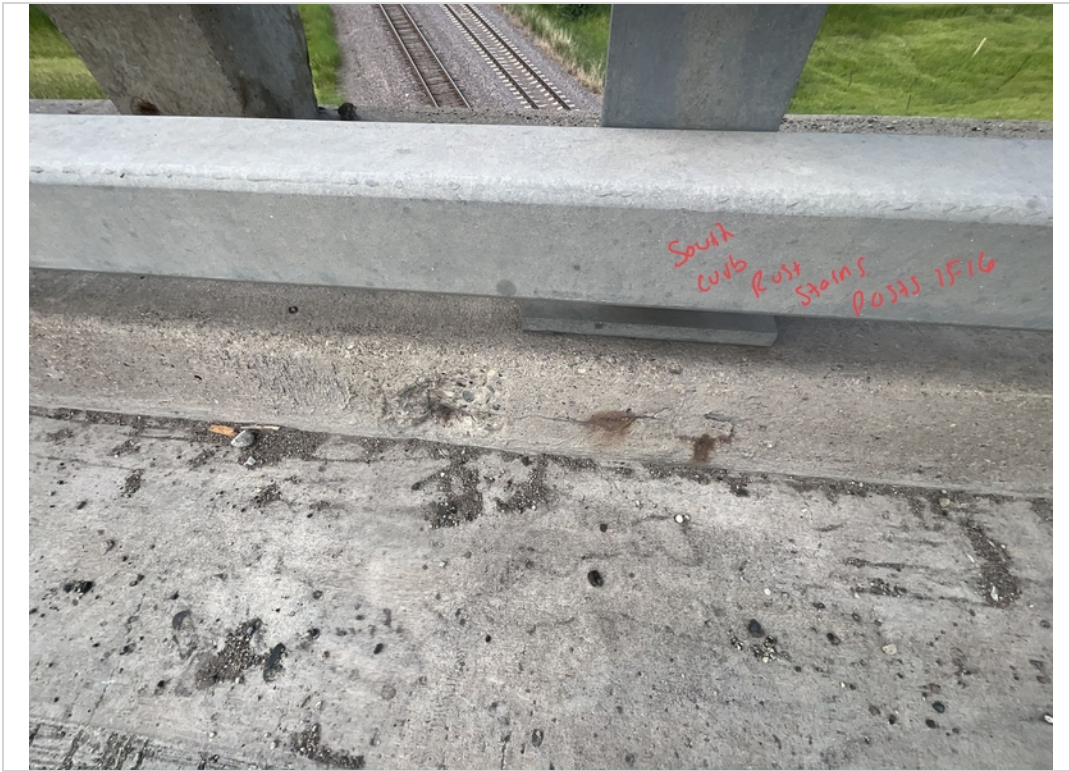
Facing South. Rust Stains to South Curb from Posts 15-16

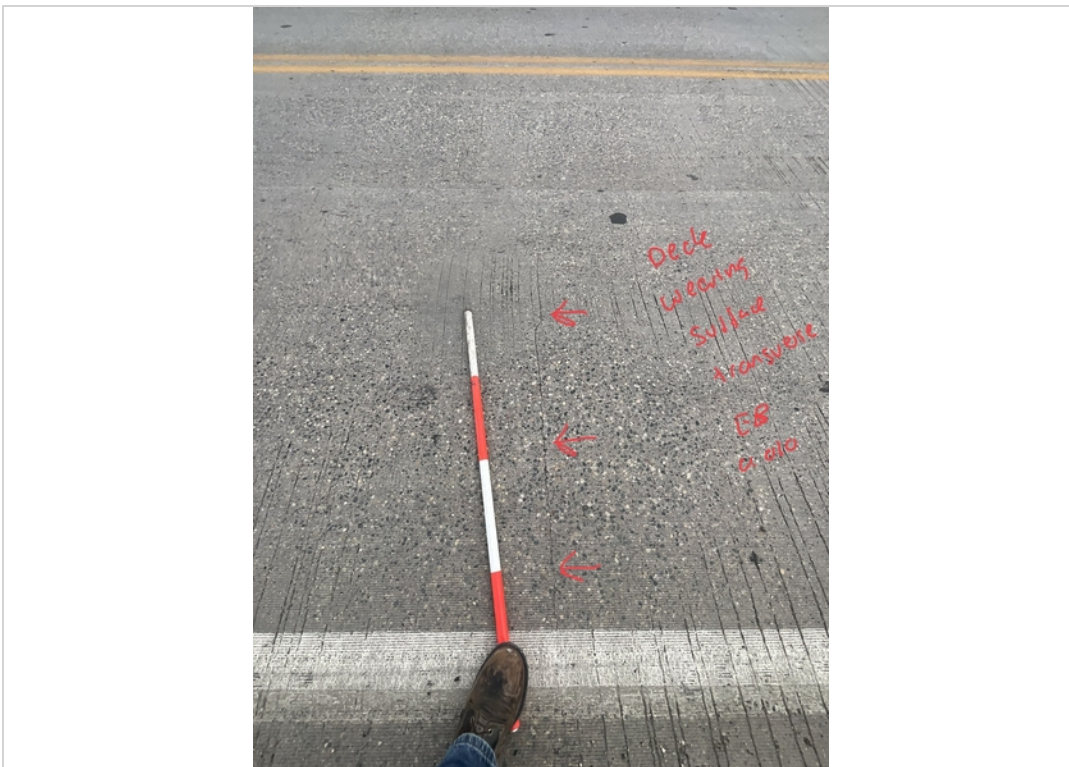
Facing North and Downward. Transverse Crack to Deck Wearing Surface EB Lane.
