IDENTIFICATION	
(1) State Names	38 - North Dakota
(8) Structure Number	0029-069.374 N
(5) Inventory Route	1
(2) Highway Agency District	8 - Fargo
(3) County Code	9 - Cass

(4) Place Code	25700
(6) Features Intersected	BNRR
(7) Facility Carried	COUNTY HIGHWAY
(9) Location	EAST OF NO. FARGO INTCHG
(11) Mile Point	0.1 mi
(12) Base Highway Network	No

INSPECTIONS *			
(90) Inspection Date	07/17/2023		
(91) Frequency	24		
(92) Critical Feature Inspection	Done	Freq. (Mon)	Date
A: Fracture Critical Detail	No		
B: Underwater Inspection	No		
C: Other Special Inspection			
* The inspection date and frequency information in this box contains the current NBI date and frequency information. Please refer to the report header for the date this inspection was conducted.

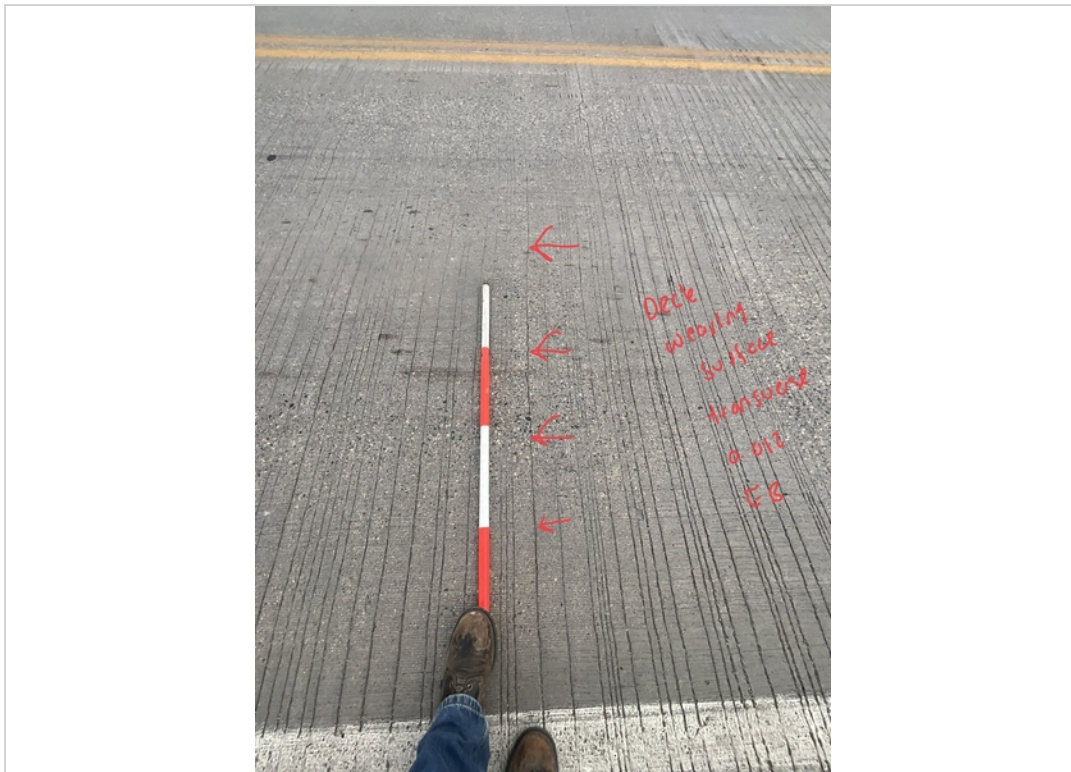
Facing North and Downward. Transverse Crack to Deck Wearing Surface EB Lane.

Recommendation to apply appropriate sealant to cracking per the Maintenance Manual. See Photos.

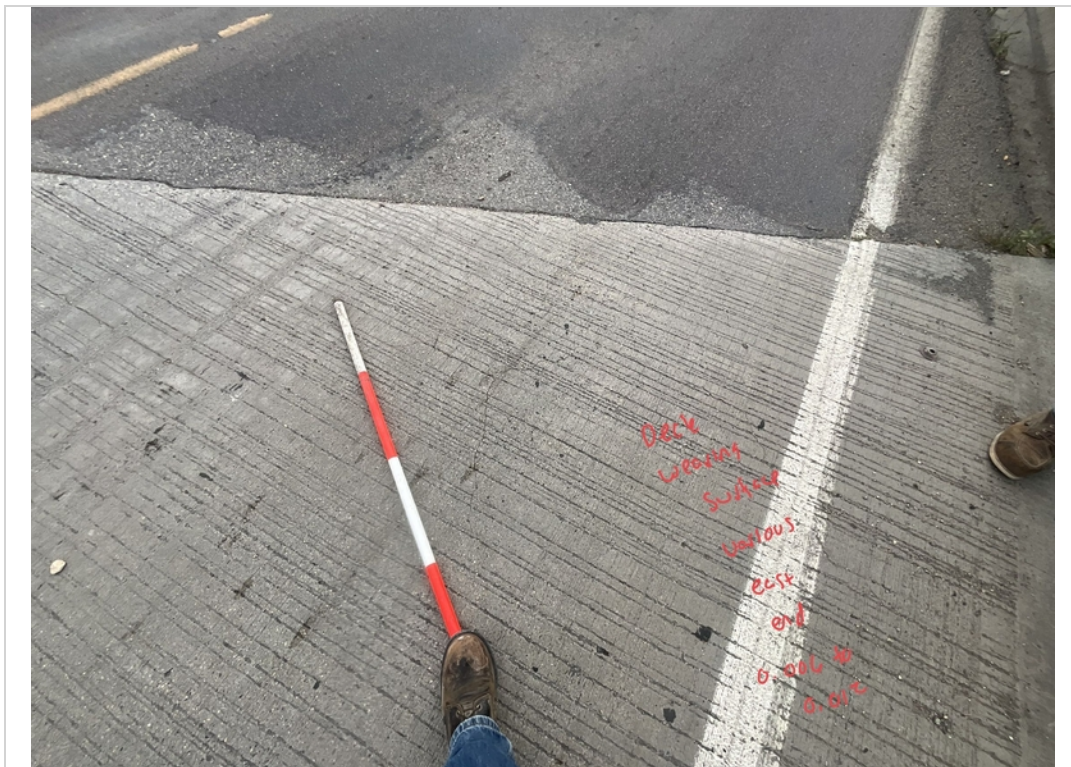
Facing East and Downward. Various Cracking to Deck Wearing Surface East End.

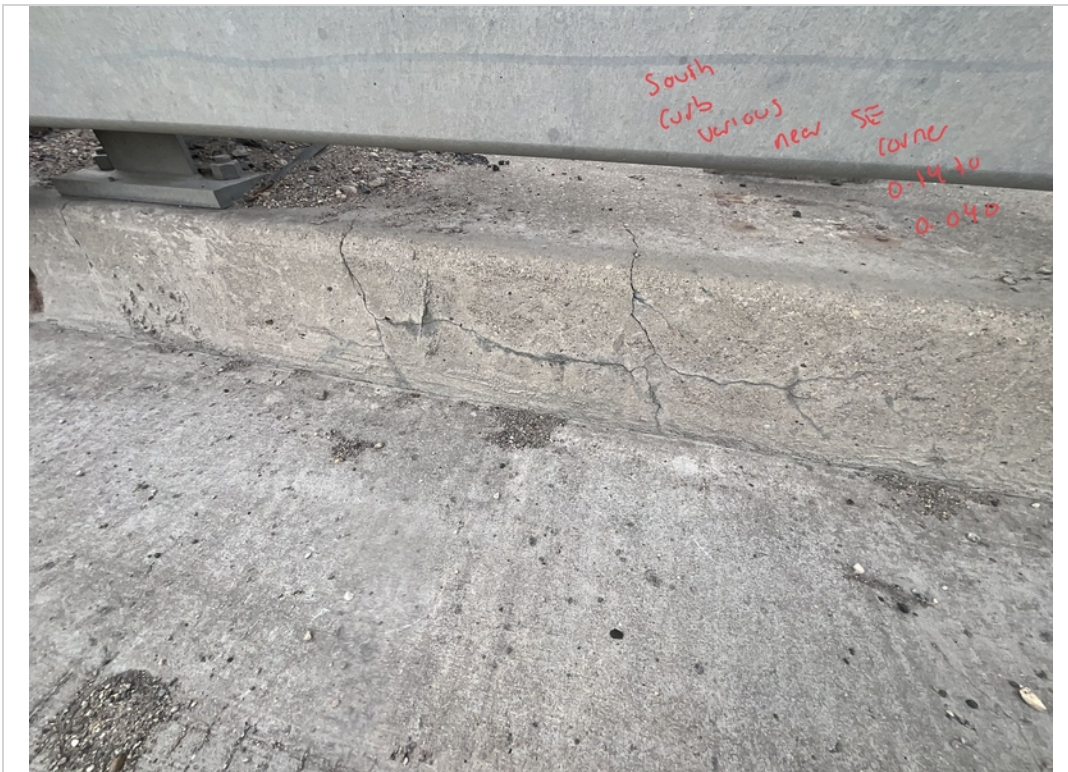
Facing South and Downward. Various Cracking to South Curb near SE Corner.

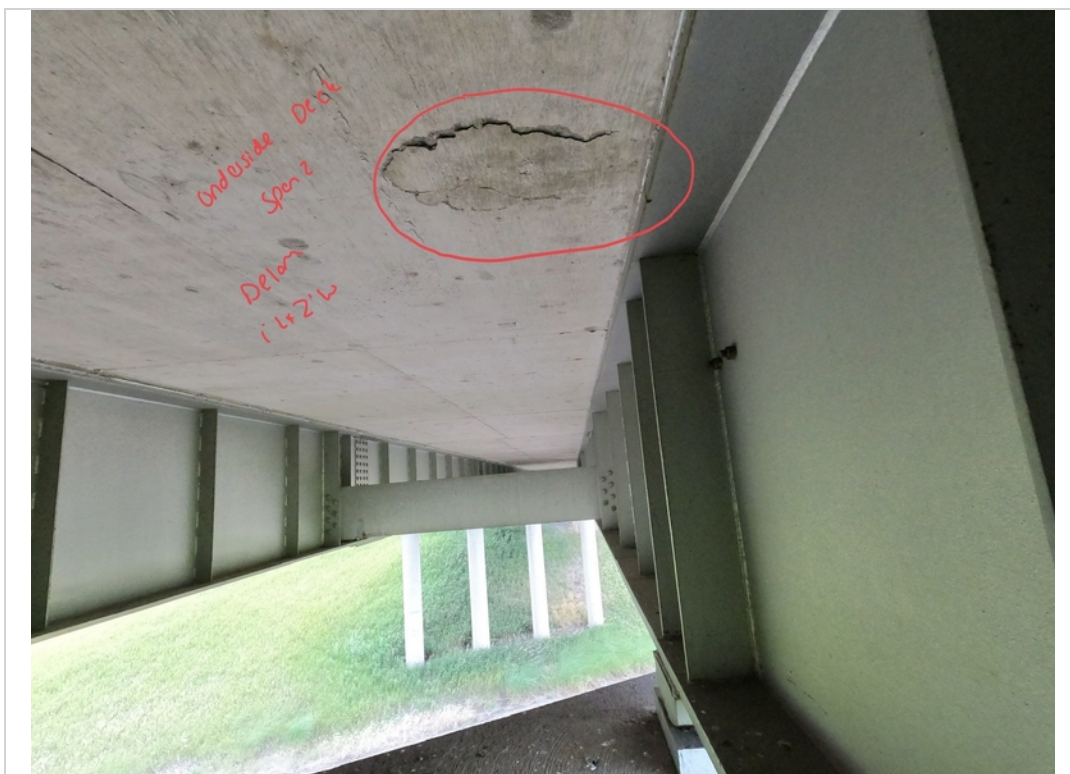
Facing East and Downward. Delamination to Underside Deck Span 1

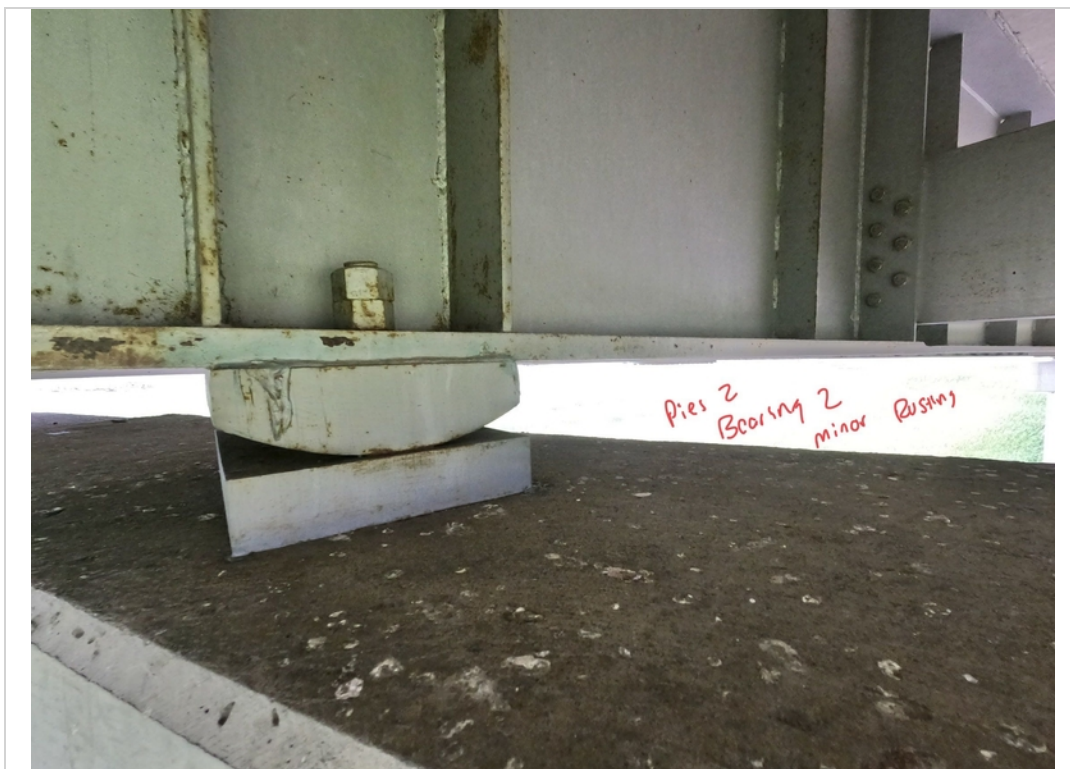
(1000-313) 7/12/2021 - Minor Rusting to Bearings 1, 2 and 4 at Pier 2 and Bearings 1 and 4 at Pier 3. See Photos. 7/17/2023 - Continued Minor Rusting to Pier 2 Bearings 1, 2, and 4 and Pier 3 Bearings 1, 3 and 4. Areas mainly along Masonry Plate. See Photos. (515-313) 7/12/2021 - Estimated 5 SF for EA Bearing.

Facing NE. Pier 2 Bearing 2 Minor Rusting.

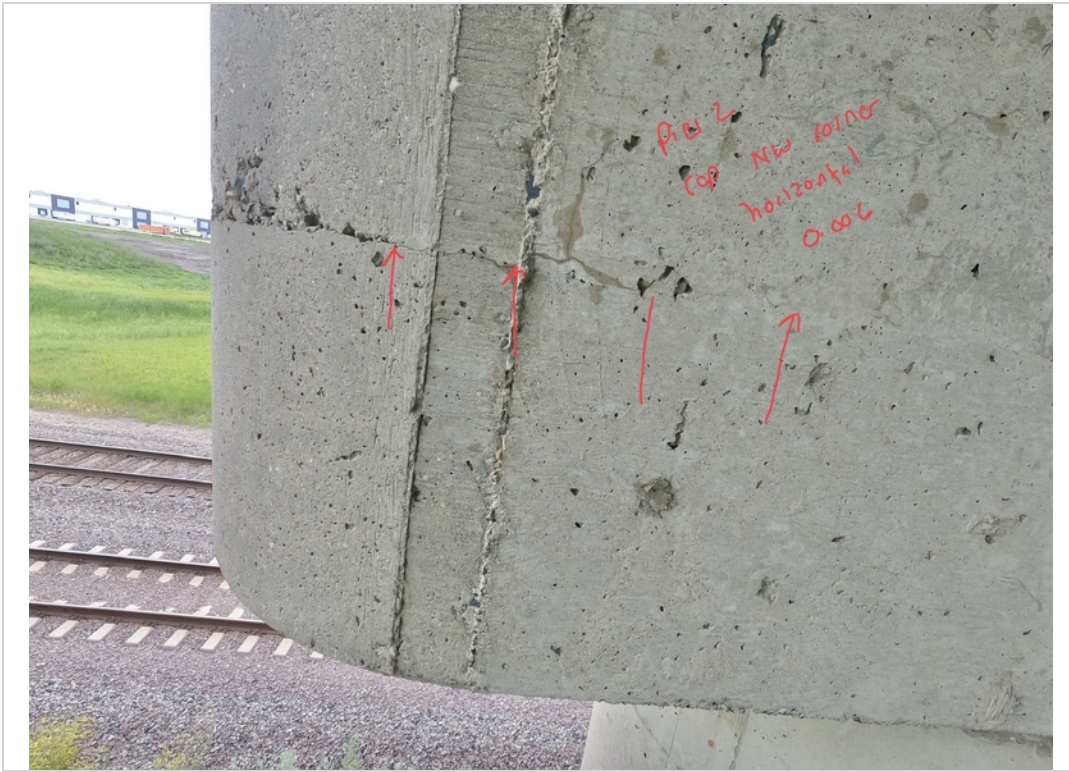
Facing East. Minor Horizontal Crack to Pier 2 Cap North of Bearing 1.

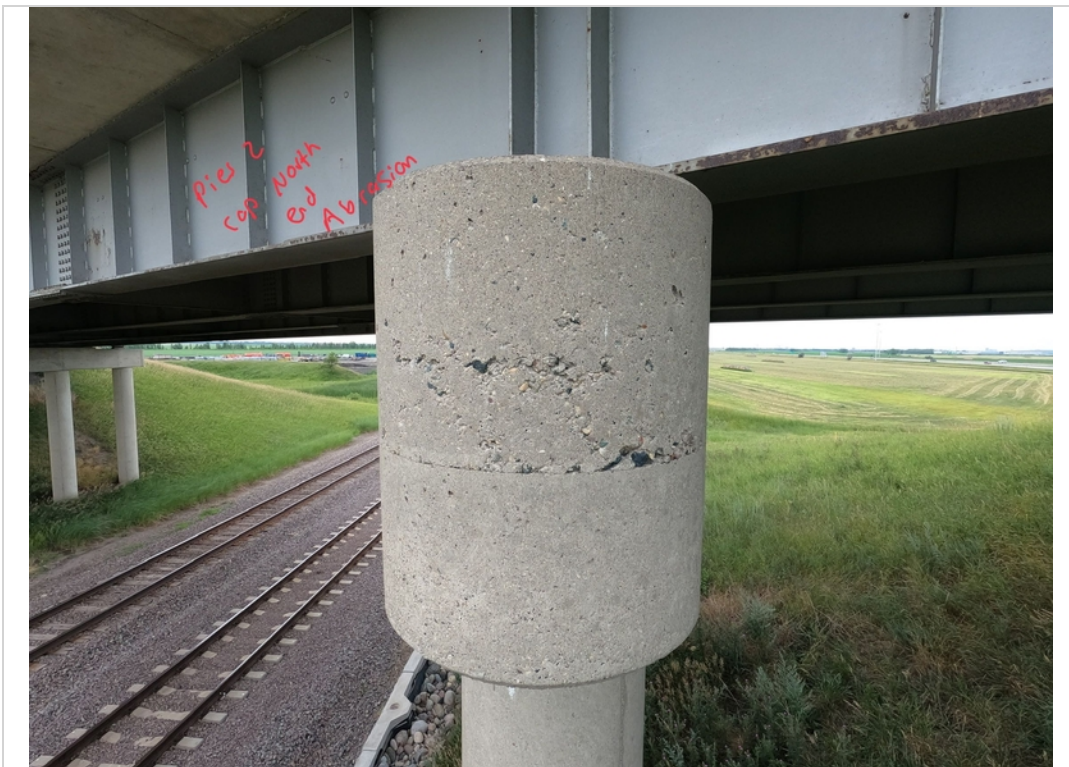
Facing South. Abrasion to Pier 2 Cap North End.

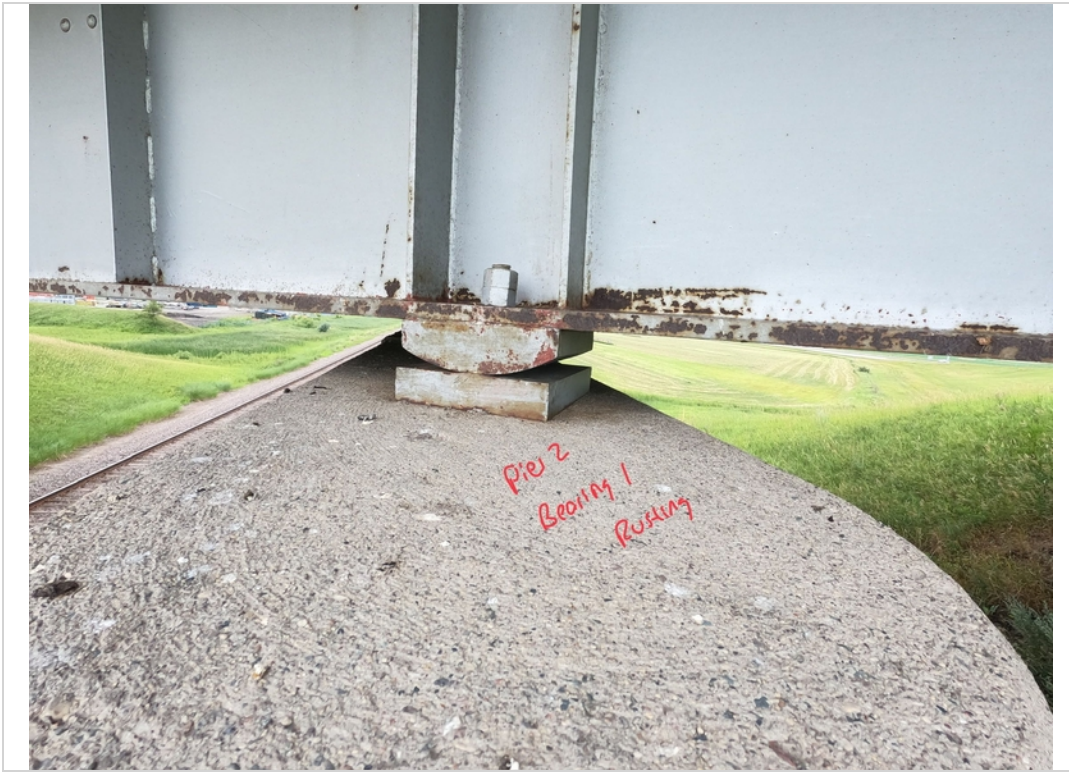
Facing South. Rusting to Pier 2 Bearing 1.

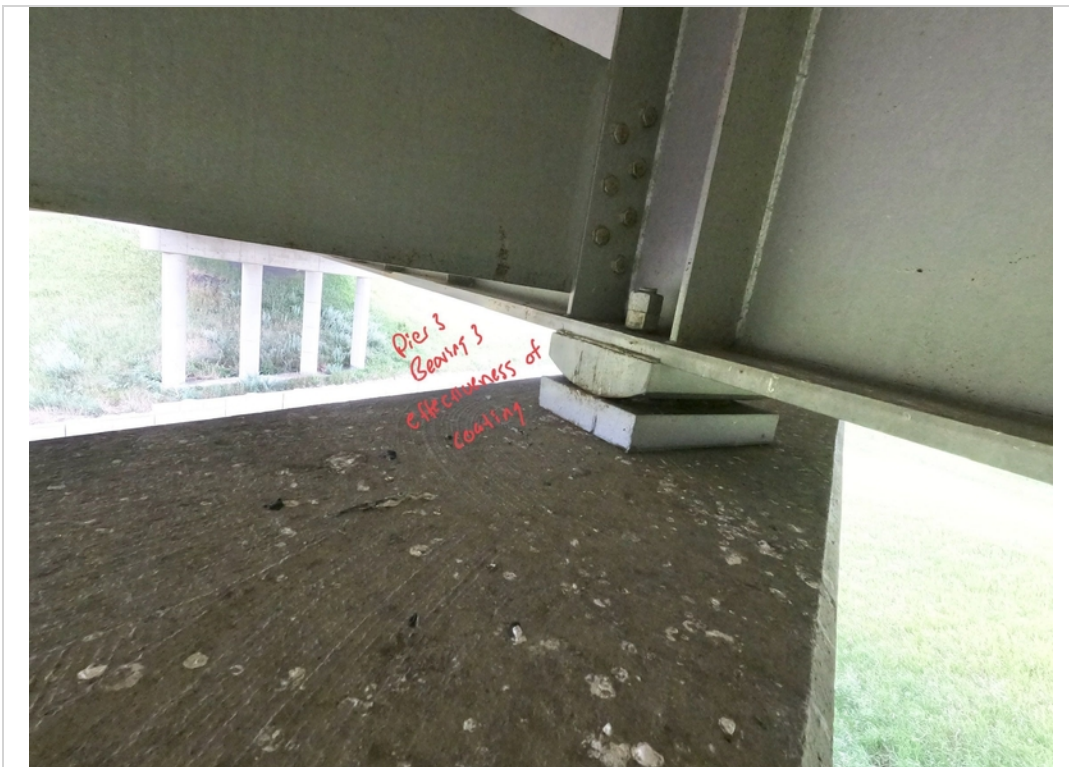
Facing NW. Effectiveness of Coating to Pier 3 Bearing 3.

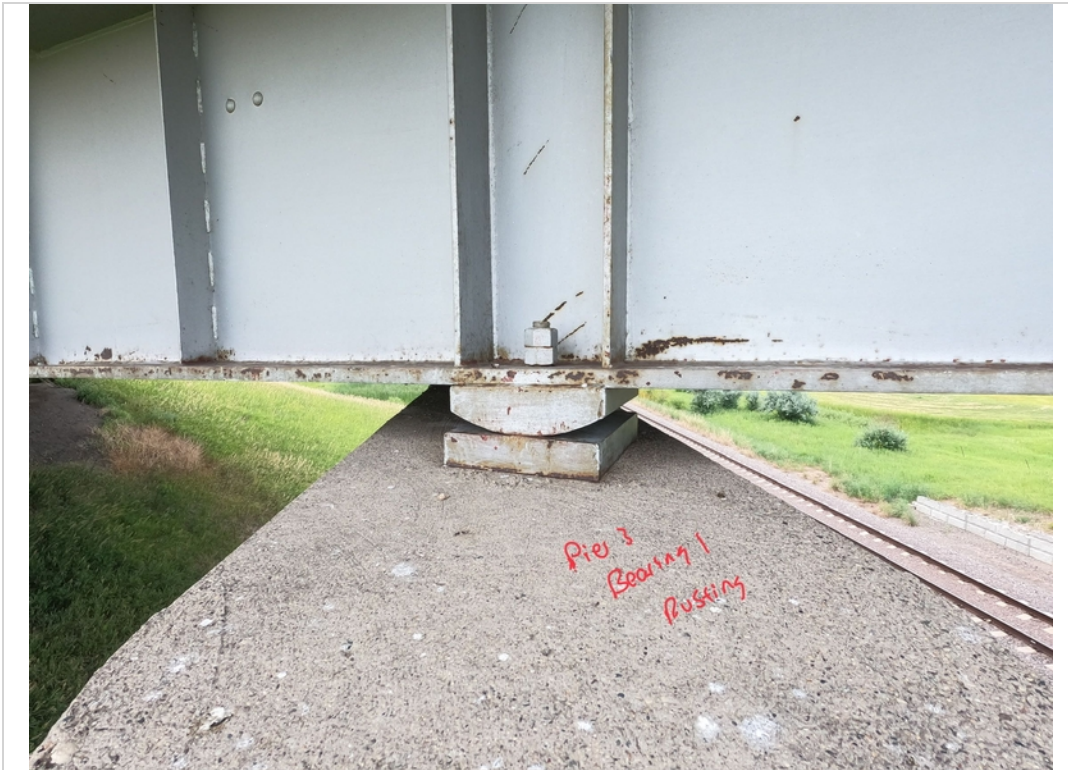
Facing South. Pier 3 Bearing 1 Rusting with Limited Effectiveness of Coating.

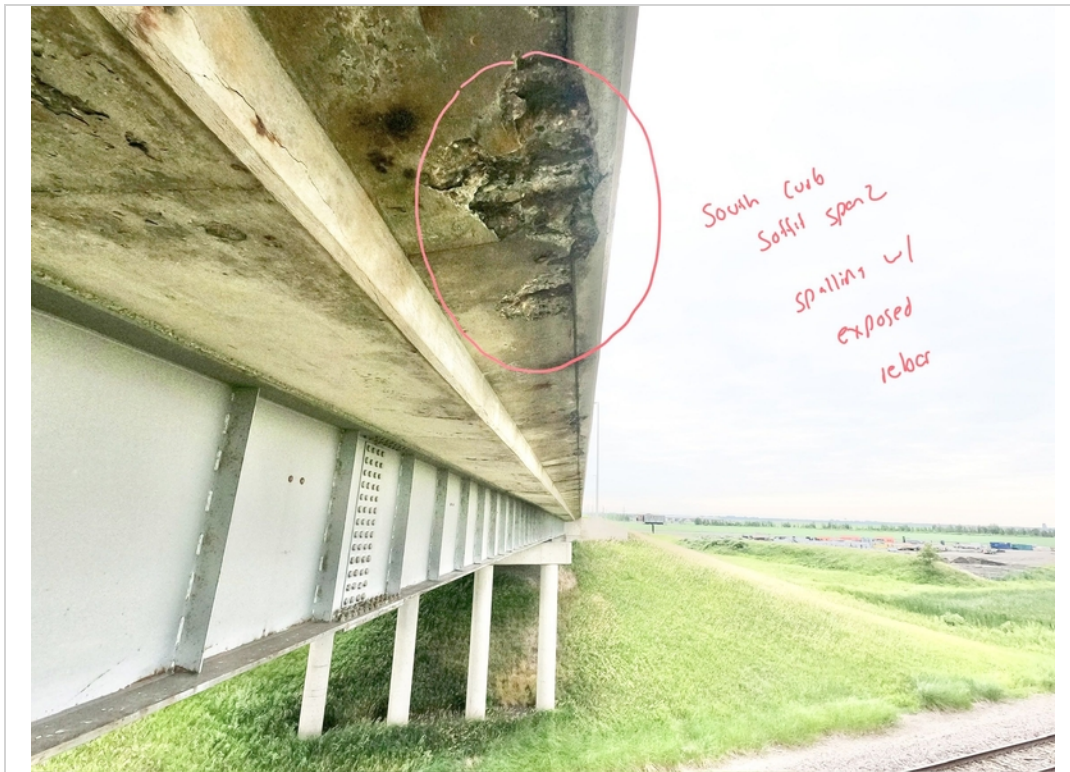
Facing East and Upwards. South Curb Soffit with Spalling and Exposed Rebar in Span 2.

Recommendation to remove delaminated Concrete and patch area. See Photo.

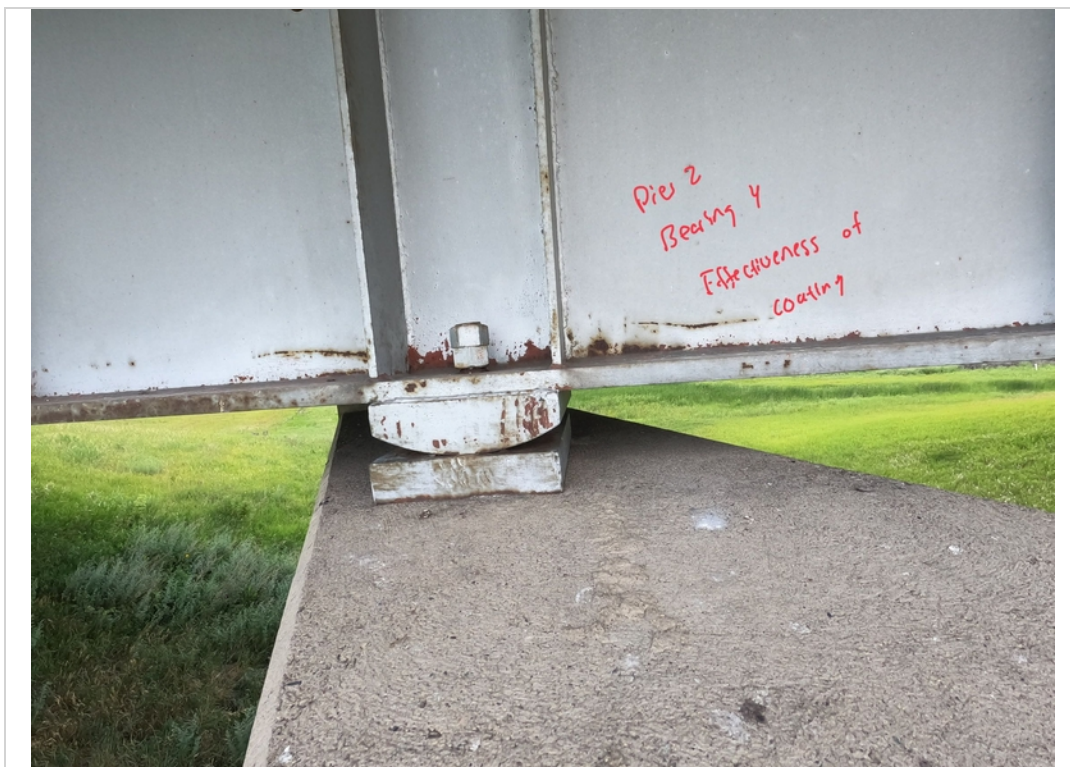
Facing North. Effectiveness of Coating to Pier 2 Bearing 4.

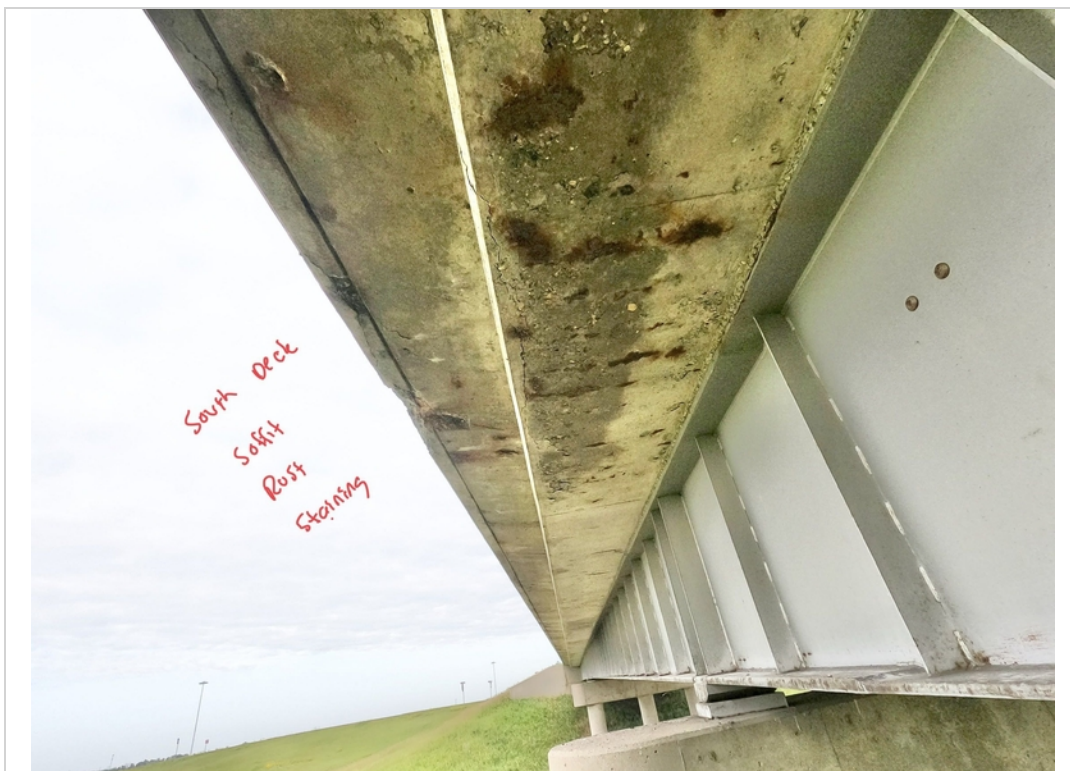
Facing West and Upwards. Rust Stains to South Soffit.

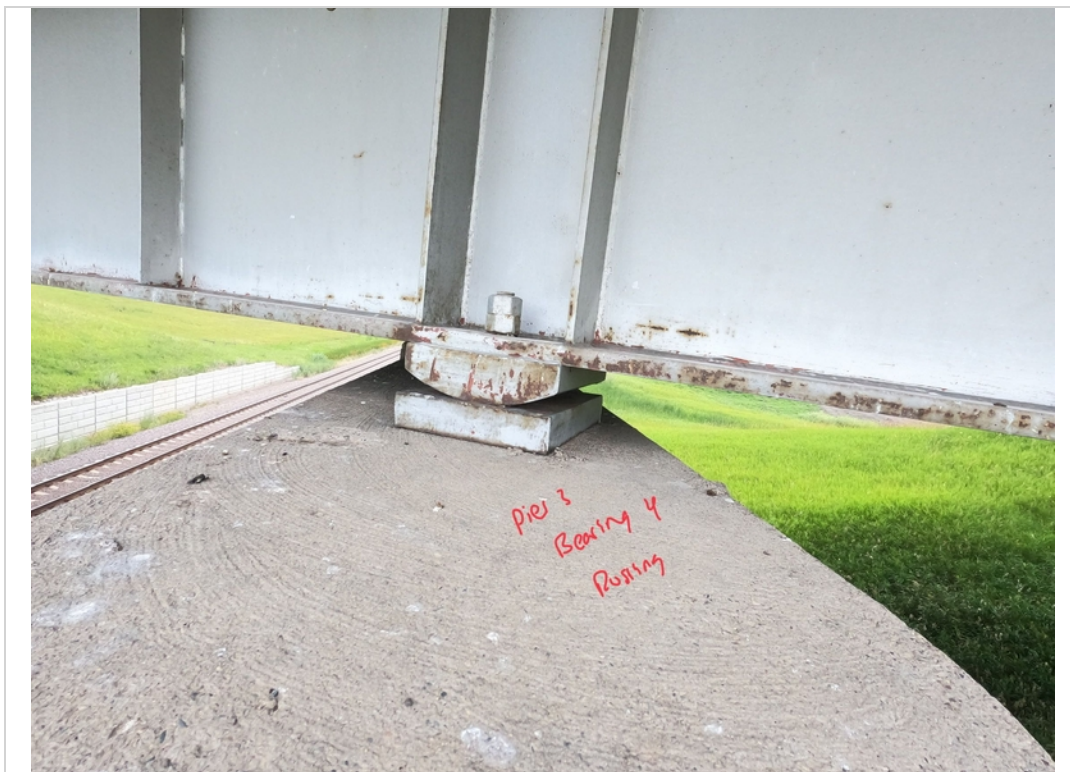
Facing North. Rusting to Pier 3 Bearing 4.
