Dakota County Intersection Study

Location: CSAH 54 & CSAH 68

Date: November 2018

Reason for Study

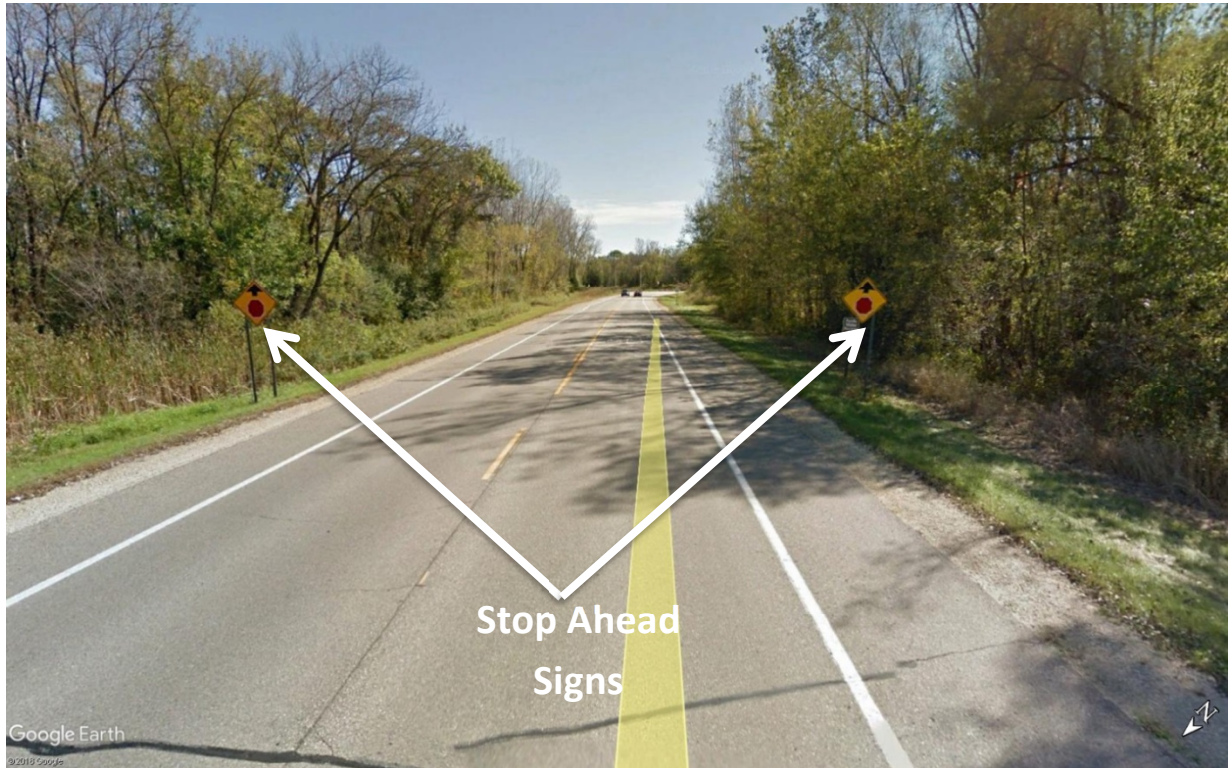
Figure 2 below shows CSAH 54 approximately 700 ft. northwest of the intersection with CSAH 68, facing southeast. The stop ahead signs on both sides (36"x36") of the road are approximately 670 ft. away from the intersection. Faded "STOP AHEAD" pavement markings follow these signs a short distance after. The roadway curves to the right approaching the stop at CSAH 68 – the left/right stop signs at the intersection are likely in place to increase visibility due to this curve.

Figure 2. Google Earth aerial of intersection of CSAH 54 and CSAH 68.

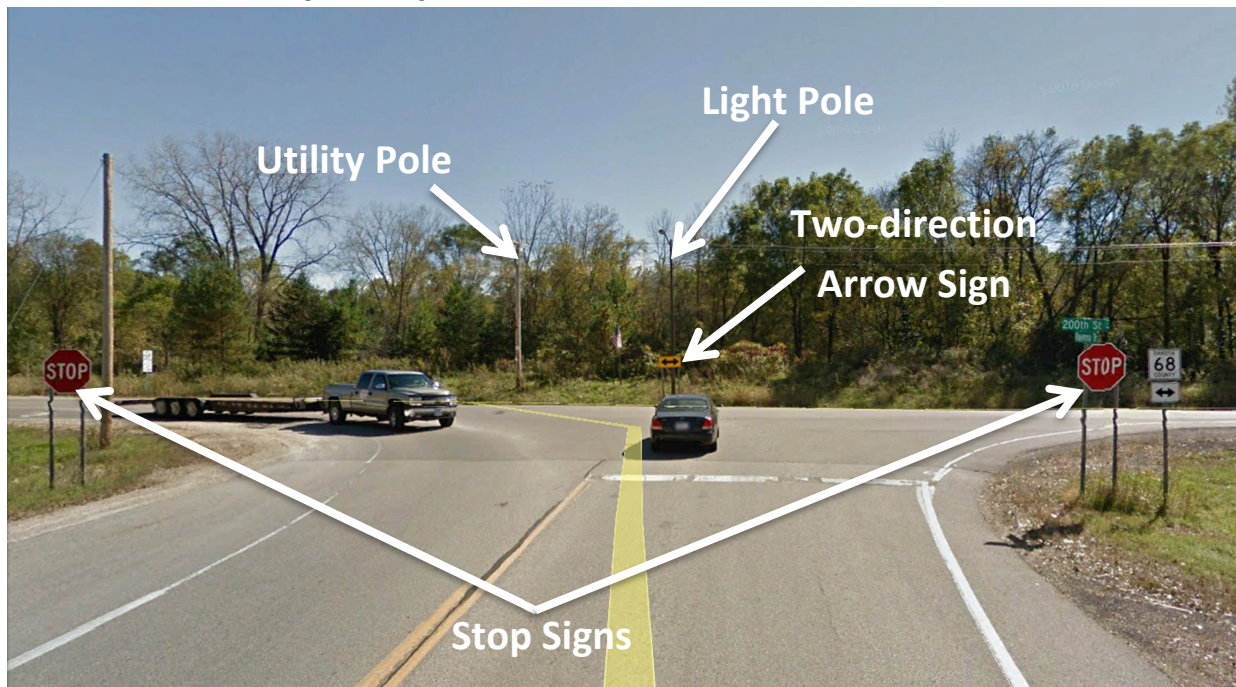
Traffic control at this intersection is a stop sign for CSAH 54. Area is rural with brush and trees along each quadrant of this intersection. At the intersection there are two stop signs (36"x36") on both sides of CSAH 54 and a two-direction large arrow sign (48"x24") at the T, as seen in Figure 3.

Figure 3. Google street view of intersection of CSAH 54 and CSAH 68, looking southeast.

1. Light pole relocation:
 - a. As previously mentioned and as Figure 3 of this report shows, there are several vertical features on the southeast side of CSAH 68 that vehicles failing to stop at the stop sign on CSAH 54 are colliding with. To address this issue it is recommended that the light pole is relocated: A street light was installed at this intersection as part of a rural intersection lighting project to increase intersection recognition to improve safety. The pole is directly across from the intersection.

- b. Based on the crash review, relocation of this light would be appropriate to address crashes. Relocate the street light -- The pole was installed by Dakota Electric for the County. County staff will contact the utility to relocate the pole.

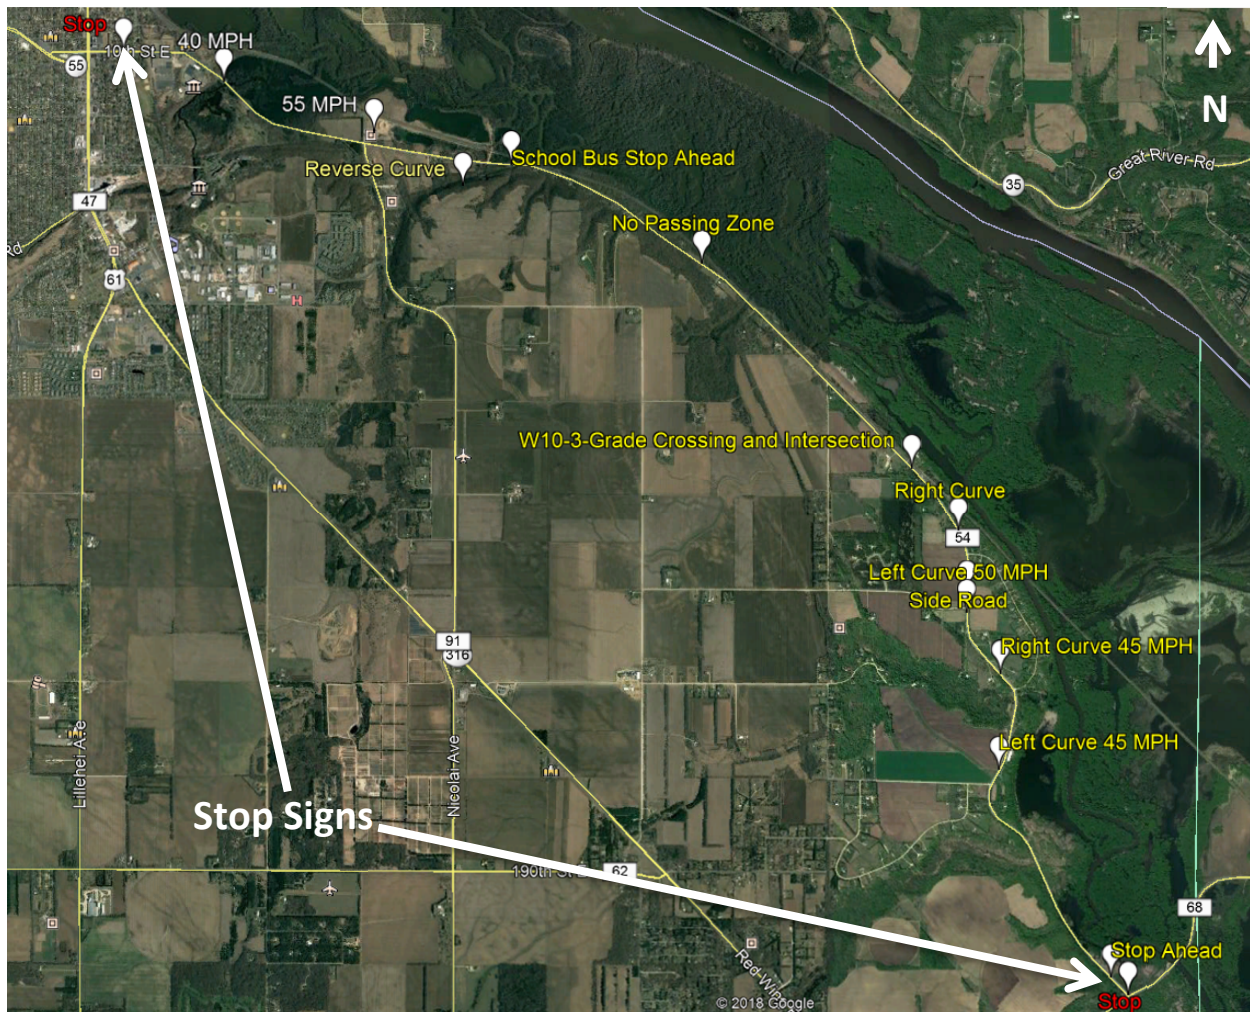
Figure 4 shows signage leading up to the intersection of 54 and 68. Note that the nearest previous stop sign is 8.25 miles prior, near downtown Hastings. This distance, as well as the numerous horizontal curves leading up to the stop sign, are possible contributing factors leading to drivers not stopping at the stop sign.

Figure 4. Google Earth aerial depicting signage for southeast-bound traffic along CSAH 54. The distance between both stop signs is 8.25 miles.

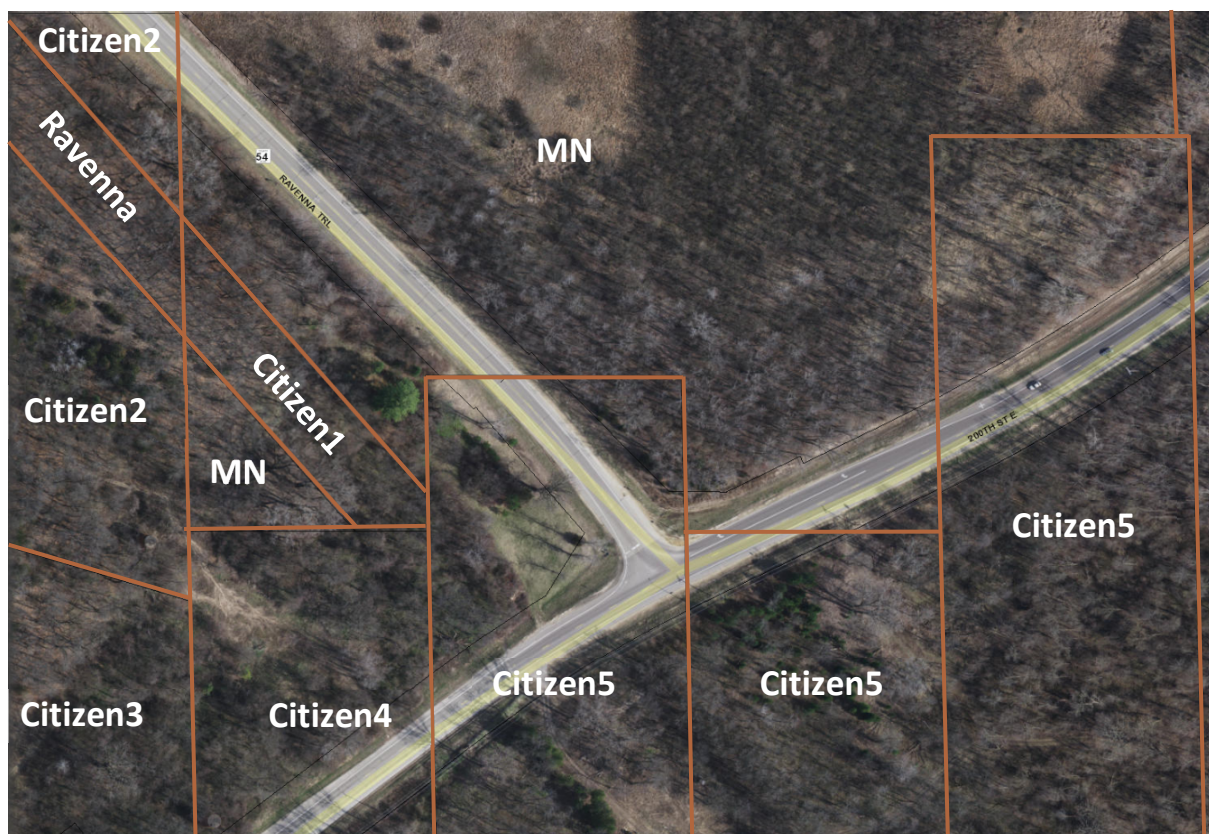
Figure 5. Tax Parcel information.

- c. Figure 5 above shows tax parcel information useful in seeing right of way distribution if tree and shrub removal are implemented.
3. Other considerations:
