LINEAR SOILS SURVEY AND RECOMMENDATIONS

Project NO. NH-4-052(104)141

HWY 52, RP 141.0 to 185.548

Near JCT 53 to Near Fessenden

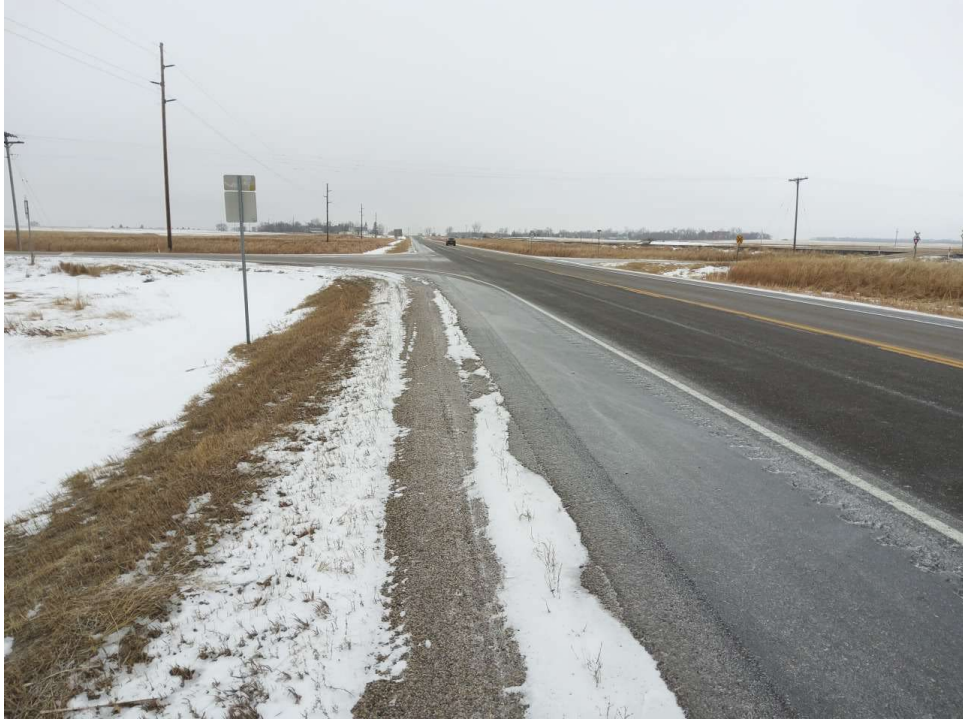
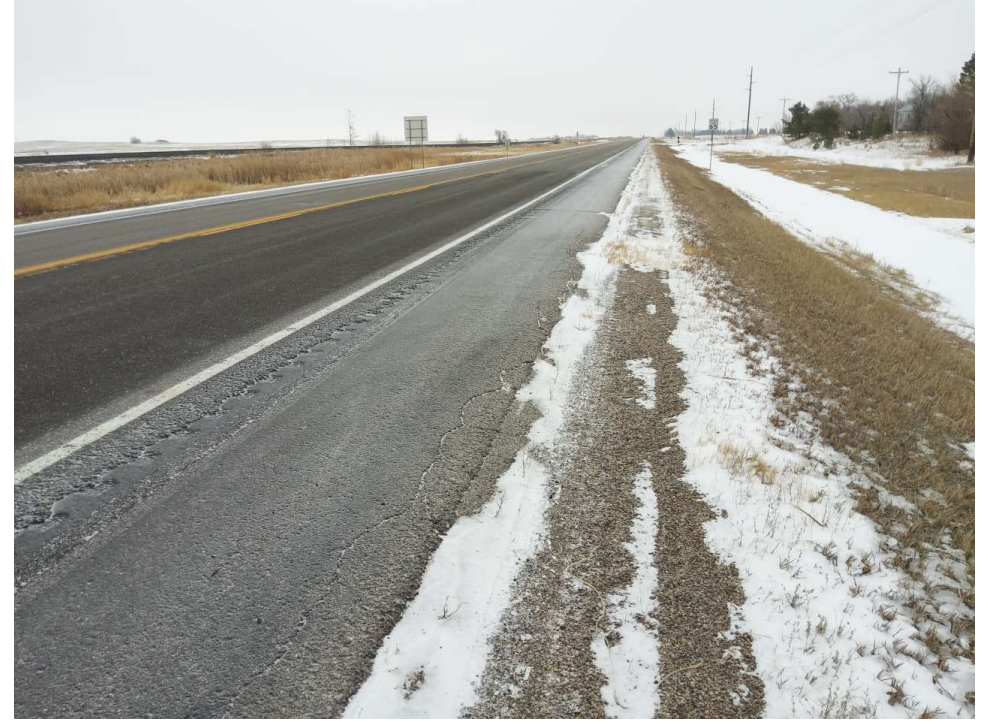
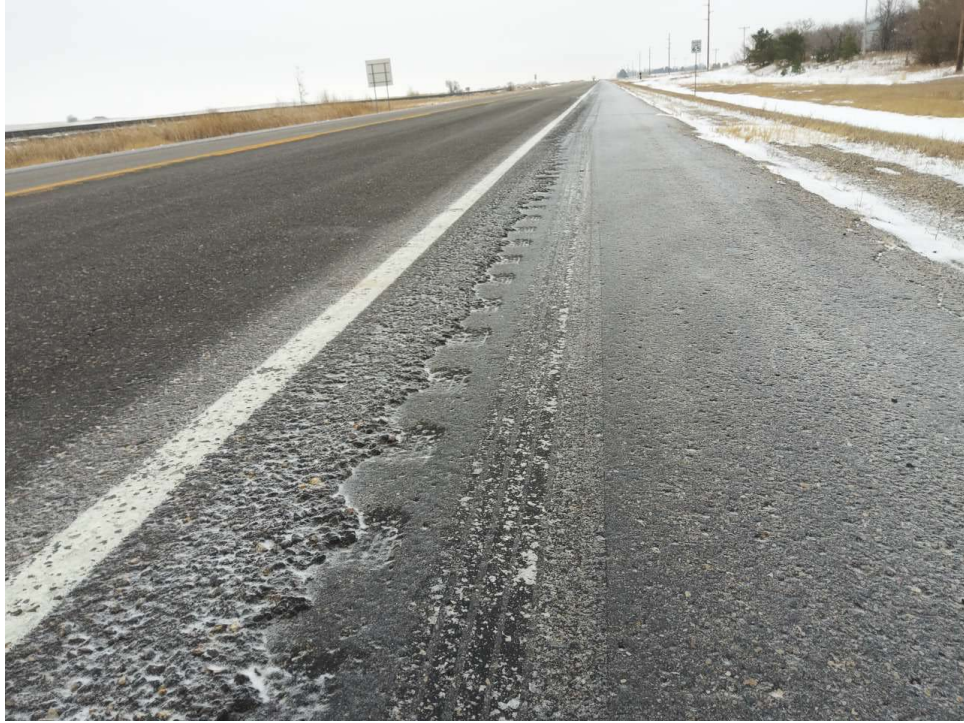
Identified Maintenance Area – 137+1540 to 137+4224: The soils within the identified maintenance area are sandy lean clays. There is not a change in soil type, geology or water content that would indicate that the subgrade is causing the roadway distress at this location. The scoping report calls out this location as a protentional subcut. However, the condition of the subgrade does not indicate that it is causing the issue at this maintenance area. Therefore, it is recommended to conduct a pavement repair section from RP+feet 137+1490 to 137+4275. See table 4 for pavement repair sections.

1
137+4224

2
137+4224

3
137+4224

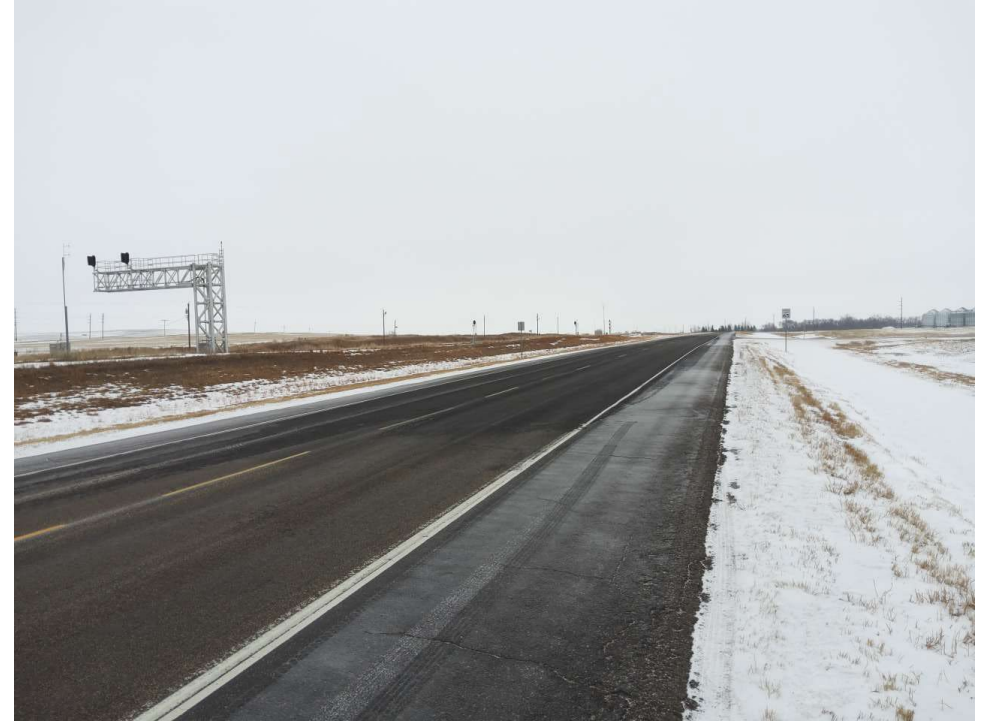
4
145+0866 to 145+1344

Identified Maintenance Area – 145+0866 to 145+1344: The soils within the identified maintenance area are clayey sand. There is not a change in soil type, geology or water content that would indicate that the subgrade is causing the roadway distress at this location. No subgrade mitigation is recommended.

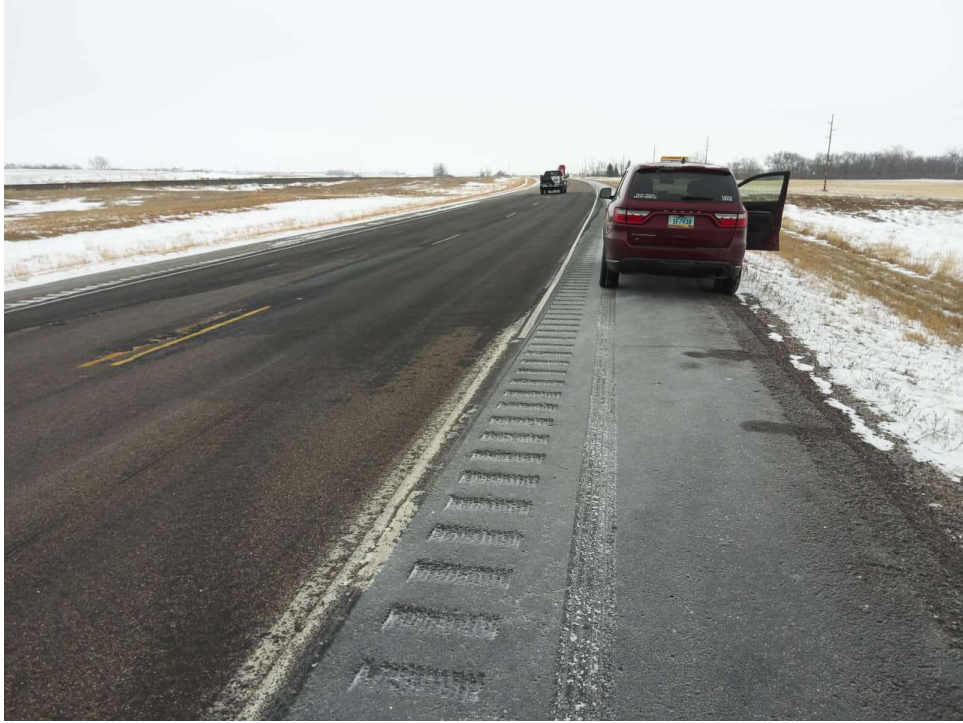
5
145+2640

Identified Maintenance Area – 145+2440 to 145+2840: The soils within the identified maintenance area are clayey sand. There is not a change in soil type, geology or water content that would indicate that the subgrade is causing the roadway distress at this location. The scoping report calls out this location as a protentional subcut. However, the condition of the subgrade does not indicate that it is causing the issue at this maintenance area. Therefore, it is recommended to conduct a pavement repair section from RP+feet 145+2390 to 145+2890. See table 4 for pavement repair sections.

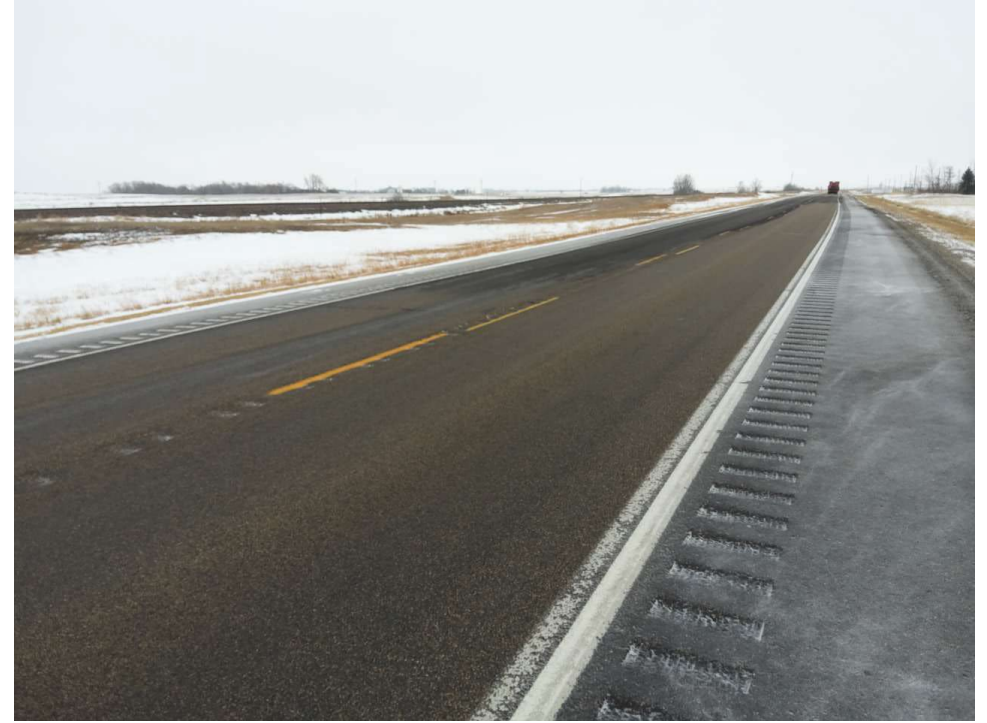
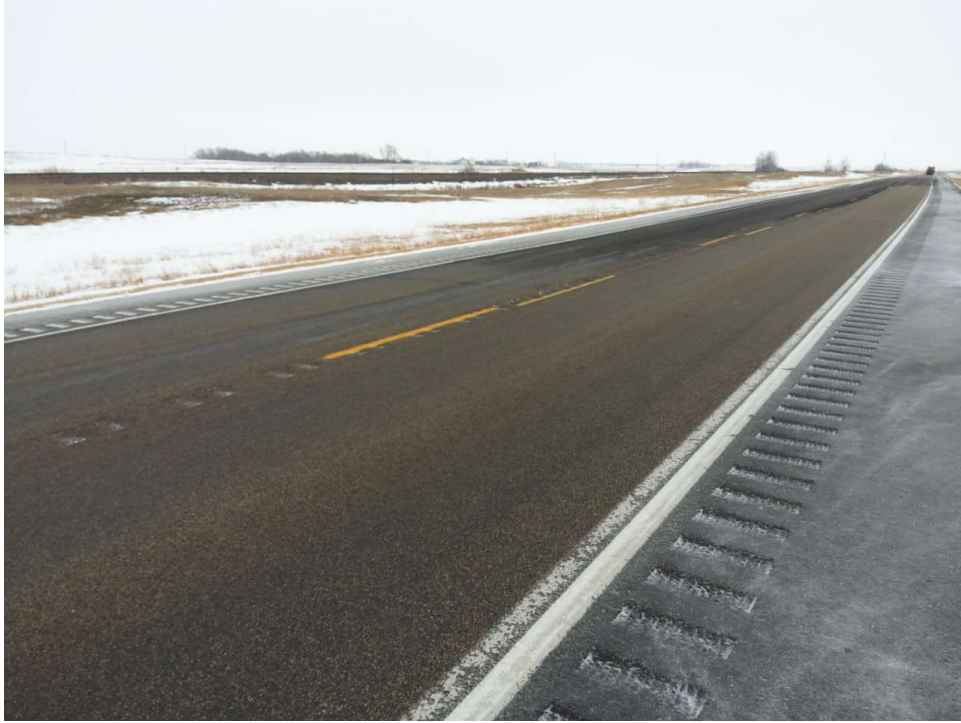
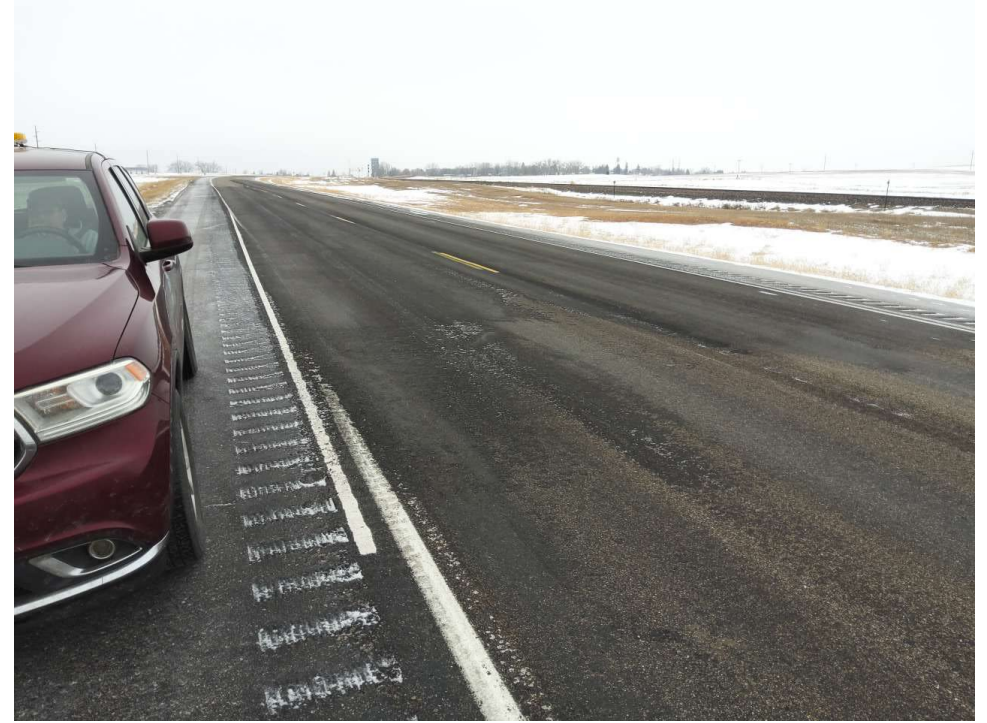
Identified Maintenance Area – 145+3101 to 145+3696: The soils within the identified maintenance area are sandy lean clays. There is not a change in soil type, geology or water content that would indicate that the subgrade is causing the roadway distress at this location. The scoping report calls out this location as a protentional subcut. However, the condition of the subgrade does not indicate that it is causing the issue at this maintenance area. Therefore, it is recommended to conduct a pavement repair section from RP+feet 145+3050 to 145+3750. See table 4 for pavement repair sections.

6
145+3101 to 145+3696

145+3101 to 145+3696

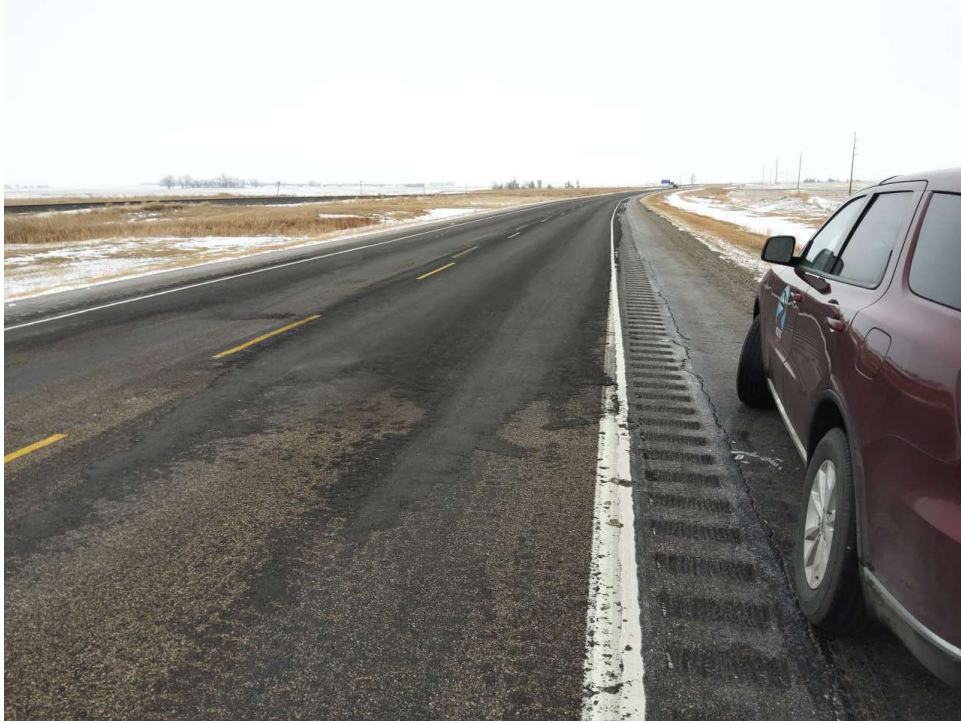
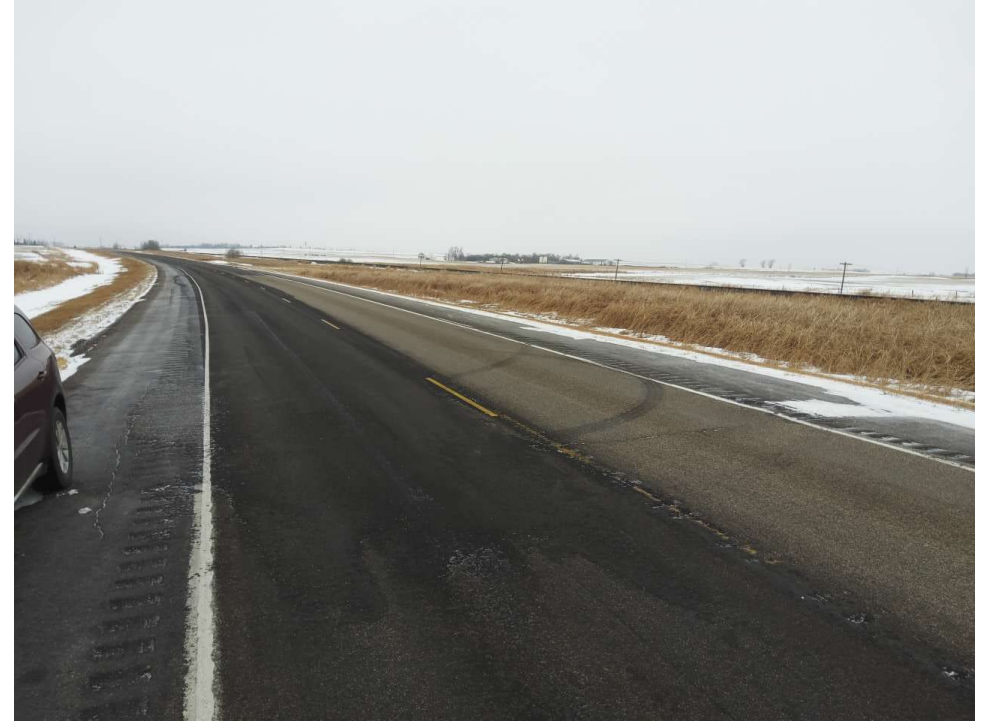
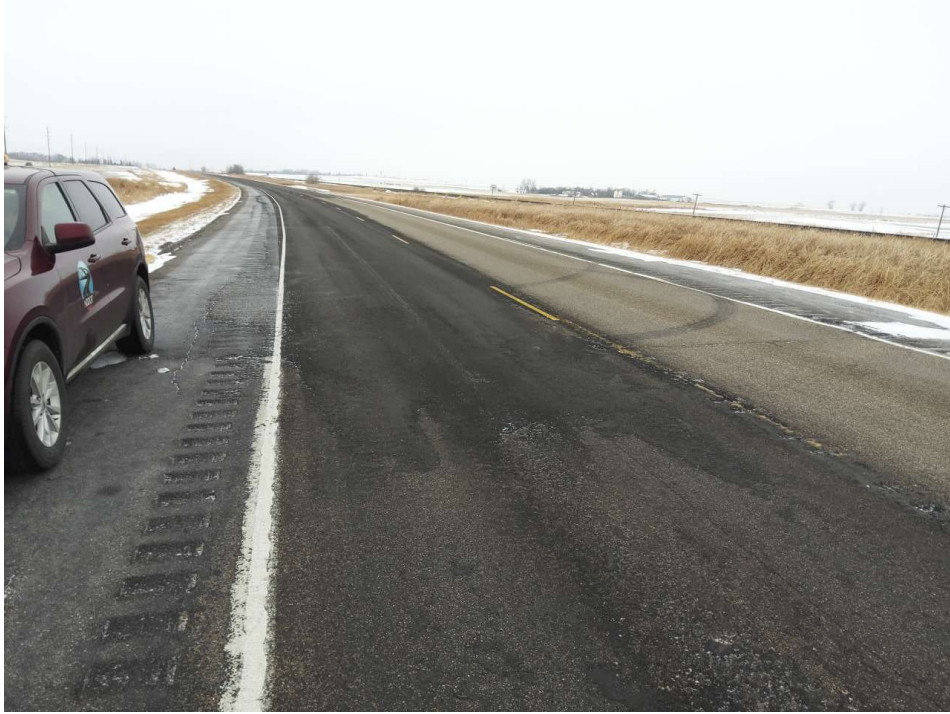
Identified Maintenance Area – 146+2218 to 146+3432: The soils within the identified maintenance area are sandy lean clays. There is not a change in soil type, geology or water content that would indicate that the subgrade is causing the roadway distress at this location. No subgrade mitigation is recommended.

9
146+2218 to 146+3432

10
146+2218 to 146+3432

11
146+2218 to 146+3432

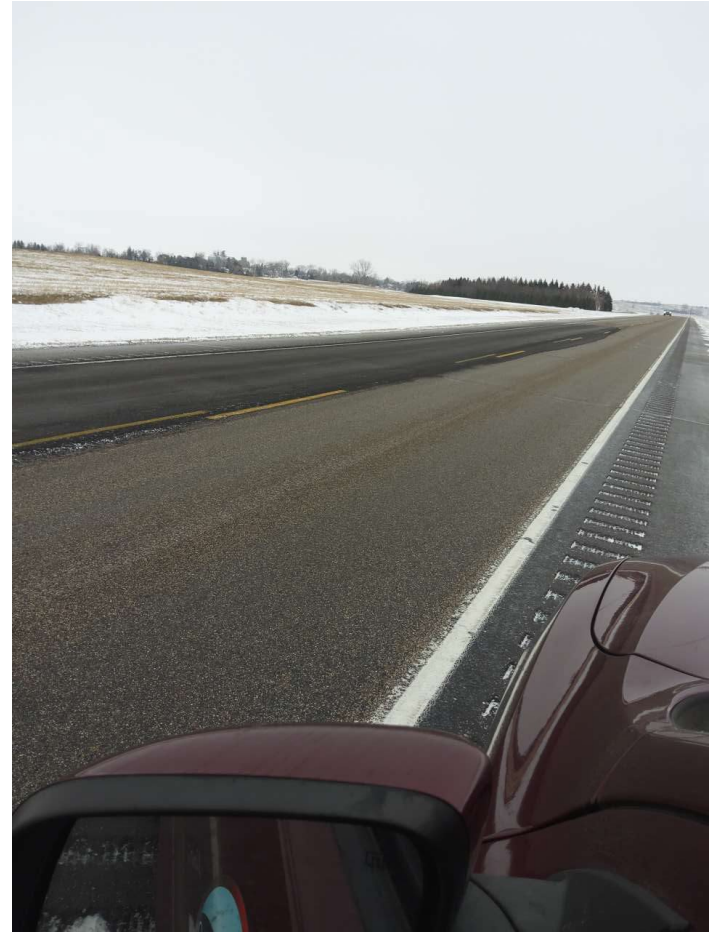
12
150+4382 to 150+4594

Identified Maintenance Area – 150+4382 to 150+4594: The soils within the identified maintenance area are sandy lean clay. There is not a change in soil type, geology or water content that would indicate that the subgrade is causing the roadway distress at this location. No subgrade mitigation is recommended.

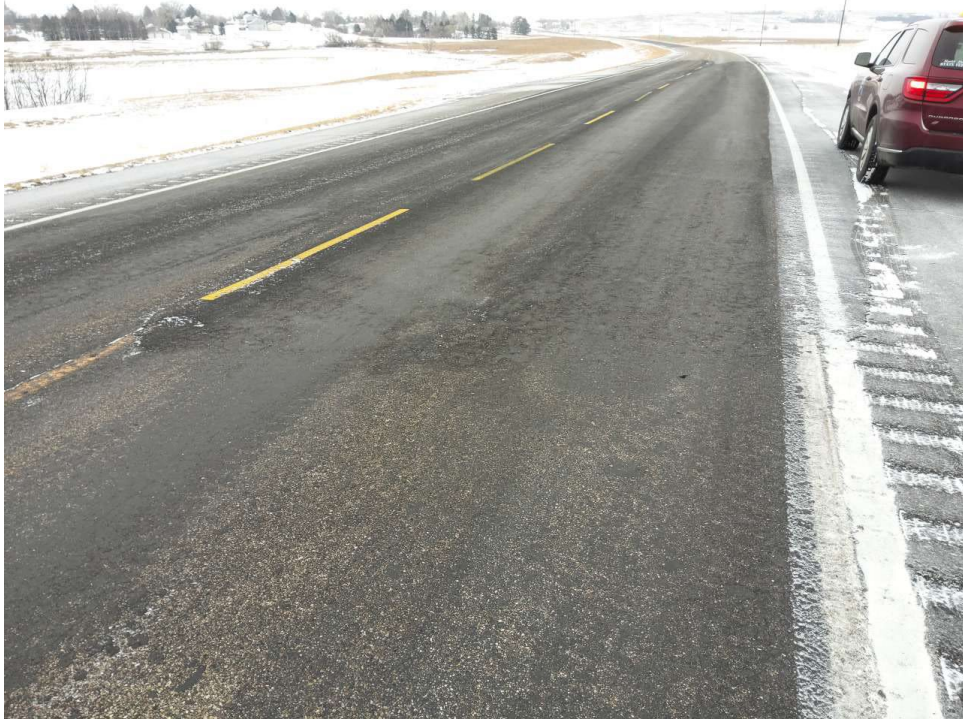
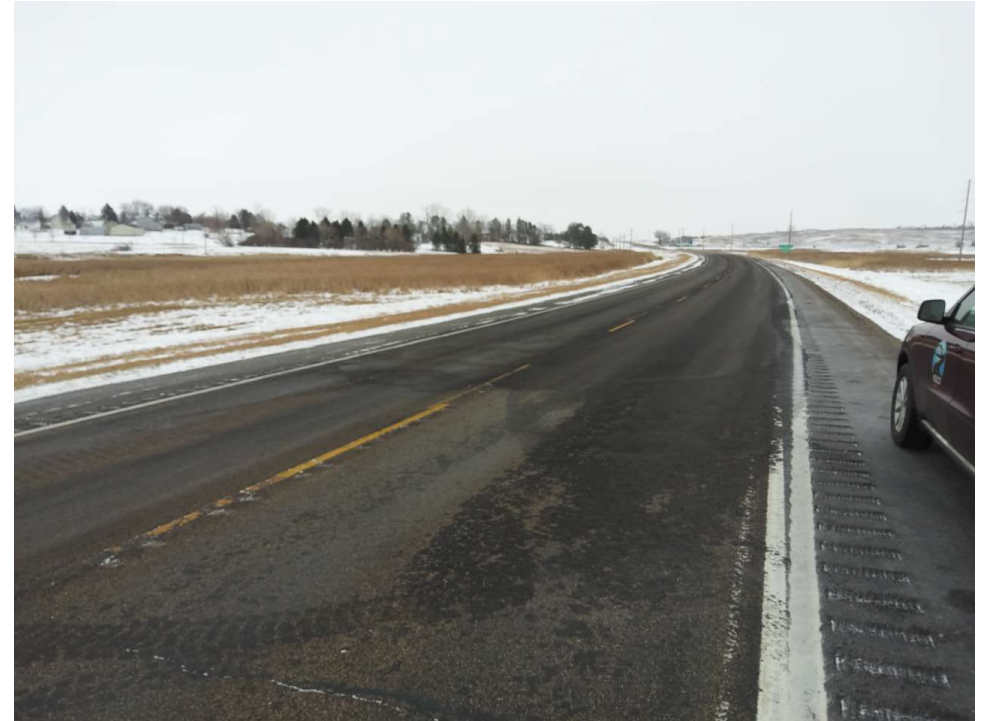
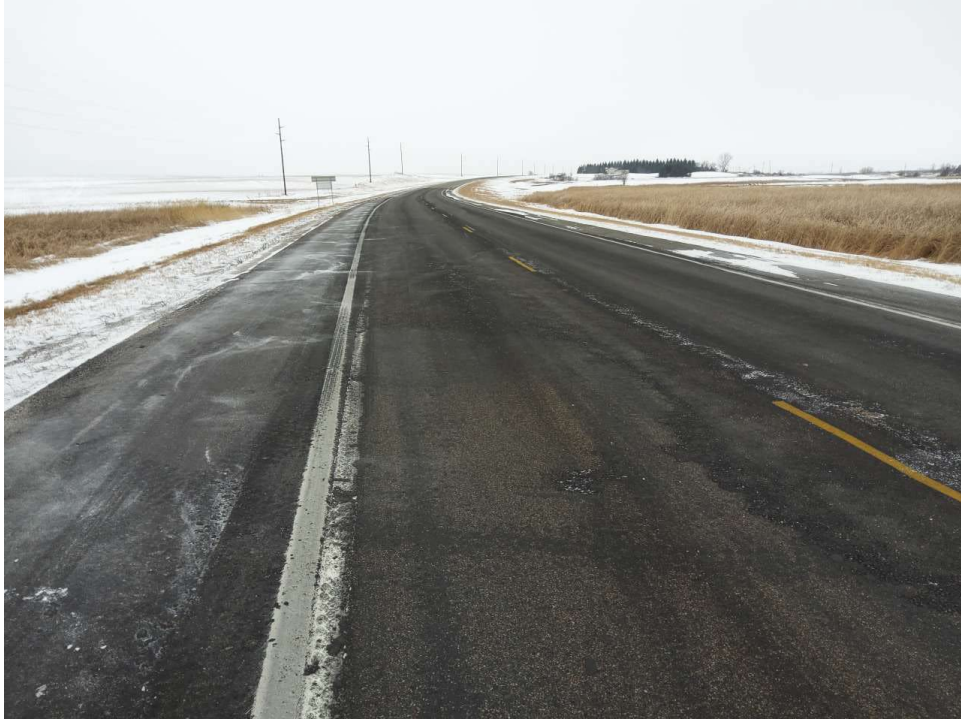
Identified Maintenance Area – 151+1278 to 151+3034: The soils within the identified maintenance area are silt/clayey sand. There is not a change in soil type, geology or water content that would indicate that the subgrade is causing the roadway distress at this location. No subgrade mitigation is recommended.

13
151+1278 to 151+3034

14
151+1278 to 151+3034

15
151+1278 to 151+3034

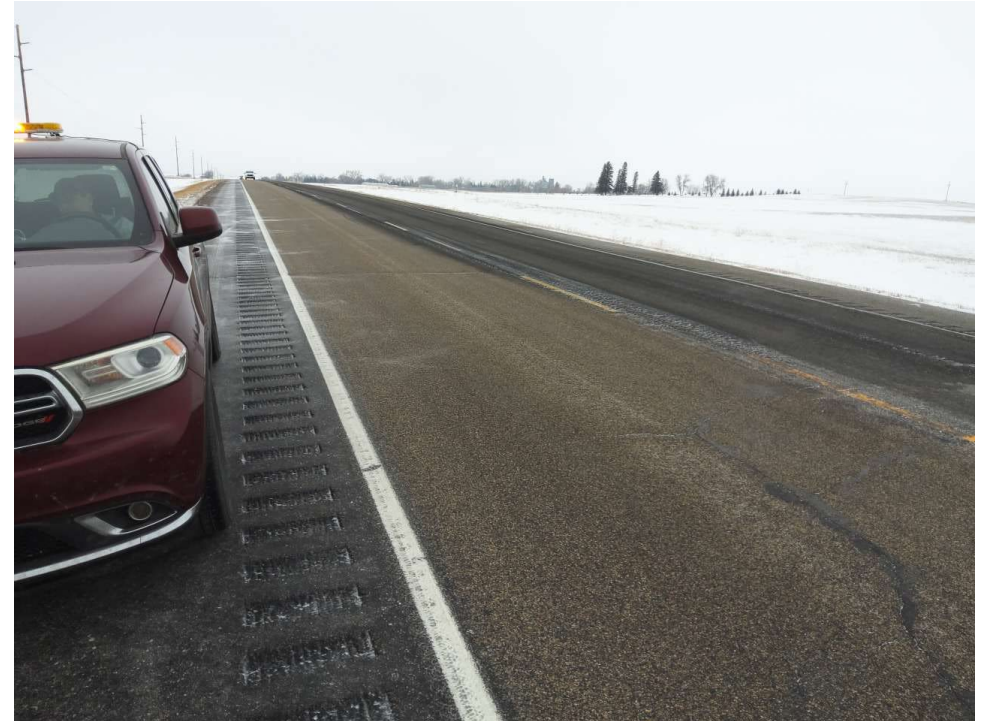
16
152+3464 to 152+4118

Identified Maintenance Area – 152+3464 to 152+4118: The soils within the identified maintenance area are clayey sand. There is not a change in soil type, geology or water content that would indicate that the subgrade is causing the roadway distress at this location. No subgrade mitigation is recommended.

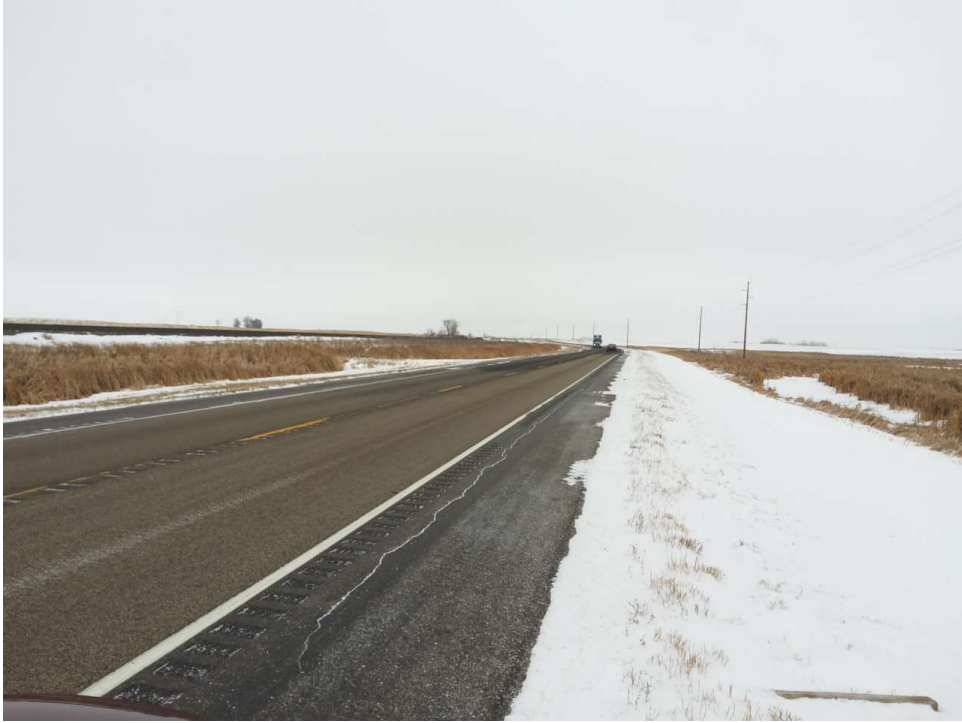
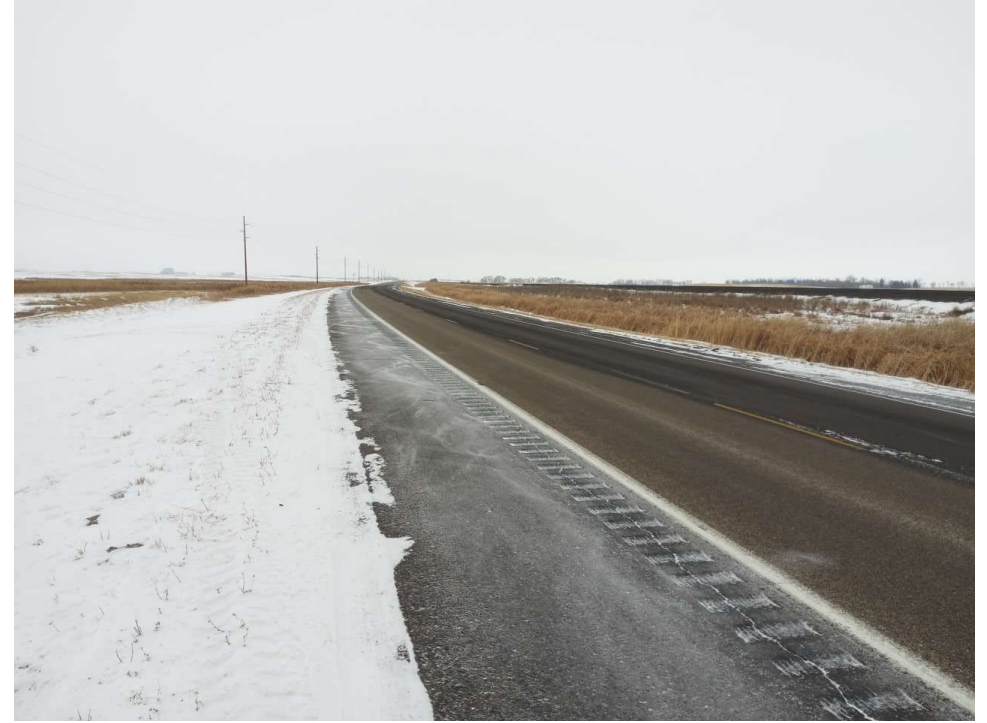
Identified Maintenance Area – 156+3062 to 156+4066: The soils within the identified maintenance area are silty, clayey sand. There is not a change in soil type, geology or water content that would indicate that the subgrade is causing the roadway distress at this location. The scoping report calls out this location as a protentional subcut. However, the condition of the subgrade does not indicate that it is causing the issue at this maintenance area. Therefore, it is recommended to conduct a pavement repair section from RP+feet 156+3010 to 156+4120. See table 4 for pavement repair sections.

17
156+3062 to 156+4066

18
156+3062 to 156+4066

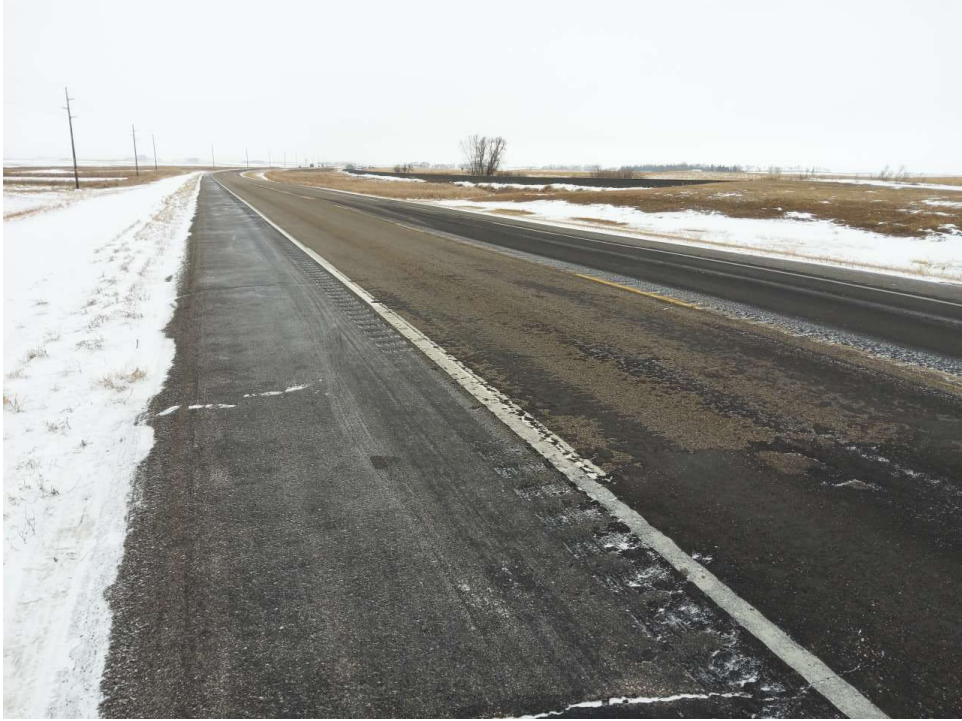
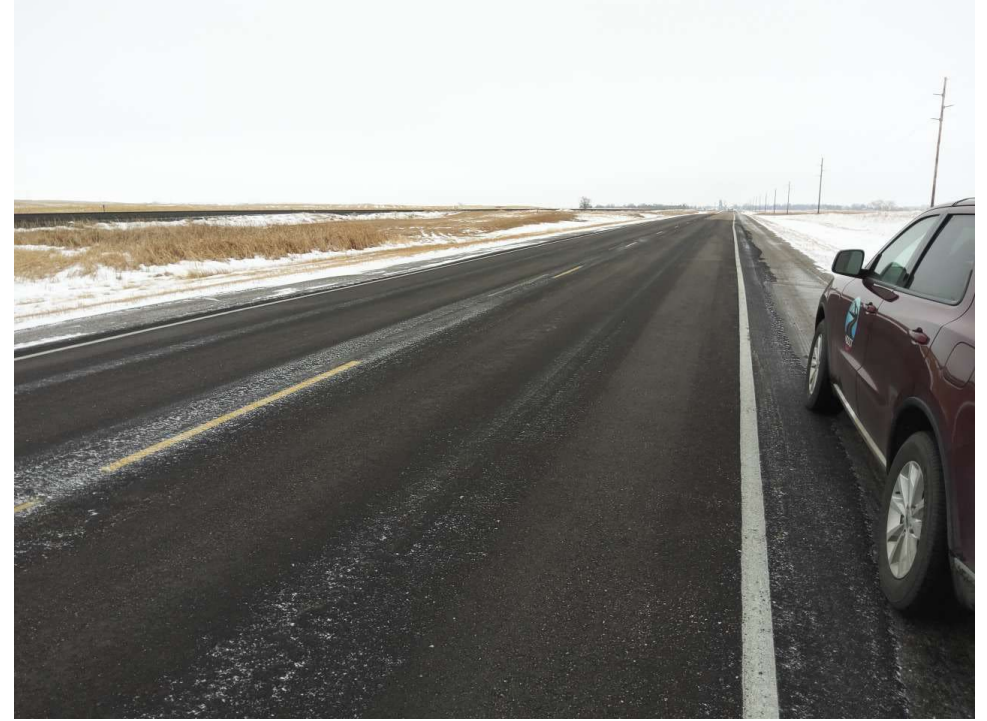
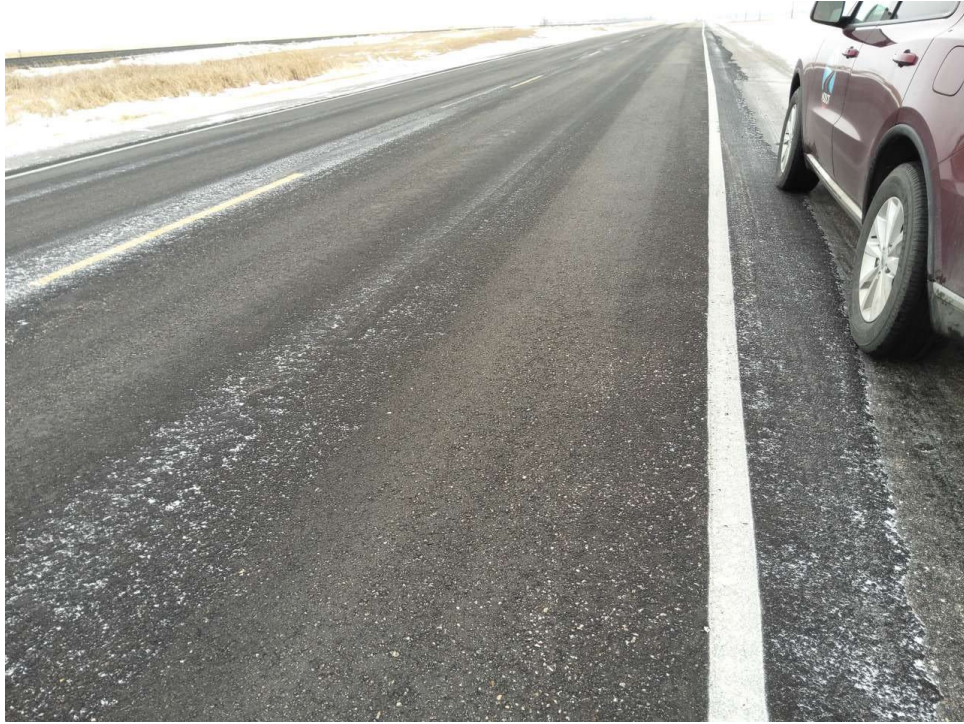
Identified Maintenance Area – 157+0000 to 157+0589: The soils within the identified maintenance area are sandy lean clay. This maintenance area occurs in a cut/fill transition which likely correlates to the change in soil type and the substandard performance of the pavement through this area. Based on the change in soil type it is recommended to perform a subcut from RP+feet 156+5180 to 157+0700 at a depth of 36". See table 3 for subcut specifications.

19
157+0000 to 157+0589

20
157+0000 to 157+0589

21
157+0000 to 157+0589

Location RP + Feet	Length	Depth
156+5180 to 157+0700	800'	36"
157+1800 to 157+2110	310'	36"

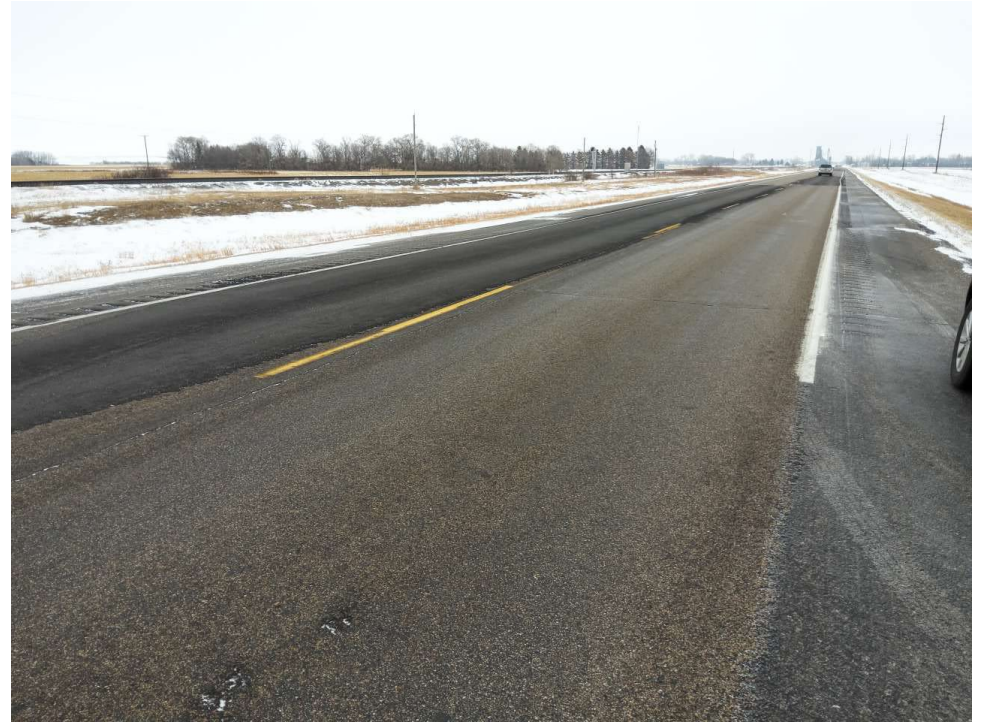
22
157+2990 to 157+3901

Identified Maintenance Area – 157+2990 to 157+3901: The soils within the identified maintenance area are clayey sand. There is not a change in soil type, geology or water content that would indicate that the subgrade is causing the roadway distress at this location. No subgrade mitigation is recommended.

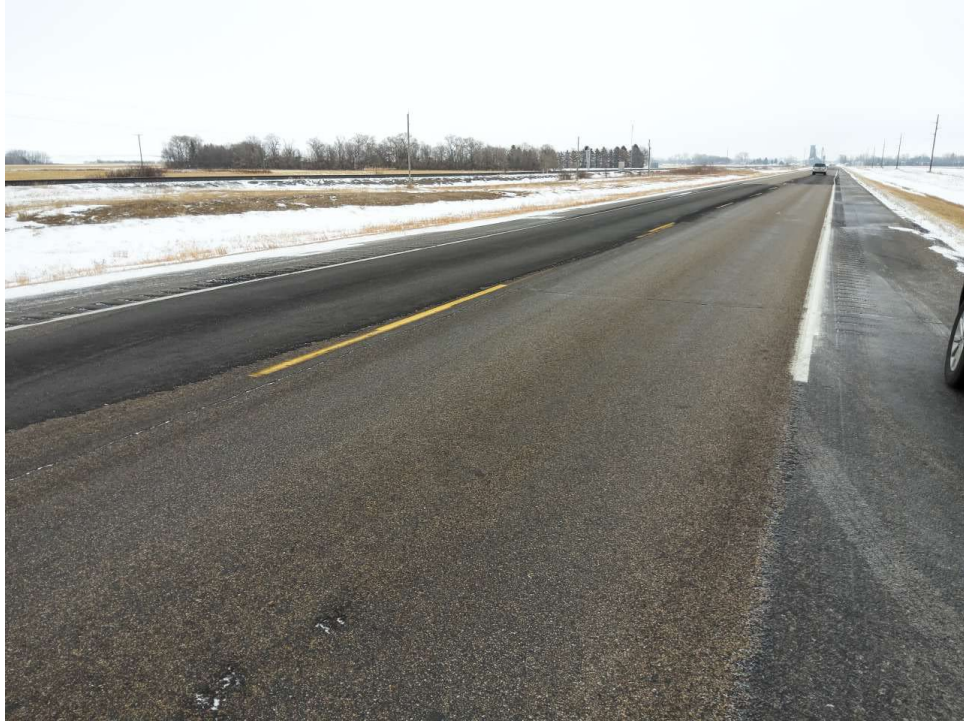
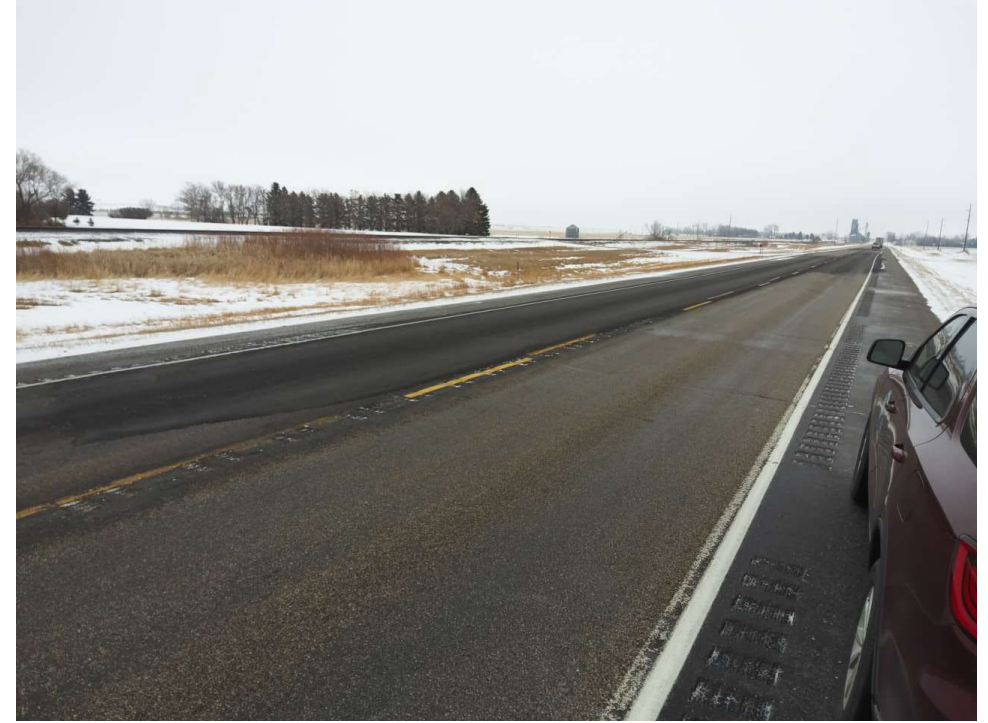
Identified Maintenance Area – 157+3960 to 157+4382: The soils within the identified maintenance area are sandy lean clay. There is not a change in soil type, geology or water content that would indicate that the subgrade is causing the roadway distress at this location. No subgrade mitigation is recommended.

23
157+3960 to 157+4382

24
157+3960 to 157+4382

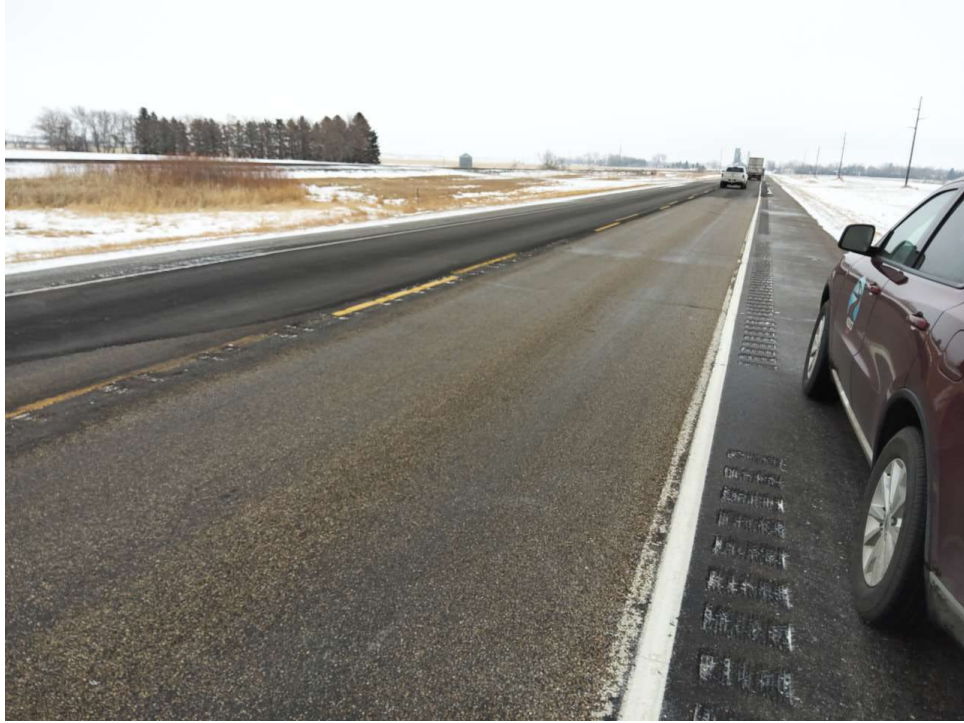
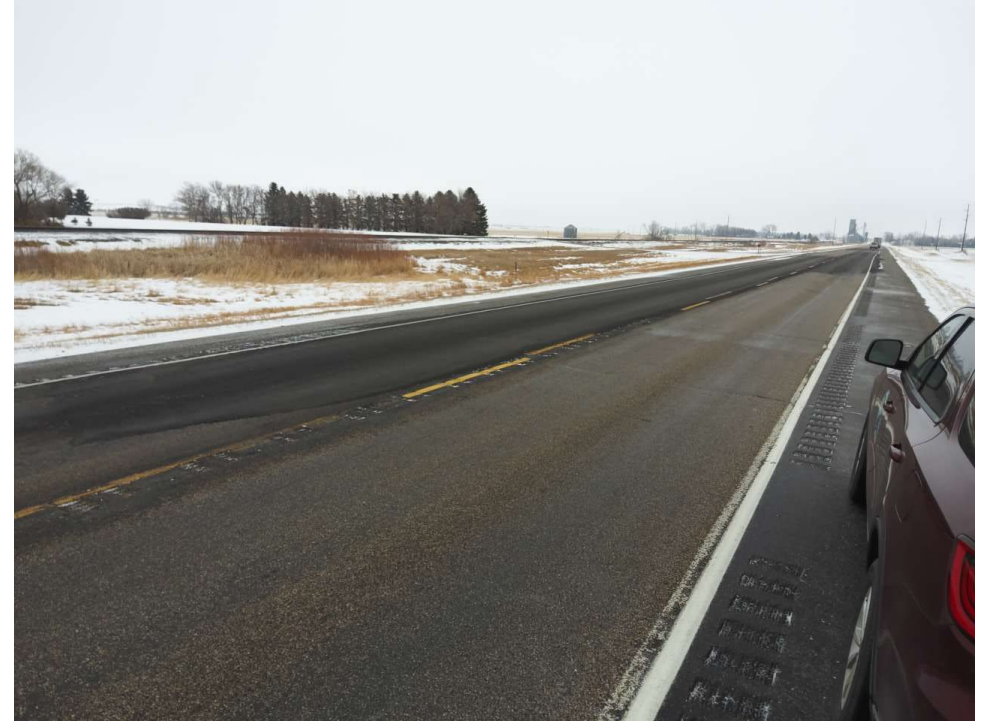
Identified Maintenance Area – 157+4699 to 157+5544: The soils within the identified maintenance area are sandy lean clay. There is not a change in soil type, geology or water content that would indicate that the subgrade is causing the roadway distress at this location. No subgrade mitigation is recommended.

25
157+4699 to 157+ 1.05

26
157+4699 to 157+ 1.05

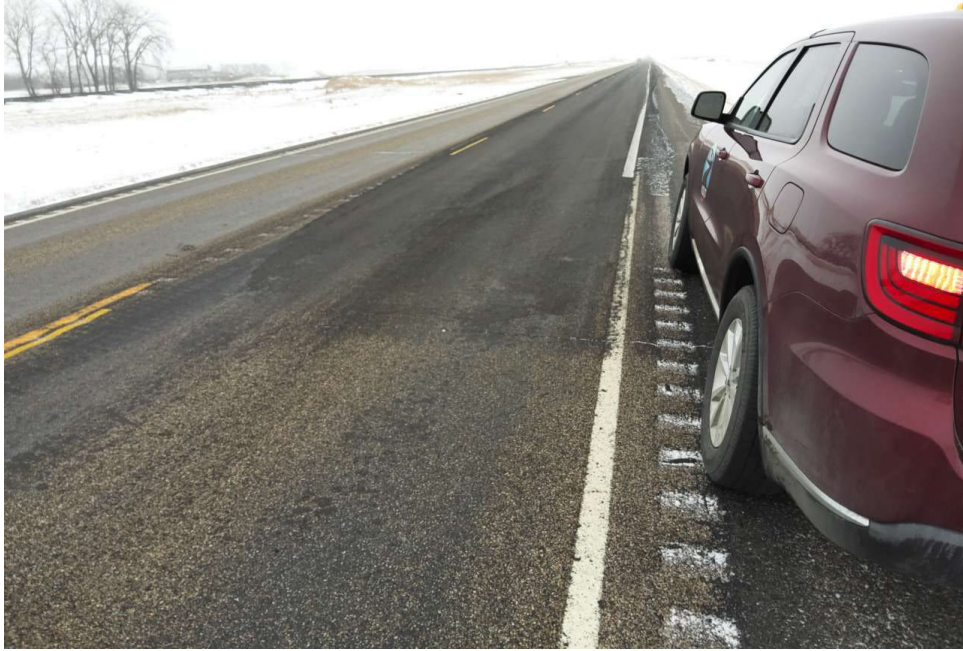
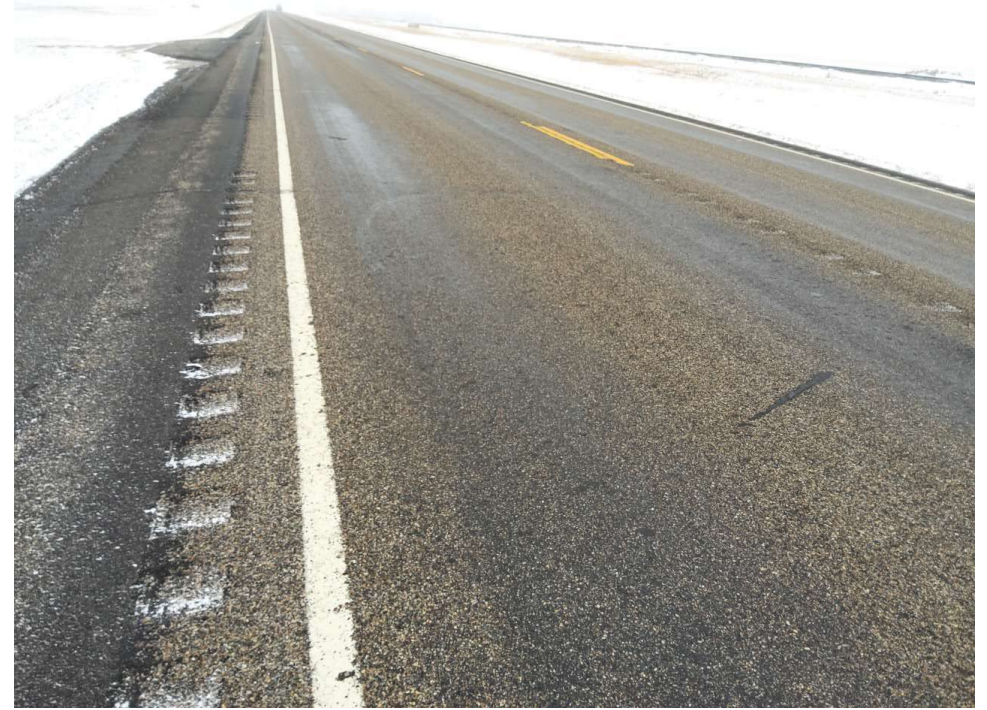
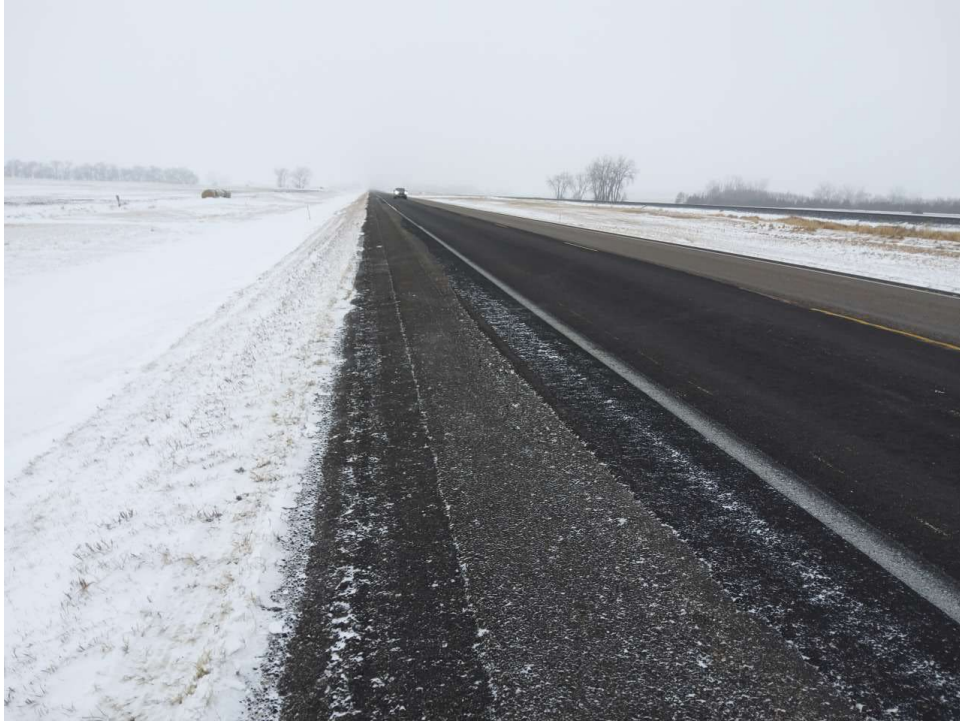
Identified Maintenance Area – 180+0845 to 180+2534: The soils within the identified maintenance area are clayey sand. There is not a change in soil type, geology or water content that would indicate that the subgrade is causing the roadway distress at this location. The scoping report calls out this location as a protentional subcut. However, the condition of the subgrade does not indicate that it is causing the issue at this maintenance area. Therefore, it is recommended to conduct a pavement repair section from RP+feet 180+0800 to 180+2580. See table 4 for pavement repair sections.

27
180+0845 to 180+2534

28
180+0845 to 180+2534

29
180+0845 to 180+2534
