LINEAR SOILS SURVEY AND RECOMMENDATIONS

Project NO. NH-4-052(104)141

HWY 52, RP 141.0 to 185.548

Near JCT 53 to Near Fessenden

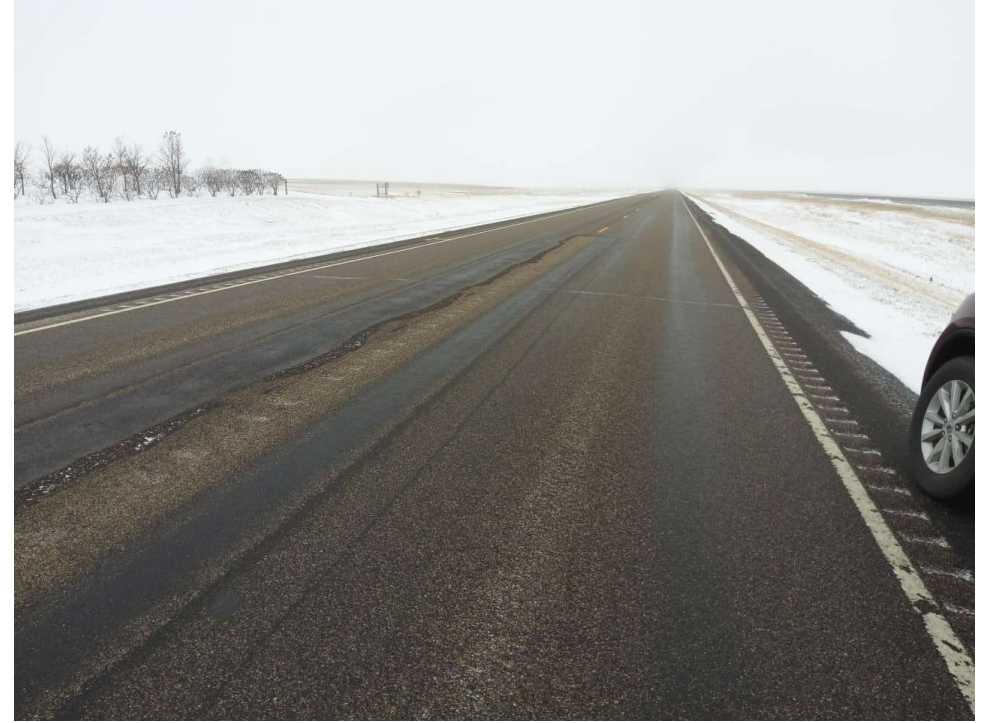
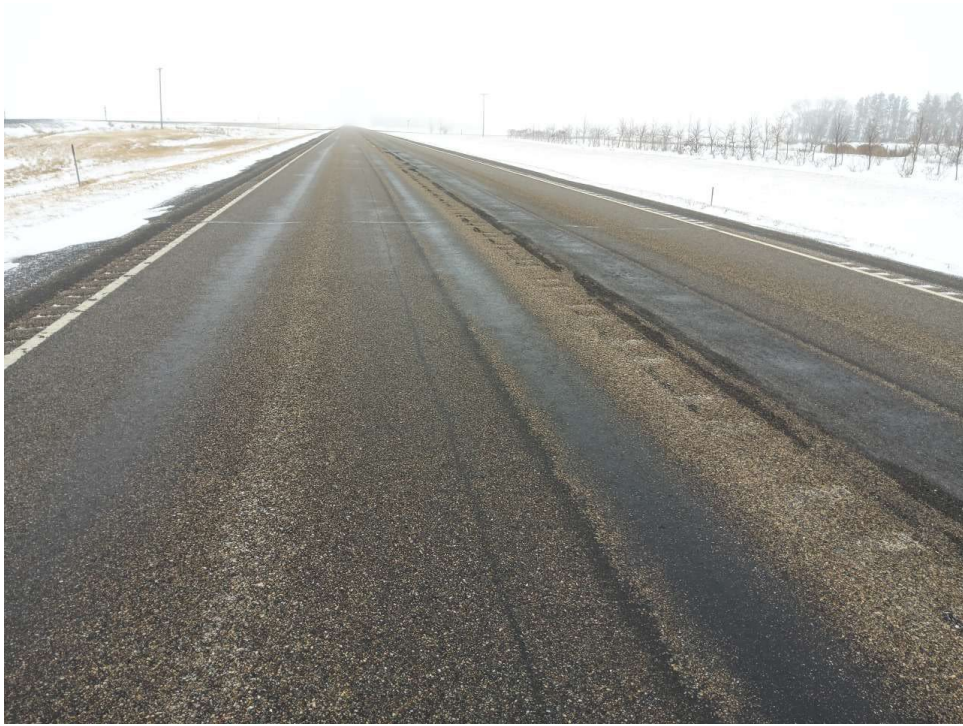
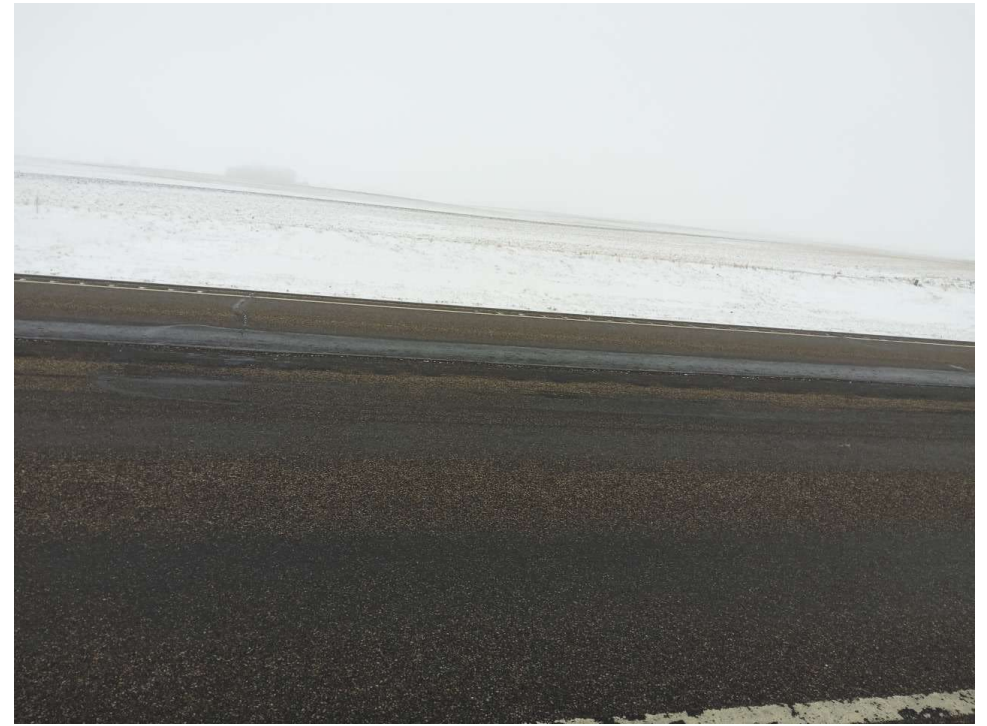
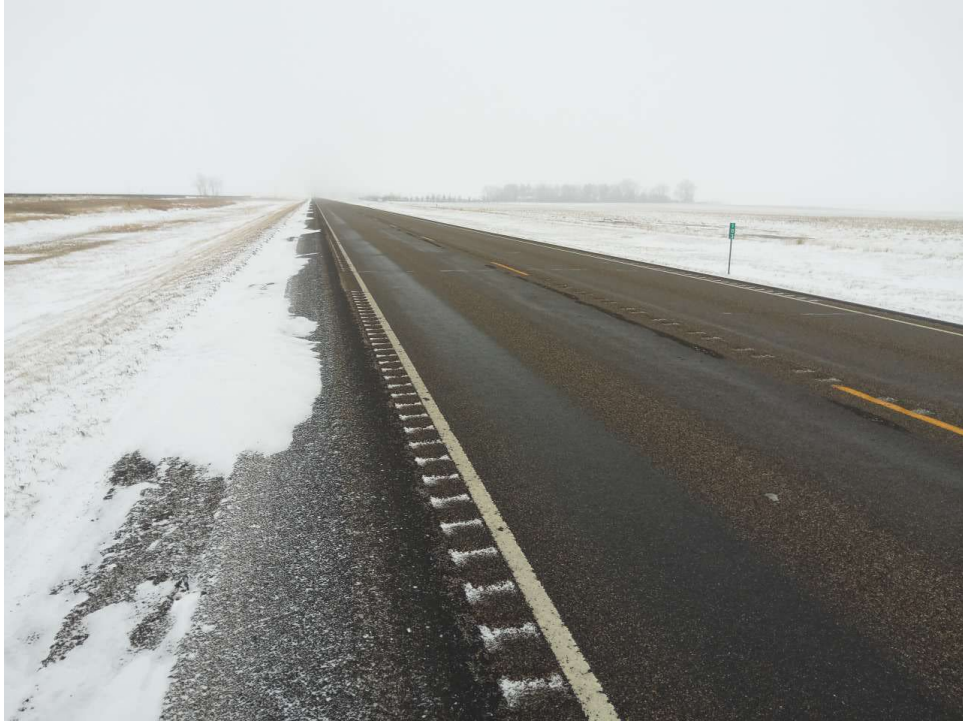
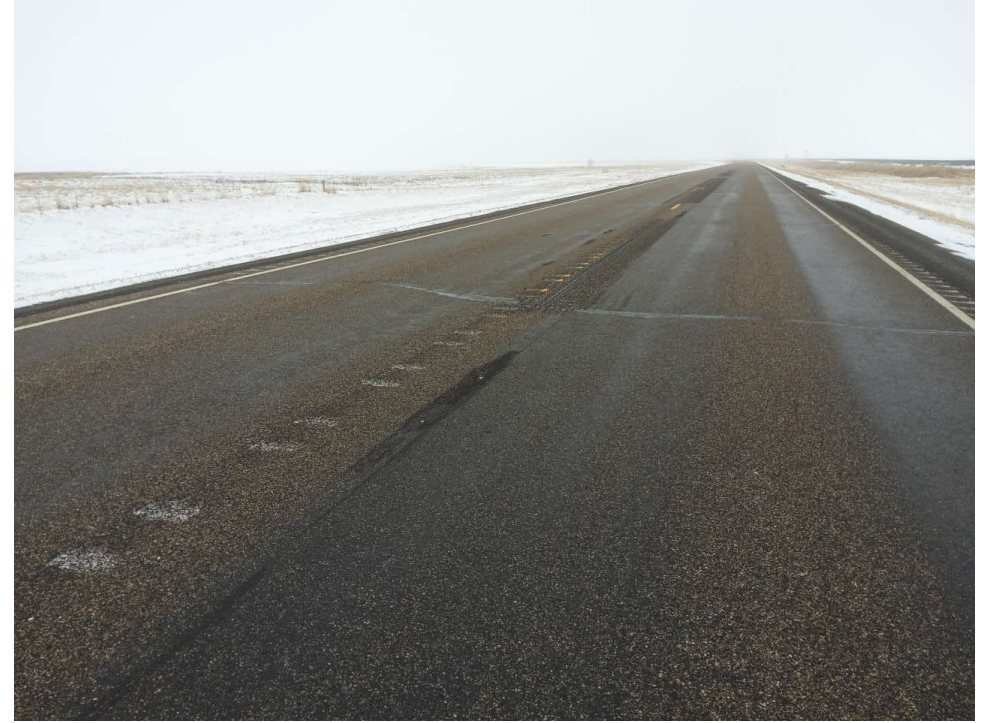
Identified Maintenance Area – 182+4858 to 183+1320: The soils within the identified maintenance area are sandy lean clay. There is not a change in soil type, geology or water content that would indicate that the subgrade is causing the roadway distress at this location. The scoping report calls out this location as a protentional subcut. However, the condition of the subgrade does not indicate that it is causing the issue at this maintenance area. Therefore, it is recommended to conduct a pavement repair section from RP+feet 182+4800 to 183+1370. See table 4 for pavement repair sections.

Location	Pavement Distress	Description	Maintenance Comment	Picture Number	Drilling Required
182+4858 to 183+1320	Bituminous Patch	Rutting lanes likely pushing up in center. Center of lane possibly ground down from snowplow blade	Scoping report calls out a subcut at this location	30-34	Yes
145+0565 to 167+4224	Rutting	Whole project varying in depth.		NA	No
145+0565 to 167+4224	Transv. Cracks	Scattered throughout project.		NA	No

30
182+4858 to 183+1320

31
182+4858 to 183+1320

32
182+4858 to 183+1320

33
182+4858 to 183+1320

34
182+4858 to 183+1320
