# Standing Rock Sioux Tribe

## Pavement Management Plan

*May 2017*

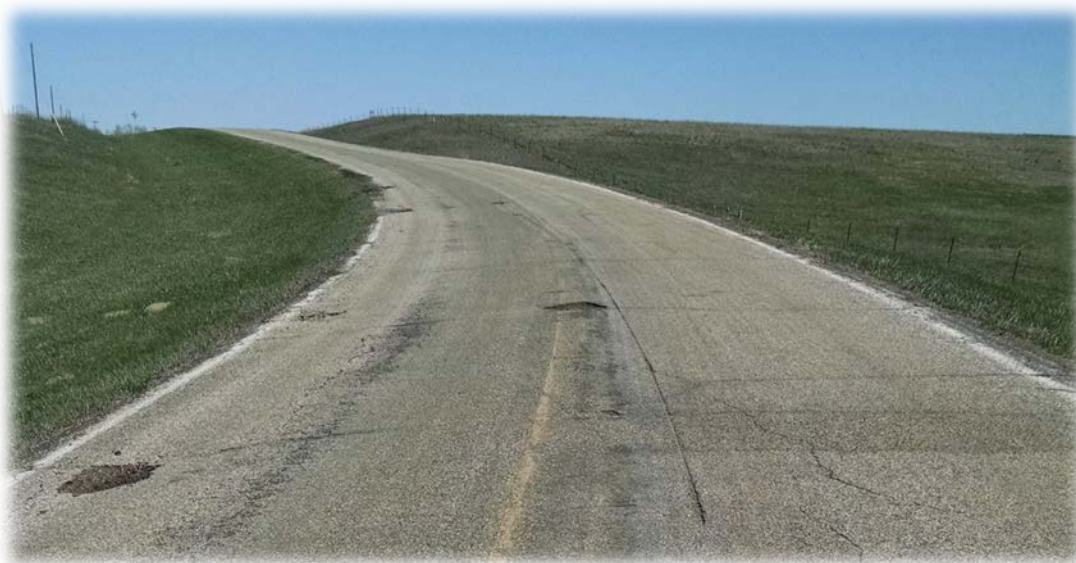
*Photo of Pavement Condition on a Standing Rock Reservation Road*

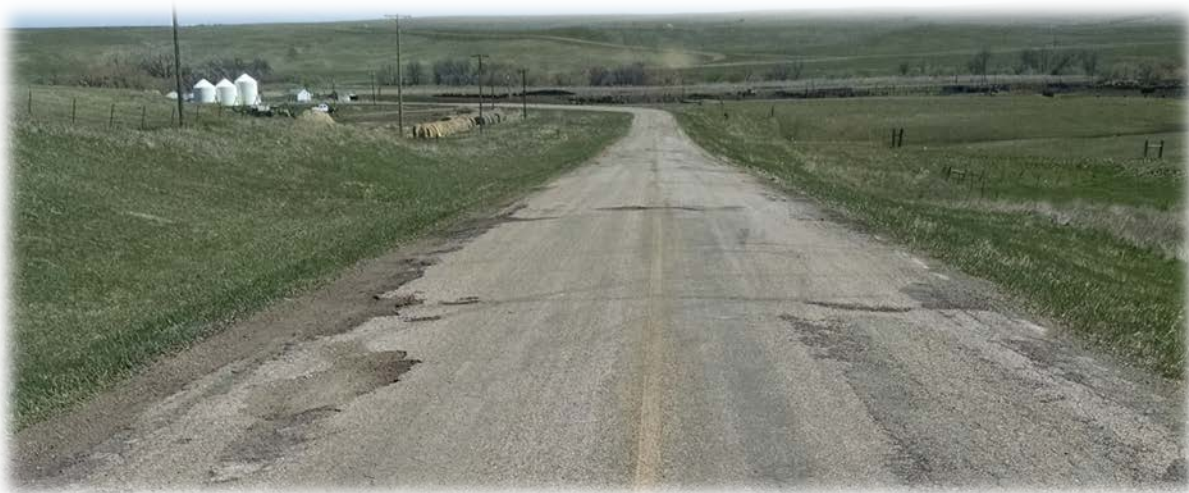
Very poor. Severe cracking and rutting with moderate visible potholes. Heavy patching with some patches on old patches. Limited striping. Shoulders are deteriorated. Areas are marked with flags. You cannot drive this road at the posted speed limit. Drivers need to slow down. Example: BIA Route 44, two miles south of Mahto, SD.

*Photo of a PASER Rating 3 Road on the Standing Rock Reservation*

Patching and repair will need to be done prior to a major structural overlay (greater than 2"). Milling and removing deteriorated areas will extend the life of the overlay. The Tribe has expressed interest in reverting one particular area that was given a PASER Rating of 3, BIA 44 near Mahto, back to a gravel road.

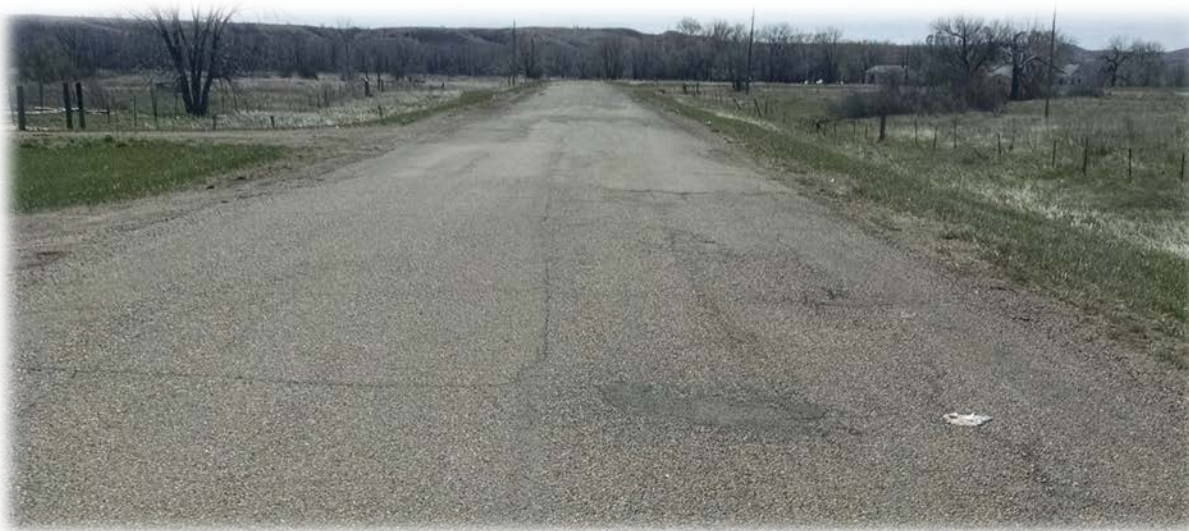
Poor. Heavy cracking and rutting with moderate visible potholes. Heavy patching with some patches on old patches. Limited striping. Shoulders are deteriorated. Cracks are not sealed. You cannot drive this entire road at the posted speed limit. Drivers need to slow down in areas. Example: BIA Route 3400, south from Little Eagle, SD.

*Photo of a PASER Rating 4 Road on the Standing Rock Reservation*

Due to significant signs of aging, a structural overlay is required (greater than 2").

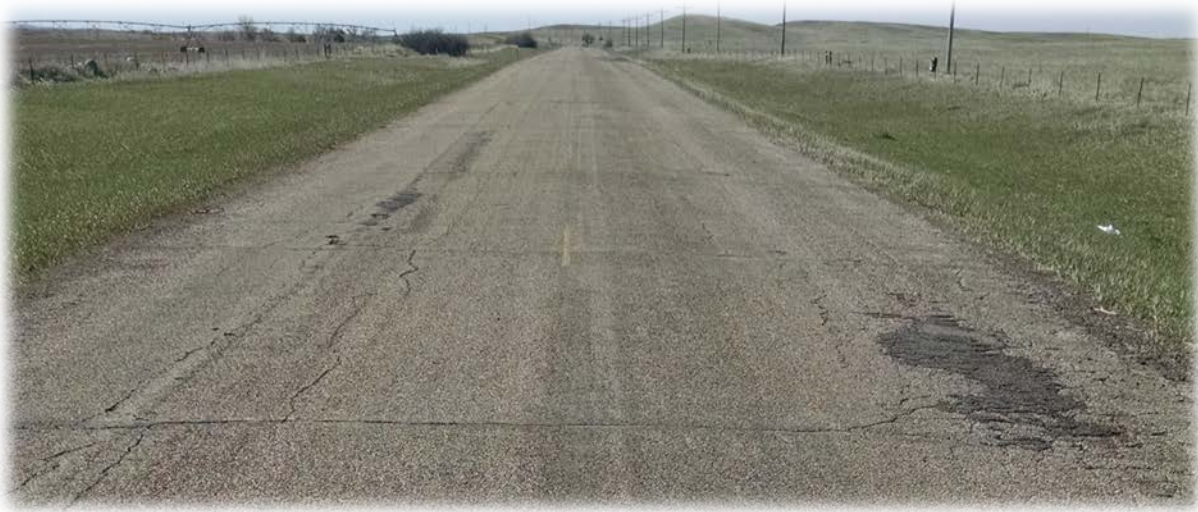
Fair. Moderate to heavy cracking with moderate rutting. Moderate patching with some patches on old patches. Limited striping. Cracks are mostly not sealed. You can still drive this road at the posted speed limit. Example: BIA Route 1, south of Cannon Ball, ND.

*Photo of a PASER Rating 5 Road on the Standing Rock Reservation*

Primarily consists of aging asphalt, but with sound structural conditions. The roadway can benefit from patching where necessary, followed by a non-structural overlay (less than 2”).

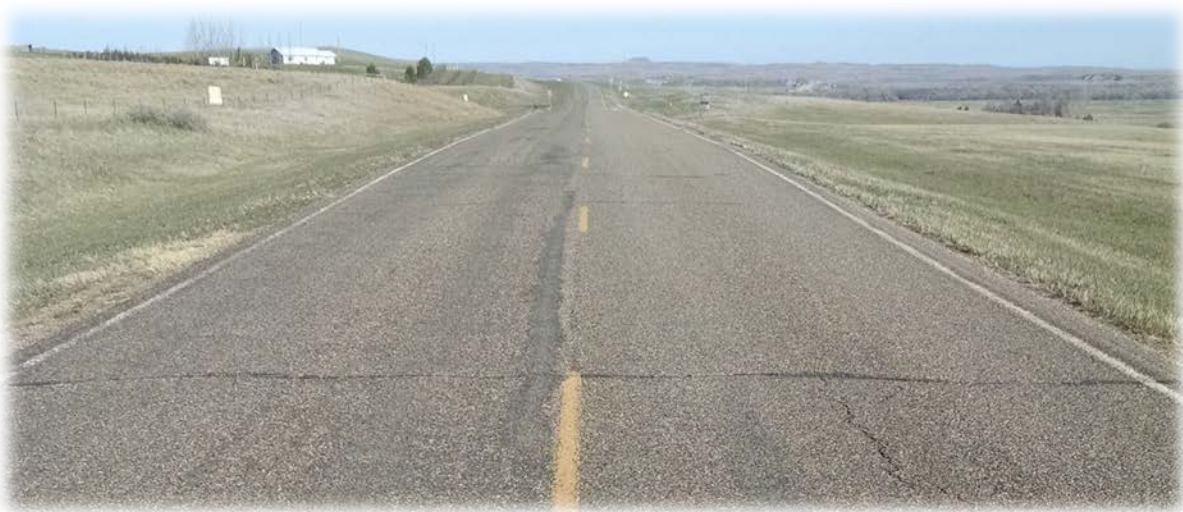
Fair. Moderate to heavy cracking or some raveling and rutting exists. Moderate polishing with occasional patches visible. Cracks are mostly sealed. Example: BIA Route 7 near Porcupine, ND.

*Photo of a PASER Rating 6 Road on the Standing Rock Reservation*

Light signs of aging. The roadway life can be extended with routine crack sealing and a sealcoat.

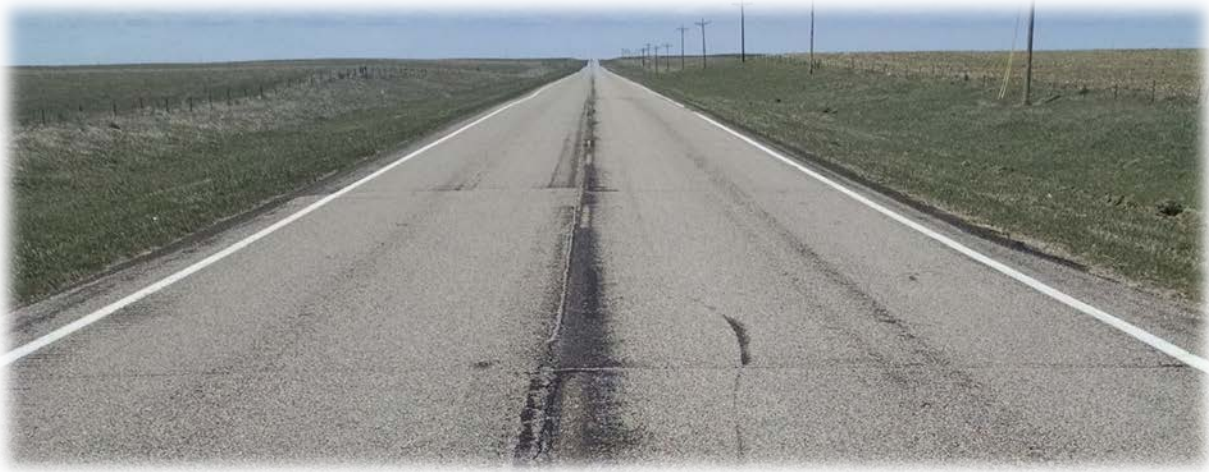
Good. Some cracking, no raveling and little rutting. No patches are visible. Cracks are sealed. This roadway is not in need of immediate repair. Example: BIA Route 20, near Bullhead, SD.

*Photo of a PASER Rating 7 Road on the Standing Rock Reservation*

Roadway shows very few signs of aging and can be maintained with routine crack filling.

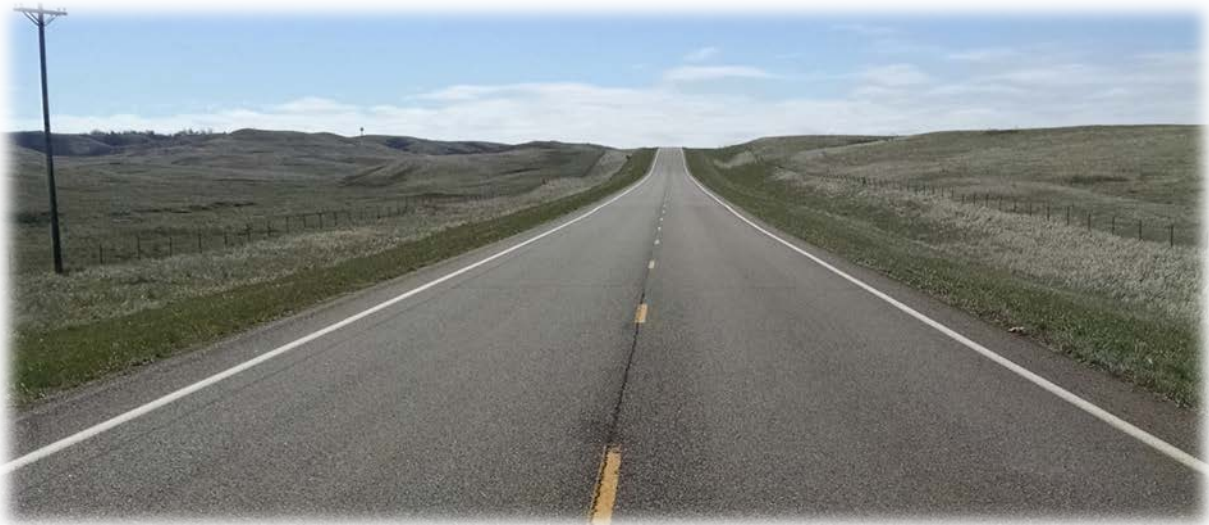
Great. No cracking, raveling or rutting present. No patches or sealed cracks are visible. This roadway is not in need of repair. Example: BIA Route 3, near Kenel, SD.

*Photo of a PASER Rating 8 Road on the Standing Rock Reservation*

No immediate maintenance is required on these roadways. In the future, routine crack filling and maintenance should be performed to continue to extend the life of the roadway.

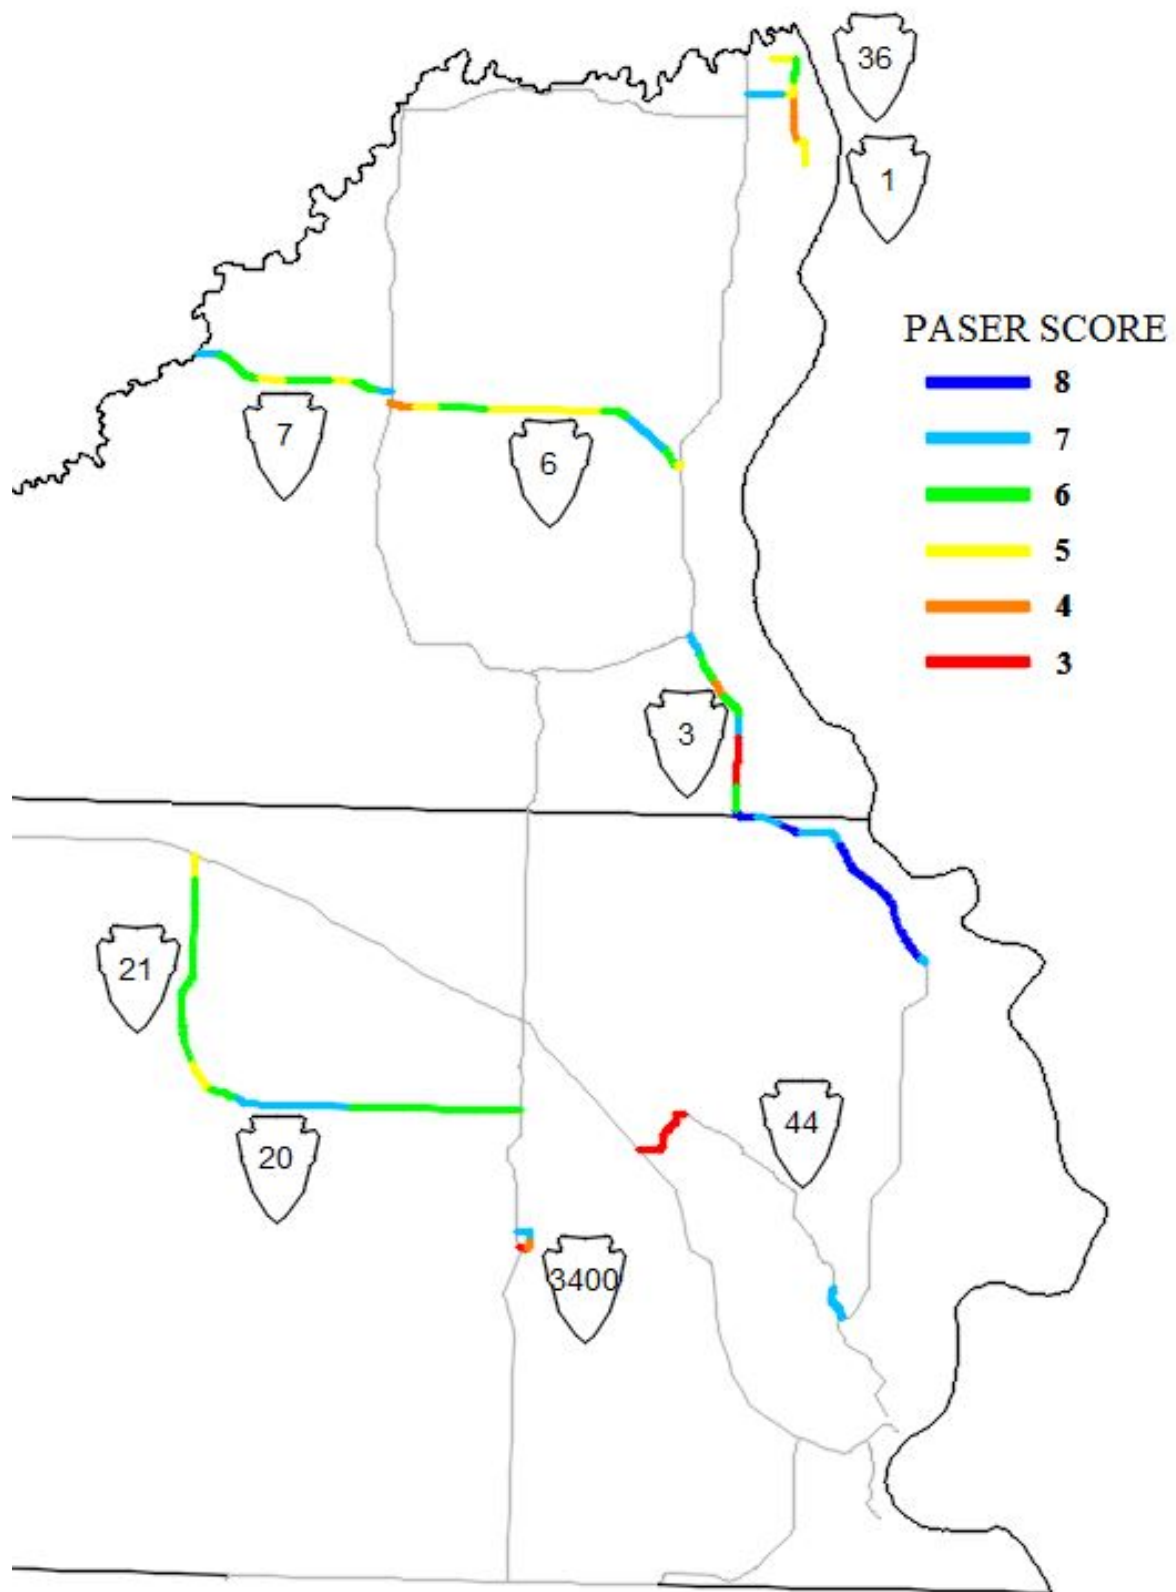
Figure 3 – Existing Pavement Conditions (2017)

Every one-mile segment of highway was given a PASER score and the results were mapped. Figure 3 is a map that displays the PASER ratings in a color coded system. Blue being the highest values or best conditions going down through the rainbow with red and black being the lowest values or worst conditions found in the study area. Figure 3 is also attached as an 11"x17" as Exhibit 3 at the end of this report.

Approximately 83 miles of tribal/BIA roadway were assigned PASER ratings throughout the course of the study. The average (mean) rating for the studied roadways was 5.99. That number may not signify much, but it does indicate that the Standing Rock highways scored tend to be in fair to good condition. In fact, if a rating of five is to be considered the minimum acceptable pavement condition, (able to drive at posted speed limit) then 86% of scored roads meet that standard today. This is visualized in the Figure 3 as it indicates there are more miles of orange, green, and blue than there are of red and black. There were 4 miles of roads rated an eight or nine. These miles in great or excellent condition were short intermittent segments along the southern half of BIA 3 near Kenel, SD.
