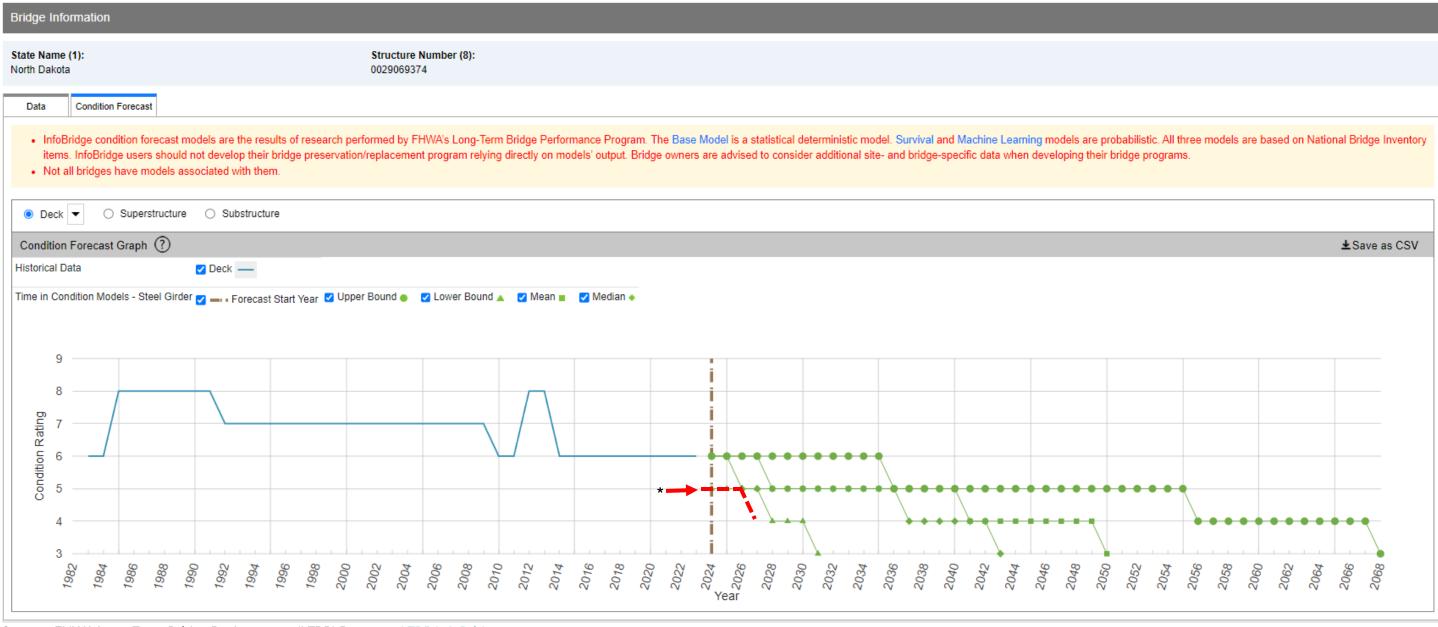
Figure 1. Bridge 29-69.374 (over I-29) Deck Condition Forecast

\*2023 Bridge Inspection Deck Condition Rating of 5 (Fair) is currently not reflected in the LTBP InfoBridge Data. Given the current and growing traffic volume over the bridge, NDDOT believes bridge 29-69.374 is at risk of falling into poor condition within three years, or 2027.

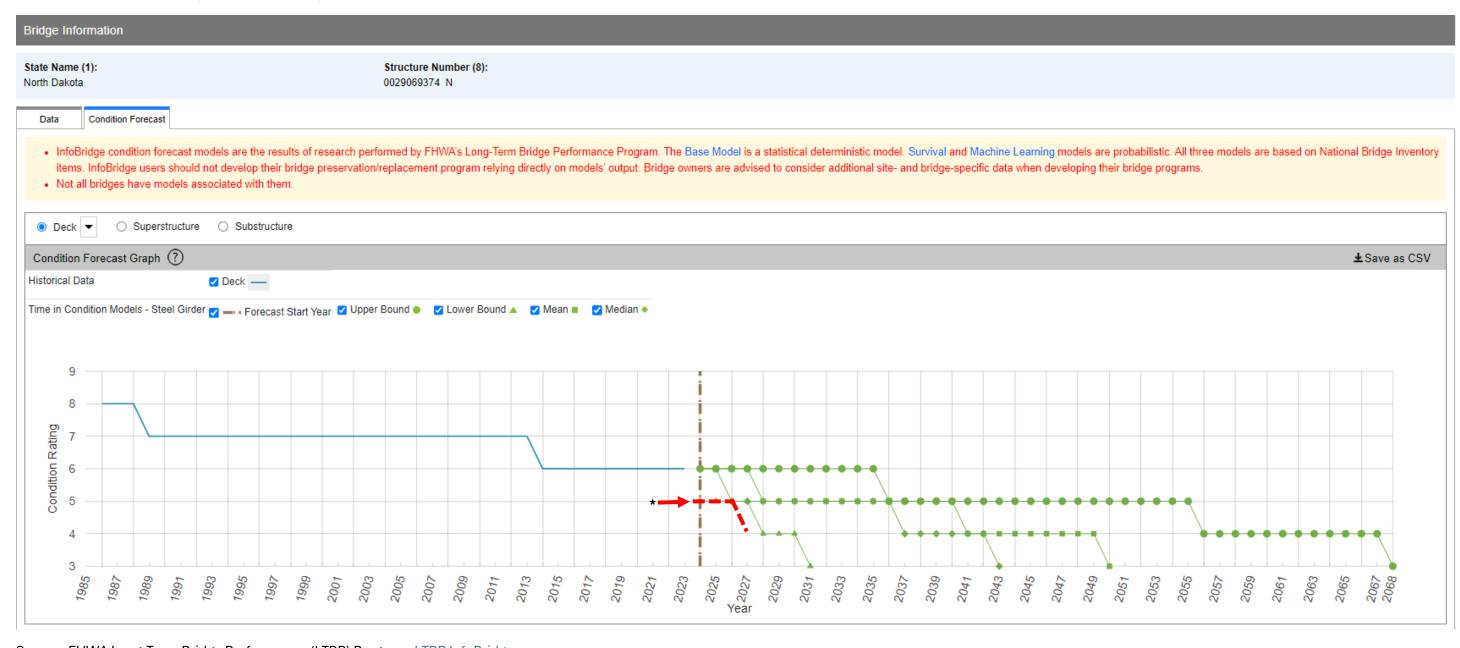
Figure 4. Bridge 29-69.374 N (over BNSF Railway) Deck Condition Forecast

\*2023 Bridge Inspection Deck Condition Rating of 5 (Fair) is currently not reflected in the LTBP InfoBridge Data. Given the current and growing traffic volume over the bridge, NDDOT believes bridge 29-69.374 N is at risk of falling into poor condition within three years, or 2027.

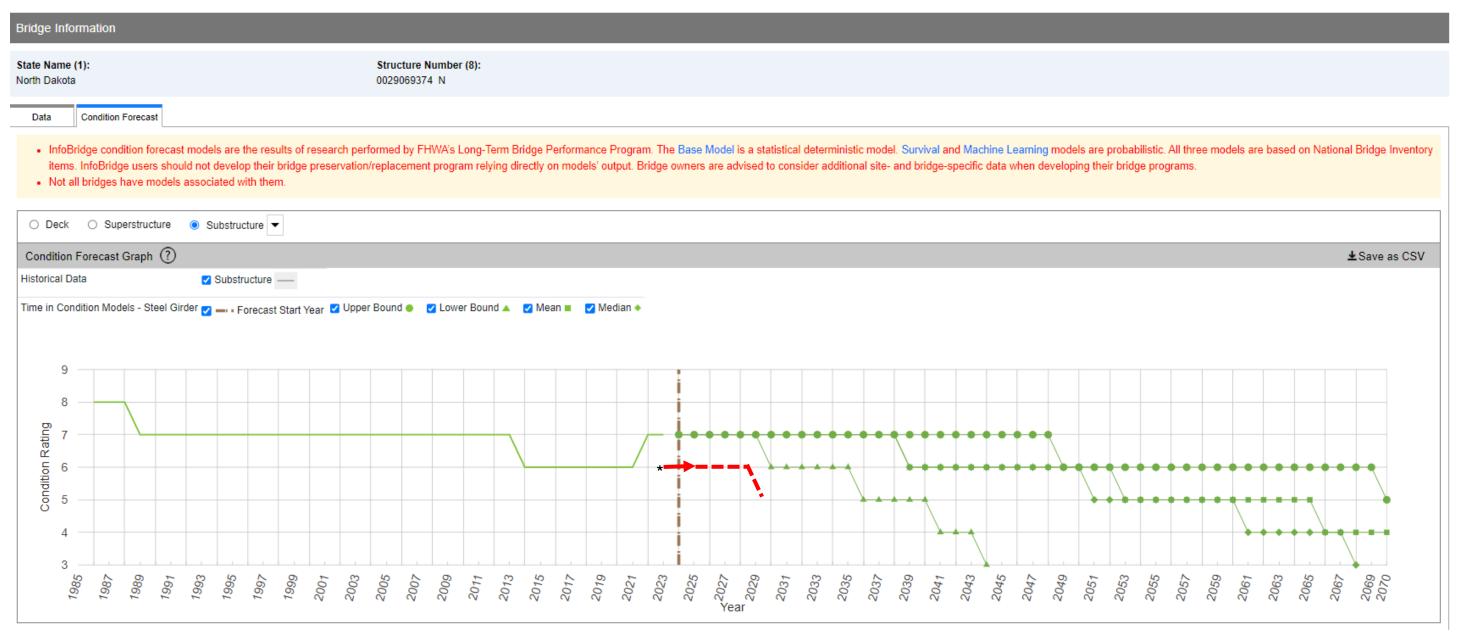
Figure 6. Bridge 29-69.374 N (over BNSF Railway) Substructure Condition Forecast

\*2023 Bridge Inspection Substructure Condition Rating of 6 (Fair) is currently not reflected in the LTBP InfoBridge Data. Given the current and growing traffic volume over the bridge, NDDOT believes bridge 29-69.374 N is at risk of falling into poor condition within three years, or 2027.
