Road Safety Audit

MNTH 200

R.P. 48.5 to R.P. 74.3 - within the boundaries of the
White Earth Indian Reservation

March 2018

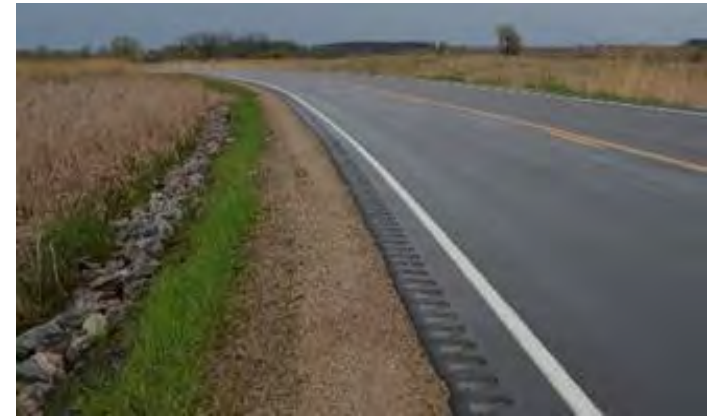
- There were reported twenty-four crashes along this corridor between 2011 and 2015.
- There were no fatalities and four incapacitating injuries.
- The predominant type of crashes were off road single vehicles.
- Sustained FAR (Fatal and Serious) Index = 1.21.

MNTH 200 near T-190 Mill and Overlay 2016

Highly Recommended	Potential High Impact	Suggested to Consider
<ul style="list-style-type: none"> • Edgeline rumble strips • Centerline rumble strips 	<ul style="list-style-type: none"> • Install chevrons near horizontal curves 	<ul style="list-style-type: none"> • Widen shoulders • Improve inslopes, approach slopes and ditch depths

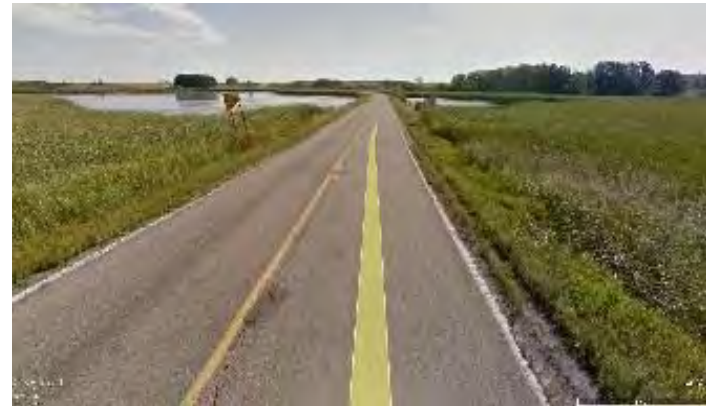
- This section of roadway has narrow shoulders, steep in-slopes to ditches and approaches.
- MnDOT District 4 completed a Mill and Overlay project in 2016.
- This segment of the roadway is very unforgiving for vehicles that
- leave the roadway.

MNTH 200 with narrow shoulders approaching Perch Lake.

Highly Recommended	Potential High Impact	Suggested to Consider
<ul style="list-style-type: none"> • Widen shoulders from two feet to six feet • Improve inslopes, approach slopes and ditch depths 	<ul style="list-style-type: none"> • Install chevrons near horizontal curves 	<ul style="list-style-type: none"> • Edgeline rumble strips • Centerline rumble strips

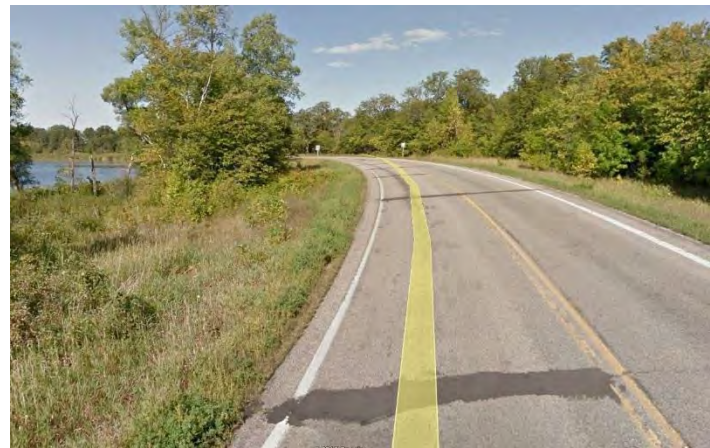
- There were reported nine crashes along the MNTH 200 from CSAH 7 to Zerker corridor between 2006-2015.
- There were reported twenty-four crashes along the MNTH 200 E of Mahnomen to CSAH 7 corridor between 2011 and 2015.
- The predominant type of crashes were off road single vehicles.
- MNTH 200 E of Mahnomen to CSAH 7 Sustained FAR (Fatal and Serious) Index = 1.21
- MNTH 200 from CSAH 7 near Roy Lake to Zerker Sustained FAR (Fatal and Serious) Index = 1.26

Westbound MNTH 200 crash location near Roy Lake

Highly Recommended	Potential High Impact	Suggested to Consider
<ul style="list-style-type: none"> • Widen shoulders from two feet to six feet • Improve inslopes, approach slopes and ditch depths 	<ul style="list-style-type: none"> • Install chevrons near horizontal curves 	<ul style="list-style-type: none"> • Edgeline rumble strips • Centerline rumble strips

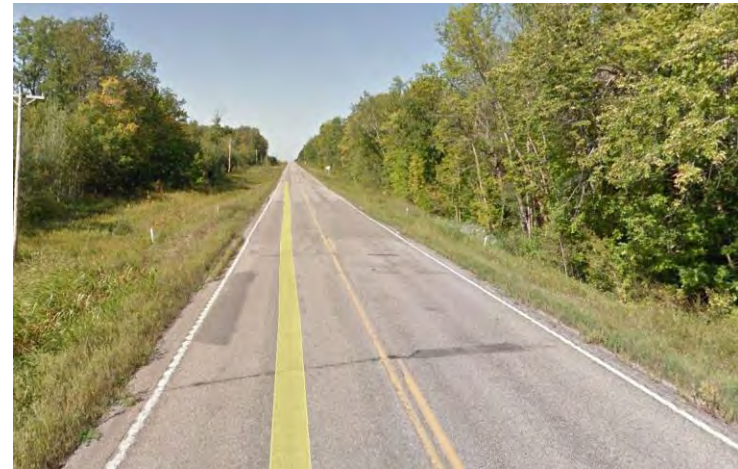
Steep inslope east of Blair Road

- This section of roadway has steep inslopes, deep ditches, steep approach slopes and deep water depths along the roadway.
- The roadway segment will require the elimination of hazards in the clear zone.
- Multiple inslopes bordering water feature that require guard rails and signage.

Highly Recommended	Potential High Impact	Suggested to Consider
<ul style="list-style-type: none"> • Widen shoulders from two feet to six feet • Improve inslopes, approach slopes and ditch depths 	<ul style="list-style-type: none"> • Install guard rails and signage near water features 	<ul style="list-style-type: none"> • Edgeline rumble strips • Centerline rumble strips

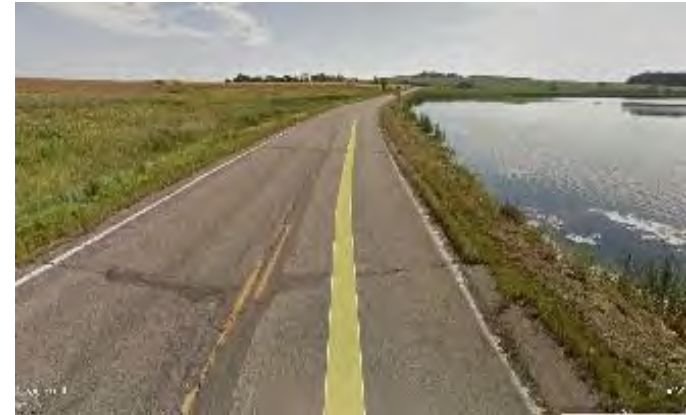
No Passing Zone (NPZ) near Perch Lake

- This section of roadway has a 28 percent of No Passing Zones (NPZ), which is much higher than typical.
- The passing segments that are present between the NPZ are inadequate in length.

Highly Recommended	Potential High Impact	Suggested to Consider
<ul style="list-style-type: none"> • Placement of wider pavement markings along corridor • Reduce percentage or NPZ locations 	<ul style="list-style-type: none"> • Install chevrons near horizontal curves 	<ul style="list-style-type: none"> • Inventory short passing segments for usability and potential inclusions to NPZs

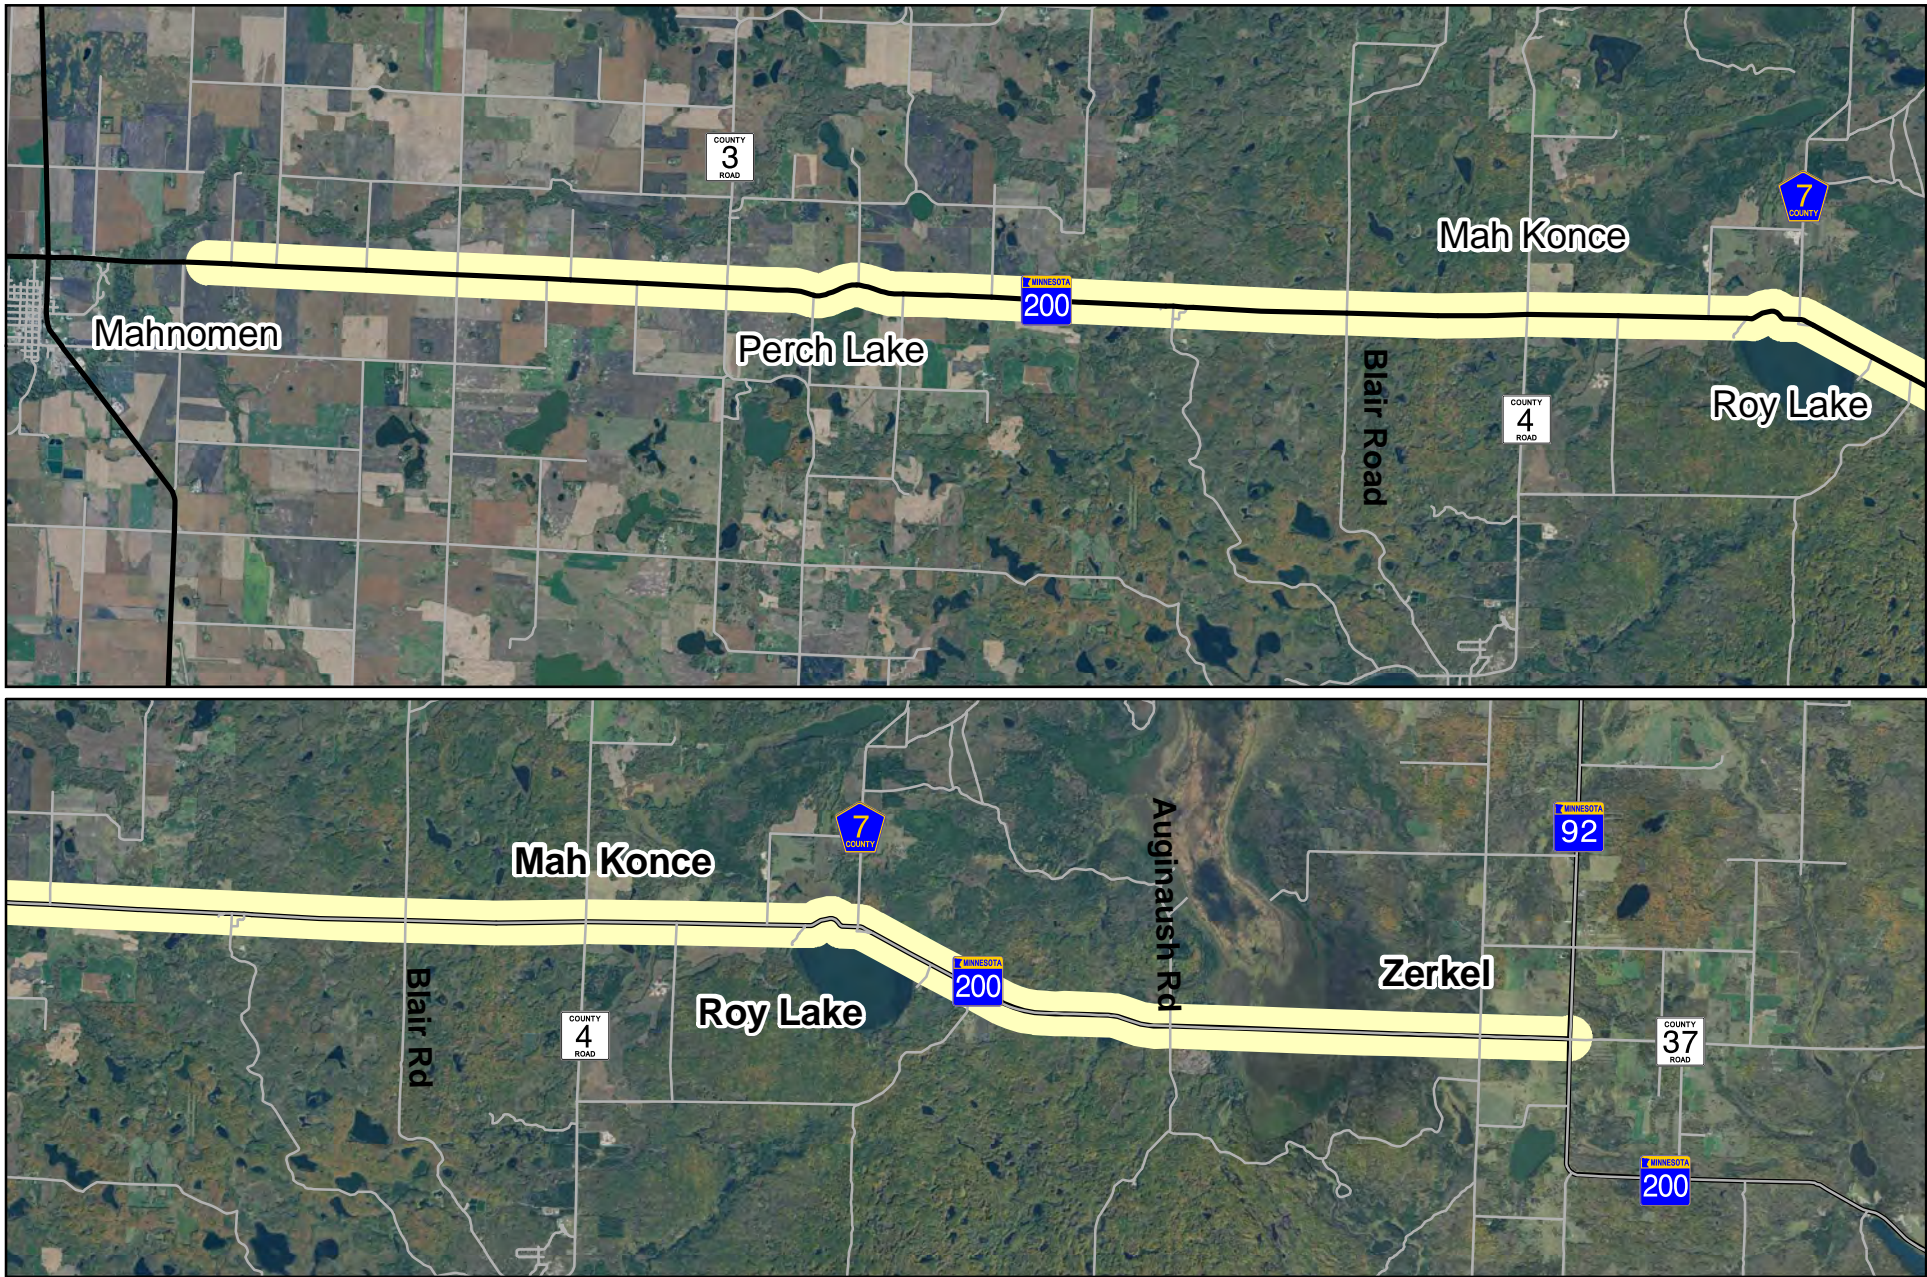
Site #6 – R.P. 48.5 to 74.3 HIGH FIXED OBJECT SEVERE CRASH RATE TYPE

This roadway segment of MNTH 200 is located to the east of the City of Mahnomen. MNTH 200 runs east-west. The segment lies to the east of the intersection of MNTH 200/CSAH 25 to the intersection of MNTH 200/MNTH 92 (Zerkel) on the White Earth Indian Reservation. An aerial photo of Site 6 is shown in Figure 11.

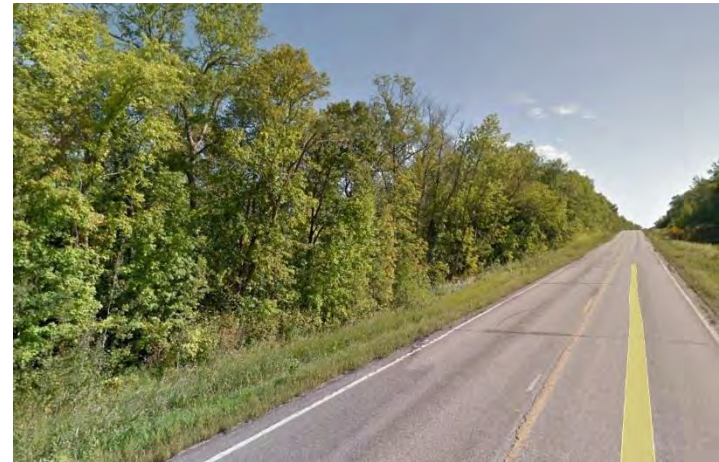
- There were reported nine crashes along the MNTH 200 from CSAH 7 to Zerkel corridor between 2006-2015.
- There were reported twenty-four crashes along the MNTH 200 E of Mahnomen to CSAH 7 corridor between 2011 and 2015.
- There were 8 fixed object crashes along the corridor from May 2010 to May 2015.
- MNTH 200 E of Mahnomen to CSAH 7 Sustained FAR (Fatal and Serious) Index = 1.21
- MNTH 200 from CSAH 7 near Roy Lake to Zerkel Sustained FAR (Fatal and Serious) Index = 1.26

Fixed objects along roadway near Goodwin Lake

Highly Recommended	Potential High Impact	Suggested to Consider
<ul style="list-style-type: none"> • Remove fixed object from clear zones along corridor 	<ul style="list-style-type: none"> • Remove fixed objects located near the clear zones that restrict sight distances and pose dangers 	<ul style="list-style-type: none"> • Develop inventory of fixed objects within clear zones

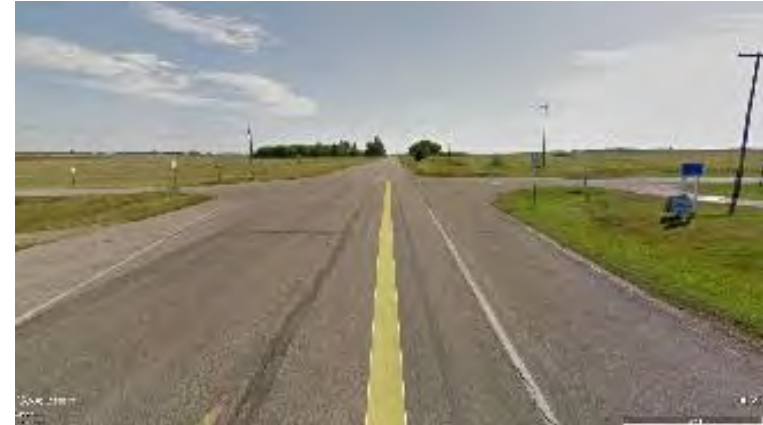
- There is no existing lighting at this intersection.
- CSAH 3 AADT is greater than 200.

Poorly lit intersection at intersection of MNTH 200 and CSAH 3

Highly Recommended	Potential High Impact	Suggested to Consider
<ul style="list-style-type: none"> • Improve street lighting to provide lighting to entire intersection. 	<ul style="list-style-type: none"> • None 	<ul style="list-style-type: none"> • Install new stop signs.

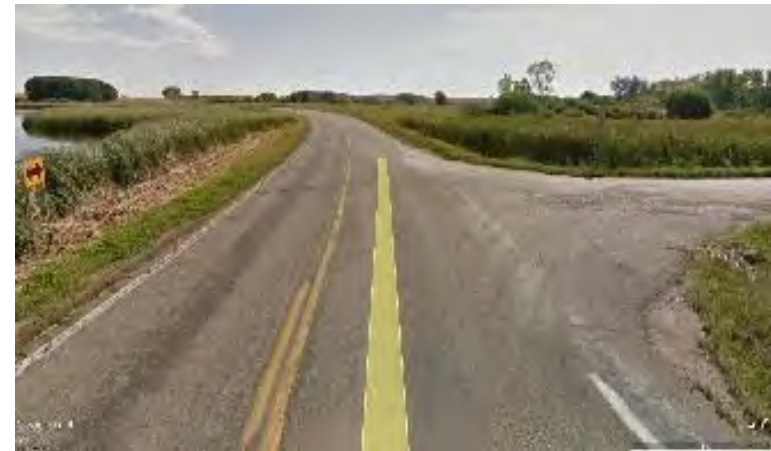
- This section of roadway has a high-risk curve ranking in the 2016 District 4 District Safety Plan Update.
- Relatively high traffic volumes exist on MNTH 200.

Horizontal curve at intersection of MNTH 200 and T-190

Highly Recommended	Potential High Impact	Suggested to Consider
<ul style="list-style-type: none"> • Install chevrons along the curves. 	<ul style="list-style-type: none"> • None 	<ul style="list-style-type: none"> • Additional signage to the east and west of the curves along the segment.

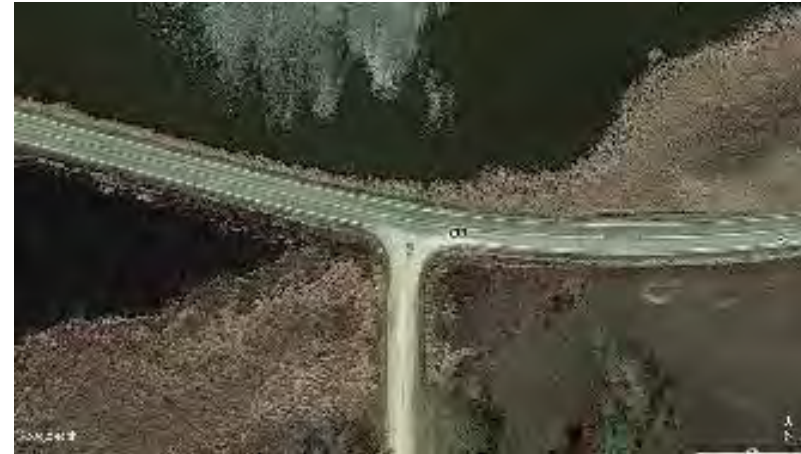
- There are a high number of East Bound right-turn deceleration conflicts, in addition to the intersection being along a curve.
- T-190 traffic is greater than 100 AADT

Curved intersection at MNTH 200 and T-190

Highly Recommended	Potential High Impact	Suggested to Consider
<ul style="list-style-type: none"> • Install eastbound right-turn lane. • Improve inslopes, approach slopes and ditch slopes. • Eliminate hazards in clear zones 	<ul style="list-style-type: none"> • None 	<ul style="list-style-type: none"> • Adjust and add permanent signage to incorporate the addition of right-turn lane.

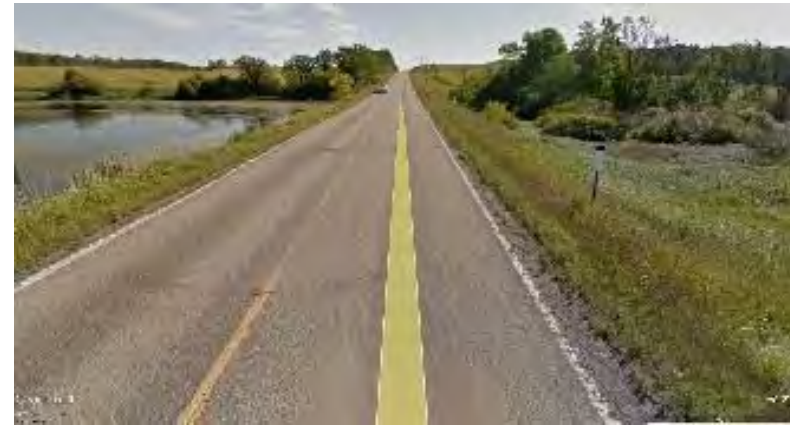
- This section of roadway has no shoulders, steep in-slopes to ditches and approaches adjacent to a pond.

MNTH 200 one half mile west of Blair Road.

Highly Recommended	Potential High Impact	Suggested to Consider
<ul style="list-style-type: none"> • Widen shoulders • Improve inslopes, approach slopes and ditch depths 	<ul style="list-style-type: none"> • Add guard rails along water feature 	<ul style="list-style-type: none"> • Use granite as shoulder material to minimize wetland impact.

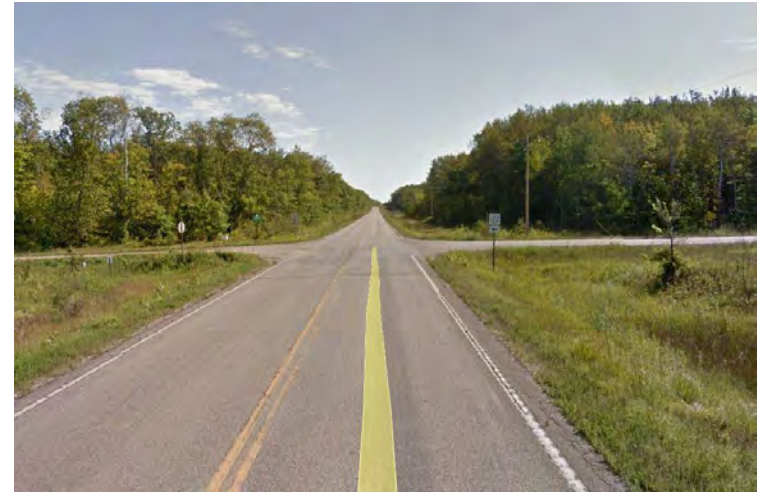
- There are a high number of right-turn deceleration conflicts, in addition to a having no lighting at the intersection.
- Blair Road has an AADT greater than 100

Deceleration conflict at MNTH 200 and Blair Road

Highly Recommended	Potential High Impact	Suggested to Consider
<ul style="list-style-type: none"> • Install right-turn lane 	<ul style="list-style-type: none"> • Install intersection lighting 	<ul style="list-style-type: none"> • Conduct updated traffic counts on Blair Road

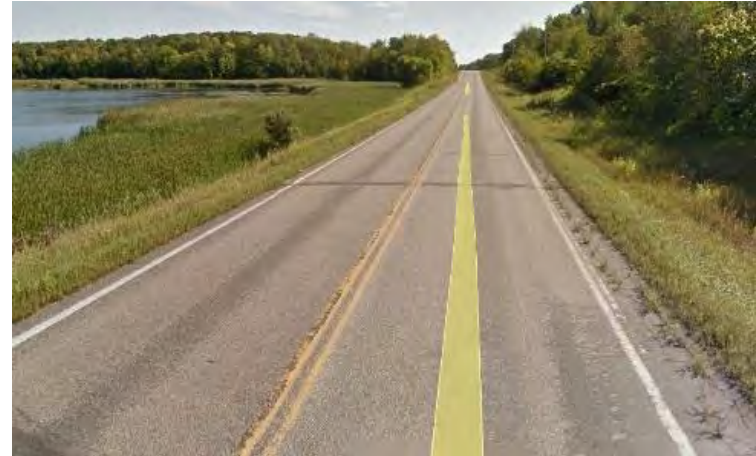
- This section of roadway has no shoulders, steep in-slopes to ditches and approaches adjacent to a pond.

Steep ditch inslope near Goodwin Lake

Highly Recommended	Potential High Impact	Suggested to Consider
<ul style="list-style-type: none"> • Widen shoulders • Improve inslopes, approach slopes and ditch depths 	<ul style="list-style-type: none"> • Add guard rail along water feature location 	<ul style="list-style-type: none"> • Use granite as a shoulder material to minimize wetland impact.

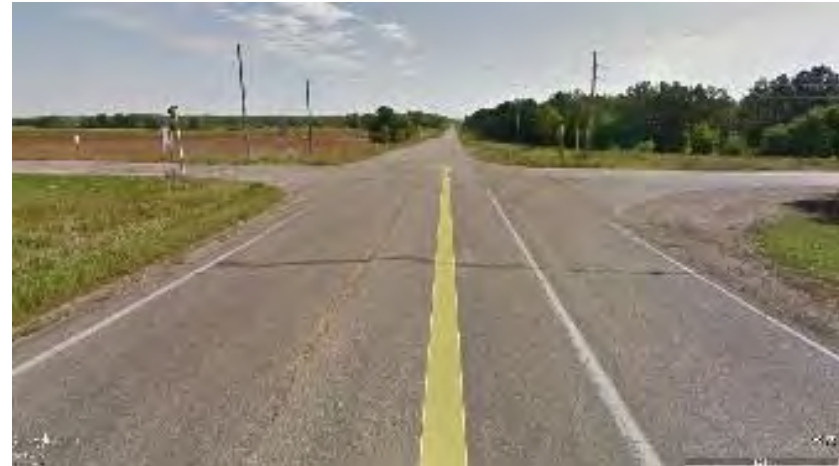
- Poorly lit intersection with pedestrian traffic
- Relatively high number of pedestrian traffic at this intersection.
- AADT on CSAH 4 is greater than 200

Poorly lit intersection at intersection of MNTH 200 and CSAH 4

Highly Recommended	Potential High Impact	Suggested to Consider
<ul style="list-style-type: none"> • Install intersection lighting 	<ul style="list-style-type: none"> • None 	<ul style="list-style-type: none"> • Installation of new stop signs

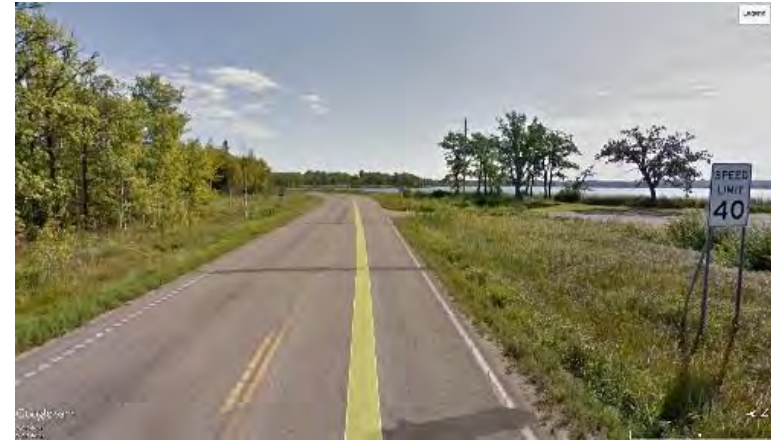
- This section of roadway is a high-risk segment due to several factors which include: critical radius curve density, narrow shoulder width, edge risk and access density.
- High access density, leaving several vulnerable locations for potential accidents
- Several curves along this corridor which cause poor site distances

Proposed stretch of enhanced edgeline installation near Roy Lake

Highly Recommended	Potential High Impact	Suggested to Consider
<ul style="list-style-type: none"> • Install enhanced edgelines (6" to 8") • Widen shoulders 	<ul style="list-style-type: none"> • Install chevrons near horizontal curves 	<ul style="list-style-type: none"> • 2016 MnDOT District 4 District Safety Plan Update recommended project

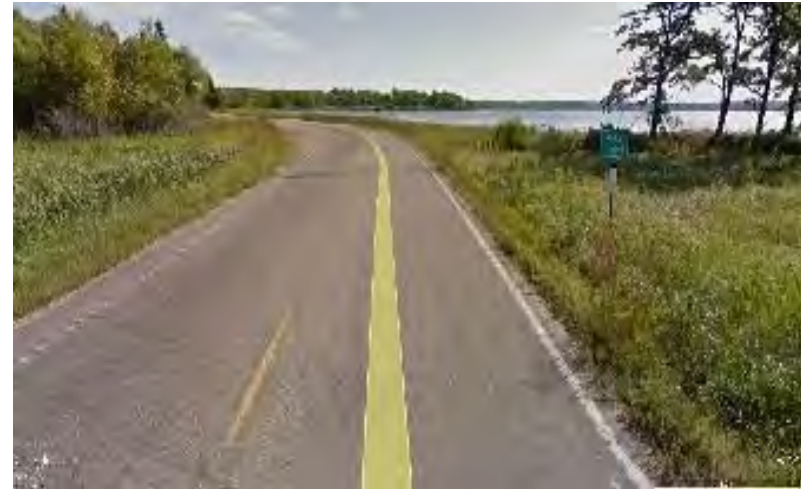
- This section of roadway has a sharp horizontal curve causing single vehicle crashes.
- A single sharp curve to left sign is present at the curve of Roy Lake.
- The gravel shoulder area in this curve area has experienced pot holes.

Horizontal curve at Roy Lake

Highly Recommended	Potential High Impact	Suggested to Consider
<ul style="list-style-type: none"> • Install chevrons along the horizontal curve 	<ul style="list-style-type: none"> • Additional signage prior to the curve 	<ul style="list-style-type: none"> • Consider realigning roadway to the north, however, this may not be environmentally or economically feasible

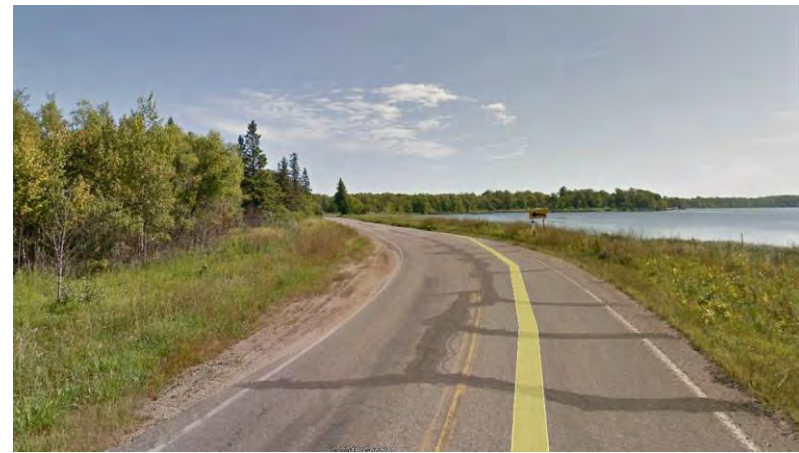
- This area has a high number of pedestrians who walk the roadway to get from C-Store to residences.
- Southern roadway shoulder has little clearance from Roy Lake

Roy Lake near Sunfish Rd

Highly Recommended	Potential High Impact	Suggested to Consider
<ul style="list-style-type: none"> • Realign existing roadway to north • Install pedestrian walkway between realigned roadway and Roy Lake from Sunfish Rd to intersection of MNTH 200/Clearwater CSAH 7. 	<ul style="list-style-type: none"> • Install solar panel speed signs to inform in-coming traffic 	<ul style="list-style-type: none"> • Install lighting along corridor from Sunfish Rd to intersection of MNTH 200/CSAH 7

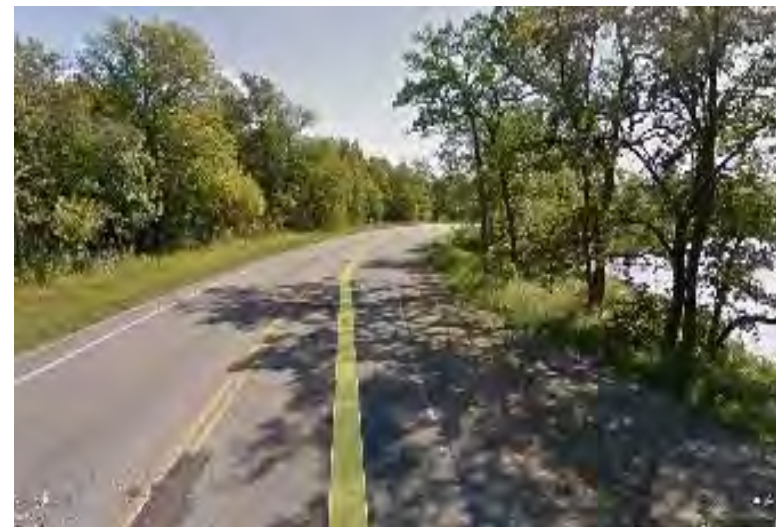
- This section of roadway has trees close to the highway in the clear zone causing site distance issues.
- A relatively high rate of the crashes that occurred (60%) were collision with fixed object.
- There are trees located within the clear zone along the segment causing site distance issues.

Fixed objects within clear zone at R.P. 65.9

Highly Recommended	Potential High Impact	Suggested to Consider
<ul style="list-style-type: none"> • Eliminate fixed objects in clear zone • Widen shoulder 	<ul style="list-style-type: none"> • Edgeline rumble strips 	<ul style="list-style-type: none"> • Install safety barrier

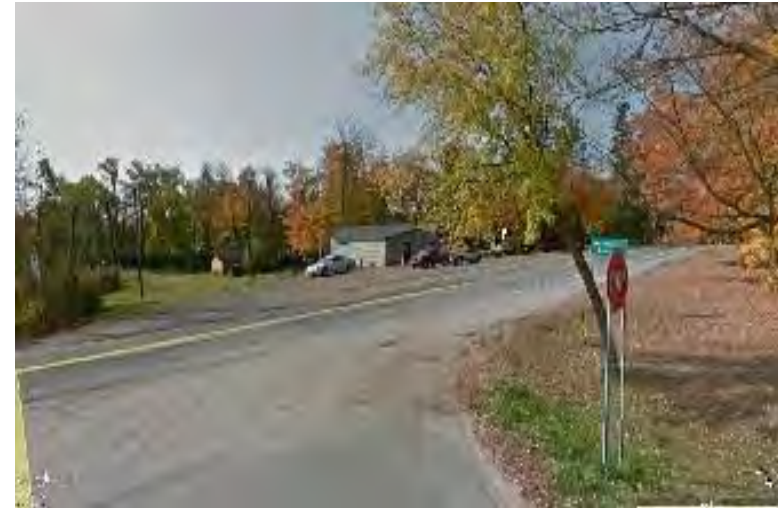
- Sight distance issues due to vehicles parking along the north side of MNTH 200 by convenience store.
- Relatively high volume of pedestrian traffic through this area.
- Season cabins/lake home traffic increases between June – August.

Intersection site distance issues MNTH 200/Clearwater CSAH 7

Highly Recommended	Potential High Impact	Suggested to Consider
<ul style="list-style-type: none"> • Eliminate parking on the north side of MNTH 200 across from Roy Lake Store. 	<ul style="list-style-type: none"> • None 	<ul style="list-style-type: none"> • Define an access area at Roy Lake Store

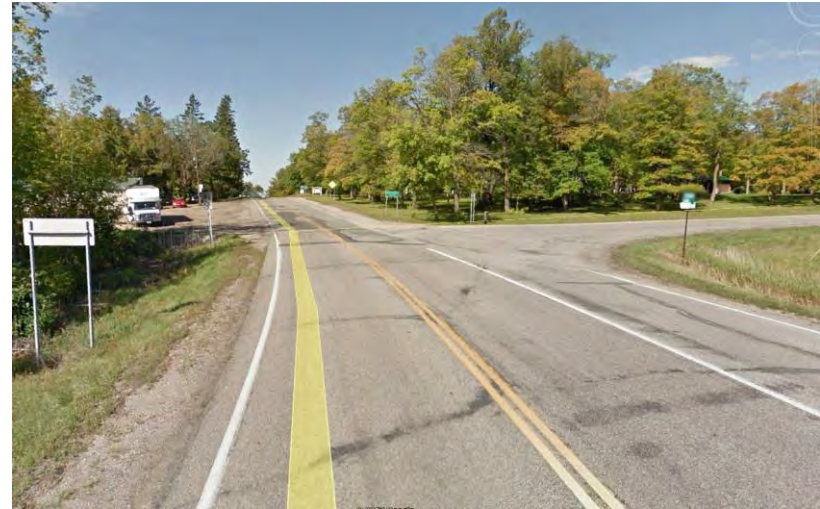
- This is a poorly lit intersection with pedestrian traffic, which makes it so unsafe for pedestrians.
- The intersection has a high vehicular volume
- Relatively high volume of pedestrian traffic in the area.

Poorly lit intersection MNTH 200/Clearwater CSAH 7

Highly Recommended	Potential High Impact	Suggested to Consider
<ul style="list-style-type: none"> • Install lighting in the intersection to improve visibility due to crashes that have occurred in dark conditions. 	<ul style="list-style-type: none"> • None 	<ul style="list-style-type: none"> • Installation of new stop signs

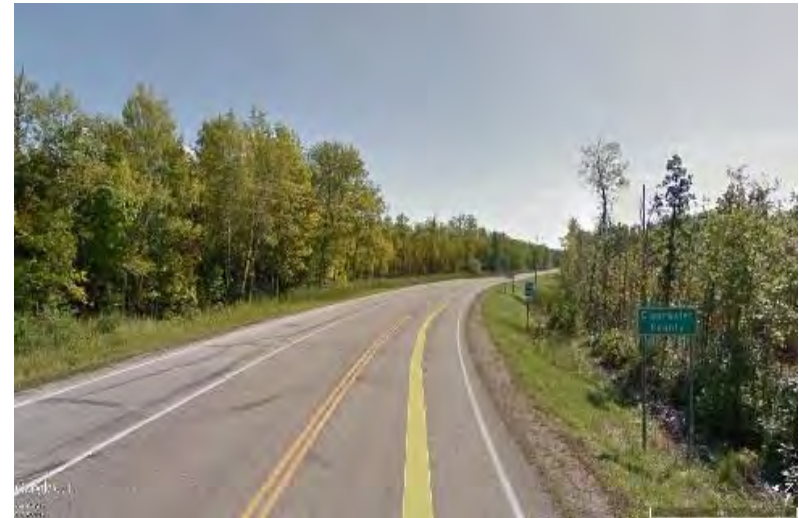
- This section of roadway is a high-risk segment due to several factors which include: critical radius curve density, narrow shoulder width, edge risk and access density.
- Sustained FAR Index = 1.26. A prominent number of the crashes are single vehicle ran off the road crashes.
- There is a high access density, leaving several vulnerable locations for potential accidents.

Roadway segment for proposed enhanced edgeline installation

Highly Recommended	Potential High Impact	Suggested to Consider
<ul style="list-style-type: none"> • Install enhanced edgelines (6"-8") • Widen shoulders 	<ul style="list-style-type: none"> • Install chevrons near horizontal curves 	<ul style="list-style-type: none"> • 2016 MnDOT District 4 District Safety Plan Update recommended project • Install edgeline rumble strips • Install centerline rumble strips

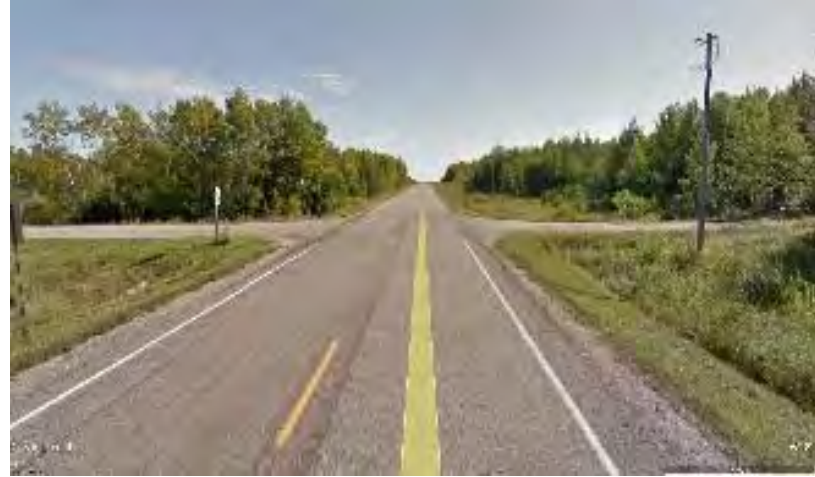
- The intersection is poorly lit with high pedestrian traffic making it extremely unsafe for the pedestrians
- CSAH 7 / 16 AADT > 100

Poorly lit intersection MNTH 200/ Auginaush Road

Highly Recommended	Potential High Impact	Suggested to Consider
<ul style="list-style-type: none"> • Install intersection lighting 	<ul style="list-style-type: none"> • None 	<ul style="list-style-type: none"> • Conduct Auginaush Road traffic counts • Install EB right-turn lane

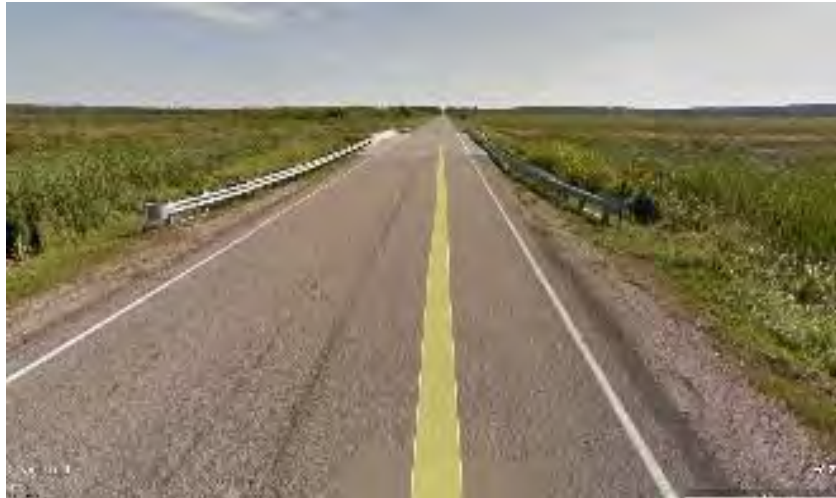
- There are no object markets on the guard rail terminal ends for the Wild Rice River Bridge

Wild Rice River Bridge guard rails

Highly Recommended	Potential High Impact	Suggested to Consider
<ul style="list-style-type: none"> • Install object marker panels and the guard rail terminal ends 	<ul style="list-style-type: none"> • None 	<ul style="list-style-type: none"> • None
