# Standing Rock Sioux Tribe

## Urban Pavement Management Plan

*June 2017*

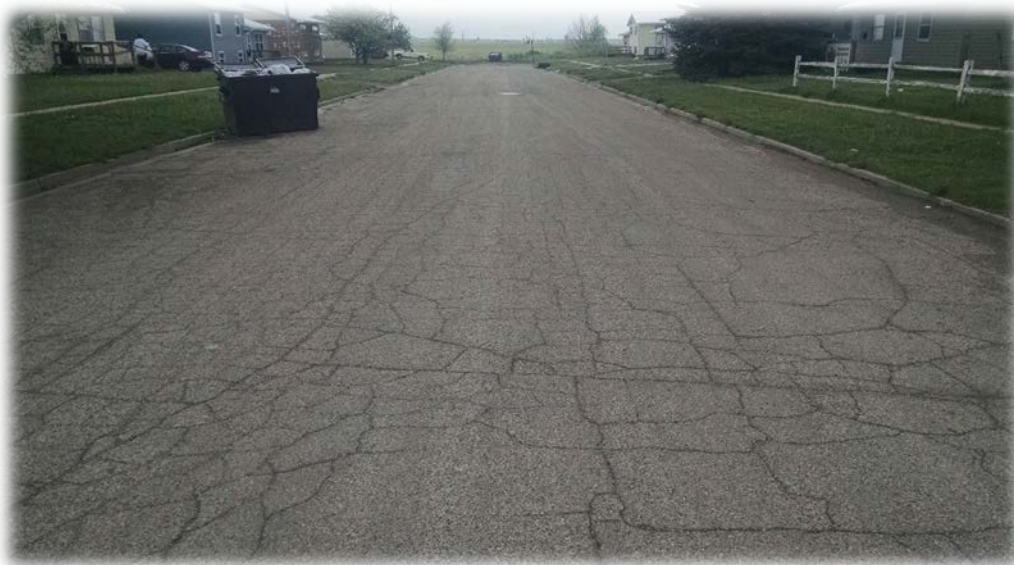
*Photo of Pavement Condition on a Standing Rock Reservation Street*

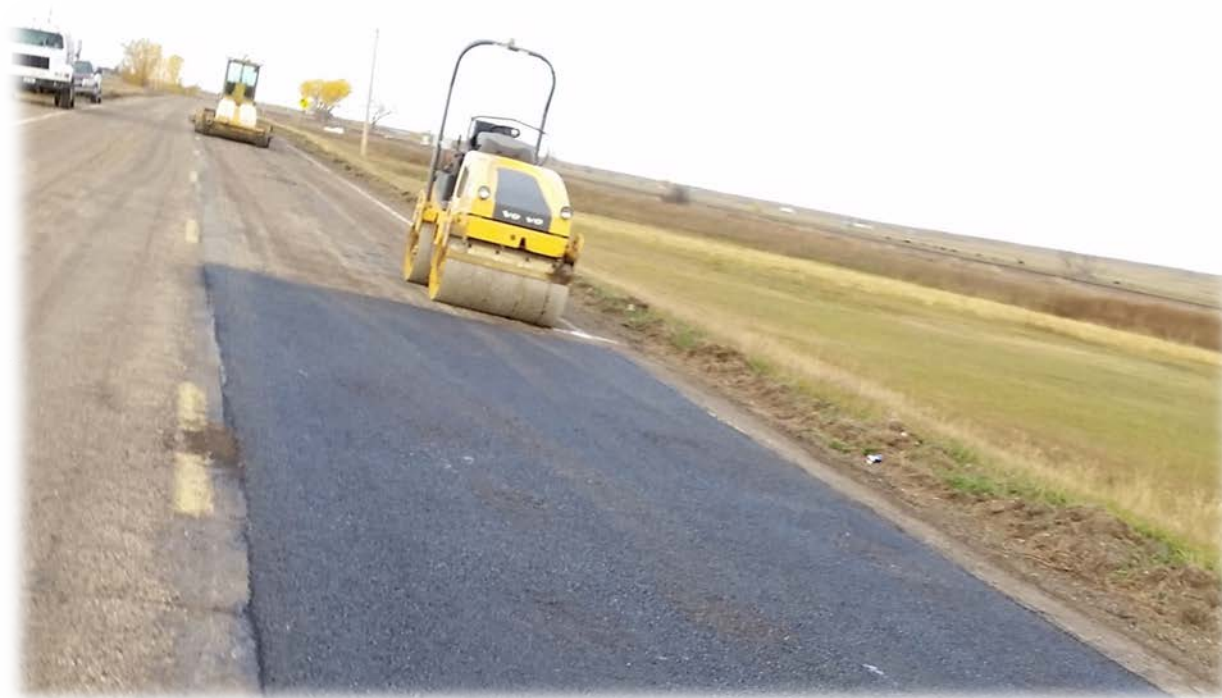
*Figure 2 - Study Area Roads: Sioux County*

This study was focused on assessing the current condition of the streets around the reservation and developing a maintenance strategy to improve and repair them. Tribal officials identified housing streets, streets near schools, pedestrian pathways, and several other heavily travelled areas, consisting of approximately 22 miles of pavement of varying widths to be evaluated. Not all paved roads were to be evaluated; very few city owned streets were studied, and all routes included in the Rural Pavement Management Plan were excluded. Figures 2 and 3 highlight the roadways that were evaluated on the Standing Rock Reservation in this study.

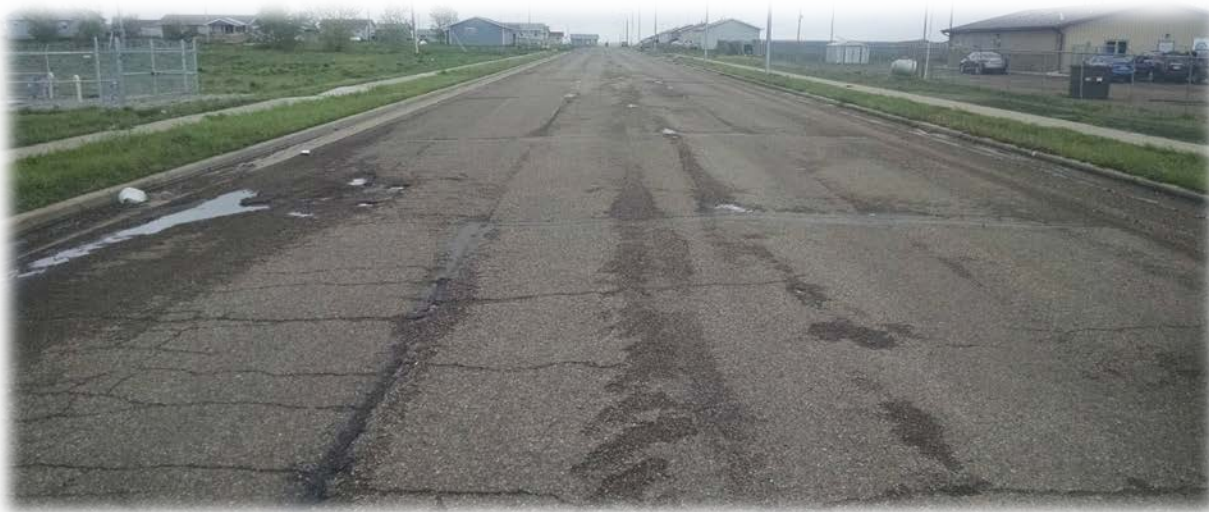
Very poor. Severe cracking and rutting with moderate visible potholes. Heavy patching with some patches on old patches. Limited striping. Shoulders are deteriorated. Areas are marked with flags. You cannot drive this road at the posted speed limit. Drivers need to slow down. Example: All Nations Street at intersection with SD Hwy 63, one mile south of McLaughlin, SD.

*Photo of a PASER Rating 3 Road on the Standing Rock Reservation*

Patching and repair will need to be done prior to a major structural overlay (greater than 2"). Milling and removing deteriorated areas will extend the life of the overlay. The Tribe has recently begun the process to procure an asphalt Zipper (or similar) to pulverize and recycle asphalt in-place. Owning and operating their own piece of equipment will greatly reduce the cost of rehabilitating the roads that are in the poorest condition.

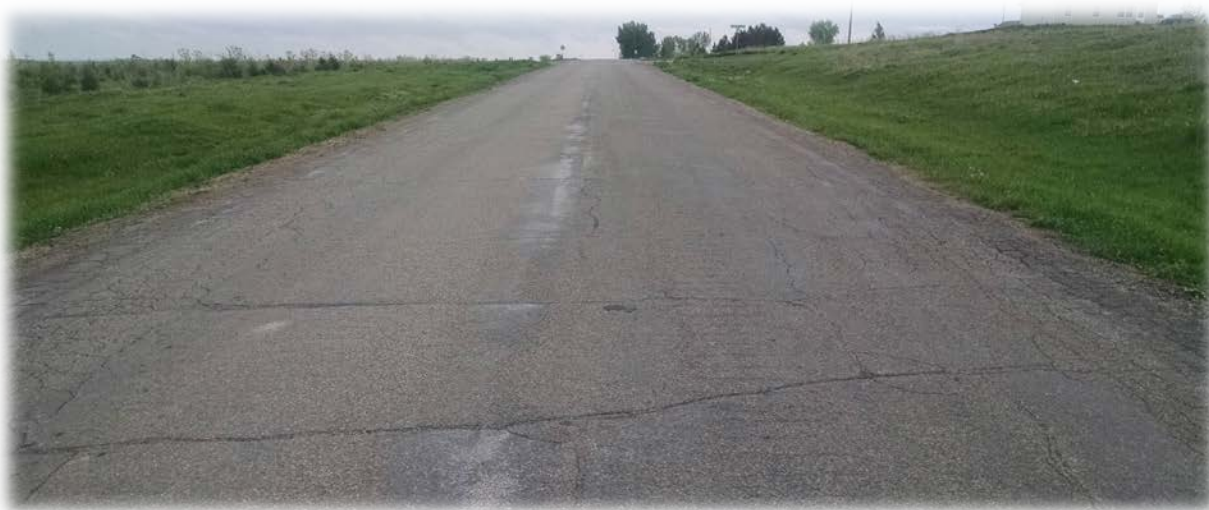
Poor. Heavy cracking and rutting with moderate visible potholes. Heavy patching with some patches on old patches. Limited striping. Shoulders are deteriorated. Cracks are not sealed. You cannot drive this entire road at the posted speed limit. Drivers need to slow down in areas. Example: 1<sup>st</sup> Avenue, Cannon Ball, ND.

*Photo of a PASER Rating 4 Road on the Standing Rock Reservation*

Because the Tribe is purchasing an asphalt zipper, several roadways with a PASER rating of 4 are shown as “Pulverize and Repave” projects. The reduced project costs associated with owning the equipment as well as the severely deteriorated pavement conditions support the rationale of a reconstructed roadway, rather than the structural overlay that would traditionally be recommended for a PASER rating of 4.

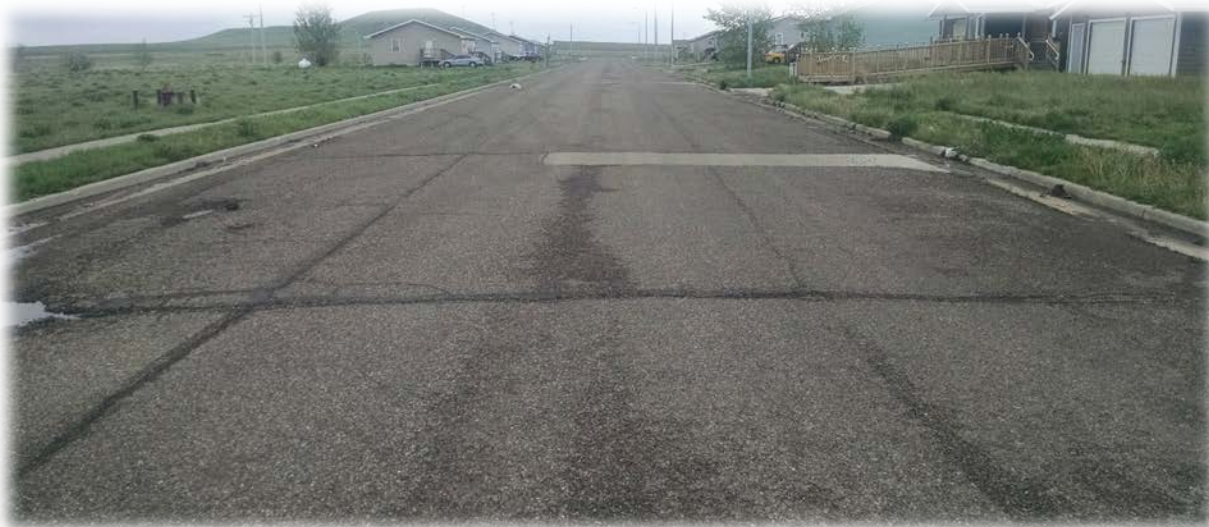
Fair. Moderate to heavy cracking with moderate rutting. Moderate patching with some patches on old patches. Limited striping. Cracks are mostly not sealed. You can still drive this road at the posted speed limit. Example: Cedar Avenue, 1 mile south of McLaughlin, SD.

*Photo of a PASER Rating 5 Road on the Standing Rock Reservation*

Primarily consists of aging asphalt, but with sound structural conditions. The roadway can benefit from patching where necessary, followed by a non-structural overlay (less than 2”).

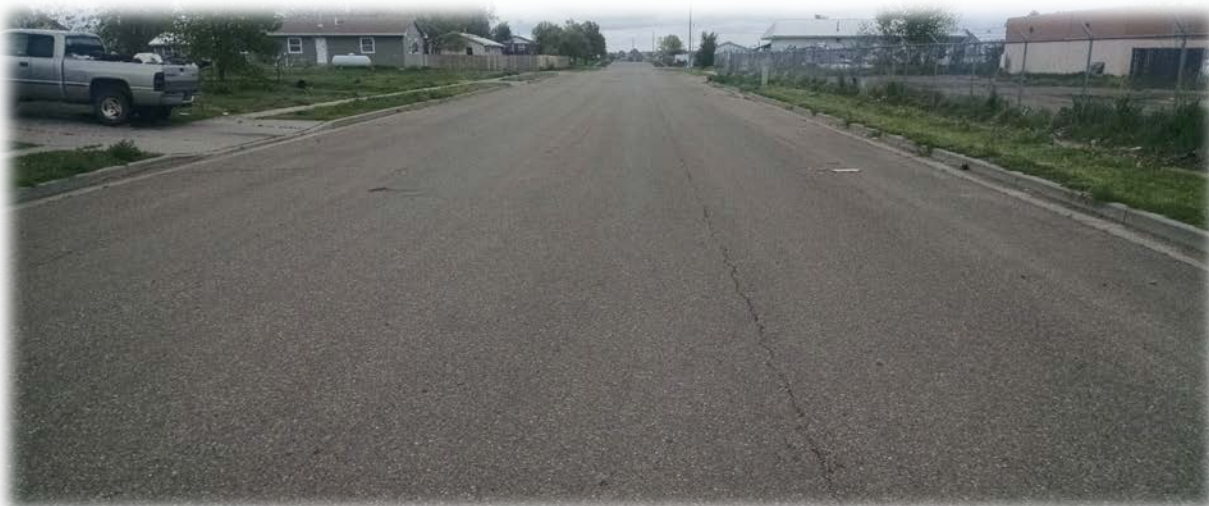
Fair. Moderate to heavy cracking or some raveling and rutting exists. Moderate polishing with occasional patches visible. Cracks are mostly sealed. Example: Wolf Street in Fort Yates, ND.

*Photo of a PASER Rating 6 Road on the Standing Rock Reservation*

Light signs of aging. The roadway life can be extended with routine crack sealing and a sealcoat.

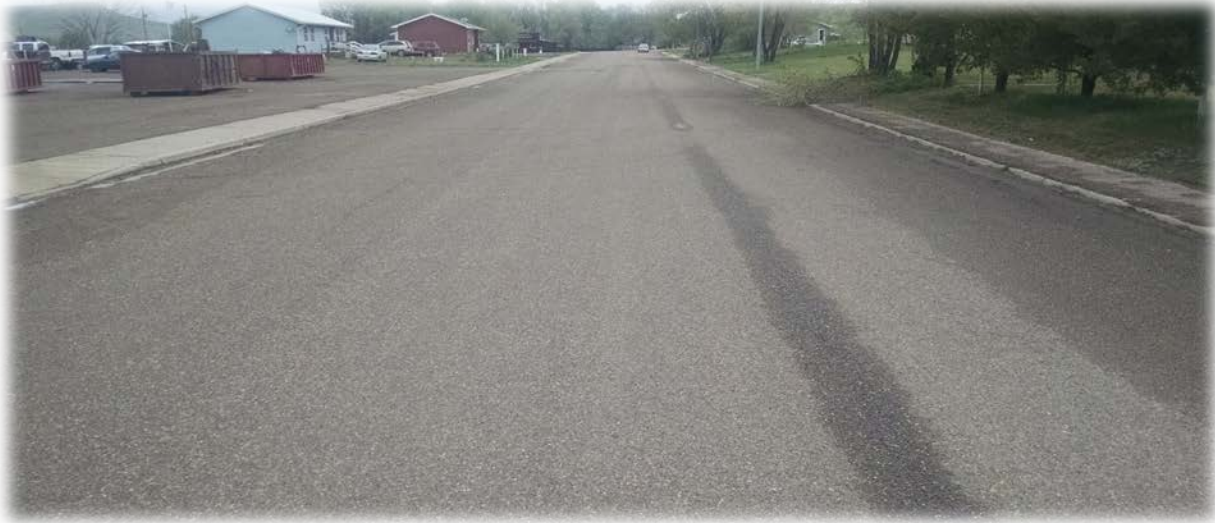
Good. Some cracking, no raveling and little rutting. No patches are visible. Cracks are sealed. This roadway is not in need of immediate repair. Example: Rain in the Face Avenue in Bullhead, SD.

*Photo of a PASER Rating 7 Road on the Standing Rock Reservation*

Roadway shows very few signs of aging and can be maintained with routine crack filling.

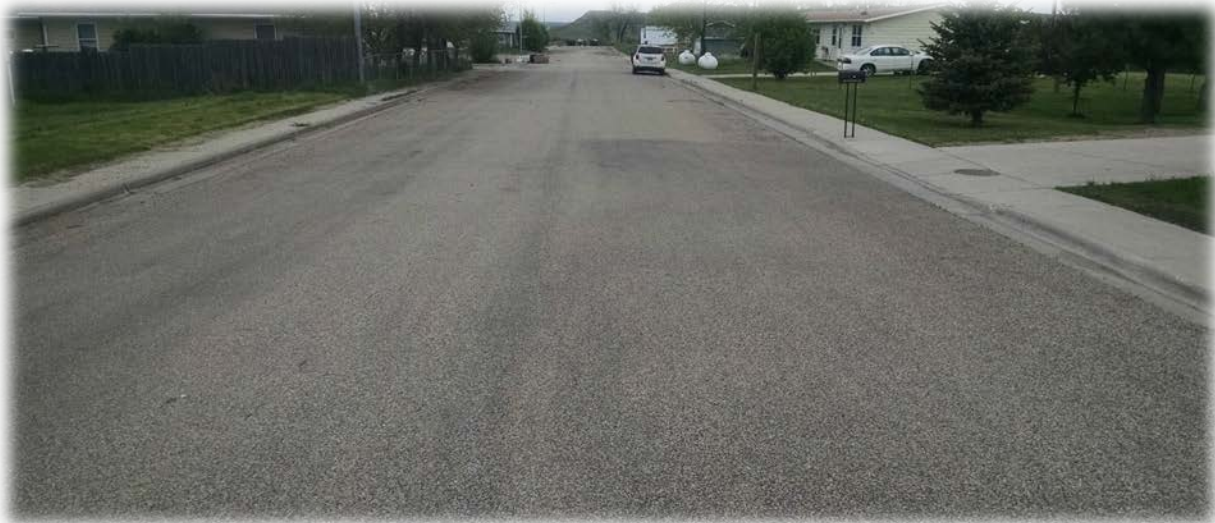
Great. No cracking, raveling or rutting present. No patches or sealed cracks are visible. This roadway is not in need of repair. Example: Wiyohiyampta Street in Porcupine, ND.

*Photo of a PASER Rating 8 Road on the Standing Rock Reservation*

No immediate maintenance is required on these roadways. In the future, routine crack filling and maintenance should be performed to continue to extend the life of the roadway.

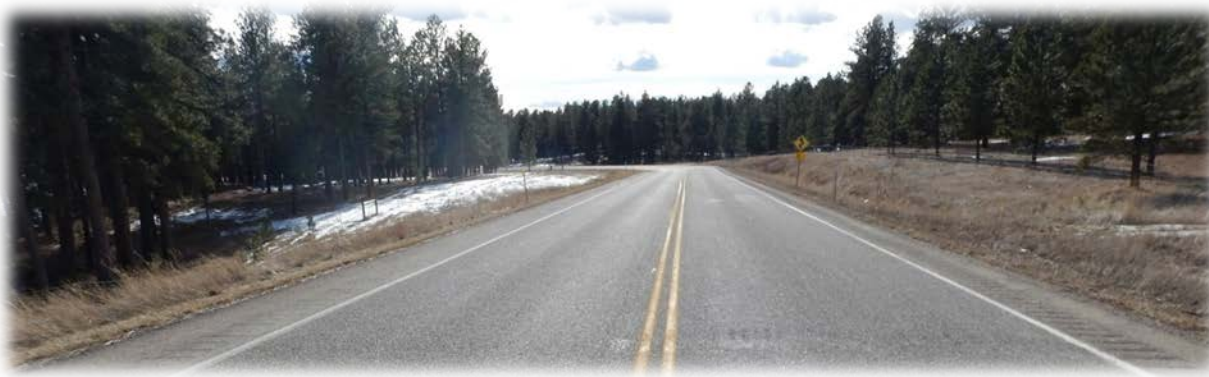
*Photo of a PASER Rating 9 Road*

Excellent. A relatively new road with new striping. This is usually a roadway that was reconstructed or overlaid recently. Example: None in the study area.
