Standing Rock Sioux Tribe

Pavement Management Plan

May 2017

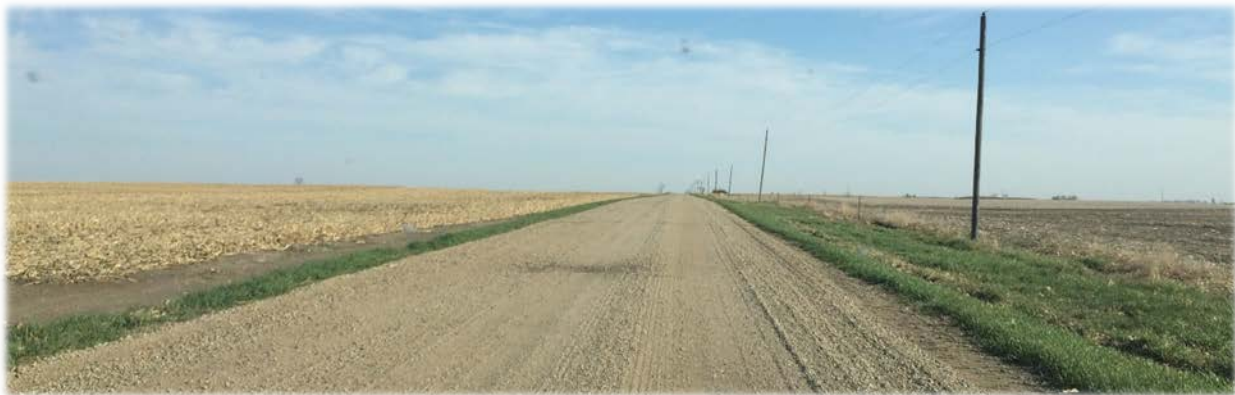
Example Photo of a PASER Rating 1 Road

No pavement. A PASER rating of 1 indicates a gravel road section with virtually no visible pavement. Example: none in the study area.

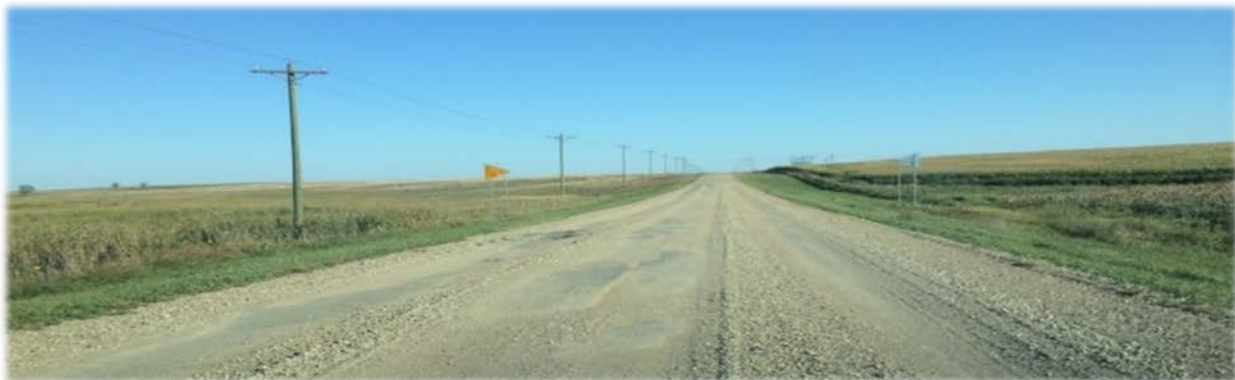
Example Photo of a PASER Rating 2 Road

Terrible. Heavy patching with gravel patches on failed asphalt. Limited pavement intact. No striping. Shoulders are deteriorated. You cannot drive this road at the posted speed limit. Drivers need to slow down. Example: none in the study area.

Due to severe deterioration, the roadway needs reconstruction with extensive base repair; or the decision can be made to pulverize any remaining asphalt and maintain it as a gravel road. As with PASER rating 1, no roads in the study area were severely deteriorated enough to receive a PASER rating of 2.

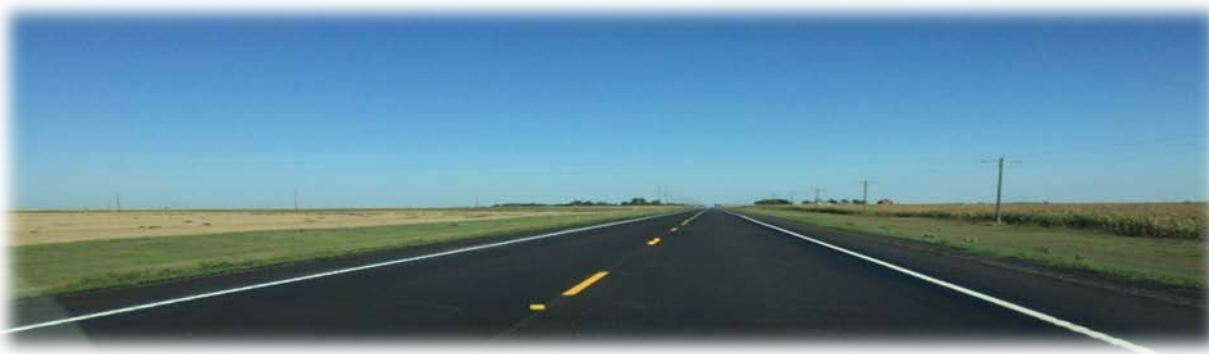
Example Photo of a PASER Rating 10 Road

Perfect. A brand new road with appropriate striping and shoulders. This is a roadway that was most likely reconstructed or overlaid in the last year. Example: None in the study area.

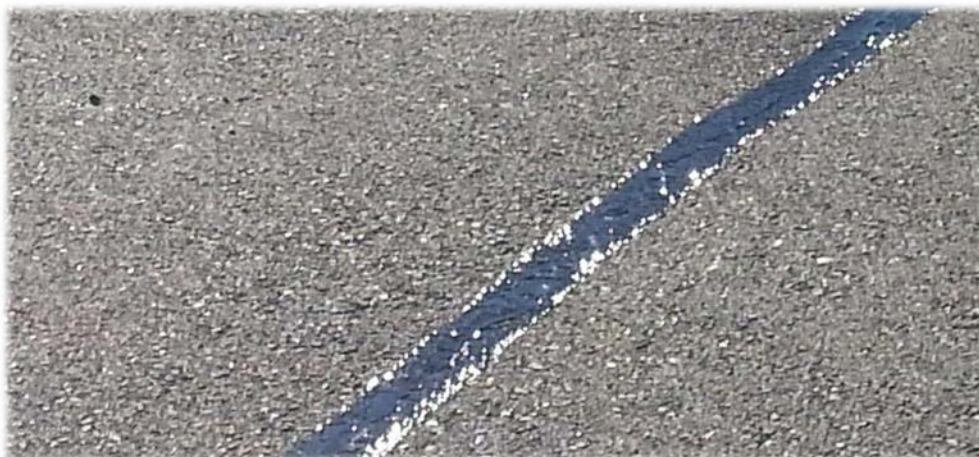
PASER Rating of 7:

Good. Some cracking, no raveling and little rutting. No patches are visible. Cracks are sealed. This roadway is not in need of immediate repair. Example: BIA Route 20, near Bullhead, SD.

Roadway shows very few signs of aging and can be maintained with routine crack filling.
