Bridge Inspection Report for Minnehaha County South Dakota **2022**

Structure No. 50-216-015 Jasper Street / Co. Hwy 104

Dell Rapids Township

10/28/22

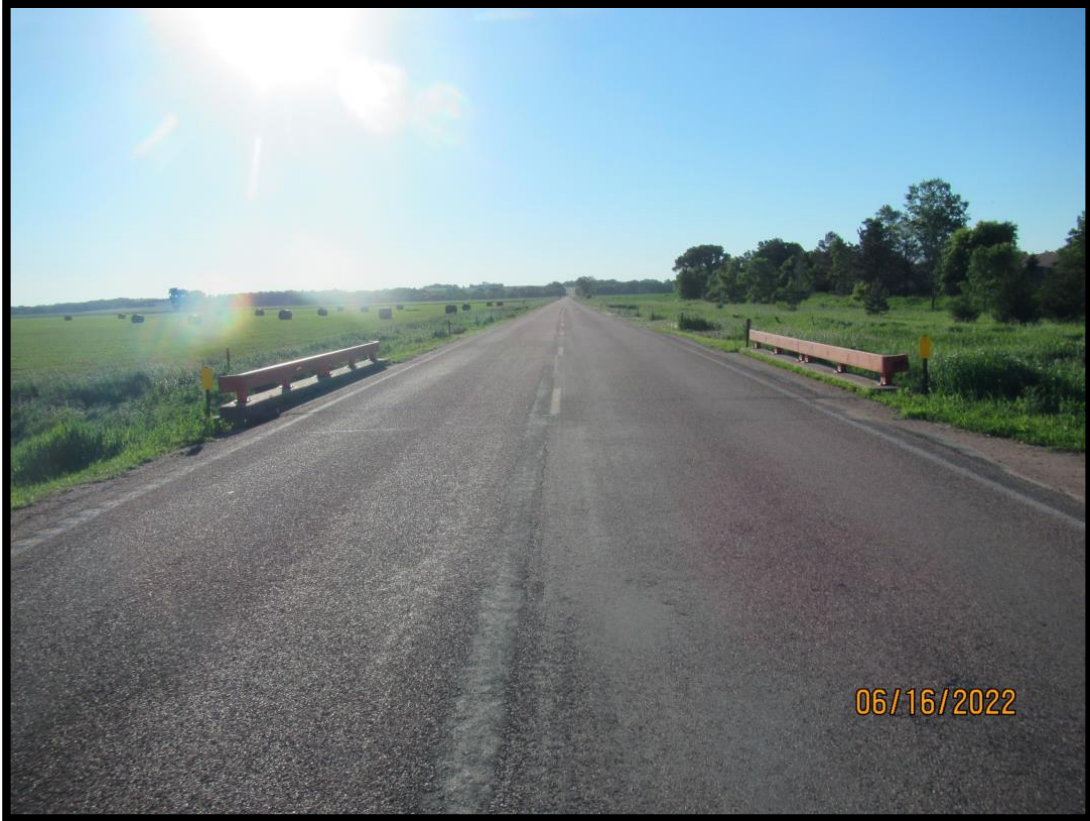
50-216-015_2022_1_CDI_Approach looking East

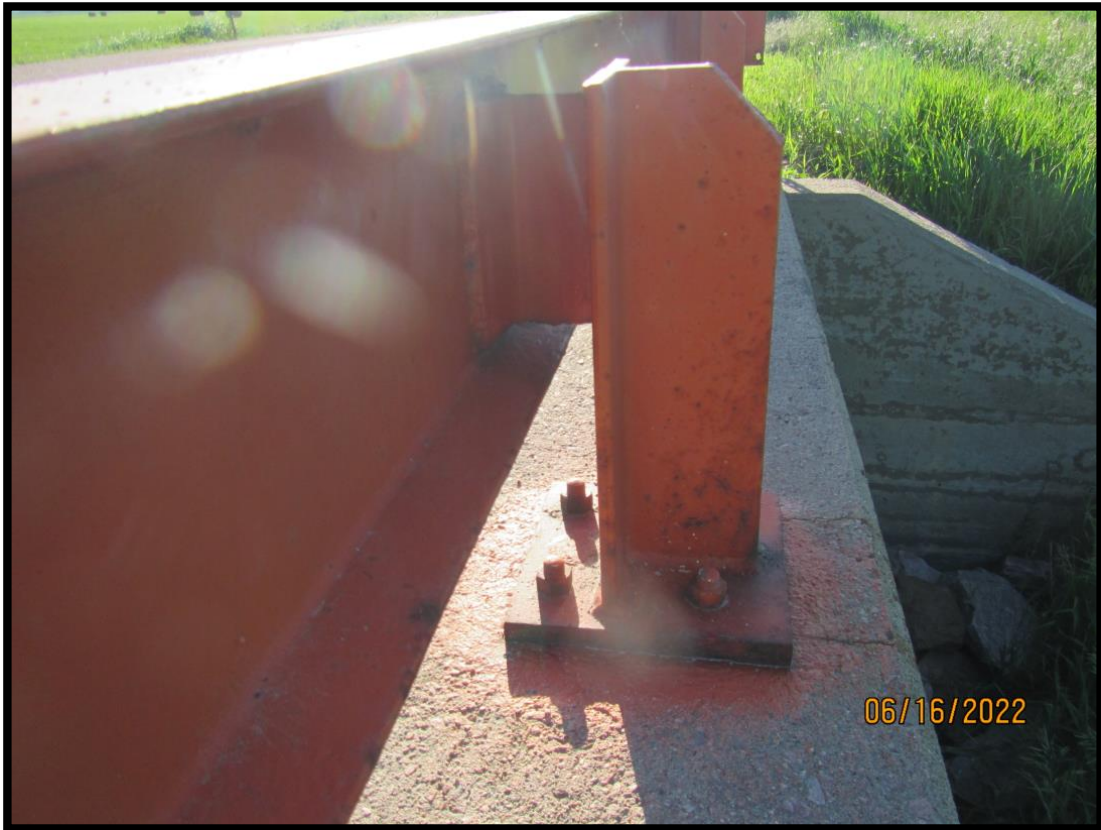
50-216-015_2022_11_CDI_Typical Rail Post Condition

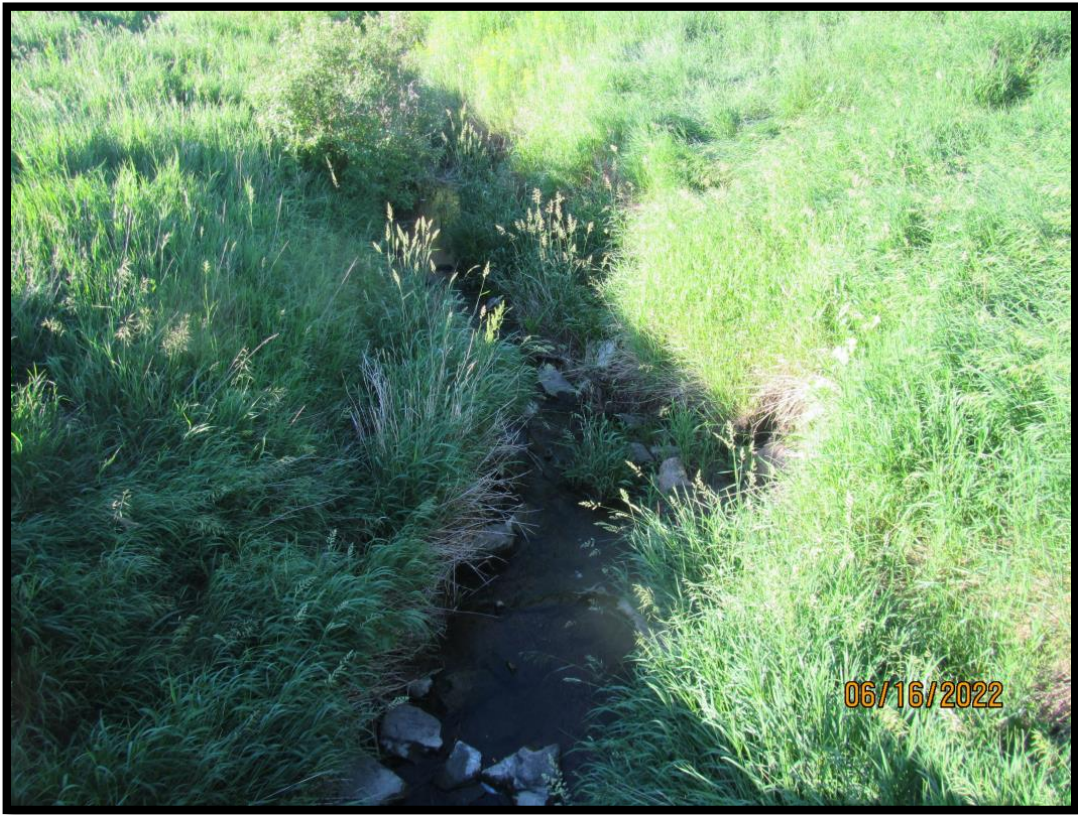
50-216-015_2022_27_CDI_Downstream Channel looking South

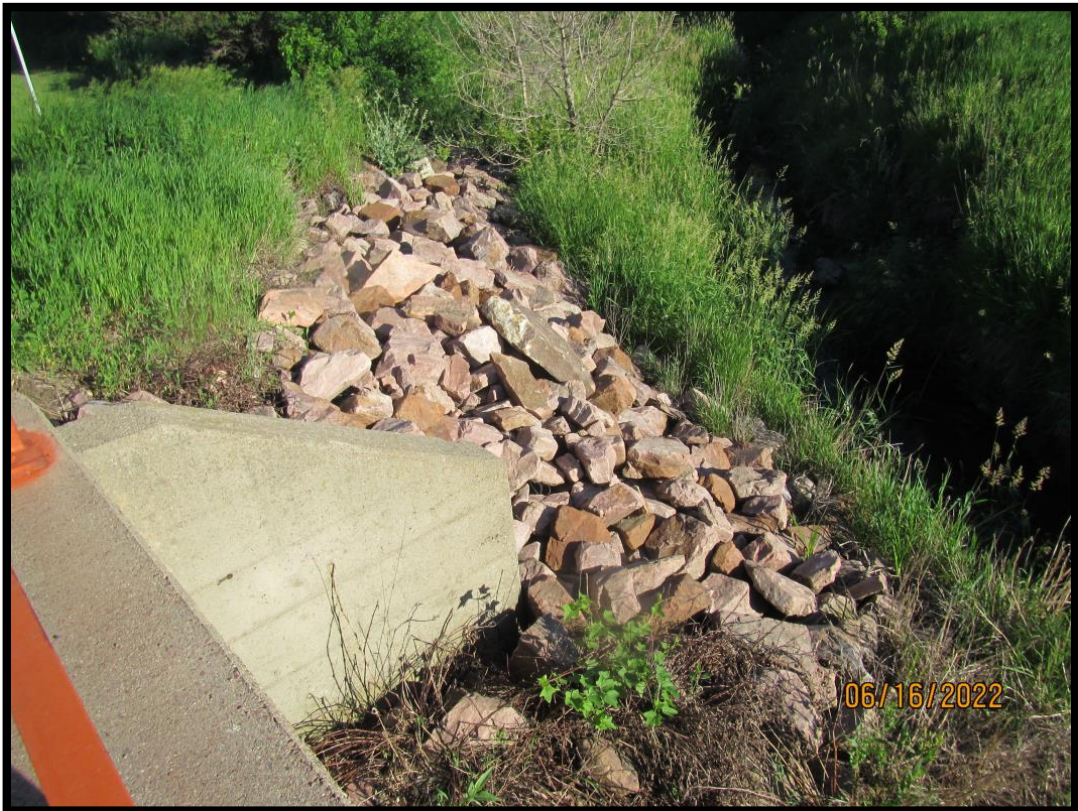
50-216-015_2022_28_CDI_Riprap along NW Channel Bank

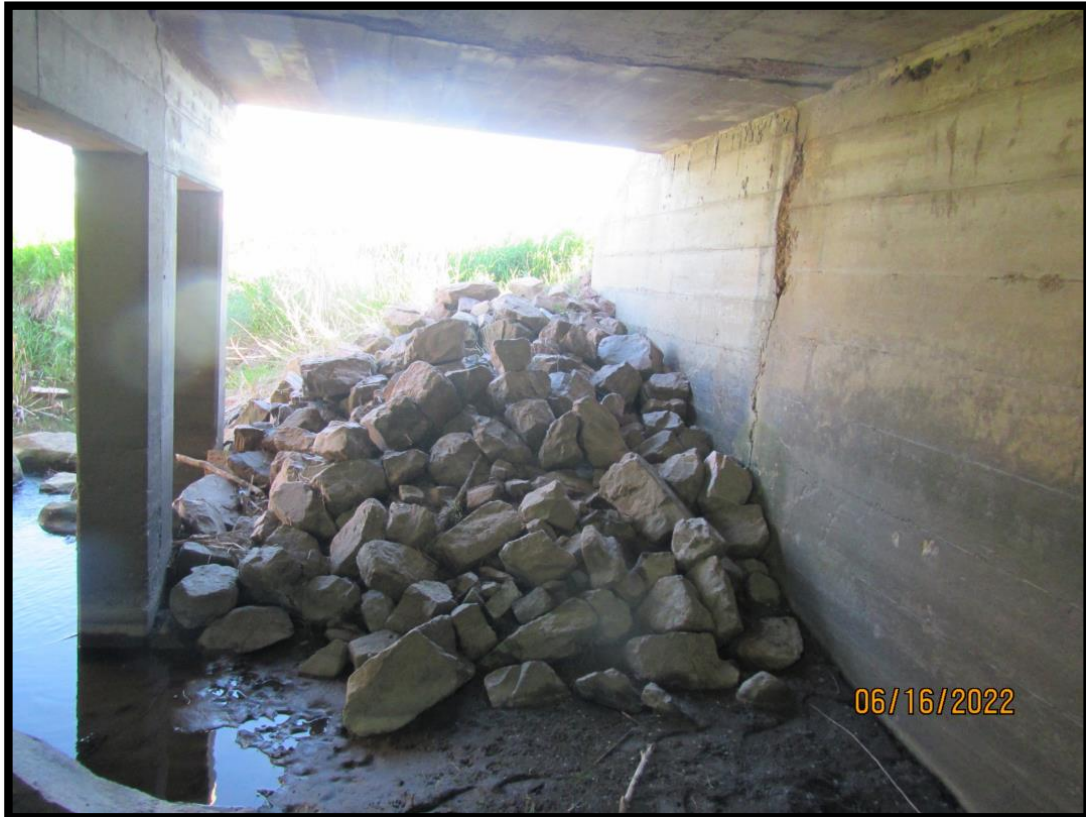
1. ABUTMENTS -
 - A. WINGWALLS - The wingwalls consist of cast-in-place concrete and are direct extensions of the backwalls. Some chips are evident along the tops of the wingwalls. It appears these chips occurred during the placement of the riprap. Overall, the wingwalls appear to be in relatively good condition.

50-216-015_2022_30_CDI_Riprap in front of NE Wingwall

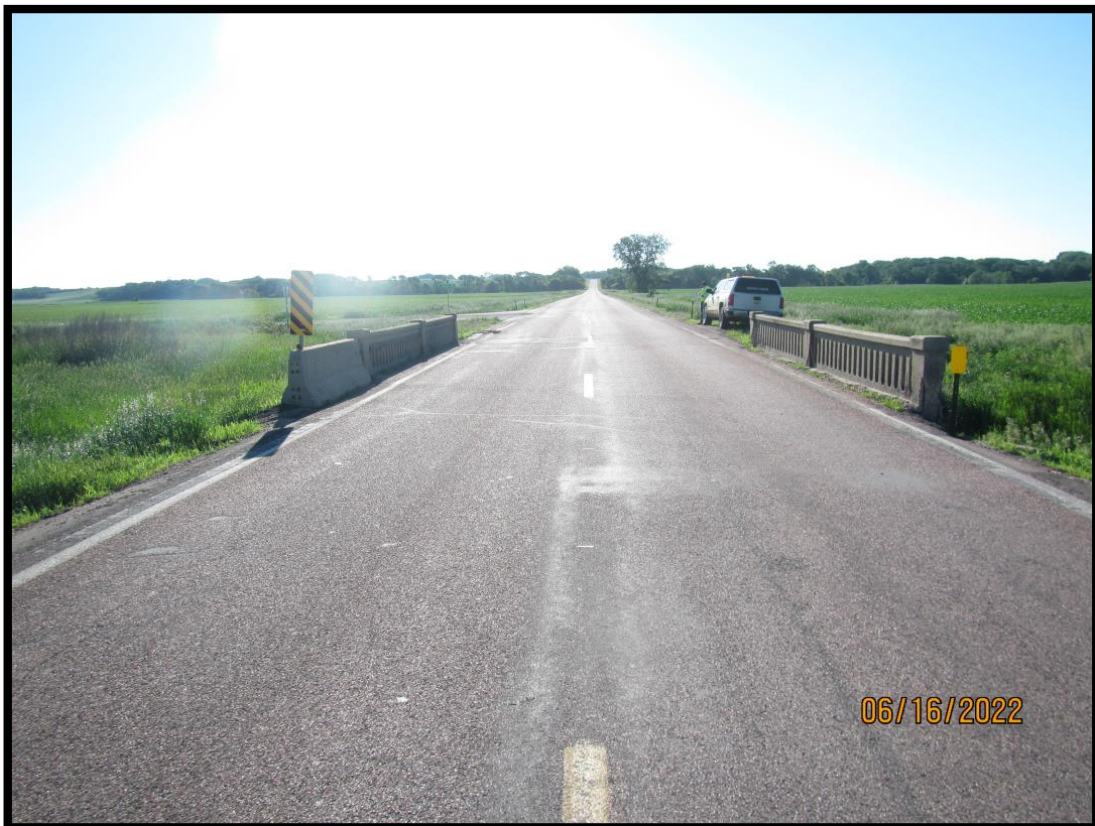
50-219-015_2022_2_CDI_Approach looking East

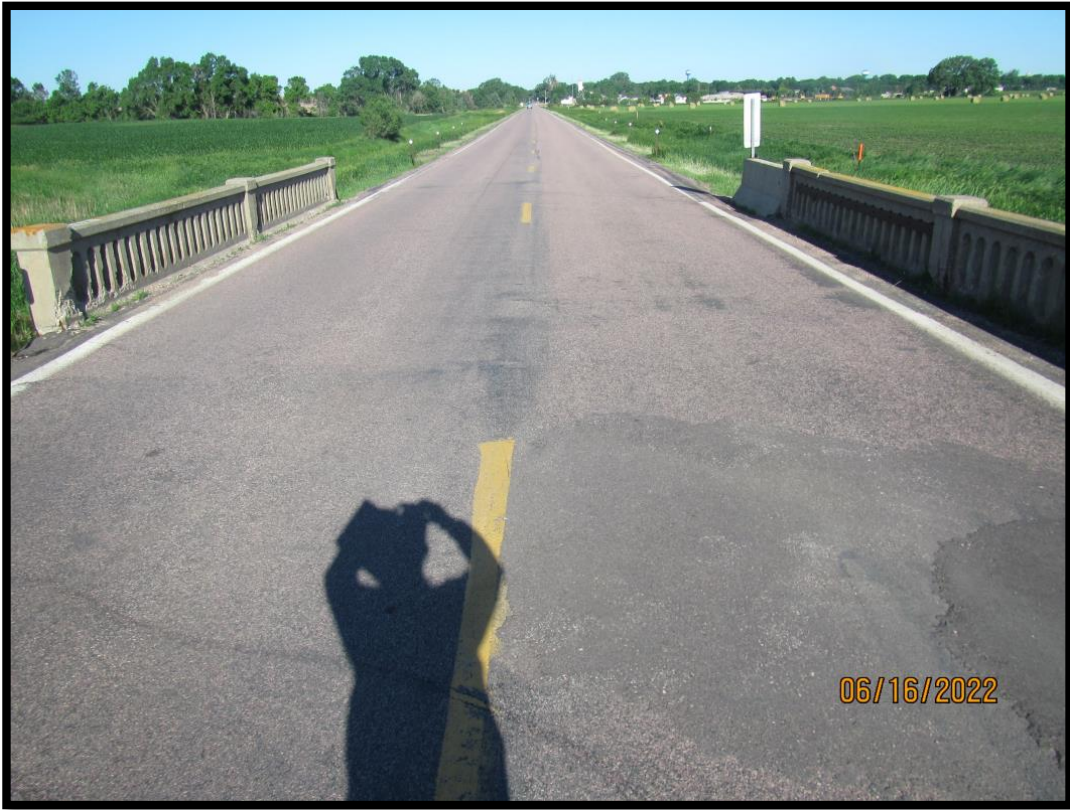
50-219-015_2022_7_CDI_Top of Bituminous Overlay looking West

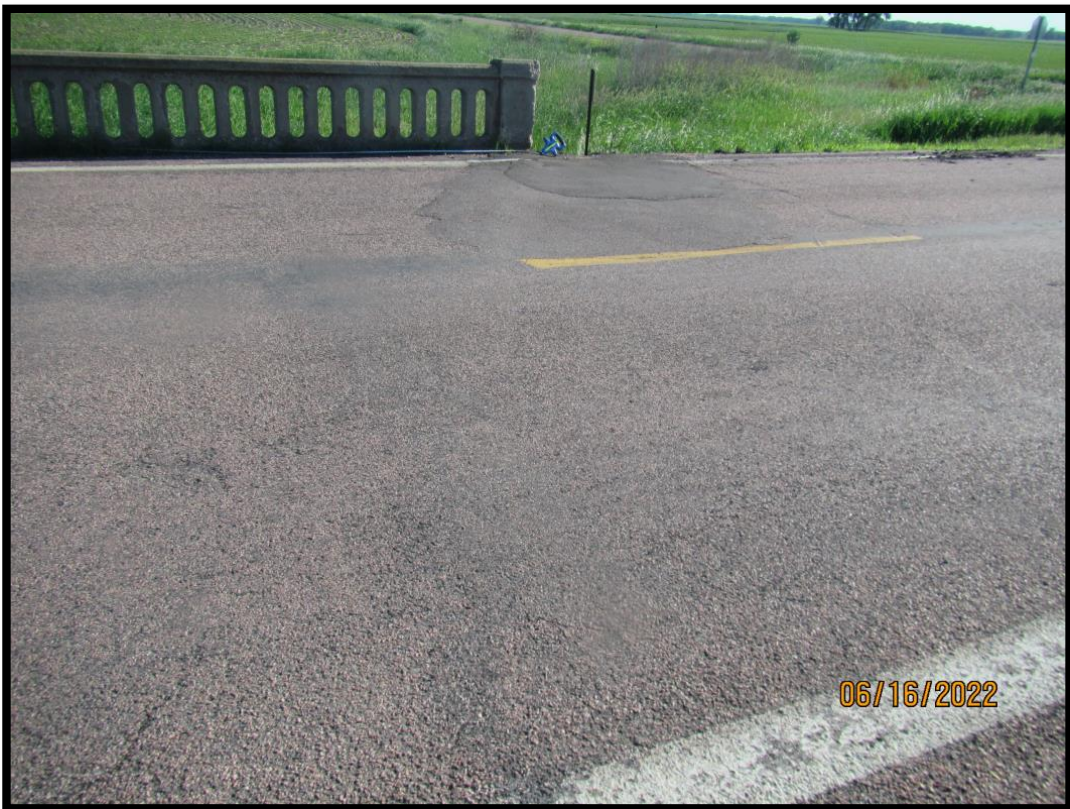
50-219-015_2022_8_CDI_Bituminous Patch at NE Bridge end

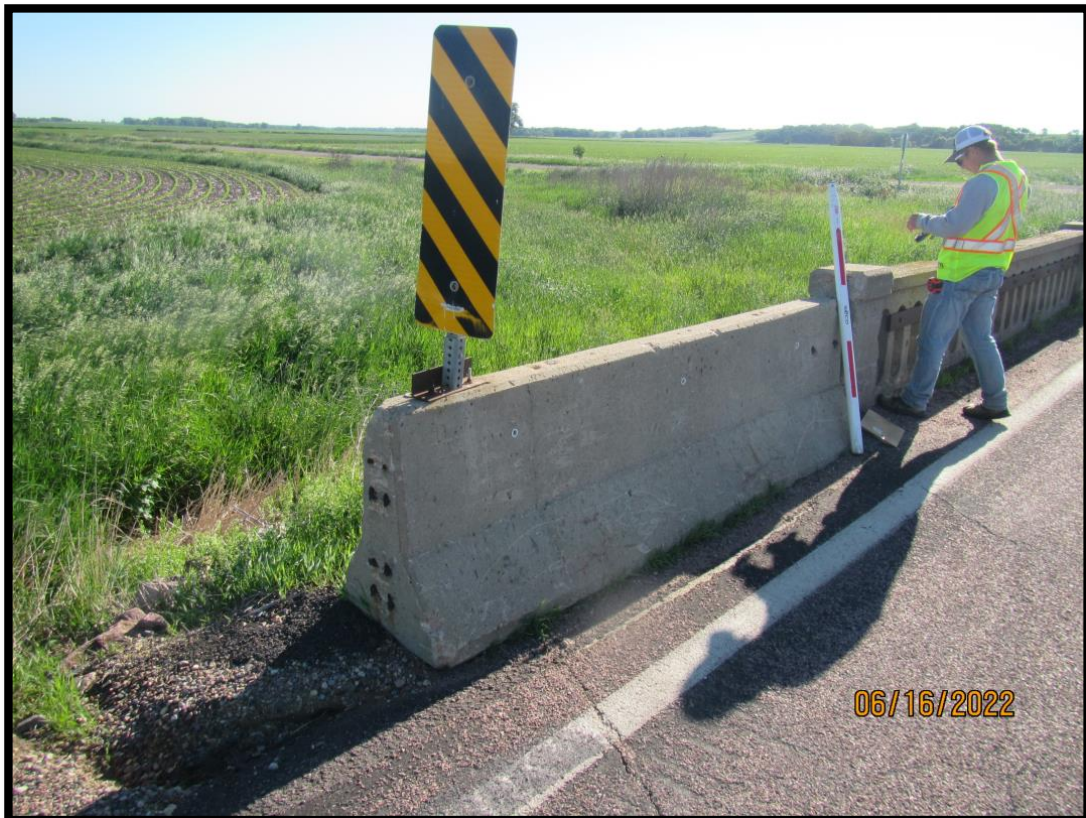
50-219-015_2022_14_CDI_NW Portable Concrete Jersey Barrier

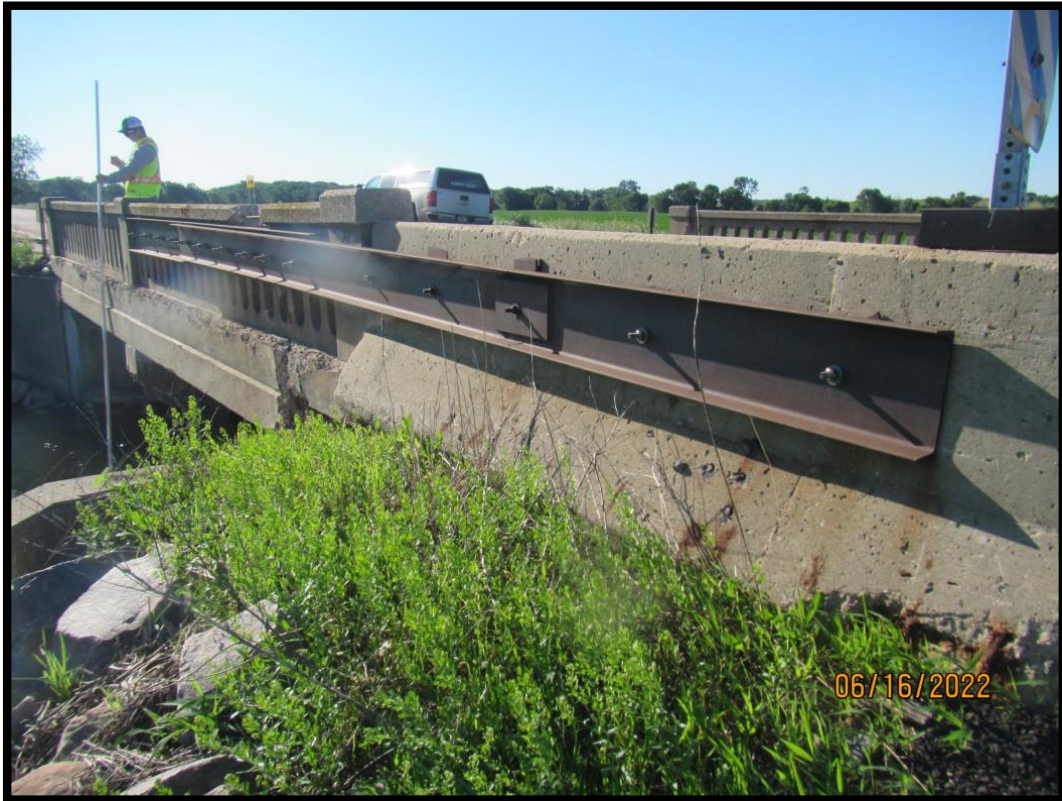
50-219-015_2022_16_CDI_Steel Channel Attached to Backside of NW Railing

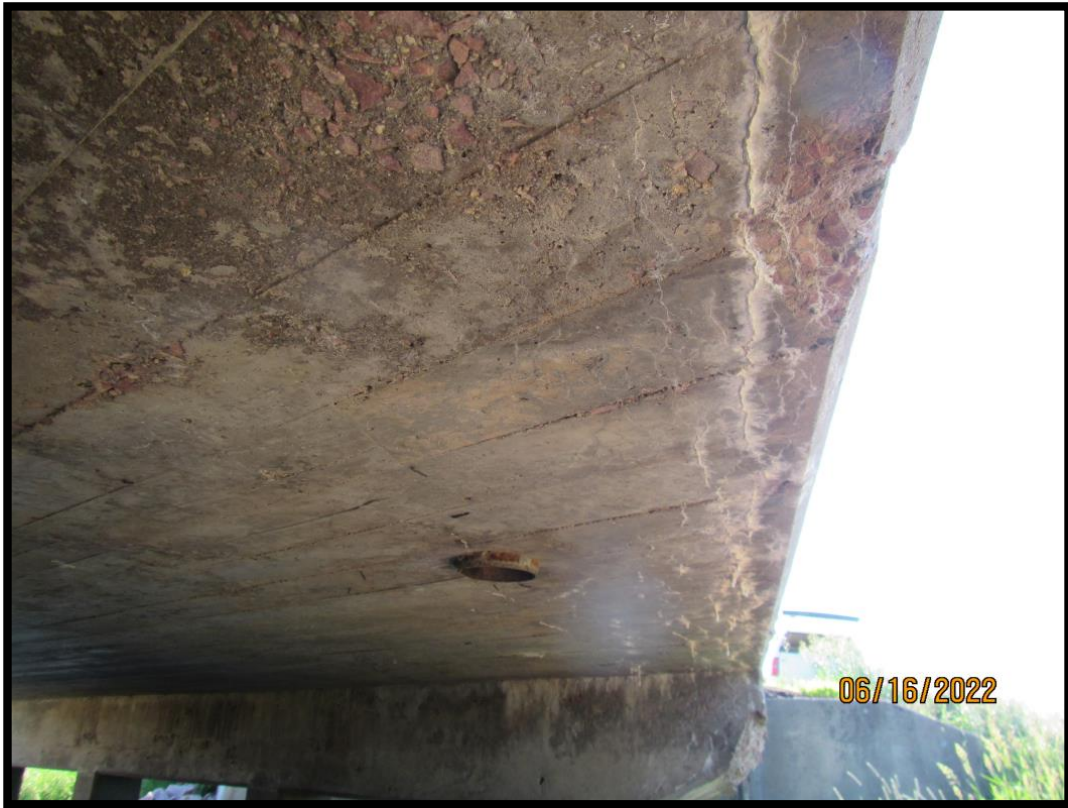
50-219-015_2022_17_CDI_Underside of South Edge of Slab in West Span with Stalactites

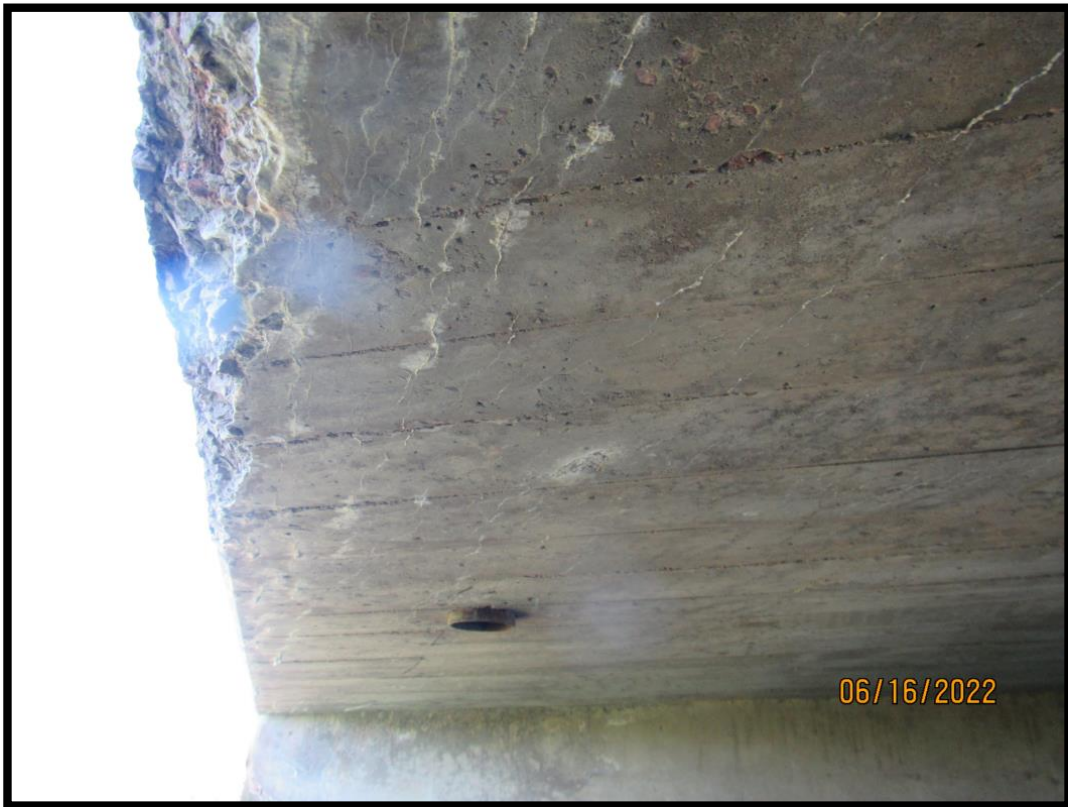
50-219-015_2022_18_CDI_Underside of South Edge of Slab in East Span with Stalactites

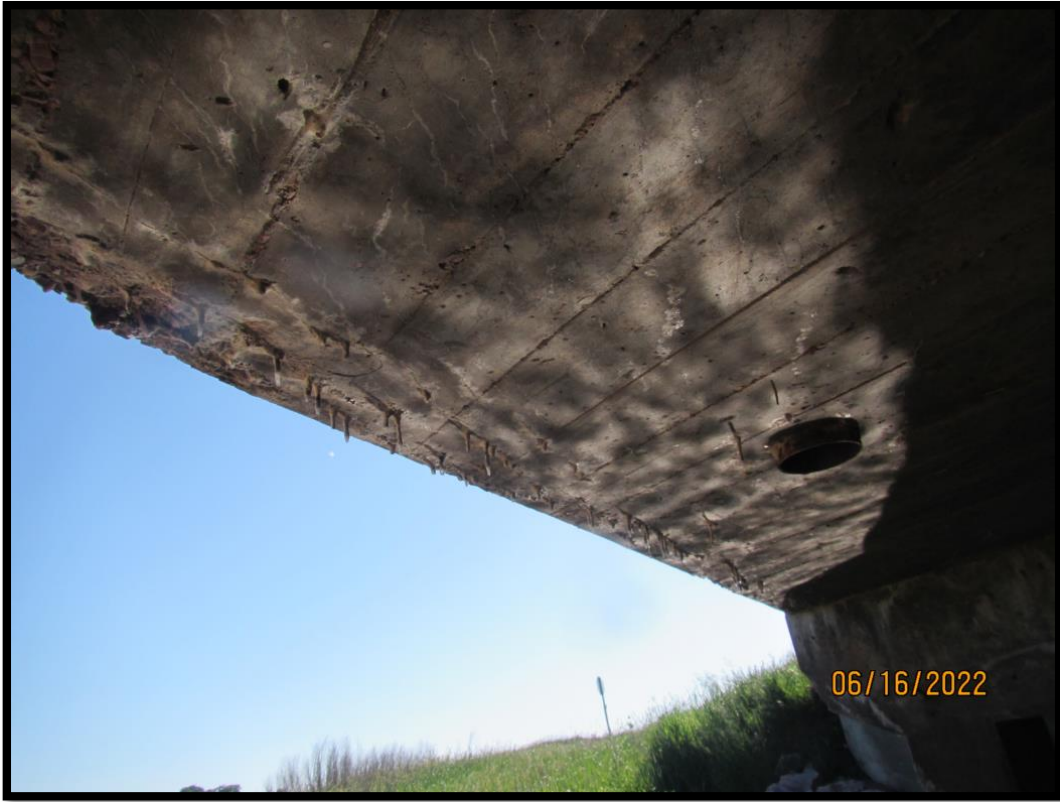
50-219-015_2022_19_CDI_Underside of North Edge of Slab in West Span with Stalactites

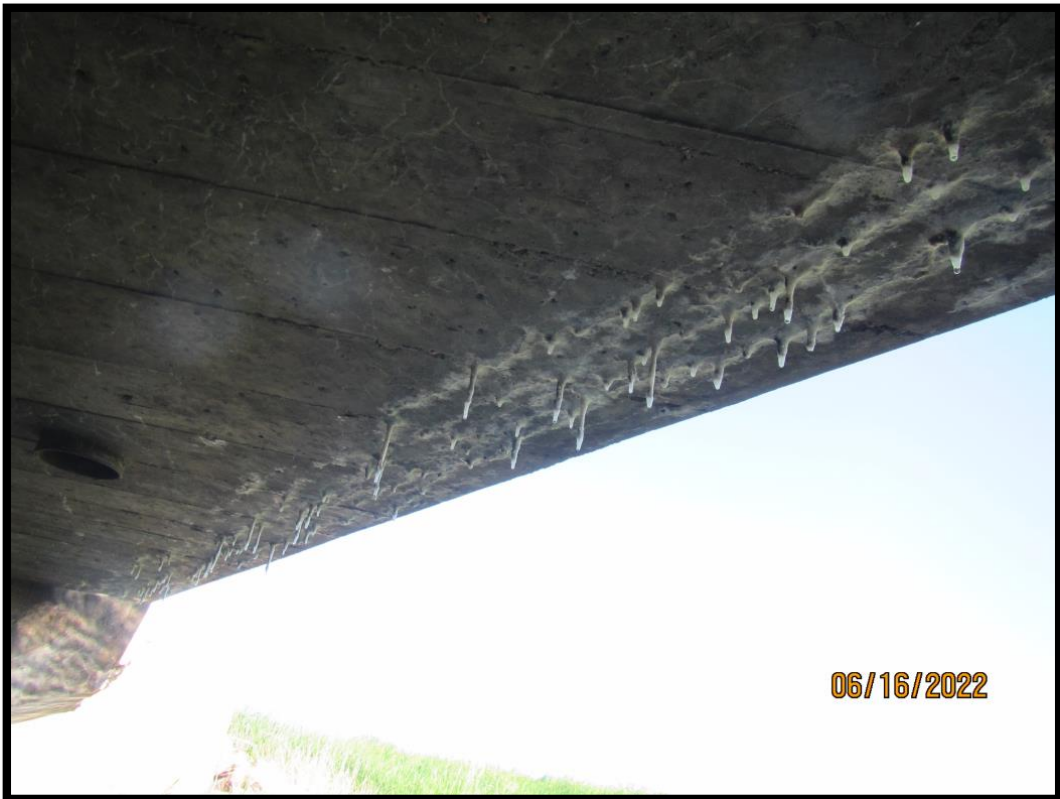
50-219-015_2022_20_CDI_Underside of North Edge of Slab in East Span with Stalactites

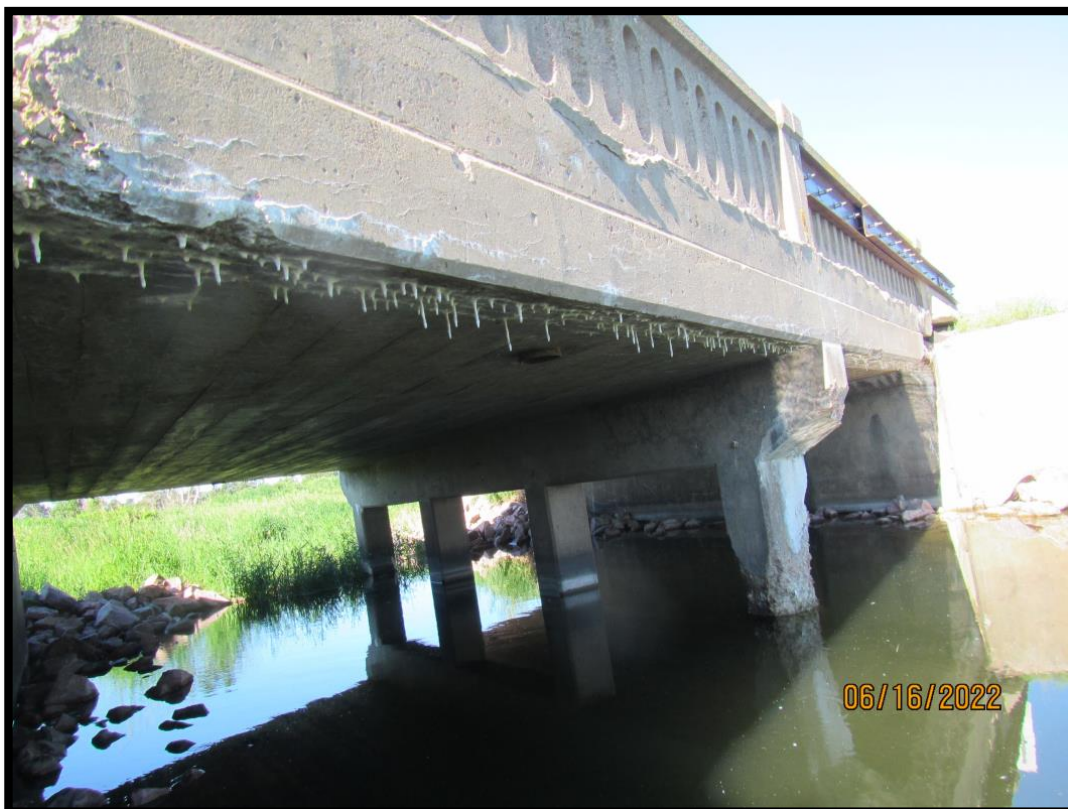
50-219-015_2022_22_CDI_North Edge of Slab with Active Stalactite Dripping

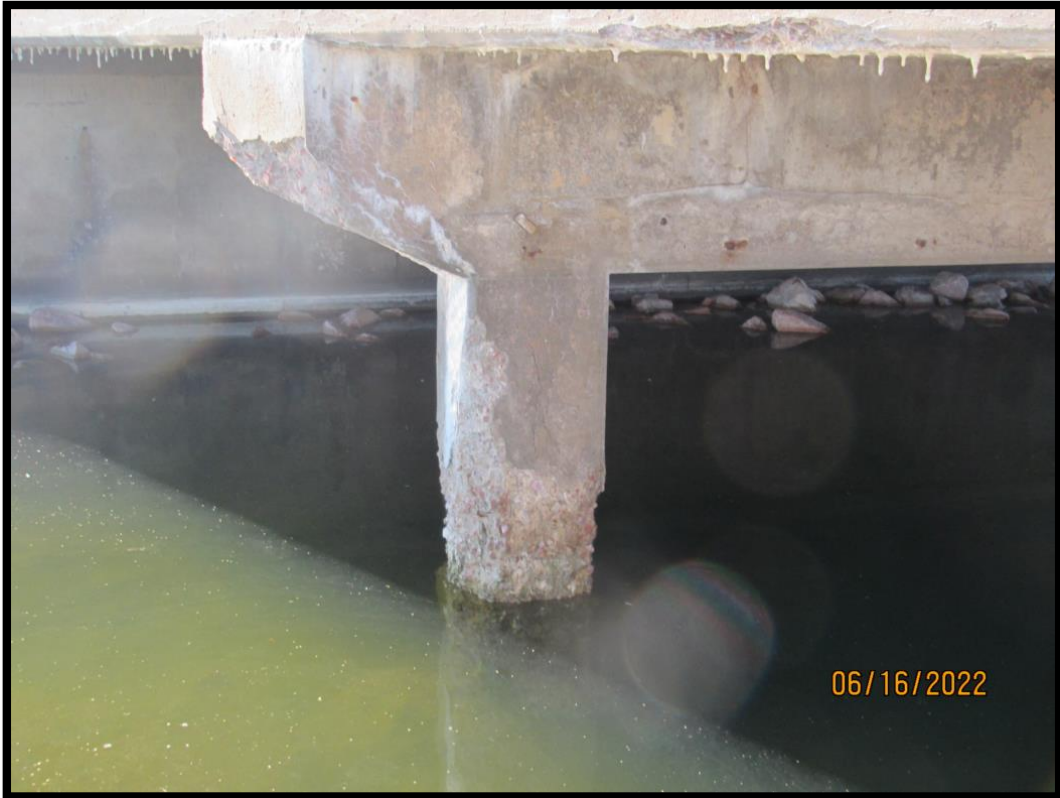
50-219-015_2022_24_CDI_North Bent Column Scaling

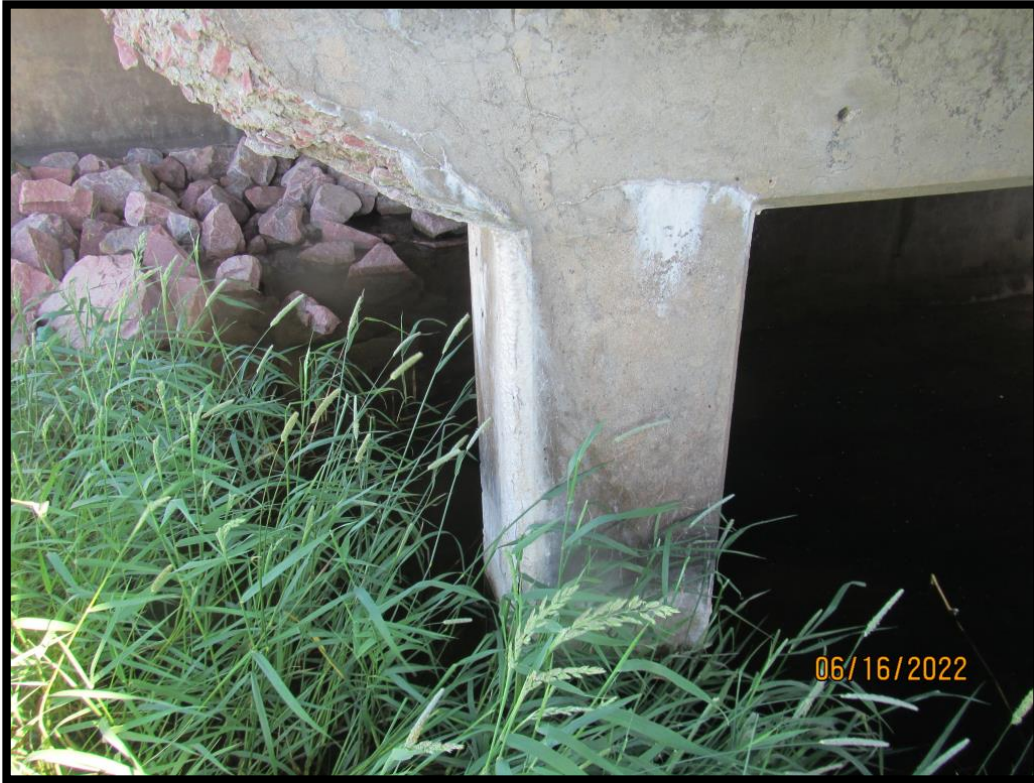
50-219-015_2022_25_CDI_Center Bent South Column Efflorescence Buildup

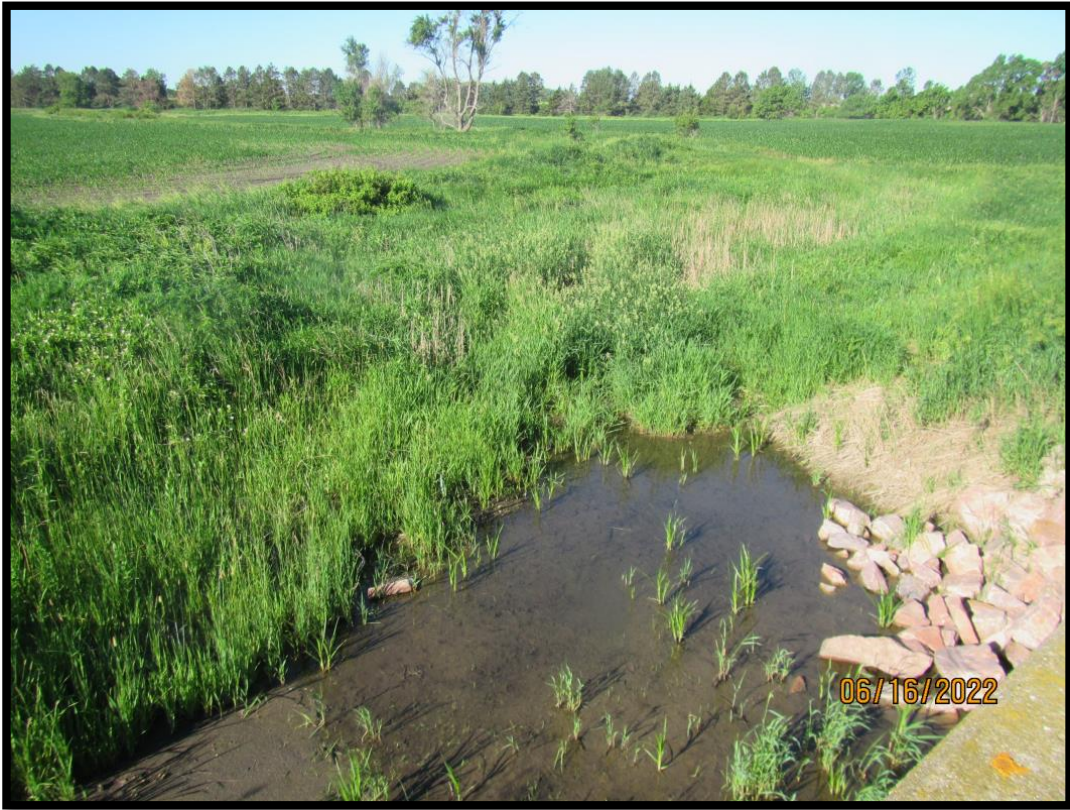
50-219-015_2022_27_CDI_Downstream Channel looking South

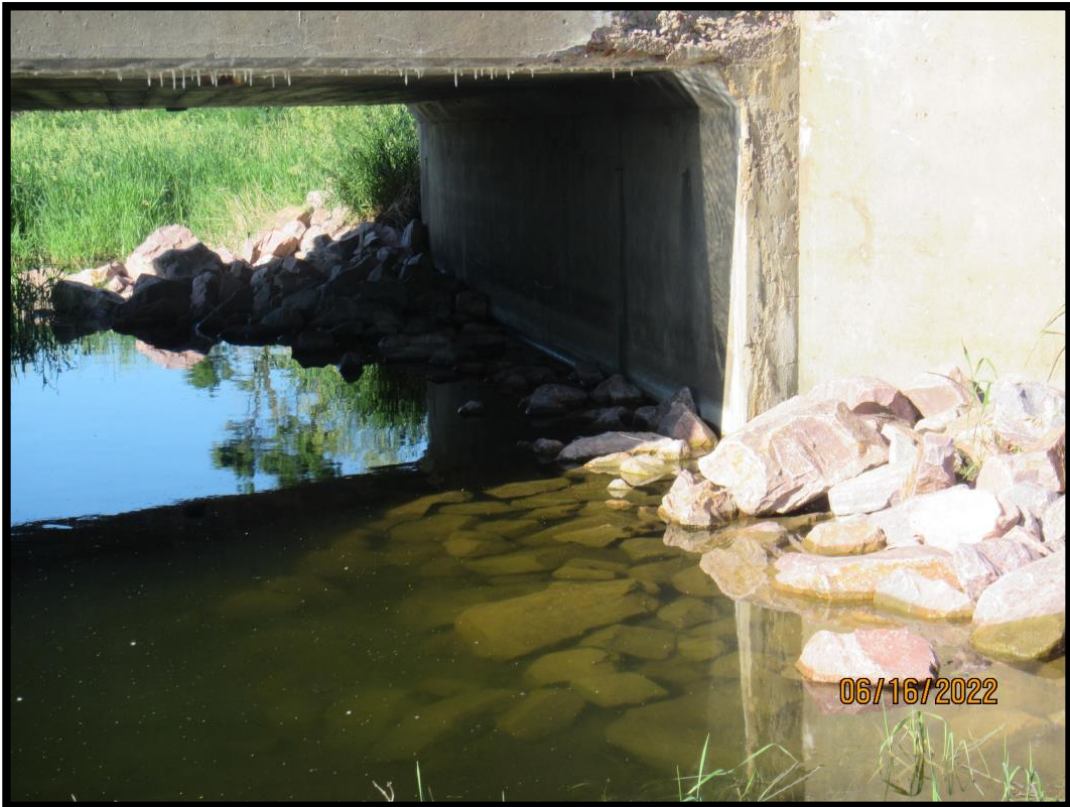
50-219-015_2022_28_CDI_Riprap in front of West Abutment

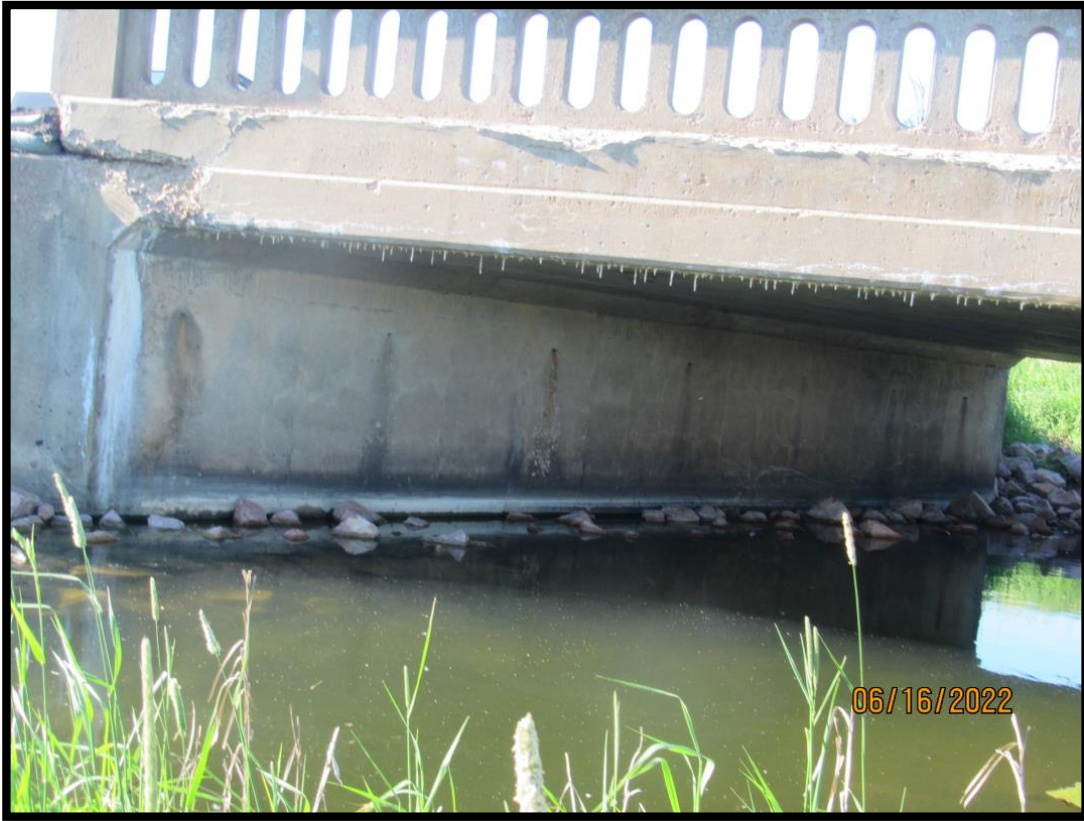
50-219-015_2022_29_CDI_Riprap in front of East Abutment

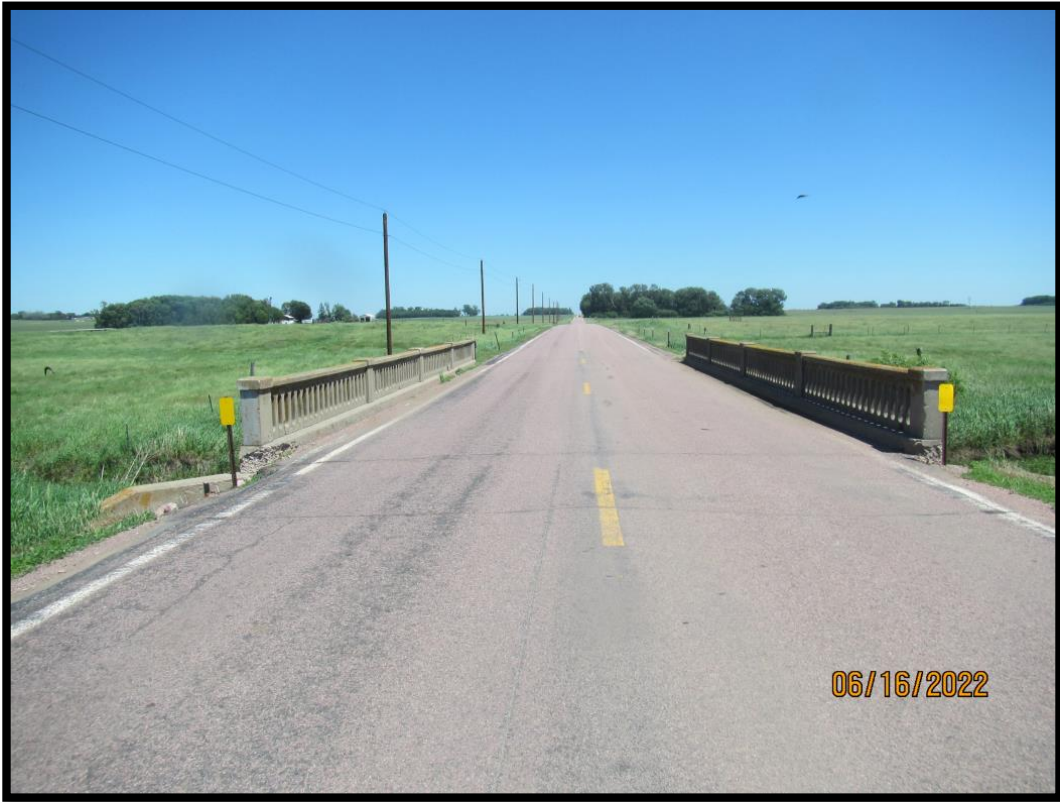
50-277-015_2022_1_CDI_Approach looking East

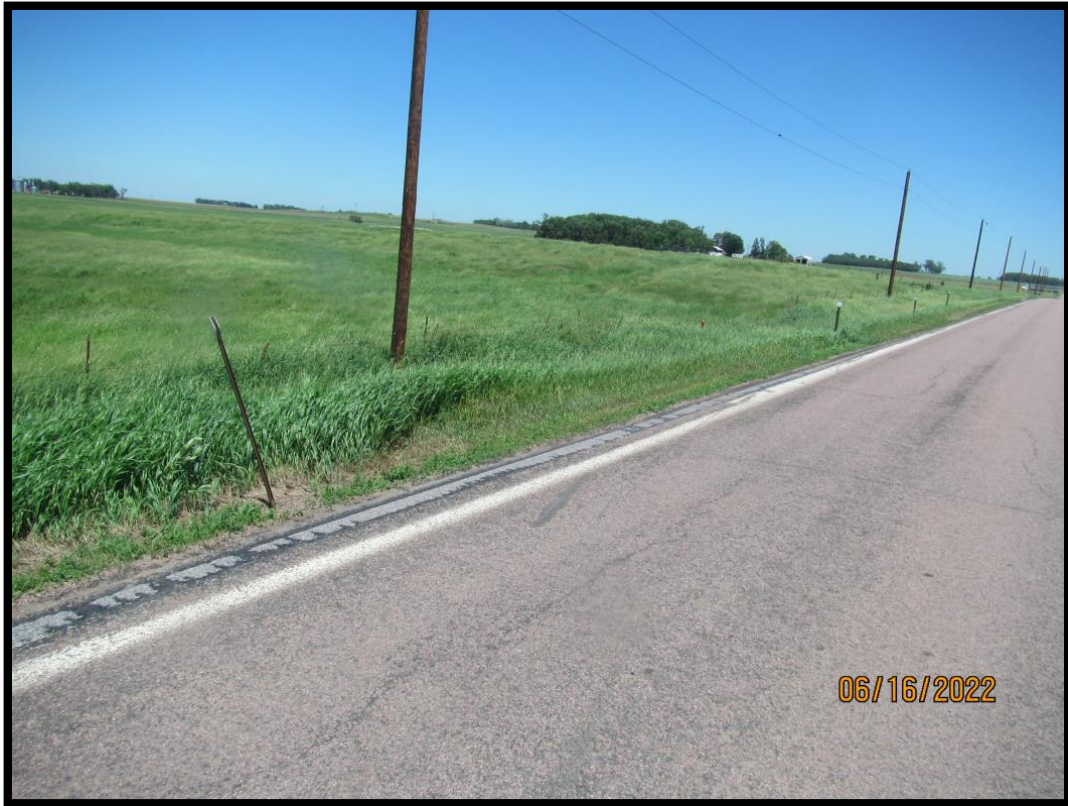
50-277-015_2022_5_CDI_1st NE Approach Delineator Bent

1. Straighten 1st NE and 4th SW approach delineators that are bent.
2. Install bridge railing rubrails and approach guardrails as required.
3. Clear deck drains as required.
4. Monitor scour at the bents.
5. **Structure is currently in the 5-year capital improvement plan & scheduled for future replacement.**

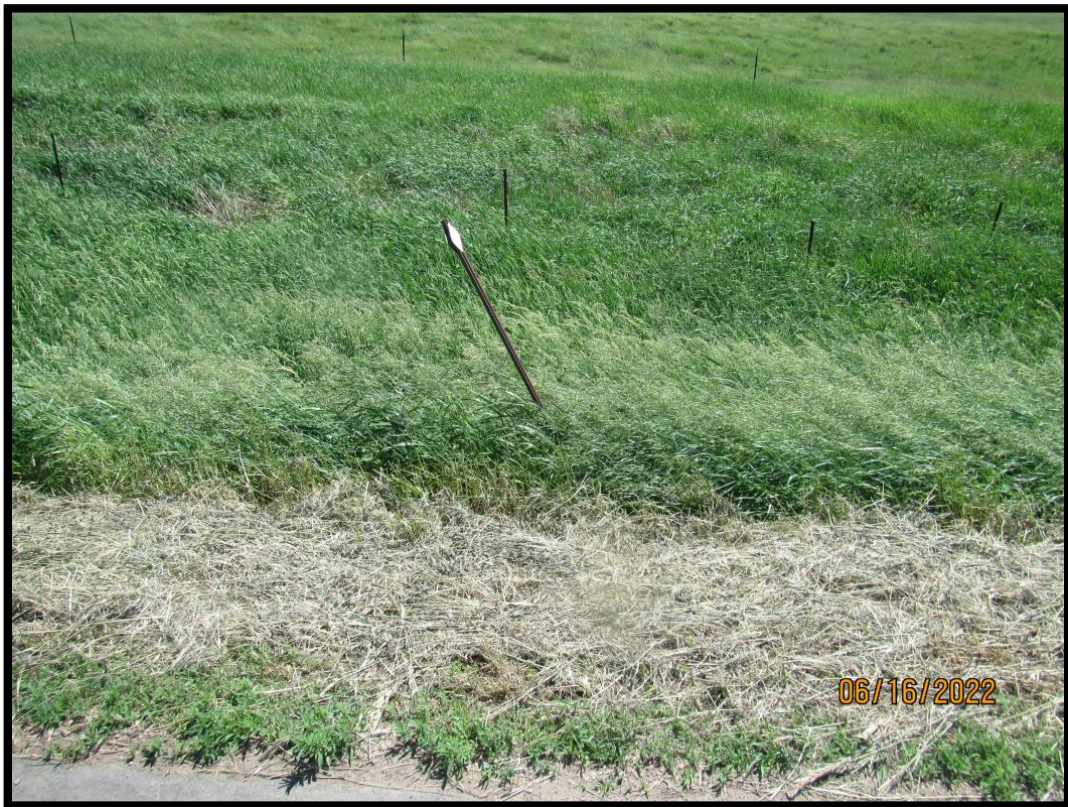
50-277-015_2022_6_CDI_4th SW Approach Delineator Bent

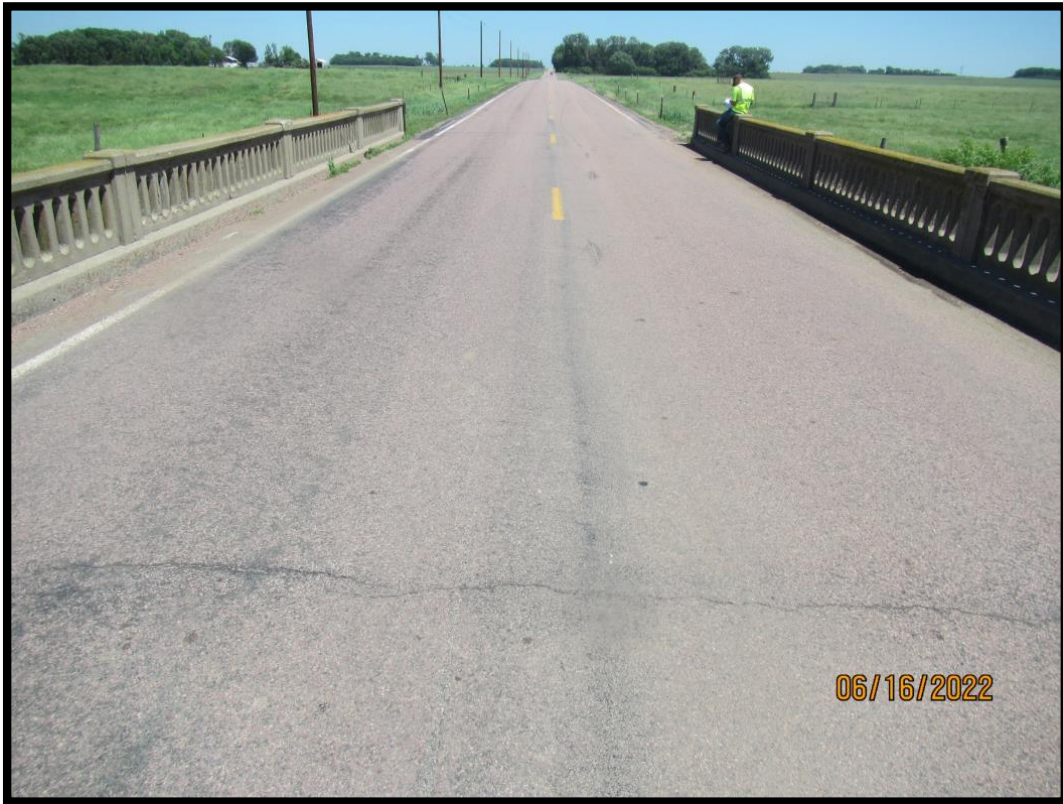
Cast-in-place concrete - The top surface of the concrete slab is not visible due to the bituminous overlay.
2. OVERLAY - TYPE, THICKNESS, AND CONDITION -

50-277-015_2022_7_CDI_Top of Bituminous Overlay looking East

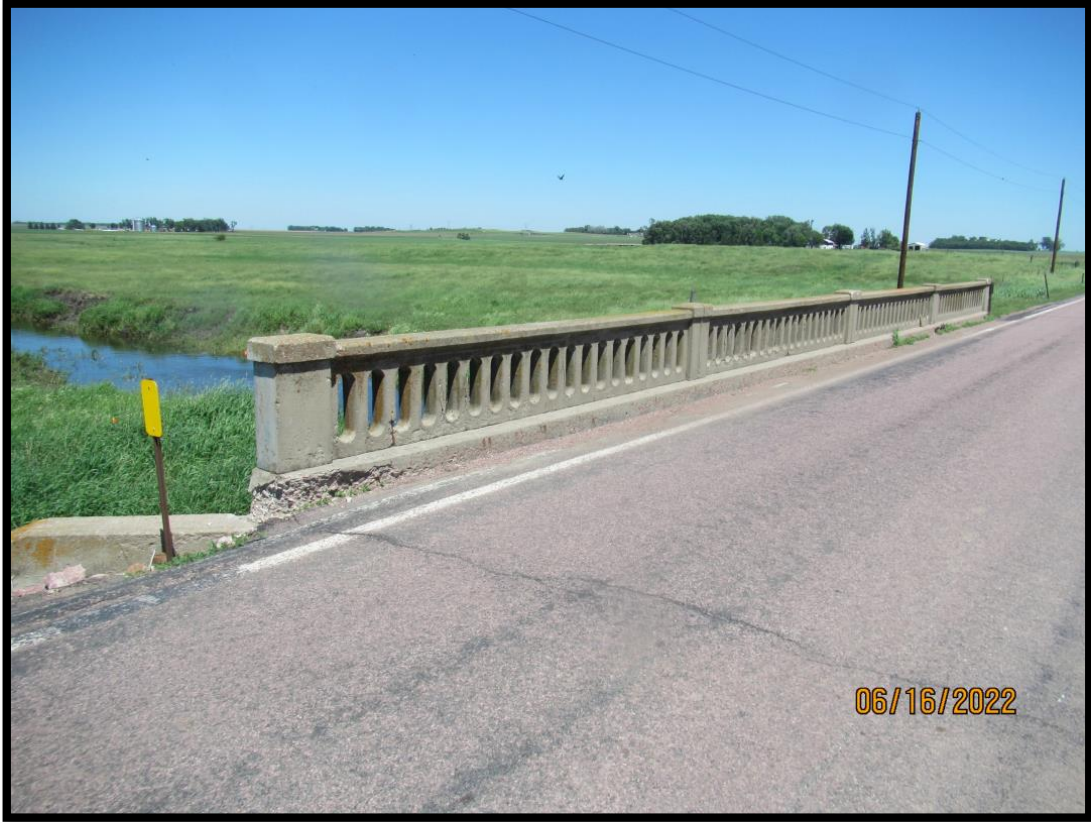
6. SIDEWALKS - None
7. RAILING OR BARRIER - The railings consist of reinforced concrete pigeon hole railings. Several spalls, cracks, and areas of exposed reinforcing steel are evident throughout. The south railing has a moderately to heavily weathered appearance with some moss evident on the surface of the railing. There are some small chips and some scrapes evident at the west end of the south railing. It appears these chips and scrapes are due to a vehicle impact.

50-277-015_2022_14_CDI_North Bridge Rail
