Bridge Inspection Report for Minnehaha County South Dakota **2022**

Structure No. 50-216-015 Jasper Street / Co. Hwy 104

Dell Rapids Township

10/28/22

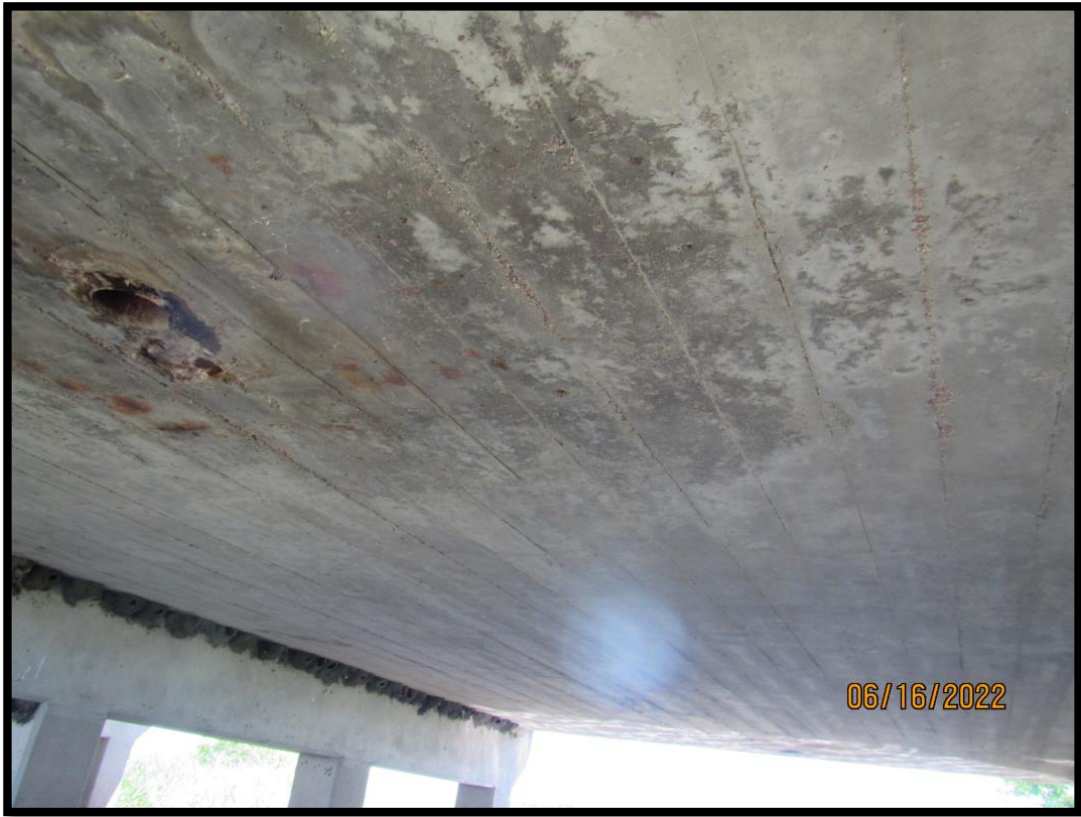
50-277-015_2022_17_CDI_Underside of Slab Span #2

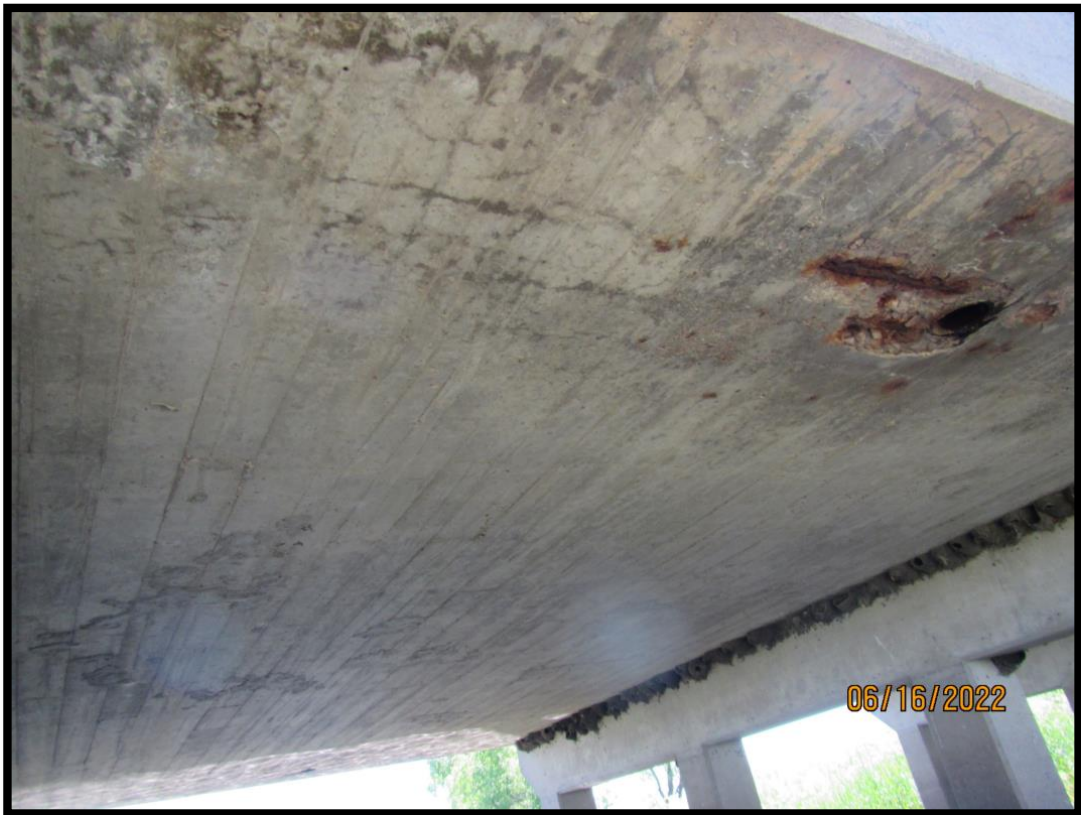
50-277-015_2022_18_CDI_Underside of Slab Span #3

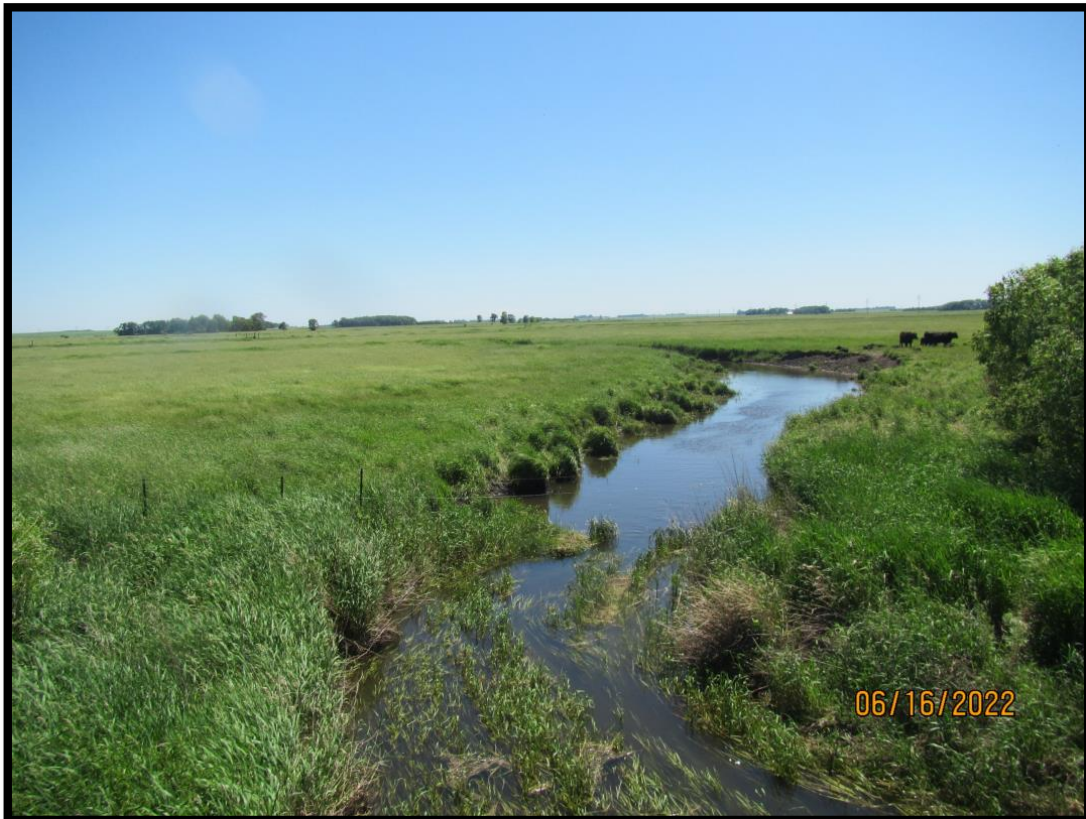
50-277-015_2022_26_CDI_Downstream Channel looking South
