Bridge Inspection Report for Minnehaha County South Dakota **2022**

Structure No. 50-219-015 Jasper Street / Co. Hwy 104

Repair and Posting Recommendations Bridges Maintained by Local Governments

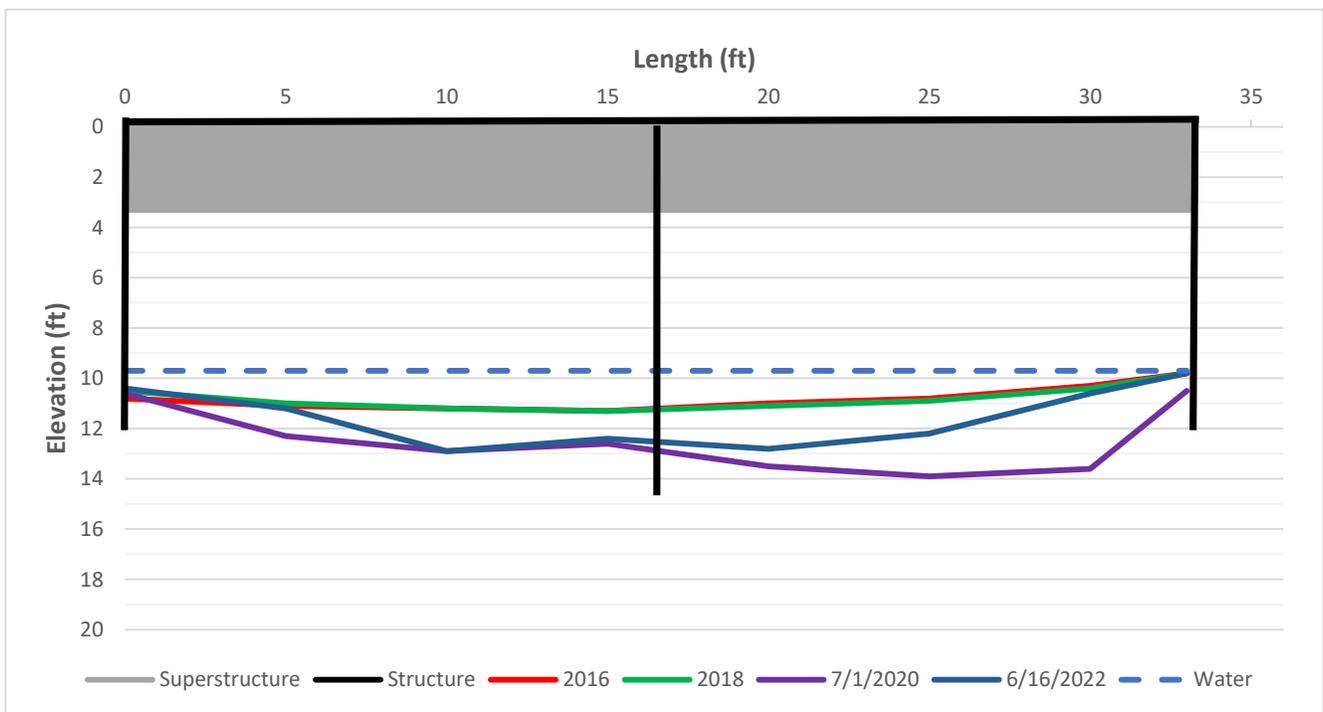
WATER ELEV: **9.7**

2016	2018	7/1/2020	6/16/2022	ABUT./BENT	
West End	0	10.8	10.5	10.6	10.4	1	0
	5	11.1	11.0	12.3	11.2	2	16.5
	10	11.2	11.2	12.9	12.9	3	33
	15	11.3	11.3	12.6	12.4		
	20	11.0	11.1	13.5	12.8		
	25	10.8	10.9	13.9	12.2		
30	10.3	10.4	13.6	10.6	Top of RAIL to bottom of Superstructure 3.6 ft.		
East End	33	9.8	9.8	10.5	9.8
