**INTERSTATE 94 over SUNSET DR/NW MANDAN INT.**

**Location: 5 EAST OF ND 25**

**Inspection Date: 04/26/2023**

IDENTIFICATION	
(1) State Names	38 - North Dakota
(8) Structure Number	0094-152.329 R
(5) Inventory Route	1
(2) Highway Agency District	1 - Bismarck
(3) County Code	30 - Morton

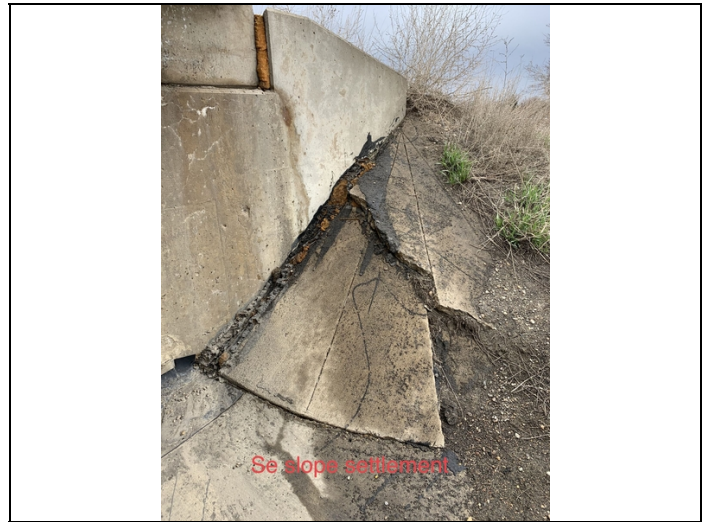
South end east slope protection broke and erosion
