Dakota County Intersection Study

Location: CSAH 54 & CSAH 68

Date: November 2018

Reason for Study

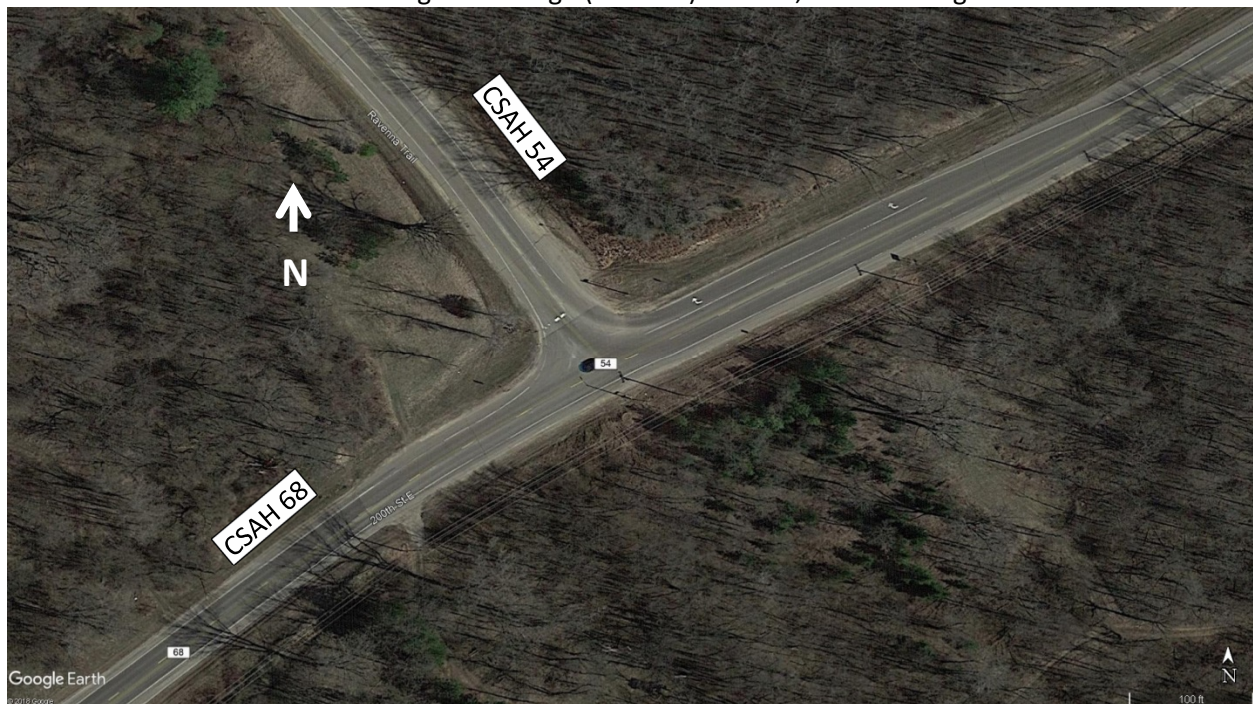
The intersection of CSAH 54 and CSAH 68 (see Figure 1) is located within Ravenna Township on the eastern end of Dakota County. CSAH 54 runs northwest/southeast, with one lane going in each direction, and it comes to a T at its intersection with CSAH 68. It has shoulders approximately eight ft. wide, it is classified as a Major Collector and has a statutory (55mph) speed limit. CSAH 68 is classified as a B Minor arterial and runs northeast-southwest. The NE-bound direction has one through lane with an approximately eight ft. shoulder and the SW-bound direction has one through lane, one dedicated right turn lane and an approximately eight ft. shoulder before the taper for the right turn lane. On its northeast leg, it has a posted speed limit of 55 mph and on its southwest leg; it has a posted speed limit of 45 mph.

Figure 1. Google Earth aerial of intersection of CSAH 54 and CSAH 68.
