# Standing Rock Sioux Tribe

## Pavement Management Plan

*May 2017*

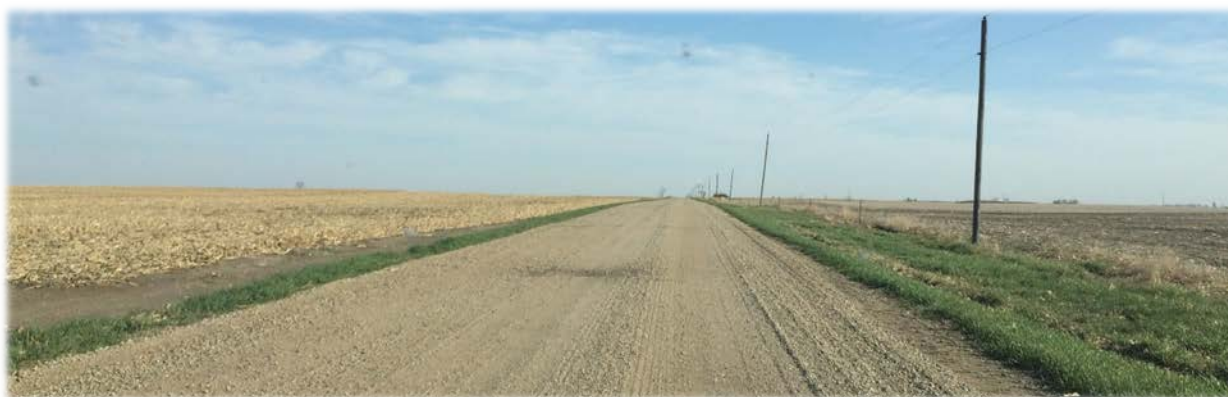
*Example Photo of a PASER Rating 1 Road*

No pavement. A PASER rating of 1 indicates a gravel road section with virtually no visible pavement. Example: none in the study area.

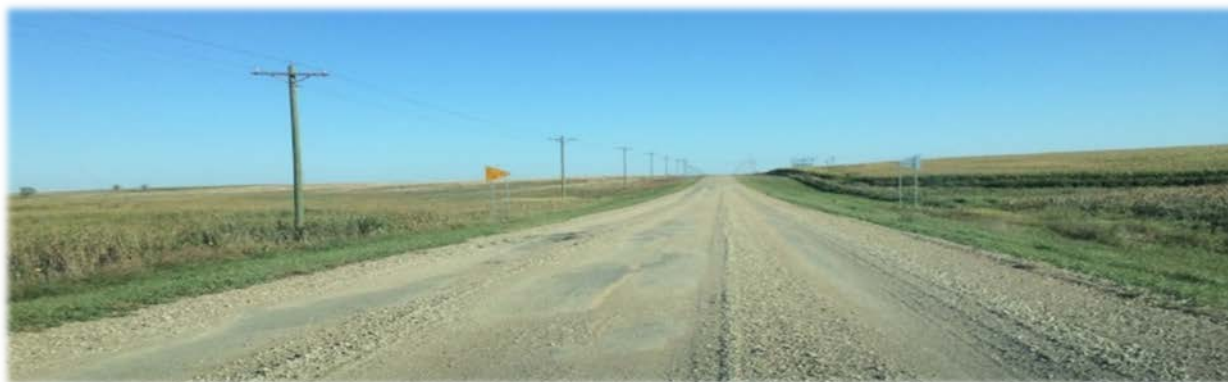
*Example Photo of a PASER Rating 2 Road*

Terrible. Heavy patching with gravel patches on failed asphalt. Limited pavement intact. No striping. Shoulders are deteriorated. You cannot drive this road at the posted speed limit. Drivers need to slow down. Example: none in the study area.

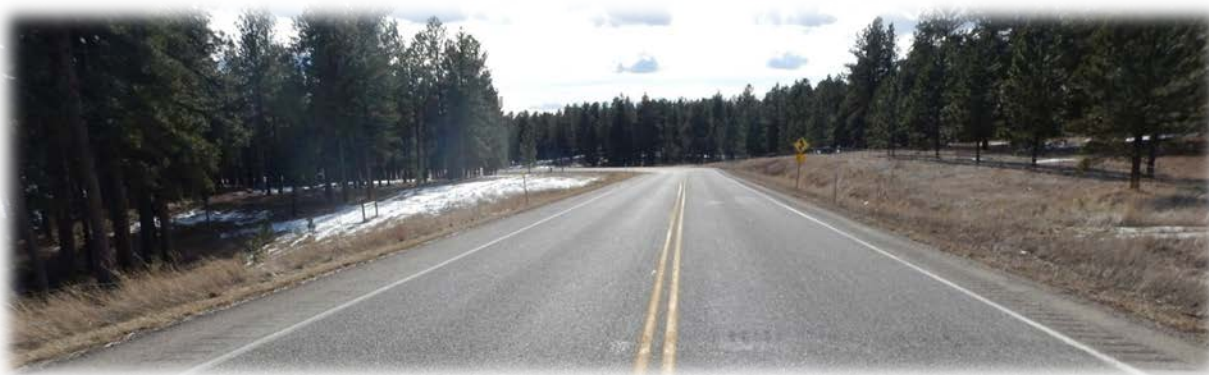
*Photo of a PASER Rating 9 Road*

Excellent. A relatively new road with new striping. This is usually a roadway that was reconstructed or overlaid recently. Example: None in the study area.

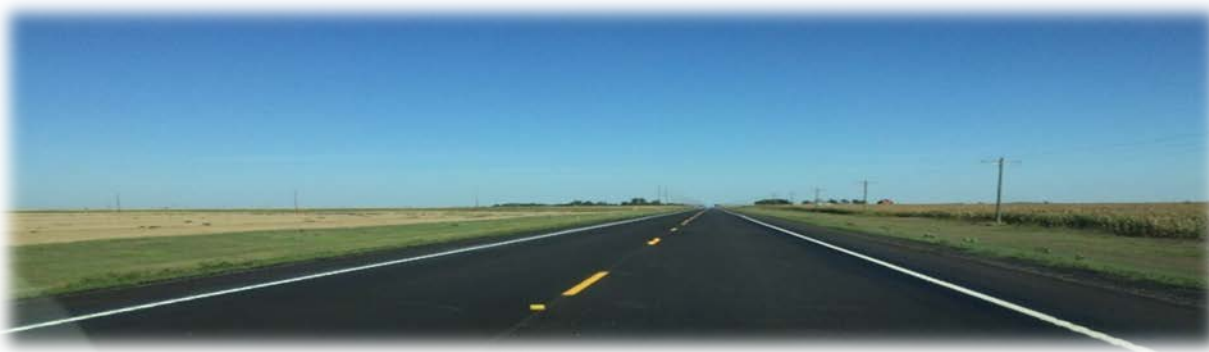
*Example Photo of a PASER Rating 10 Road*

Perfect. A brand new road with appropriate striping and shoulders. This is a roadway that was most likely reconstructed or overlaid in the last year. Example: None in the study area.

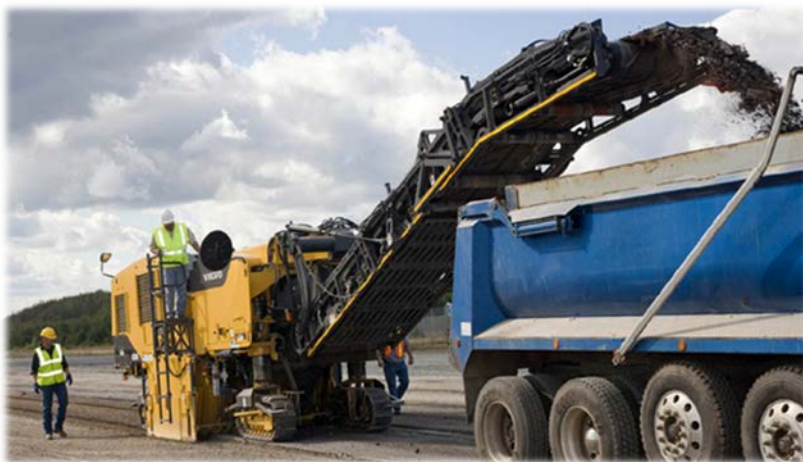
### **PASER Rating of 3:**

Very poor. Severe cracking and rutting with moderate visible potholes. Heavy patching with some patches on old patches. Limited striping. Shoulders are deteriorated. Areas are marked with flags. You cannot drive this road at the posted speed limit. Drivers need to slow down. Example: BIA Route 44, two miles south of Mahto, SD.

Patching and repair will need to be done prior to a major structural overlay (greater than 2"). Milling and removing deteriorated areas will extend the life of the overlay. The Tribe has expressed interest in reverting one particular area that was given a PASER Rating of 3, BIA 44 near Mahto, back to a gravel road.

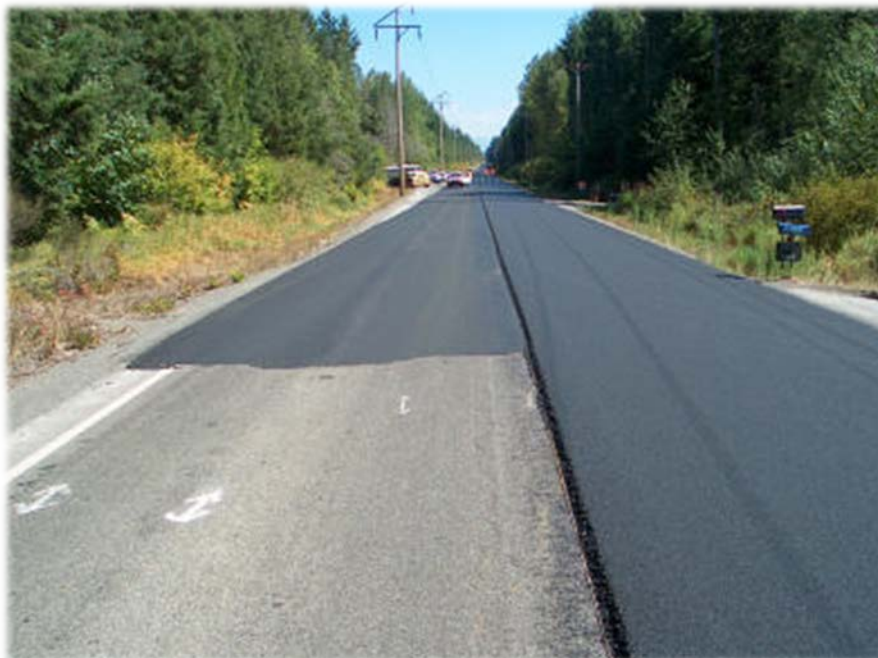
### **PASER Rating of 4:**

Poor. Heavy cracking and rutting with moderate visible potholes. Heavy patching with some patches on old patches. Limited striping. Shoulders are deteriorated. Cracks are not sealed. You cannot drive this entire road at the posted speed limit. Drivers need to slow down in areas. Example: BIA Route 3400, south from Little Eagle, SD.

Due to significant signs of aging, a structural overlay is required (greater than 2").

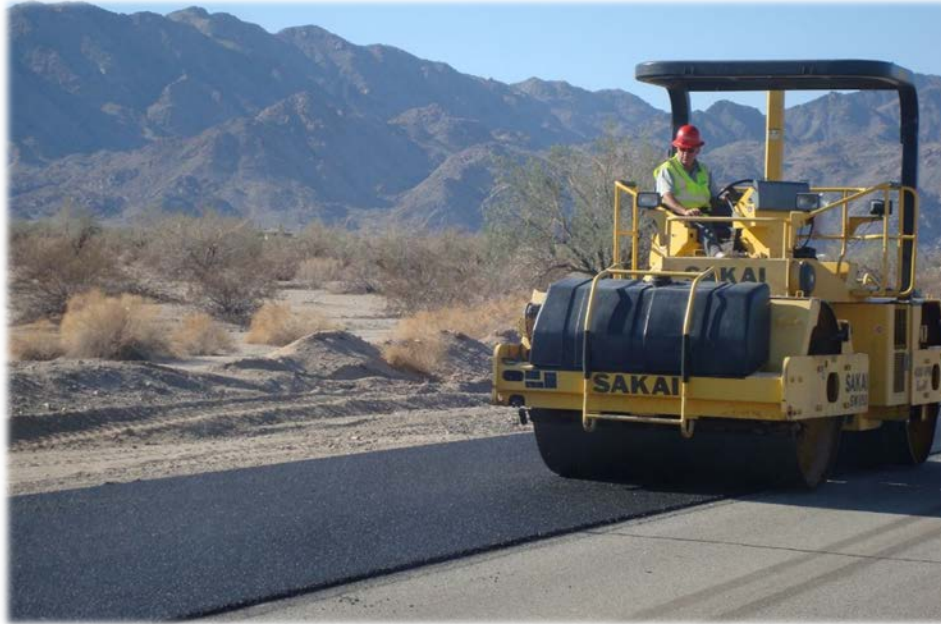
### **PASER Rating of 5:**

Fair. Moderate to heavy cracking with moderate rutting. Moderate patching with some patches on old patches. Limited striping. Cracks are mostly not sealed. You can still drive this road at the posted speed limit. Example: BIA Route 1, south of Cannon Ball, ND.

Primarily consists of aging asphalt, but with sound structural conditions. The roadway can benefit from patching where necessary, followed by a non-structural overlay (less than 2”).

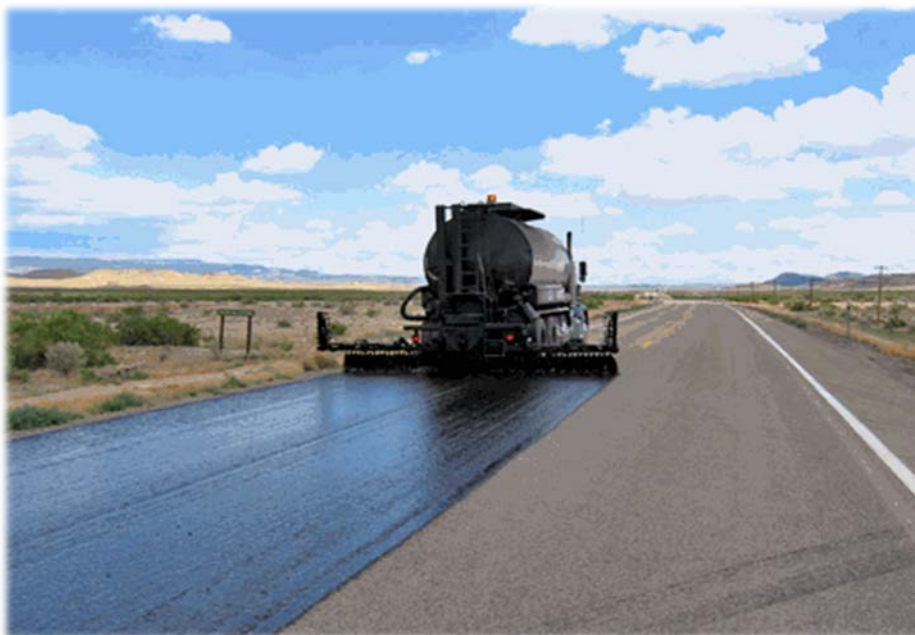
### **PASER Rating of 6:**

Fair. Moderate to heavy cracking or some raveling and rutting exists. Moderate polishing with occasional patches visible. Cracks are mostly sealed. Example: BIA Route 7 near Porcupine, ND.

Light signs of aging. The roadway life can be extended with routine crack sealing and a sealcoat.

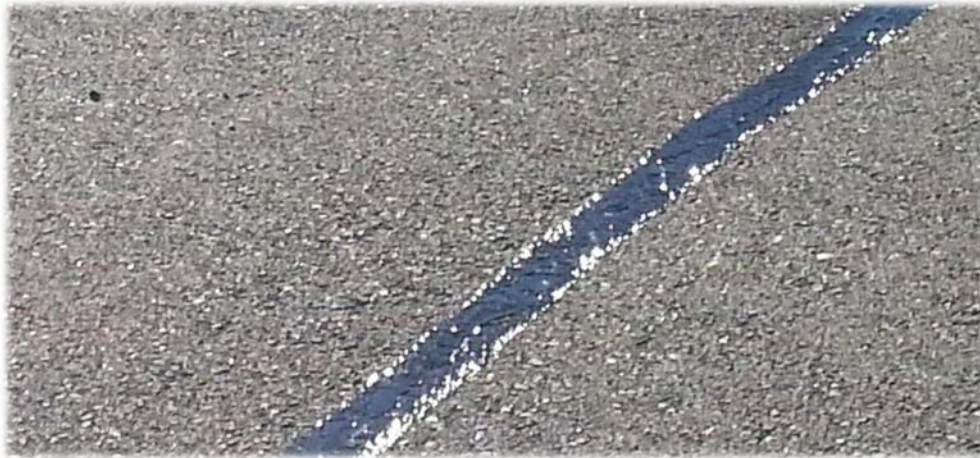
**PASER Rating of 7:**

Good. Some cracking, no raveling and little rutting. No patches are visible. Cracks are sealed. This roadway is not in need of immediate repair. Example: BIA Route 20, near Bullhead, SD.

Roadway shows very few signs of aging and can be maintained with routine crack filling.

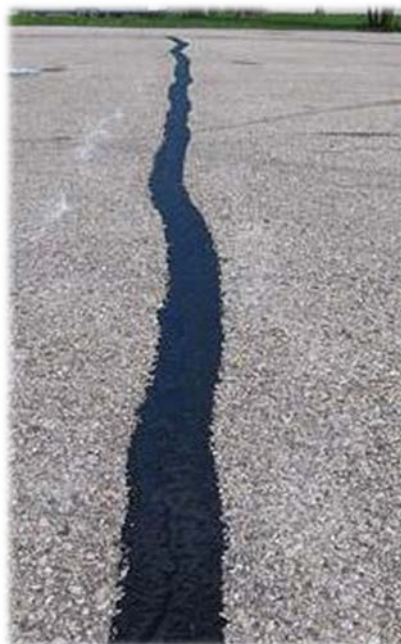
**PASER Rating of 8 and 9:**

Great. No cracking, raveling or rutting present. No patches or sealed cracks are visible. This roadway is not in need of repair. Example: BIA Route 3, near Kenel, SD.

No immediate maintenance is required on these roadways. In the future, routine crack filling and maintenance should be performed to continue to extend the life of the roadway.
