MINNESOTA STRUCTURE INVENTORY REPORT

Bridge ID: 9183

MN 105 over I 90

Date: 05/11/2022

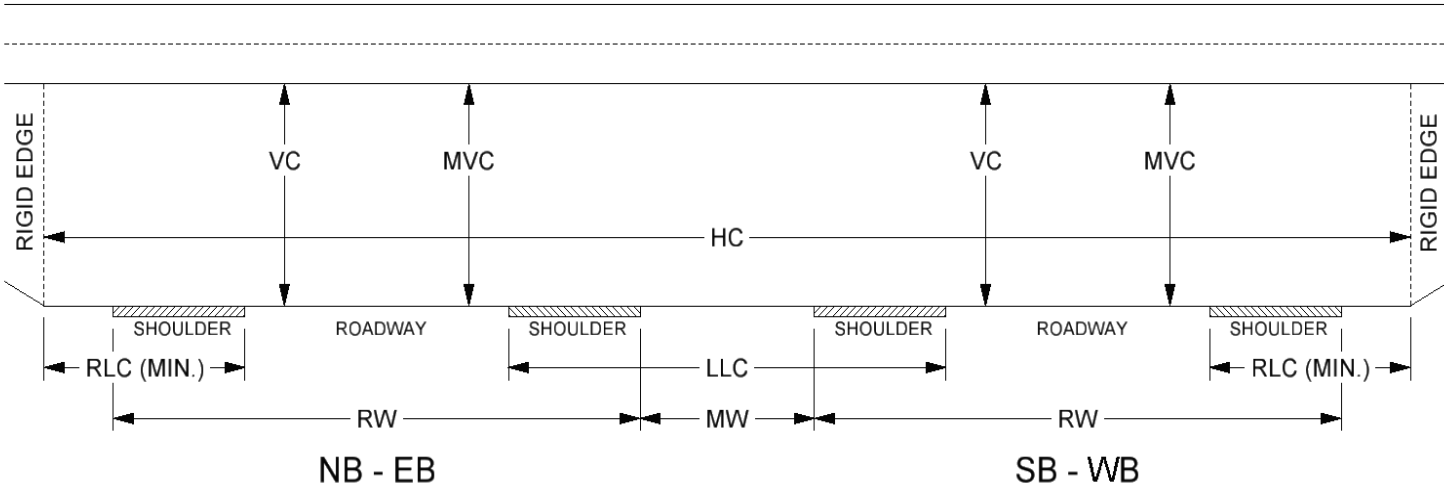
DIVIDED HIGHWAY WITHOUT MEDIAN OBSTRUCTION

RIGID EDGE IS A TOE OF SLOPE STEEPER THAN 1 TO 3 OR A FIXED OBJECT SUCH AS GUARDRAIL, PIER STRUT OR OTHER BARRIER.

LLC (LEFT LATERAL CLEARANCE) IS THE MEASUREMENT BETWEEN OUTSIDE ROADWAY EDGES.

+ FEATURES +			+ DIMENSIONS +			
Item Description	NBI (if appl)	Value	Item Description	Diagram Abbrev.	Values	
					NB-EB	SB-WB *
Road Name		I 90	Roadway Width	RW	38.0 ft	38.0 ft
Functional Class.	26	URB/PR ART ISTH	Vertical Clearance	VC	17.3 ft	16.6 ft
ADT (YEAR)	29 (& 30)	18,316 (2019)	Max. Vert. Clear	MVC	17.3 ft	16.6 ft
HCA DT	109	2,015	Horizontal Clear	HC	52.9 ft	52.9 ft
National Highway System	104	Y	Lateral Clr. - Lt	LLC	17.4 ft	
Route Sys/Nbr (TIS)		ISTH 90	Lateral Clr. - Rt	RLC	11.4 ft	
Ref. Point (TIS)		177+00.474	Median Width	MW	30.0 ft	
Detour Length	19	5 mi.	* Entered only if this record is for a divided roadway			
Lanes	28B	4 Lanes UNDER Bridge				
Control Section (TH Only)		5080				
Function	5C	MAINLINE				
Type	102	2 WAY TRAF				
Bridge Match ID		1				
Roadway Key	5A	2-UNDER
