Bridge Inspection Report for Minnehaha County South Dakota **2022**

Structure No. 50-216-015 Jasper Street / Co. Hwy 104

Dell Rapids Township

10/28/22

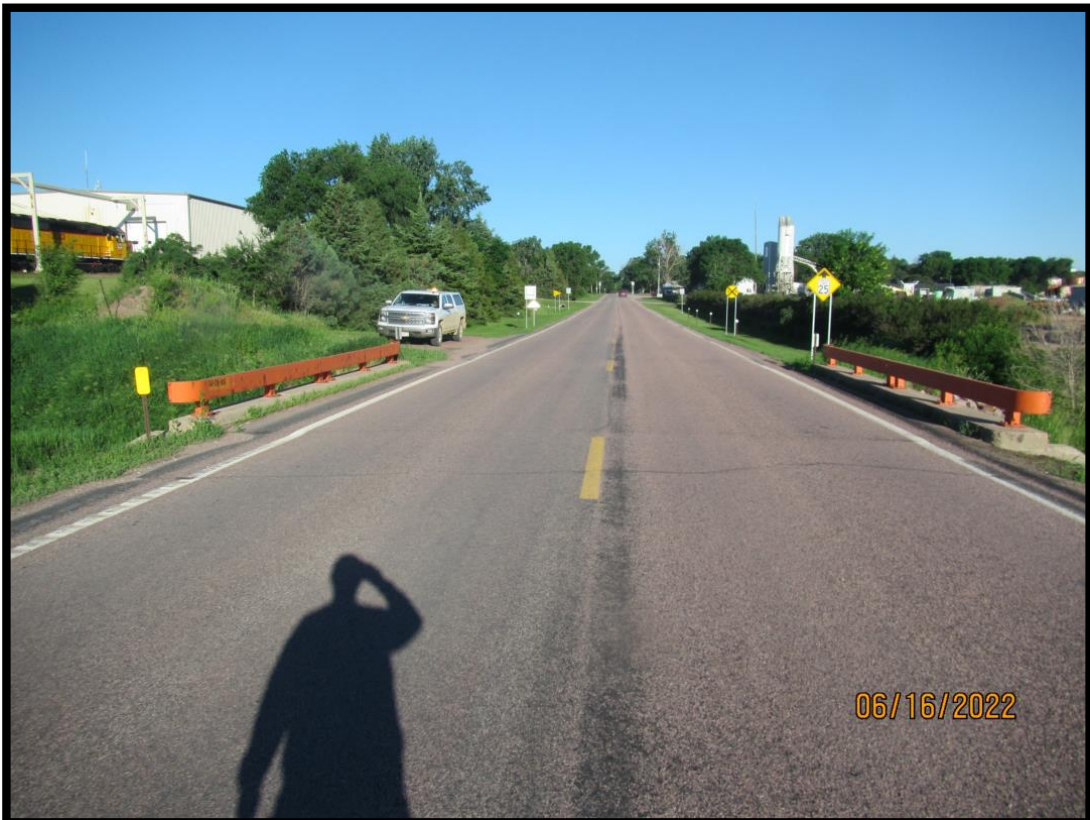
50-216-015_2022_2_CDI_Approach looking West

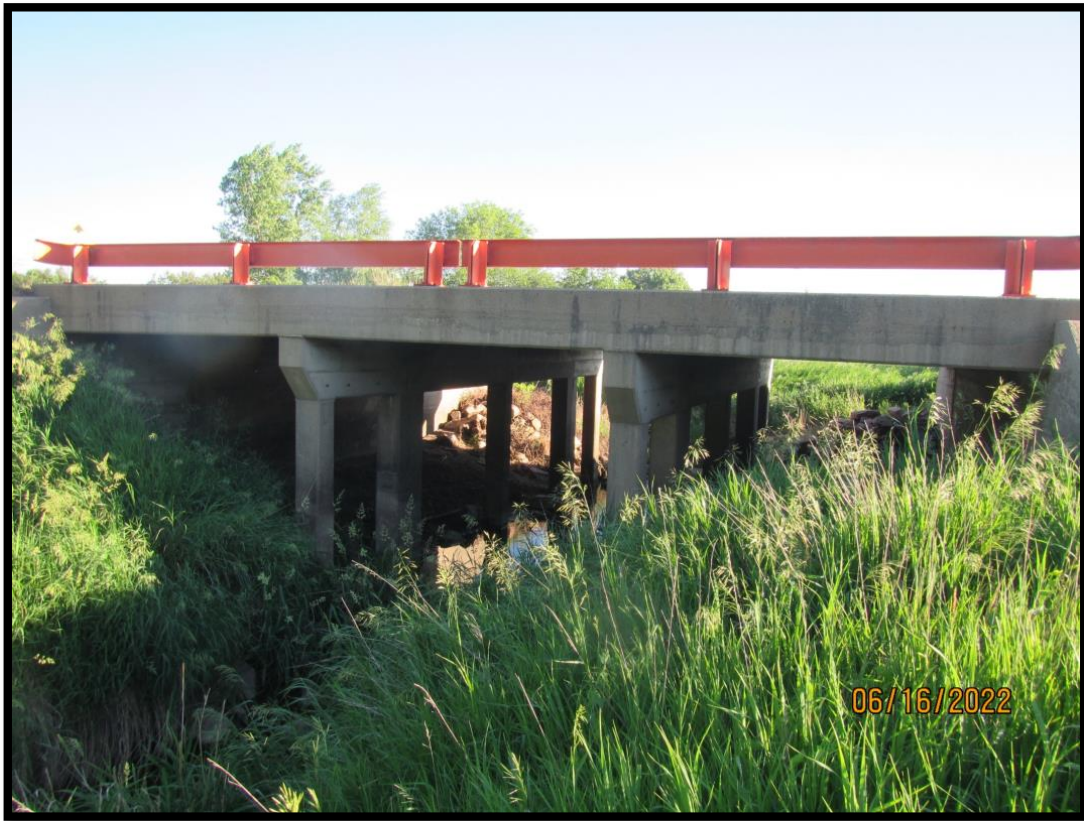
50-216-015_2022_3_CDI_Profile looking North

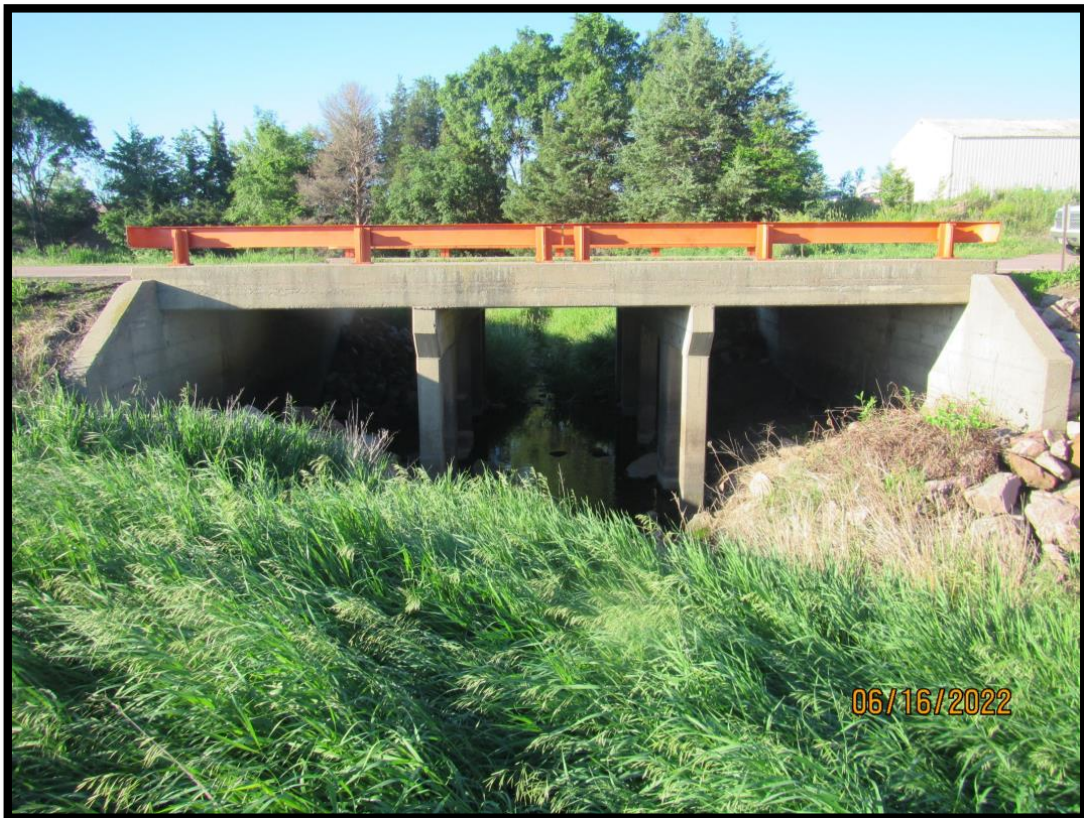
50-216-015_2022_4_CDI_Profile looking South

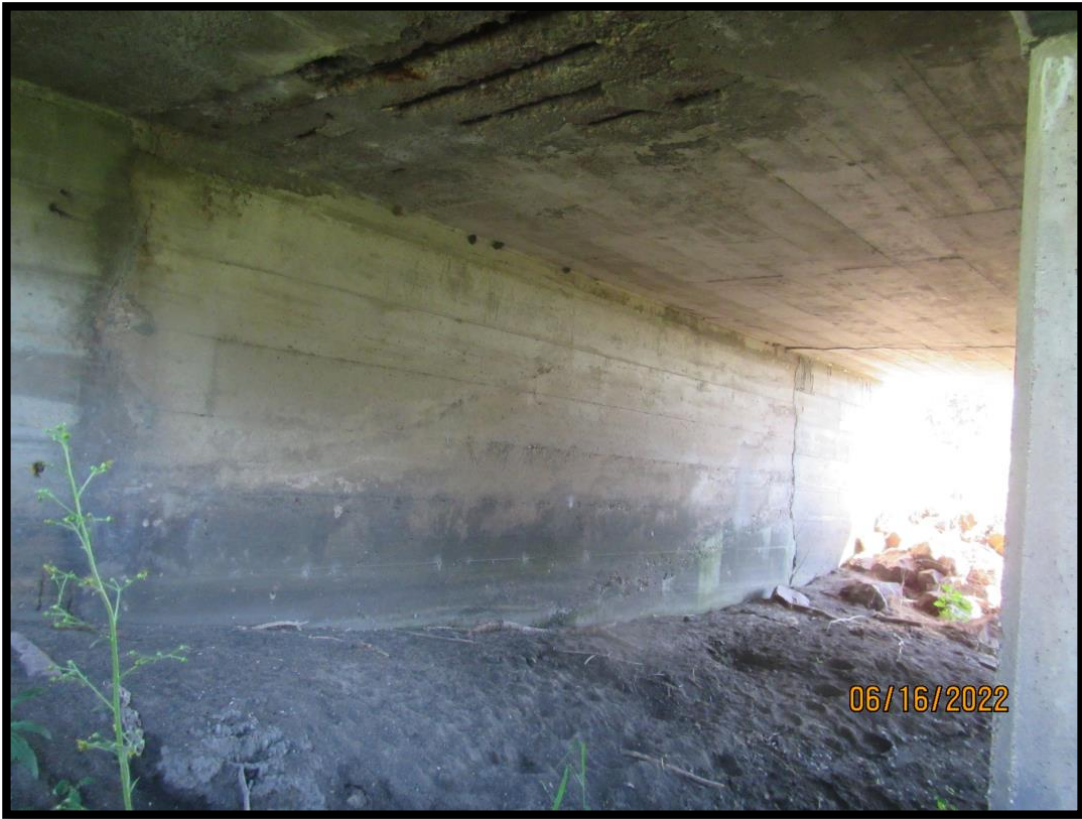
- B. BACKWALLS - The backwalls consist of cast-in-place concrete. Both ends of the original backwalls were extended when the structure was widened. There are some areas of honeycombing evident in the original portions of the backwalls. A spall is evident at the north end of the original portion of the east backwall. The widening portions of the backwalls appear to be in relatively good condition.

50-216-015_2022_19_CDI_West Backwall

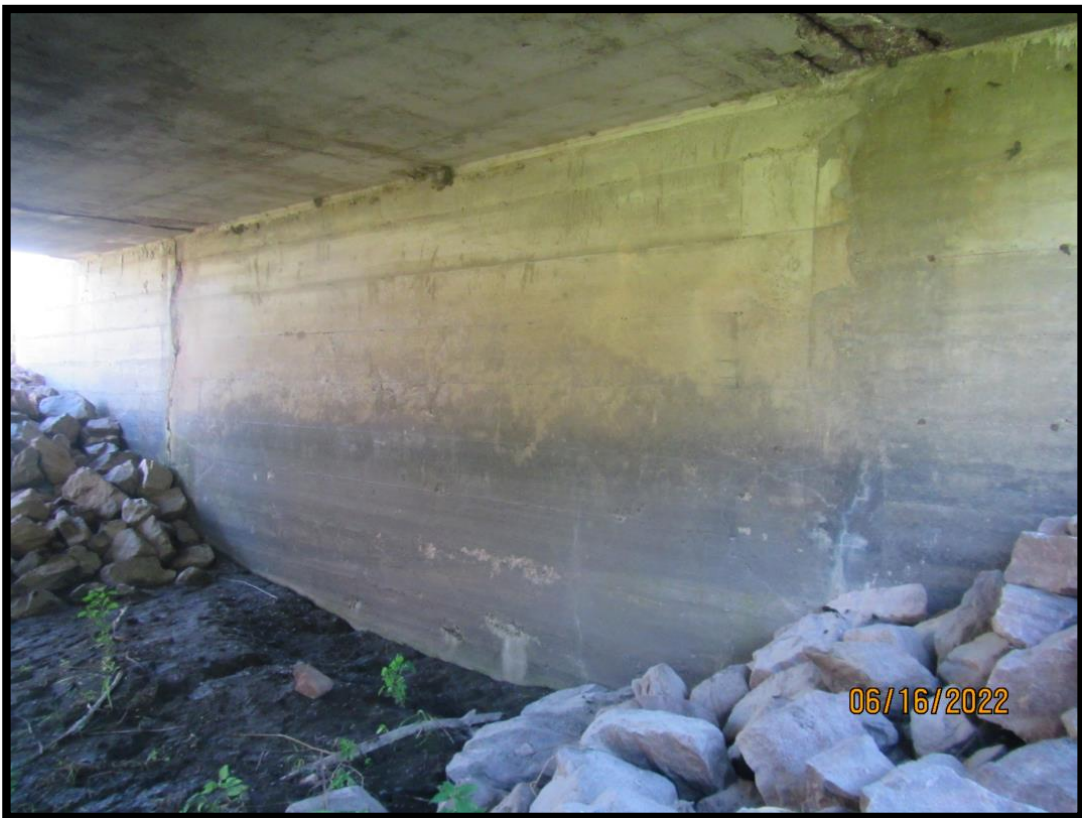
50-216-015_2022_20_CDI_East Backwall

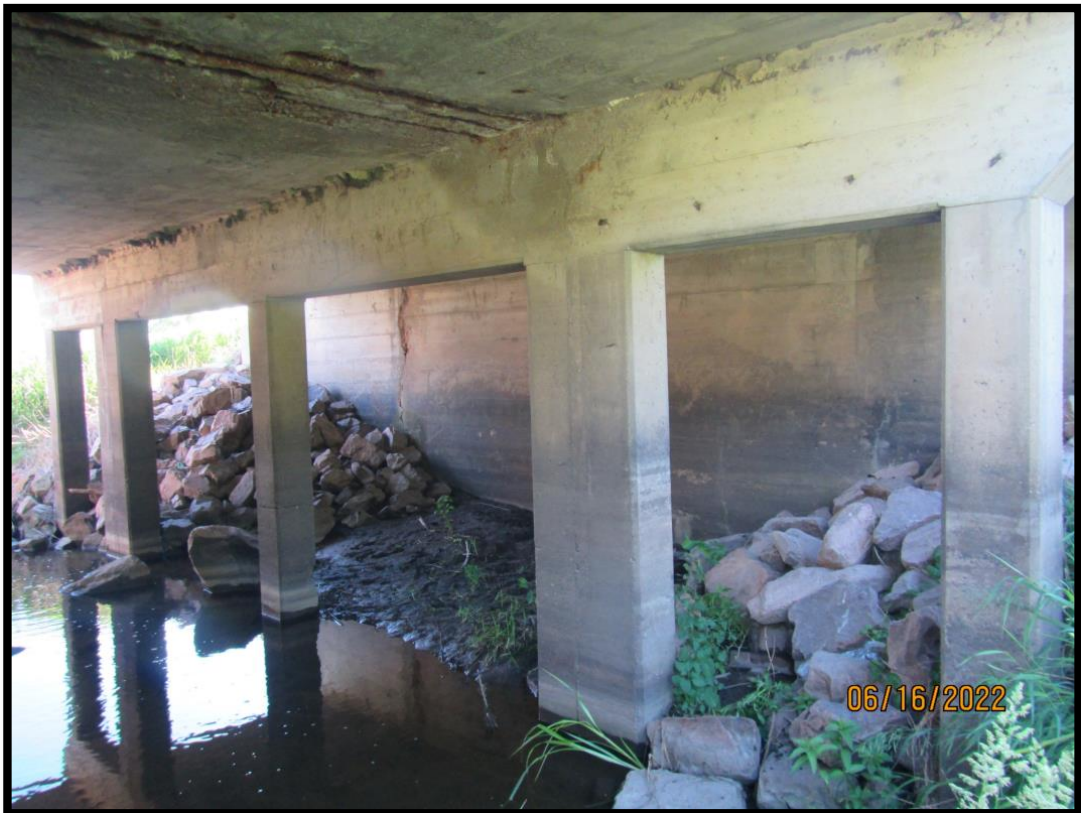
- C. FOOTINGS - None
 - D. PILE CAPS - None
2. PIERS OR BENTS -
 - A. CAPS - Cast-in-place concrete - The original concrete caps were extended when the structure was widened. Some areas of light to moderate scaling are evident throughout and some vertical hairline cracks are evident over the columns. Overall, the concrete bent caps appear to be in satisfactory condition.

50-216-015_2022_22_CDI_Typical Configuration of Bent

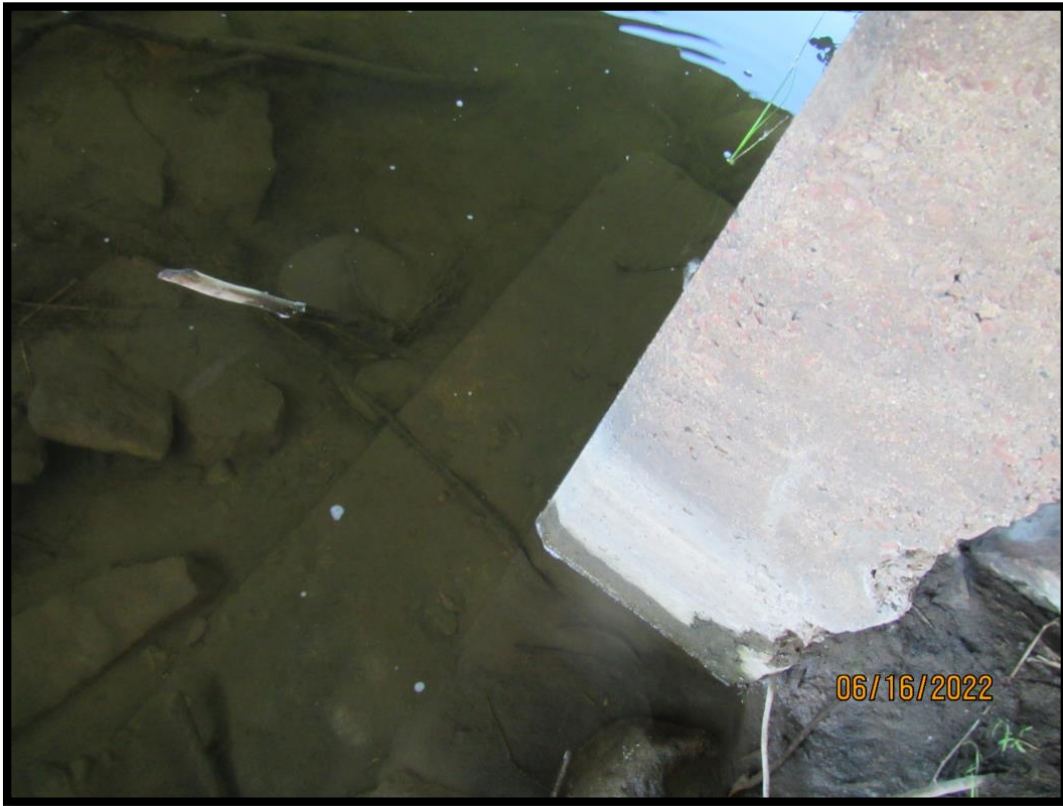
50-216-015_2022_25_CDI_Typical Exposed Concrete Footing (West Bent Column #3 shown)

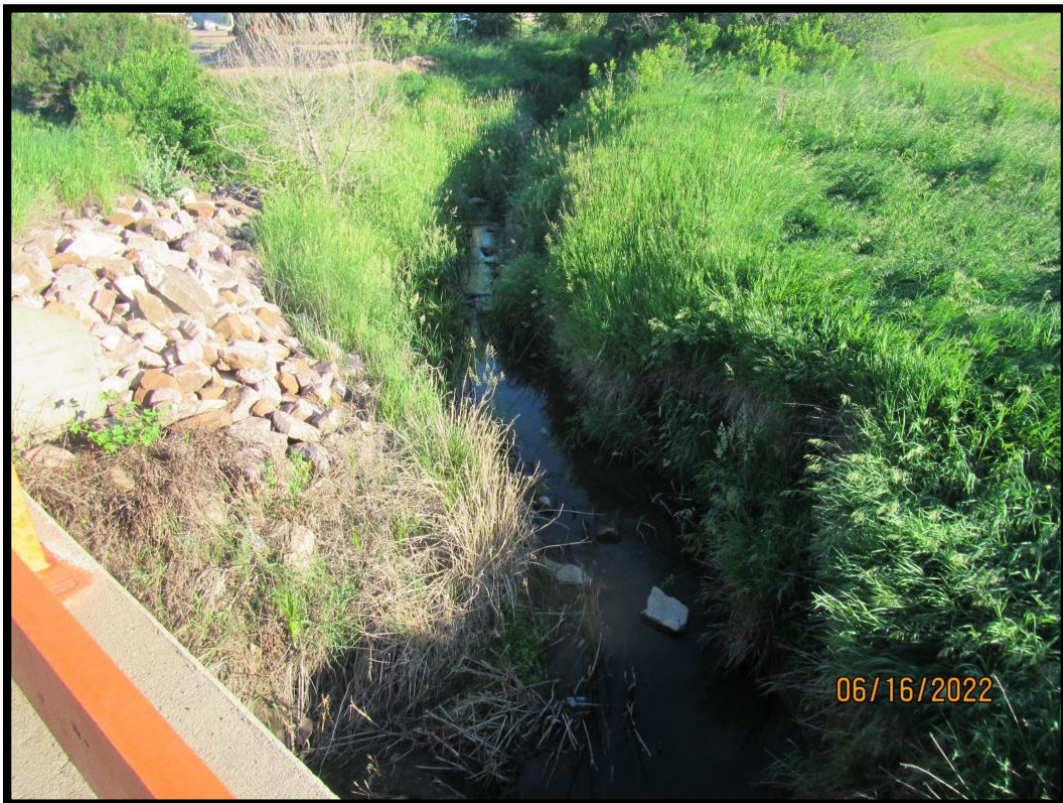
50-216-015_2022_26_CDI_Upstream Channel looking NW

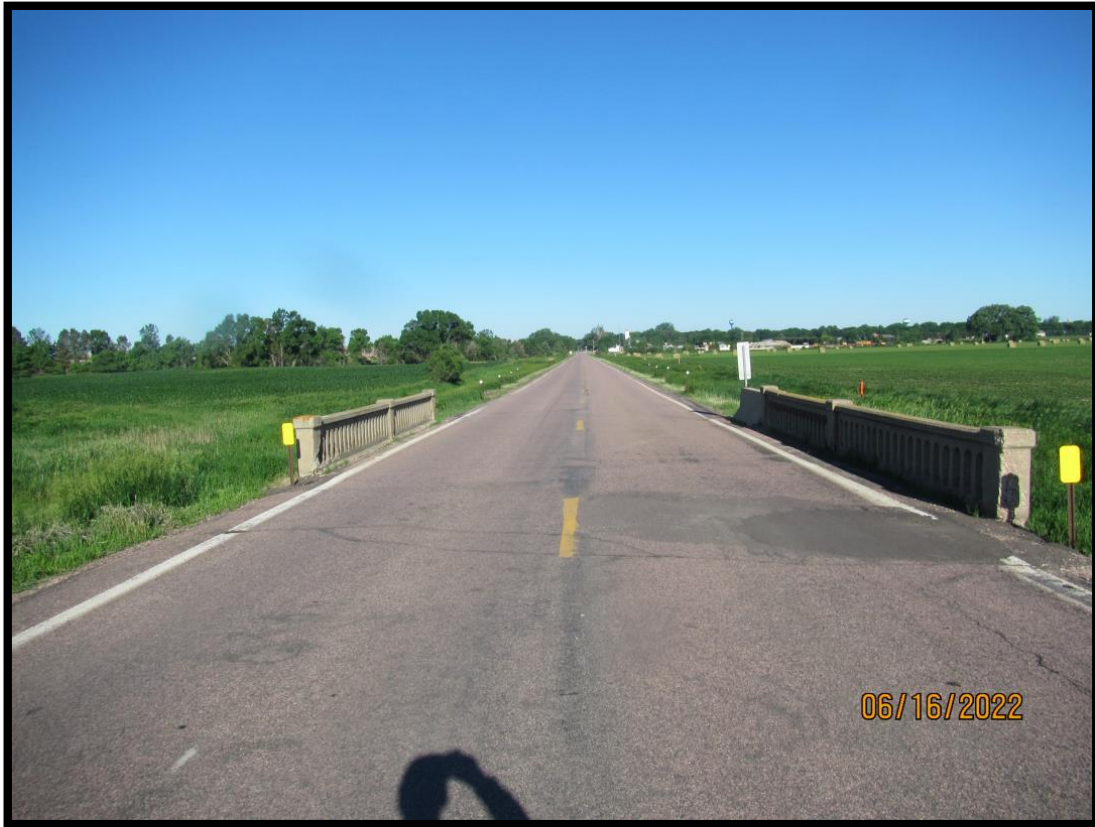
50-219-015_2022_1_CDI_Approach looking West

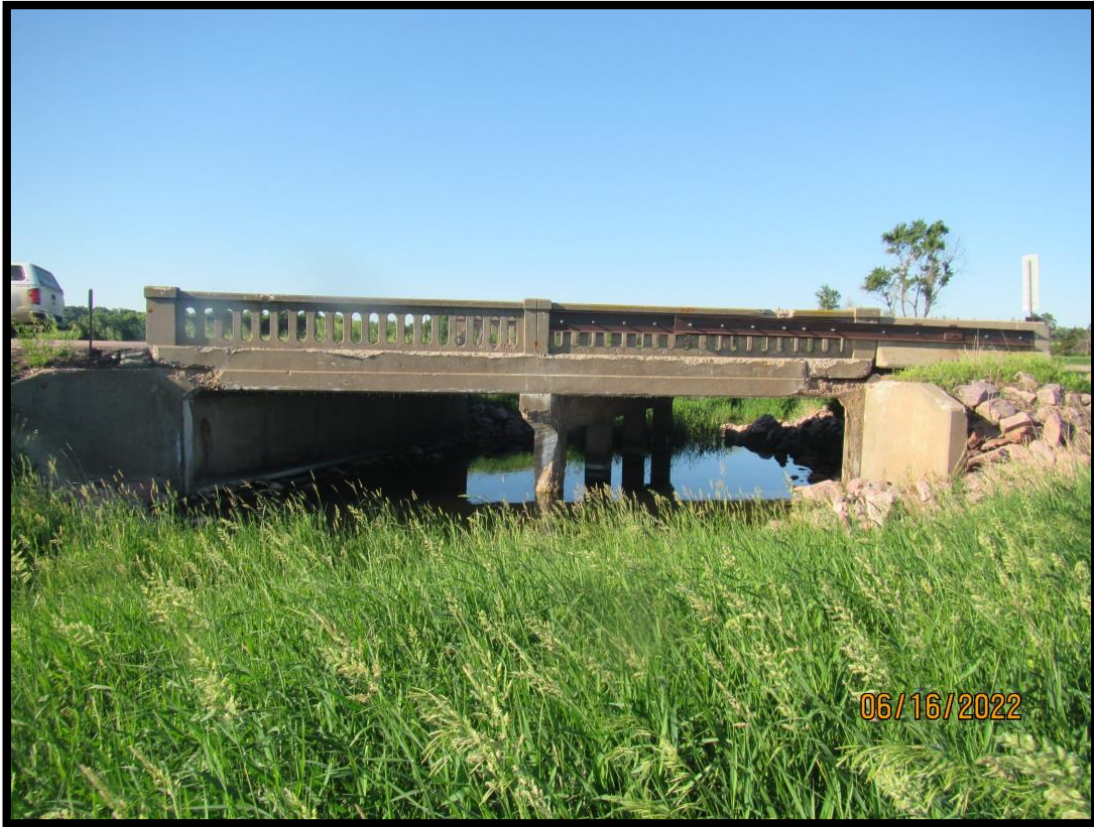
50-219-015_2022_3_CDI_Profile looking South

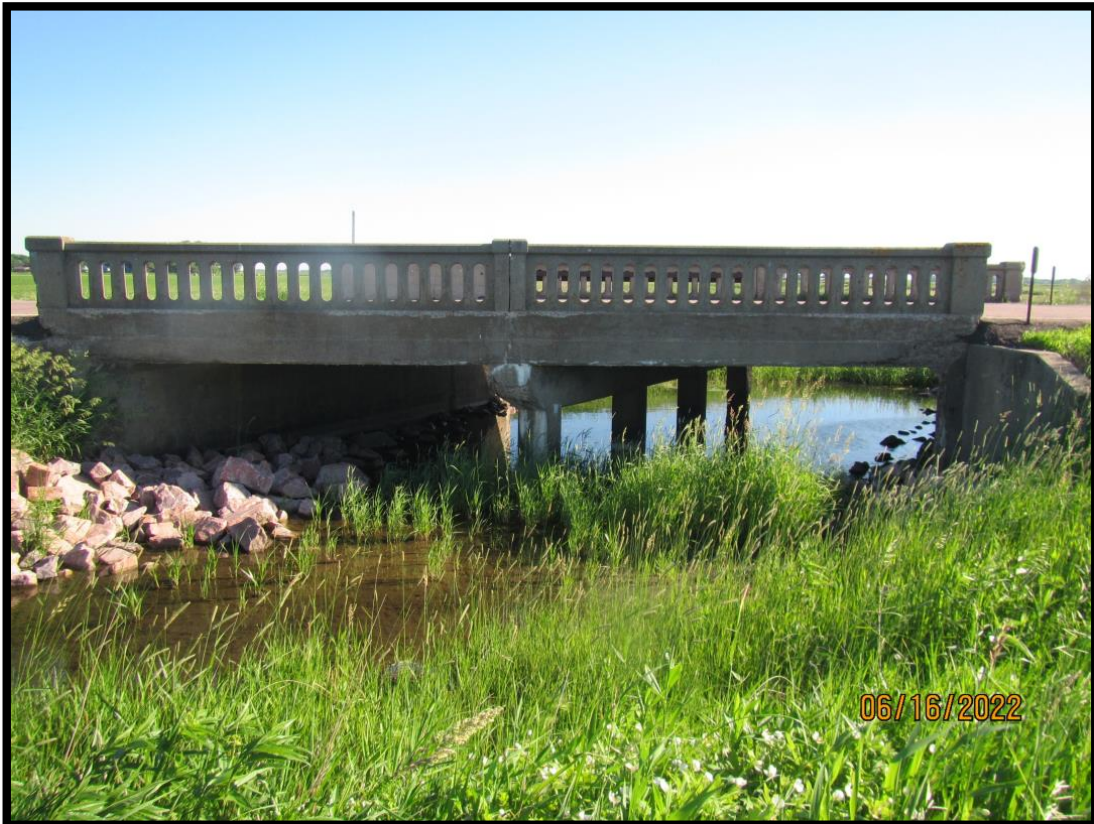
50-219-015_2022_4_CDI_Profile looking North

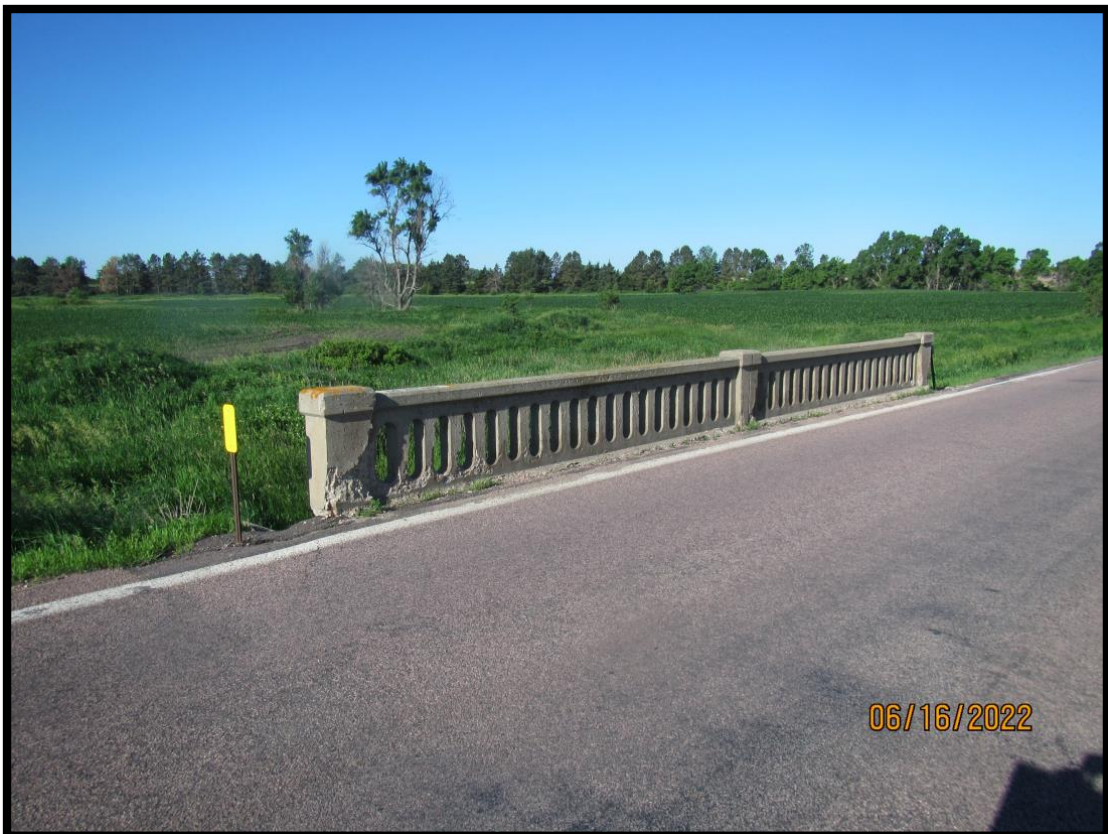
50-219-015_2022_12_CDI_South Rail

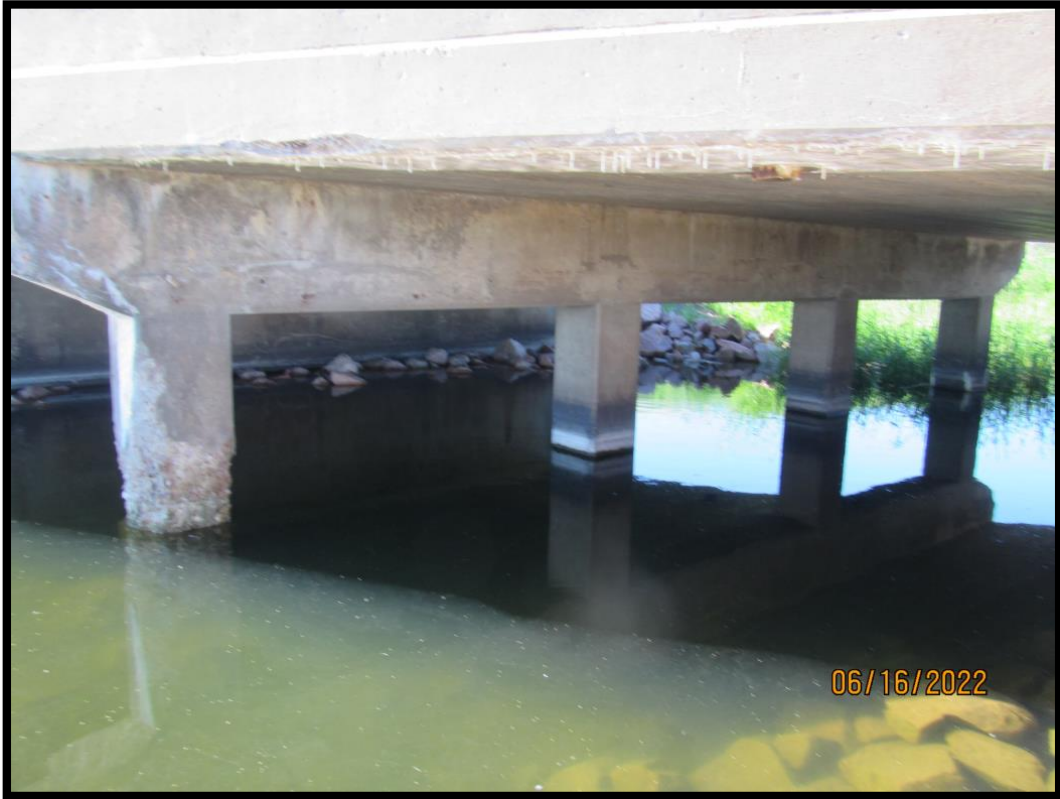
50-219-015_2022_23_CDI_Center Bent

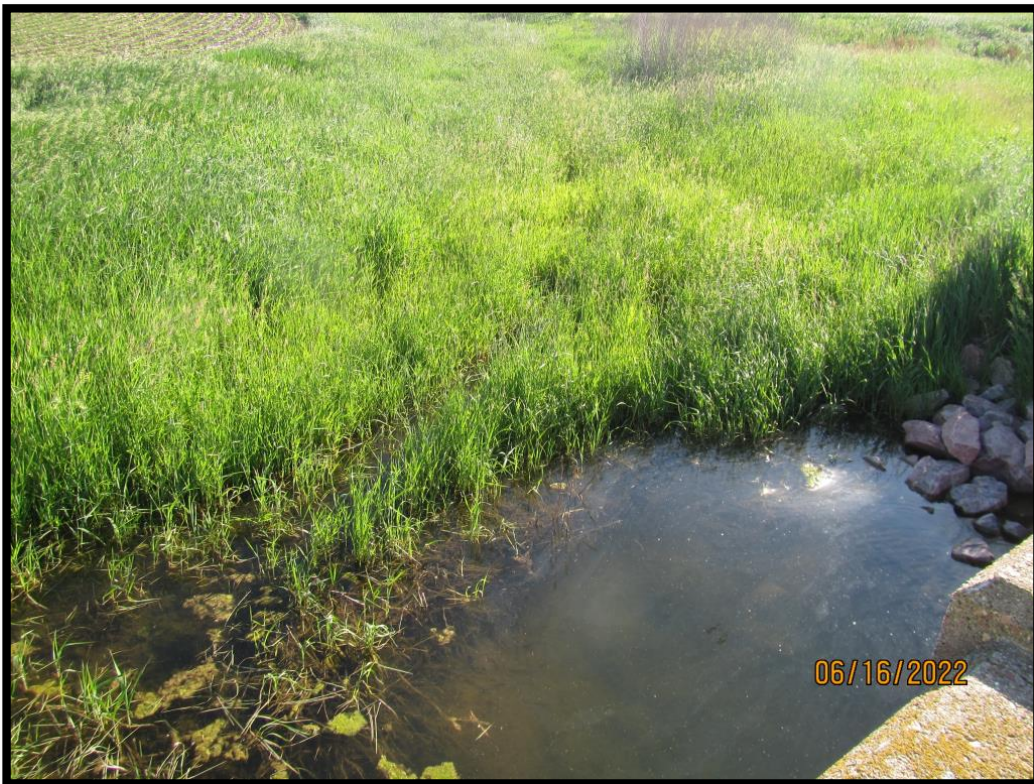
50-219-015_2022_26_CDI_Upstream Channel looking North

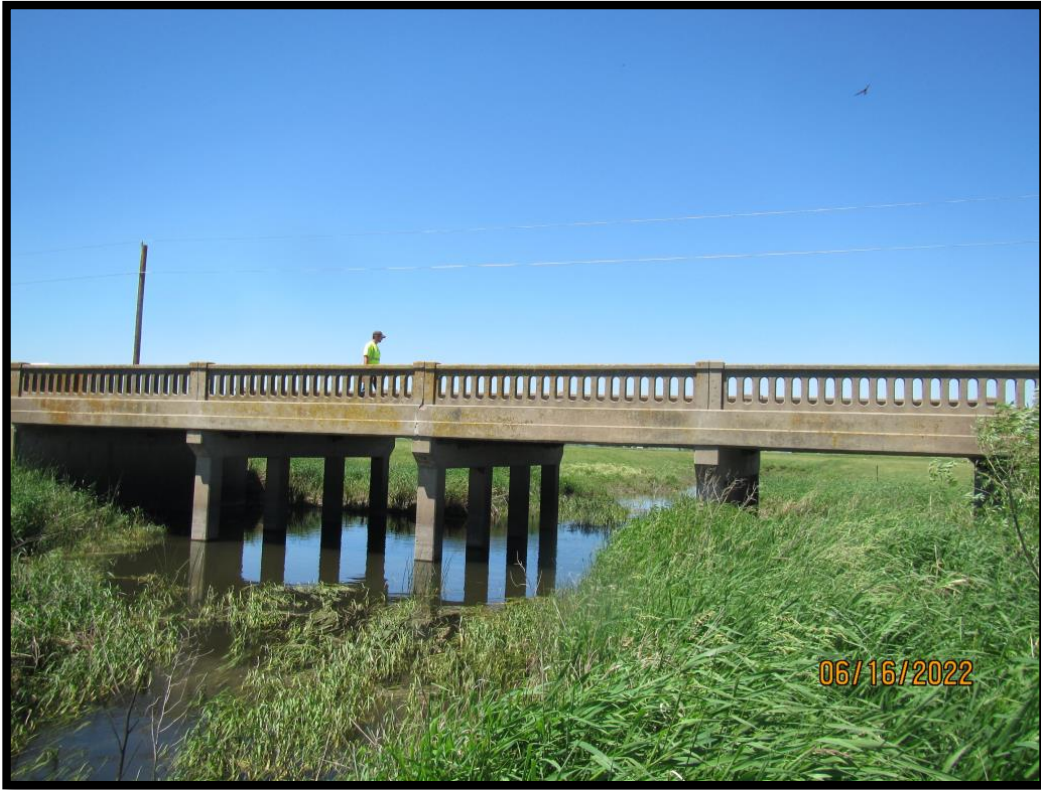
50-277-015_2022_3_CDI_Profile looking North

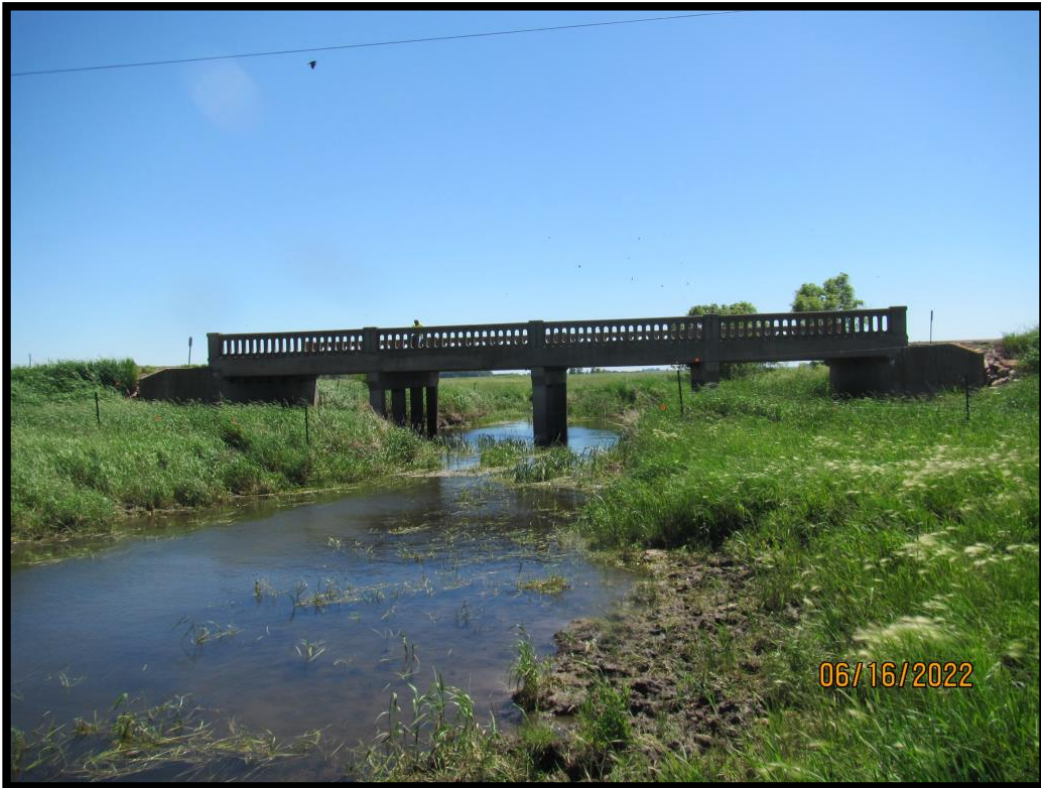
50-277-015_2022_4_CDI_Profile looking South

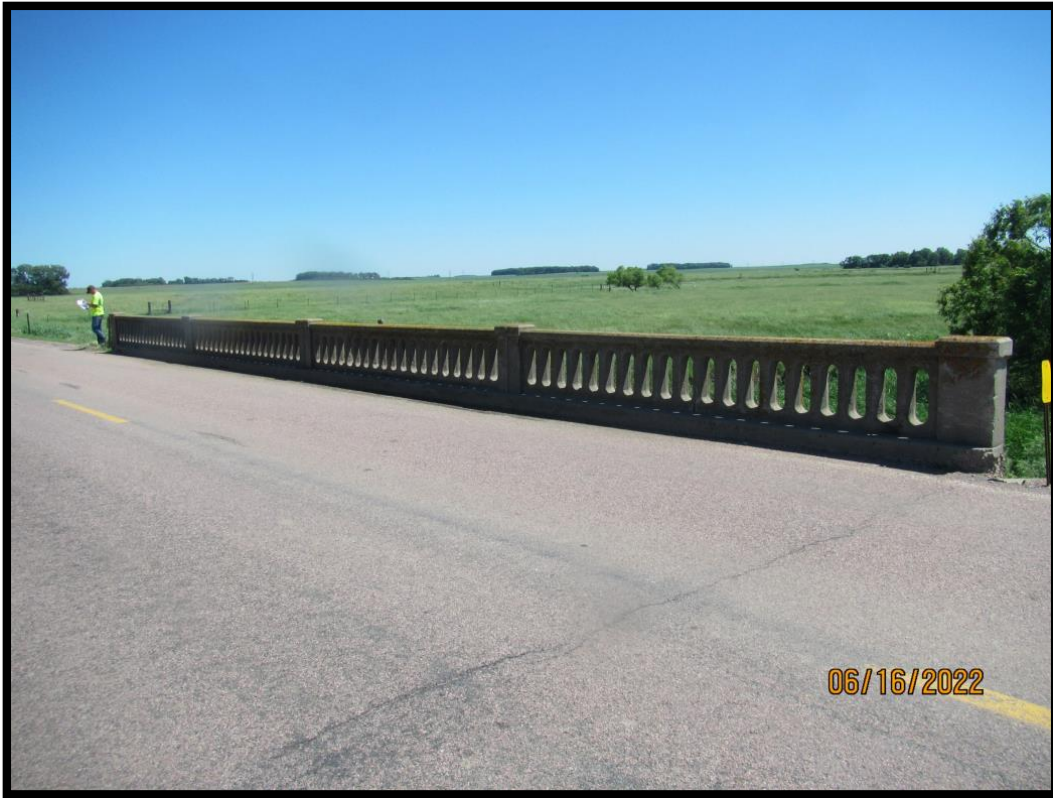
6. SIDEWALKS - None
7. RAILING OR BARRIER - The railings consist of reinforced concrete pigeon hole railings. Several spalls, cracks, and areas of exposed reinforcing steel are evident throughout. The south railing has a moderately to heavily weathered appearance with some moss evident on the surface of the railing. There are some small chips and some scrapes evident at the west end of the south railing. It appears these chips and scrapes are due to a vehicle impact.

50-277-015_2022_15_CDI_South Bridge Rail

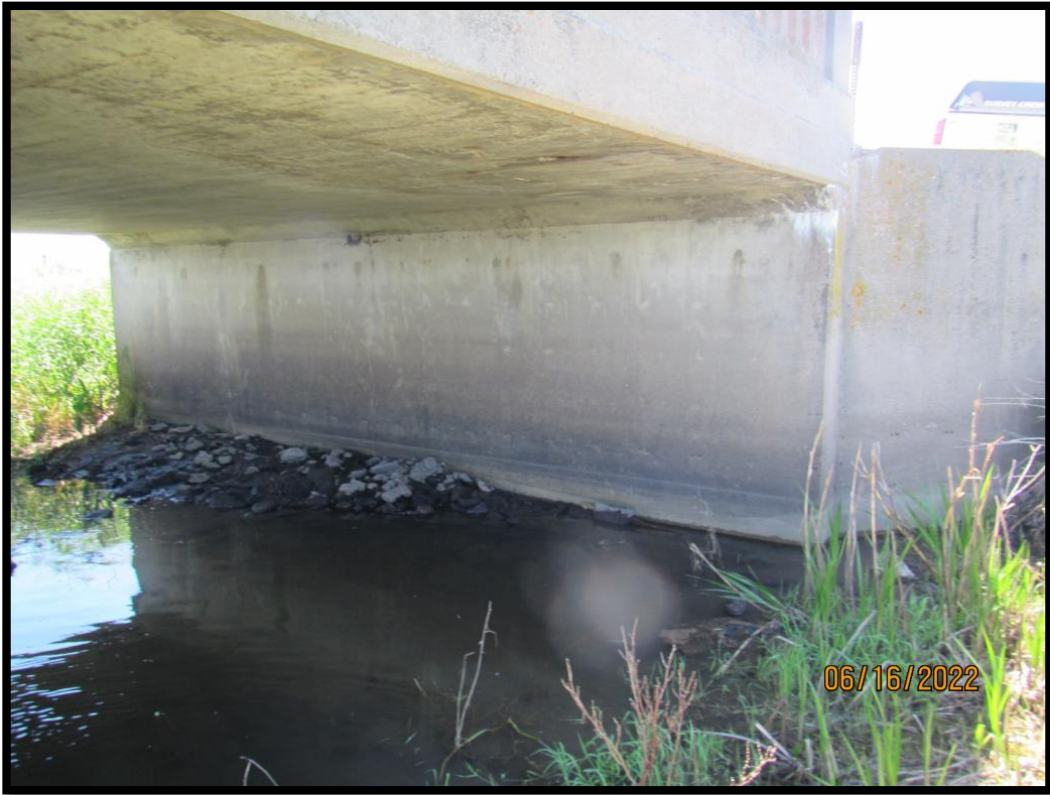
50-277-015_2022_21_CDI_West Abutment

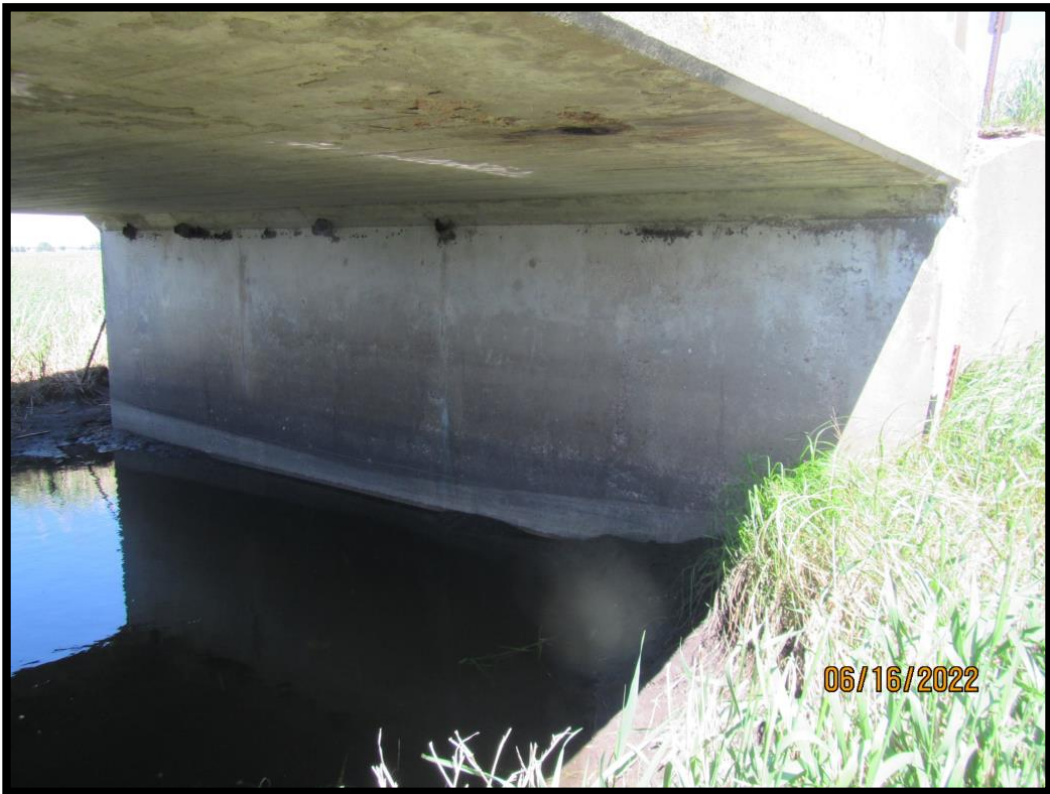
50-277-015_2022_22_CDI_East Abutment
