**INTERSTATE 94 over SUNSET DR/NW MANDAN INT.**

**Location: 5 EAST OF ND 25**

**Inspection Date: 04/26/2023**

IDENTIFICATION	
(1) State Names	38 - North Dakota
(8) Structure Number	0094-152.329 R
(5) Inventory Route	1
(2) Highway Agency District	1 - Bismarck
(3) County Code	30 - Morton

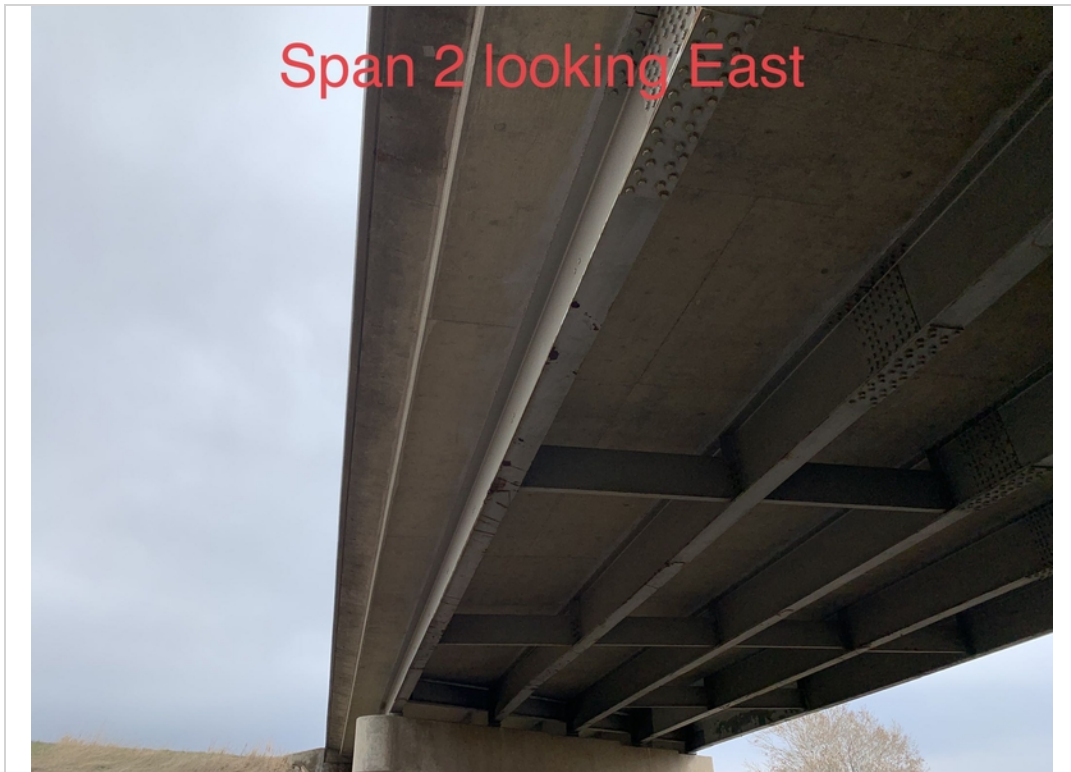
1September2022 - The structure was impacted by an over height vehicle in the Northbound lane. Beam 2 was bent out of plane at the lower flange. The upper flange remained in place and no deck concrete was broken. Beams 5, 4 and 3 were impacted with only minor damage to the lower flanges and to a diaphragm stiffener on Beam 4. The underside of the deck next to the top flange of Beam 5 is cracked and beginning to spall. Beam 5 was damaged on the bottom flange from an over height impact.

Span2 beam 2 distortion

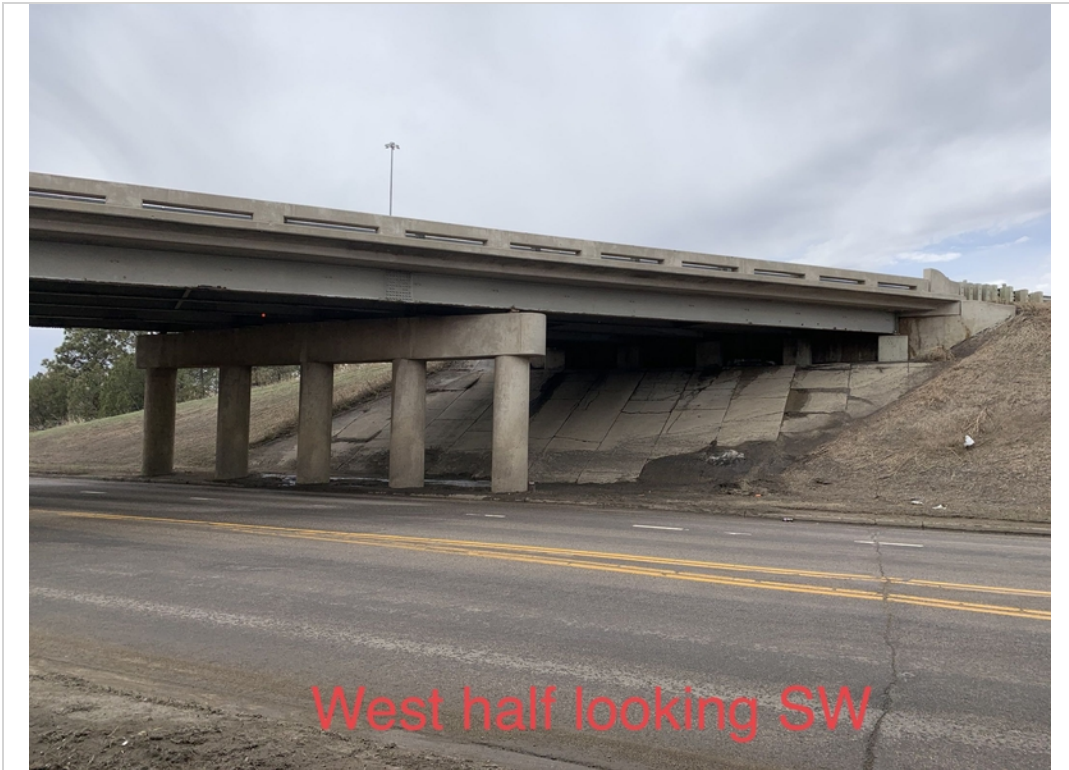
<p>(8401) All wings have minor cracking - 4/1/2019</p> <p>(1080-8401) 26April2023 - The Southwest wing has a spall on the end of the wing that is approximately 8 inches by 6 inches in size.</p>

SW wing spall

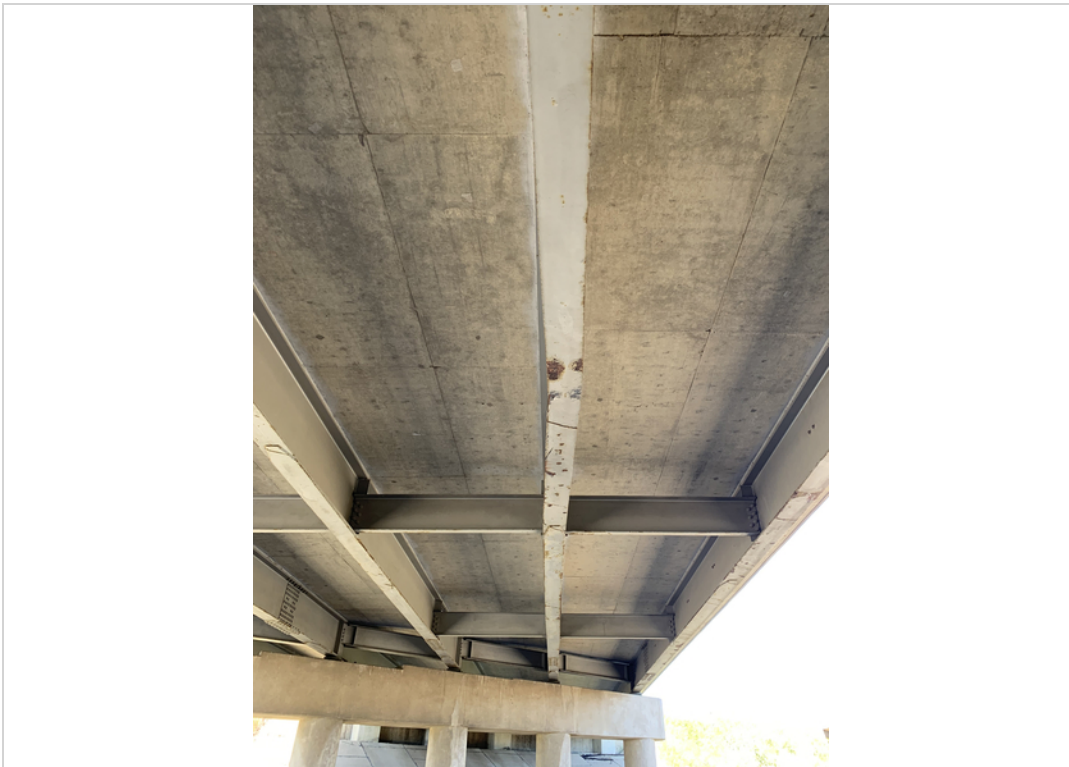
Damage
