IDENTIFICATION	
(1) State Names	38 - North Dakota
(8) Structure Number	0029-069.374
(5) Inventory Route	1
(2) Highway Agency District	8 - Fargo
(3) County Code	9 - Cass

(4) Place Code	65860
(6) Features Intersected	I-29/NORTH FARGO INT
(7) Facility Carried	CASS COUNTY 20
(9) Location	3 SOUTH OF HARWOOD
(11) Mile Point	0.1 mi

INSPECTIONS *			
(90) Inspection Date	07/17/2023		
(91) Frequency	24		
(92) Critical Feature Inspection	Done	Freq. (Mon)	Date
A: Fracture Critical Detail	No		
B: Underwater Inspection	No		
C: Other Special Inspection			
* The inspection date and frequency information in this box contains the current NBI date and frequency information. Please refer to the report header for the date this inspection was conducted.

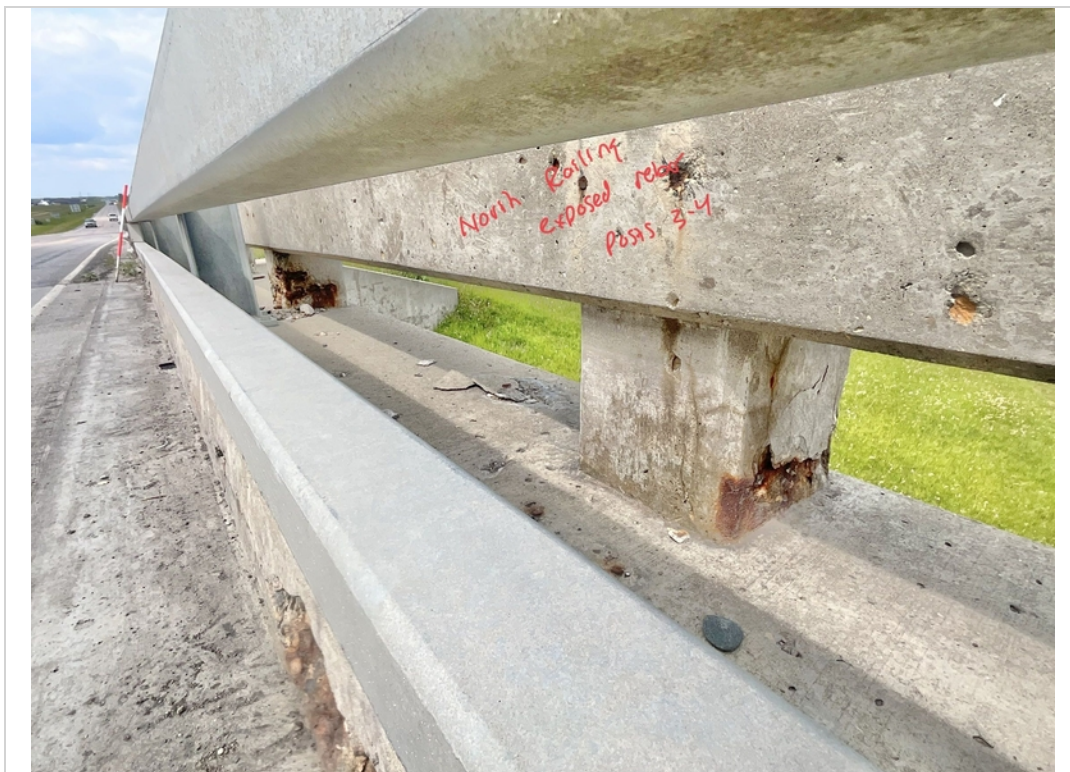
Facing NW. Exposed Rebar to North Railing Posts 3 and 4.

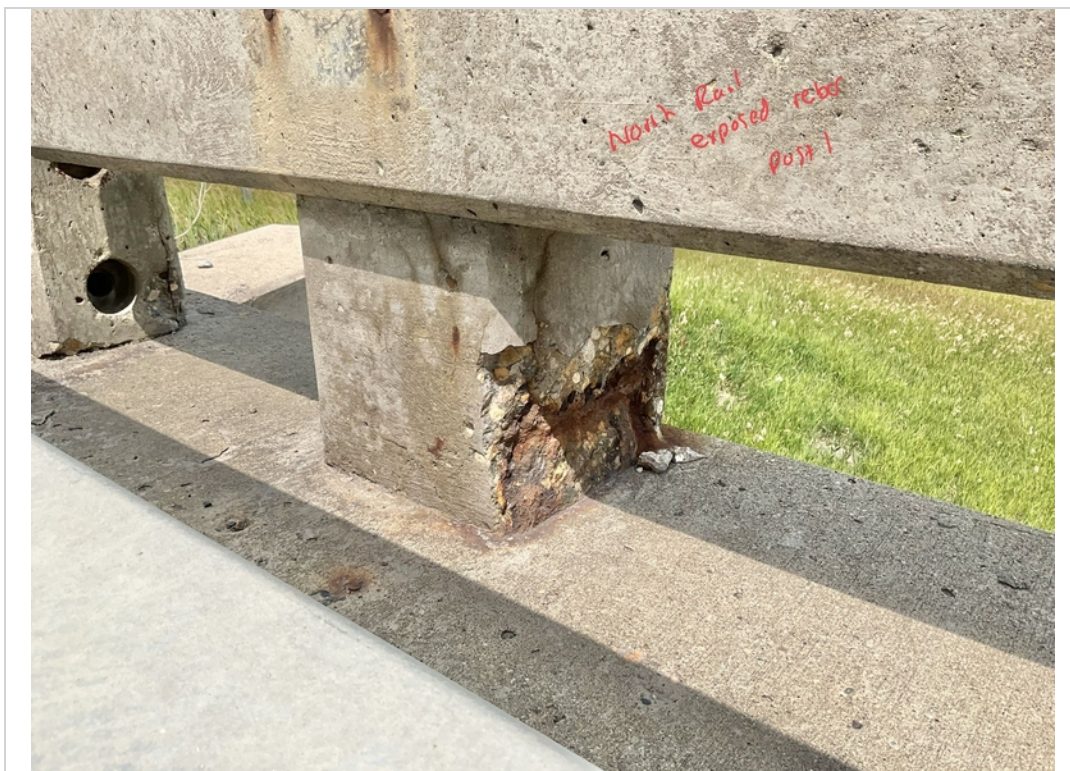
Facing NW. Exposed Rebar to North Railing Post 1.

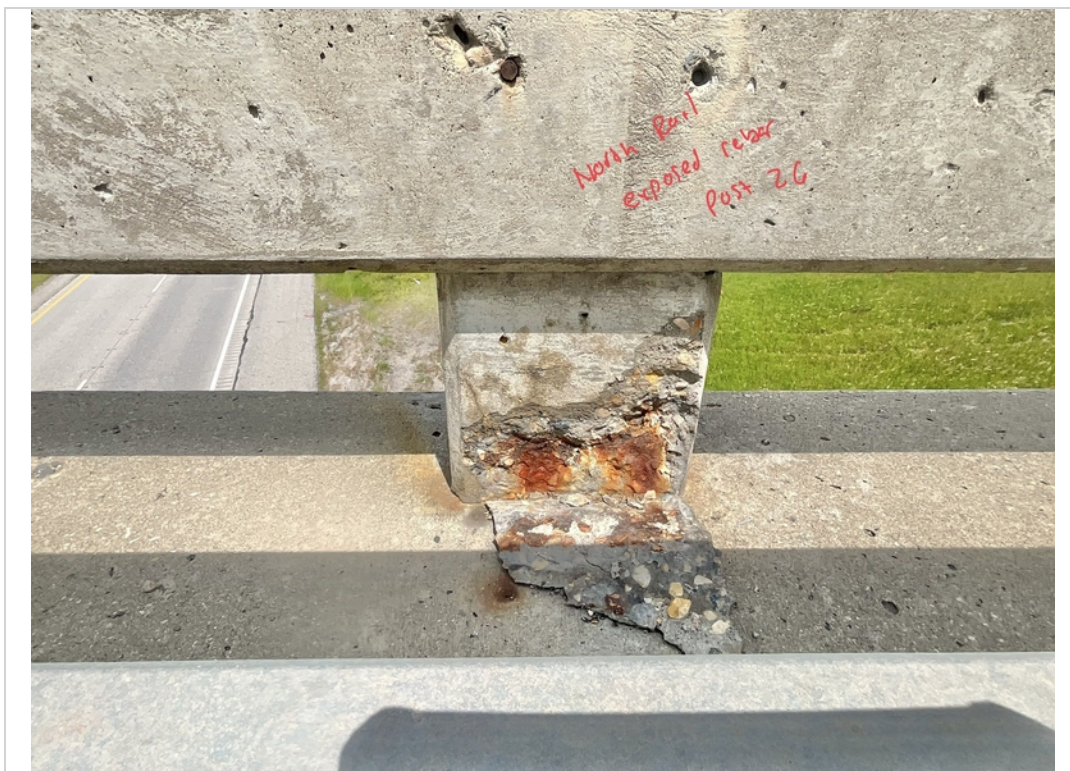
Facing North. Exposed Rebar to North Railing Post 26.

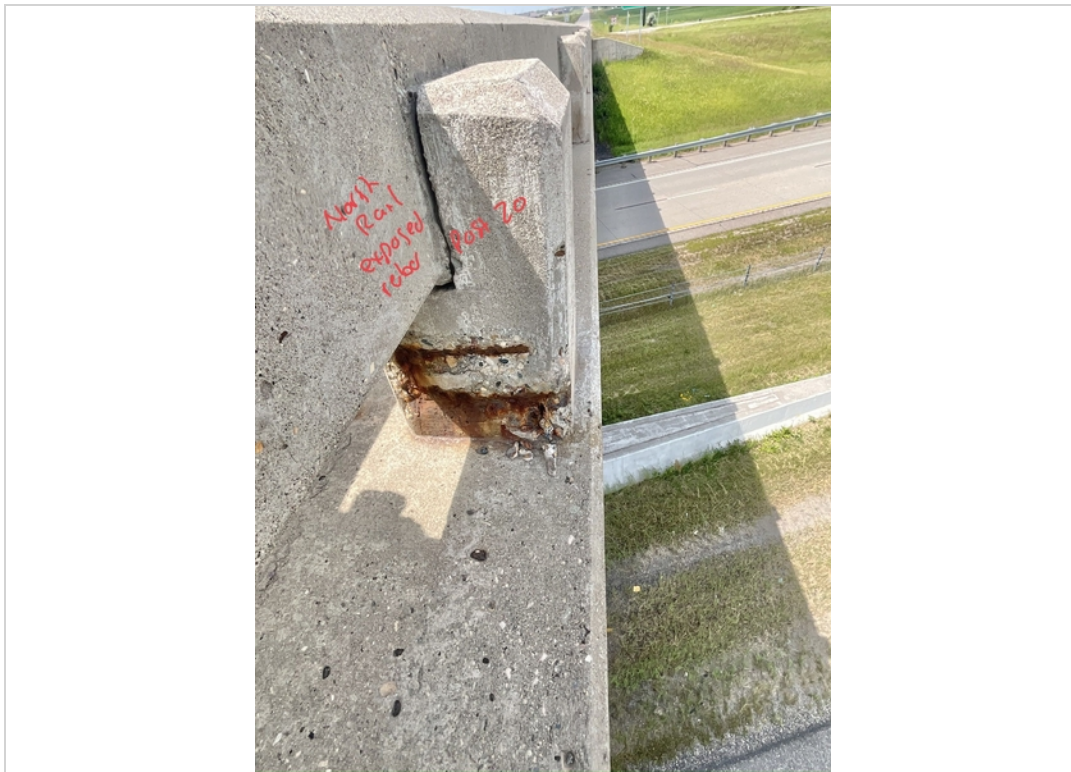
Facing West. Exposed Rebar to North Railing Post 20.

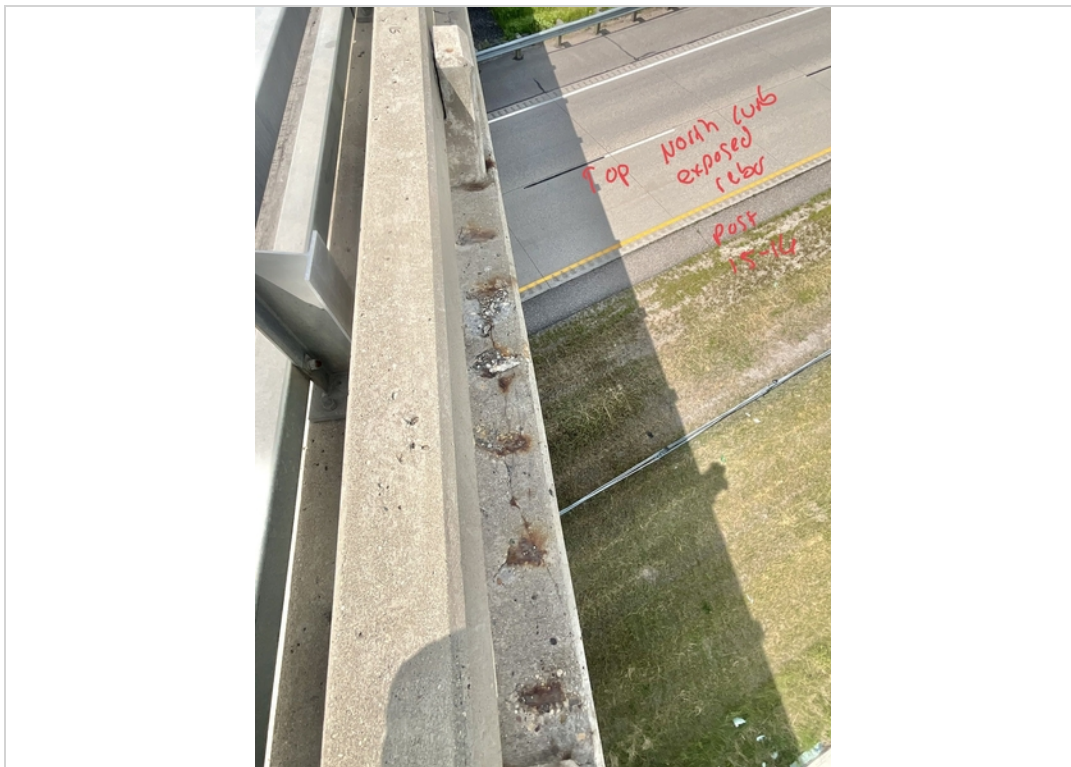
Facing West and Downward. Exposed Rebar to Top of North curb from Posts 15-16.

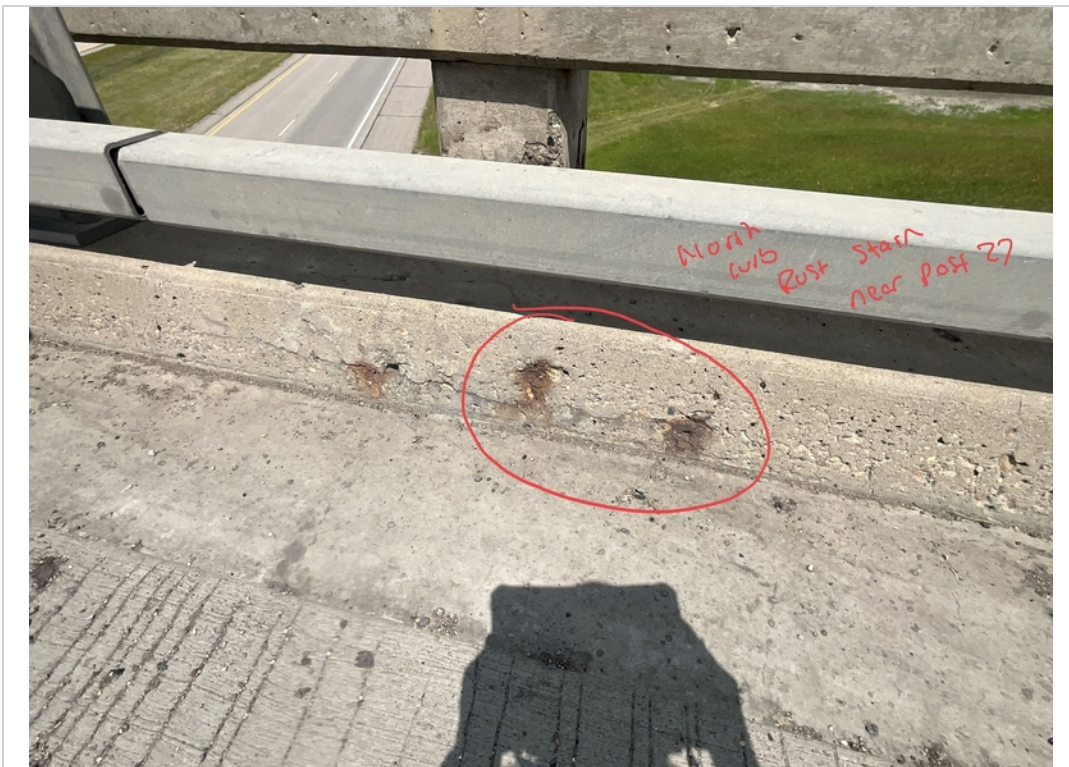
Facing North and Downward. Rust Staining to North Curb near Post 27.

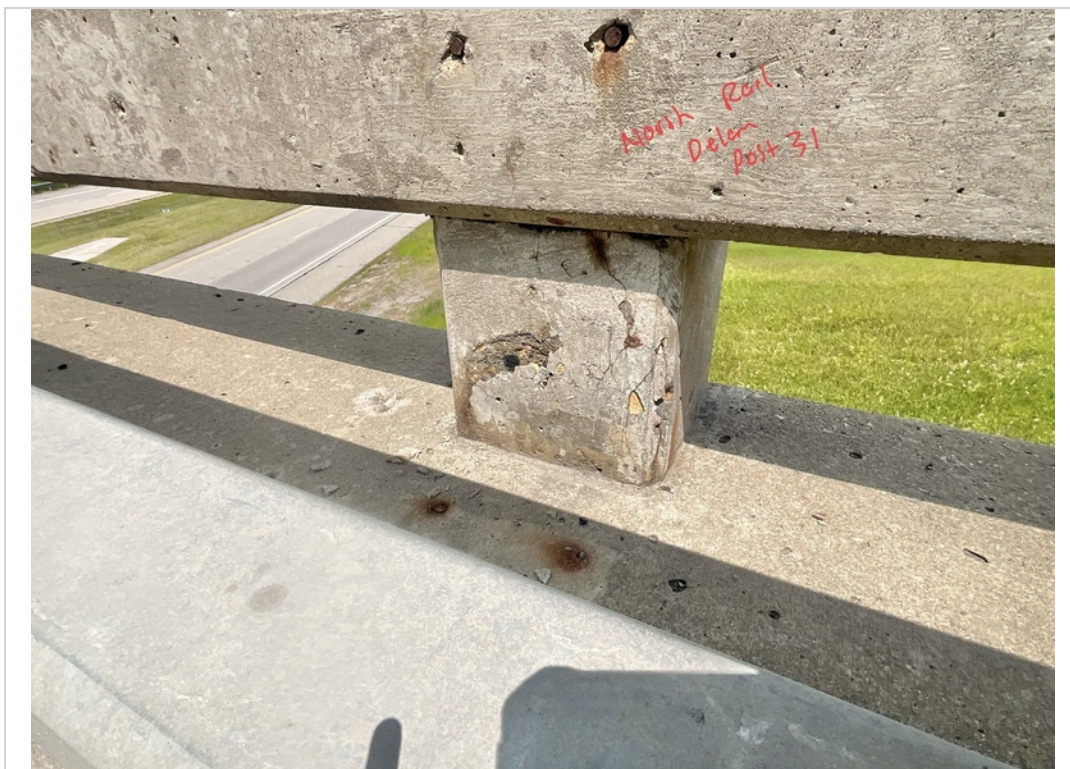
Facing North. Delamination to North Railing Post 31.

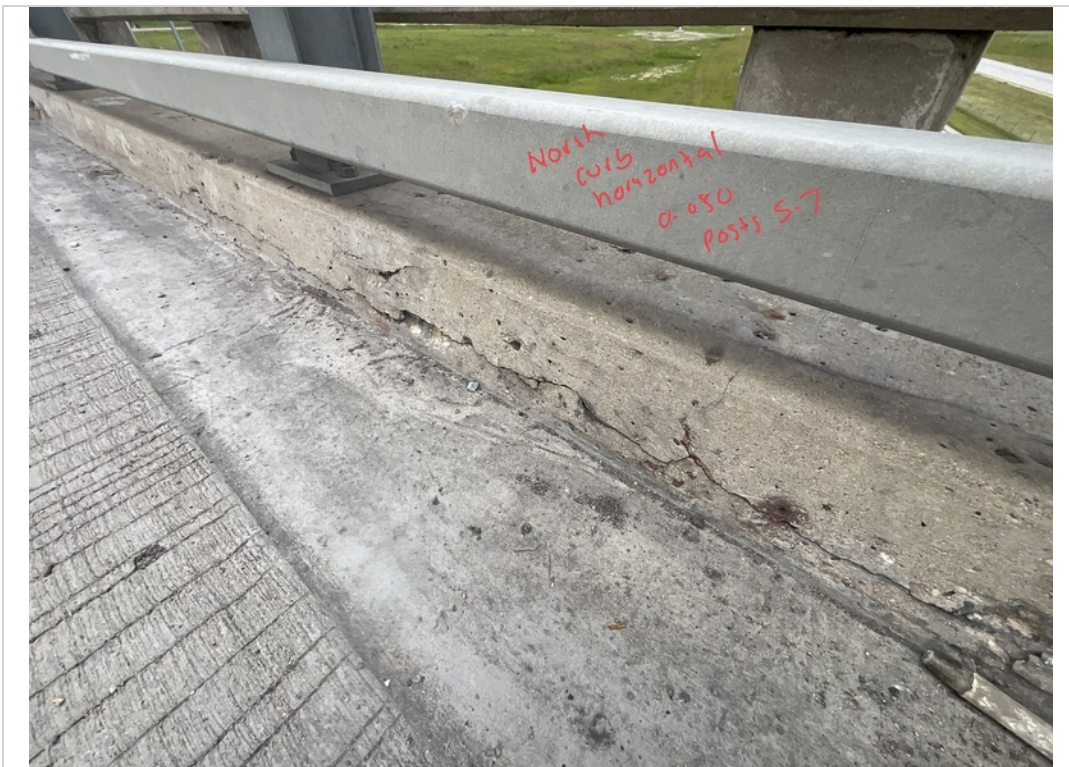
Facing NW. Horizontal Crack to Face of North Curb from posts 5-7.

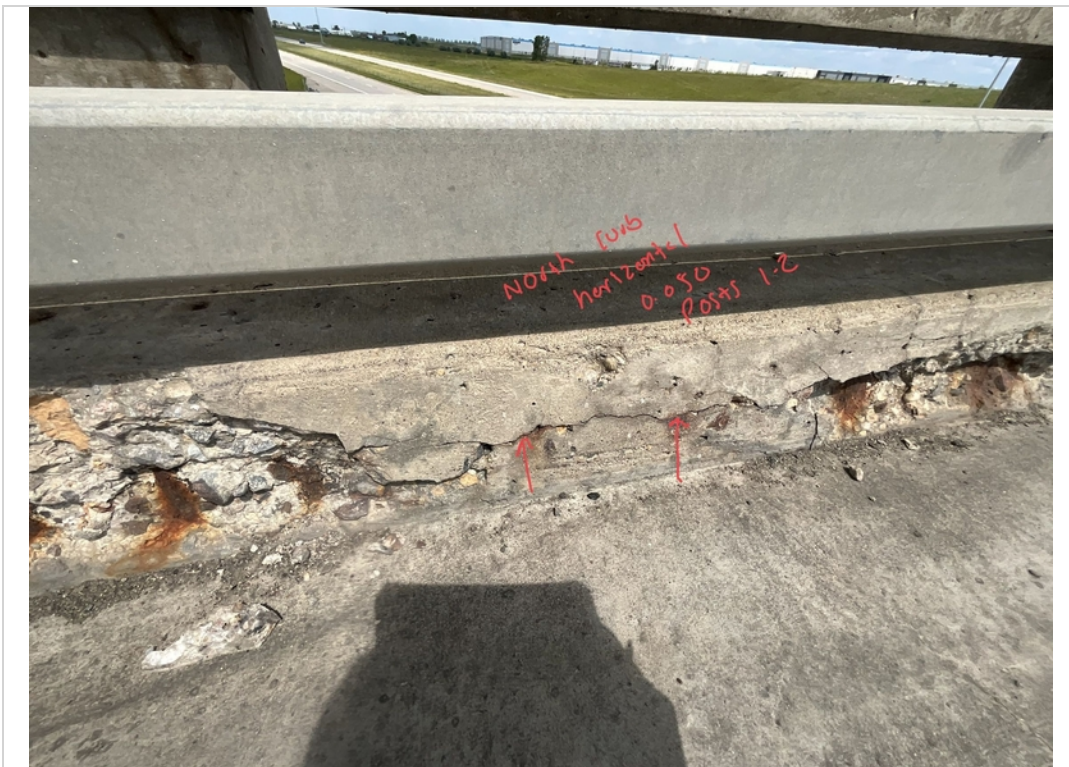
Facing North. Horizontal Crack to Face of North curb from Posts 1-2.

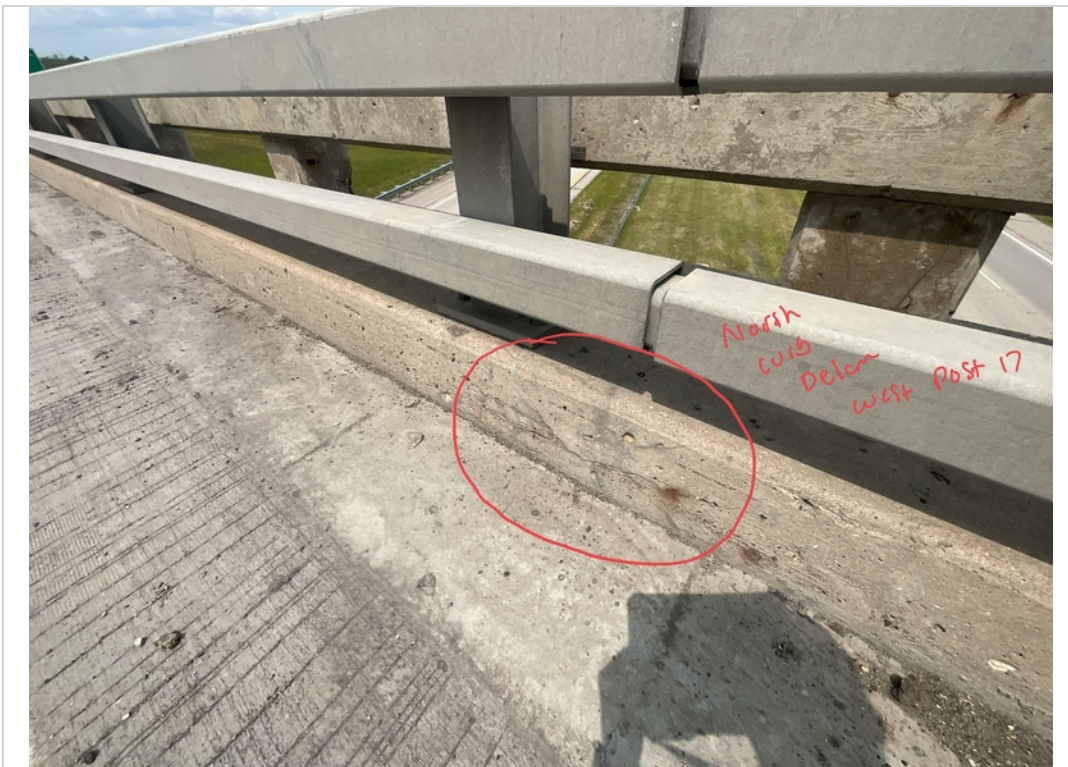
Facing NW. Delamination to Face of North Curb near Post 17.

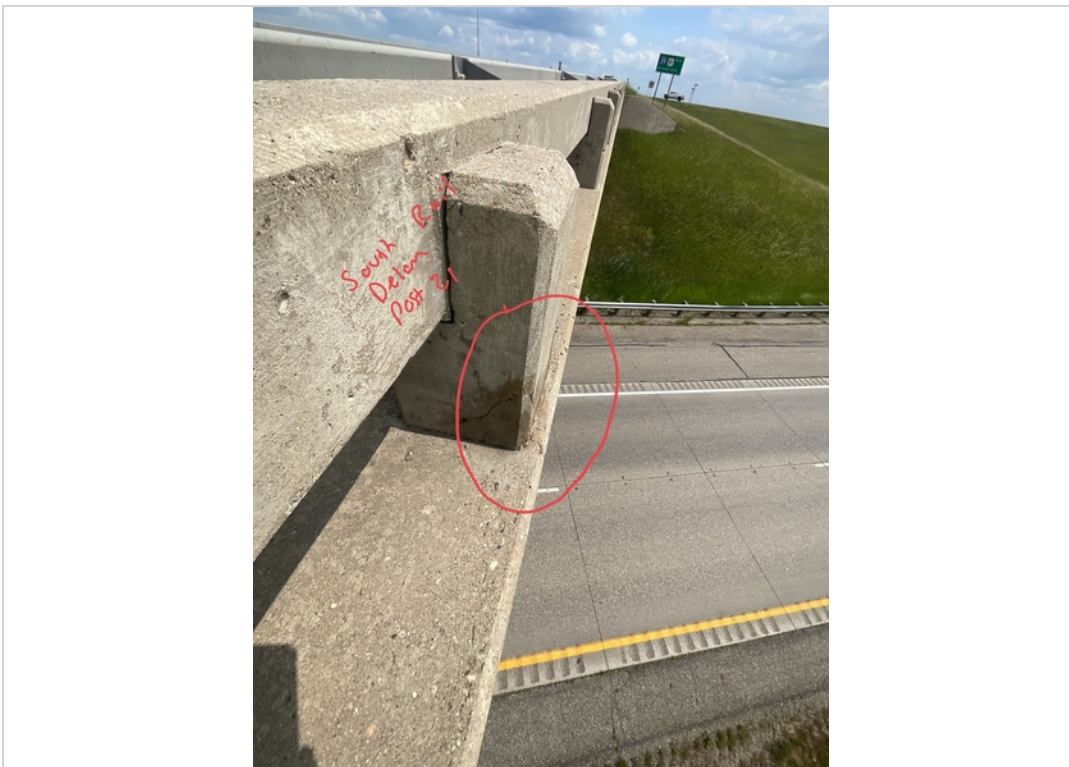
Facing East. Delamination to South Railing Post 21.

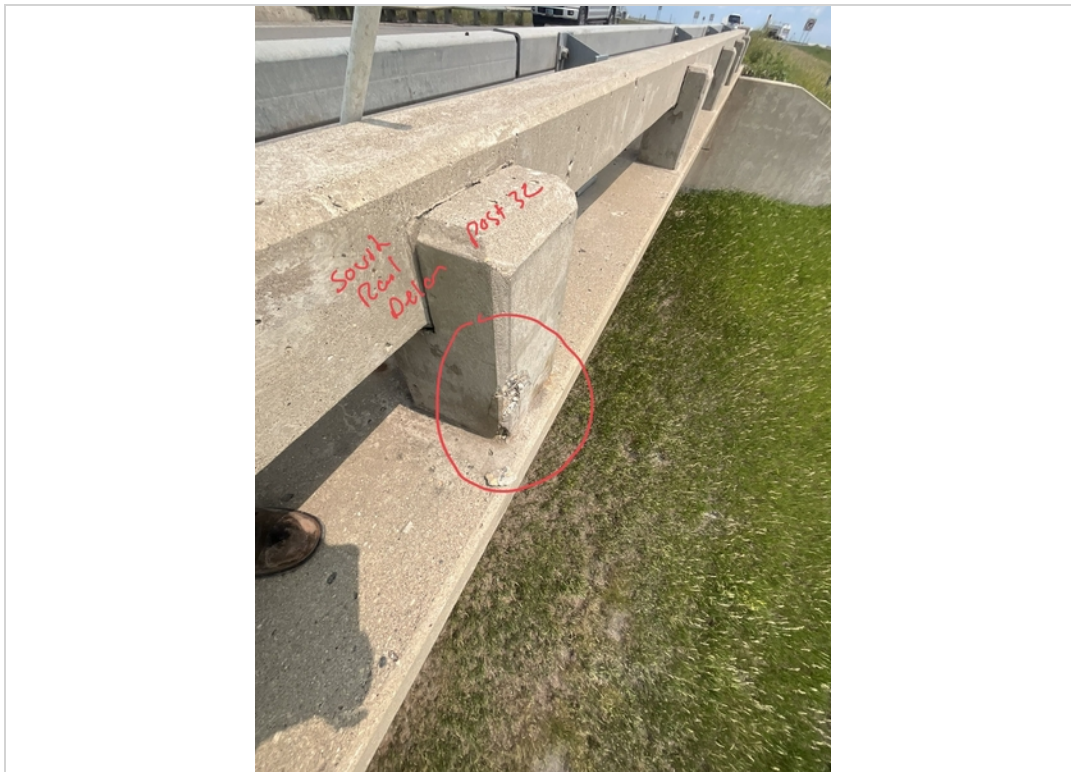
Facing NE. Delamination to South Railing at Post 32

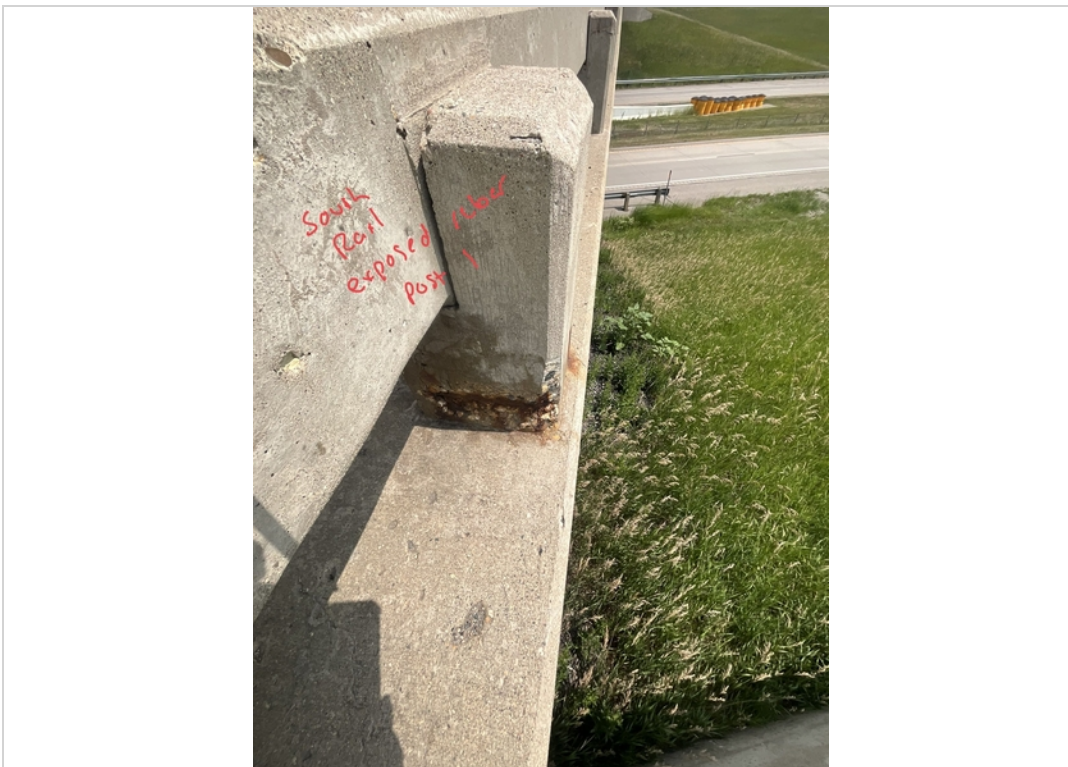
Facing East. Exposed Rebar to South Railing at Post 1.

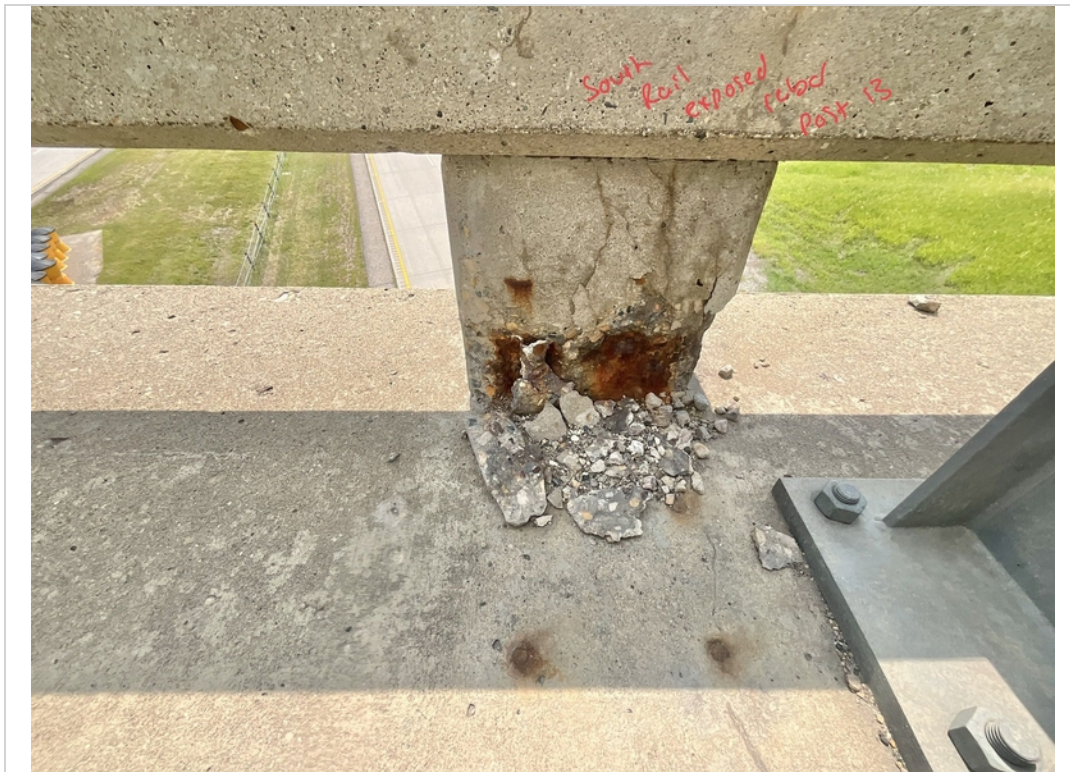
Facing South. South Railing Post 13 with Exposed Rebar.

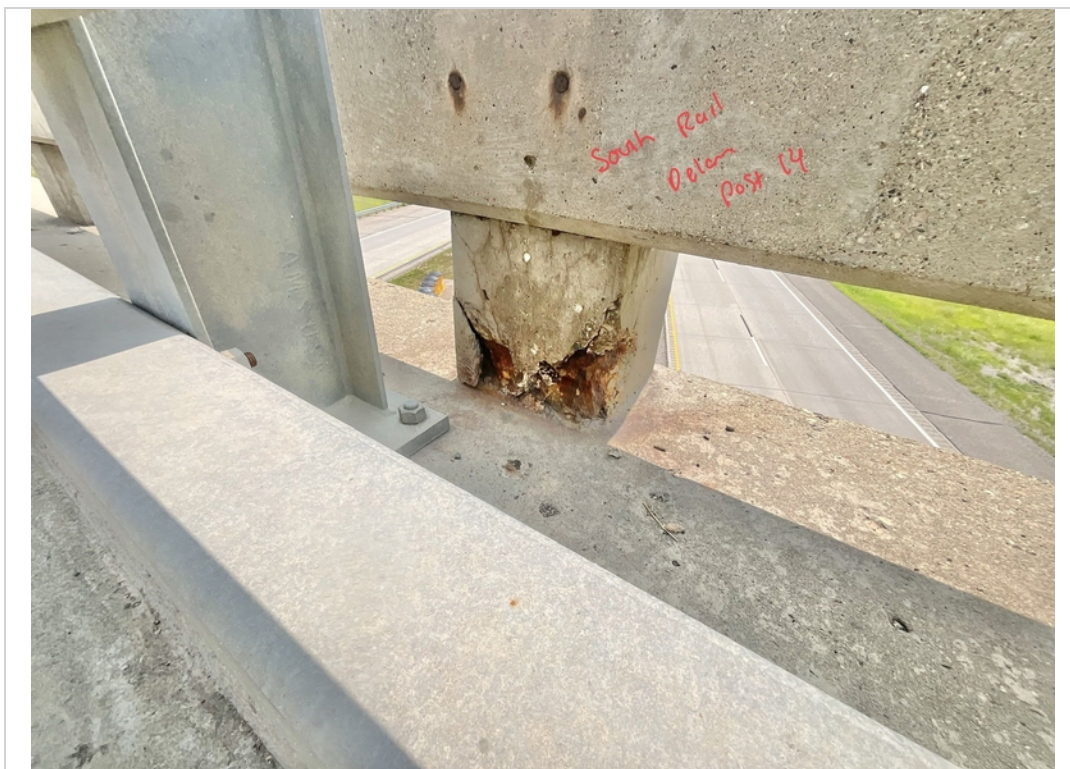
Facing SE. Delamination to South Railing Post 14.

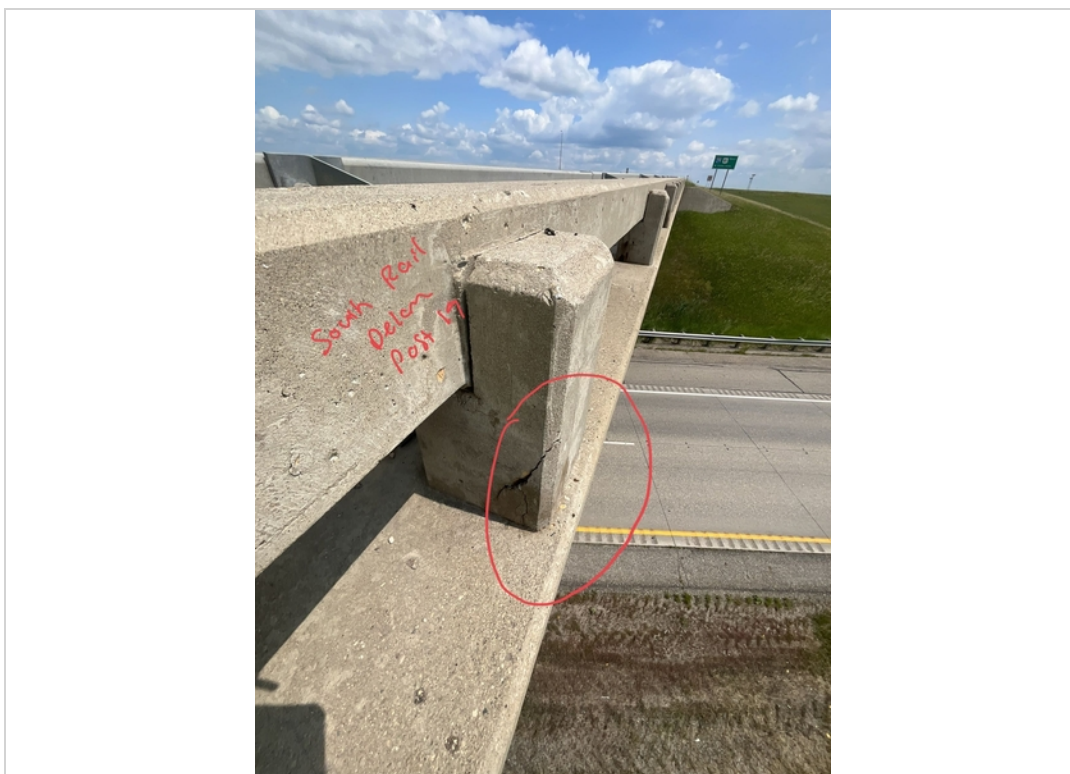
Facing East. Delamination to South Railing Post 17.

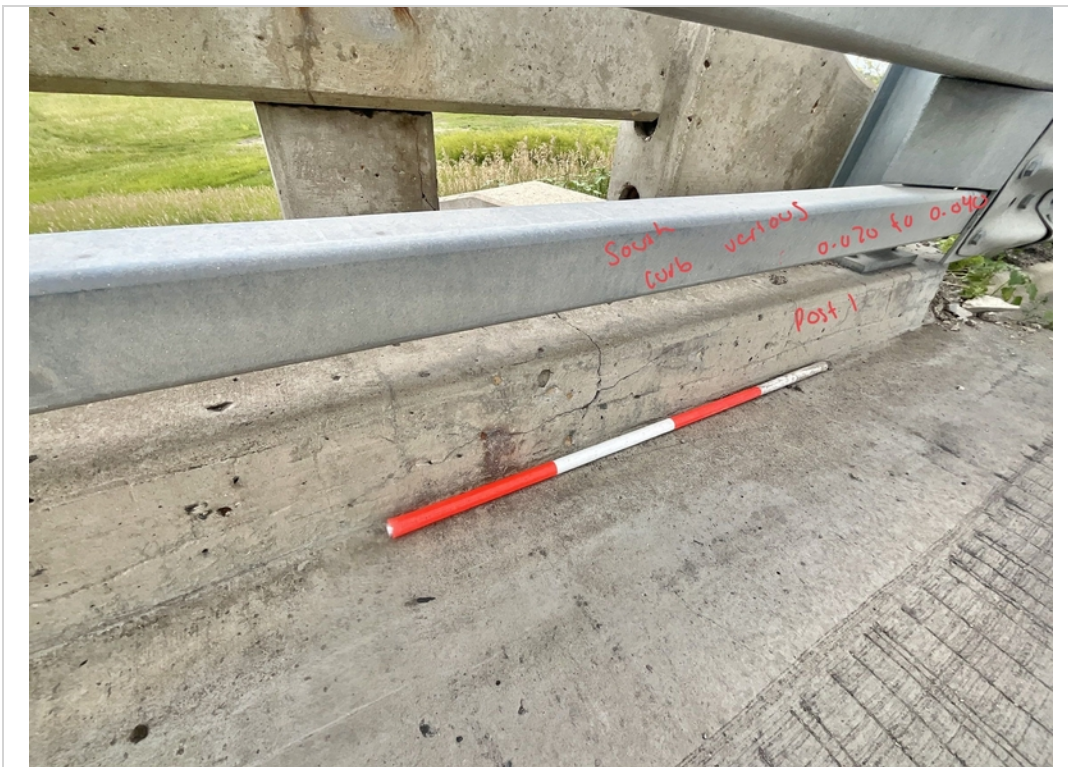
Facing SW. Various Cracks to South curb near Post 1.

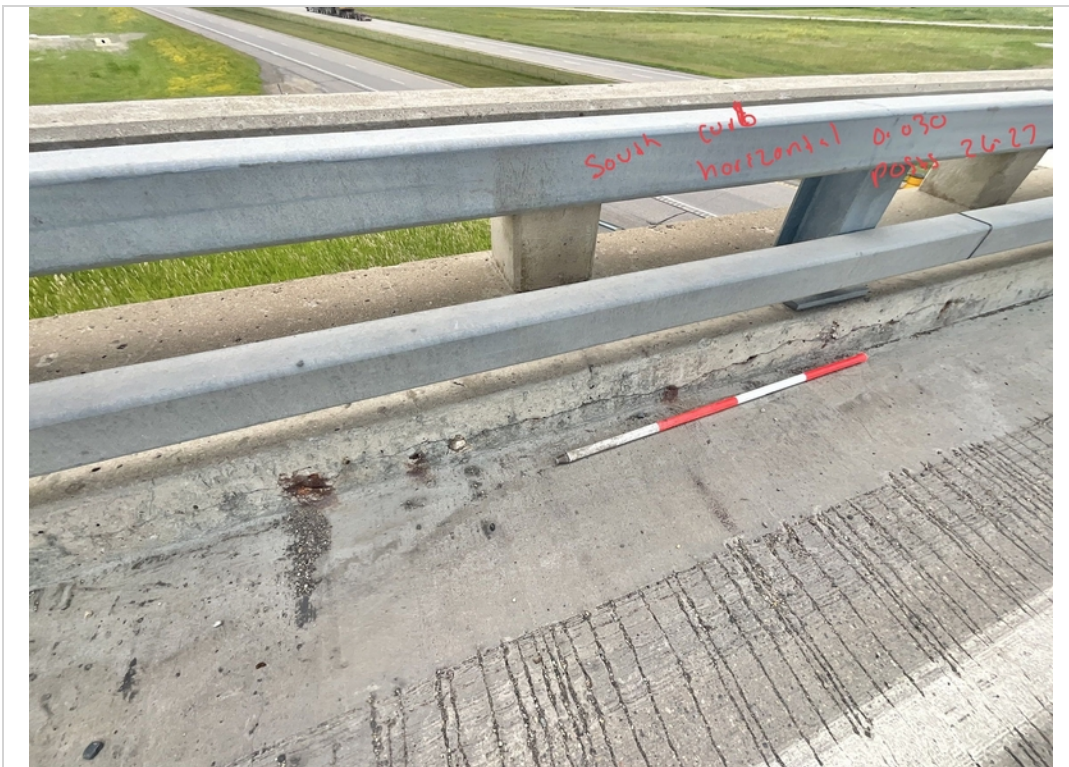
Facing SW and Downward. Continued Horizontal Crack to Face of South Curb from Posts 26-27.

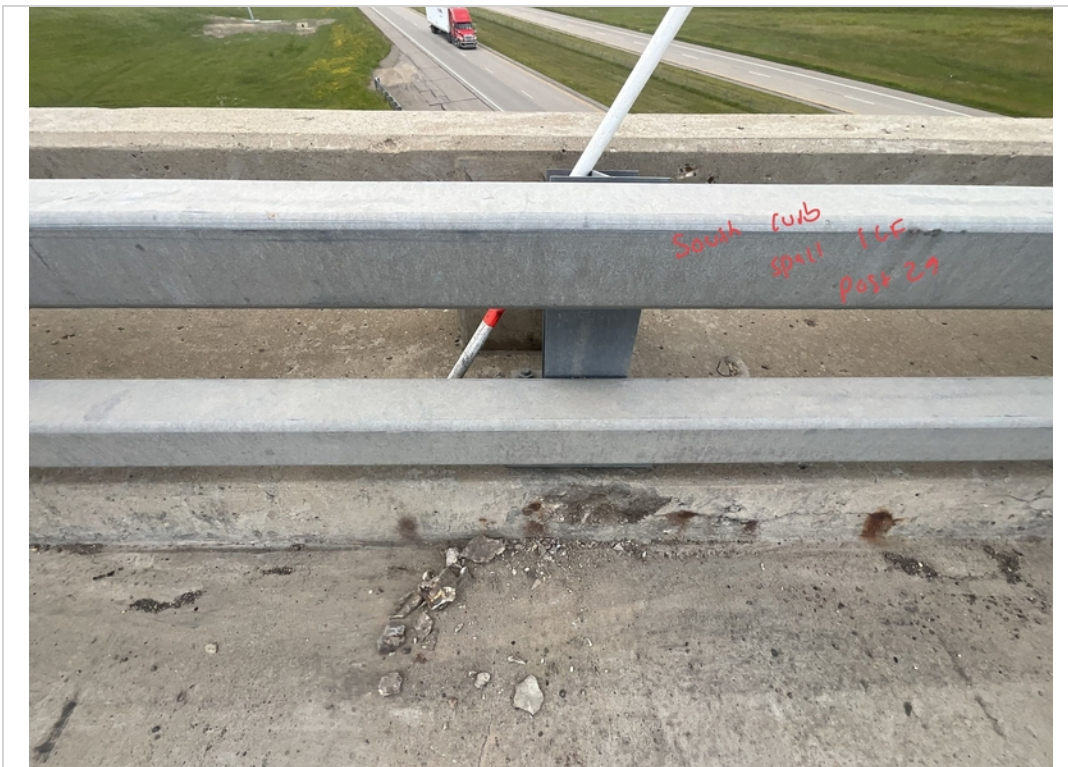
Facing South. Spall to Face of South Curb at Post 29.

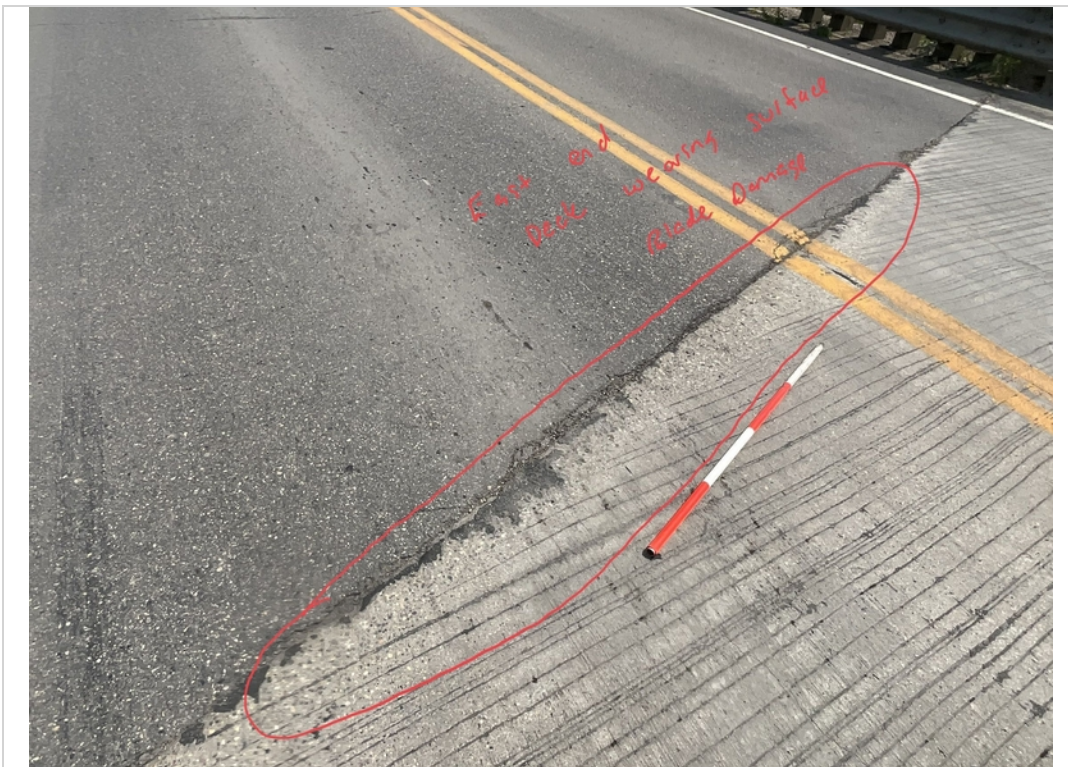
ELEMENTS	DESCRIPTION	UNITS	TOTAL	CS1	CS2	CS3	CS4
(7000-12) 7/17/2023 - Area of CS 2 Blade Damage to Wearing Surface with, East end: 8 SF at CL, area of 6"L x 16"W. See photos.							
107	Steel Open Girder/Beam	LF	1175	0	1175	0	0
1000	Corrosion	LF	1175	0	1175	0	0
515	Steel Protective Coating	SF	12826	3206	0	0	9620
3420	Peeling/Bubbling/Cracking	LF	1924	0	0	0	1924
3440	Effectiveness (Steel Protective Coatings)	LF	7696	0	0	0	7696
(1000-107) minor to moderate corrosion throughout girders - 10/31/2019 7/12/2021 - Minor to Moderate Rusting to bare metal to Girders 1-4 in all Spans. No Section Loss Observed. See Photos. 7/17/2023 - No Change to Condition State or Quantity. Areas of Rusting include bottom and top flange, lips of flanges, and portions of Webs. No Section Loss observed. See Photos.							
(3420-515-107) Paint protection peeling through finish and primer coats - 10/31/2019 7/12/2021 - Freckled Bubbling and some peeling of coating to bare metal to Girders 1-4 mainly to the webs and bottom flanges. Estimated 10%. See Photos. 7/17/2023 - Continuing and Advancement of Rusting from CS 4 peeling of coating down to Bare Metal along lips of flanges and toes of flanges to webs. Estimated 15%. See Photos.

Facing SE and Downward. Minor Blade Damage to East End of Deck Wearing Surface

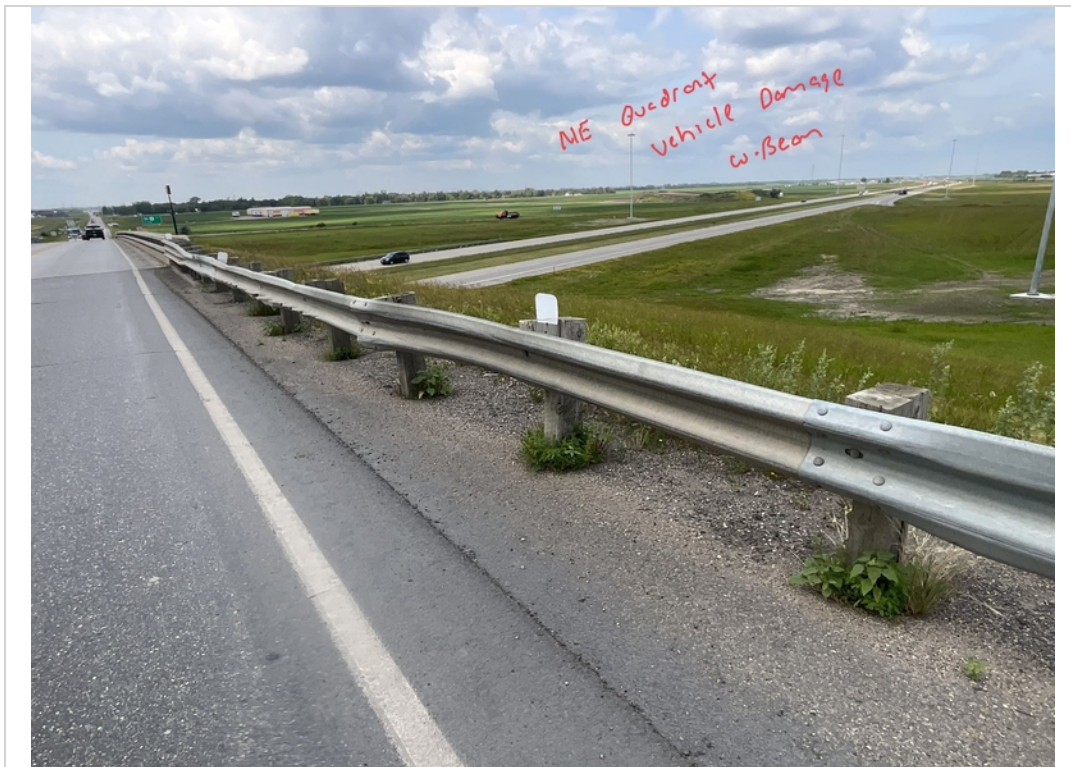
Facing NW. Vehicle Impact Damage to NE W-Beam.

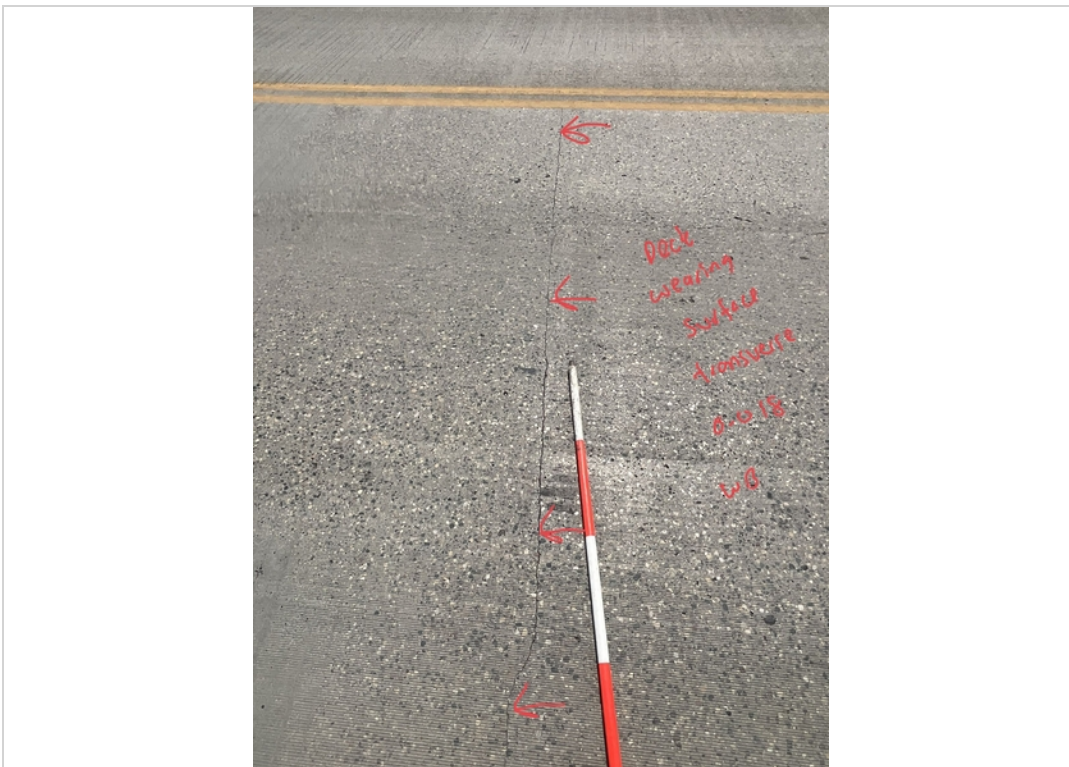
Continued and advancement of Cracking to Deck Wearing surface with:							
Longitudinal and Shear Cracks near Ends and Corners. Total = 50 SF							
Patterned Transverse Cracking to both lanes with:							
WB Lane - 57 Cracks @ 15' W = 855 SF							
EB Lane - 45 Cracks @ 15' W = 675 SF. Crack widths 0.008 to 0.025. All Cracks unsealed.							
UNDERSIDE DECK:							
No Change to Longitudinal Crack along CL throughout Structure Length. Total 295 SF. See Photos.

Facing South and Downward. Transverse Crack to Deck Wearing Surface WB Lane.

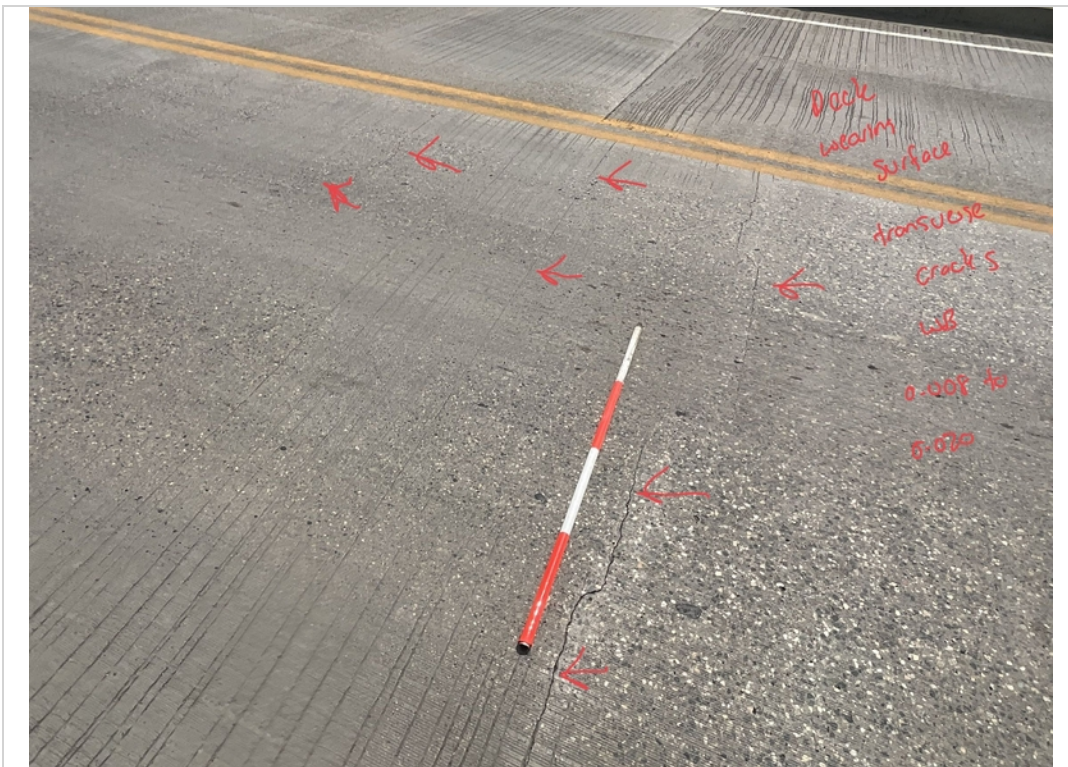
Facing South. Continued Patterned Transverse Cracking to Deck Wearing Surface.

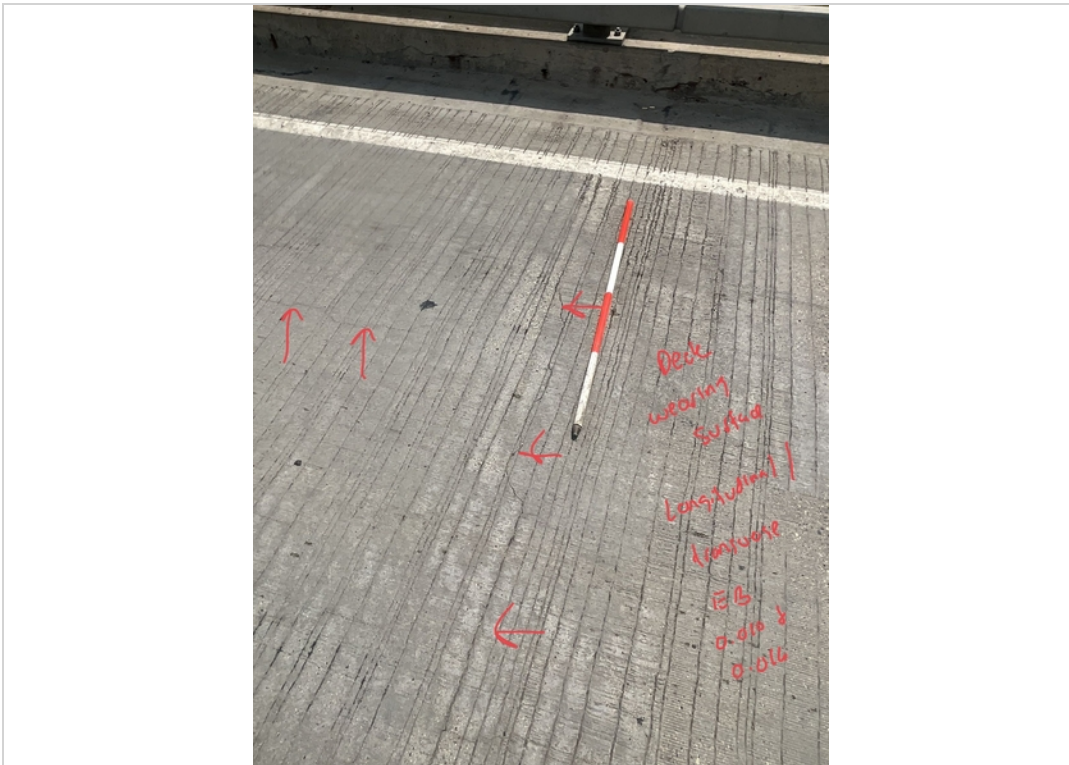
Facing South and Downward. Longitudinal Cracks to Deck Wearing Surface EB Lane.

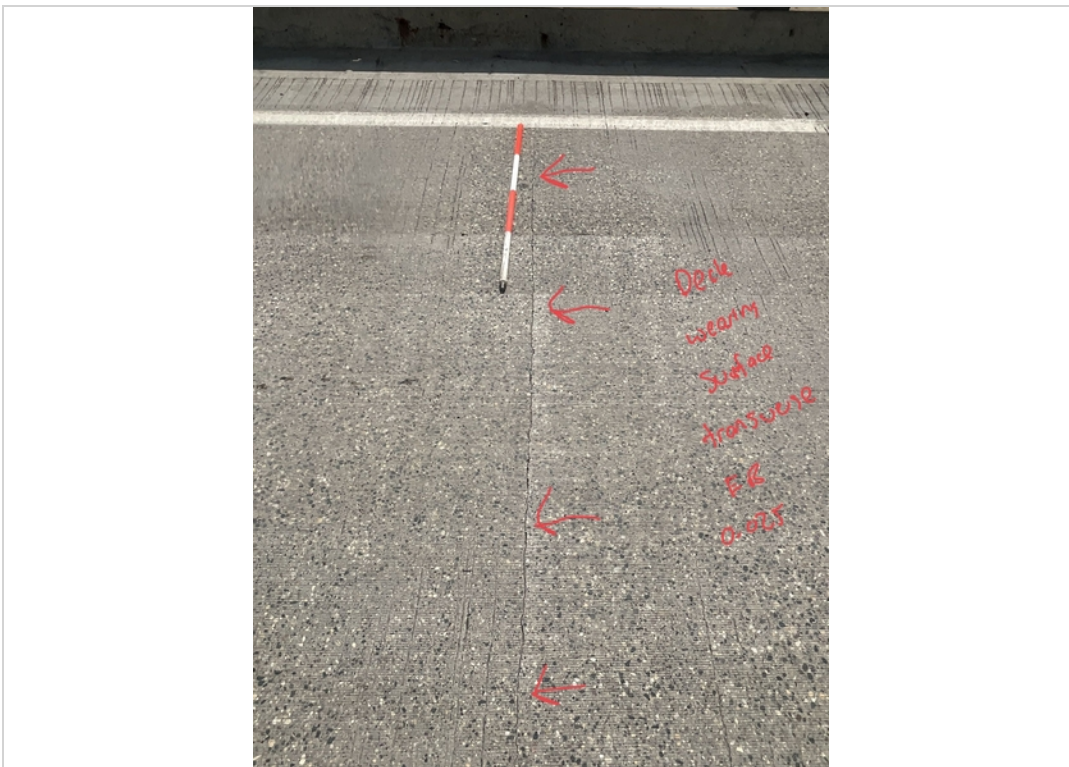
Facing South and Downward. Transverse Crack to Deck Wearing Surface EB Lane.

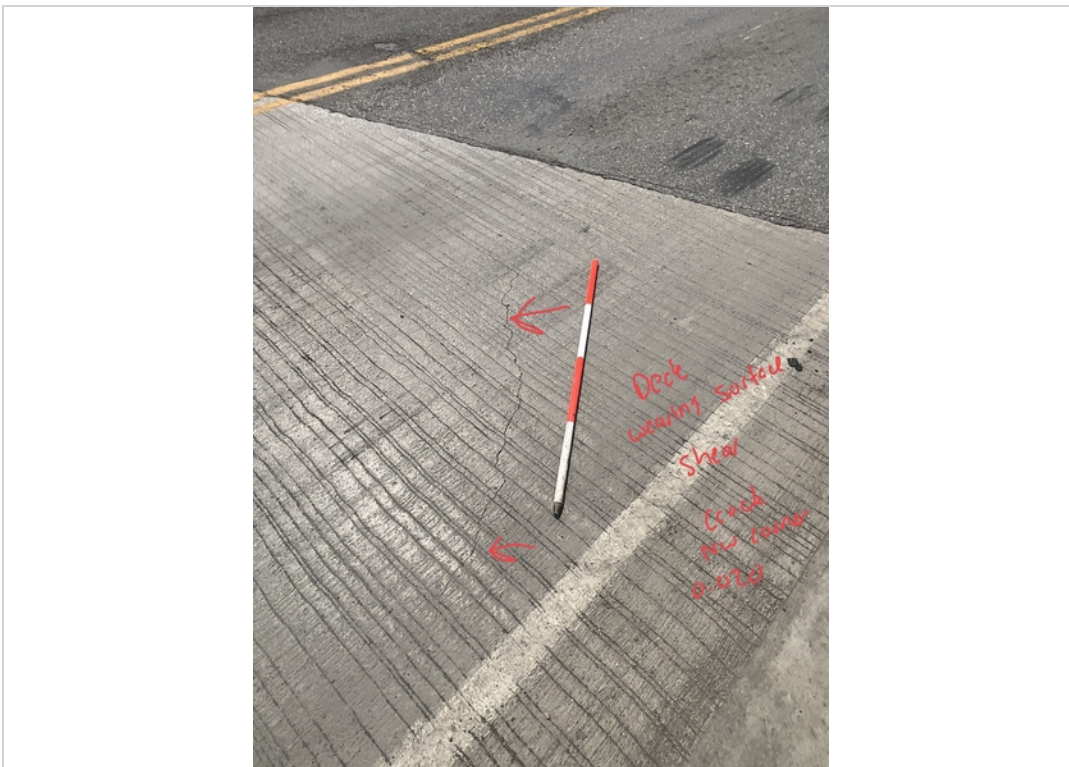
Facing SW and Downward. Shear Cracks to Deck Wearing Surface NW Corner.

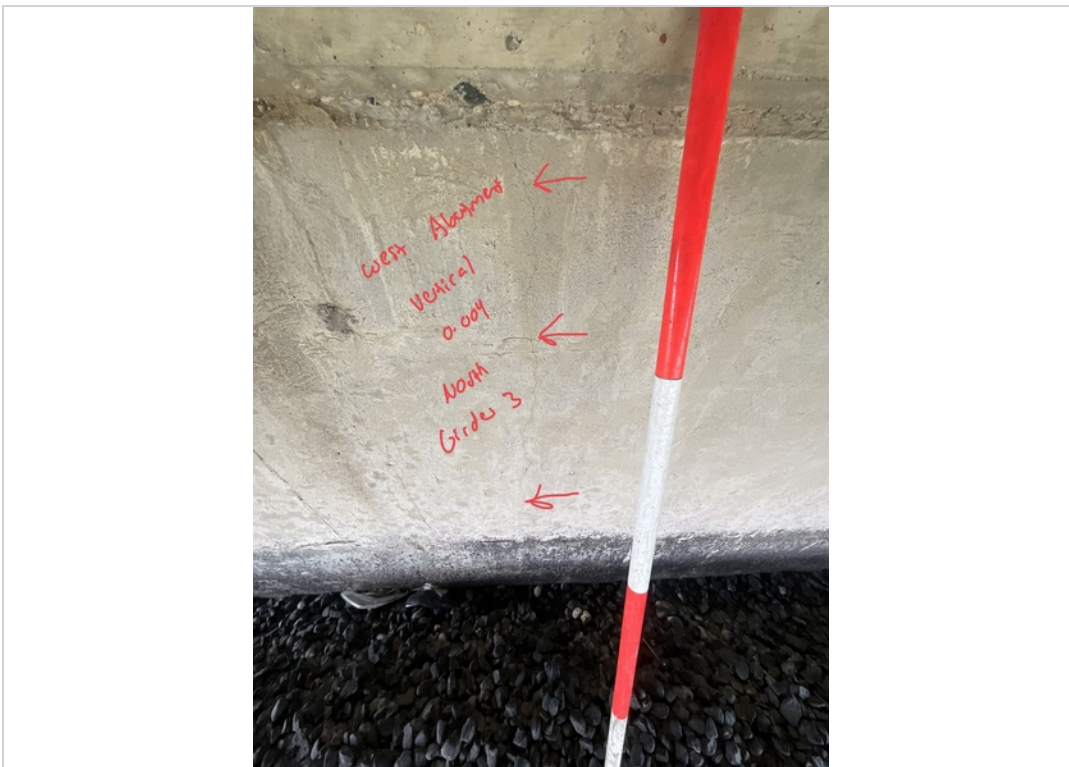
Facing West. Minor Vertical Crack to West Abutment North of Girder 3.
