IDENTIFICATION	
(1) State Names	38 - North Dakota
(8) Structure Number	0029-069.374
(5) Inventory Route	1
(2) Highway Agency District	8 - Fargo
(3) County Code	9 - Cass

(4) Place Code	65860
(6) Features Intersected	I-29/NORTH FARGO INT
(7) Facility Carried	CASS COUNTY 20
(9) Location	3 SOUTH OF HARWOOD
(11) Mile Point	0.1 mi

INSPECTIONS *			
(90) Inspection Date	07/17/2023		
(91) Frequency	24		
(92) Critical Feature Inspection	Done	Freq. (Mon)	Date
A: Fracture Critical Detail	No		
B: Underwater Inspection	No		
C: Other Special Inspection			
* The inspection date and frequency information in this box contains the current NBI date and frequency information. Please refer to the report header for the date this inspection was conducted.

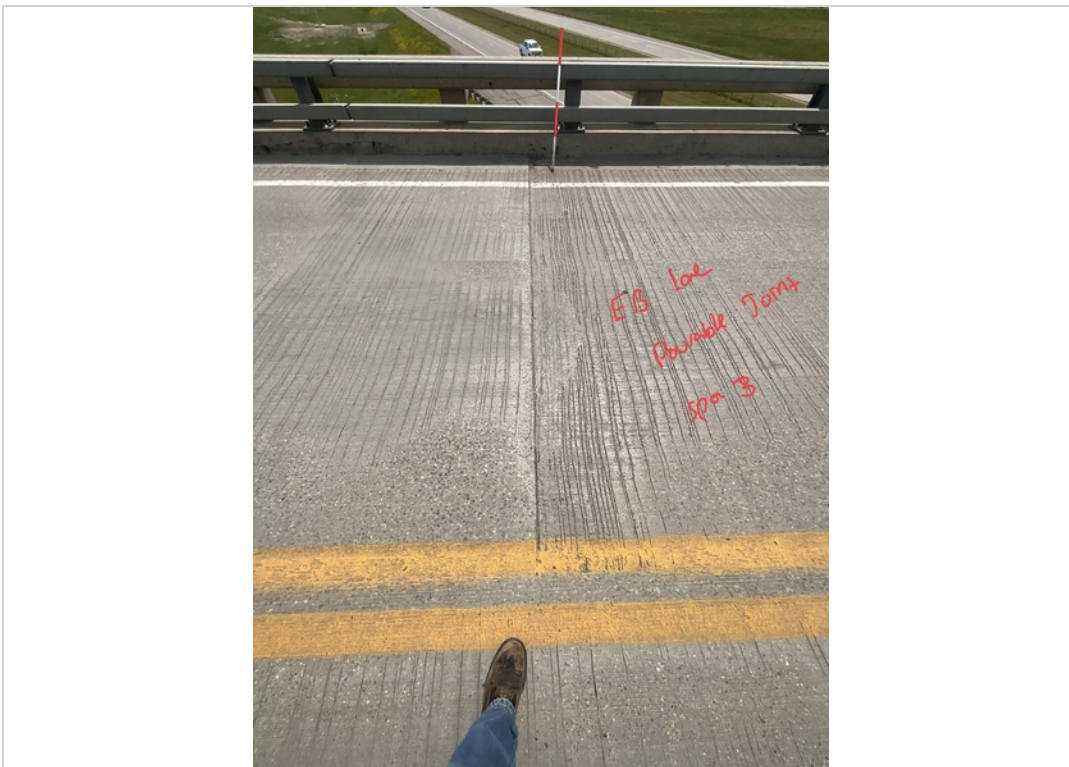
234	Reinforced Concrete Pier Cap	LF	96	96	0	0	0
301	Pourable Joint Seal	LF	15	15	0	0	0
(301) 7/17/2023 - 15 LF of Pourable Joint in the EB Lane in Span 4.							
313	Fixed Bearing	EA	12	0	12	0	0
1000	Corrosion	EA	12	0	12	0	0
515	Steel Protective Coating	SF	60	39	0	0	21
3440	Effectiveness (Steel Protective Coatings)	EA	21	0	0	0	21
<p>(1000-313) 7/12/2021 - Minor Rusting to all bearings at Piers 2, 3, and 4. More rusting to Bearings 1 and 4. See Photos. 7/17/2023 - No Change to Condition State or Quantity. Piers 2, 3, and 4 Bearings 1 and 4 with advancement of Rusting. See Photos. (515-313) 7/12/2021 - Estimated 5 SF for EA Bearing. (3440-515-313) Paint protection is peeling through the finish coat - 10/31/2019 7/12/2021 - Loss of Effectiveness of coating to Bearings 1-4 at Piers 2, 3, and 4. Estimated an average of 25%. See Photos. 7/17/2023 - CS 4 Loss of Effectiveness to Piers 2, 3, and 4 Bearings 1-4. Bearings 1 and 4 Estimated at 50% and Bearings 2 and 3 estimated at 20%. See Photos.</p>

Facing South and Downward. Pourable Joint to EB Lane in Span 4.

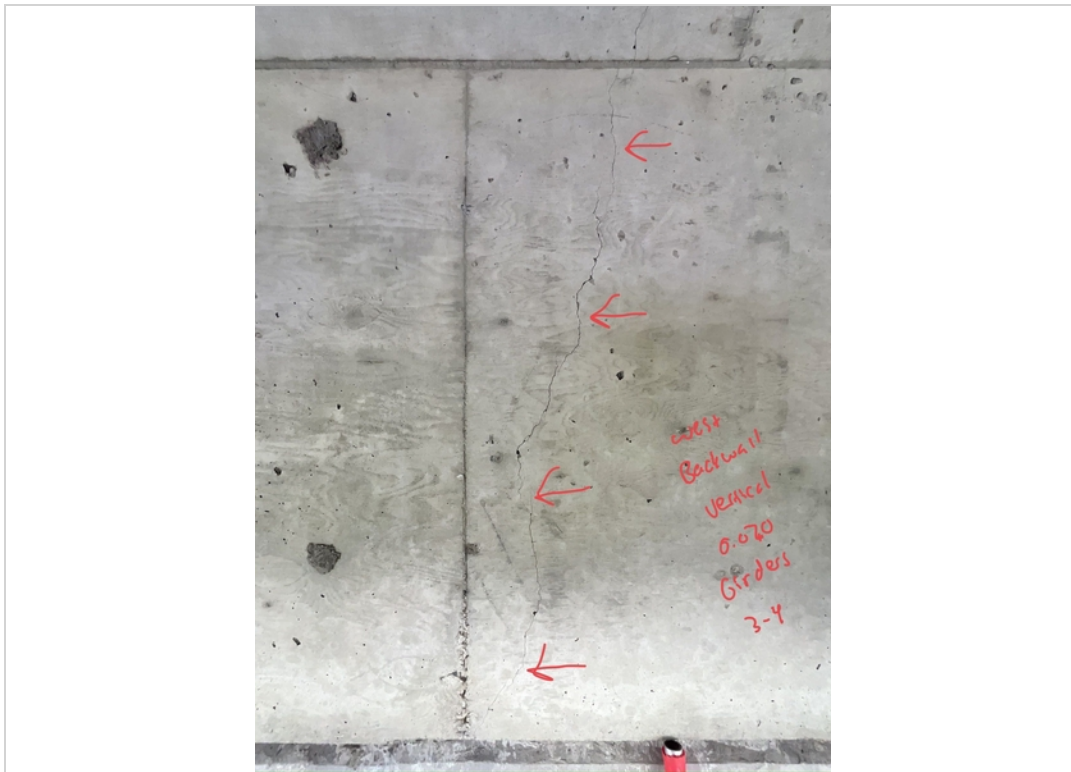
815	Re Conc Backwall	LF	76	36	35	5	0
1120	Efflorescence/Rust Staining	LF	12	0	8	4	0
1130	Cracking (RC and Other)	LF	37	9	27	1	0
<p>(1120-815) 7/12/2021, 7/17/2023 - Various cracking with seepage and efflorescence to backwalls progressing with, West Backwall: 3 LF Moderate CS 3 North of Girder 1. 4 LF South of Girder 4. East Backwall: 2 LF North of Girder 1. 1 LF South of girder 1. 1 LF North of Girder 3. 1 LF Moderate CS 3 area South of Girder 4. See photos.</p> <p>(1130-815) 7/12/2021, 7/17/2023 - Vertical cracking to backwalls progressing with, West Backwall: 2 LF CS 2 Diagonal North of Girder 1, widths of 0.008"-0.020". 1 LF CS 1 between Girders 1-2, width of 0.008". 1 LF CS 1 North of Girder 2, width of 0.004". 1 LF CS 2 between Girders 2-3, width of 0.018". 5 LF CS 2 Various between Girders 2-3, widths of 0.004". 1 LF CS 2 between Girders 3-4, width of 0.020". 8 LF CS 2 Various between Girders 3-4, widths of 0.004"-0.006". 1 LF CS 1 Various North of Girder 4, width of 0.004"-0.006". East Backwall: 3 LF CS 1 between Girders 1-2, width of 0.004"-0.008". 3 LF CS 1 between Girders 2-3, width of 0.004"-0.008". 1 LF CS 2 between Girders 2-3, width of 0.014". 6 LF CS 2 between Girders 3-4, width of 0.006"-0.012". 3 LF CS 2 Diagonal South of Girder 4, width of 0.004"-0.050". 1 LF CS 3 Diagonal South of Girder 4, width of 0.060". See photos.</p>

Facing West. Vertical Crack to West Backwall in-between Girders 3 and 4.

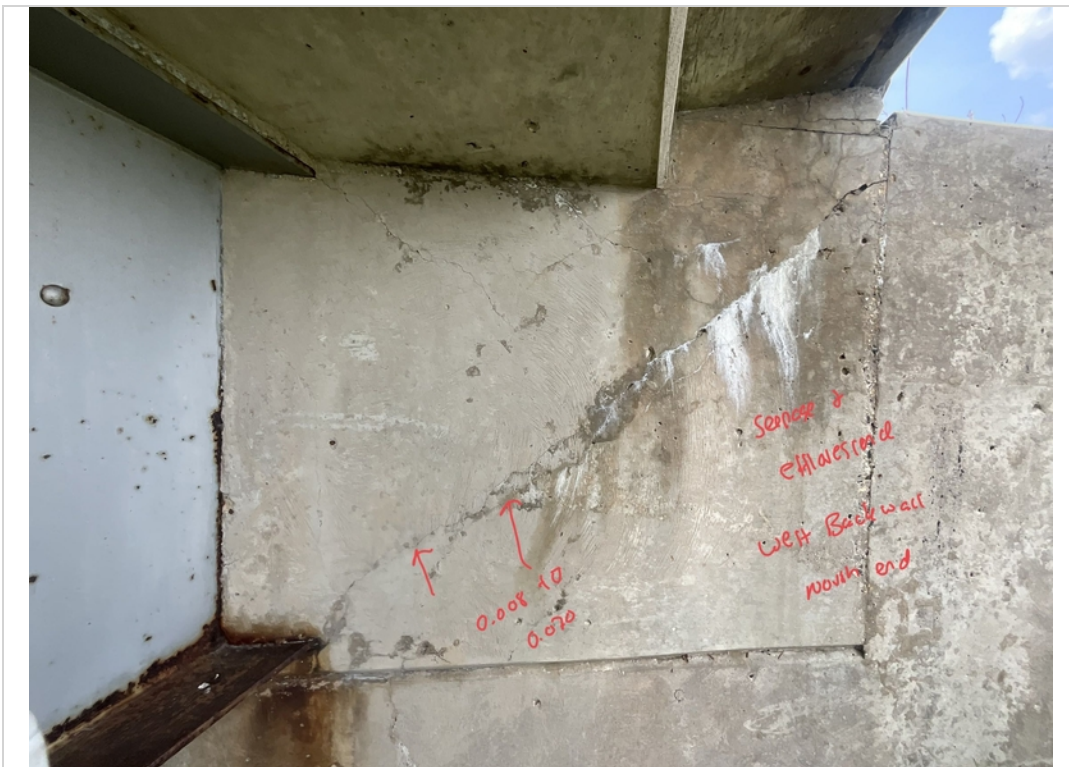
Facing West. Diagonal Crack with seepage and efflorescence to West Backwall North End.

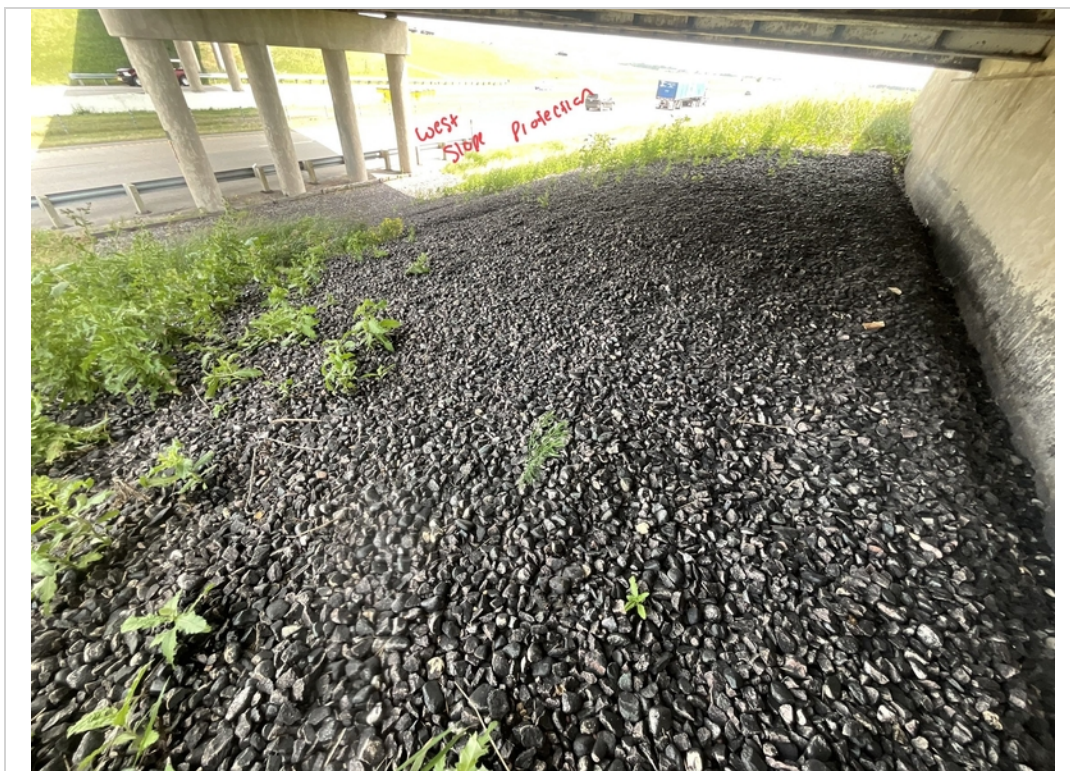
Facing SE. West Slope Protection.

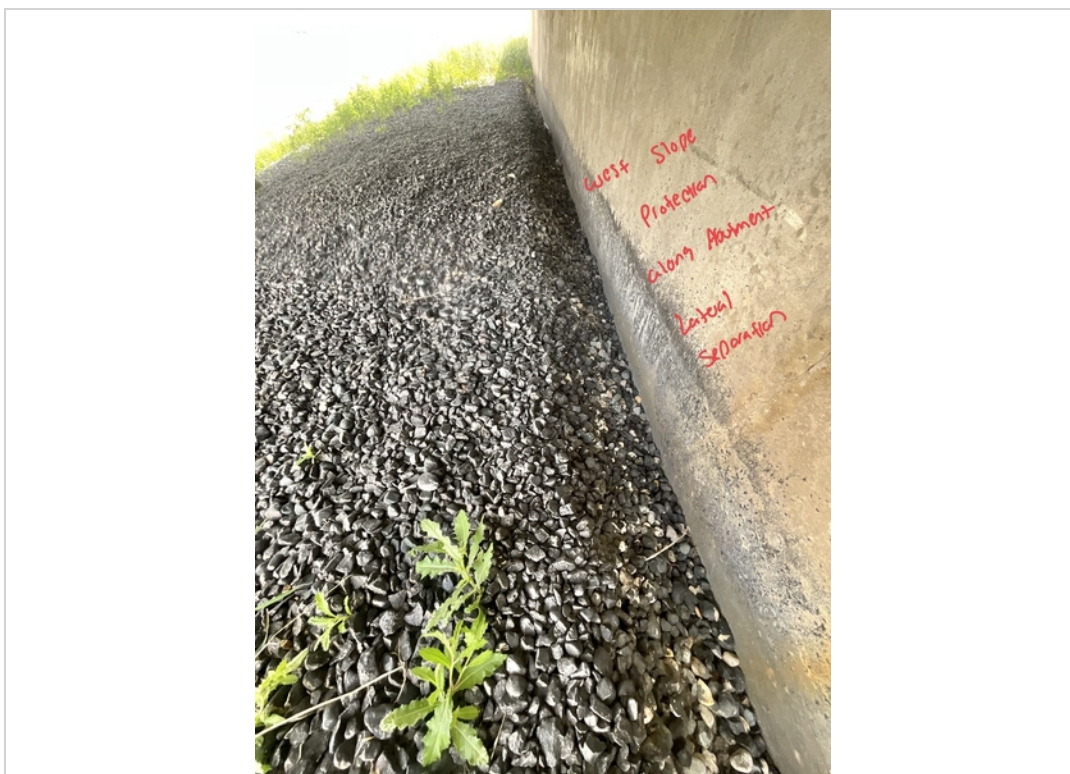
Facing South. West Slope Protection along Abutment with Lateral Separation.

Recommendation to fill with appropriate rock and apply oil to area along Abutment. See Photos.

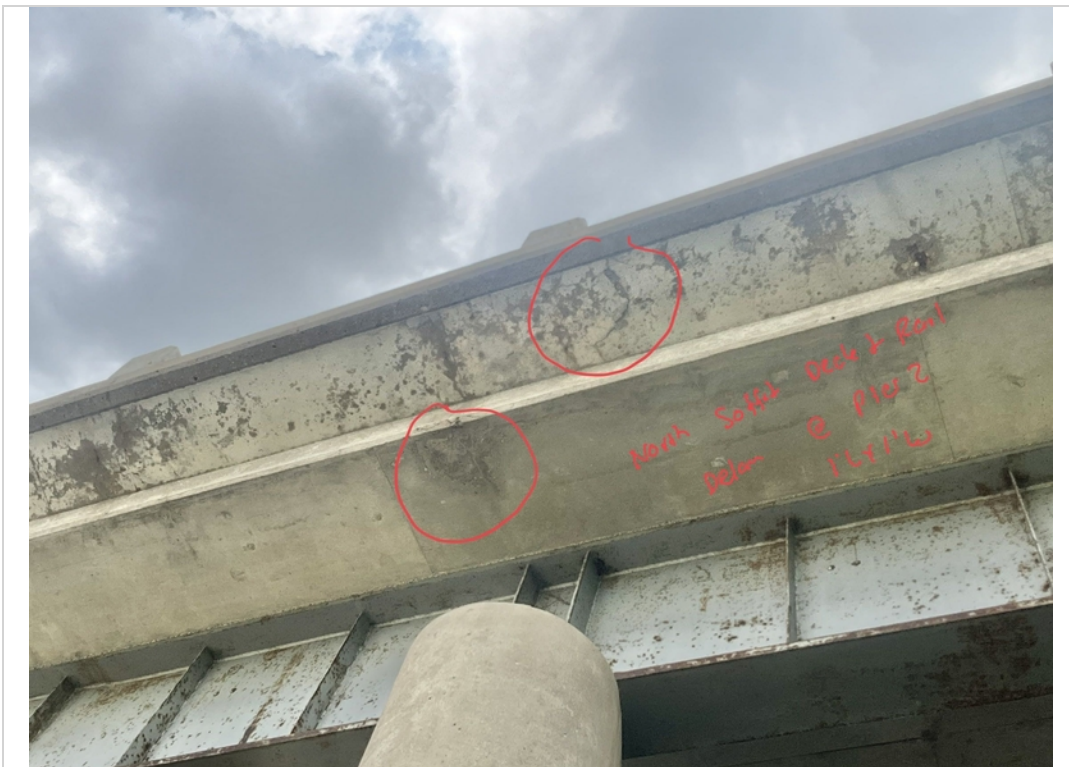
Facing South and Upwards. Delamination to North Soffit of Deck and Railing near Pier 2.

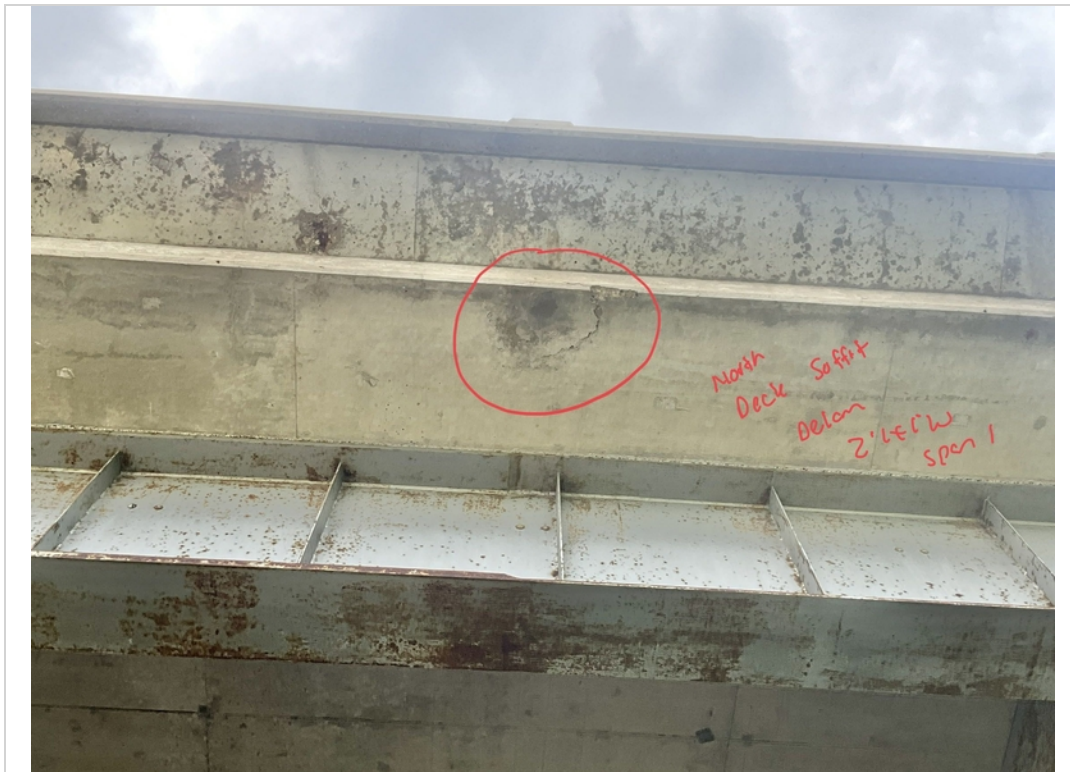
Facing South and Upwards. Delamination to North Soffit in Span 1.

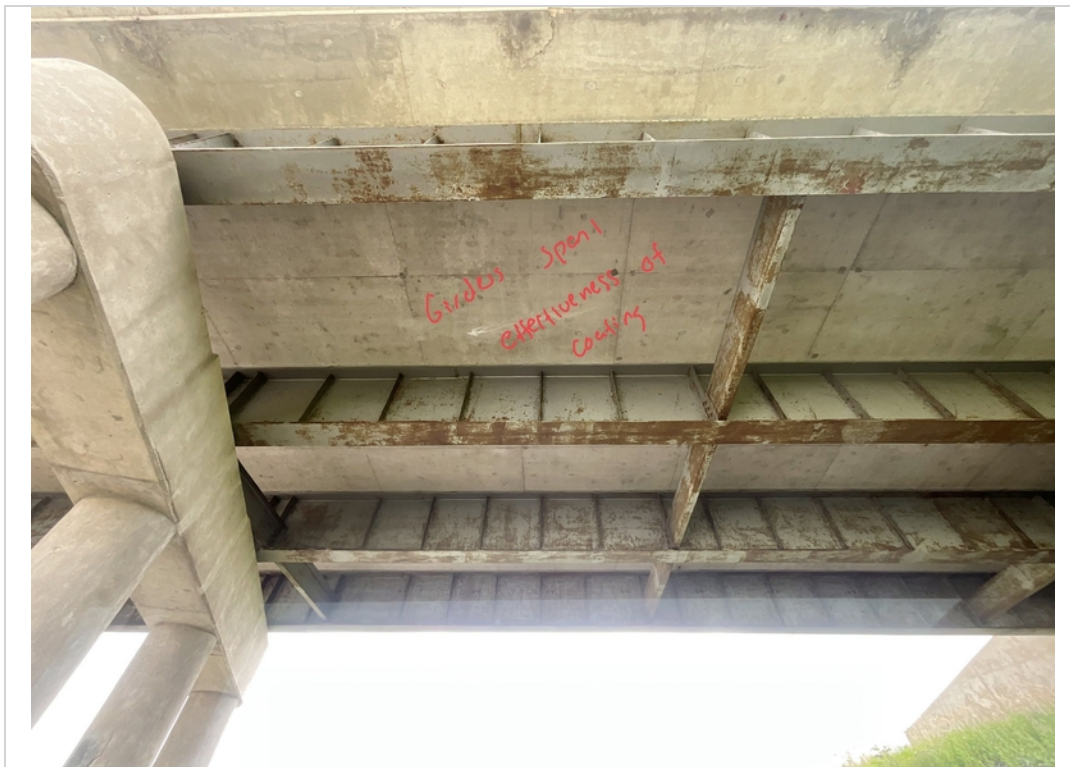
Facing South and Upwards. Effectiveness of Coating to Girders in span 1.

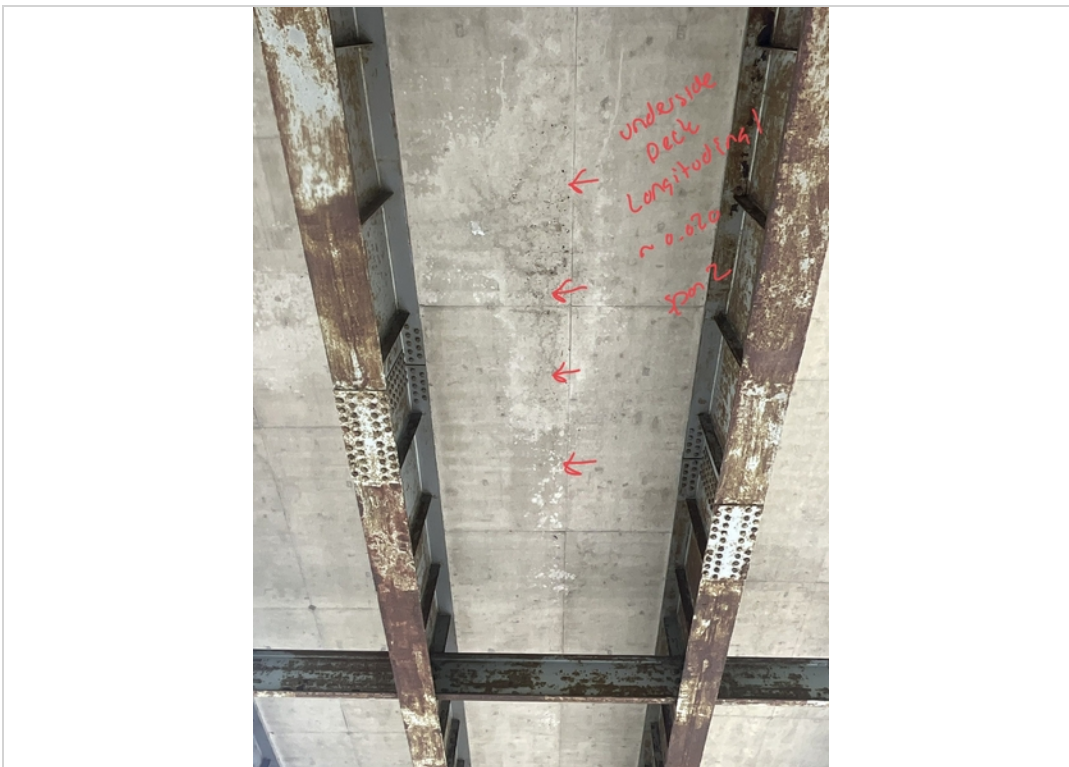
Facing East and Upwards. Longitudinal Crack to Underside Deck CL in Span 2.

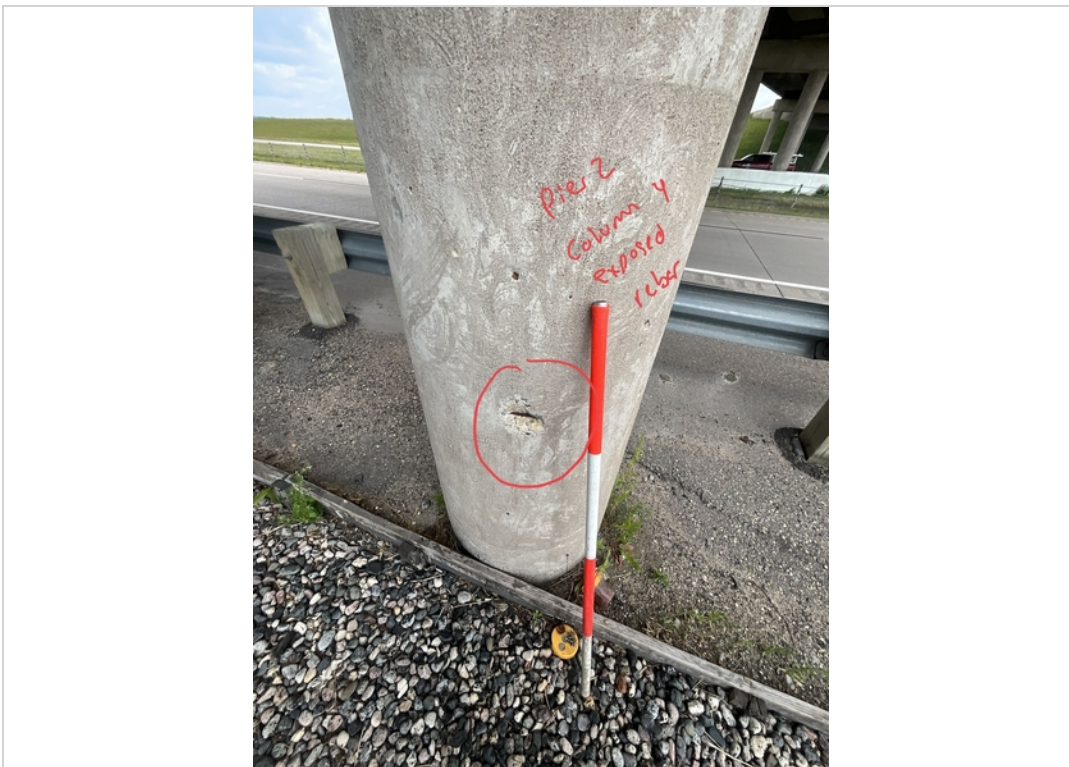
Facing NE. Pier 2 Column 4 Exposed Rebar.

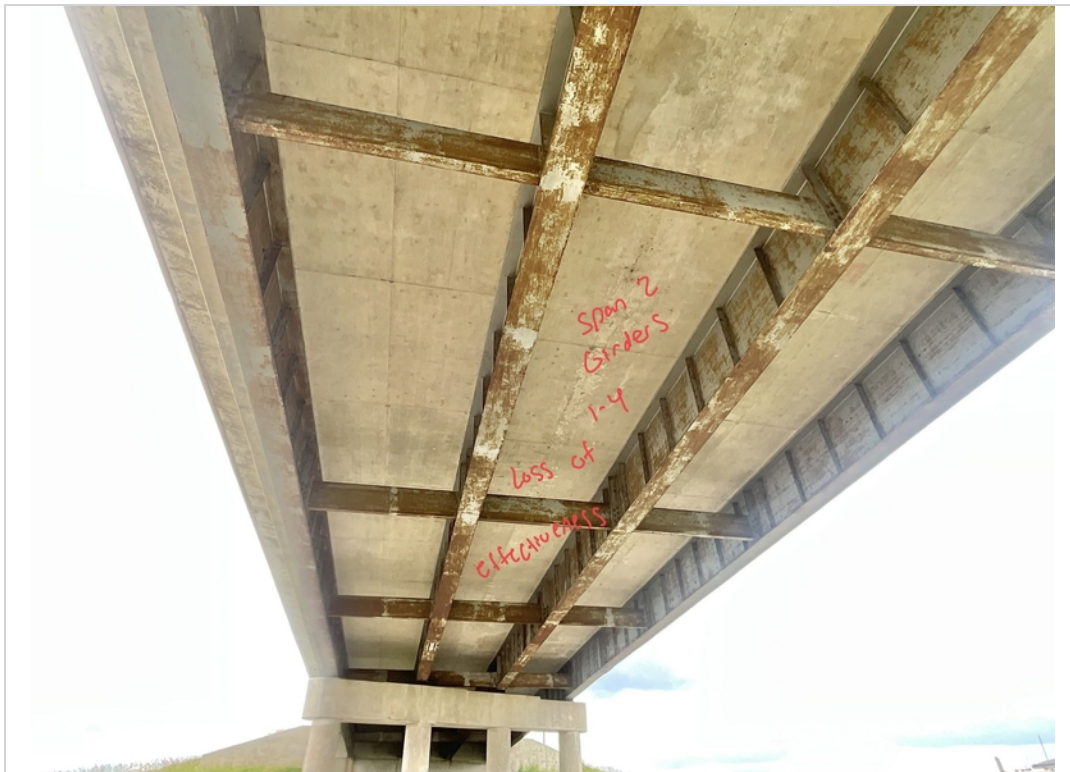
Facing West and Upwards. Loss of Effectiveness to coating system Girders in Span 2.

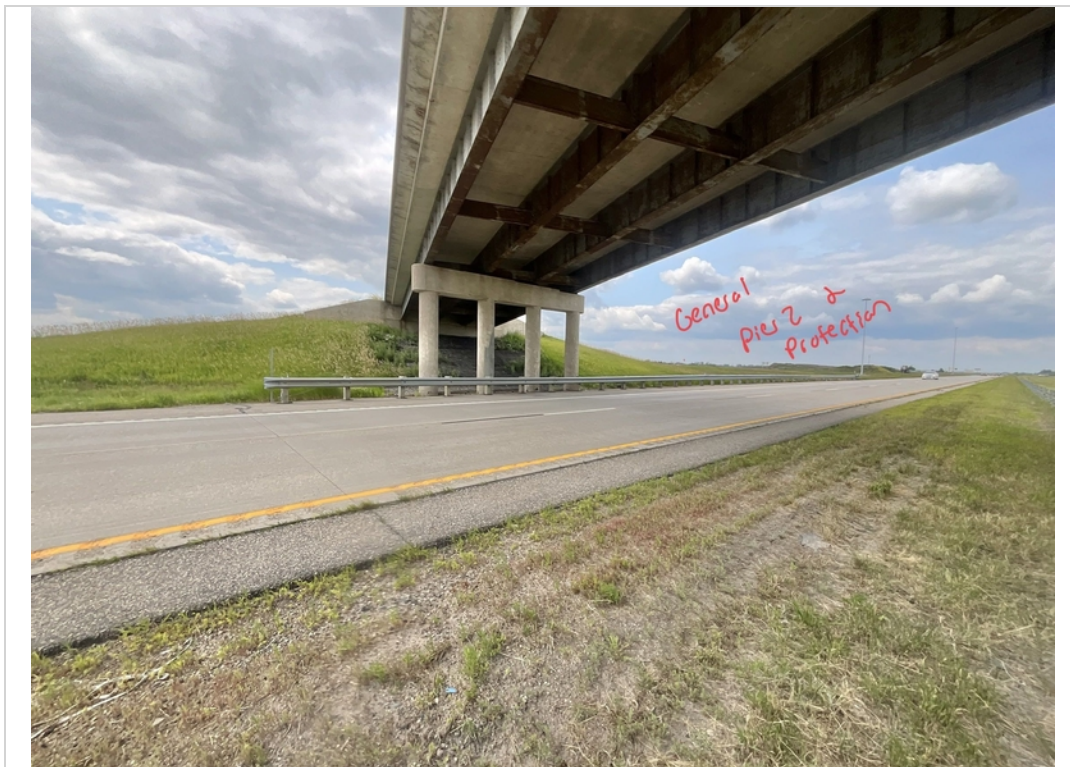
Facing NW. General of Pier 2 and Pier 2 Protection.

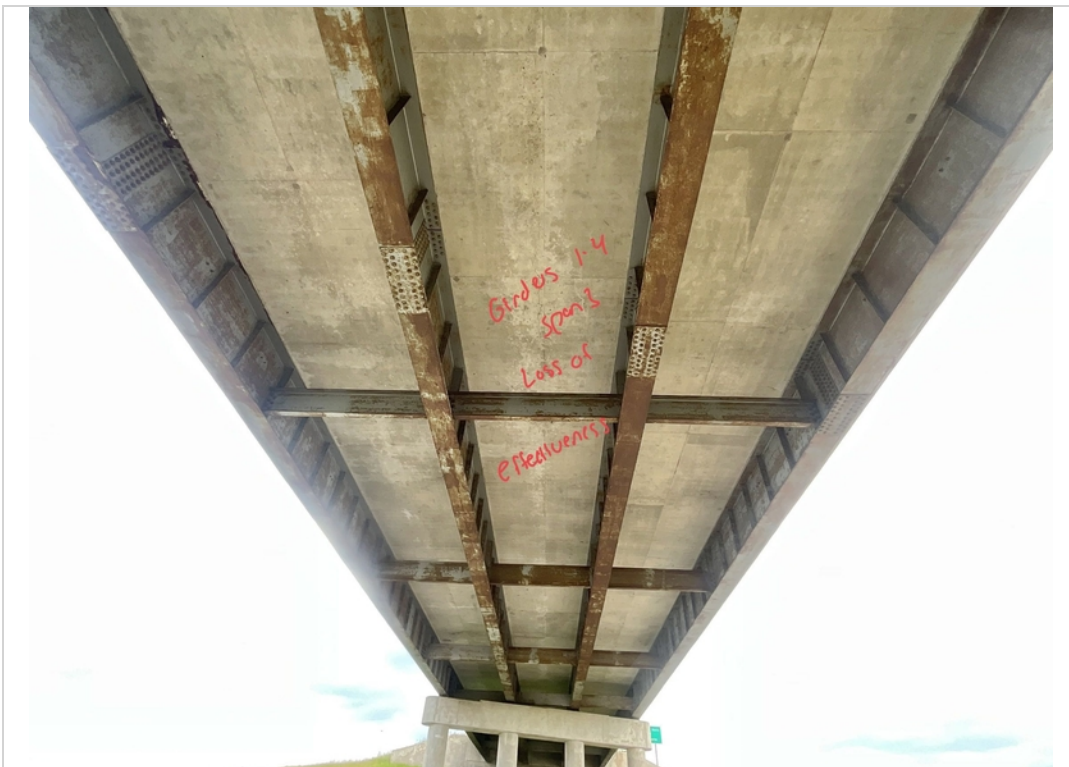
Facing East and Upwards. Loss of effectiveness of Girders 1-4 in Span 3.

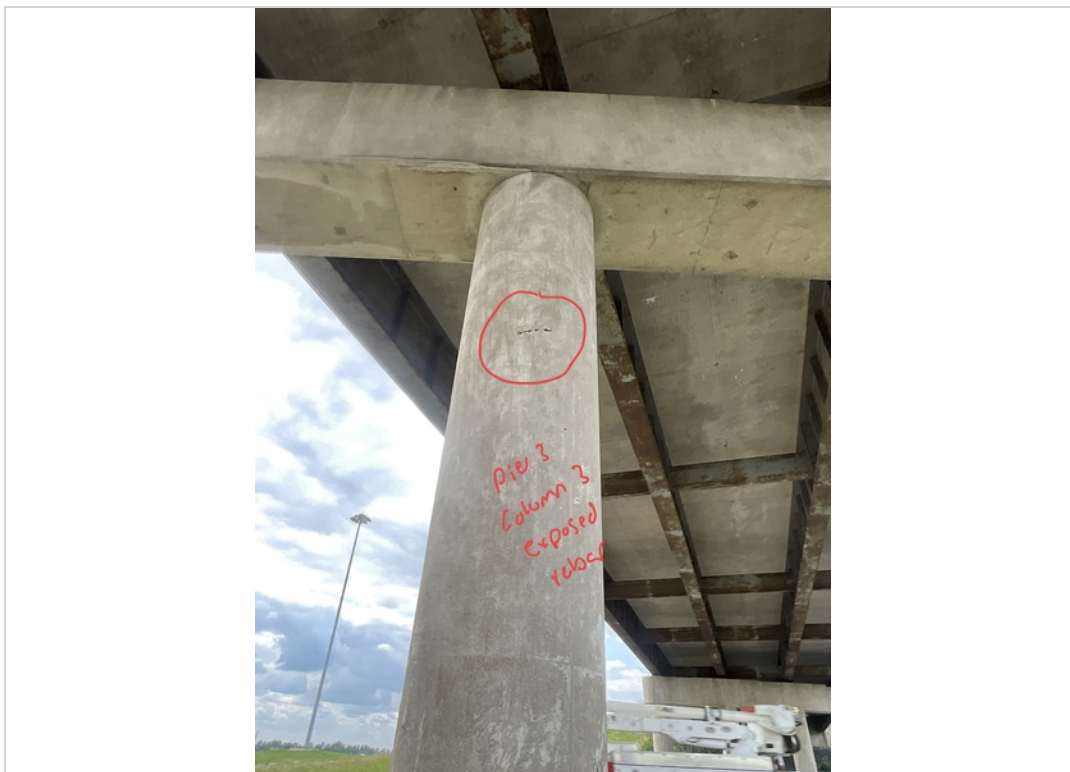
Facing West and Upwards. Exposed Rebar to Pier 3 Column 3.

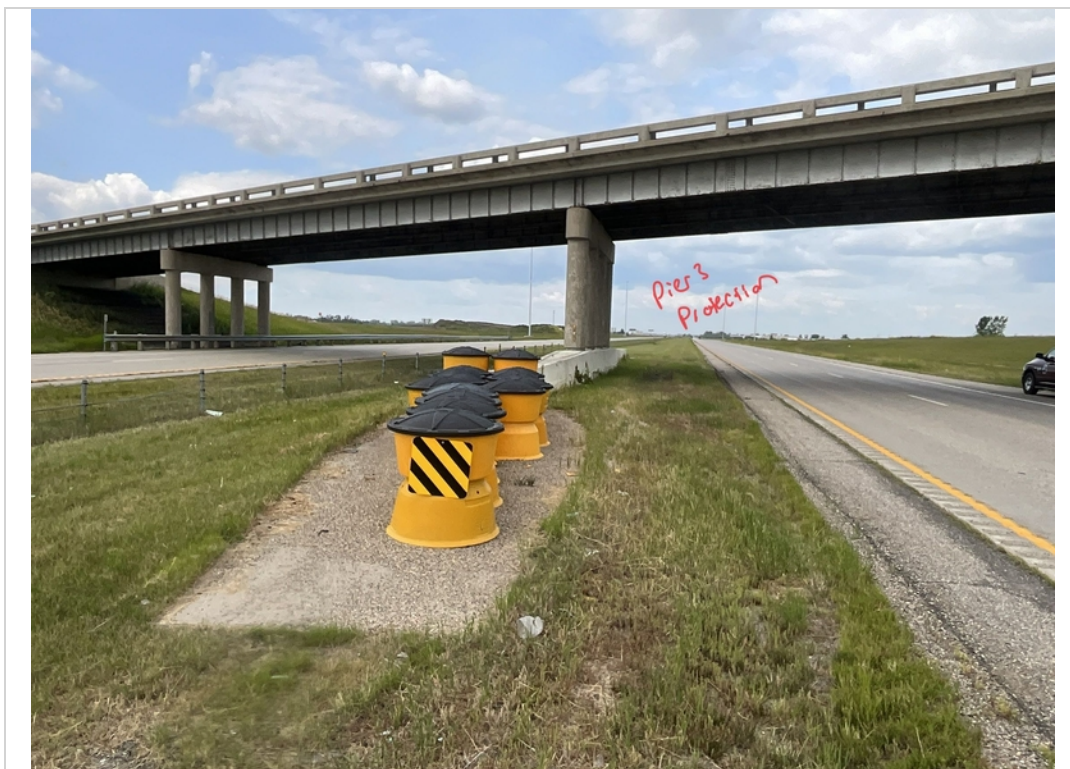
Facing North. Pier 3 Protection.

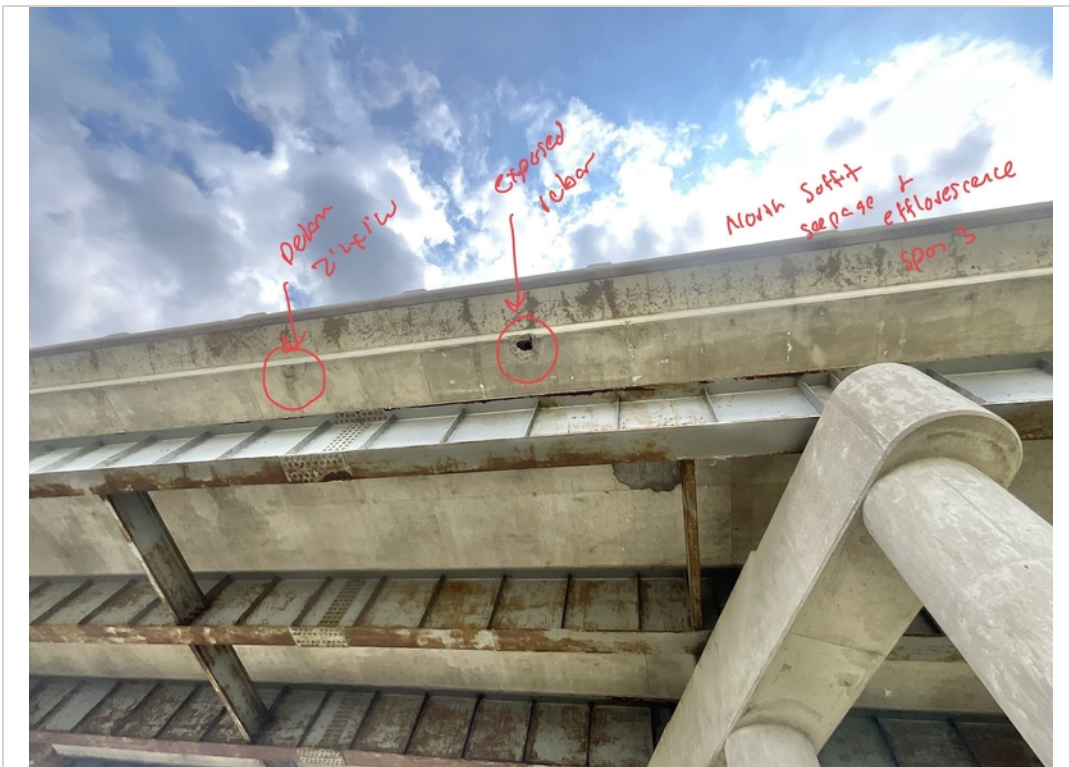
Facing South and Upwards. Delamination and Exposed Rebar to North Soffit in Span 3.

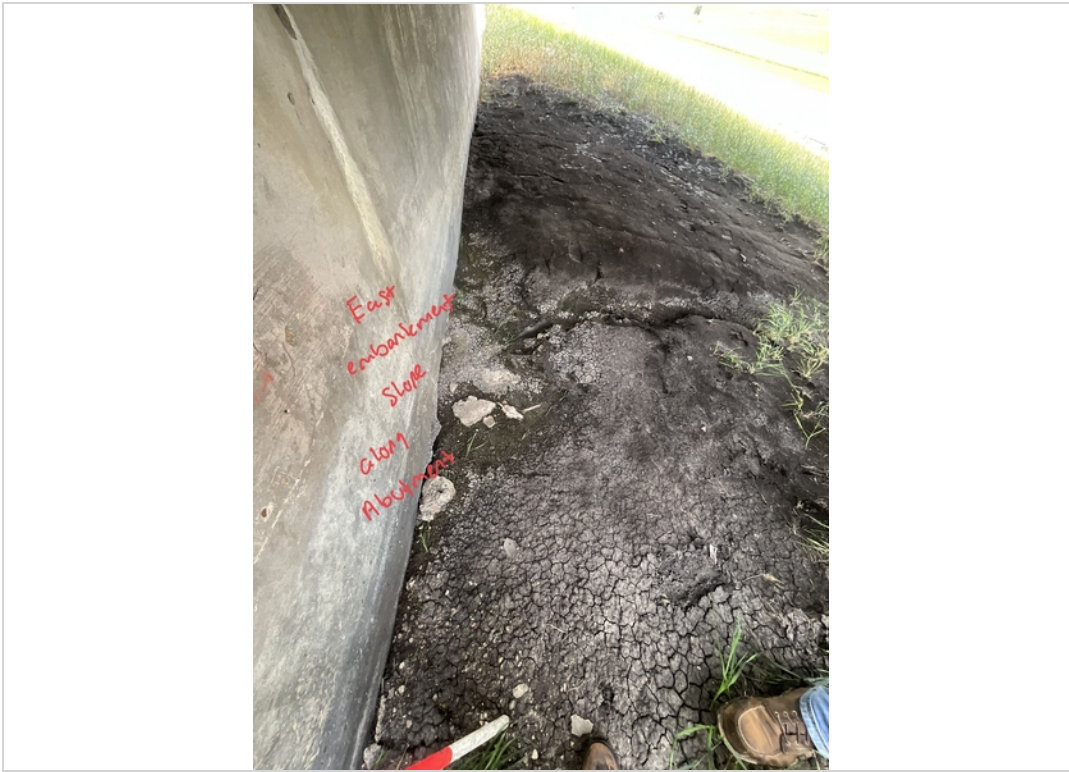
Facing South. East Embankment Slope along Abutment.

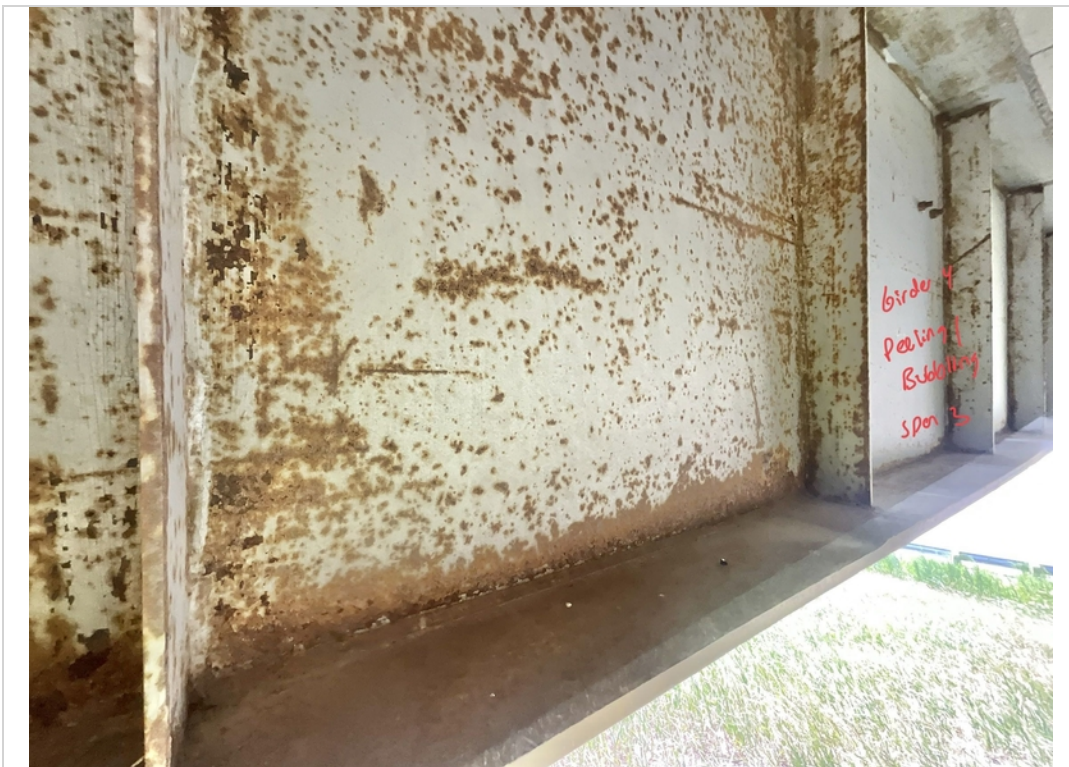
Facing SW. Peeling and Bubbling of Coating to Girder 3 in Span 4.

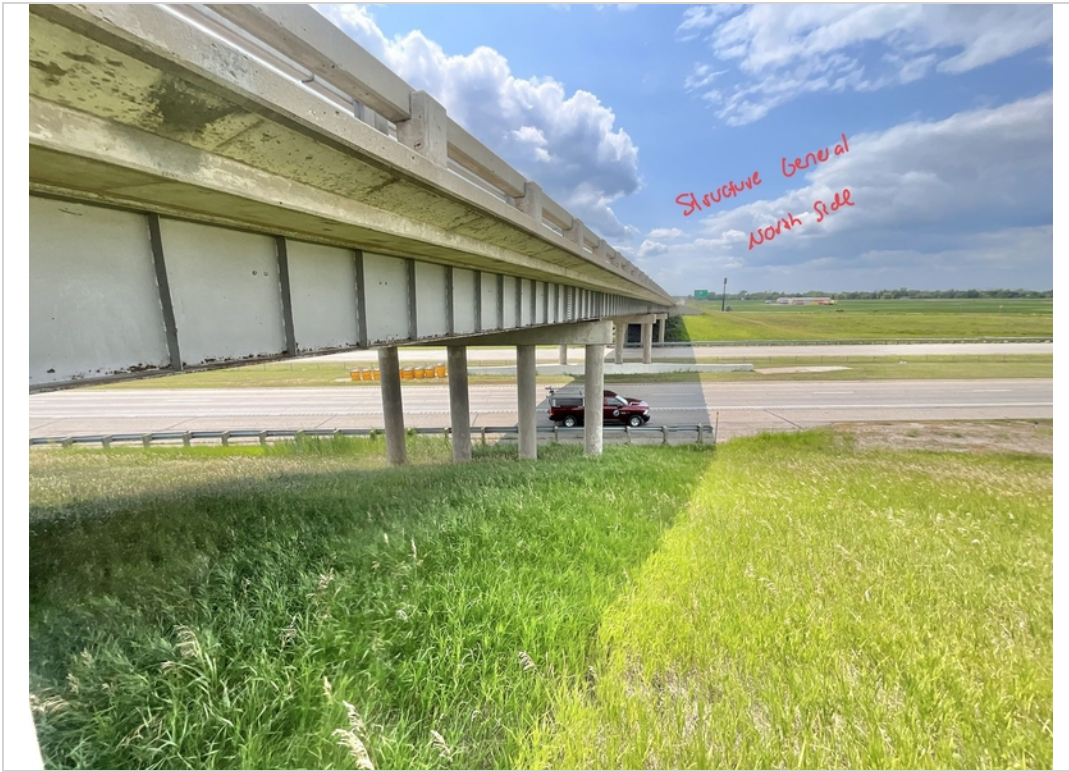
Facing West. Structure General along North Side.

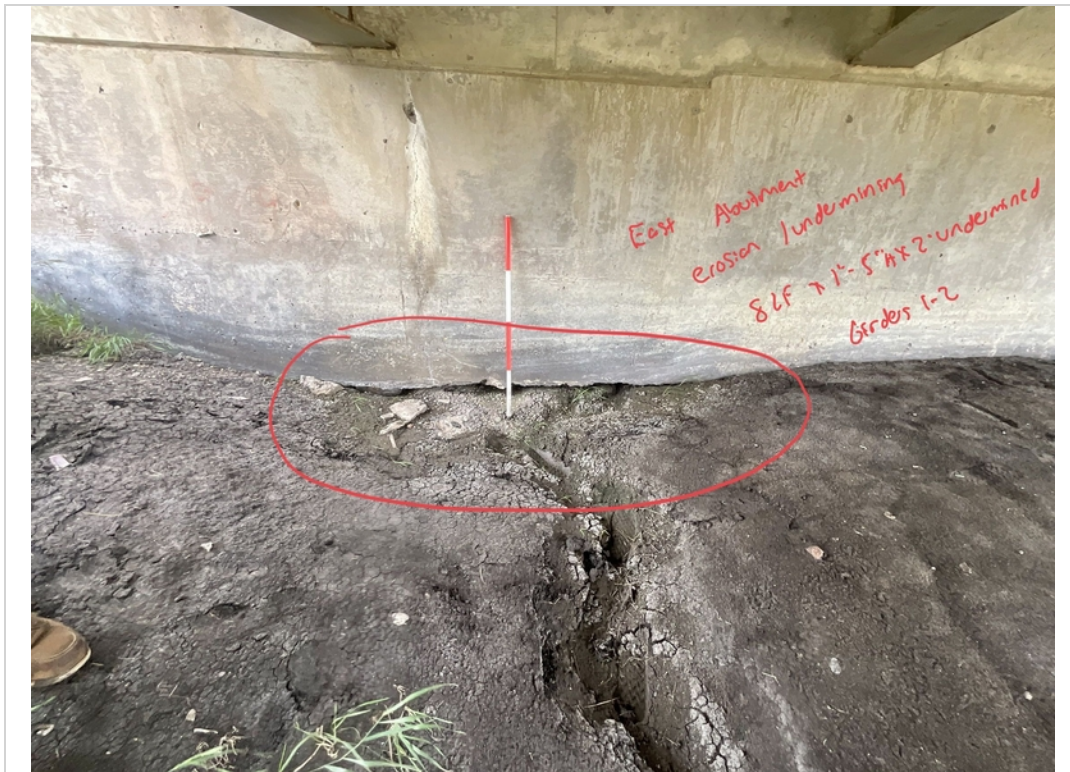
Facing East. Continued Erosion area to East Abutment.

Recommendation to provide fill and grade along Abutment and East Embankment Slope. See Photos.

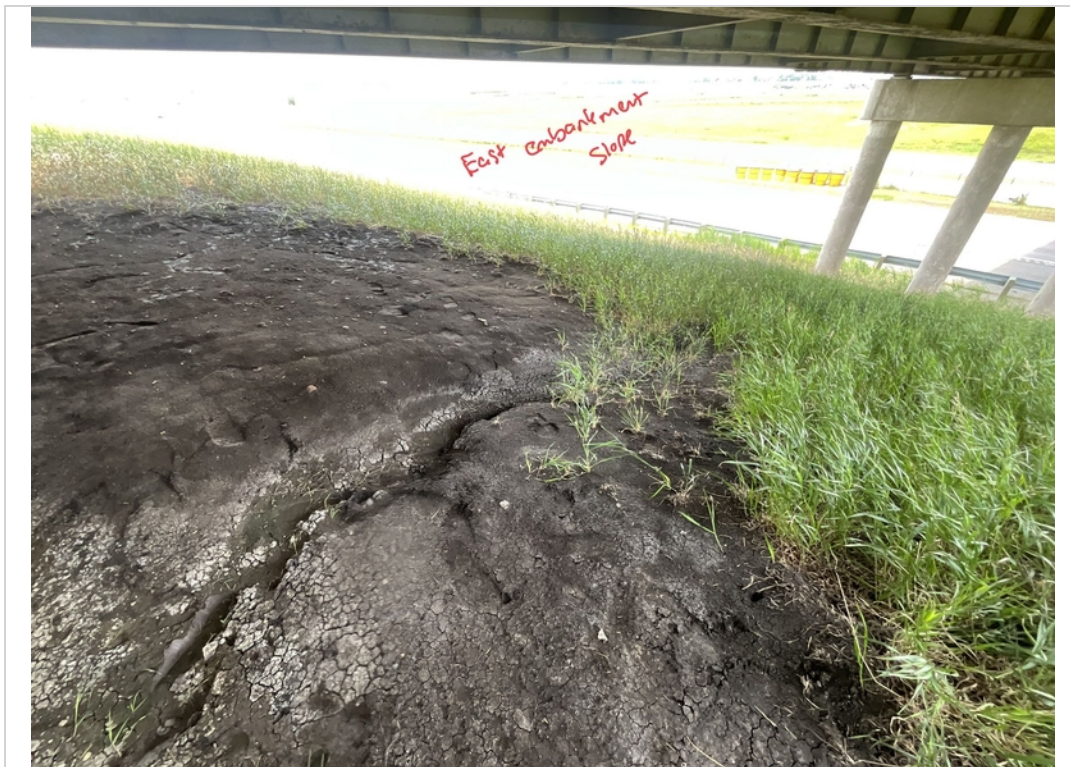
Facing SW. East Embankment Slope.

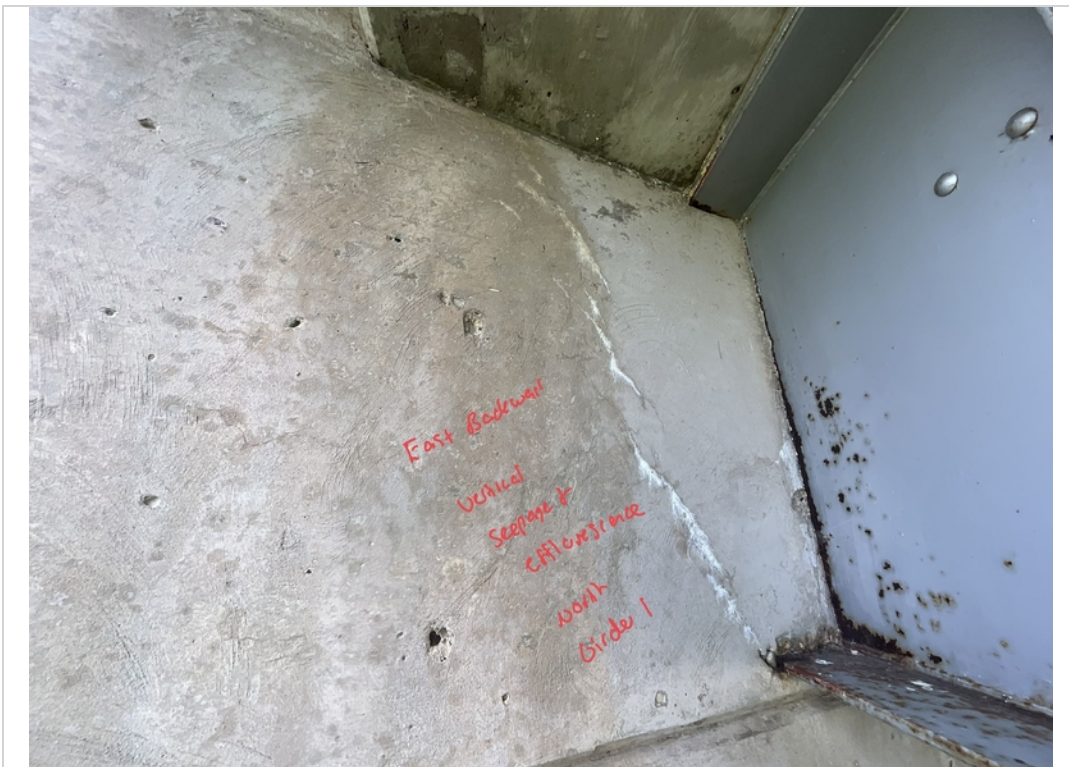
Facing SE. Vertical Crack with seepage and efflorescence to East Backwall North of Girder 1.

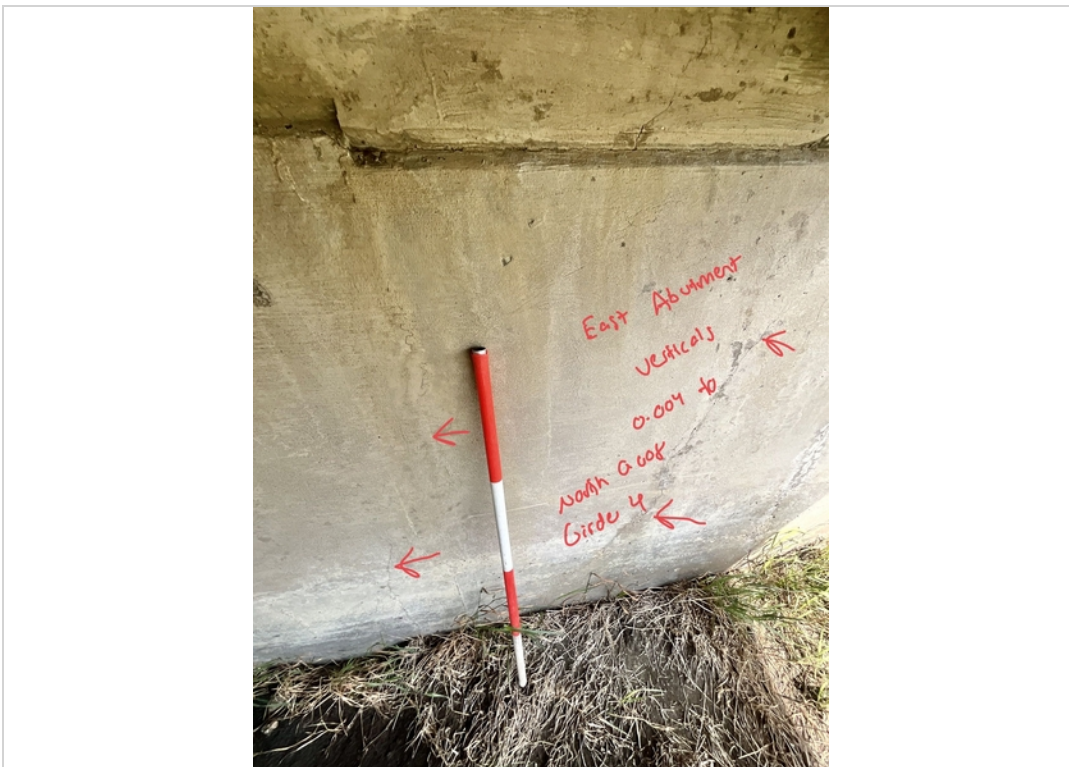
Facing East. Attempting to show minor vertical cracks to East Abutment North of Girder 4.

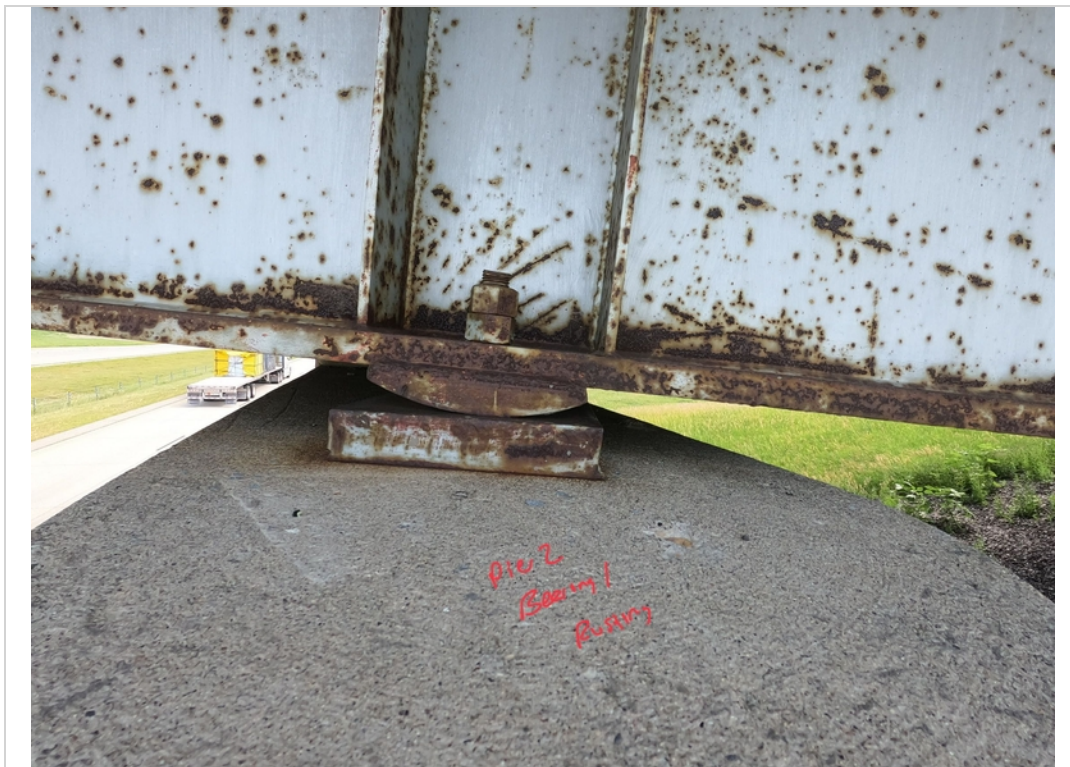
Facing South. Pier 2 Bearing 1 Rusting.

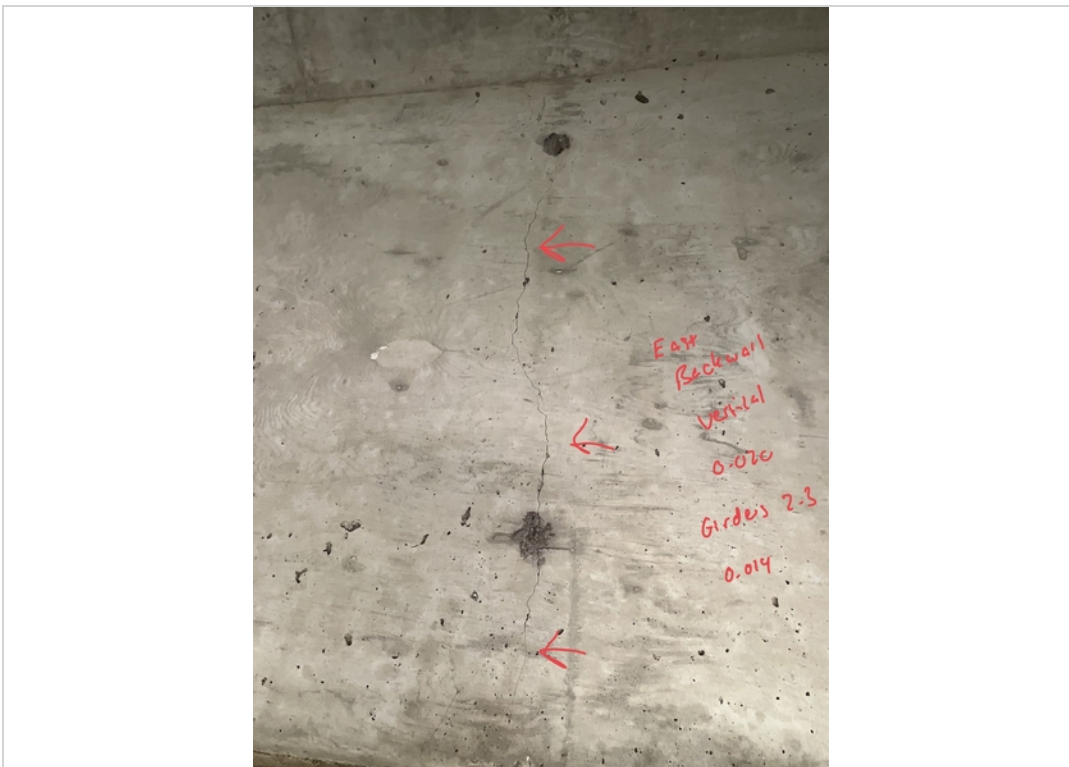
Facing East. Vertical Crack to East Backwall in-between Girders 2 and 3.

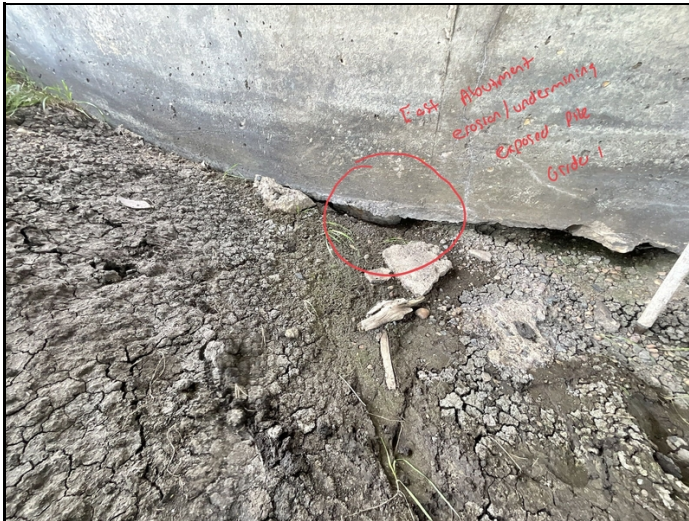
Facing East. Erosion area under East Abutment Exposing 1 Pile.

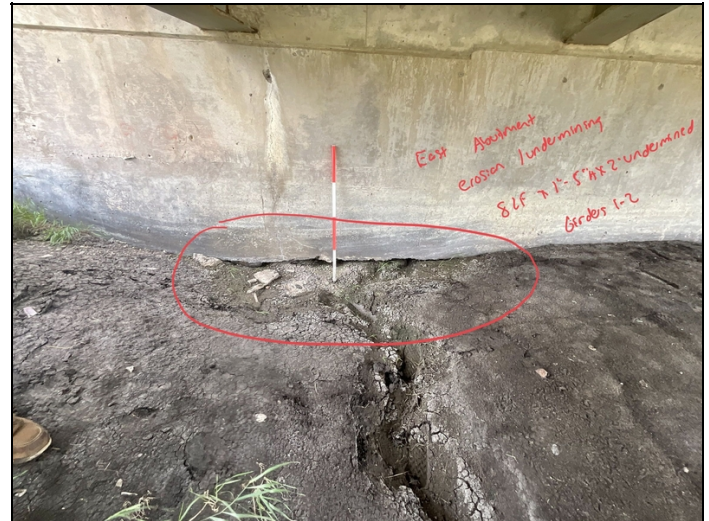
Facing East. Continued Erosion area to East Abutment.

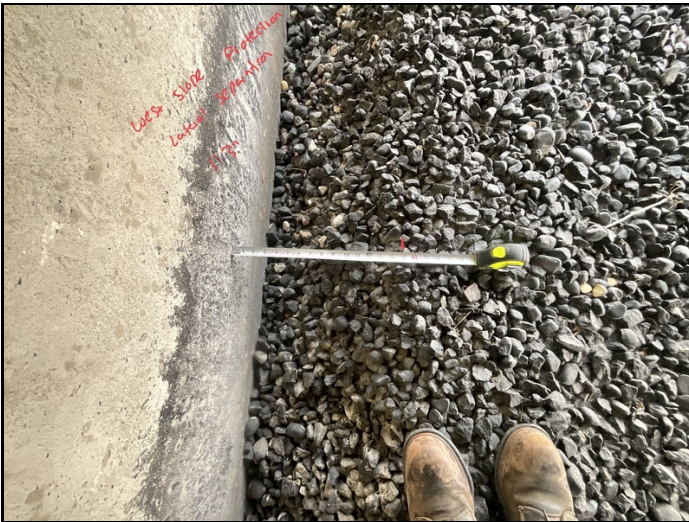
Facing North and Downward. West Slope Protection with Lateral Separation.
