IDENTIFICATION	
(1) State Names	38 - North Dakota
(8) Structure Number	0029-069.374
(5) Inventory Route	1
(2) Highway Agency District	8 - Fargo
(3) County Code	9 - Cass

(4) Place Code	65860
(6) Features Intersected	I-29/NORTH FARGO INT
(7) Facility Carried	CASS COUNTY 20
(9) Location	3 SOUTH OF HARWOOD
(11) Mile Point	0.1 mi

INSPECTIONS *			
(90) Inspection Date	07/17/2023		
(91) Frequency	24		
(92) Critical Feature Inspection	Done	Freq. (Mon)	Date
A: Fracture Critical Detail	No		
B: Underwater Inspection	No		
C: Other Special Inspection			
* The inspection date and frequency information in this box contains the current NBI date and frequency information. Please refer to the report header for the date this inspection was conducted.

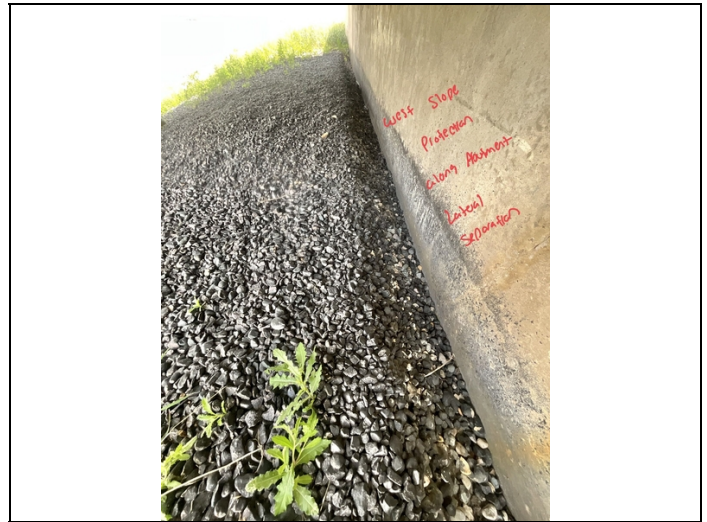
Facing South. West Slope Protection along Abutment with Lateral Separation.

Recommendation to fill with appropriate rock and apply oil to area along Abutment. See Photos.

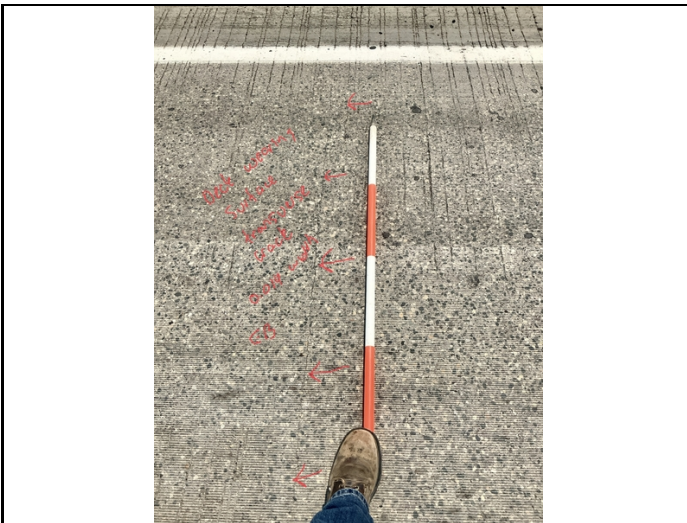
All cracking to Deck Wearing surface are unsealed.

Facing South and Downward. Deck Wearing Surface
Transverse Crack to EB Lane.

Recommendation to apply appropriate and approved sealant to cracking as per the Maintenance Manual. See Photos.

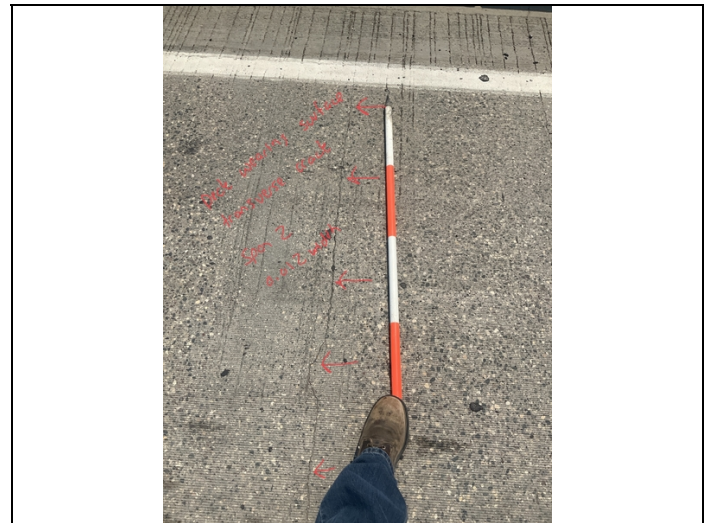
Facing South and Downward. Transverse Crack to Deck
Wearing Surface in the EB Lane of Span 2.

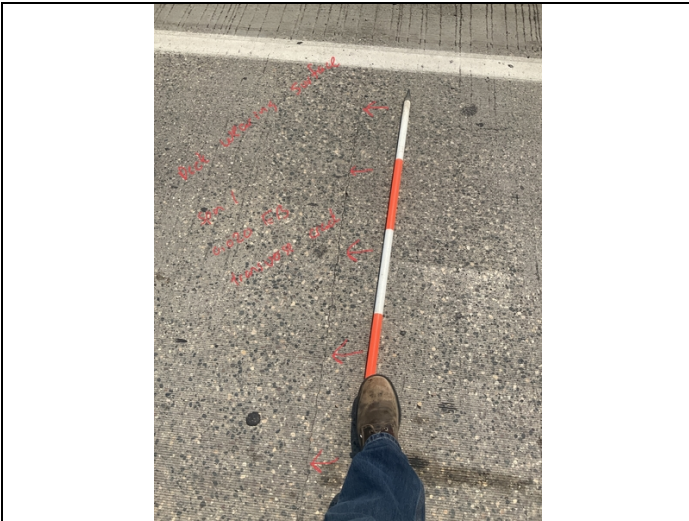
Facing South and Downward. Transverse Crack to Deck Wearing Surface in the EB Lane of Span 1.

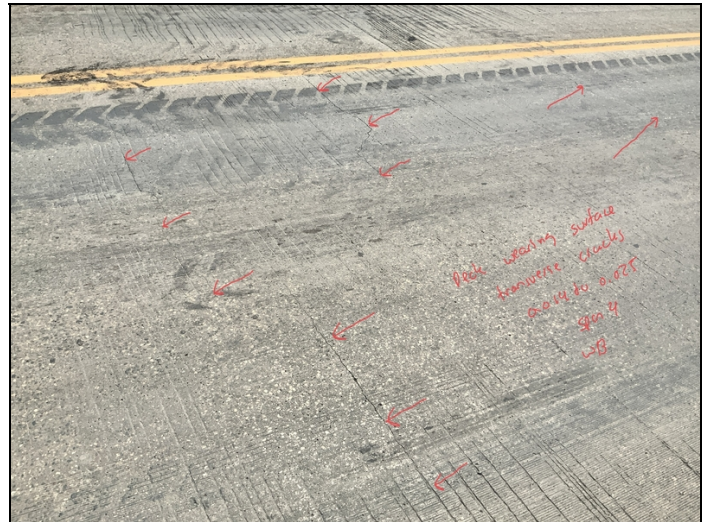
Facing SW and Downward. Transverse cracking to Deck Wearing Surface of the WB Lane of Span 4.

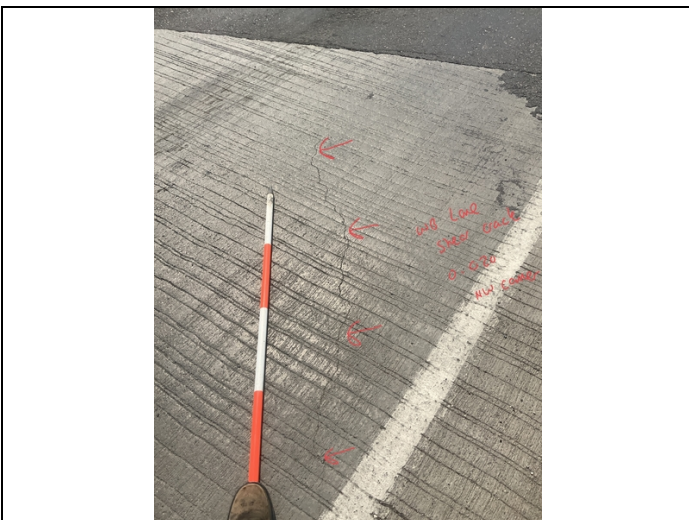
Facing SW and Downward. Shear Crack to Deck Wearing Surface near NW Corner.

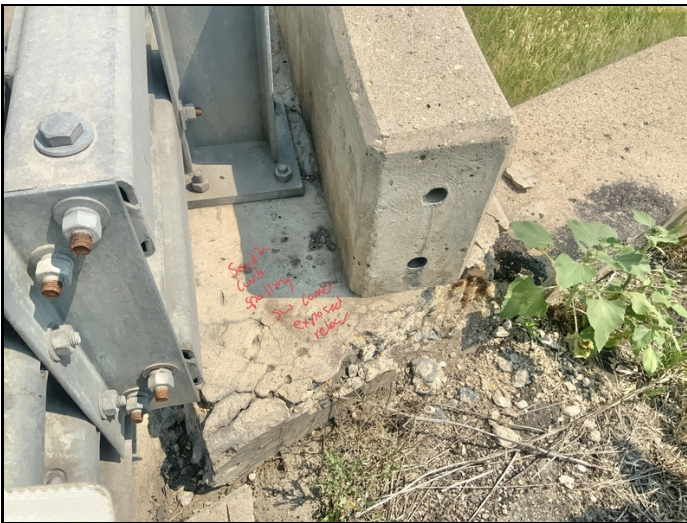
Moderate spalling with exposed rebar to portions of the North and South Curb near ends, Corners, and throughout. Various posts with delamination and exposing reinforcing steel throughout both Railings.

Facing East and Downward. Spalling to South Curb at West End.

Recommendation to Remove Delaminated Concrete and perform spall repairs/patches to the various areas. See Photos.

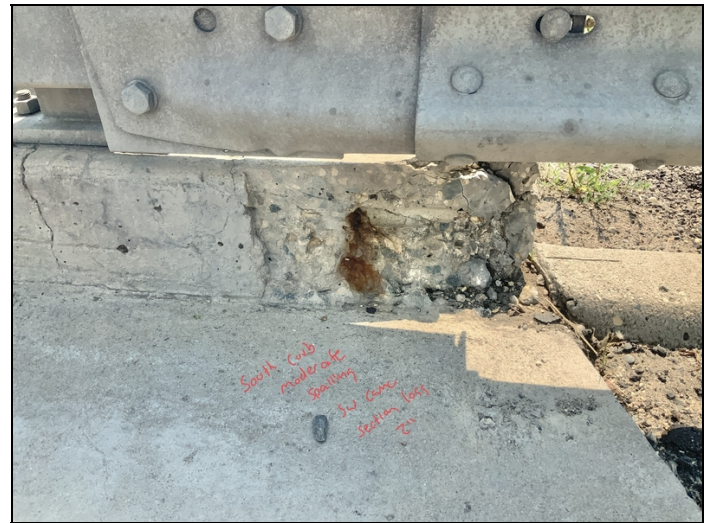
Facing South. Moderate Spalling to South Curb at SW Corner.

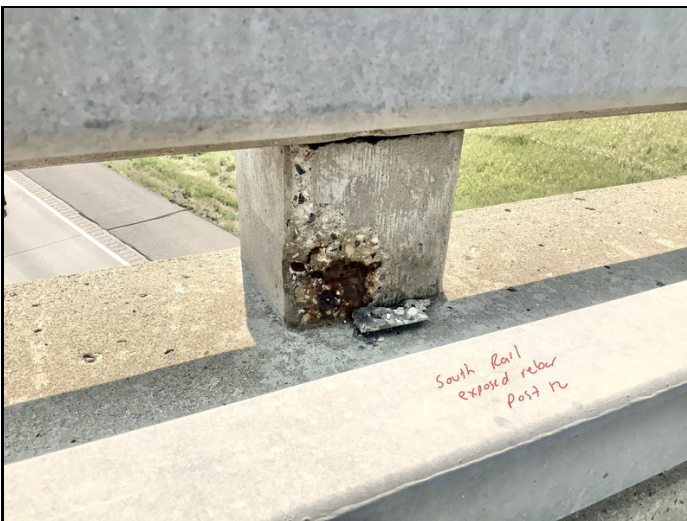
Facing South. Exposed Rebar to South Railing Post 12.

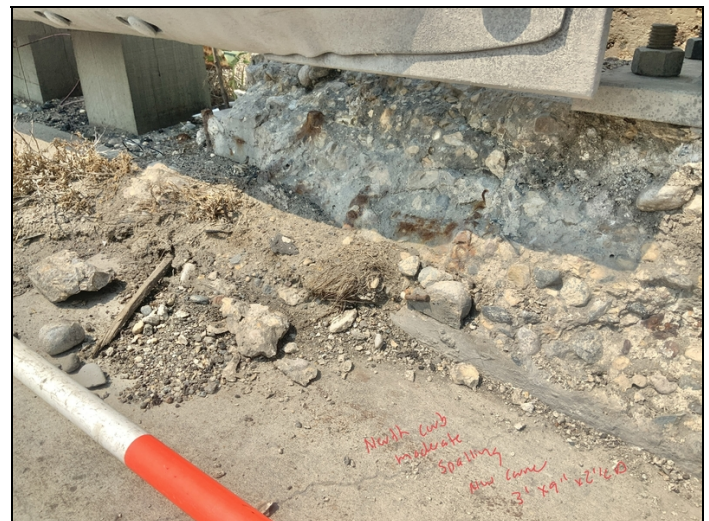
Facing NW. Moderate Spalling to North Curb near SW Corner.

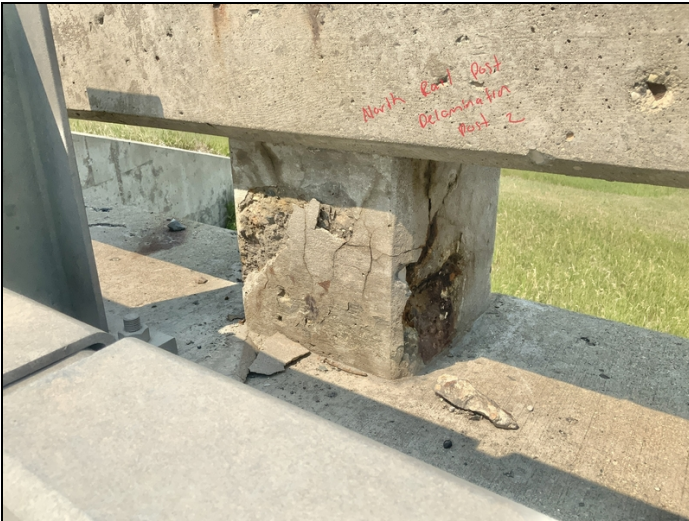
Facing NW. Spalling with Exposed Rebar to North Rail at Post 2.

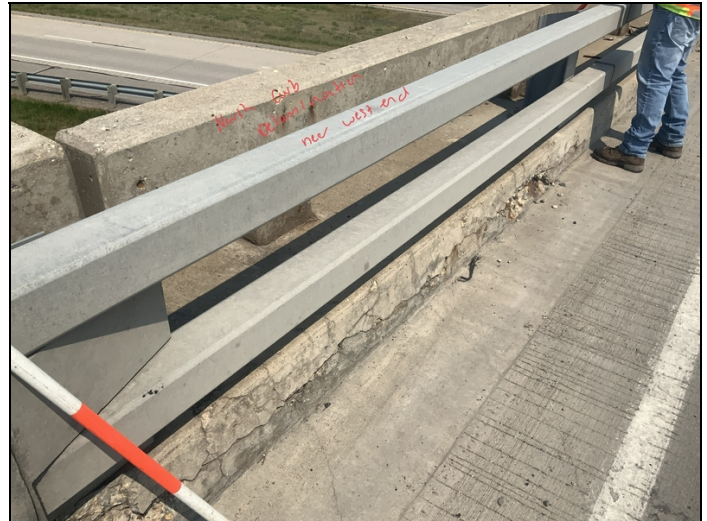
Facing NE. Spalling and Delamination to North Curb near West End.

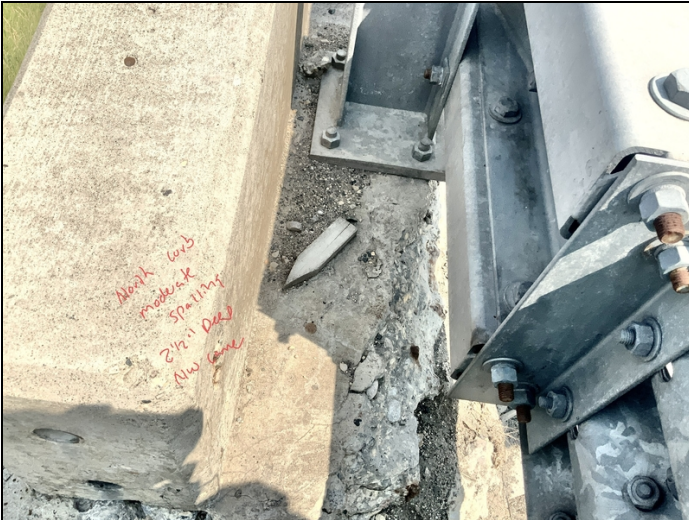
Facing East and Downward. Another View of the Moderate Spalling to North Curb near West End.

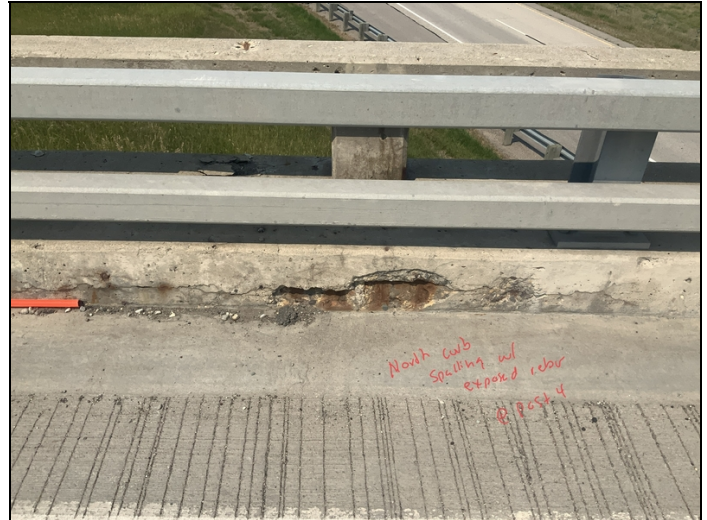
Facing North. Spalling with Exposed Rebar to North Curb at Post 4.

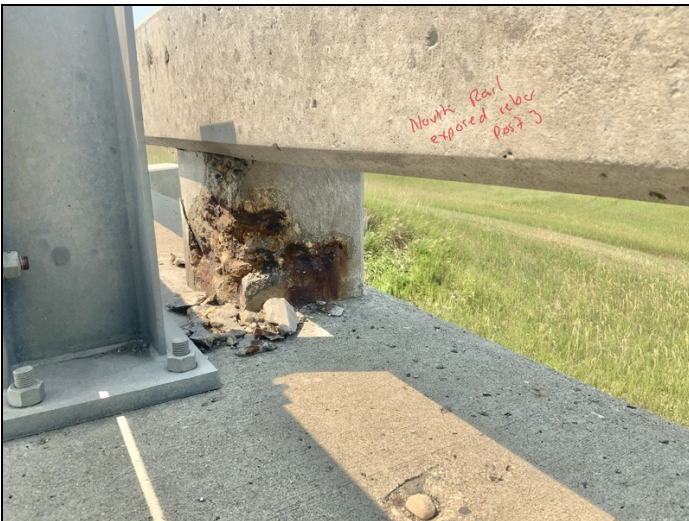
Facing NW. Spalling with Exposed Rebar to North Railing at Post 3.

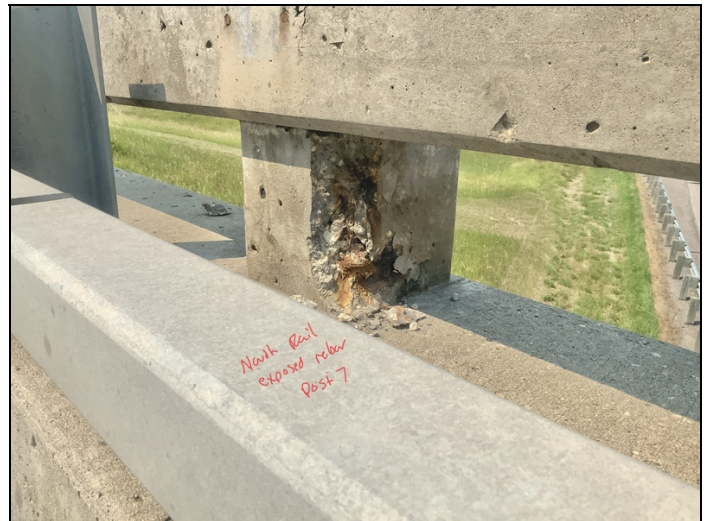
Facing NW. Spalling with Exposed Rebar to North Rail Post 7.

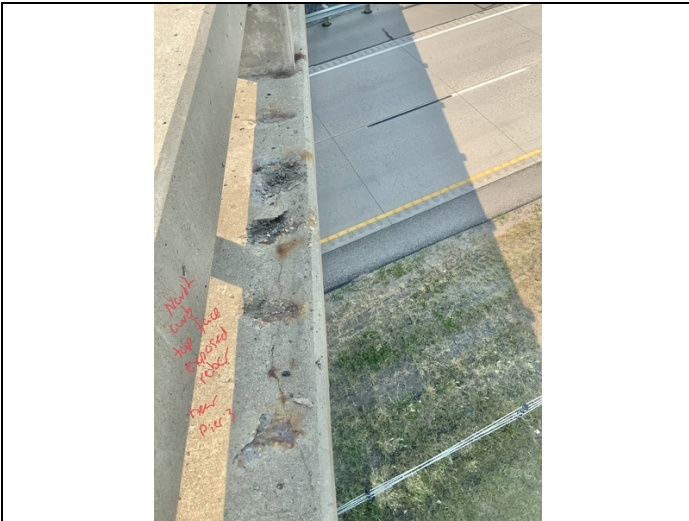
Facing West and Downward. Exposed Rebar to Top of North Curb near Pier 3.

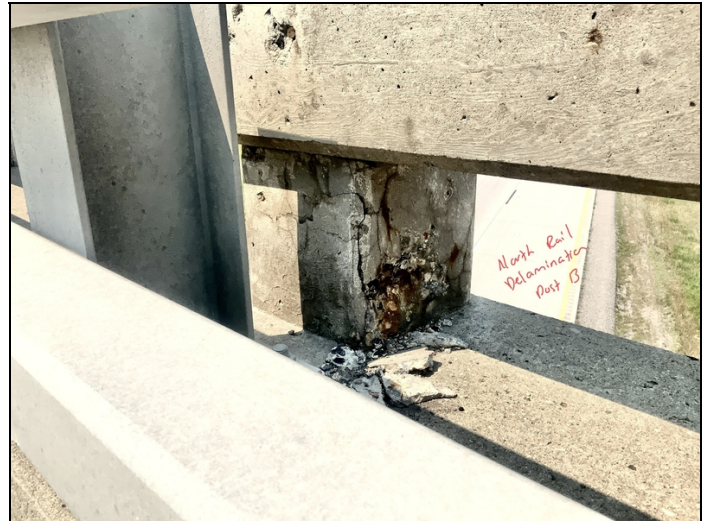
Facing NW. Spalling with Exposed Rebar to North Railing at Post 13.

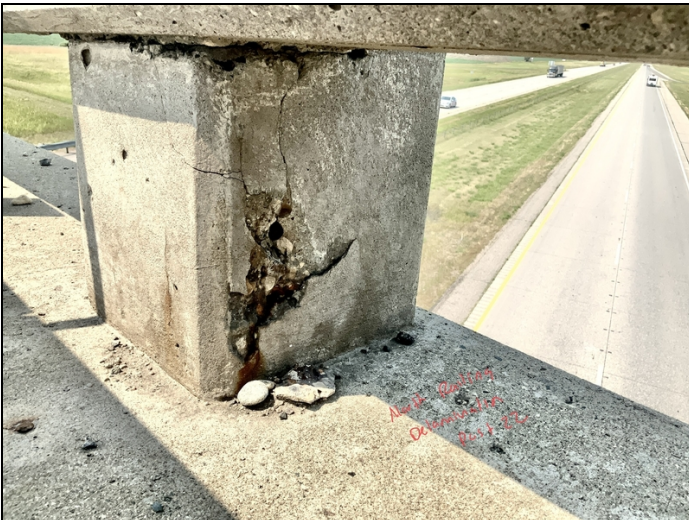
Facing NW. Spalling to North Railing at Post 22.

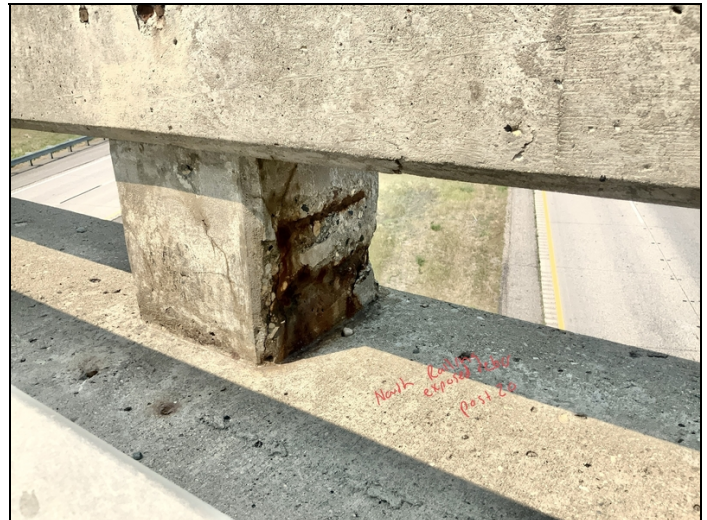
Facing NW. Spalling with Exposed Rebar to North Railing at Post 20.

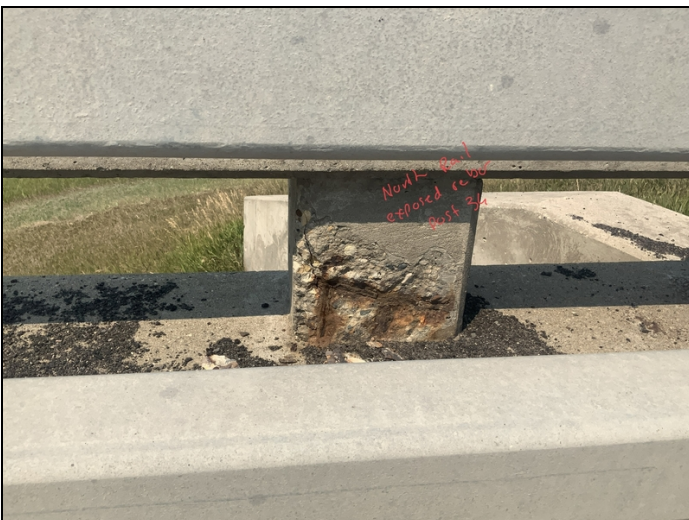
Facing North. Exposed Rebar to North Railing at Post 36.

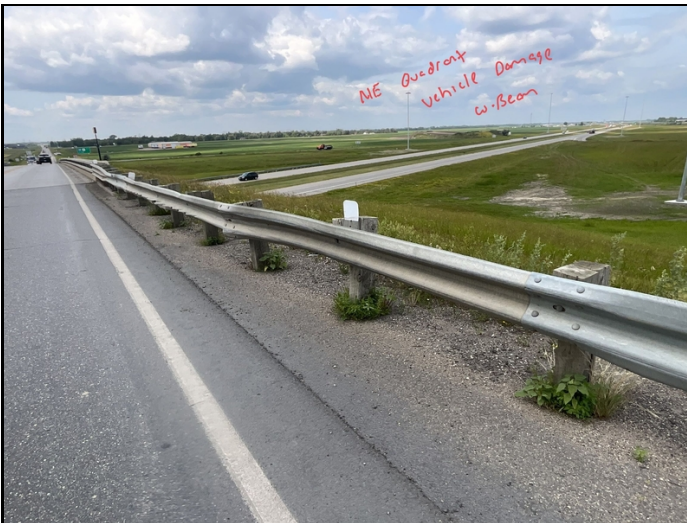
Vehicle Impact Damage to W-Beam within NE Quadrant.

Facing NW. Vehicle Impact Damage to NE W-Beam.

Recommendation to remove and replace W-Beam Section(s). See Photo.

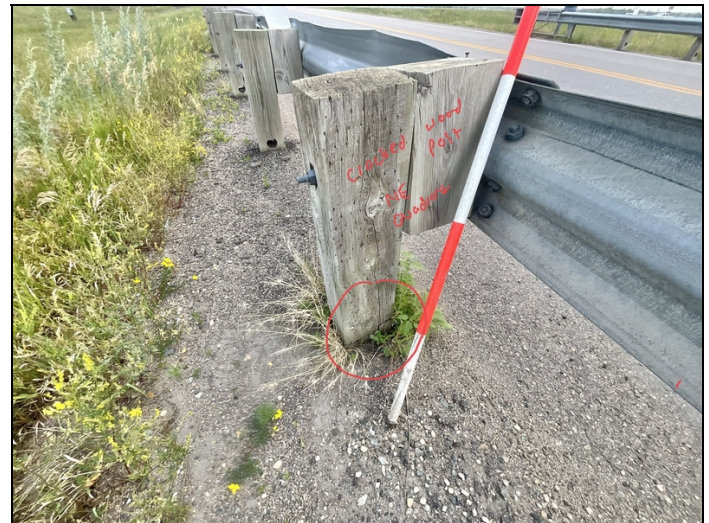
Facing East. Cracked Wood Post within NE Quadrant.

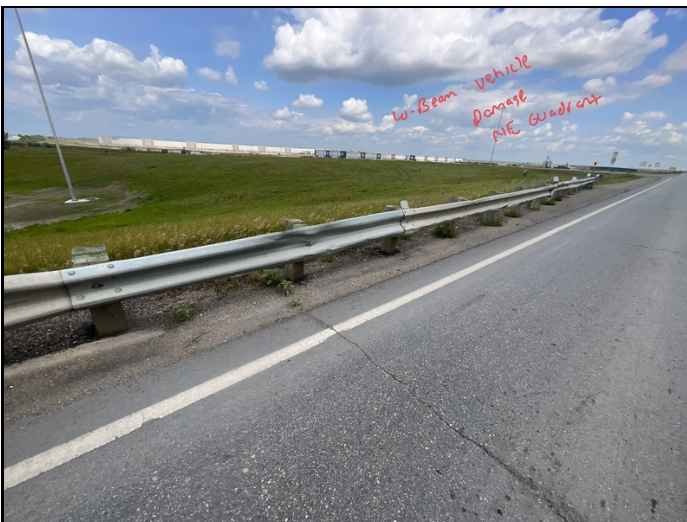
Facing NE. Another View of the Vehicle Impact Damage to W-Beam within NE Quadrant.
