IDENTIFICATION	
(1) State Names	38 - North Dakota
(8) Structure Number	0029-069.374 N
(5) Inventory Route	1
(2) Highway Agency District	8 - Fargo
(3) County Code	9 - Cass

(4) Place Code	25700
(6) Features Intersected	BNRR
(7) Facility Carried	COUNTY HIGHWAY
(9) Location	EAST OF NO. FARGO INTCHG
(11) Mile Point	0.1 mi
(12) Base Highway Network	No

INSPECTIONS *			
(90) Inspection Date	07/17/2023		
(91) Frequency	24		
(92) Critical Feature Inspection	Done	Freq. (Mon)	Date
A: Fracture Critical Detail	No		
B: Underwater Inspection	No		
C: Other Special Inspection			
* The inspection date and frequency information in this box contains the current NBI date and frequency information. Please refer to the report header for the date this inspection was conducted.

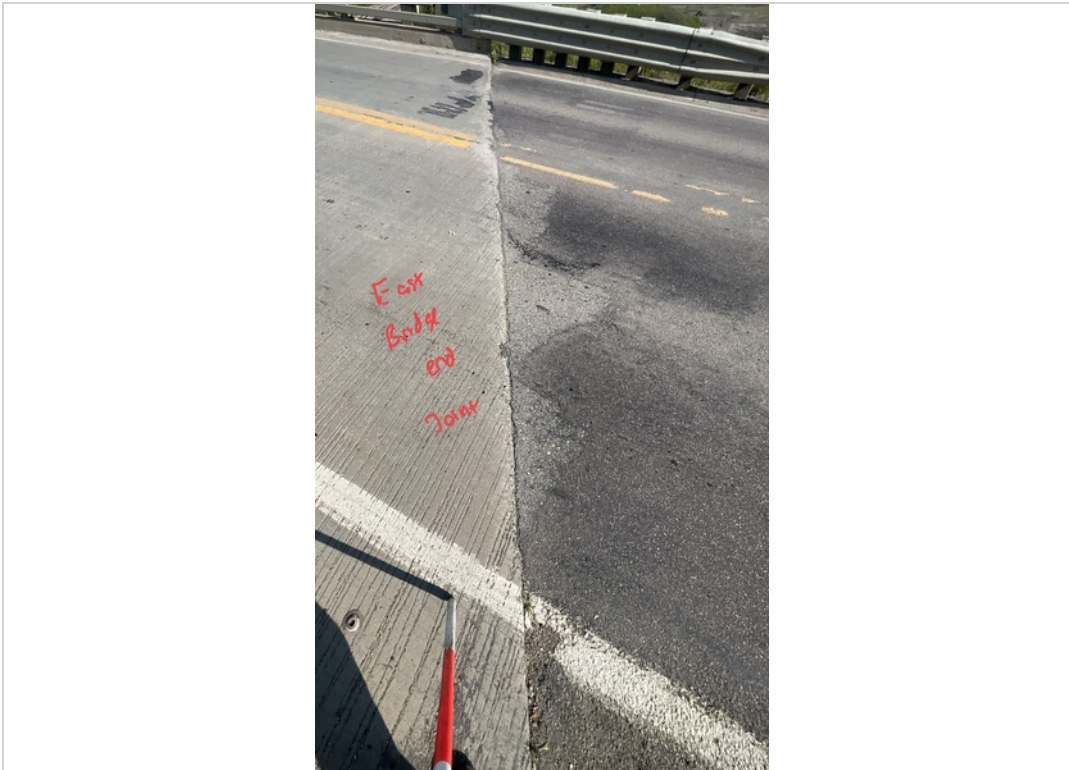
Facing North and Downward. East Bridge End Joint.

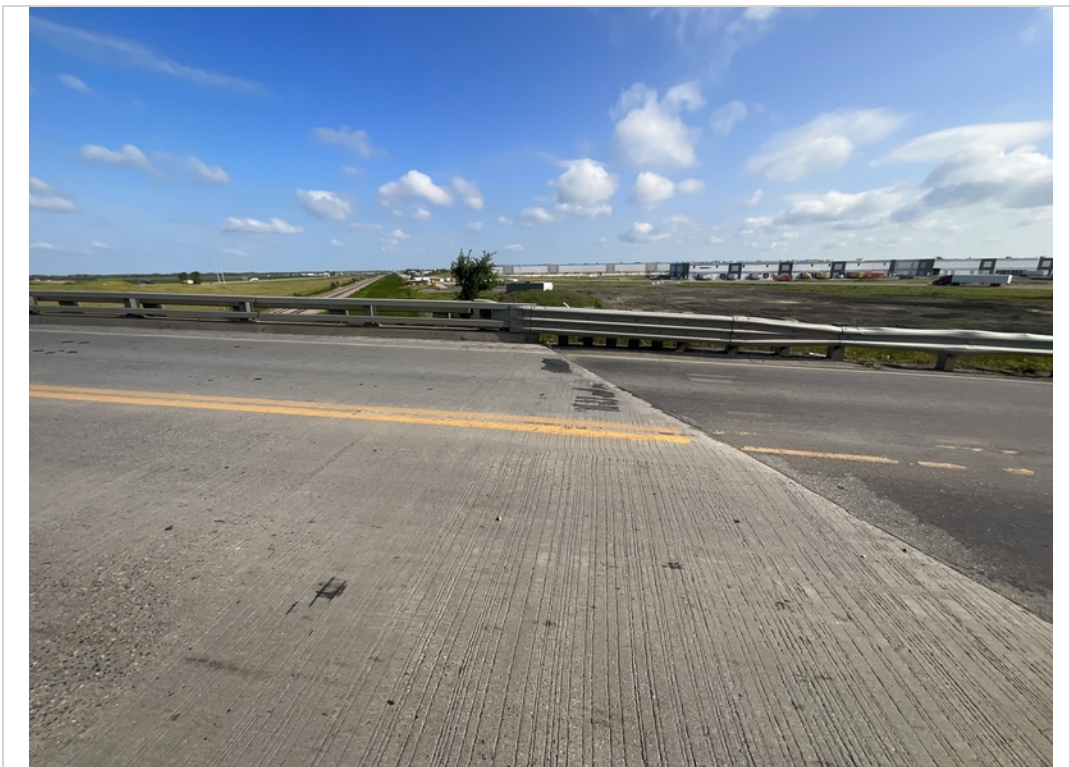
Facing North. Guardrail Transition at NE Corner. Similar at SE Corner.

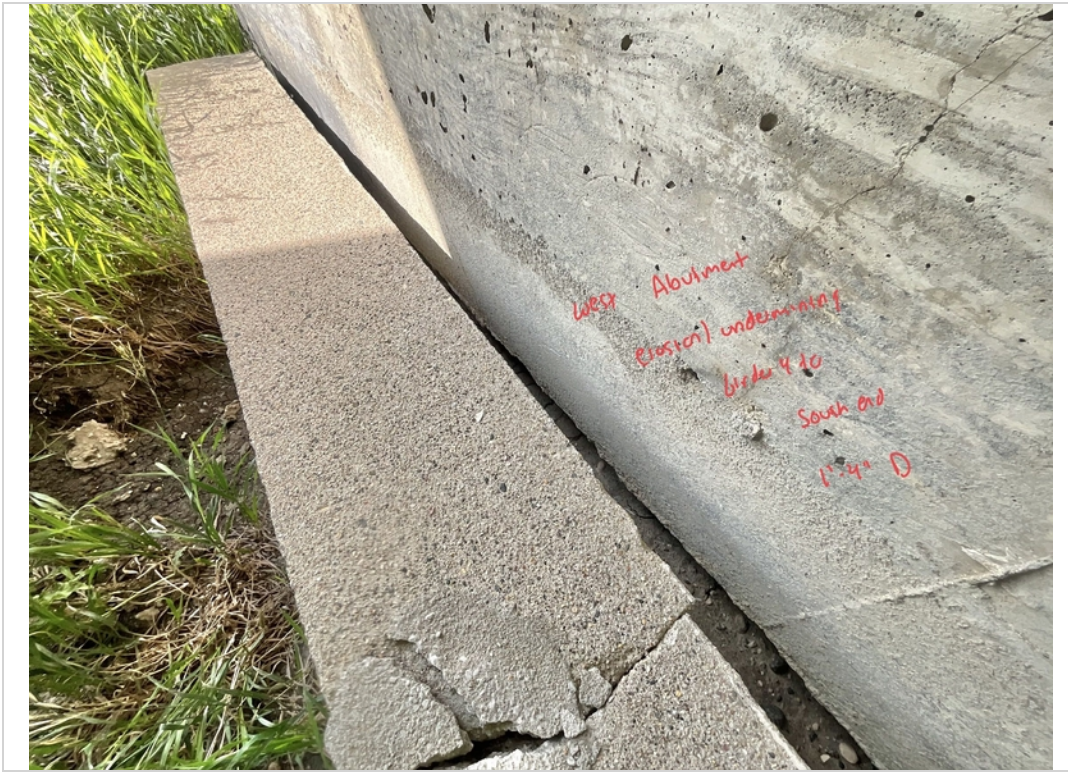
Facing SW and Downward. Erosion and Undermining along West Abutment South End.

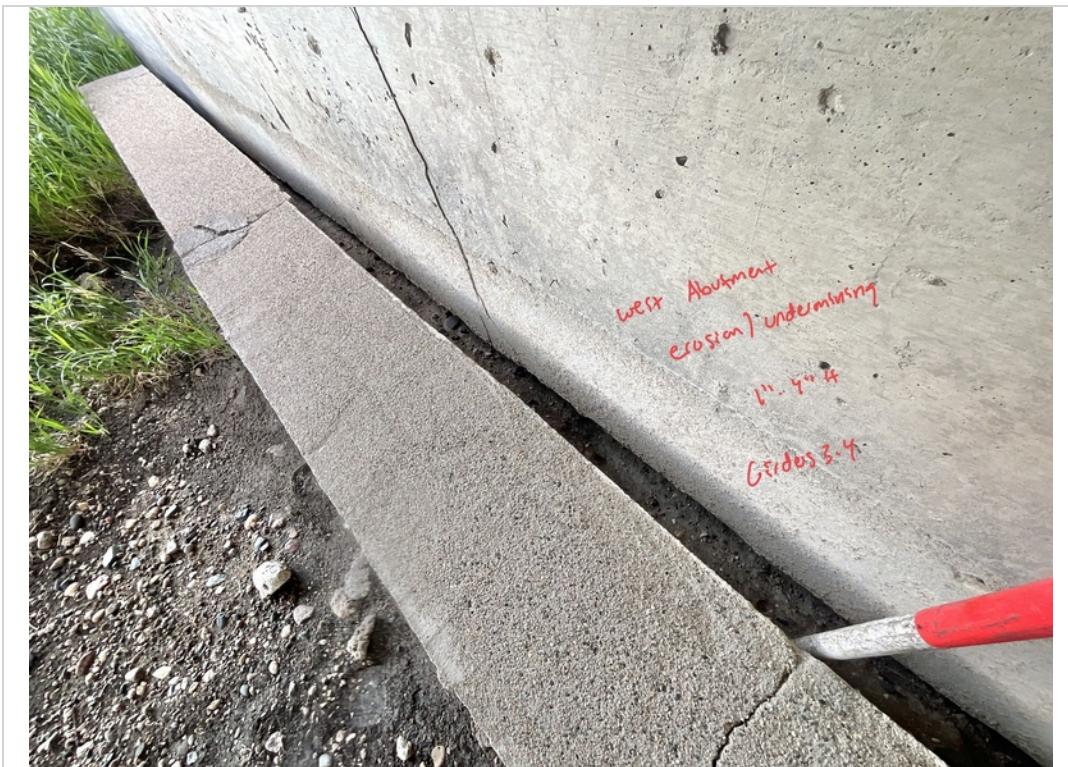
Facing SW and Downward. Continued Erosion along West Abutment from Girders 3 to 4.

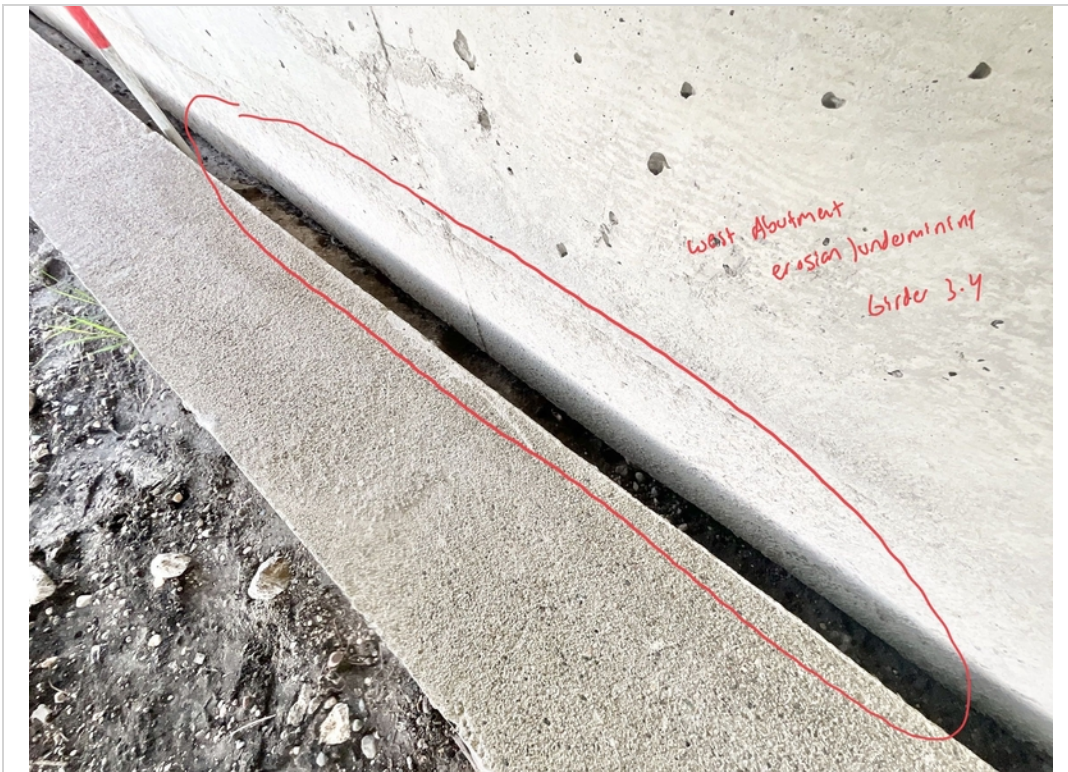
Facing SW and Downward. Area of Erosion and Undermining along Lower Portion of West Abutment from Girder 3 to 4.

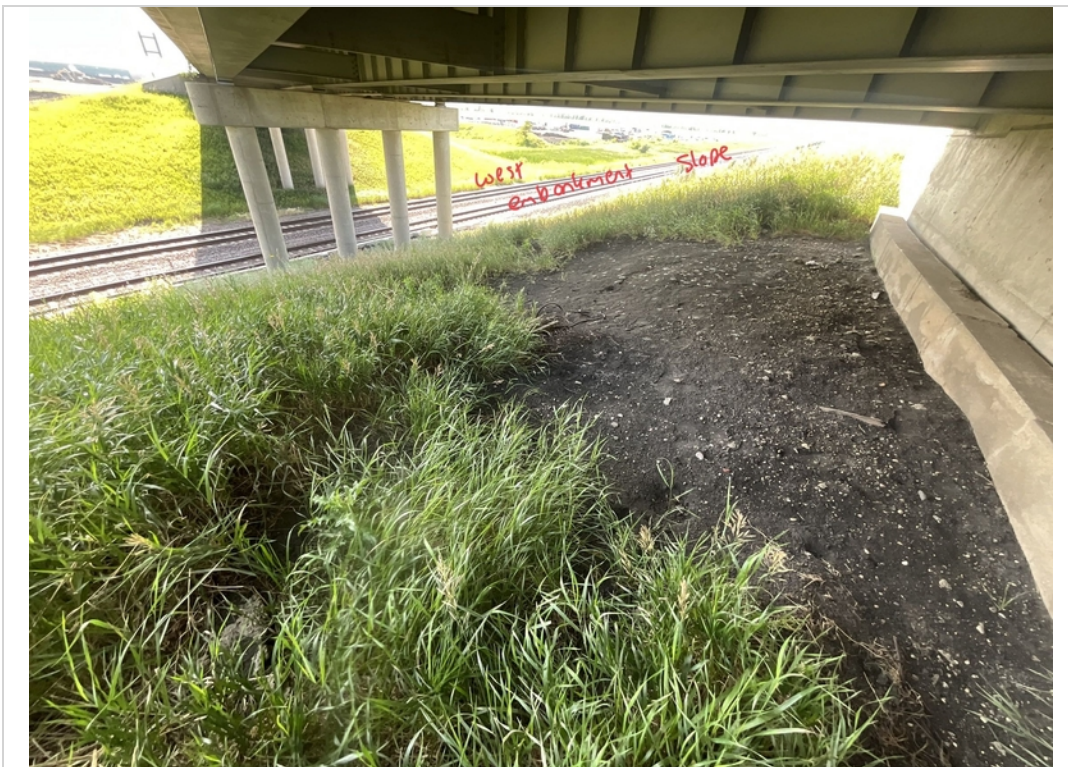
Facing South. West Embankment Slope.

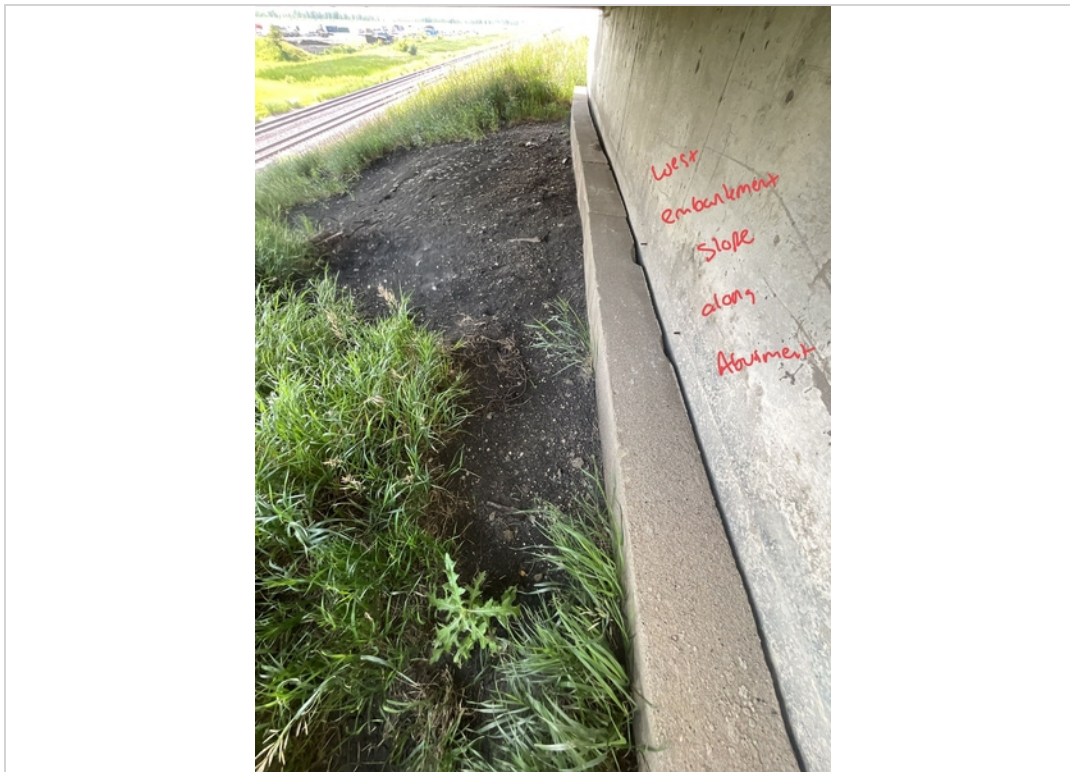
Facing South. West Embankment Slope along Abutment.

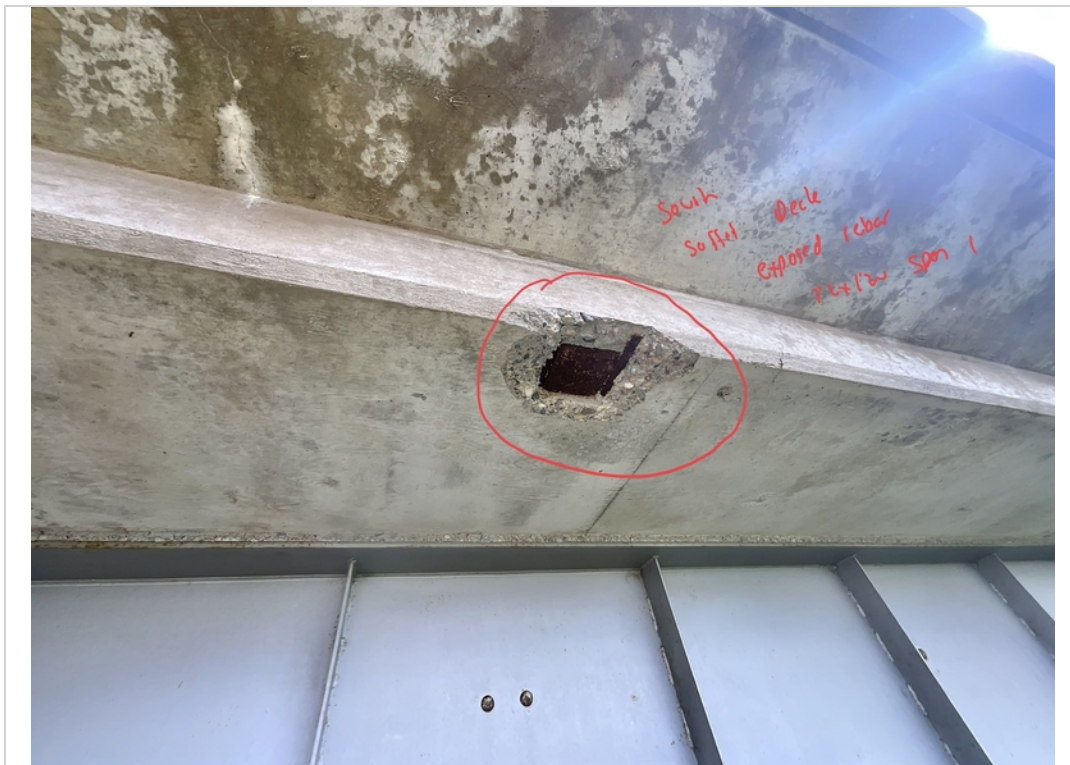
Facing South and Upwards. Exposed Rebar to South Deck Soffit in Span 1.

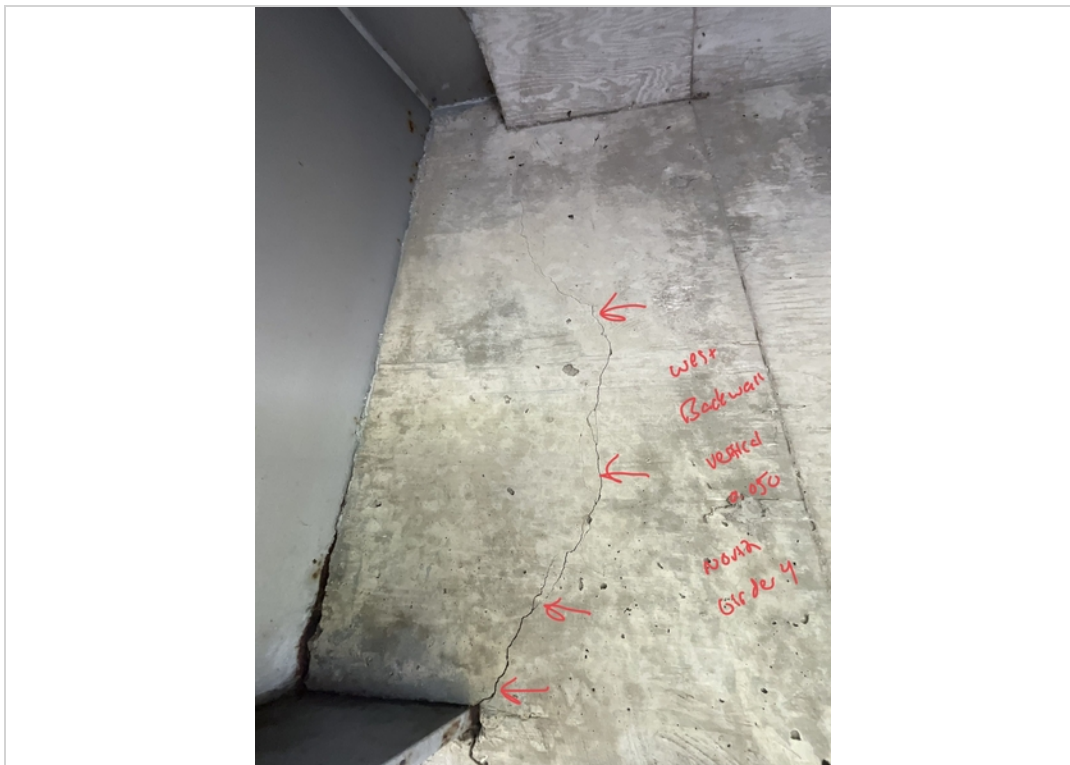
ELEMENTS	DESCRIPTION	UNITS	TOTAL	CS1	CS2	CS3	CS4
	<p>(1120-815) 7/12/2021 - Vertical crack with seepage and efflorescence to West Back Wall with 1 LF North of Girder 2. See photo. 7/17/2023 - No change in condition state or quantity. See photo.</p> <p>(1130-815) 7/12/2021, 7/17/2023 - Various cracking to backwalls progressing with, West Backwall: 4 LF CS 2 various North of Girder 1, widths of 0.004"-0.006". 1 LF CS 2 vertical South of Girder 1, width of 0.016". 1 LF CS 2 vertical between girders 1-2, width of 0.012". 1 LF CS 1 vertical South of girder 2, width of 0.006". 1 LF CS 2 vertical between Girders 2-3, width of 0.020". 1 LF CS 2 vertical South of Girder 3, width of 0.016". 3 LF CS 1 diagonal between Girders 3-4, width of 0.006". 3 LF CS 1 diagonal South of Girder 4, widths of 0.004"-0.008". 1 LF CS 2 vertical North of girder 4, width of 0.050".</p> <p>East Backwall: 4 LF CS 1 diagonal North of Girder 1, widths of 0.004"-0.006". 3 LF CS 1 vertical between Girders 1-2, width of 0.004". 1 LF CS 2 vertical between girders 1-2, width of 0.016". 1 LF CS 2 vertical between Girders 2-3, width of 0.020". 1 LF CS 1 vertical North of Girder 3, width of 0.004". 4 LF CS 2 various between girders 3-4, widths of 0.004"-0.008" 4 LF CS 2 Various at South end, widths of 0.004"-0.008". See photos.</p>

Facing West. Vertical Crack to West Backwall North of Girder 1.

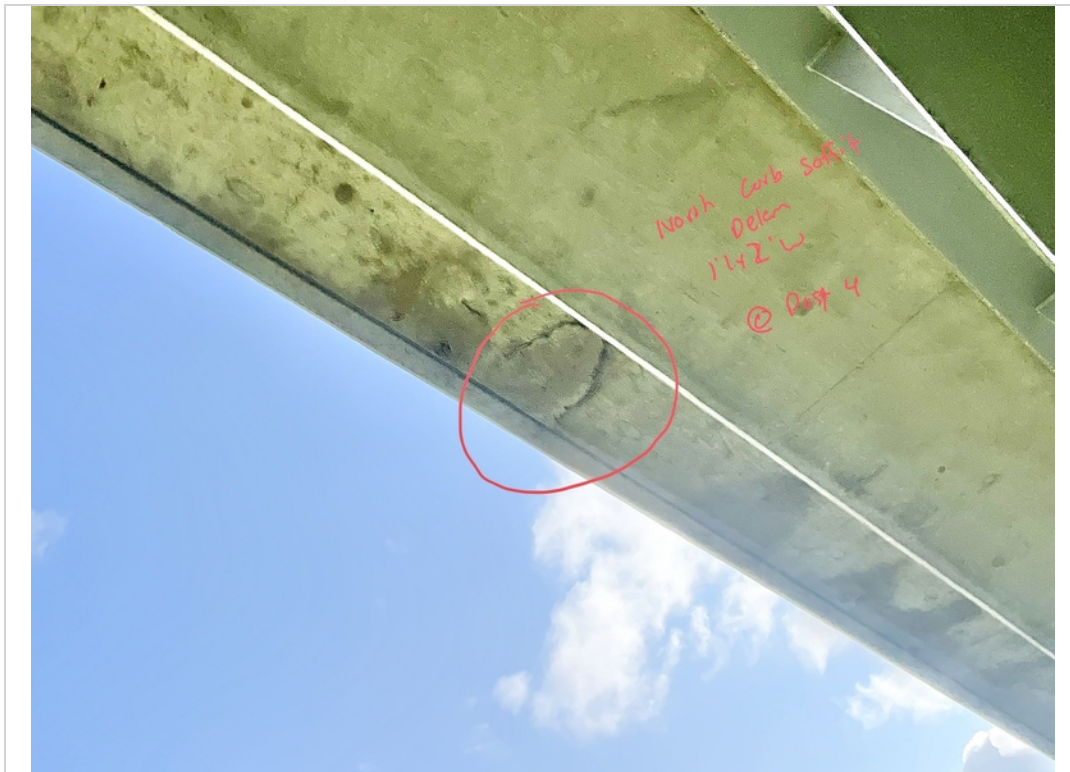
Facing NW and Upwards. Delamination to North curb Soffit in Span 1.

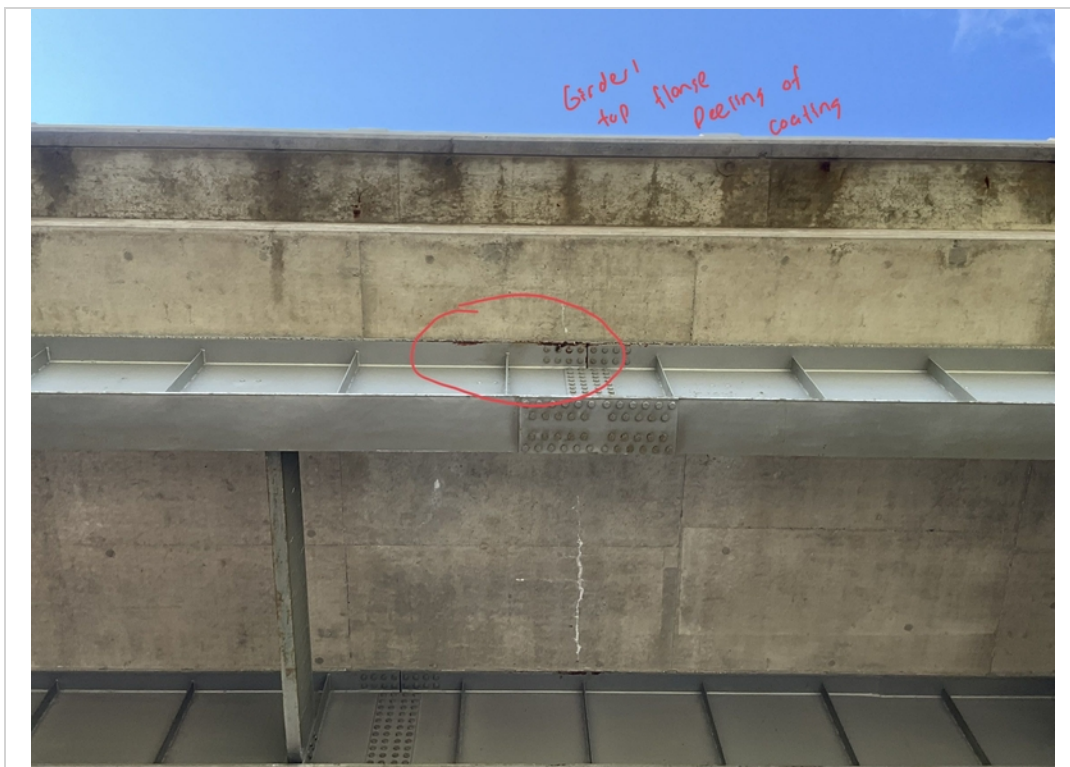
Facing South and Upwards. Peeling of Coating to Girder 1 Top Flange in Span 2.

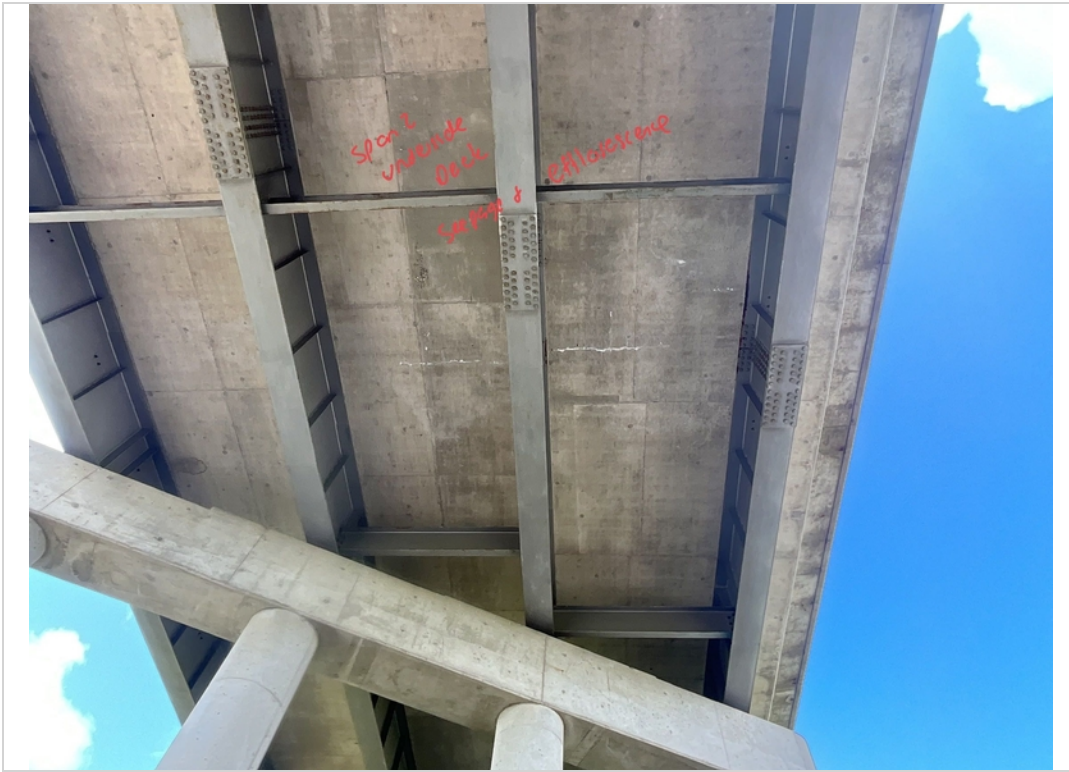
(1120-12) Cracking with efflorescence on underside of deck - 10/31/2019 7/12/2021, 7/17/2023 - Underside Deck Seepage, Efflorescence and Rusting Staining progressing with, Span 1: 2 SF on South soffit. Span 2: 40 SF between girders. 4 SF on South soffit. Span 3: 18 SF on North Soffit. 10 SF between girders. 32 SF of Rusting Staining on South Soffit. See Photos.

Facing West and Upwards. Underside Deck Seepage and Efflorescence in Span 2.

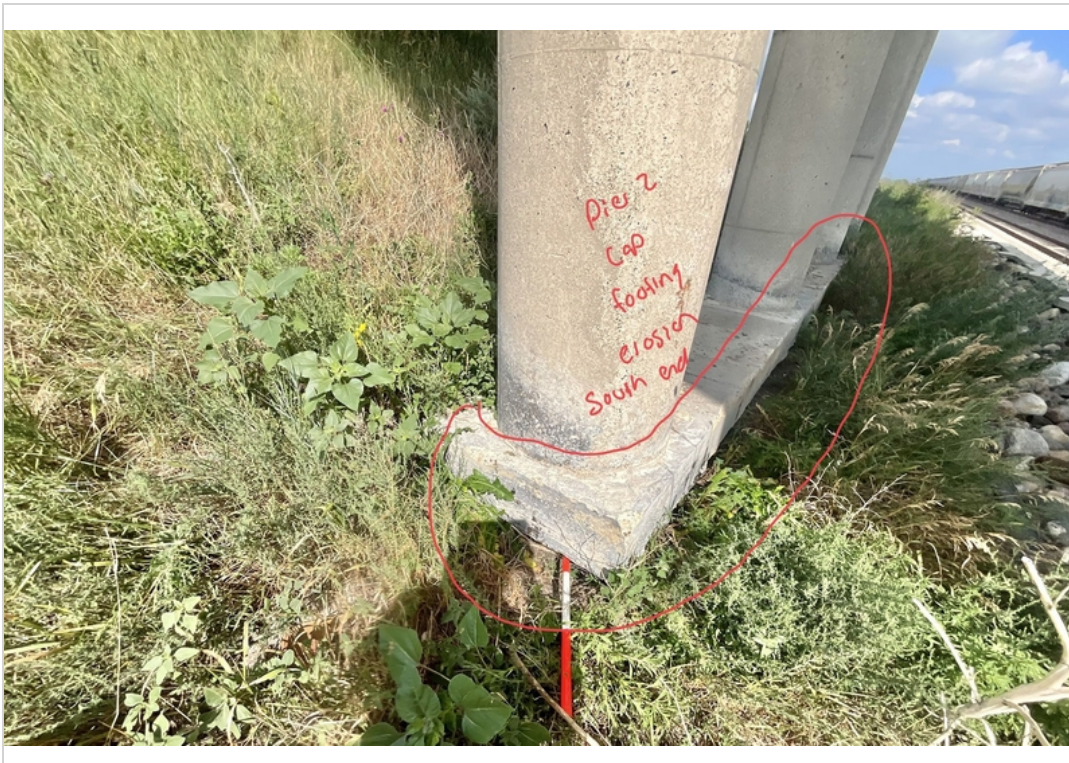
220	Reinforced Concrete Pile Cap/Footing	LF	64	48	16	0	0
8001	Erosion	LF	16	0	16	0	0
(8001-220) 7/17/2023 - Area of erosion along cap footing of pier 2 with, 16 LF on South half with 2 exposed H piles, area of 16'L x 2'-8"D x up to full width of cap footing. See photos.							
234	Reinforced Concrete Pier Cap	LF	72	71	1	0	0
1130	Cracking (RC and Other)	LF	3	3	0	0	0
1190	Abrasion/Wear (PSC/RC)	LF	1	0	1	0	0
(1130-234) 7/12/2021, 7/17/2023 - Horizontal CS 1 Cracking to pier caps progressing with, Pier 2 Cap: 2 LF near North End, widths of 0.006". Observed on West Face Pier 3 Cap: 1 LF at North End, width of 0.010". See Photo. (1190-234) 7/17/2023 - Area of abrasion with exposed aggregate to pier 2 cap with 1 LF on North face. See photo.							
313	Fixed Bearing	EA	8	2	6	0	0
1000	Corrosion	EA	6	0	6	0	0
515	Steel Protective Coating	SF	40	34	0	6	0
3440	Effectiveness (Steel Protective Coatings)	EA	6	0	0	6	0

Facing NW and Downward. Erosion and Undermining area along Pier 2 Cap Footing South End.

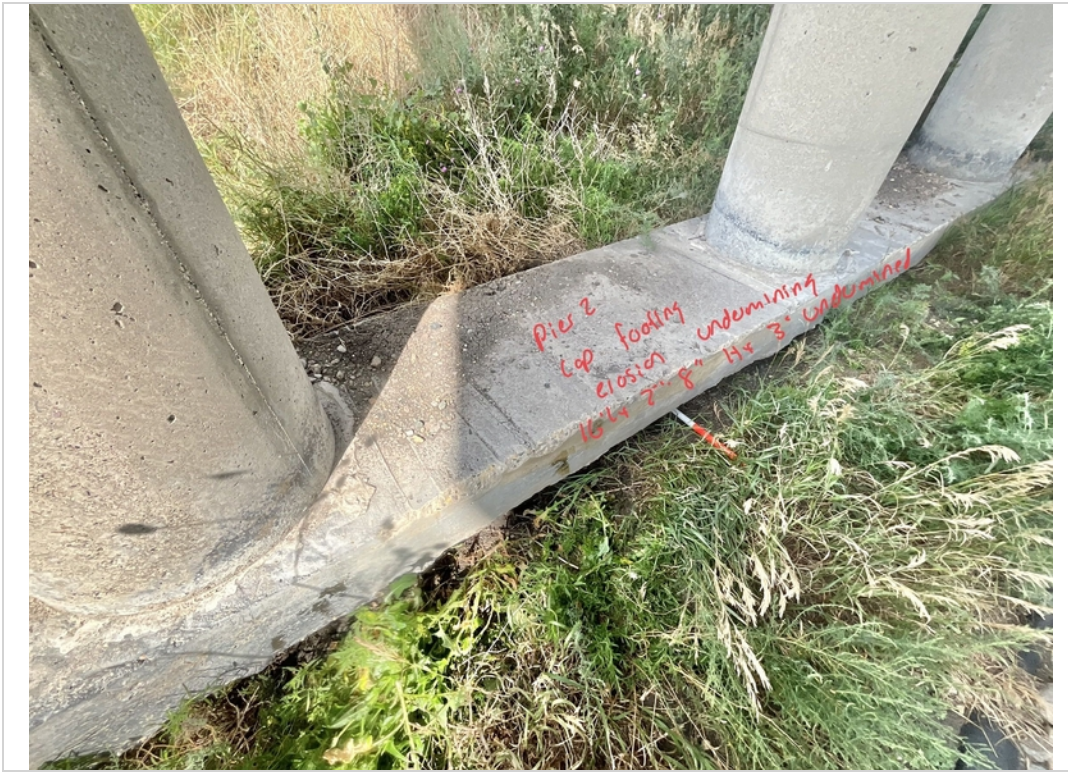
Erosion along Pier 2 in-between Columns 3 and 4 with an area of 7' L x 2" - 4" D x 2' W (Undermined). Rust forming on soffit at delaminated concrete areas. Undermining of east abutment with water running thru, and undermining of Pier 2 footing. - 10/31/2019.

Facing NW and Downward. Continued Erosion and Undermining to Pier 2 Cap Footing in-between Columns 3 and 4.

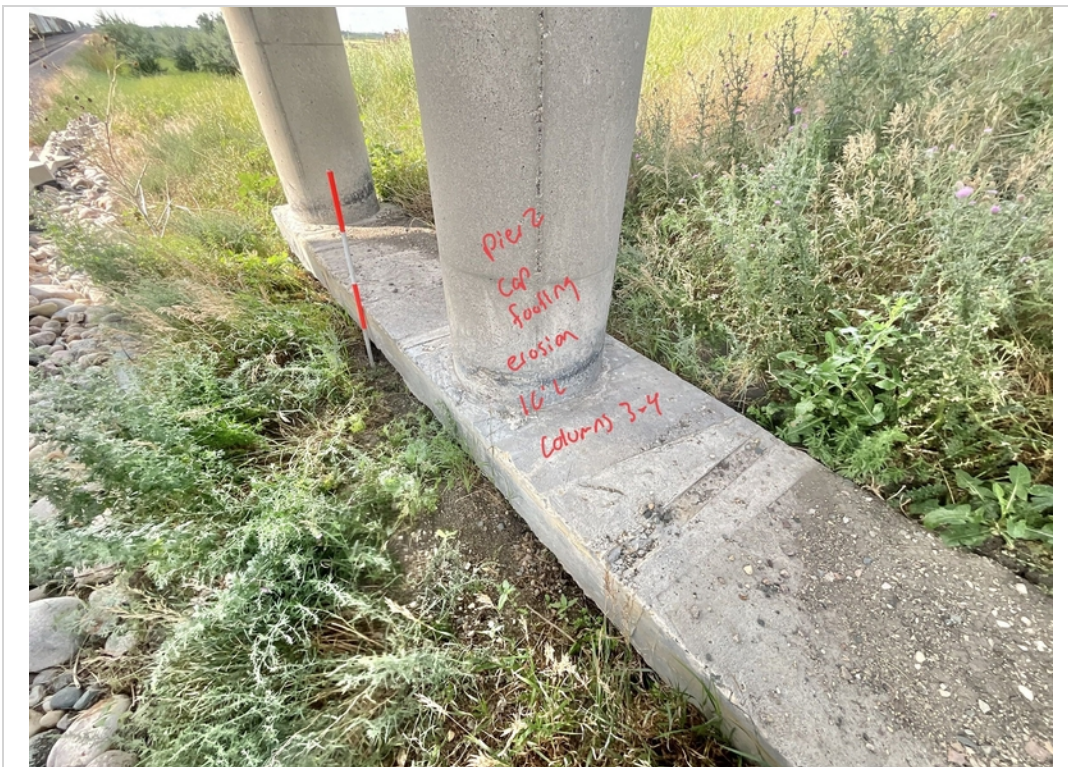
Facing SW. Erosion area along Pier 2 Cap Footing from Columns 3 to 4.

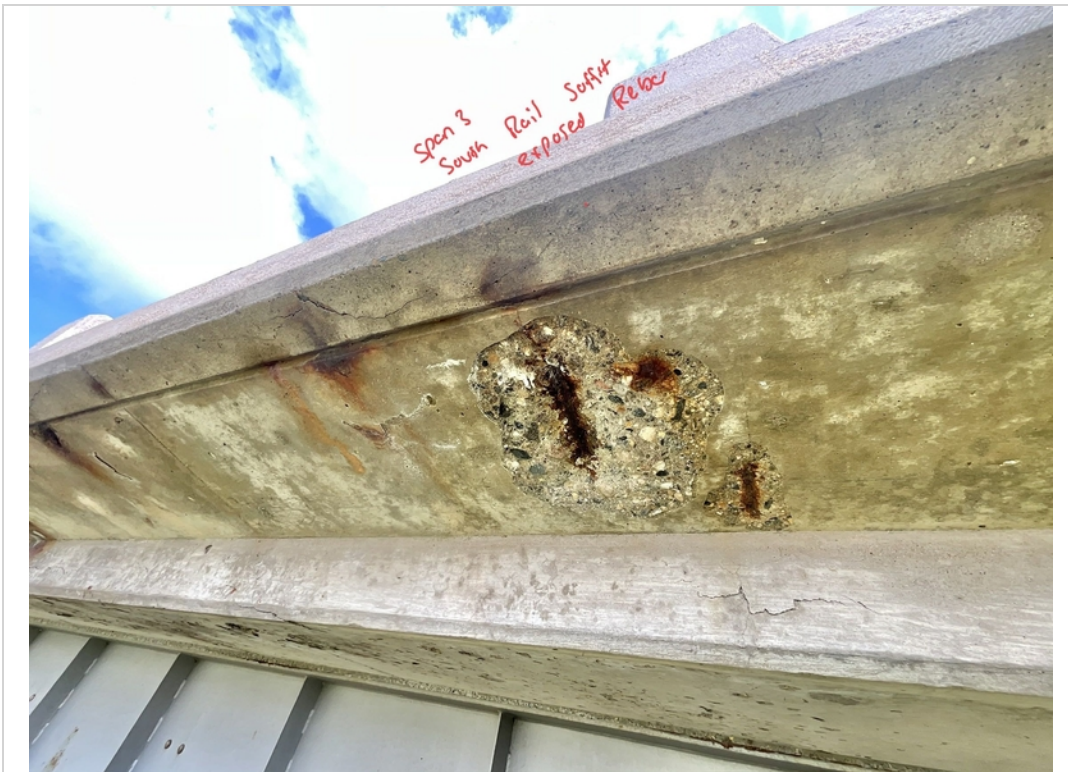
7/17/2023 - Continuing of Spalling with Exposed Rebar, Rust Staining, and Delamination along South Deck and Curb Soffit throughout.

Facing NW and Upwards. South Curb Soffit Exposed Rebar in Span 3.

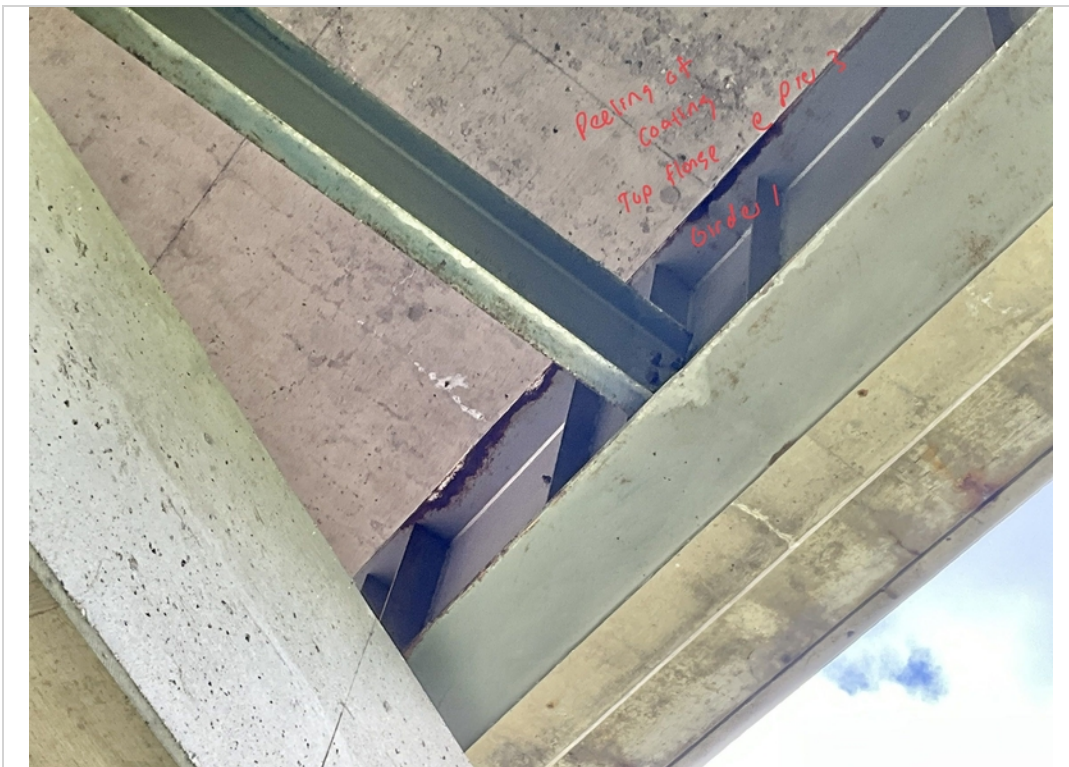
Facing NW and Upwards. Peeling of Coating down to bare metal along top flange of Girder 1 near Pier 3.

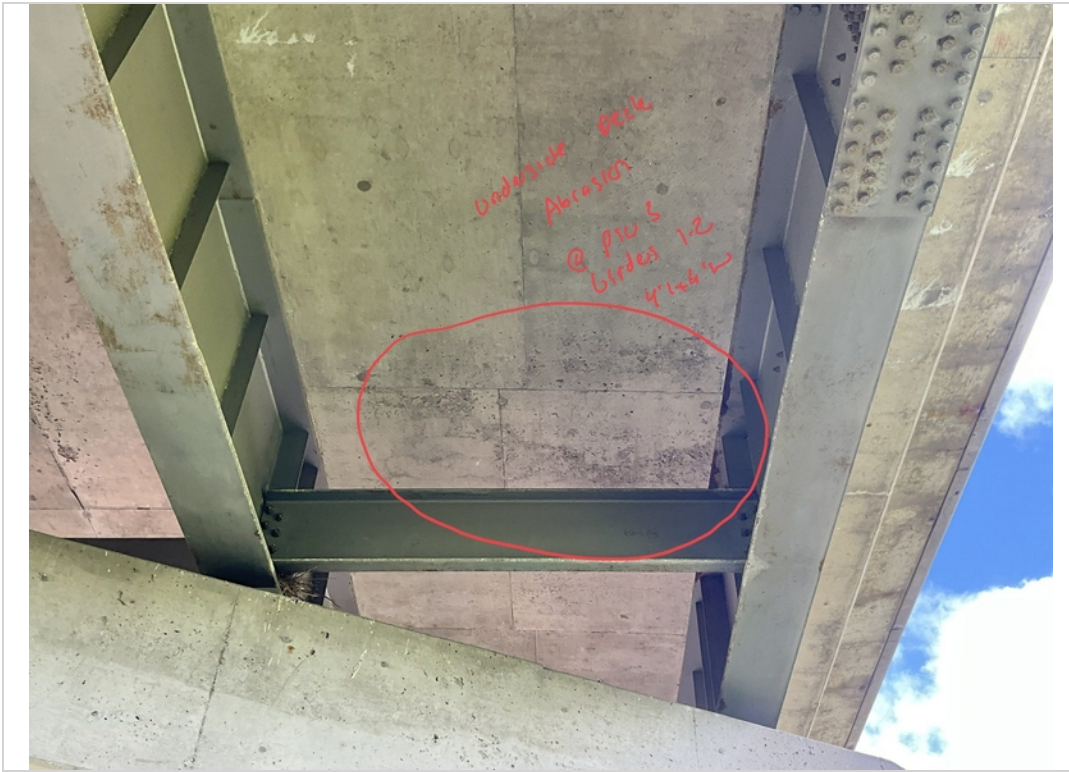
Facing West and Upwards. Abrasion with some honeycombing to underside of deck near Pier 3.

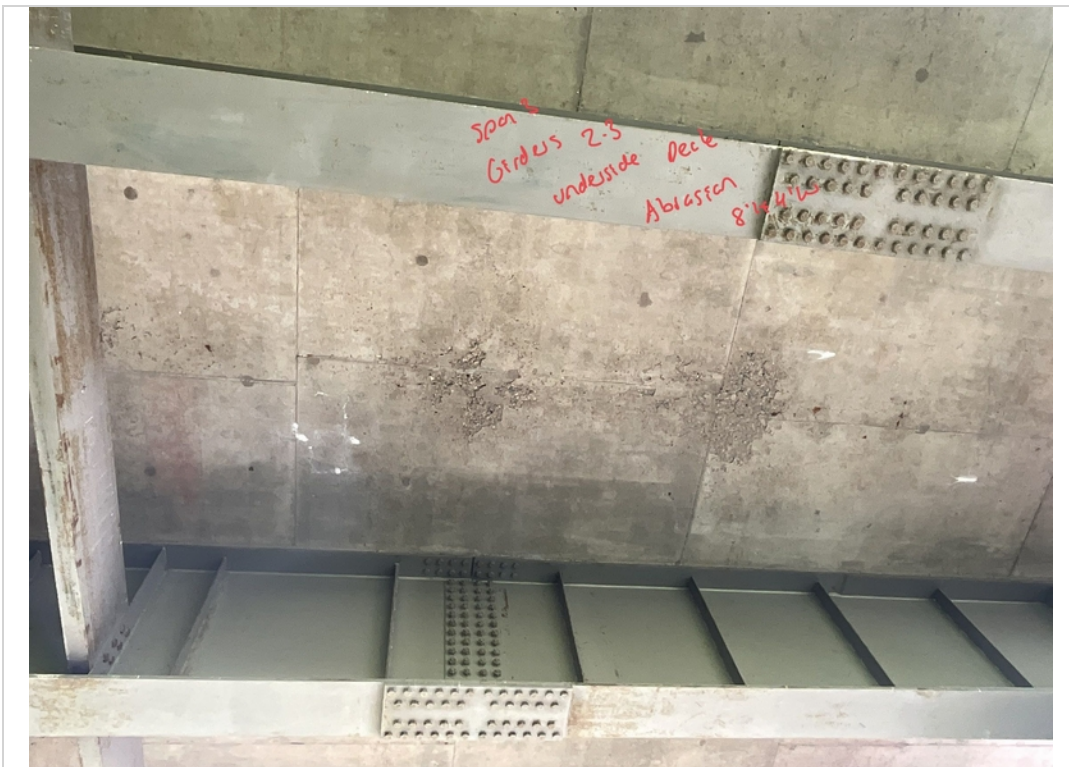
Facing South and Upwards. Abrasion to Underside Deck in Span 3 in-between Girders 2 and 3.

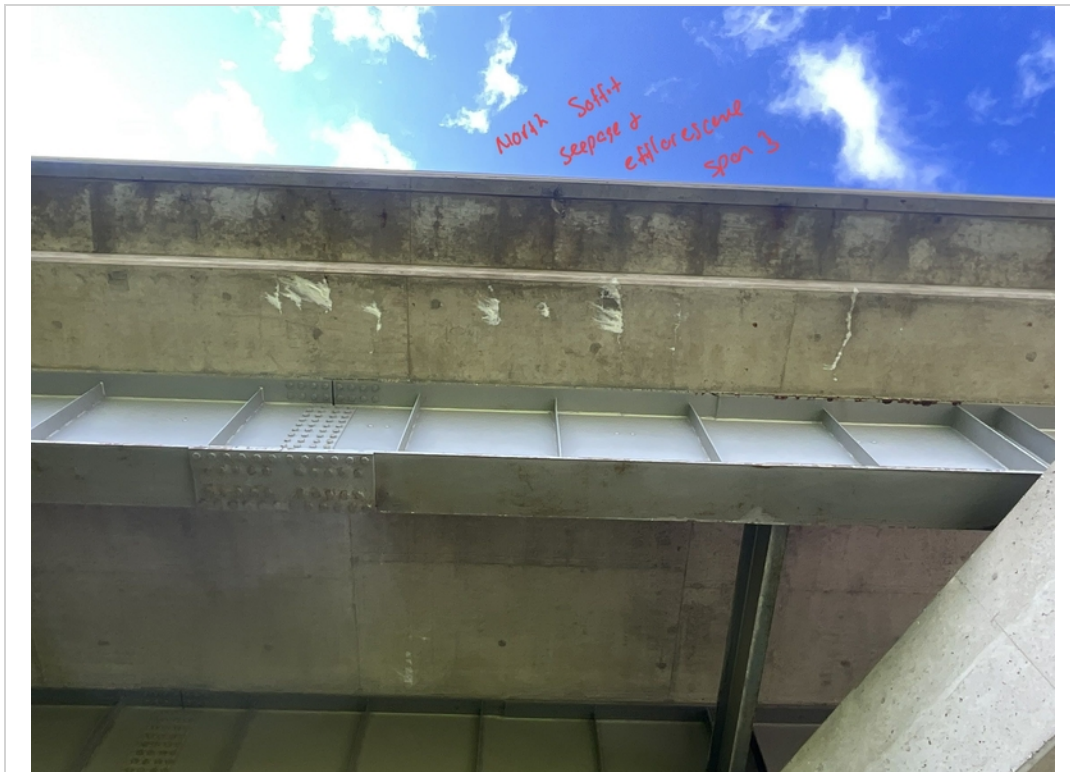
Facing South and Upwards. North Deck Soffit with Seepage and Efflorescence in Span 3.

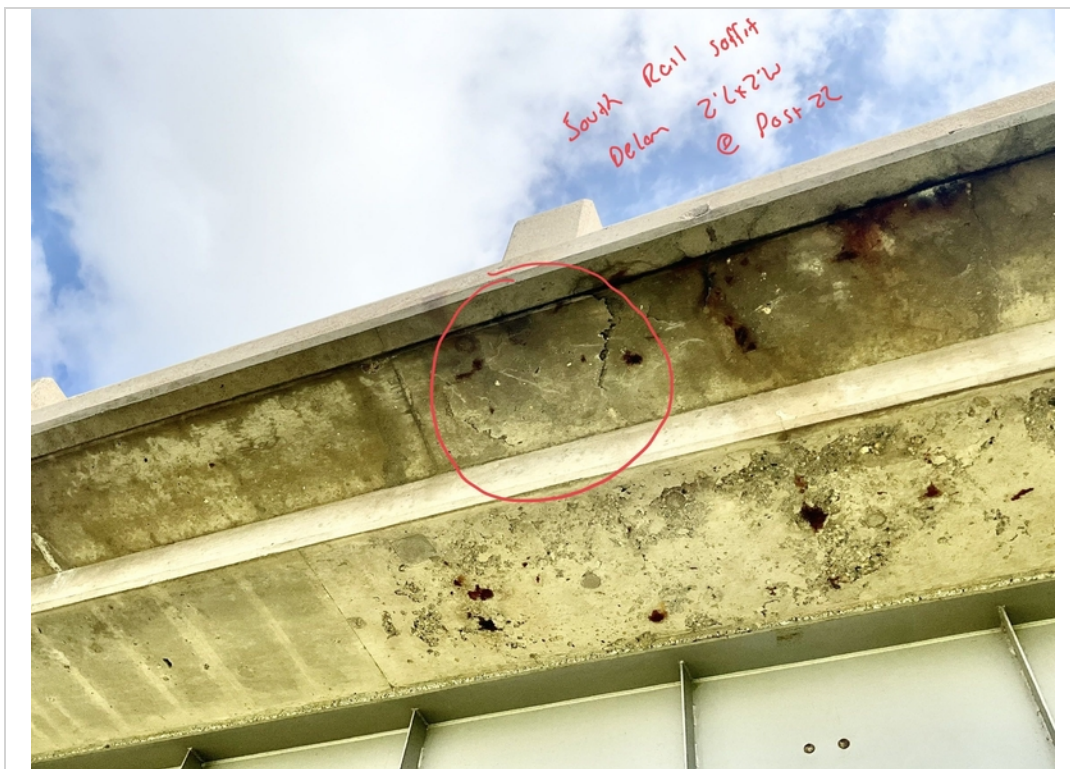
Facing NW and Upwards. Delamination to South Railing Soffit at Post 22.

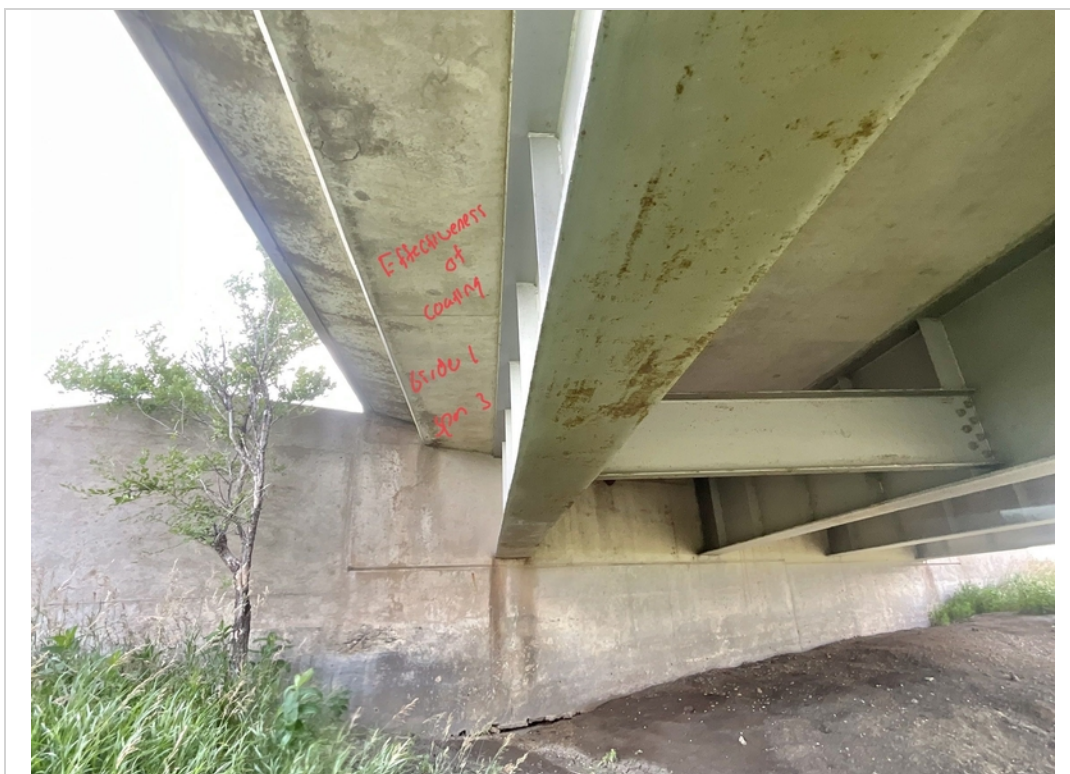
Facing East. Effectiveness of Coating to underside Girder 1 in Span 3.

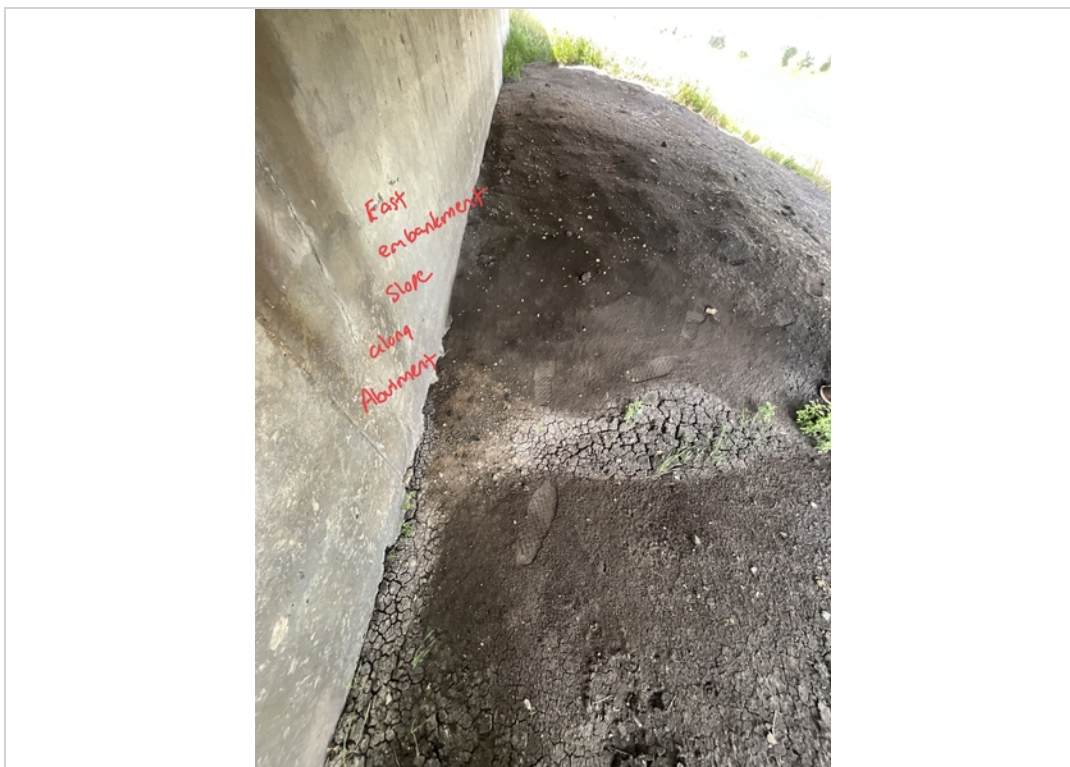
Facing South. East Embankment Slope along Abutment.

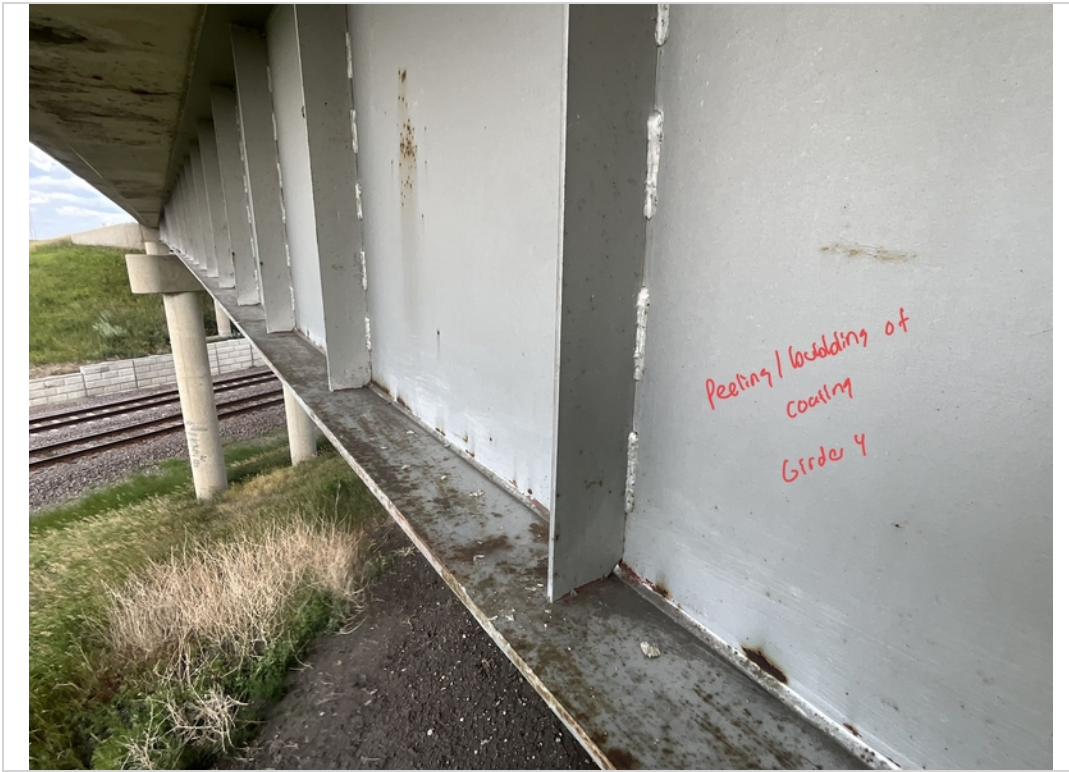
Facing SW. Peeling and Some bubbling of Coating to bottom flange of Girder 1 in Span 3.

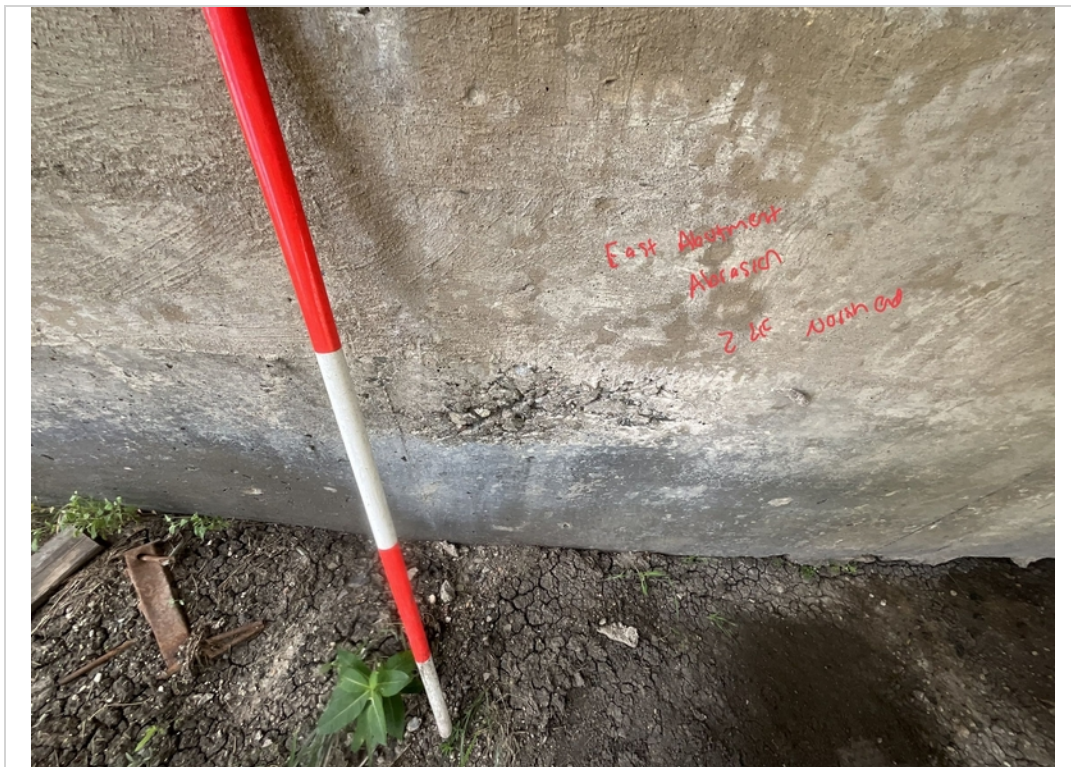
Facing East. Abrasion to East Abutment near North End.

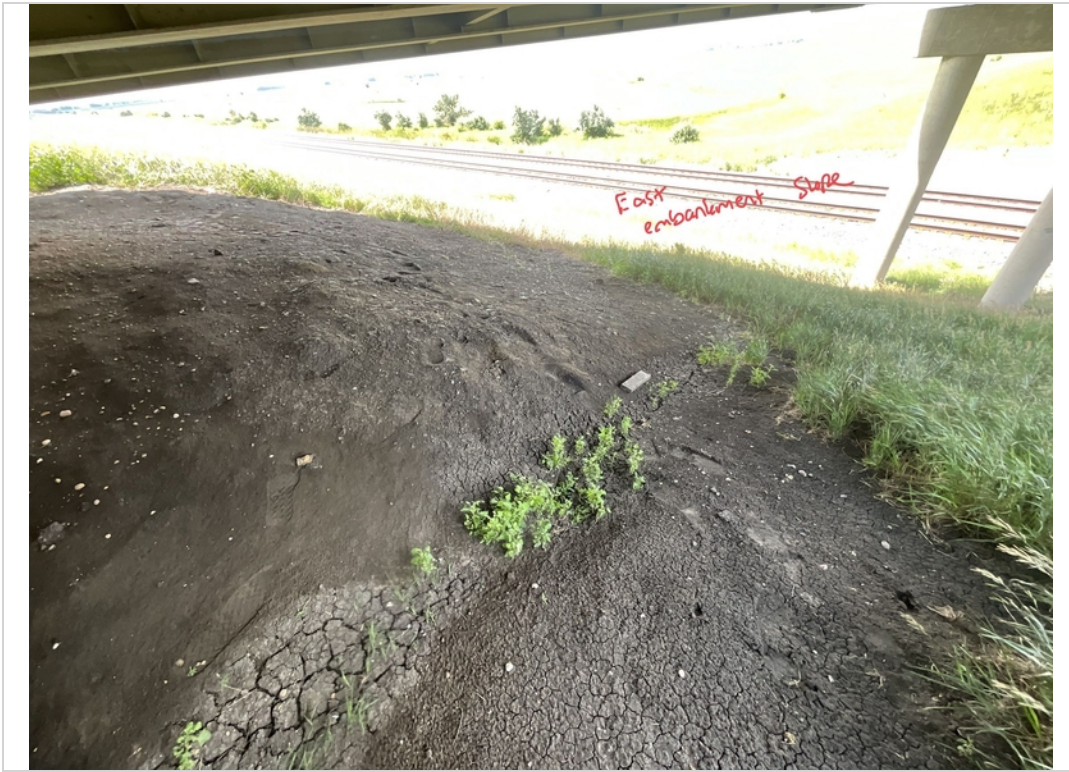
Facing SW. East Embankment Slope.
