IDENTIFICATION	
(1) State Names	38 - North Dakota
(8) Structure Number	0029-069.374 N
(5) Inventory Route	1
(2) Highway Agency District	8 - Fargo
(3) County Code	9 - Cass

(4) Place Code	25700
(6) Features Intersected	BNRR
(7) Facility Carried	COUNTY HIGHWAY
(9) Location	EAST OF NO. FARGO INTCHG
(11) Mile Point	0.1 mi
(12) Base Highway Network	No

INSPECTIONS *			
(90) Inspection Date	07/17/2023		
(91) Frequency	24		
(92) Critical Feature Inspection	Done	Freq. (Mon)	Date
A: Fracture Critical Detail	No		
B: Underwater Inspection	No		
C: Other Special Inspection			
* The inspection date and frequency information in this box contains the current NBI date and frequency information. Please refer to the report header for the date this inspection was conducted.

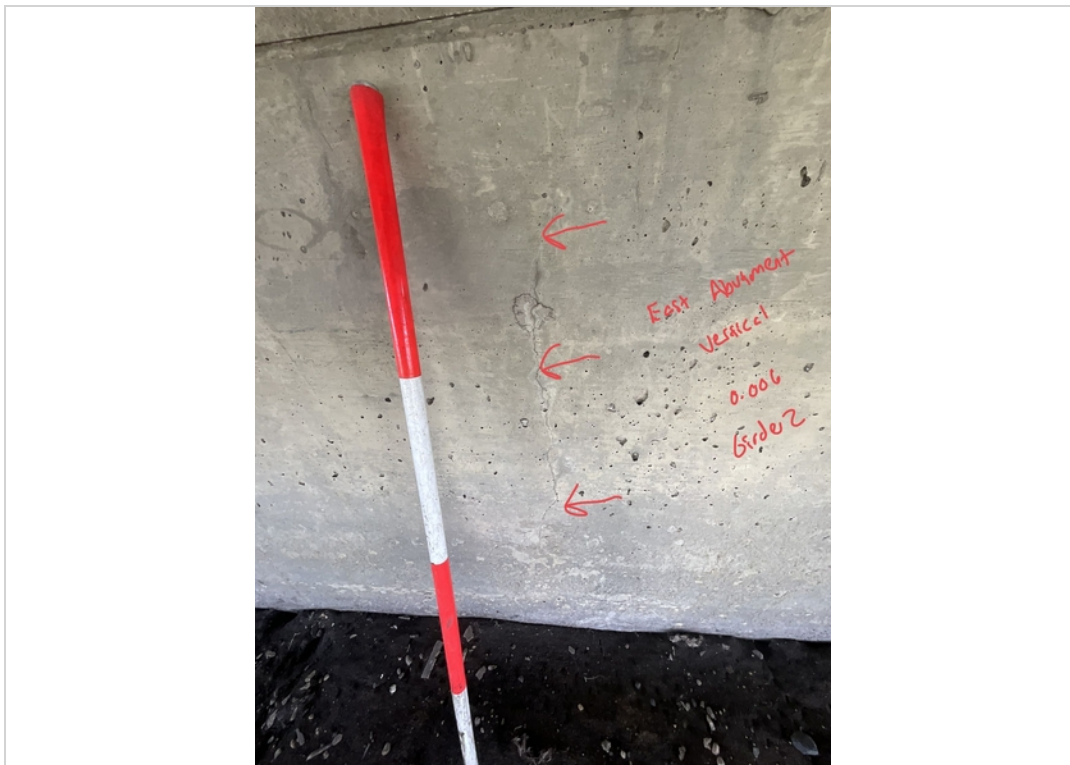
Facing East. Vertical Crack to East Abutment under Girder 2.

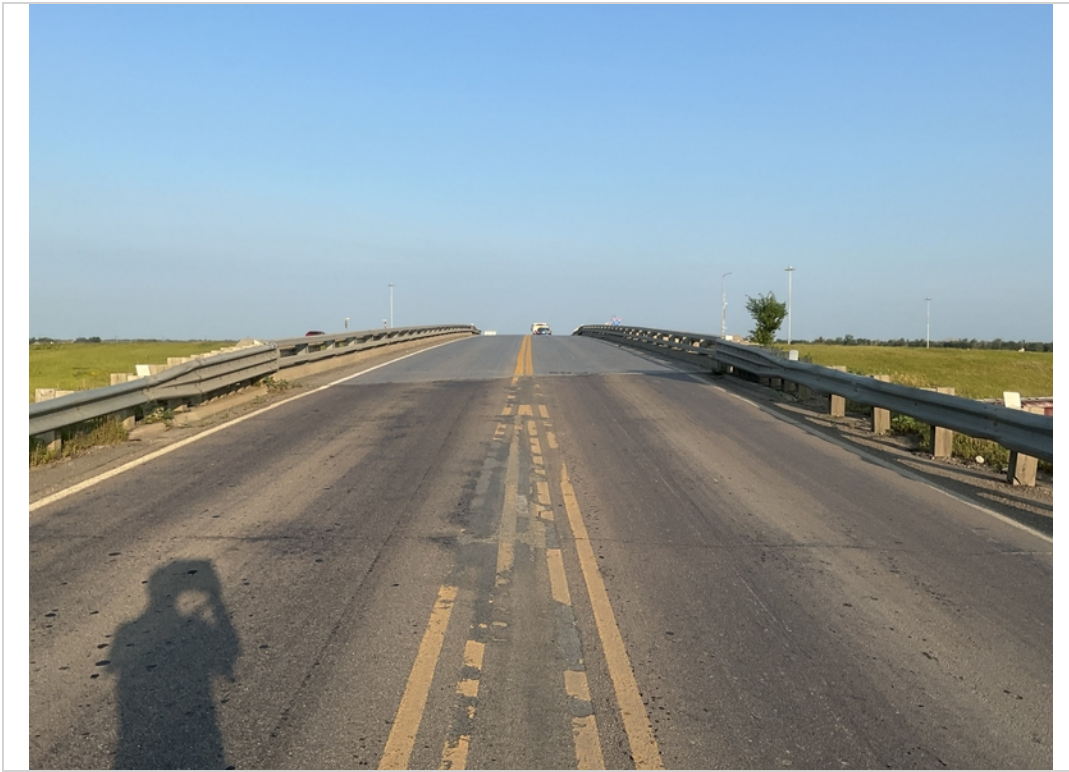
Facing West. Approach View.

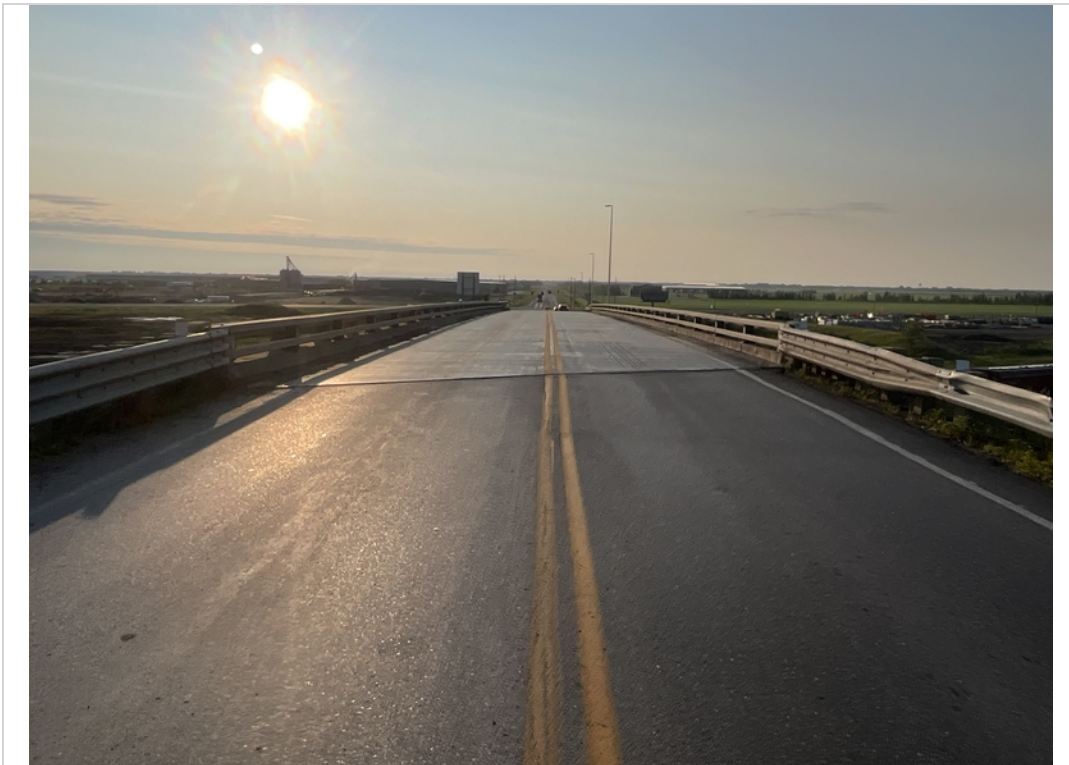
Facing East. Approach View.

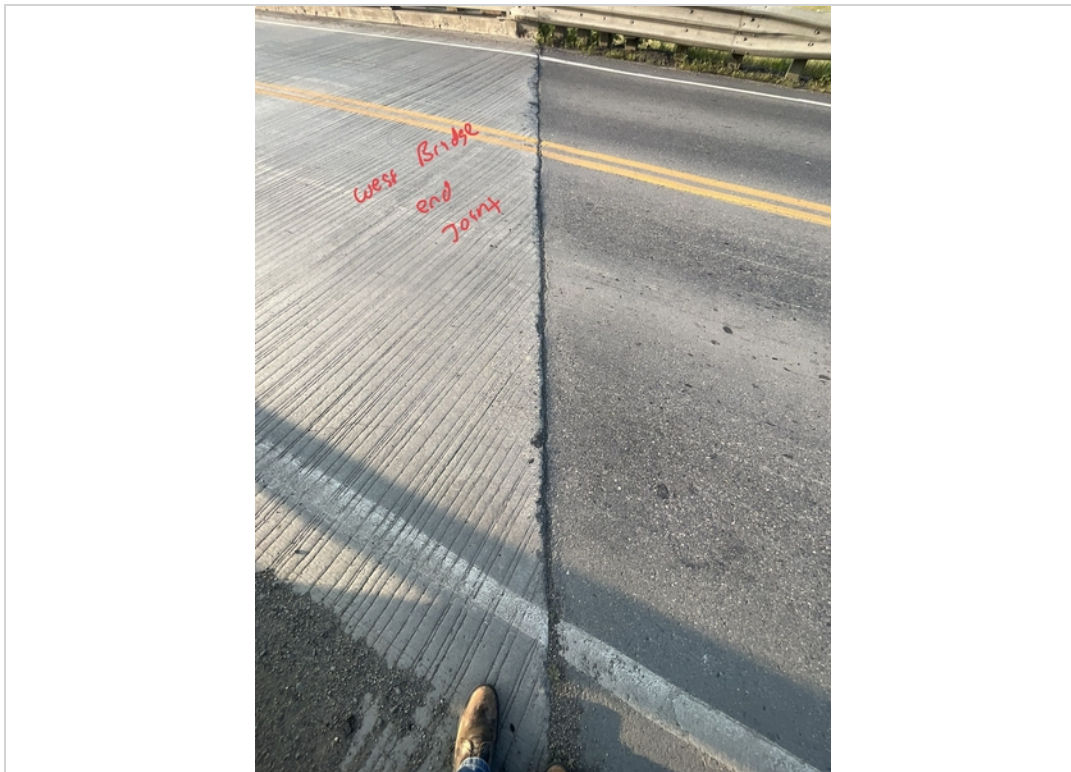
Facing South and Downward. West Bridge End Joint.

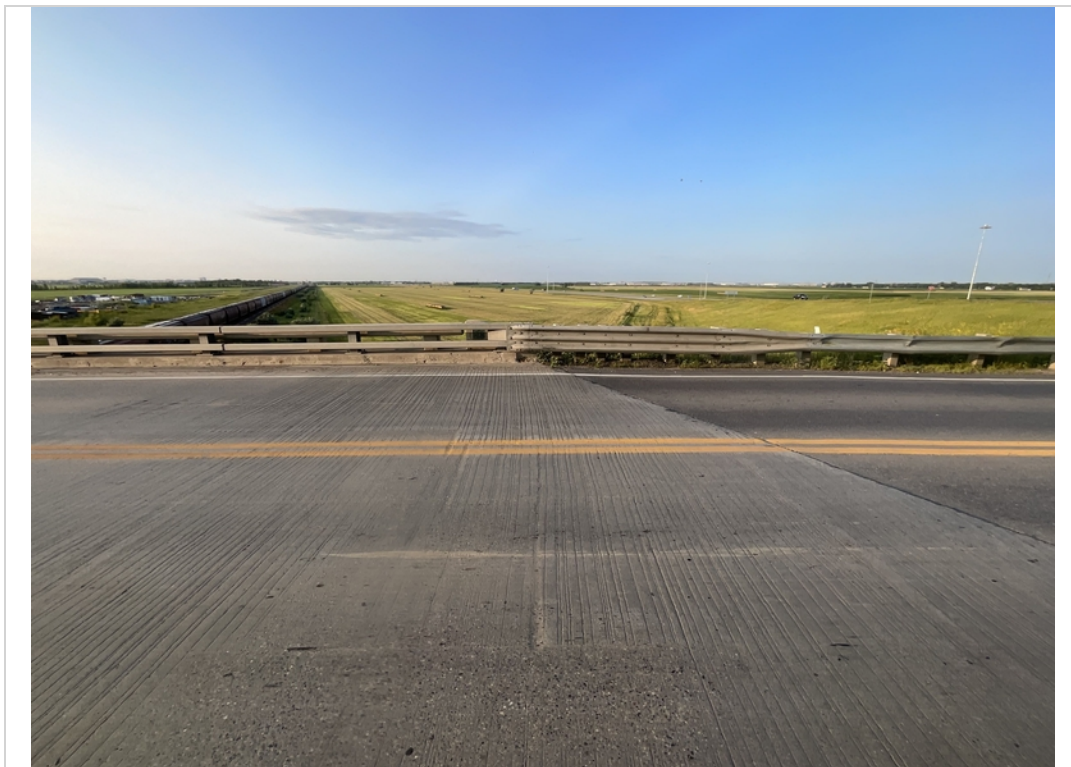
Facing South. Guardrail Transition at SW Corner. Similar at NW Corner.

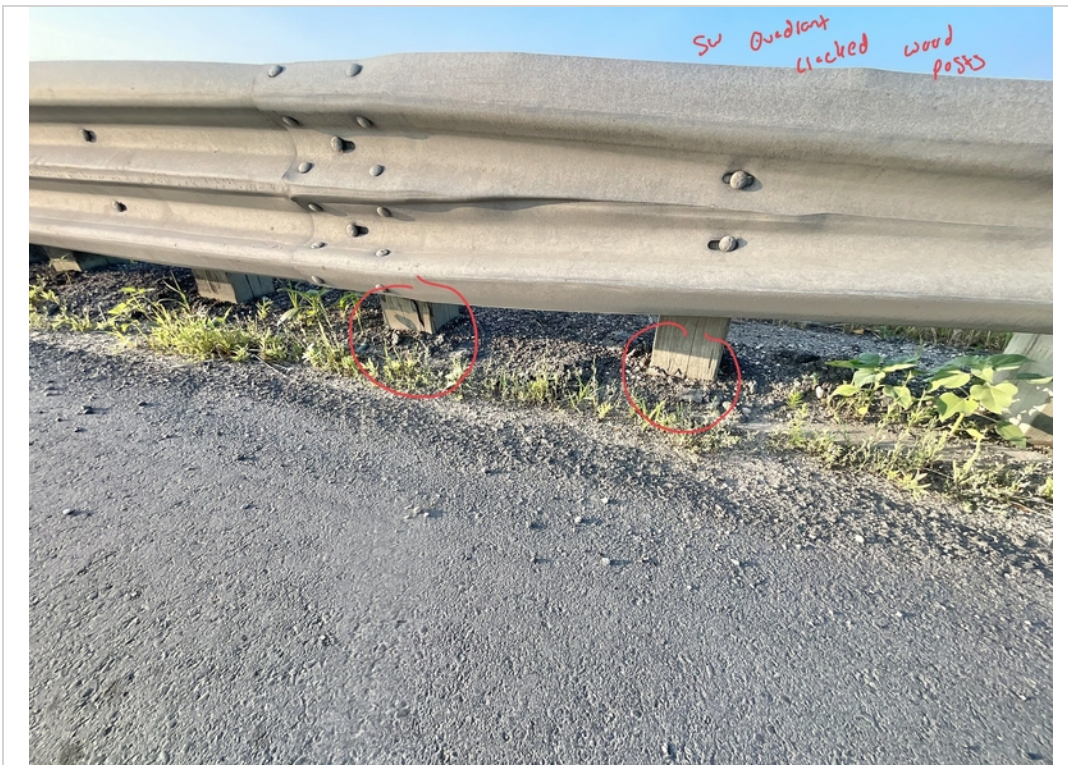
Vehicle Impact Damage to SW Guardrail with 2 cracked posts, NE Guardrail with 1 Cracked post.

Facing South. Cracked Wood Posts within SW Guardrail Quadrant.

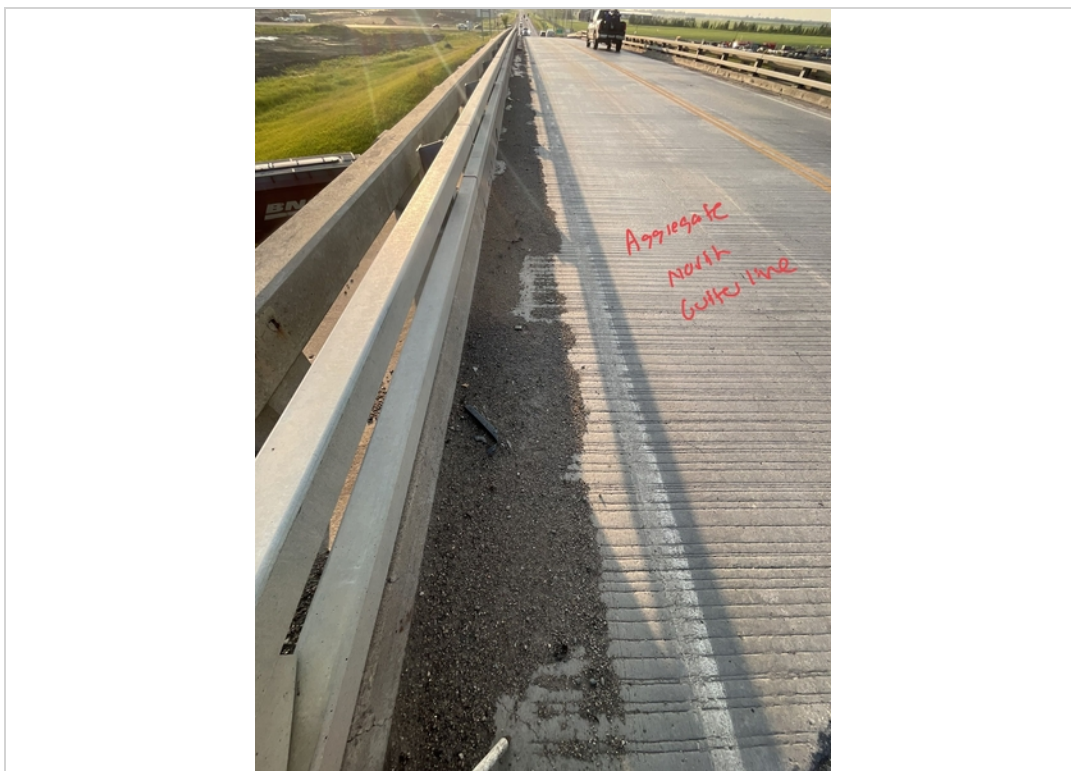
Facing East and Downward. Aggregate along North Gutter Line.

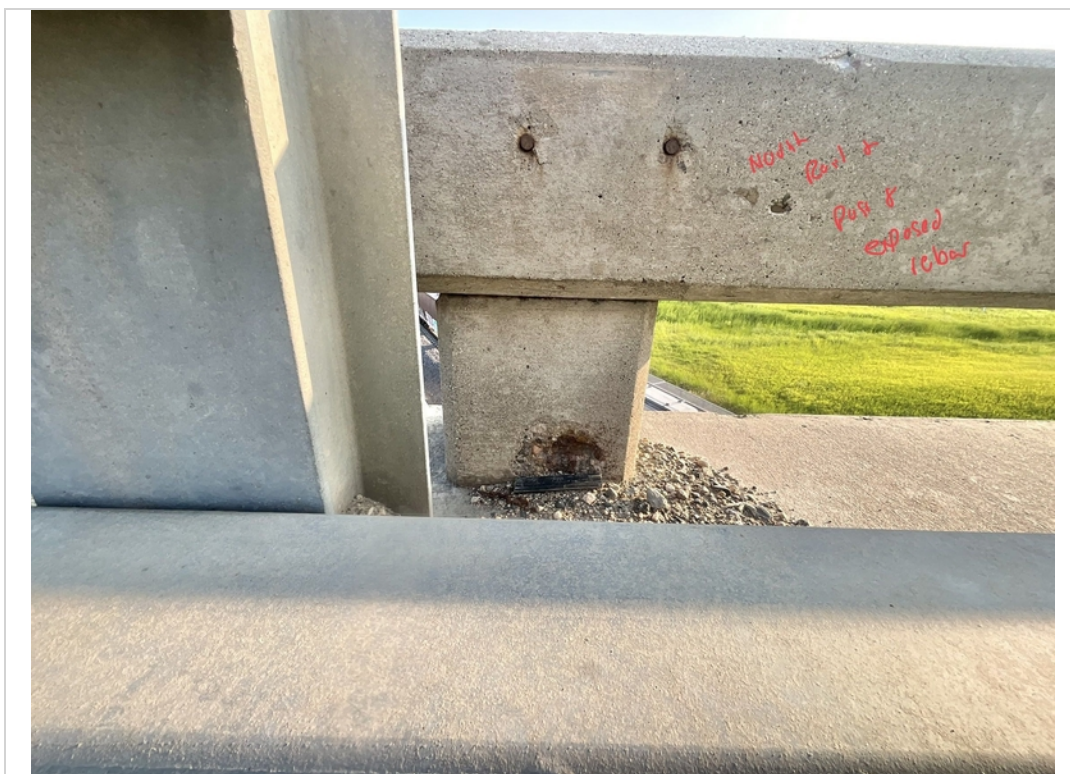
Facing North. Exposed Rebar to North Railing Post 8.

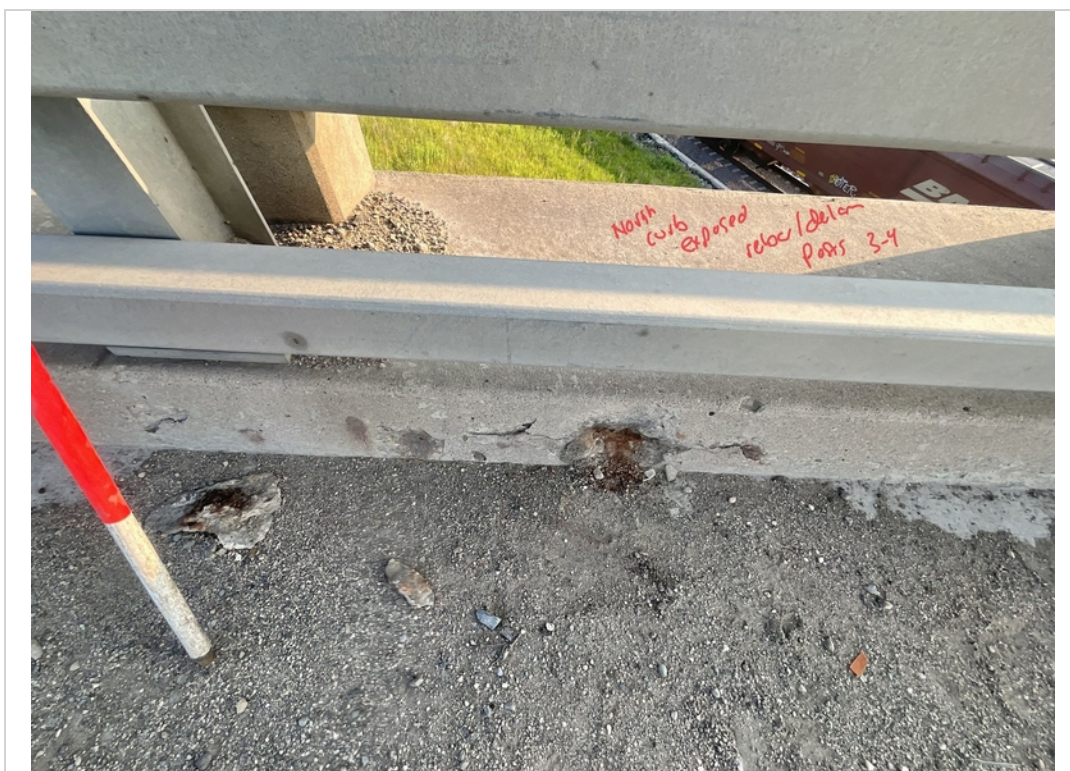
ELEMENTS	DESCRIPTION	UNITS	TOTAL	CS1	CS2	CS3	CS4
<p>(1090-331) 7/26/2021, 7/17/2023 - Spalling with exposed rebar to curbs progressing with, North curb: 1 LF on posts 1, 2, 3, 7, 8, 9, 10, 13, 14, 16, 17, 18. 5 LF between posts 2-3. 1 LF between posts 3-4. 1 LF on Rail between posts 6-7. 1 LF between posts 12-13. 10 LF between posts 17-20. South curb: 1 LF on posts 1, 8, 10, 11, 12, 14, 15, 16, 17, 19, 20, 21, 23 and East end post. 1 LF at West end. 1 LF West of Post 20 underside of Rail. 1 LF at East end. All areas with section loss up to 1/8". UNDERSIDE: South curb: 4 LF at post 9. 1 LF at post 13. 2 LF between posts 13-14. 2 LF at post 18. 1 LF between posts 19-20. 1 LF at post 23. 1 LF at post 25. See photos. (1120-331) 7/26/2021, 7/17/2023 - Rust Staining to curbs progressing with, North curb: 4 LF between posts 11-12. 8 LF between posts 17-20. South curb: 15 LF underside in Span 1. 5 LF between posts 2-3. 6 LF between posts 6-7. 12 LF underside in Span 2. 4 LF between posts 9-10. 3 LF between posts 11-12. 2 LF between posts 12-13. 9 LF between posts 15-18. 10 LF underside in Span 3. See photos. (1130-331) Random cracking throughout bridge rail - 10/31/2019 7/26/2021, 7/17/2023 - Various cracking to curbs progressing with, North curb: 3 LF CS 2 Various at West end, widths of 0.012". 8 LF CS 1 verticals throughout, widths of 0.004"-0.010". 3 LF CS 2 Various at East end, widths of 0.004"-0.008". South curb: 2 LF CS 2 various at West end, widths of 0.012"-0.040". 11 LF CS 1 verticals throughout, widths of 0.004"-0.010". 3 LF CS 2 horizontal between posts 4-5, width of 0.020". 4 LF CS 2 horizontal between posts 5-6, width of 0.020". 3 LF CS 2 verticals in Span 3, width of 0.012"-0.016". 8 LF CS 2 horizontal to underside at East end, widths of 0.014"-0.018". 2 LF CS 2 various at 2' from East end, widths of 0.014"-0.040". See photos.</p>

Facing North. Delamination with Exposed Rebar to North Curb in-between Posts 3 and 4.

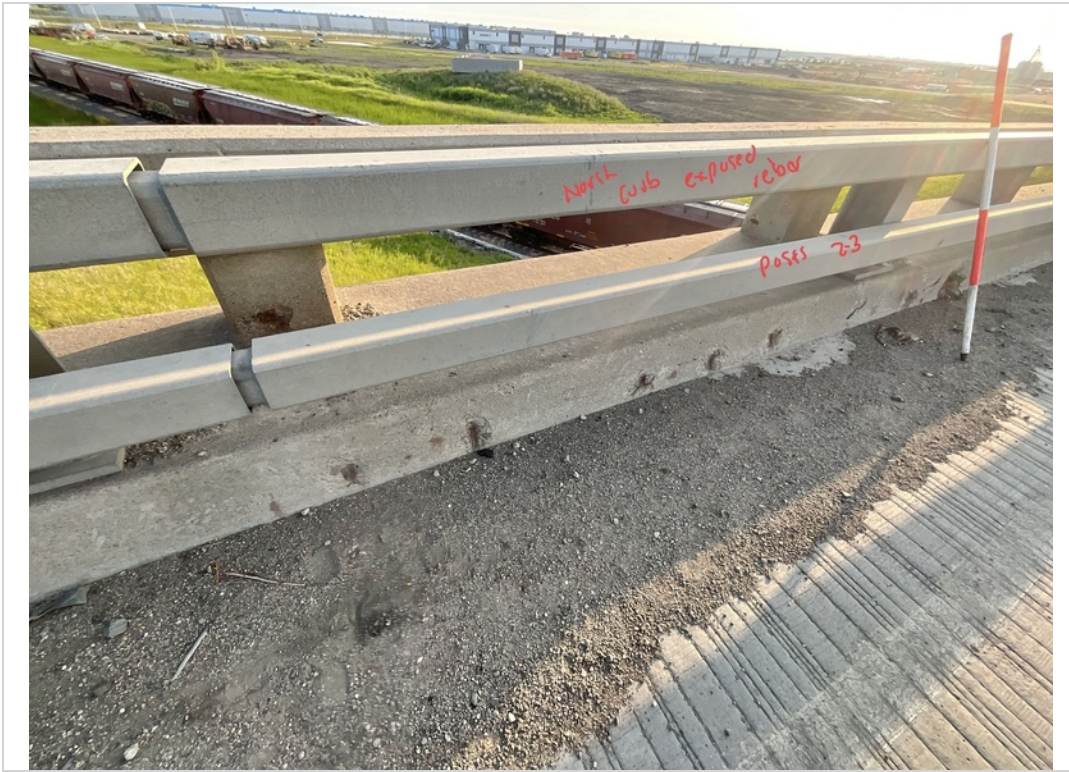
Facing NE. Exposed Rebar to North Curb from Posts 2 and 3.

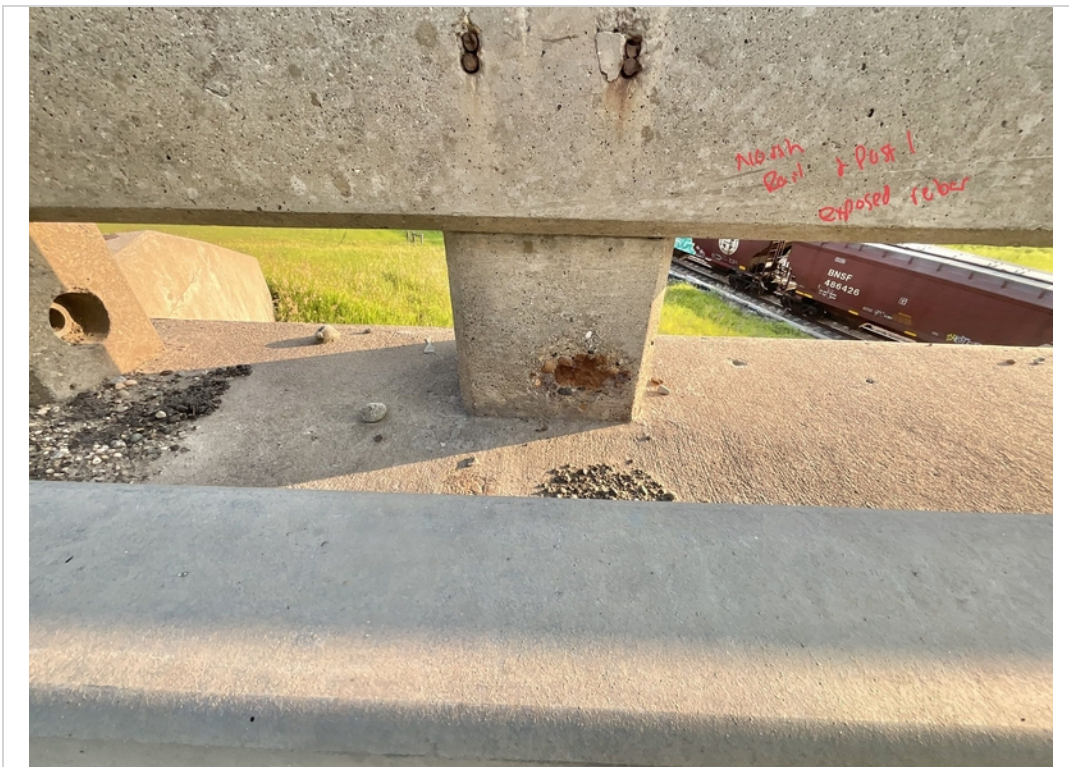
Facing North. Exposed Rebar to North Railing at Post 1.

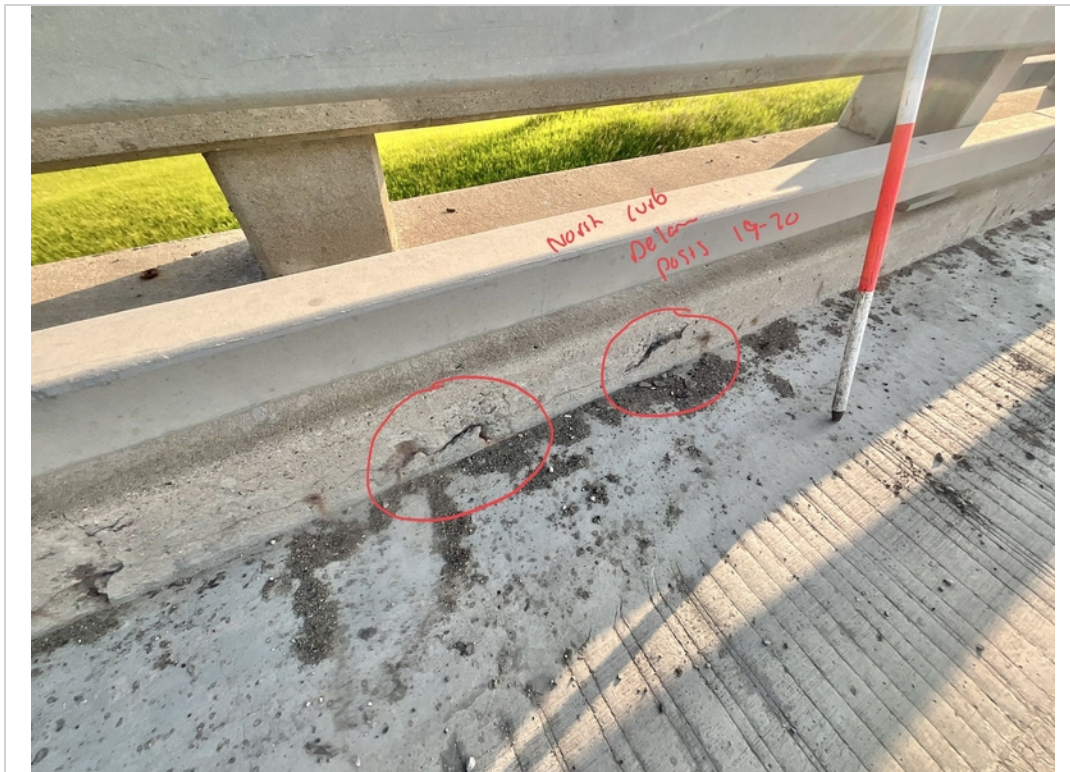
Facing NE. Delamination to North Curb in-between Posts 19-20.

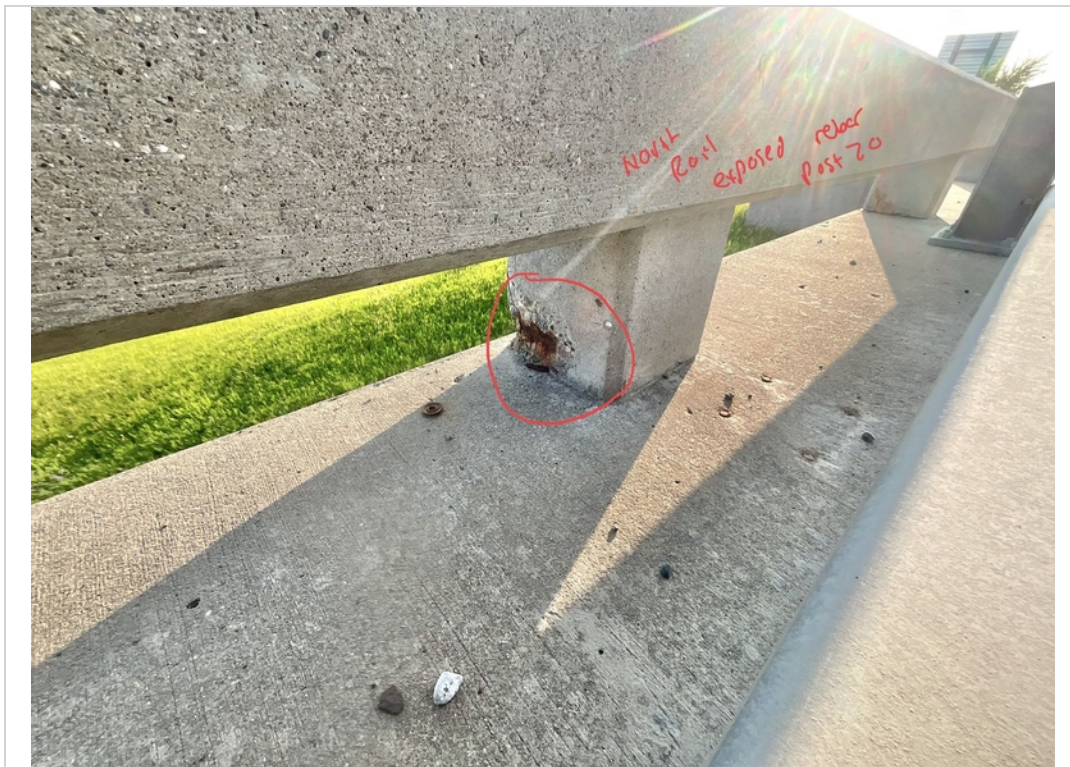
Facing NE. Exposed Rebar to North Railing Post 20.

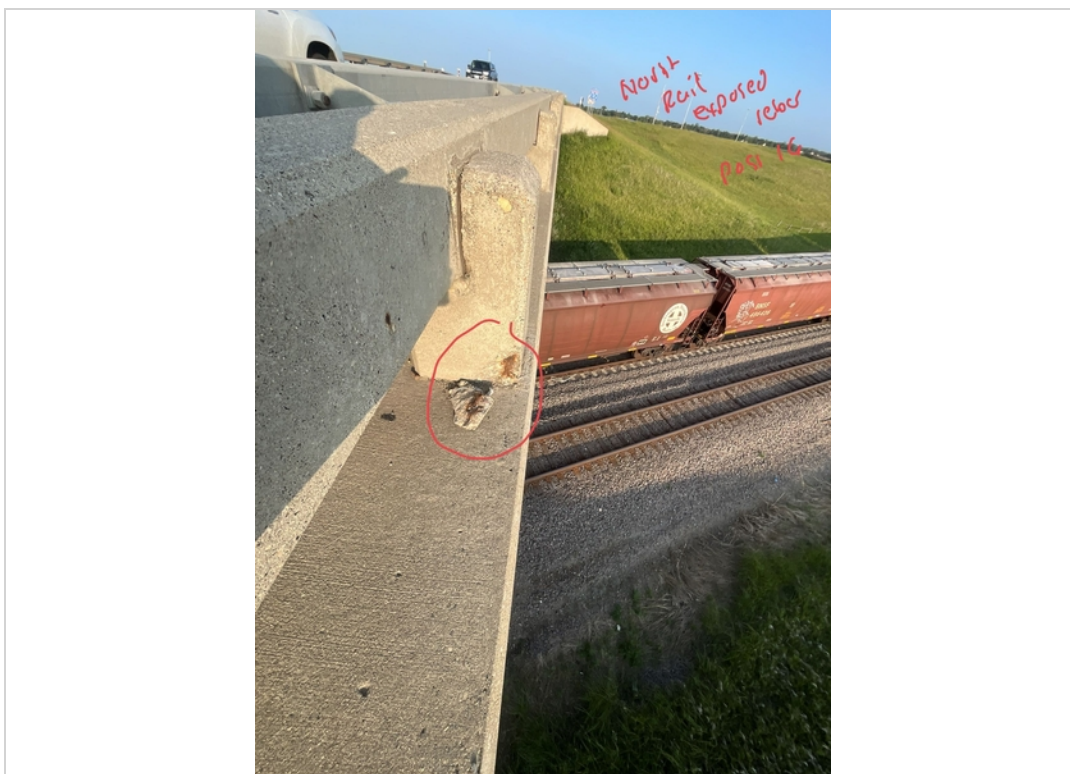
Facing West. Exposed Rebar to North Railing at Post 16.

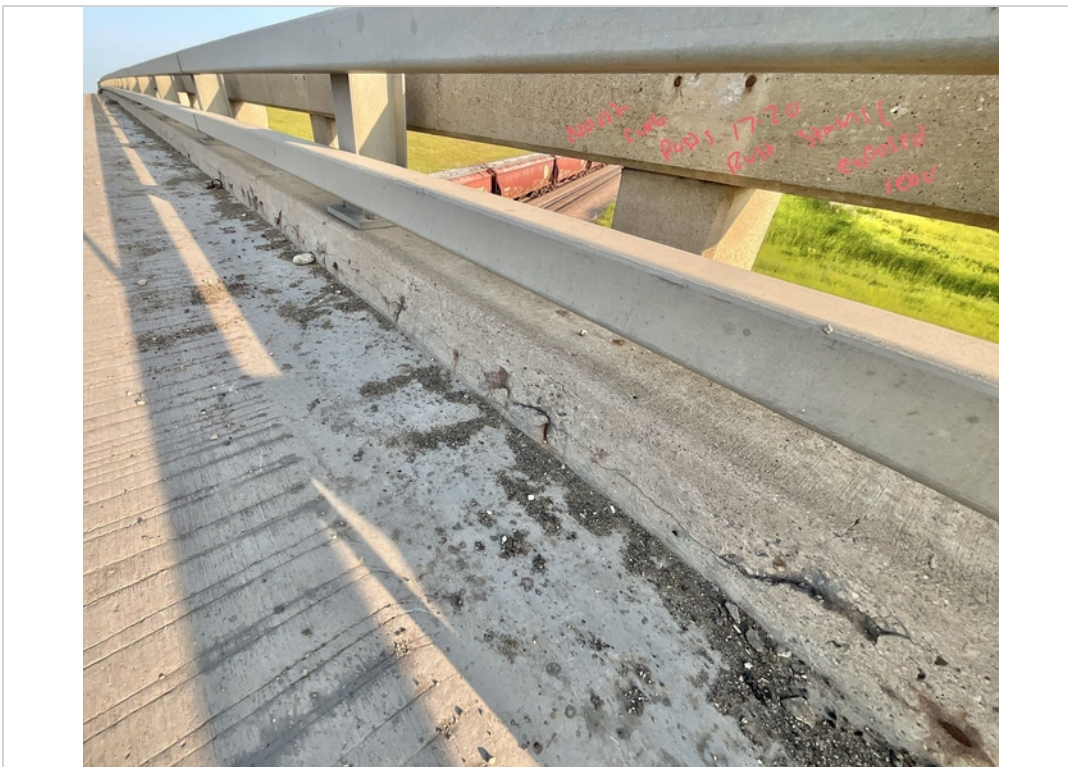
Facing SW. Cracking with Rust Staining to North Curb from Posts 17-20.

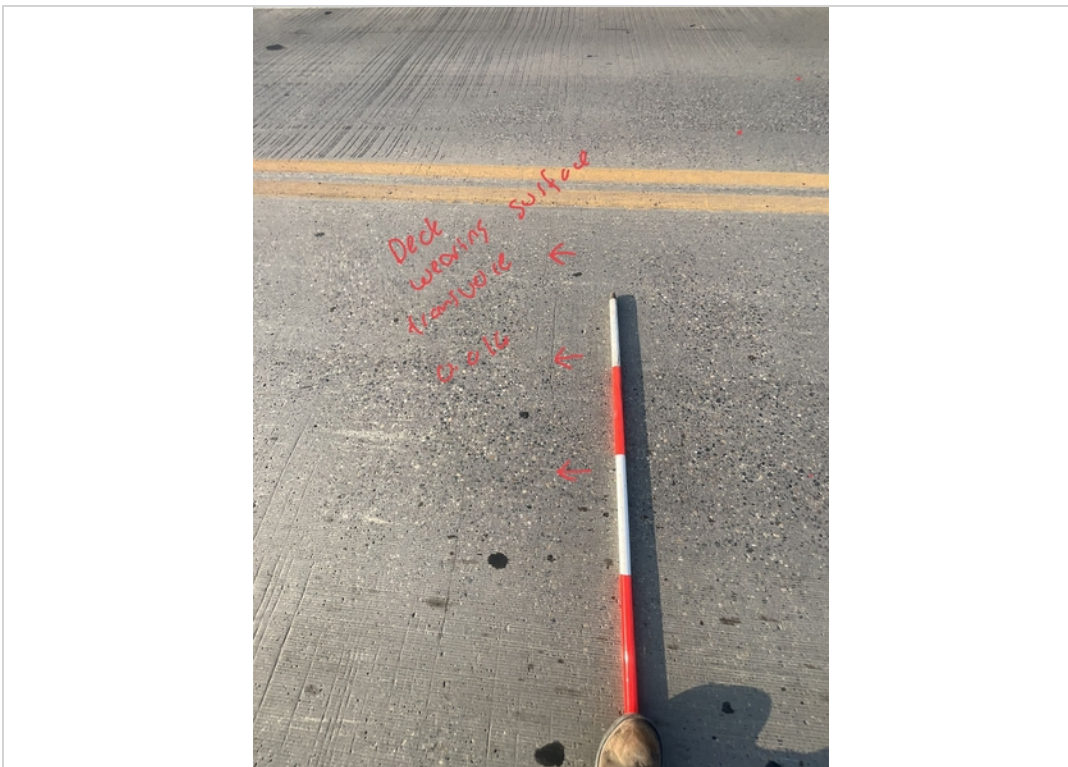
Facing South and Downward. Transverse Crack to Deck Wearing Surface WB Lane.

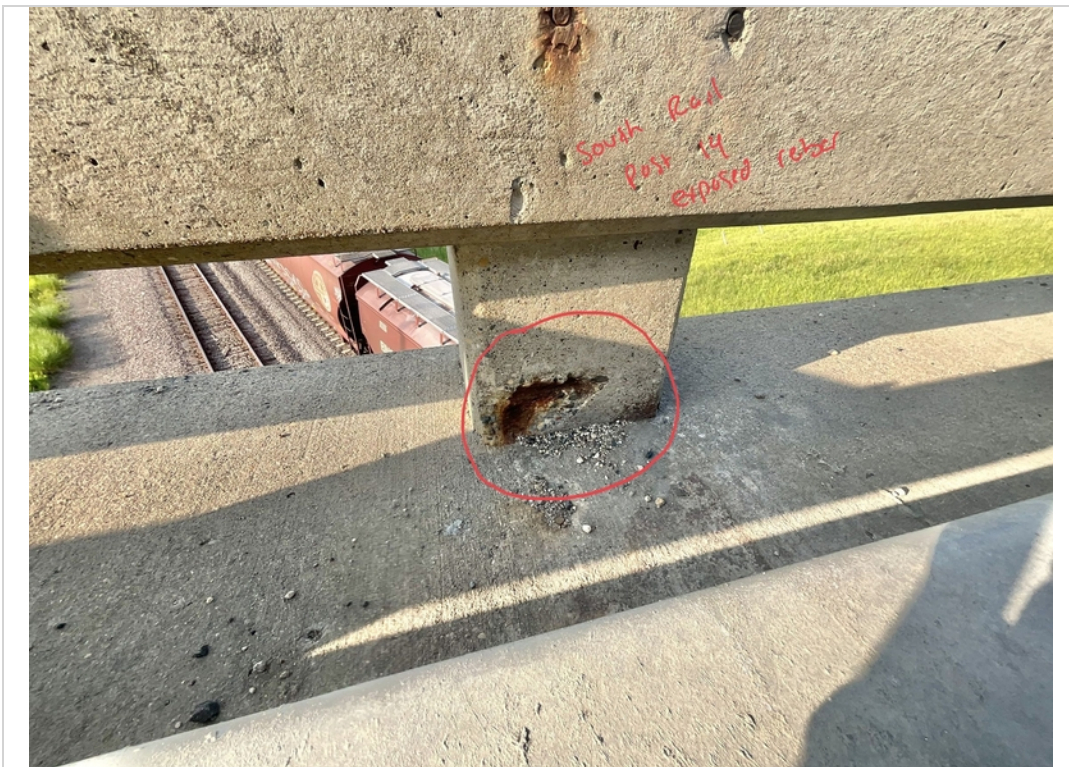
Facing South. Exposed Rebar to South Railing Post 14.

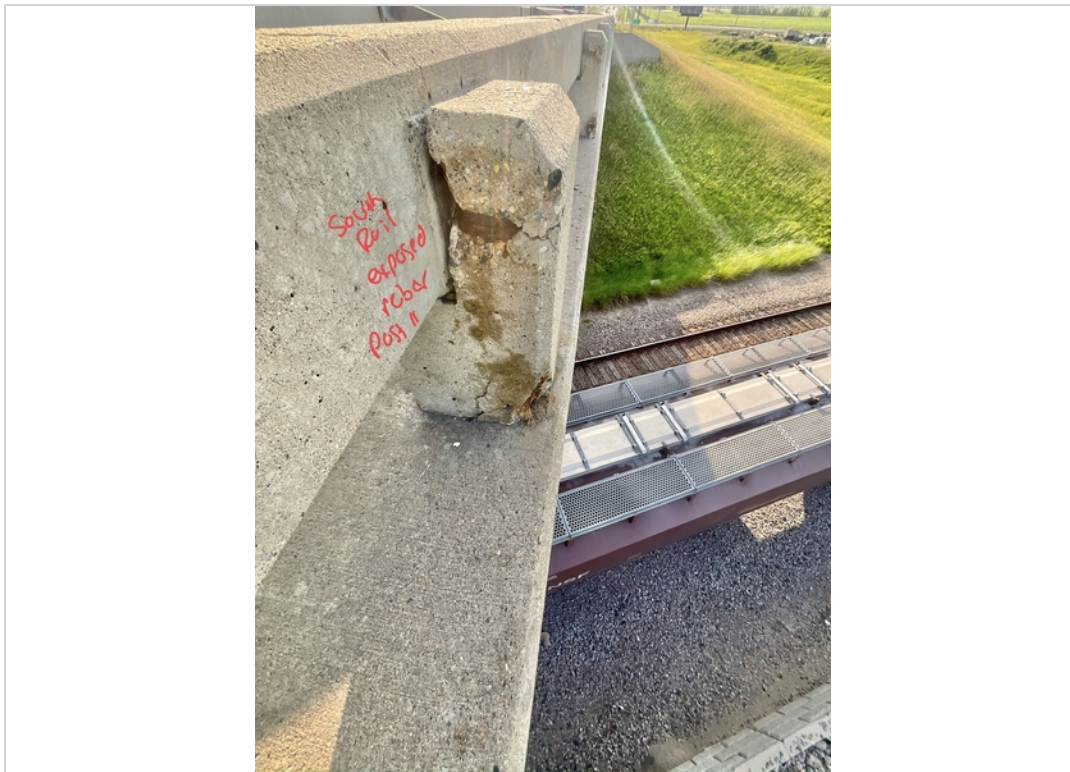
Facing East. Exposed Rebar to South Railing Post 11.

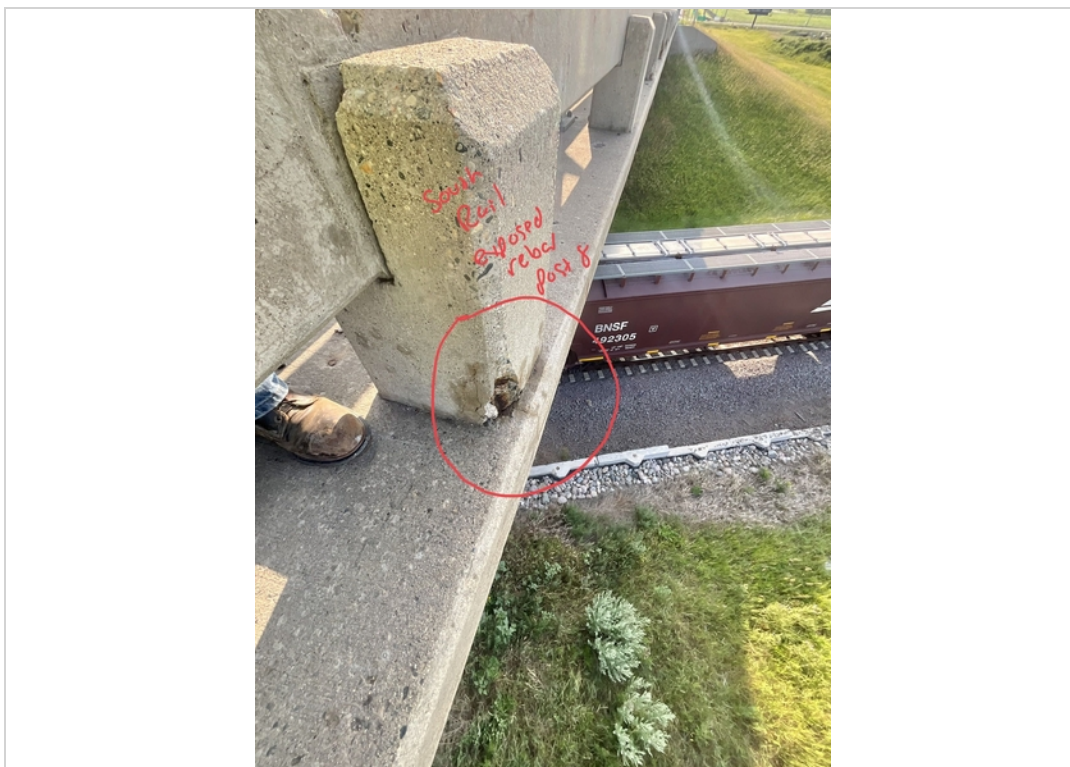
Facing NE. Exposed Rebar to South Railing Post 8.

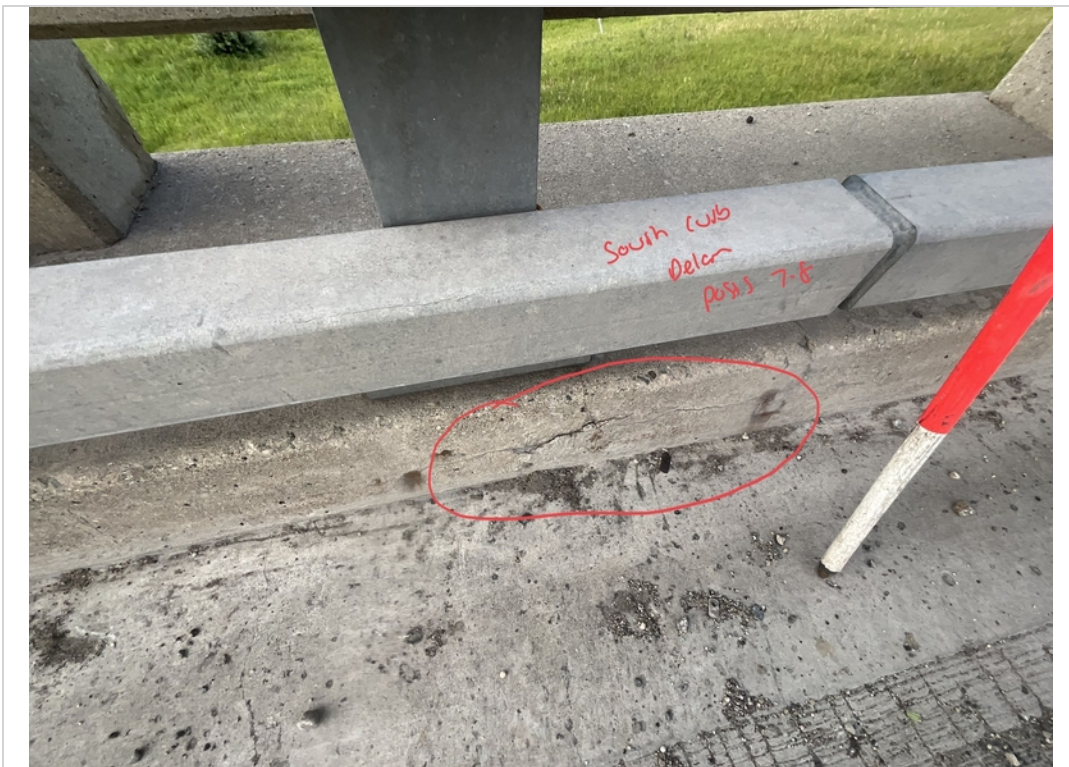
Facing South. Delamination to South Curb Posts 7 and 8.

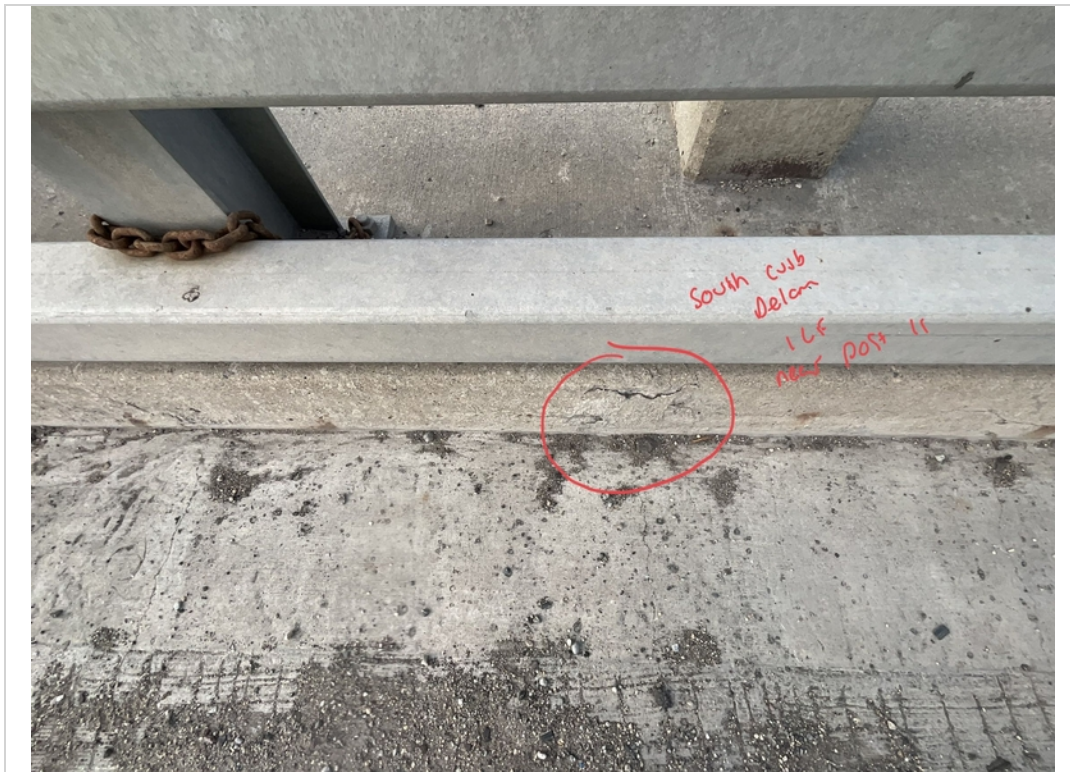
Facing South. Delamination to South Curb at Post 11.

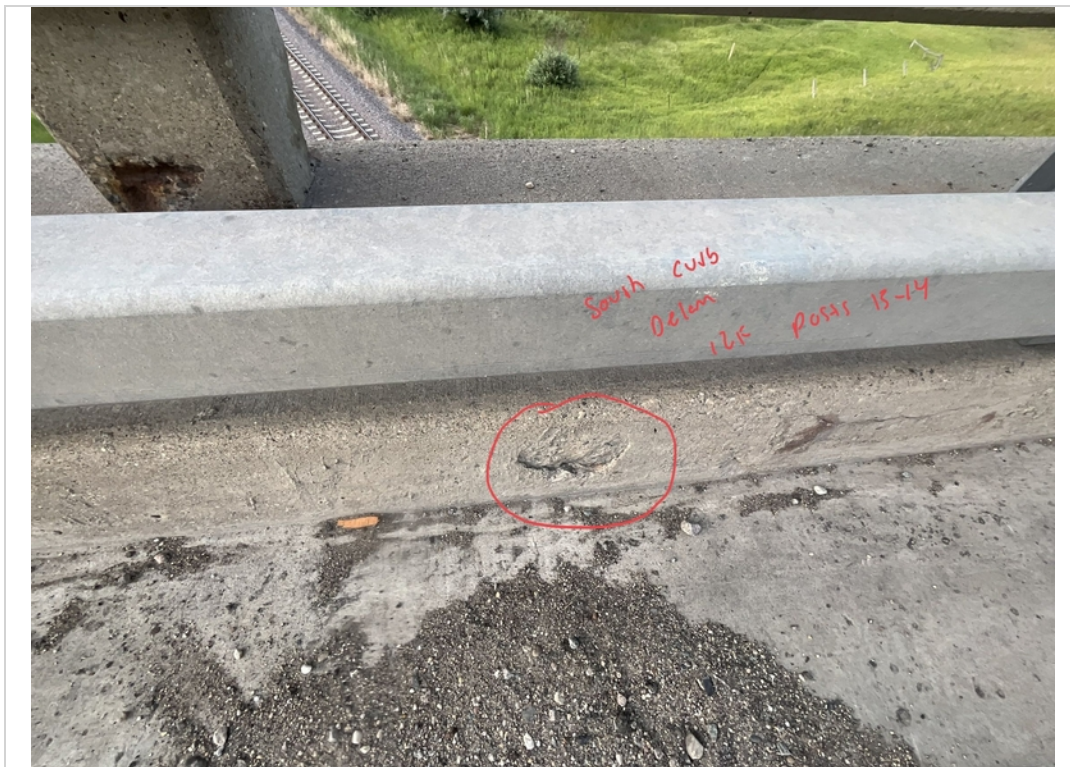
Facing South. Delamination to South Curb in-between Posts 14 and 15.

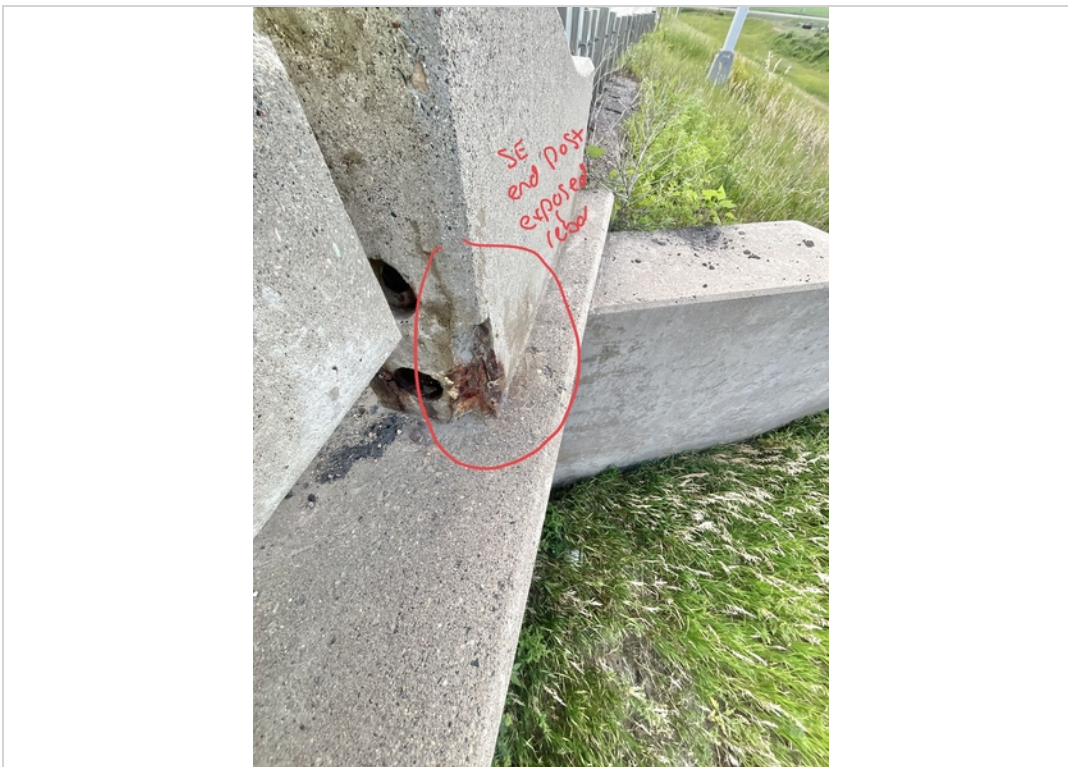
Facing East. Exposed Rebar to SE End Post.

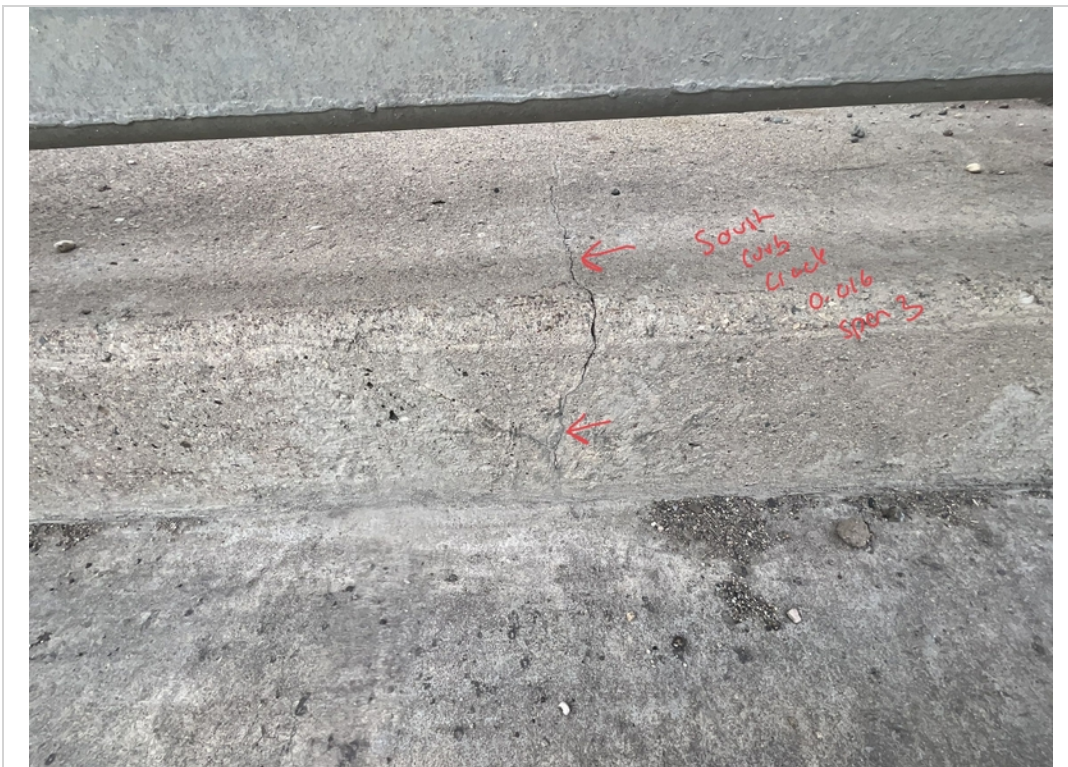
Facing South. Crack to South Curb in Span 3.

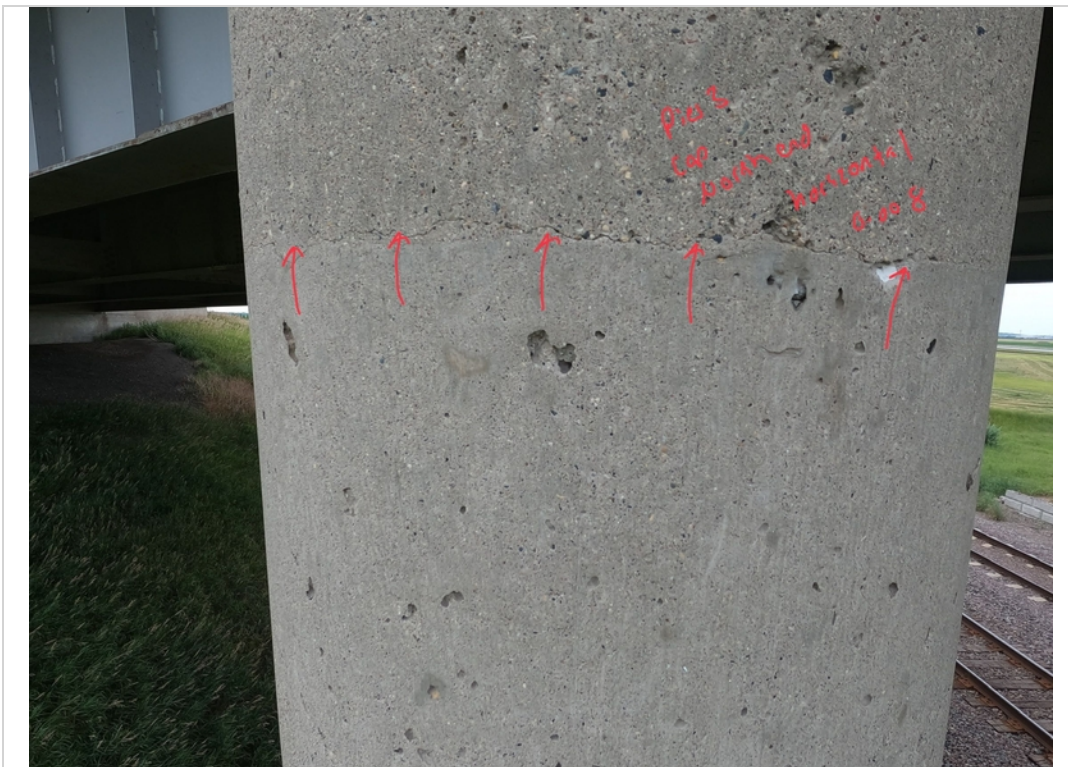
Facing South. Horizontal Crack to North End of Pier 3 Cap.

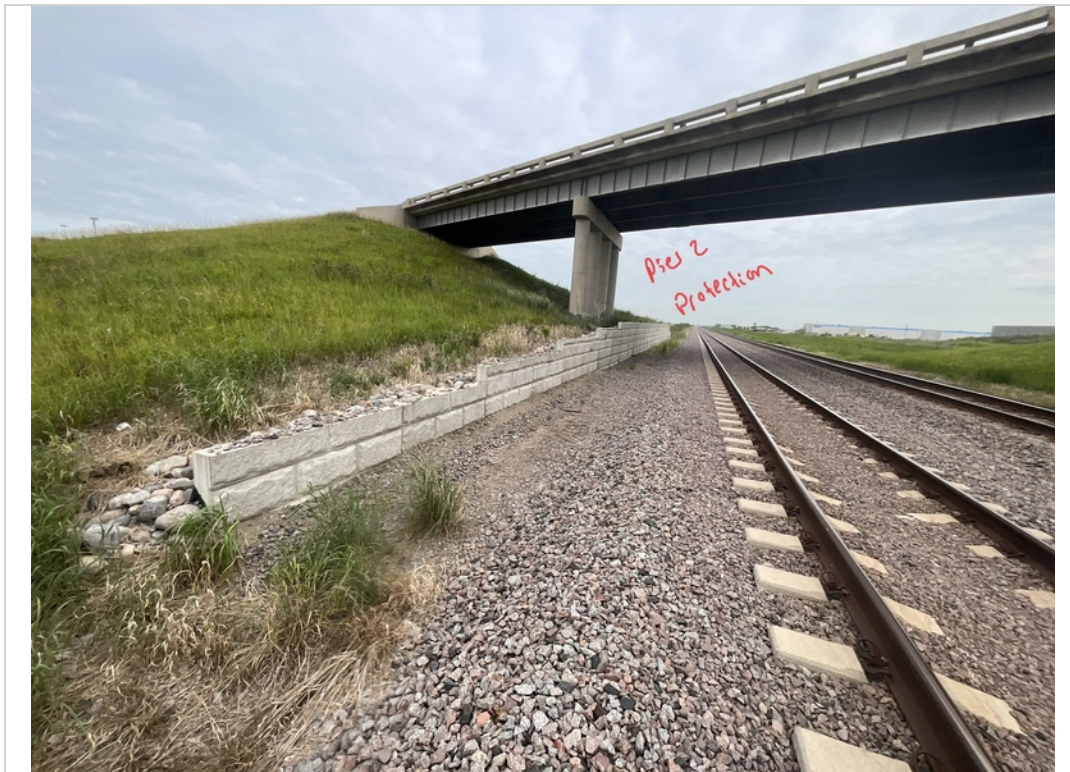
Facing North. Pier 2 Protection.
