IDENTIFICATION	
(1) State Names	38 - North Dakota
(8) Structure Number	0029-069.374 N
(5) Inventory Route	1
(2) Highway Agency District	8 - Fargo
(3) County Code	9 - Cass

(4) Place Code	25700
(6) Features Intersected	BNRR
(7) Facility Carried	COUNTY HIGHWAY
(9) Location	EAST OF NO. FARGO INTCHG
(11) Mile Point	0.1 mi
(12) Base Highway Network	No

INSPECTIONS *			
(90) Inspection Date	07/17/2023		
(91) Frequency	24		
(92) Critical Feature Inspection	Done	Freq. (Mon)	Date
A: Fracture Critical Detail	No		
B: Underwater Inspection	No		
C: Other Special Inspection			
* The inspection date and frequency information in this box contains the current NBI date and frequency information. Please refer to the report header for the date this inspection was conducted.

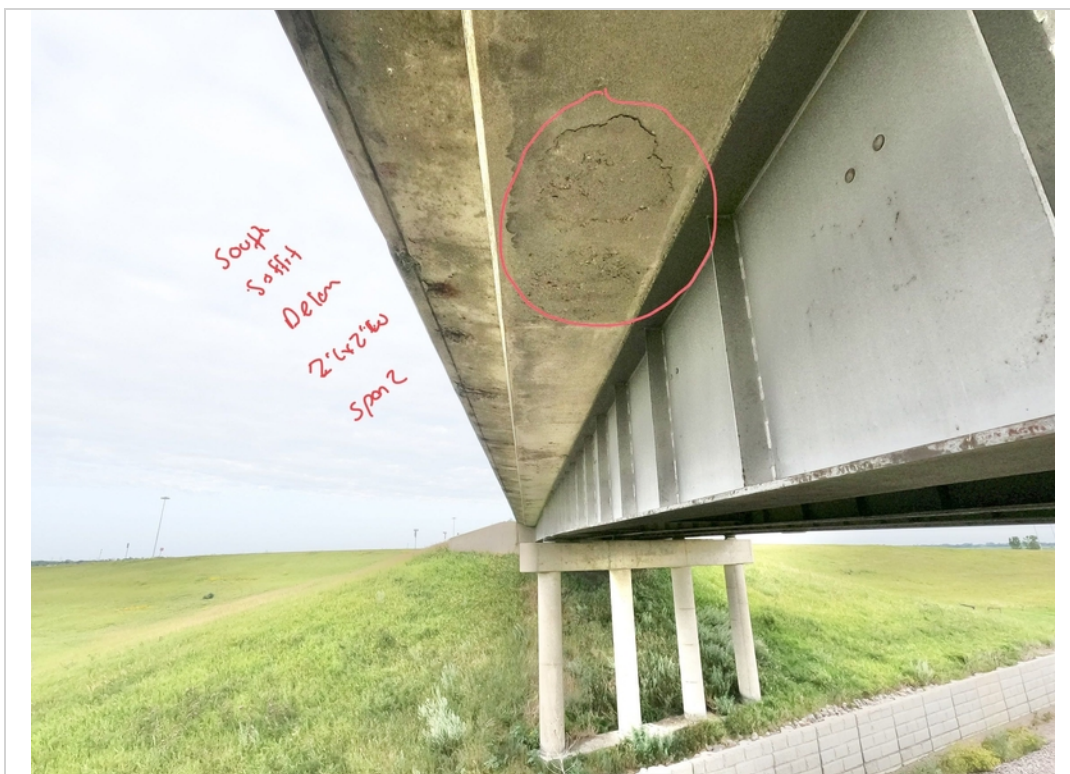
Facing West. Delamination to South Soffit in Span 2.

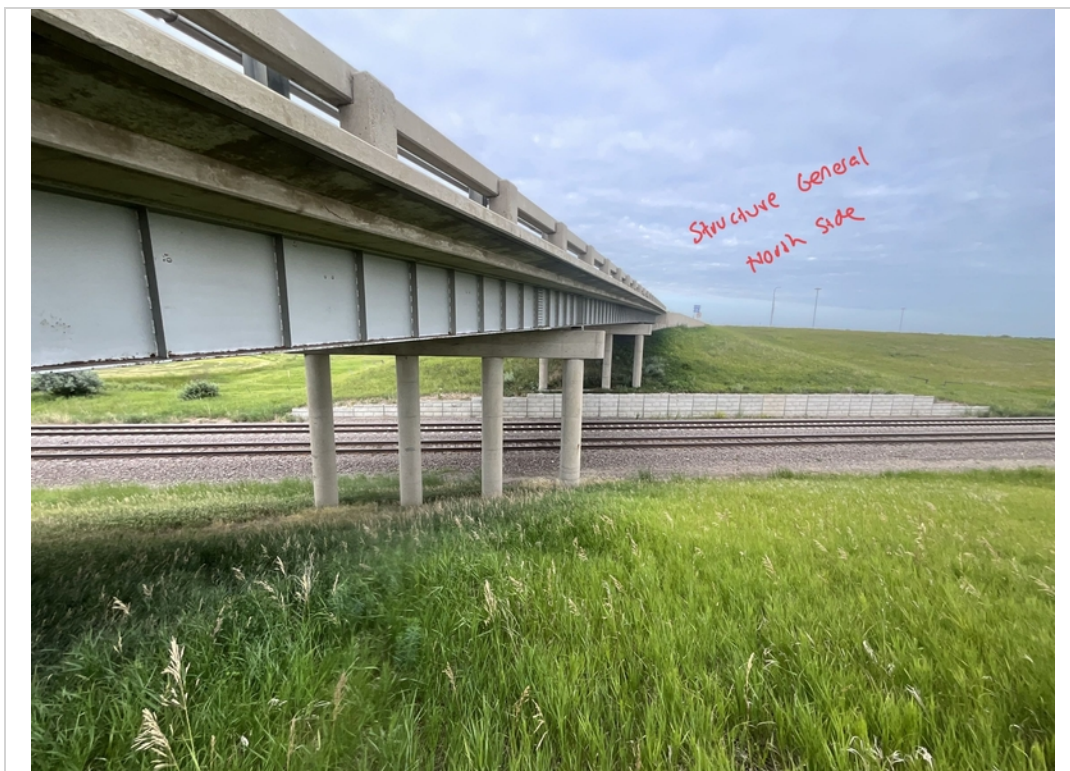
Facing West. Structure General along North Side.

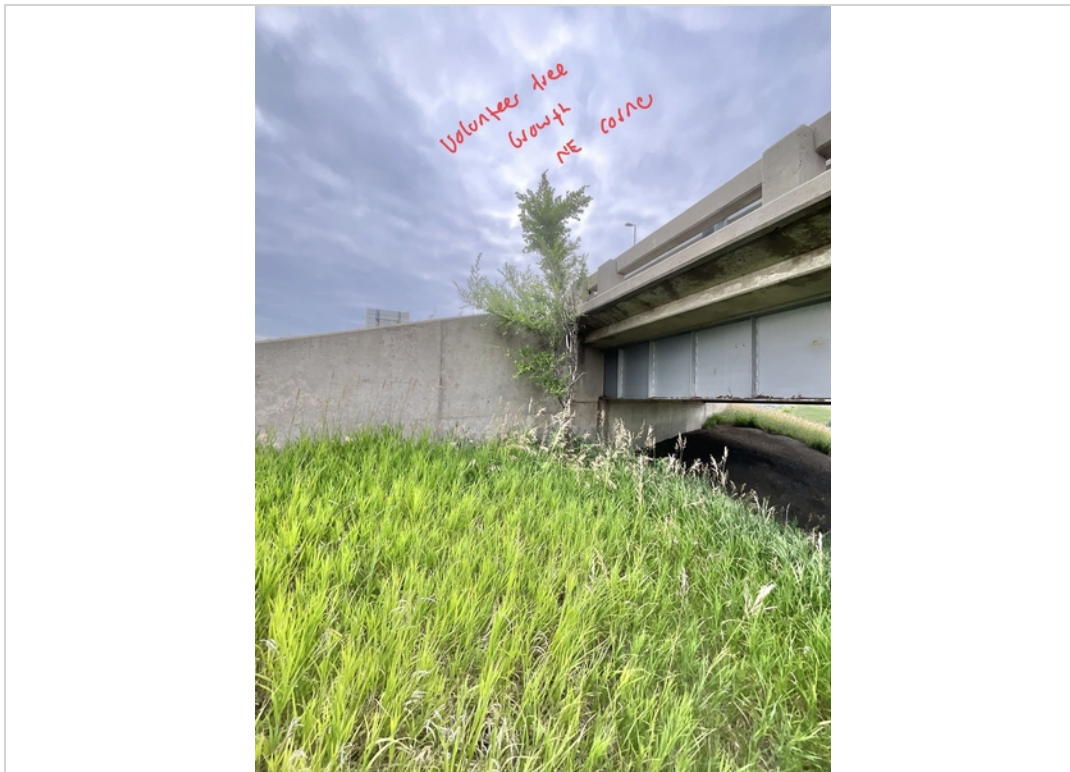
Facing NE. Volunteer Tree Growth NE Corner.

Recommendation to remove tree. See Photo.

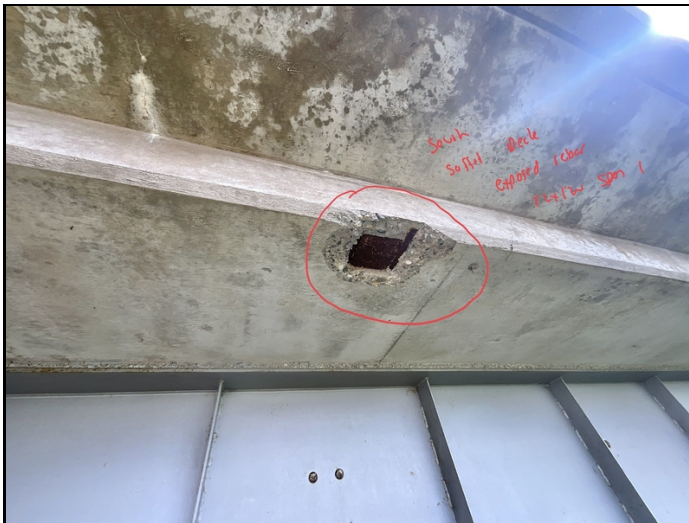
Areas of Spalling, Delamination, and Rust Staining to South Edge of Deck and South Curb Soffit throughout Spans 1 to 3.

Facing South and Upwards. Exposed Rebar to South Deck Soffit in Span 1.

Recommendation to remove delaminated Concrete and patch area. See Photo.

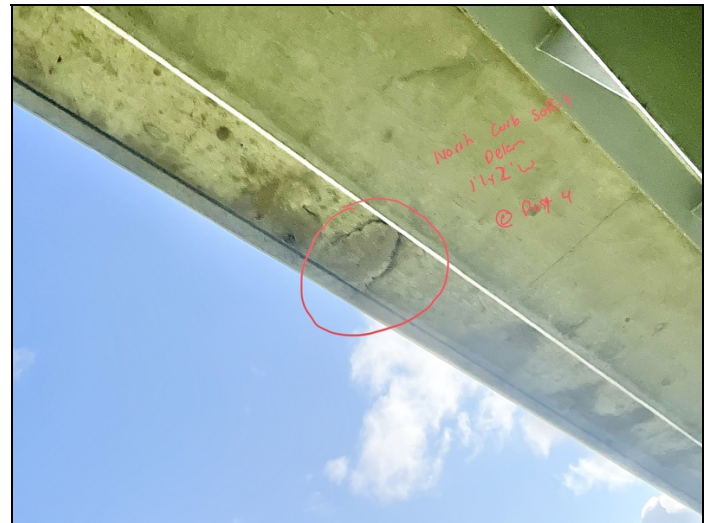
Facing NW and Upwards. Delamination to North curb Soffit in Span 1.

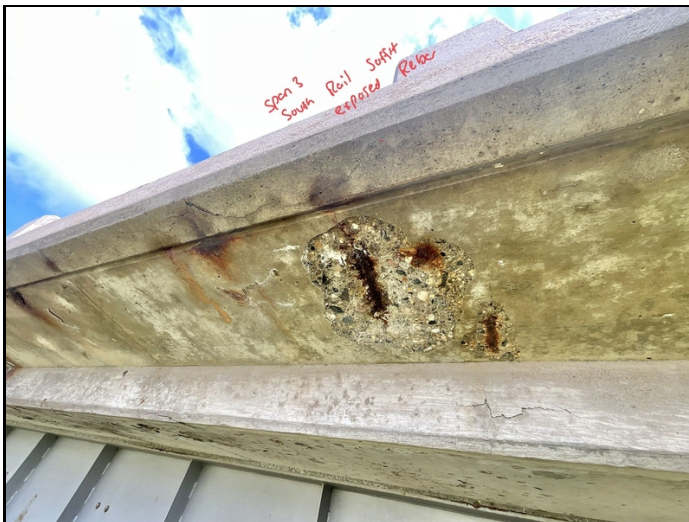
Facing NW and Upwards. South Curb Soffit Exposed Rebar in Span 3.

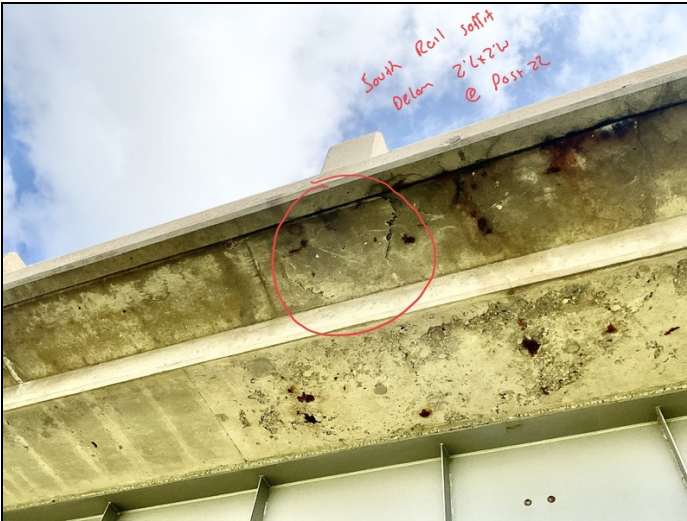
Facing NW and Upwards. Delamination to South Railing Soffit at Post 22.

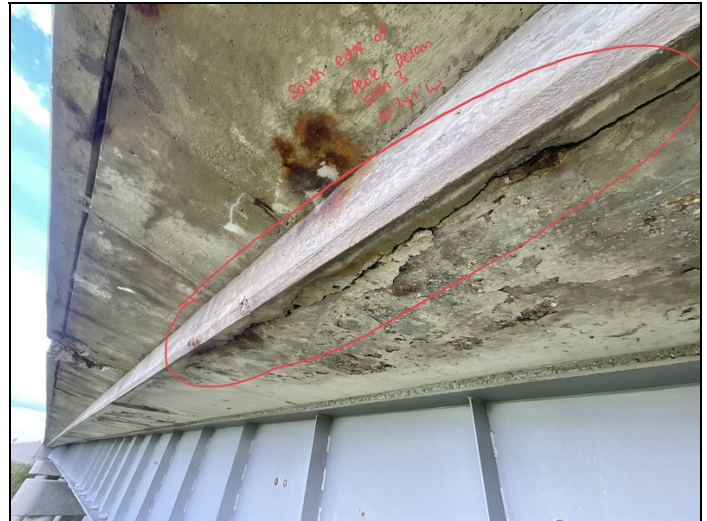
Facing NW. Moderate area of Cracking with Delamination to South Edge of Deck near East End.

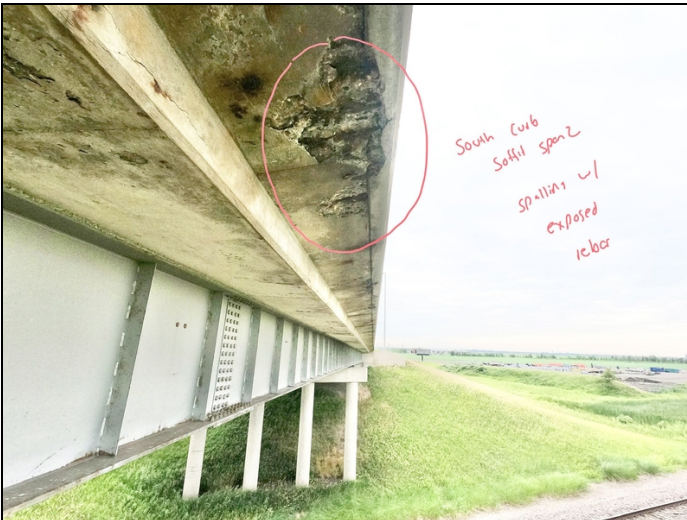
Facing East and Upwards. South Curb Soffit with Spalling and Exposed Rebar in Span 2.

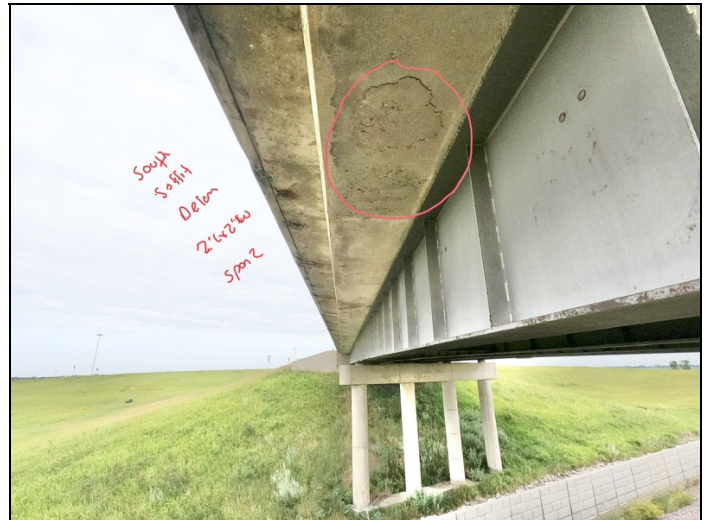
Facing West. Delamination to South Soffit in Span 2.

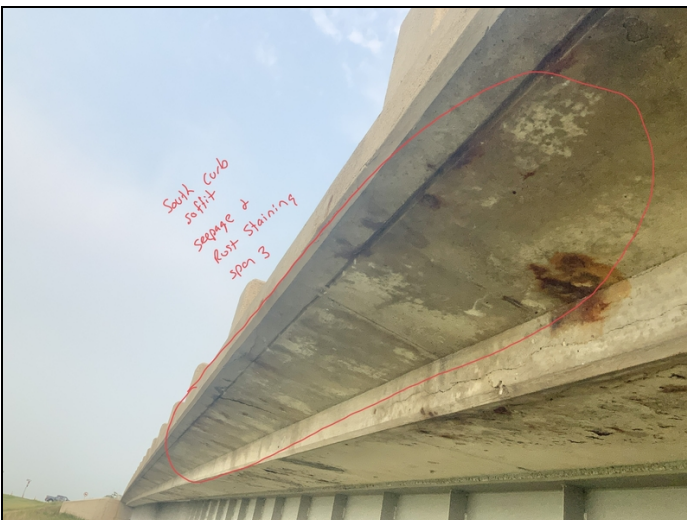
Facing West. Areas of Seepage and Rusting staining to underside South Curb in Span 3.

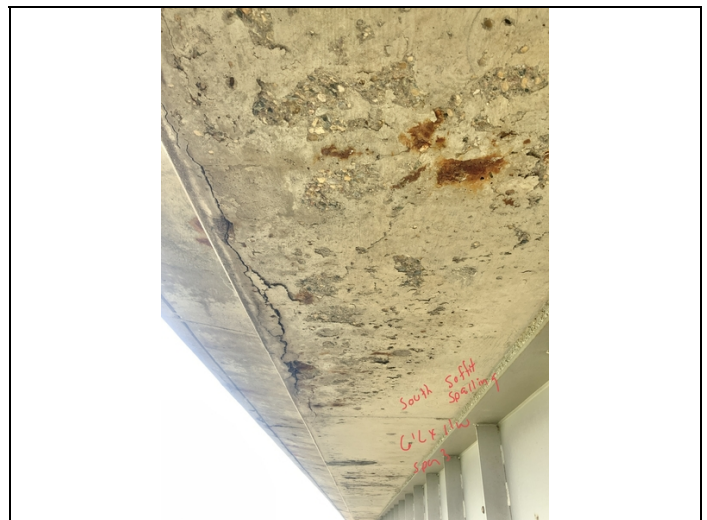
Facing West. Areas of Spalling along South Edge of Deck in span 3.

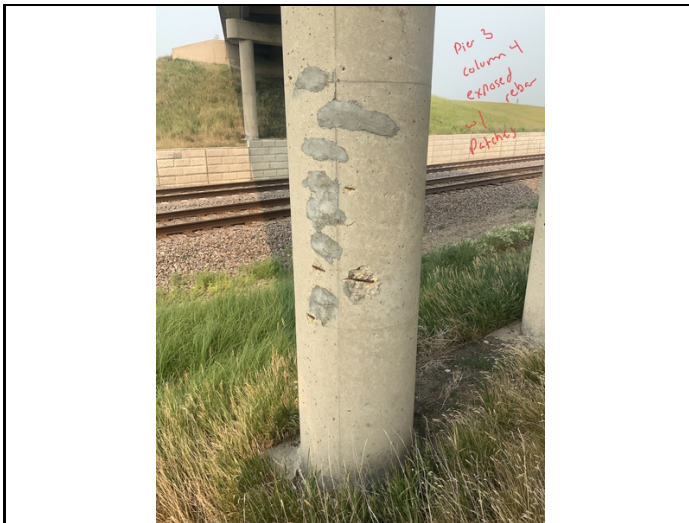
Facing NW. Exposed Rebar to Pier 3 Column 4.

Recommendation to remove any concrete, clean rebar and perform patch repairs to Column. See Photos.

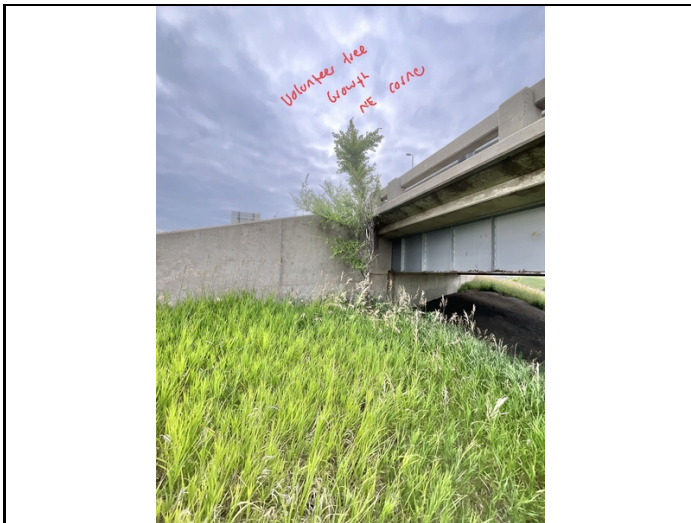
Facing NE. Volunteer Tree Growth NE Corner.

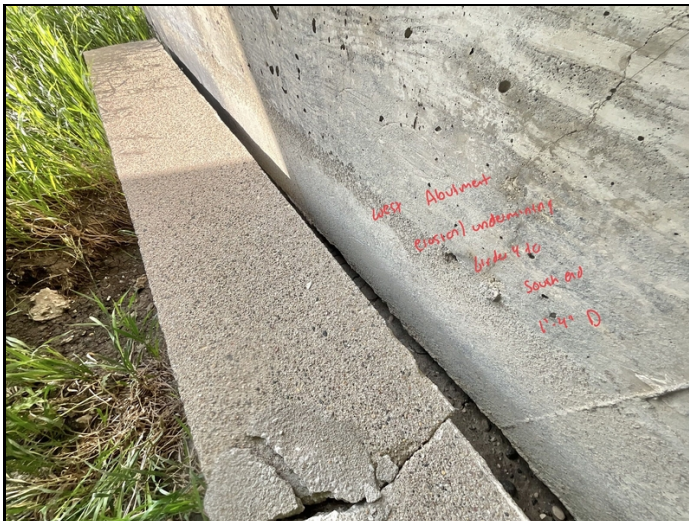
Facing SW and Downward. Erosion and Undermining along West Abutment South End.

Recommendation to provide fill and grade along both Abutments and Pier 2 Cap Footing. See Photos.

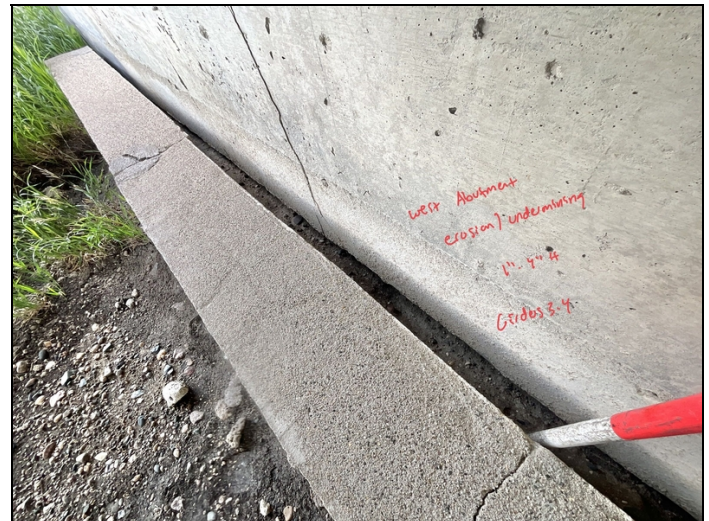
Facing SW and Downward. Continued Erosion along West Abutment from Girders 3 to 4.

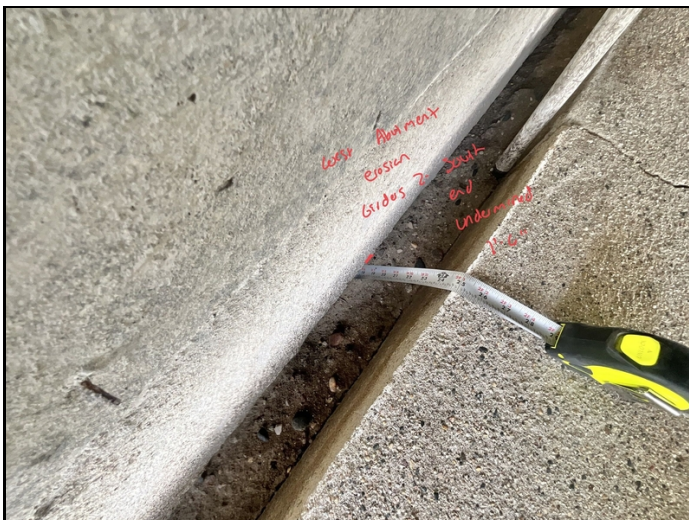
Facing NW and Downward. Erosion and Undermining Depth to West Abutment.

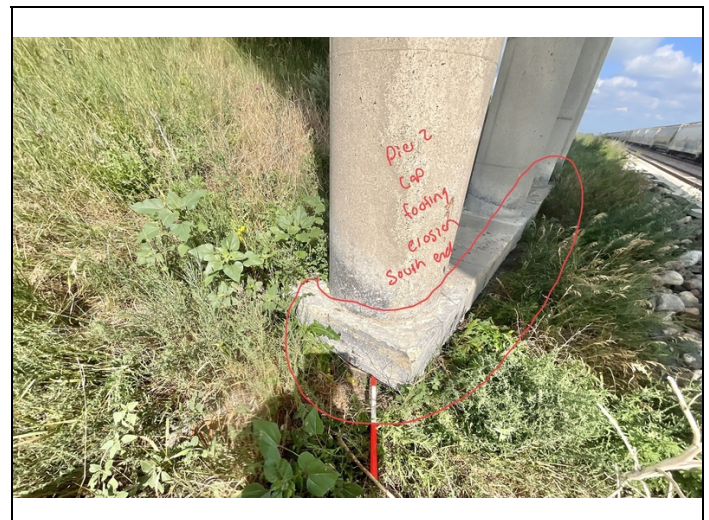
Facing NW and Downward. Erosion and Undermining area along Pier 2 Cap Footing South End.

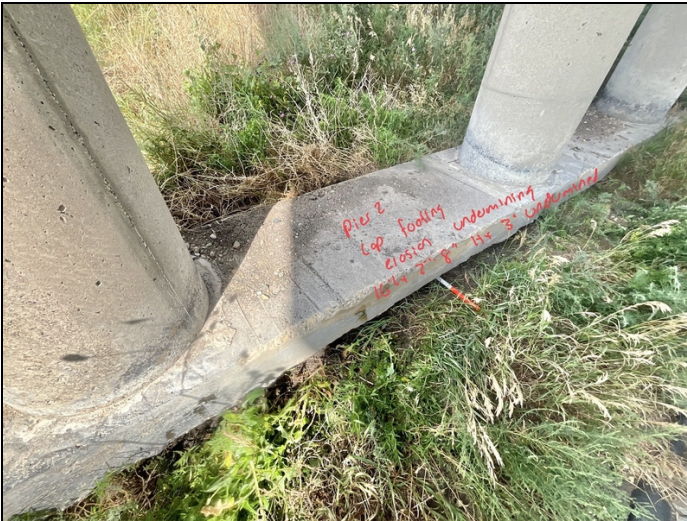
Facing NW and Downward. Continued Erosion and Undermining to Pier 2 Cap Footing in-between Columns 3 and 4.

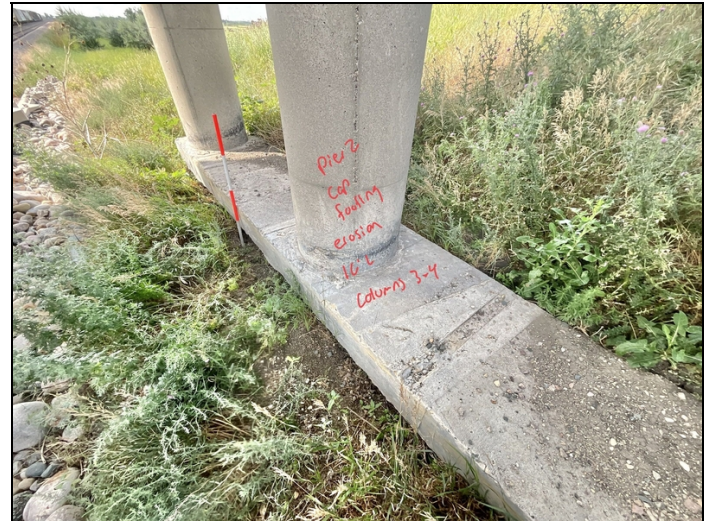
Facing SW. Erosion area along Pier 2 Cap Footing from Columns 3 to 4.

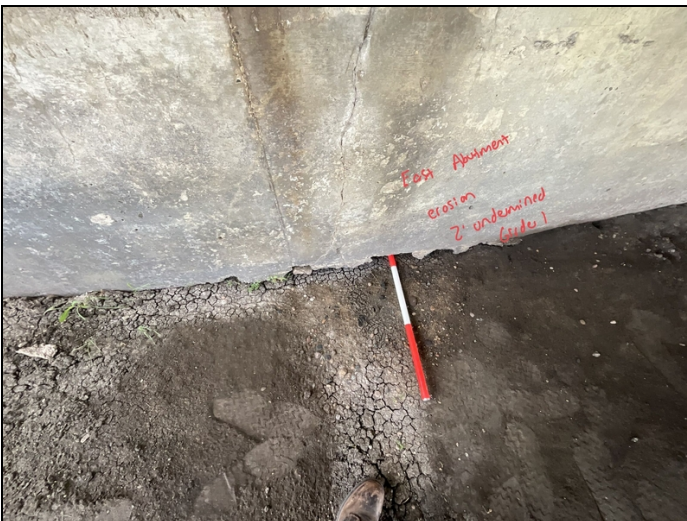
Facing East and Downward. Erosion and Undermining to East Abutment in-between Girders 1 and 2.

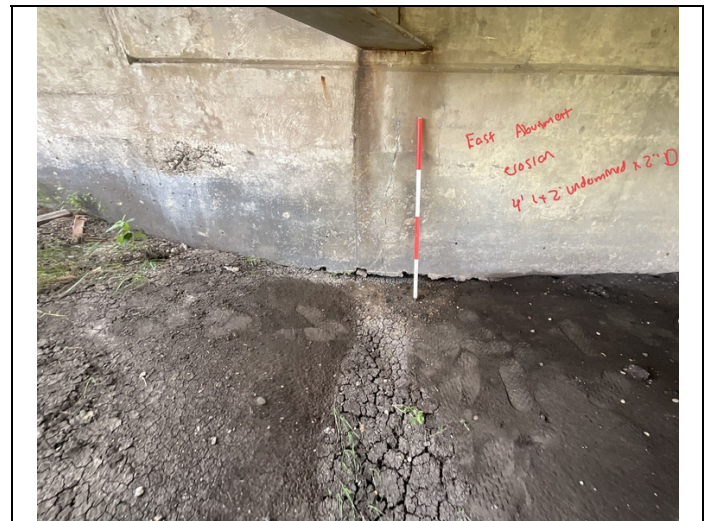
Facing East. General area of Erosion along East Embankment Slope in-between Girders 1 and 2.

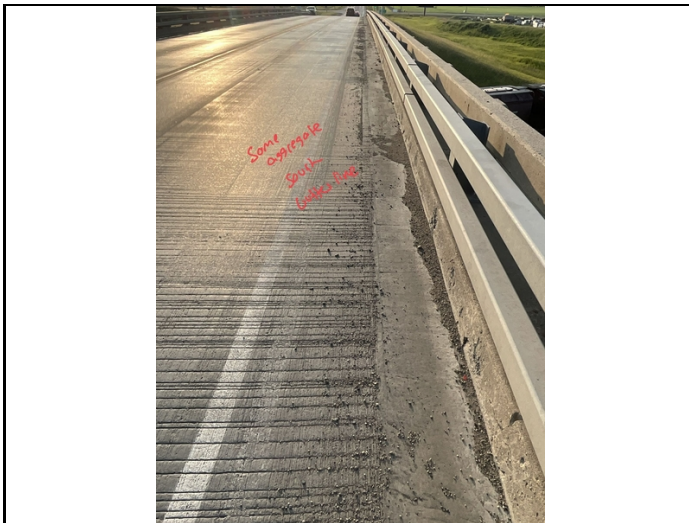
Facing East and Downward. Aggregate along South Gutter Line.

Recommendation to Sweep and clean out deck along Gutterlines. See Photos.

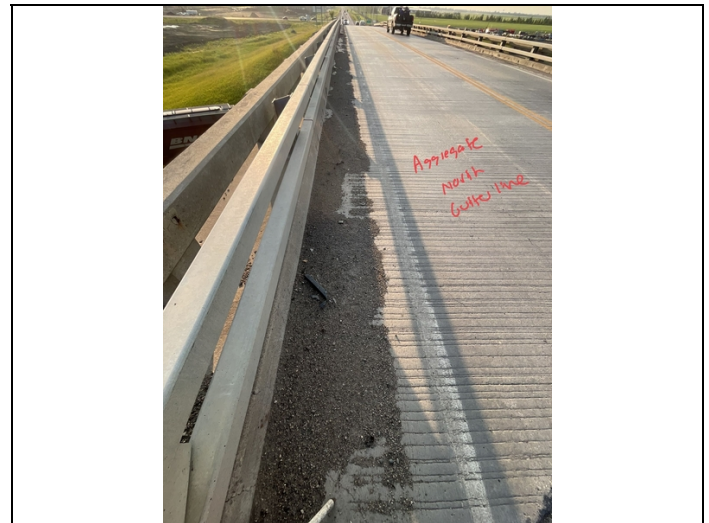
Facing East and Downward. Aggregate along North Gutter Line.

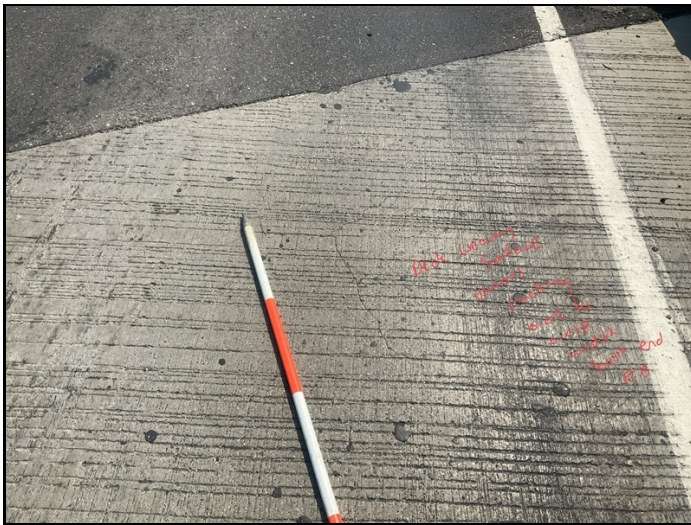
All cracking to Deck Wearing Surface are unsealed. Most of the Cracks are in the WB Lane.

Facing East and Downward. Various cracking to Deck Wearing Surface in the EB Lane near East End.

Recommendation to apply appropriate sealant to cracking per the Maintenance Manual. See Photos.

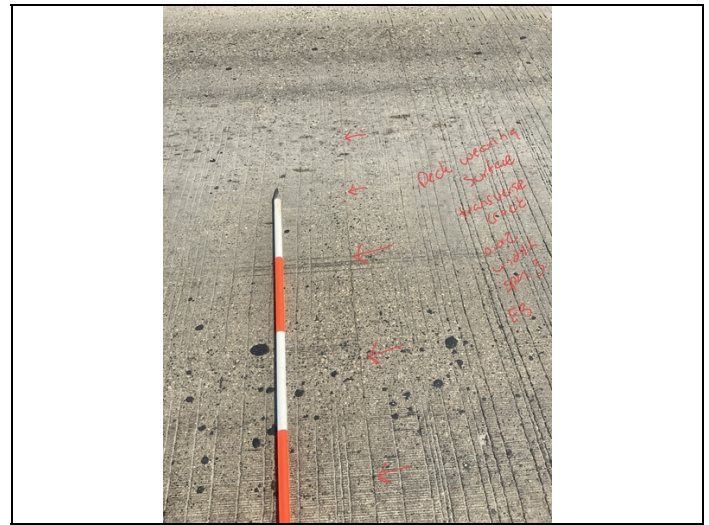
Facing North and Downward. Transverse crack to Deck Wearing Surface in Span 3 of the EB Lane.

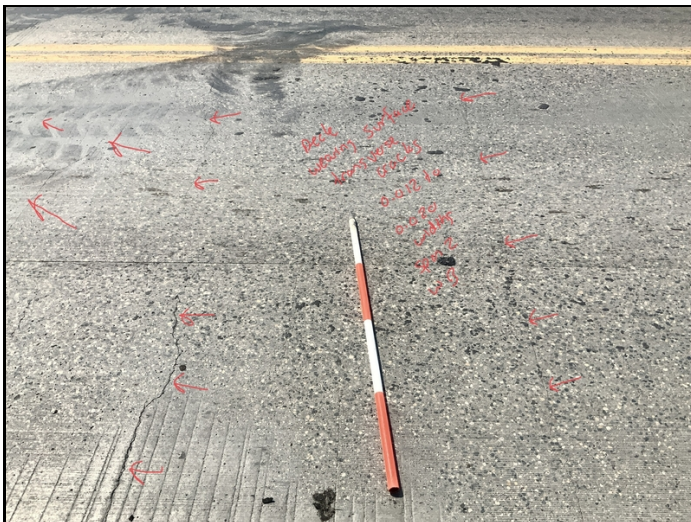
Facing South and Downward. Transverse cracking to Deck Wearing Surface in the WB Lane of Span 2.

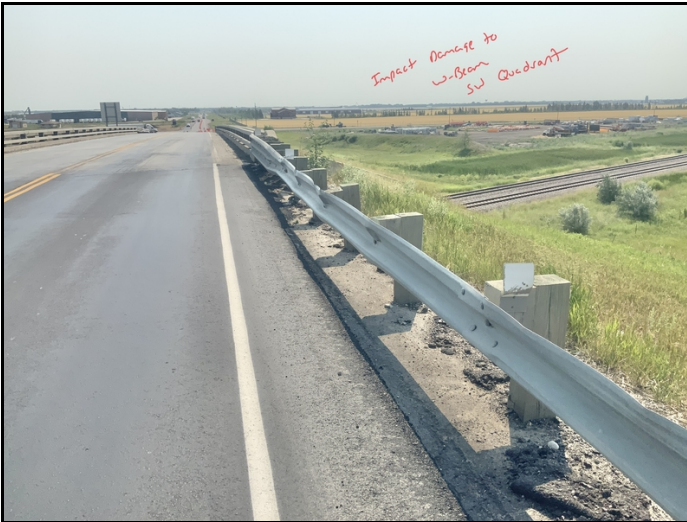
Vehicle Impact to W-Beam with the SW and NE Quadrants with a broken wood post in the NE Quadrant.
2 Cracked Wood Posts within SW Quadrant behind Thrie Beam.

Facing East. Vehicle Impact to W-Beam within SW Quadrant.

Recommendation to remove and replace sections of W-Beam in the SW and NE Quadrants along with the cracked wood posts. See Photos.

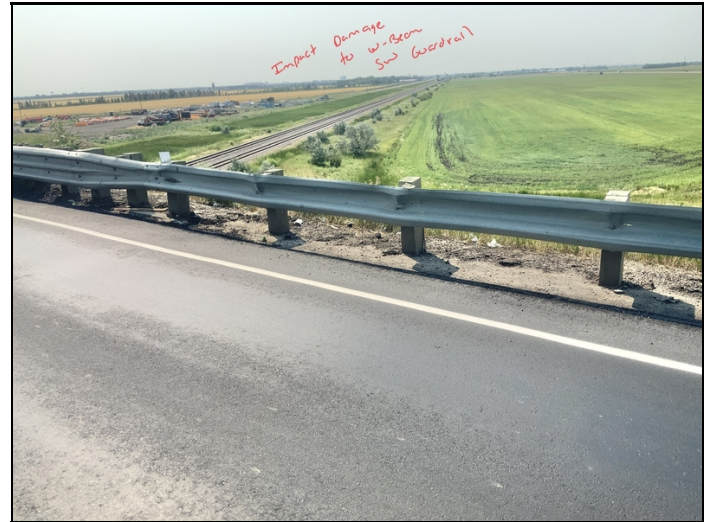
Facing SE. Another View of the Vehicle Impact to the W-Beam with the SW Quadrant.

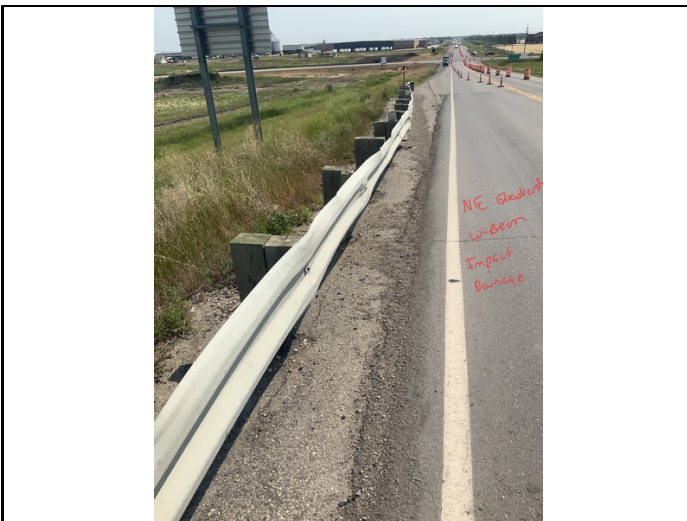
Facing East. Guardrail impact Damage to W-Beam within the NE Quadrant.

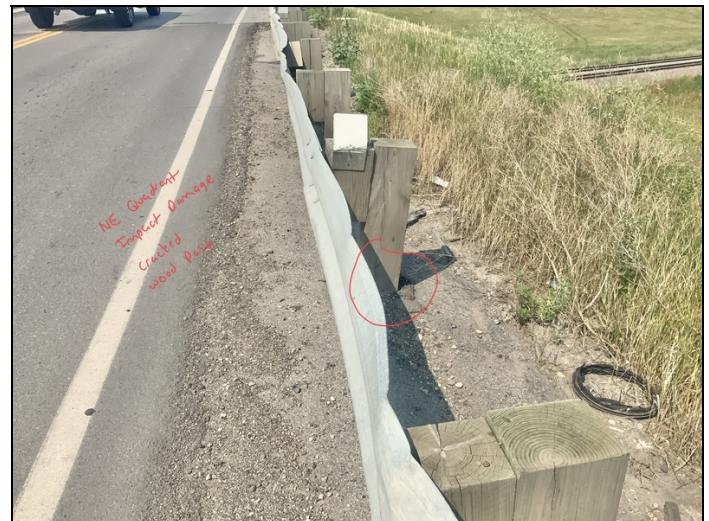
Facing West. Vehicle Impact Damage with cracked wood post within NE Quadrant.
